Fireside Corrosion of Heat Exchanger Materials for Advanced Solid Fuel Fired Power Plants

Stefano Mori¹ · Andy Pidcock¹ · Joy Sumner¹ · Nigel Simms¹ · John Oakey¹

Abstract

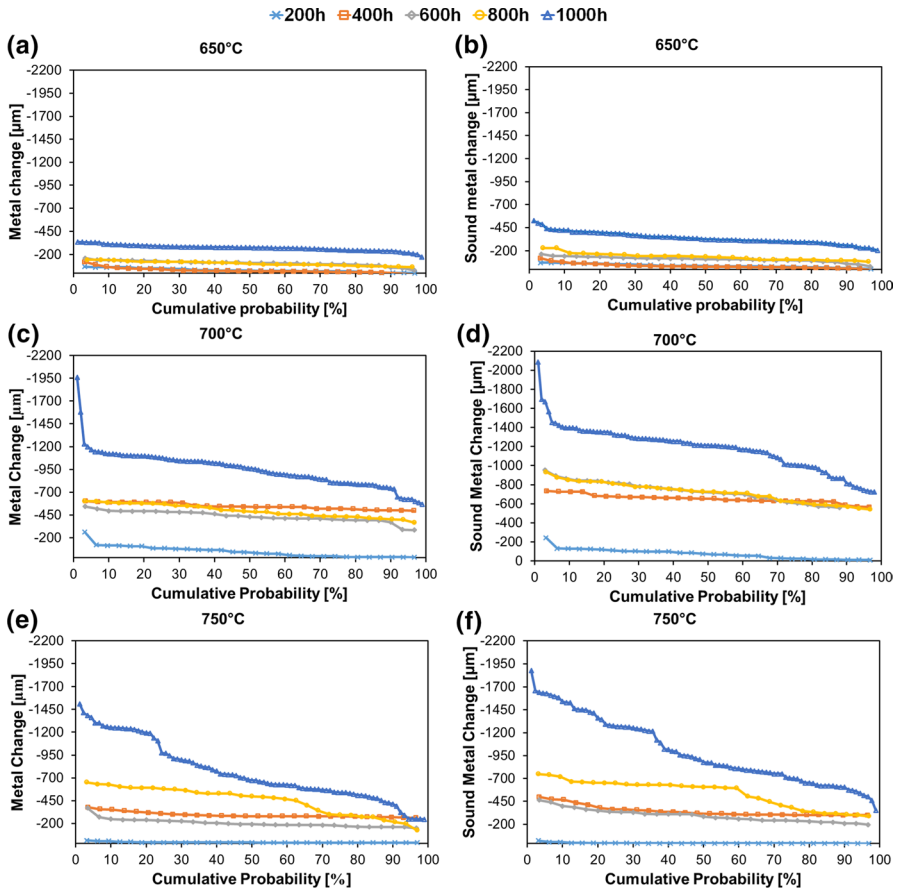
Fig. 4 Fireside corrosion-induced metal change and sound metal change for Sanicro 25 at the three different temperatures and exposure times; **a, c, e** show metal change for 650 °C, 700 °C and 750 °C, respectively, while **b, d, f** sound metal change for 650 °C, 700 °C and 750 °C, respectively (Color figure online)

For Sanicro 25 at 650 °C (Fig. 4a, b), it can be seen that, until 600 h exposure, relatively low damage is present on the samples. The median metal change for 200 h and 400 h exposures is, respectively, $-26 \mu\text{m}$ and $-20 \mu\text{m}$, while the median sound metal changes are $-37 \mu\text{m}$ and $-27 \mu\text{m}$. These values suggest little metal loss or internal damage on the deposit coated sides of the samples. Between 600 and 800 h, there is a significant increase in the fireside corrosion damage, with a metal change of $-109 \mu\text{m}$ and $-102 \mu\text{m}$, respectively. The median metal change at 800 h is 4 times higher than the damage observed at 200 h and at 400 h. The sound metal change (Fig. 4b) shows a median value of $-110 \mu\text{m}$ by 600 h and $-137 \mu\text{m}$ by 800 h (Fig. 4a, b). The amount of median damage observed after 1000 h exposure is $-275 \mu\text{m}$ for metal change and $-325 \mu\text{m}$ for sound metal change. The curves in

Fig. 4a, b suggest that, at this temperature, the alloy is not into the incubation stage anymore, but with a low level of internal damage recorded, as indicated by the small or almost negligible difference between metal change and sound metal change values, which could indicate that the attack is not fully developed yet.

In Fig. 4c, d, the metal change and sound metal change, respectively, are shown for 700 °C. In the figures, it can be seen that the damage propagation for Sanicro 25 starts sooner (at 200 h and 400 h) than for the comparable samples exposed at 650 °C, where the increase in the damage was seen at 400 h-600 h. Sample exposed for 200 h shows a median metal change of $-34 \mu\text{m}$, while the samples exposed for 400 h showed a median metal change of $-540 \mu\text{m}$. Looking at the sound metal

change, a similar behaviour is observed, with a median value of $-68 \mu\text{m}$ recorded at 200 h and $-654 \mu\text{m}$ at 400 h. Similarly for 600 h and 800 h, median metal change of $-430 \mu\text{m}$ and $-485 \mu\text{m}$ can be observed and median sound metal change of $-725 \mu\text{m}$ and $-726 \mu\text{m}$. Looking at the samples after 1000 h, a median metal change of $-959 \mu\text{m}$ was observed and a sound metal change of median $-1212 \mu\text{m}$; an increase in absolute terms of 17 times compared to the sample exposed for 200 h. Compared to the amount of damage seen at 650°C (Fig. 4a, b), the alloys showed an increase in both metal change and sound metal change, suggesting that the alloy moved into the propagation stage. This includes the development of internal attack/damage, which continues to increase in extent with exposure time.

In Fig. 4e, f, the distribution of metal and sound metal change at 750°C is reported. From the figures, it can be observed that the amount of damage after the first 200 h exposure is low but increases after 400 h of exposure with median metal change of $-279 \mu\text{m}$ (which represent about half the amount of damage shown at 700°C , but is higher than the one at 650°C). At 600 h, the Sanicro 25 shows a similar median metal change ($-190 \mu\text{m}$) to that found at 400 h, but the spread of the values is higher than the one at 400 h, meaning a less homogenous distribution of the damage. A further increase in the amount of metal lost has been observed at 800 h. After 1000 h exposure, the distribution of the damage is less uniform around the surface of the metal, as can be seen in the cumulative probability plot, which shows a higher slope. The median value of the metal change increases to $-673 \mu\text{m}$. Similar observations can be made for sound metal change. The slope of the curves shown in Fig. 4f increases with the time; the increase is more evident after 800 h and 1000 h exposure. This is related with a less homogenous distribution of both, the surface recession and the internal damage, around the samples. Comparing this with the data for the 650 and 700°C samples (for the same alloy; Fig. 4), the amount of median change (both metal and sound metal) appears to be lower than at 700°C , and higher at 650°C , before dropping again at 750°C . This behaviour is consistent with moving across the corrosion peak.

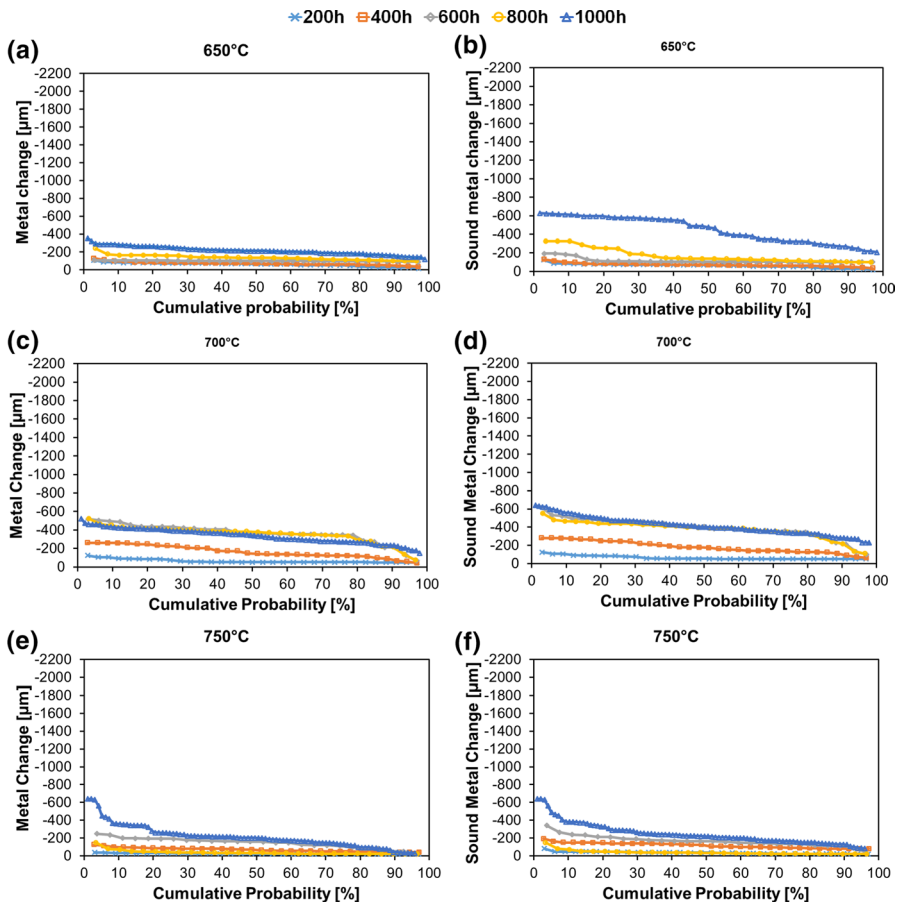
Fig. 5 Fireside corrosion-induced metal change and sound metal change for IN740 at the three different temperatures and exposure times: **a, c, e** show metal change for 650 °C, 700 °C and 750 °C, respectively, while **b, d, f** sound metal change for 650 °C, 700 °C and 750 °C, respectively (Color figure online)

In Fig. 5a, b, the data for metal and sound metal change at 650°C are shown. At an early stage of exposure (200 h), the alloy seems to suffer low damage (median metal change $-67 \mu\text{m}$), but still greater than Sanicro 25 (median $-26 \mu\text{m}$). Similar behaviour has been found after 400 h, with a median metal change of $-72 \mu\text{m}$ and small portion of the metal showing a higher damage. At these times of exposure, little presence of internal damage was observed. The amount of surface damage undergoes a small increase for both 600 h and 800 h exposure, with a median metal change of $-101 \mu\text{m}$ and $-137 \mu\text{m}$, respectively. For these exposure times as well, the amount of internal damage was small and only small portions of the samples experienced it, with a maximum value of the sound metal change

of $-125\ \mu\text{m}$, $-129\ \mu\text{m}$, $-194\ \mu\text{m}$ and $-326\ \mu\text{m}$, respectively, for 200 h, 400 h, 600 h and 800 h. An increase in damage was observed at 1000 h, where the median value of the metal change reached $-214\ \mu\text{m}$. The distribution of this damage seems to be relatively uniform around the sample; a small probability (below 10%) of finding damage above $300\ \mu\text{m}$ could be related to pitting. An increase in the sound metal change was observed as well (median sound metal change $-474\ \mu\text{m}$), but in this case the distribution plot shows a more uniform behaviour (shown by the lower slope of the curve). The difference between the metal change and sound metal change is due to the development of internal corrosion attack at this temperature ($650\ ^\circ\text{C}$).

Cumulative probability distributions of corrosion damage for the different times at $700\ ^\circ\text{C}$ exposure are shown in Fig. 5c, d. These distributions of metal damage are mostly even after all exposure times, with the exception of samples after 600 h and 800 h, where small fractions of the sample surfaces show lower damage with respect to the rest of the sample.

After 200 h exposure, the alloy shows a median metal change of $-52\ \mu\text{m}$ (and no internal damage), while after 400 h the material starts to show higher levels of damage, both from the surface and internally (median metal change $-142\ \mu\text{m}$, median sound metal change $-173\ \mu\text{m}$). At 800 h and 1000 h, the alloy shows similar median metal changes of $-376\ \mu\text{m}$ and $-338\ \mu\text{m}$, respectively. The amount of sound metal change show median values of $-389\ \mu\text{m}$ for 800 h and $-400\ \mu\text{m}$ for 1000 h. Comparing the median damage observed at $700\ ^\circ\text{C}$ (Fig. 5c, d) with the median damage recorded at $650\ ^\circ\text{C}$ (Fig. 5a, b), an increase in median metal change can be highlighted, before dropping again at $750\ ^\circ\text{C}$. This correlates with the typical bell-shaped curve for the corrosion damage, which depends on the chemistry of the environment as well as the alloy chemistry.

Lower damage (both metal and sound metal change) was recorded at $750\ ^\circ\text{C}$ than at $700\ ^\circ\text{C}$, as can be seen in Fig. 5e, f, for metal change and sound metal change, respectively. The amount of damage after 200 h exposure was below $-100\ \mu\text{m}$ (median metal change $-24\ \mu\text{m}$) which is lower than the median damage recorded at both $650\ ^\circ\text{C}$ and $700\ ^\circ\text{C}$. The distribution of the damage on the surface is mostly homogeneous at this exposure time. After 400 h exposure, there is an increase in the damage, with a median metal change of $-62\ \mu\text{m}$. The sound metal change distribution starts to increase compared to the metal change, with median values of $-35\ \mu\text{m}$ and $-108\ \mu\text{m}$ for 200 h and 400 h exposure, respectively. After 600 h exposure, a bigger increase in the damage was measured, with the damage increasing by about 6.5 times compared to the sample exposed for 200 h (median metal change $-157\ \mu\text{m}$). At this exposure time, small areas with higher levels of damage started to appear, as can be seen from the metal change distribution in Fig. 5e.

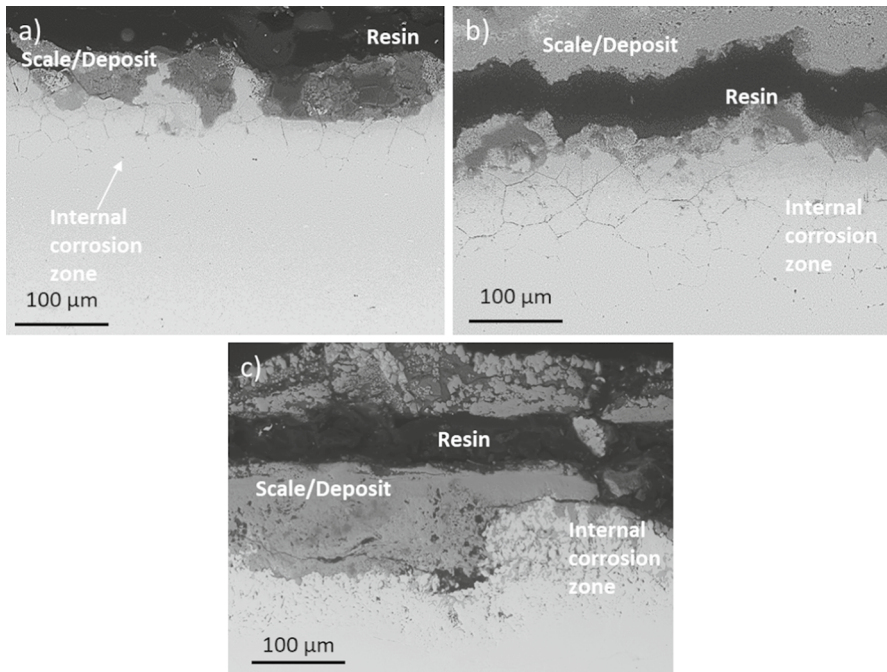
Fig. 7 SEM backscattered micrograph showing typical damage for Sanicro 25 at **a** 650 °C, **b** 700 °C, **c** 750 °C after 1000 h exposure. In the images, three regions can be clearly seen, scale/deposit, internal damage and alloy (brightest area). The black area is due to the resin used for the mounting

Samples for SEM/EDS were cross-sectioned and polished, but they were not etched to highlight the grain boundaries. In Fig. 7, SEM micrographs of the alloy Sanicro 25 are shown at the different exposure temperatures, after 1000 h. It has been chosen to report only cross sections after 1000 h exposure, to highlight clearly what happens to these alloys when they are in their propagation stages (i.e. information about the propagation rate). The typical morphologies of the three samples are different from each other. At 650 °C (Fig. 7a), the sample shows a relatively thin scale/deposit on it, which is in accordance with its low metal change data. On the other hand at 700 °C and 750 °C (Fig. 7b, c, respectively), thicker scale/deposit layers are present. For these latter two samples, the scale/deposit layers cannot entirely be shown on these micrographs, due to their thicknesses. The presence of these thicker

scale/deposit layers was in agreement with the increase in the median metal change recorded at 700 °C and 750 °C, compared to the sample exposed at 650 °C.

Another feature that can be seen is the different extent and morphology of the internal damage at the three different exposure temperature. At 650 °C and 700 °C (Fig. 7a, b), the deepest damage is shown to be intergranular corrosion; however, this is not seen at 750 °C. The sample at 700 °C also showed deeper internal damage than the sample exposed at 750 °C.

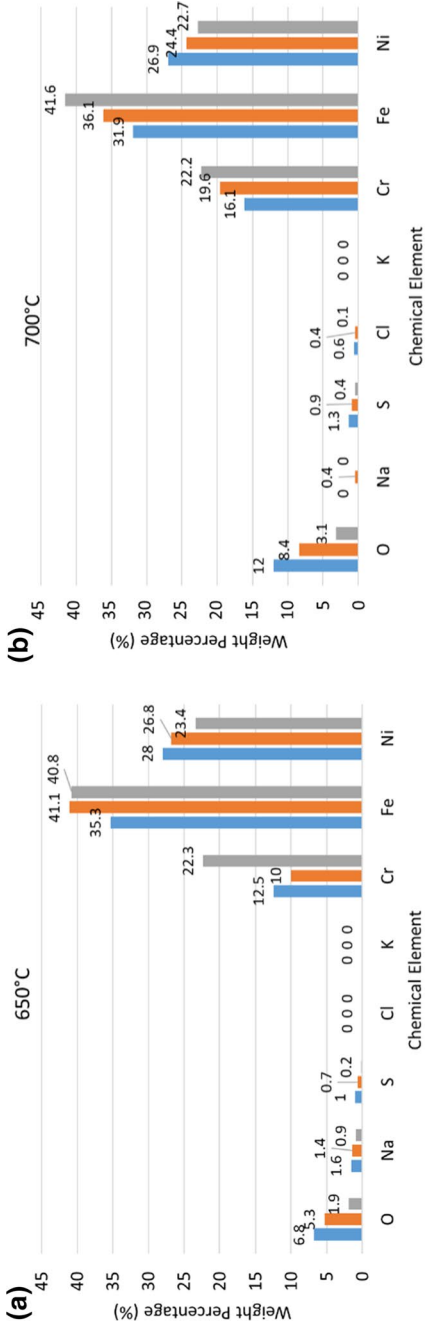
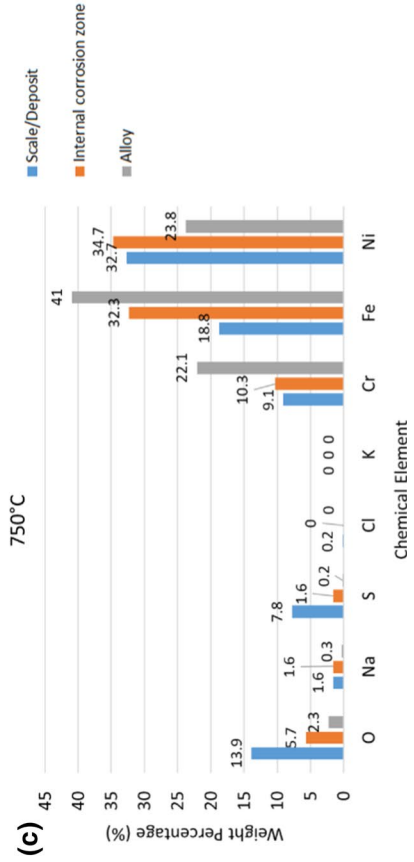
Fig. 8 EDS analyses for the Sanicro 25 at the three different temperatures; key elements only in scale/ deposit, internal corrosion zone and alloy (Fig. 7) (Color figure online) ►

The samples were analysed by EDS; the results of the analysis are shown in Fig. 8. For each sample, spectra were collected using area scans from three areas (i.e. scale/deposit, internal corrosion and underlying alloy). All the samples showed a variable range of compositions in the scale/deposit areas and internal corrosion zones. In the internal corrosion zones, there is a depletion of chromium, but the scales were enriched in chromium. This can be because the Cr diffuses into the scale from the internal corrosion zones; and the Cr-rich scale reacts with the deposit. The Cr depletion seems to be greater in percentage terms at 650 °C and 750 °C, where, in the depleted area, it was found that there was ~12 wt% decrease in Cr. At 700 °C the depleted areas showed a decrease in ~2 wt%. Sub-surface Cr depletion in Sanicro 25 has previously been observed and identified as an indication of selective oxidation to form Cr₂O₃ [26]. Iron and nickel were also found in the scale; the iron could either come from the alloy, or from the deposit itself.

In Sanicro 25, nickel shows a different behaviour compared to Cr. The amount of Ni increases (in percentage terms) on moving from the metal, to the internal corrosion zone and then into the scale/deposit. In all the samples, a diffusion of sulphur can be seen going from both the gaseous atmosphere and the scale/deposit, into the internal corrosion zones. The amount of S in the scale/deposit of the samples increases with temperature, going from 1 wt% at 650 °C to 7.8 wt% at 750 °C (Fig. 8). In the same way, the depth of the diffusion (i.e. internal corrosion zone) seems to be higher at 750 °C. The composition of the samples return to the same values as the unexposed samples (see Fig. 8 and Table 1). The width of the internal corrosion zone shows a peak at 700 °C, in accordance with the internal corrosion data that is included in the sound metal change data (compare Figs. 4, 7 and 8). In this sample, the extension of the internal corrosion zone is about 300 µm; three times higher than at the other two temperatures (Fig. 7). From Fig. 8 can also be seen the presence of Cl at 700 °C, which could have contributed to the increase of the corrosion damage, this has been already reported in literature [36]. The presence of Na has been found as well, only at 650 °C and 750 °C, while K has not been seen in any of the temperatures. That could be due to the spallation of the deposit or the deposit reacting with the gaseous environment.

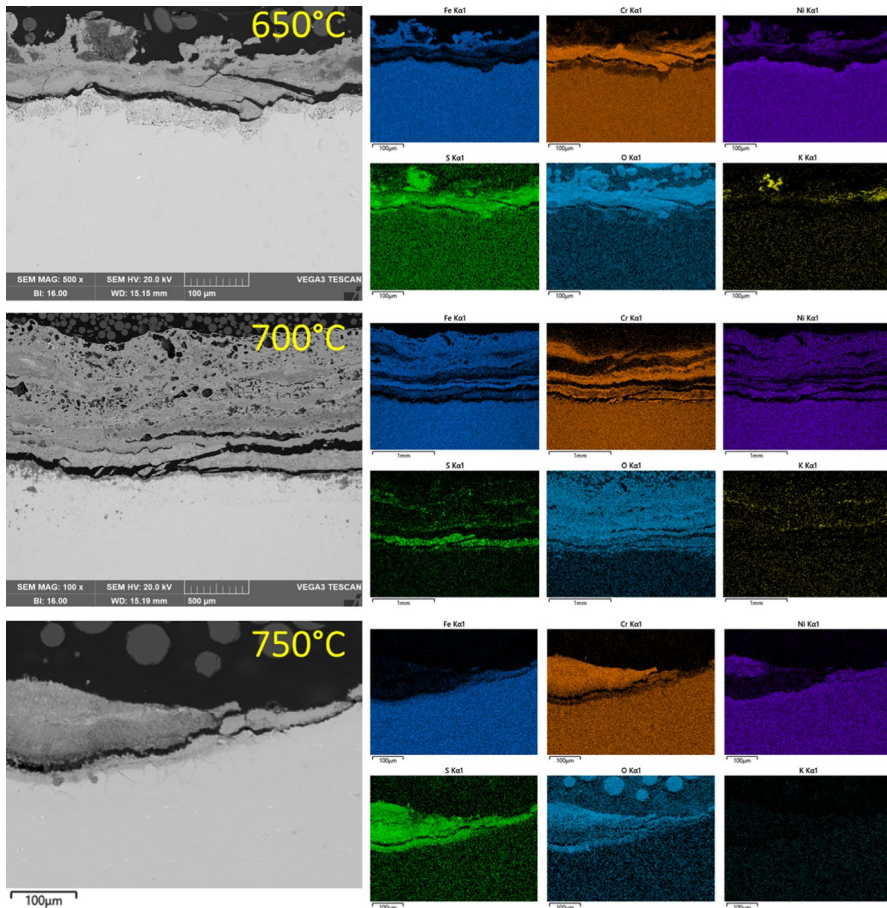
Fig. 9 SEM backscattered images and EDS maps analyses for the Sanicro 25 at three different exposure temperatures after 1000 h. The image for the sample exposed at 700 °C has been taken at lower magnitude, to allow a complete scan of the scale/deposit region (Color figure online)

In Fig. 9, EDS maps of the Sanicro 25 samples exposed at the three temperature are shown. It is worth noticing that the sample exposed at 700 °C required acquisition at lower magnitude, due to the thickness of the the scale/deposit region. In all cases, the scale/deposit region appears detached from the metal surface, but a difference in morphology in the three case can be seen. This might be responsible of the damage recorded for Sanicro 25 (see median metal and sound metal change in Fig. 6). Looking at the morphologies, it can be noticed that the scale/deposit region for the sample exposed at 700 °C appears more porous and less dense than that

observed at the other temperatures. This could be due to the interactions between the substrate, gas and deposit, which results in the most aggressive fluxing of protective scales at this temperature, and hence a less protective scale. This would have given rise to the higher metal and sound metal change observed at this temperature (see Fig. 6). Furthermore, the scale/deposit appears to be composed of a thick outer layer of an Fe-rich porous oxide layer, which is expected to give lower protection from corrosion than a Cr-rich oxide layer [37]. On the other hand, for both higher and lower temperatures (650 °C and 750 °C, Fig. 9), a compact Cr-rich oxide has been found, just above the Sanicro 25 surface. Cr-rich scale is usually responsible of enhanced corrosion protection. As the sulphate deposits first increase in reaction rate with temperature, and then destabilise, their ability to inhibit the formation of the protective Cr-rich scale will peak, here showing the most aggressive resonance at 700 °C, as already reported [21], this destabilisation is due to the change in ratio between SO_3/SO_2 . At lower temperature, the amount of SO_3 is higher, leading to a more stable deposit on the surface. On the other hand at higher temperatures, the amount of SO_2 can be found, which is responsible of the deposit destabilisation. The crossover between the two behaviours is around 700 °C, which give rise to the bell-shaped curve peaked around 700 °C observed. The change in the deposit could explain the lower metal and sound metal changes observed for Sanicro 25 at both, 650 °C and 750 °C (see Fig. 6). It is important to notice the presence of S in the scale/deposit region in all of the Sanicro 25 samples. This could come from the deposit used (which was composed of sulphates) and/or the moreover SO_2 present in the gaseous environment.

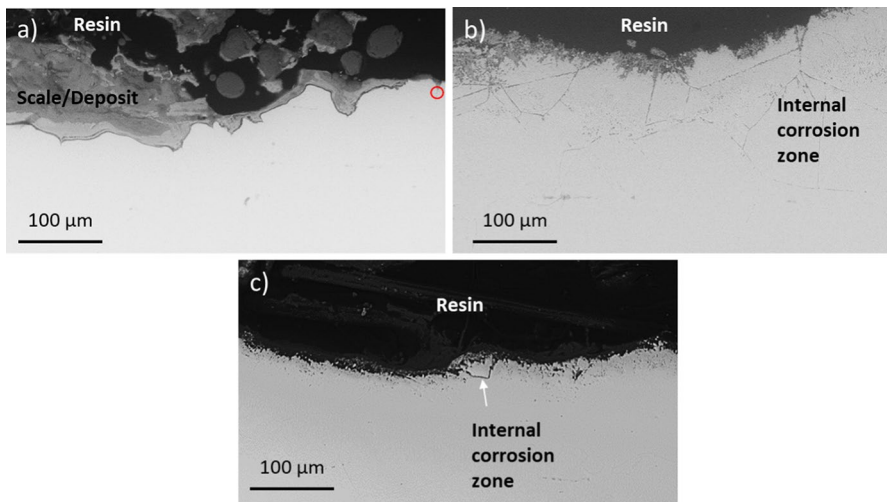
Fig. 10 SEM backscattered micrographs showing typical damage for IN740 at **a** 650 °C, **b** 700 °C and **c** 750 °C. In picture (a) the red circle shows the internal damage (Color figure online)

In Fig. 10a–c, typical images of IN740 samples exposed for 1000 h at 650 °C, 700 °C and 750 °C, respectively, are shown. From these images, different damage morphologies can be seen. The 650 °C image shows also presence of a large pit-like damage morphology, with further damage at the bottom of the peak spreading further into the metal (Fig. 10a).

The image in Fig. 10b shows the presence of internal damage areas, in particular, of grain boundary attack, even if a thick scale was not observed across the whole sample's exposed surface. The morphology of the metal surface looks irregular. This is reflected in the dimensional metrology, where the amount of metal change initially increased with the temperature. In the sample at 750 °C (Fig. 10c), the amount of internal damage shown is almost negligible. This feature was inline with the dimensional metrology data, where small amounts of internal damage were only observed in small areas.

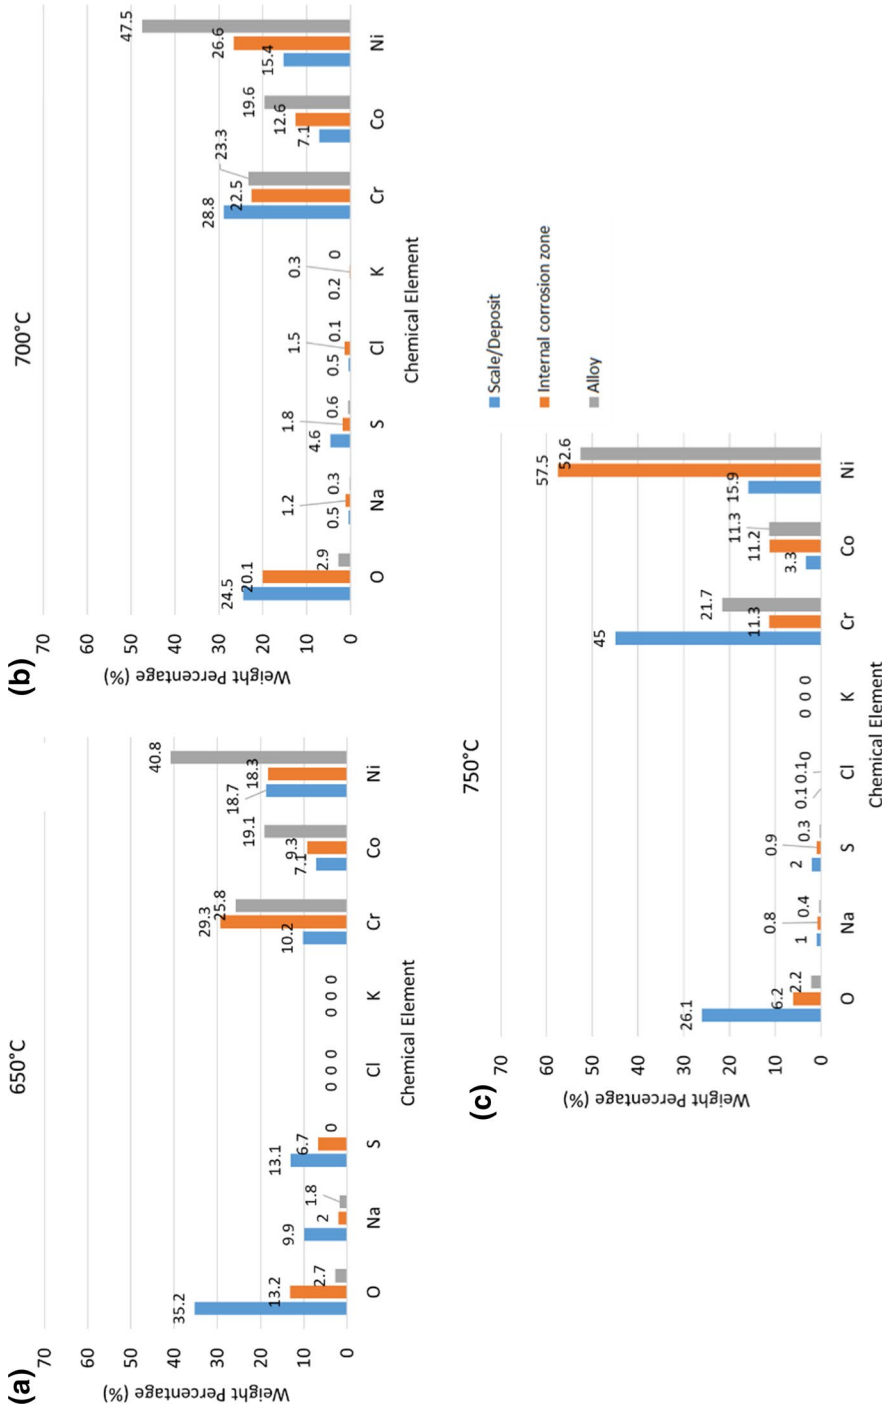
Fig. 11 EDS analyses for the IN740 at the three different temperatures; key elements only in scale/deposit, internal corrosion zone and alloy (Fig. 10) (Color figure online)

As for Sanicro 25, the EDS data obtained from IN740 samples indicated a wide range of compositions in the scale/deposit and internal corrosion zones. Looking at the EDS data presented in Fig. 11, differences in compositions are shown. In all cases, the scale/deposit area is composed of mainly chromium and oxygen, which are also present in large quantities in the internal corrosion zone. On the other hand, diffusion towards the alloy of contaminant elements, such as S, has been also detected. The behaviour of the nickel alloy differs from the stainless steel one; an internal

corrosion zone is not clearly visible in the sample exposed at 650 °C (Fig. 10a), but from the data shown in Fig. 11, a difference in concentration of nickel, chromium and cobalt has been observed. The area at the interface between scale/deposit and alloy seems to be enriched in Cr, while is depleted in Ni and Co. Data in Fig. 11, linked to Fig. 10b, c, show that at 700 °C and 750 °C the alloy shows an internal corrosion zone. In such area, a change in composition has been observed. The scale/deposit seems to be rich in chromium, and the content then decreases in the internal corrosion zone.

Different behaviour has been observed for the nickel and cobalt. The content of those element decreases from the alloy through the internal corrosion zone reaching a minimum in the scale/deposit area. The sample exposed at 700 °C showed a composition close to the undamaged one after about 200 μm (compare Table 1 with

Figs. 10 and 11). In contrast, the sample at 750 °C the concentration of Cr and Co observed was below the typical value of the alloy (compare Fig. 11 with Table 1), especially for cobalt, that was observed in 11% weight rather than 20%. This could be due to a bigger extension of the damaged area, even if the pictures do not show clear evidences of corrosive attack below the internal corrosion zone. Looking at the contaminants' concentrations, a more extensive sulphur presence was found in the sample exposed at 700 °C; this is reflected in the data collected by dimensional metrology, where the peak in metal change damage is shown at a temperature of 700 °C for IN740 (Fig. 6).

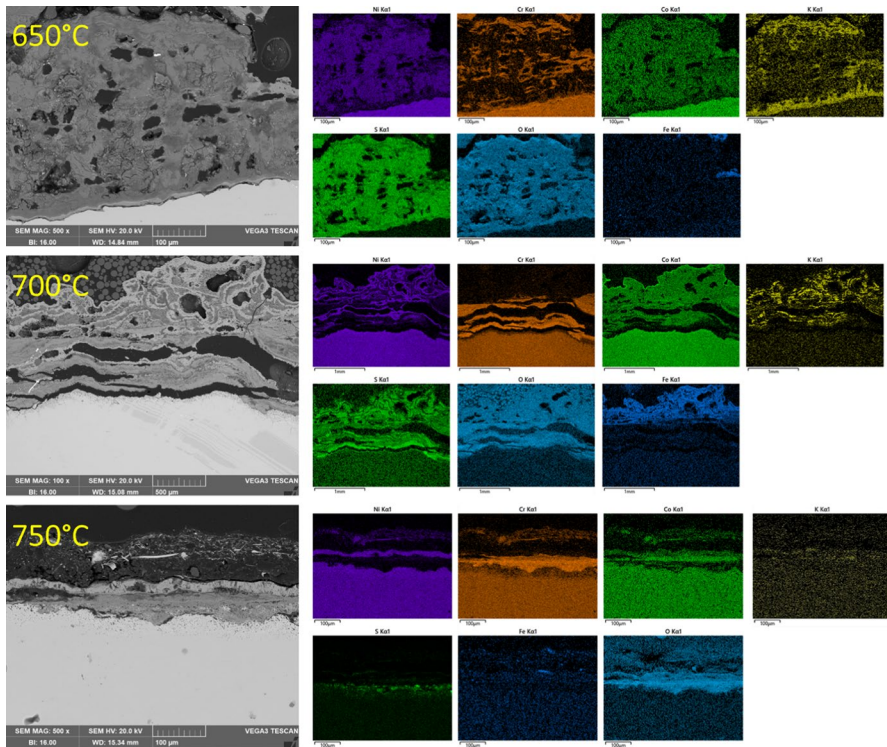
Fig. 12 SEM backscattered images and EDS maps analyses for the IN740 at three different exposure temperatures after 1000 h. The image for the sample exposed at 700 °C has been taken at lower magnitude, to allow a complete scan of the scale/deposit region (Color figure online)

Figure 12 reports EDS maps from IN740. Particular attention has been paid to assessing the scale composition. It is worth to be noted that the composition of the area indicates that the scale is not formed only by the oxides, but it comprehends, also, elements from the deposits. As can be seen, going from 650 °C to 750 °C, a progressively denser scale has been recorded, even if at 700 °C the scale appears to detach from the metal surface. A difference in composition can be observed as well, especially for the sample exposed at 700 °C (the sample that showed highest median metal change for IN740; see Fig. 6). This shows a significant part of the scale/deposit is formed by Fe-oxide, which is a more porous and less protective oxide than the Cr-rich oxides [38]. This scale formation could be due to the higher stability of the deposit at this temperature, leading to a more aggressive environment, causing a higher flux of more protective elements from the alloy to the surface, leaving the Fe as the remaining element to be oxidised. The greater presence of deposit elements (K, S) at 700 °C could be an indication of this deposit stability and have led to the higher median metal change for IN740 at 700 °C than at the other temperatures (see Fig. 6). At the other temperatures, as seen in Fig. 12, the presence of dense Ni-, Co-, Cr-rich oxide layers

(starting from top to bottom of the image) can be noted, which acted as a barrier between the environment and the samples. The presence of the Cr-rich scale is due to the increased instability and a more reactivity of the deposit at 750 °C, and a more stability and less reactivity at 650 °C, leading to a lower corrosion damage in both cases. This could explain the decrease in the median metal change, as well as median sound metal change, observed for the IN740 samples exposed at 750 °C, see Fig. 6. The reason for this frequently reported bell-shaped peak in corrosion damage is related to the stability of the deposits generated under these exposure conditions. The deposit used for this work reacts with the gaseous environment to give an alkali iron tri-sulphate; this has a melting point of ~550 °C [21], but becomes unstable above ~680–700 °C due to the decrease in SO₃ species in the gaseous environment with increasing temperature. Such changes in the deposit lead to a peak in corrosion damage between 650 °C and 700 °C (which has been reported by many authors, e.g. [21, 27]). The peak damage depends on the alloy chemistry as well. It should be noted that this kind of behaviour has been observed previously in both nickel-based alloys (i.e. 263, 617 and 740) [27] and stainless steels (e.g., 347HFG and HR3C) [21]. Hussain et al. [21] showed in the paper that the peak in metal change was observed at lower temperature for similar conditions (gas composition N₂ 73.8%, O₂ 4%, CO₂ 14%, H₂O 8%, SO₂ 1300 vppm, HCl 400 vppm [21], compare to Table 2), but the paper investigated the behaviour of other steels (i.e. T92, 347HFG and HR3C), not Sanicro 25. On the other hand, it has been reported the ability of the IN740 to create an effective barrier to sulphur penetration, at temperature equal or above 700 °C [27]. In the current study, the two alloys exhibit similar trends, with peak of median metal change at 700 °C, but with different level of damage; the median metal change in the Ni-based alloy being about three times lower at both 700 °C and 750 °C than the damage showed by Sanicro 25 (Fig. 6). From Fig. 11, it can also be seen that Cl has been found at 700 °C, corresponding to the peak in metal change for both alloys (Fig. 6), suggesting that the gas would have had access to the metal surface. It has been observed by Jonsson [39] and Olivas-Ogaz [40] that Cl plays a crucial role in high-temperature corrosion, especially HCl coupled with O₂. In this case, the Cl has the ability to form transition metal chlorides, which will decompose and leave a rough and porous, and hence unprotective, scale [40].

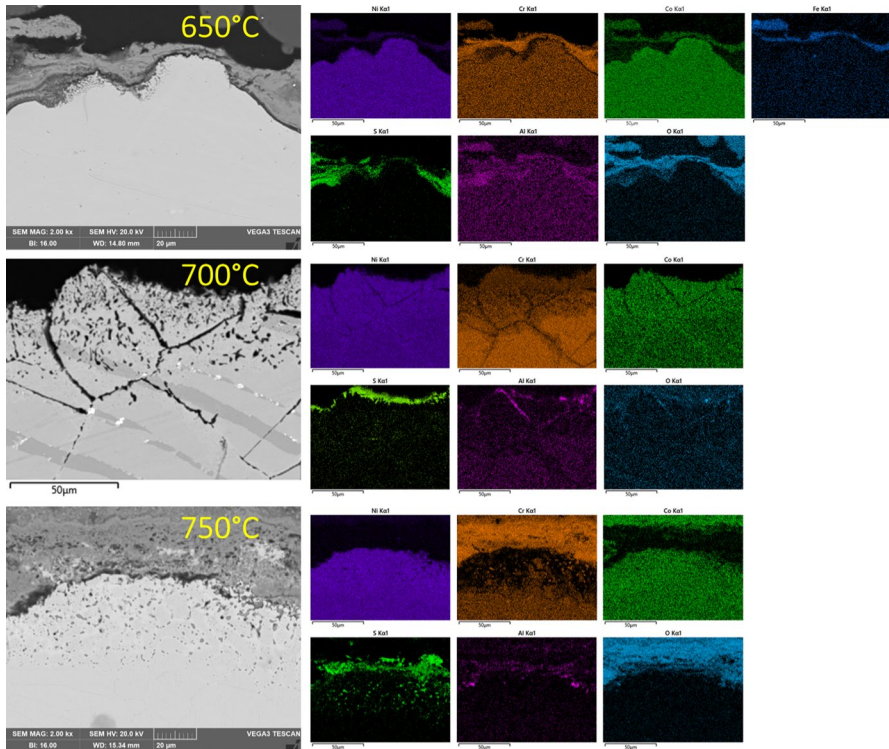
Fig. 14 SEM backscattered images and EDS maps analyses for the IN740 at three different exposure temperatures after 1000 h. Images have been taken at higher magnitude with respect to Fig. 12 (Color figure online)

In Fig. 14, areas with internal damage for IN740 at 650 °C, 700 °C and 750 °C are shown. The grain boundary attack is not as evident as in the Sanicro 25

samples, which is consistent with the dimensional metrology analysis (Fig. 6). The Cr depleted area is clearly visible only at 700 °C and 750 °C. At 700 °C, presence of Al and O is observed at grain boundaries. This could suggest the formation of Al oxide, which could potentially stop the diffusion of other species from the bulk alloy to the surface, preventing the formation of a protective Cr-rich oxide layer, as already observed [43]. It should be noted that the EDS data are in contradiction with the dimensional metrology data (Fig. 6), where the highest median sound metal change was found at 650 °C. This could be due to the fact that the feature highlighted by SEM backscattered images, cannot be seen by optical microscopy images and not everything can be resolved with the resolution limit of the optical microscopy. Furthermore, in the SEM images, there cannot be a clear indication on where the original surface, so no indication of what the sound metal change would be in the presented surface point.
