Using High-Resolution Digital Photography and Micro-CT Scanning to Investigate Deathwatch Beetle Damage to an Historic Timber from HMS *Victory*

Fiona Brock, Richard Southwell, Zoë Hazell, Roland Wessling, Matthew Green & Diana Davis

Micro-CT scanning; Timber condition; Timber preservation; Deathwatch beetle; HMS *Victory*; Naval archaeology

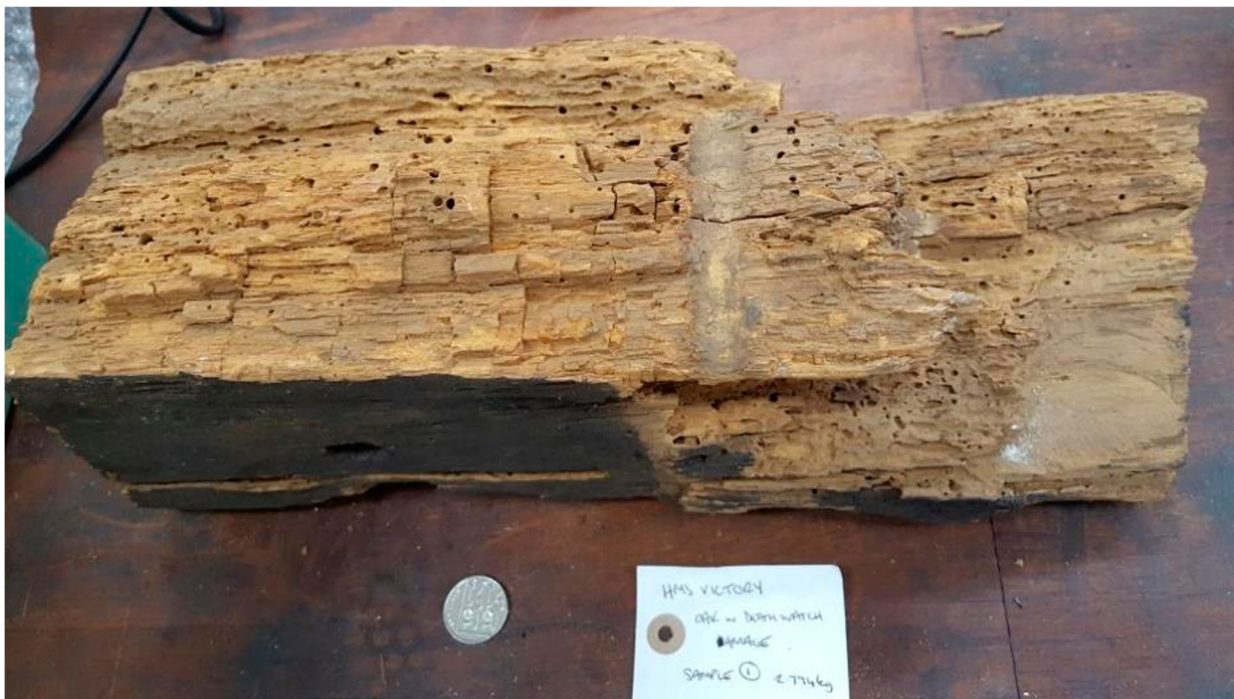
Figure 1. The investigated oak timber (previously removed from *Victory*) before subsampling. Note the original, darker and smoother, outer surface. Image taken by R Southwell.

A single timber of *Quercus* sp. (oak) from *Victory* was used for this study (Figure 1); it had been removed from the ship's hull between 1955 and 2000 during routine, on-going restoration work, because it showed evidence of damage by *X. rufovillosum*. There is no secure record of its original *in situ* position or orientation, although it is thought to be from a futtock (part of one of the ship's 'rib' frames), thereby dating to between 1759 and 1816. Since its removal, it has been kept in storage at the Royal Navy dockyard, then by a private owner, and since 2012 by the NMRN. It is most likely to be heartwood, as sapwood tended to be (though not always) removed by shipwrights during conversion, but this was not checked prior to the destructive analysis of the blocks following this study. The smooth, even faces are inferred to be

original outer edges of the timber, with the darker colour resulting from factors associated with ageing and/or exposure. It is not thought to have been topically treated, as futtocks are located within the double skin of a ship's structural frame. This timber was selected as it did not contain any high-density materials (such as copper nails or lead-painted surfaces) that would have affected the imaging.

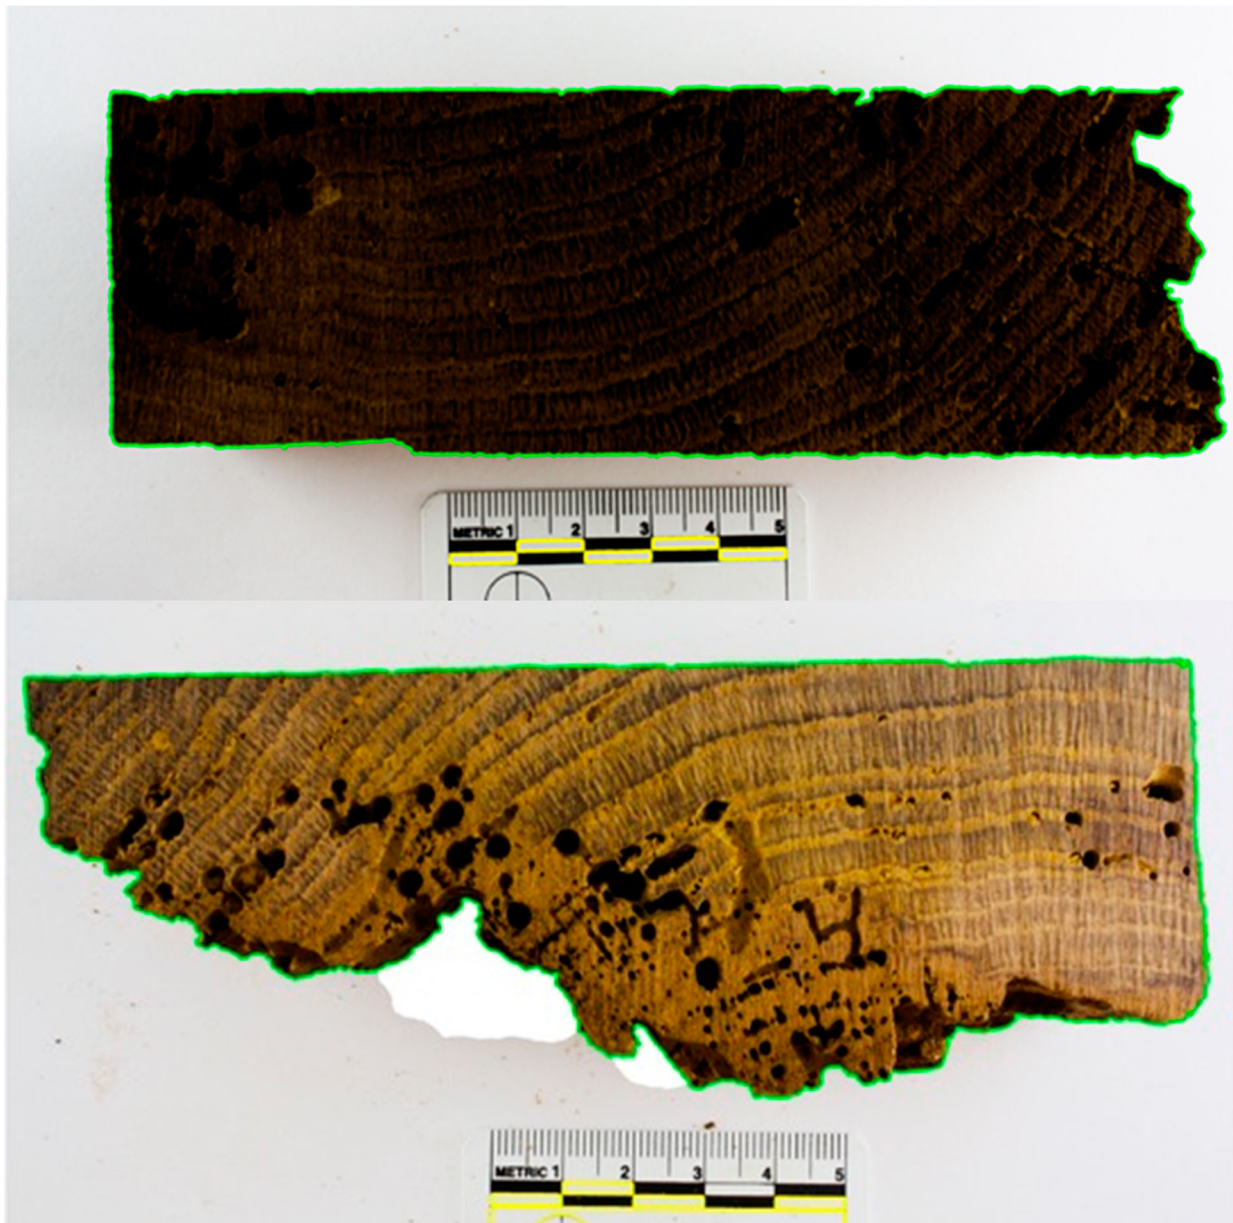
Figure 2. Matlab analysis of (a) Block 1a and (b) Block 3b to determine surface area. The yellow outlines show the automatically detected areas within the photographic scale (each 1 cm wide); the green outline shows the automatically detected border between foreground (sample) and background. Both outline types were superimposed onto the original image rather than the binary images from which they were derived.

increase to 100% to improve overall contrast between the sample and the background for automatic detection in MatLab. The MatLab function then performed two basic tasks. Firstly, it detected the photographic scale in the images (Figure 2) and measured its dimensions to later convert the area measurement of the sample from pixels to square centimetres. Using the histogram of each image, the function set a threshold between 0 and 255 and converted the image into a binary black-and-white image. In that image, it isolated shapes specific to the photographic scale (which are of known dimensions) and from this calculated a conversion factor. In the second step, the original image was again converted into a binary one but using a threshold that was specific to the colour range of the sample rather than the photographic

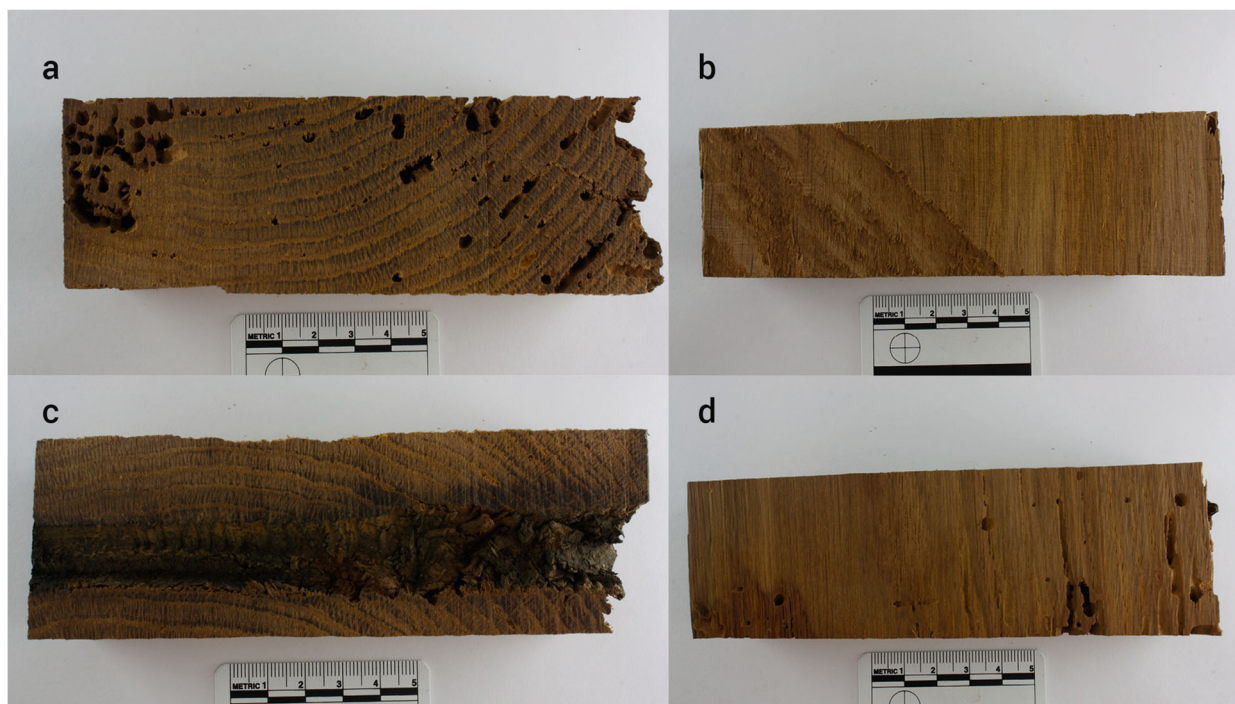
Figure 3. Block 1a, showing the reverse faces on the top and bottom rows.

These two were the only blocks to have had initial exploratory 2D X-Radiographs taken. Block 1a (Figure 3) is a near-complete rectangular cuboid,

with an uneven void running through the centre where a fastening (likely an oak treenail (dowel) or large copper spike) to hold the ship's timbers together would have been (Figure 3(c)), whereas Block 1b (Figure 4) is irregularly-shaped due to missing wood mass.

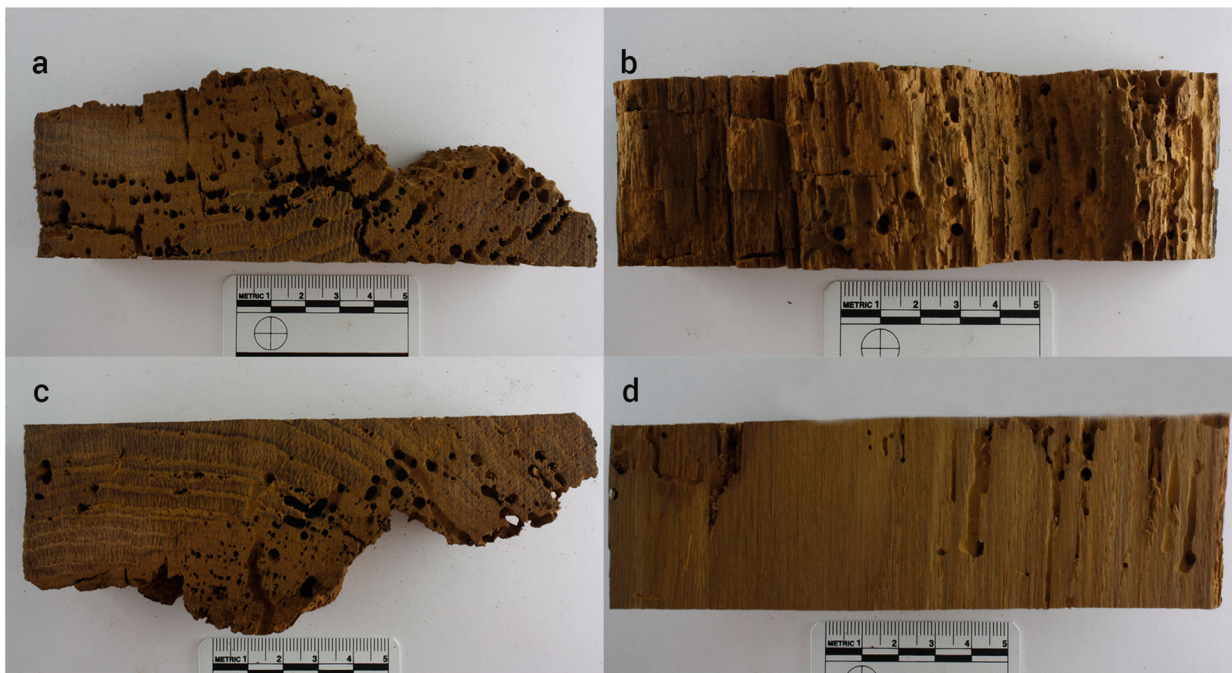
Figure 4. Block 1b, showing the reverse faces on the top and bottom rows.

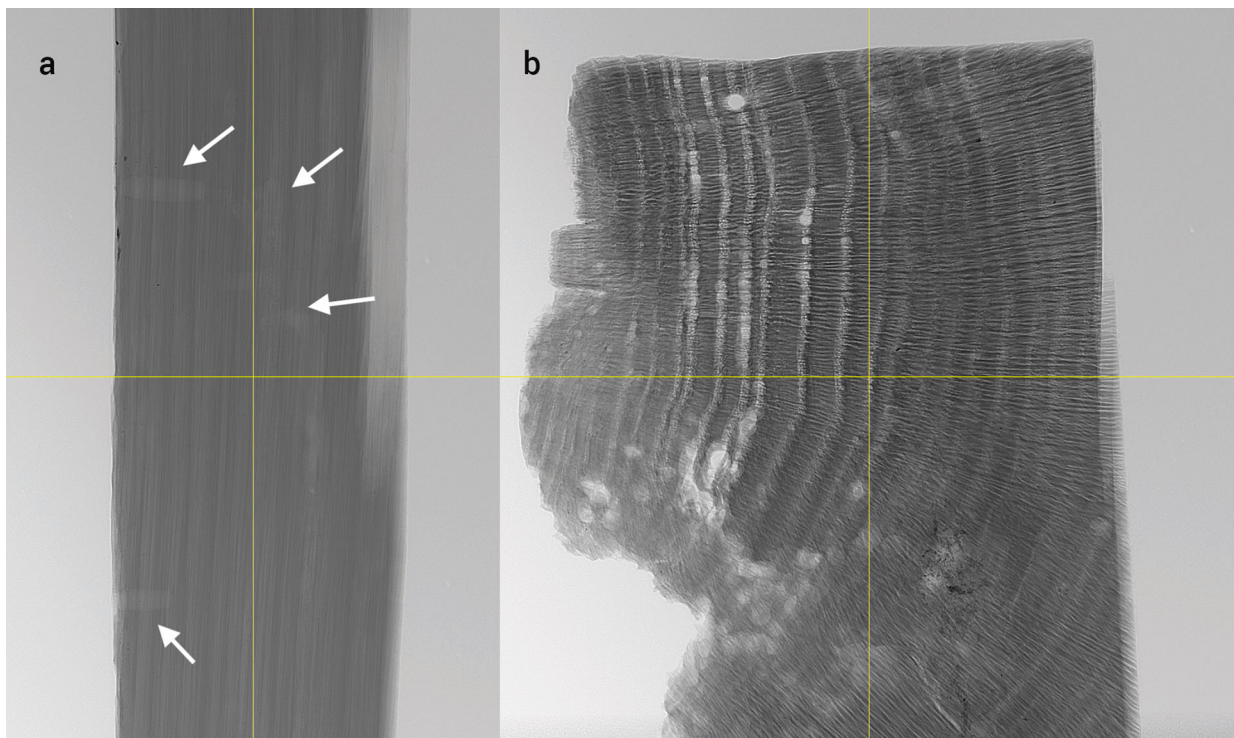
Figure 5. X-radiographs of Block 1a (a) and Block 1b (b). Note that for Block 1a, the direction of imaging is not completely perpendicular to the flat surface plane of the blocks but was optimised to visualise the tunnels which can be seen penetrating the wood from the left-hand side of the image (indicated by white arrows).

The X-radiographs of Blocks 1a and 1b are shown in Figure 5. Although they demonstrate the tunnels' presence and thereby some detail of the level of infestation, they represent the sum of X-ray absorption through the complete thickness of the sample and so cannot provide insights into the 3D nature of the tunnels.

The X-radiograph showing the transverse section of the wood ([Figure 5\(b\)](#)) shows characteristics of the wood itself (i.e. the growth rings) as well as some insect damage manifest as tunnels, including holes of different diameters. An area of wood along some of the uneven, degraded edge of the fragment appears to be paler in appearance on the X-radiograph (i.e. with a lighter greyscale value) than the rest of the sample. Close inspection of the wood block itself ([Figure 6\(a\)](#)) appears to show the same area being

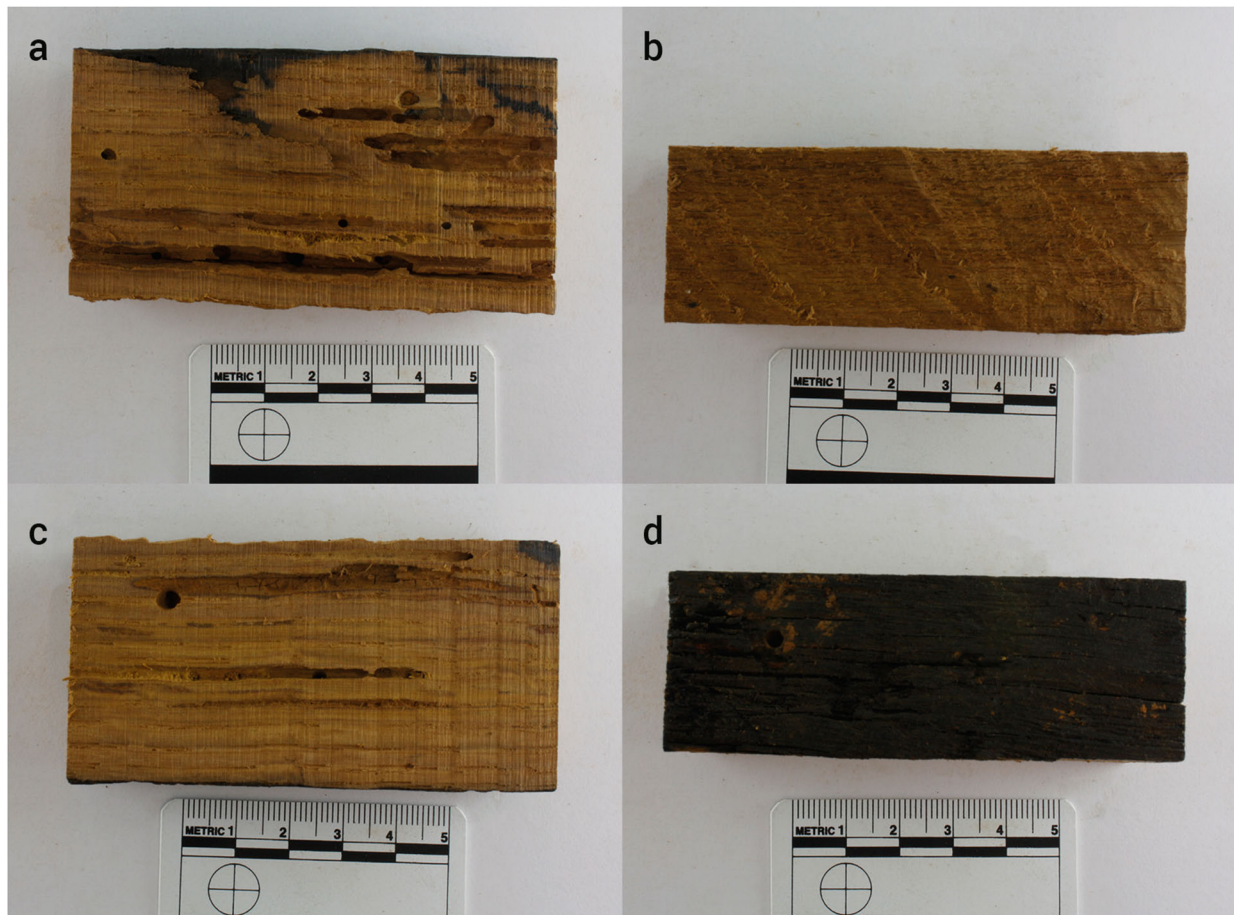
Figure 7. Block 6a, showing the reverse faces on the top and bottom rows.

This is a complete, rectangular block (Figure 7) with a single flight hole on the original outer edge (Figure 7(d)) and less extensive internal damage (Figure 8).

lighter coloured wood (broken, eroding surfaces), those on the (original) external surfaces of the wood which were darker in colour (e.g. Block 6a, Figure 7(d)) were not always detected due to insufficient contrast between the holes and the wood surface.

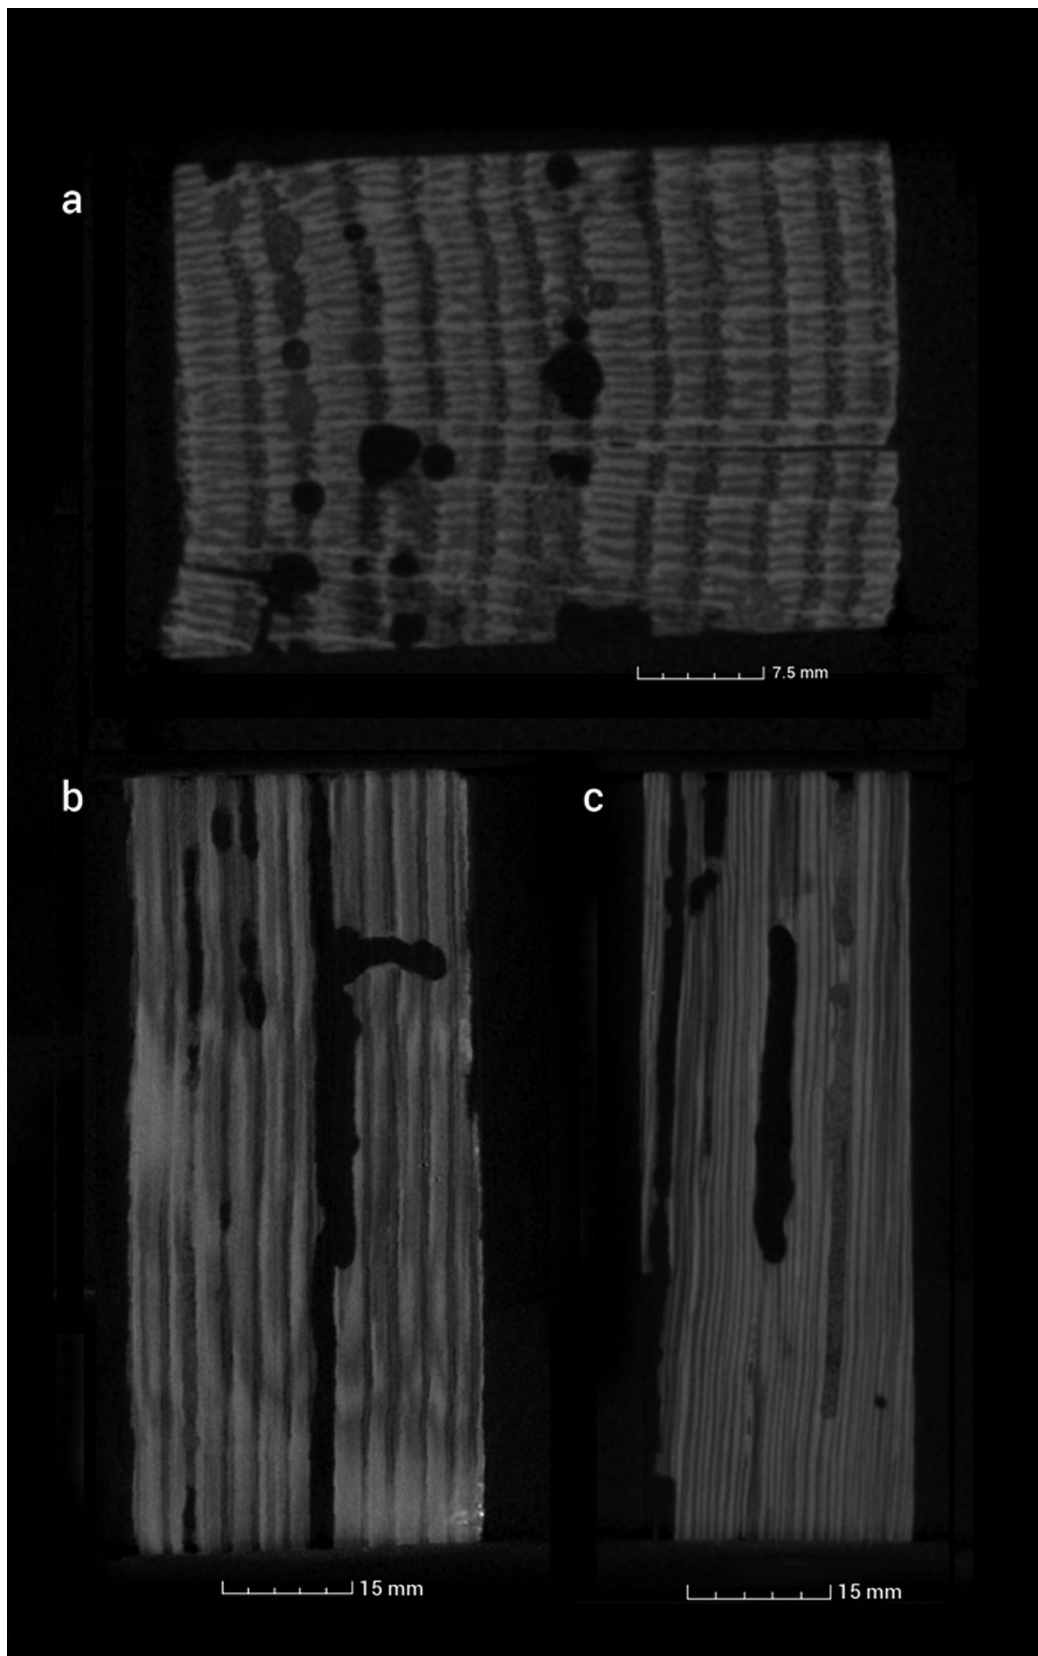
Figure 8. Micro-CT slices from Block 6a: (a) transverse, and (b) and (c) longitudinal.

The micro-CT slices from Block 6a suggest a tendency for the avoidance of particularly large multiseriate rays (Figure 8(a)) and show a preference for the longitudinal alignments of the tunnels (Figure 8(b, c)). Figure 8(b) also shows a characteristic right-angle turn of the tunnel. Frass is observed within some of the tunnels, in particular in Figure 8(c).

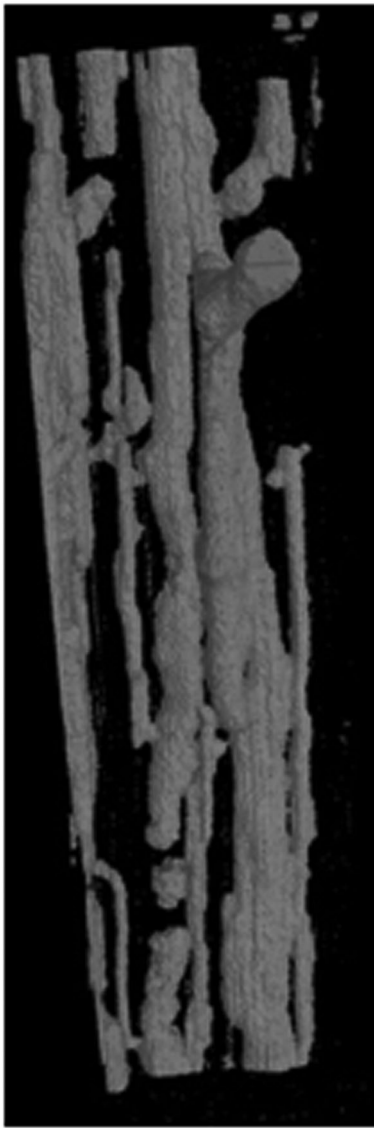
Figure 9. Model of the tunnel voids from Block 6a. Total height of block is ca. 90 mm.

Isolating and inverting the tunnel volumes from the wood matrix helps to visualise their form (e.g. Figure 9), particularly the prevalence of longitudinally-aligned linear tunnels. It should be noted that some tunnels are 'lost' during this process or appear as patches of noise on the images due to the difficulty in digitally isolating the frass from the wood matrix (see further discussion, below).

When zooming in as far as possible to the voxel limit on the isolated tunnel volumes (Figure 9) using the VG StudioMax software, a semi-regular, characteristic pattern appears to be visible along the length of the tunnels. Images are not presented here as the resolution is not sufficiently high to provide confidence that these are an actual feature, rather than an artefact of imaging. However, such patterns should not be unexpected, due to the tunnelling physics of the larval stage of wood-boring insects, which exert hydrostatic pressure against the walls with the front end of their bodies to get purchase on the face of the tunnel. Once the larva has eaten all the timber within reach, it deflates, shuffles forward, inflates at a tunnel face, and begins again. Such activity can only be seen using X-radiographic techniques, as once a tunnel is sectioned open, it loses pressure. Micro-CT-scanning smaller

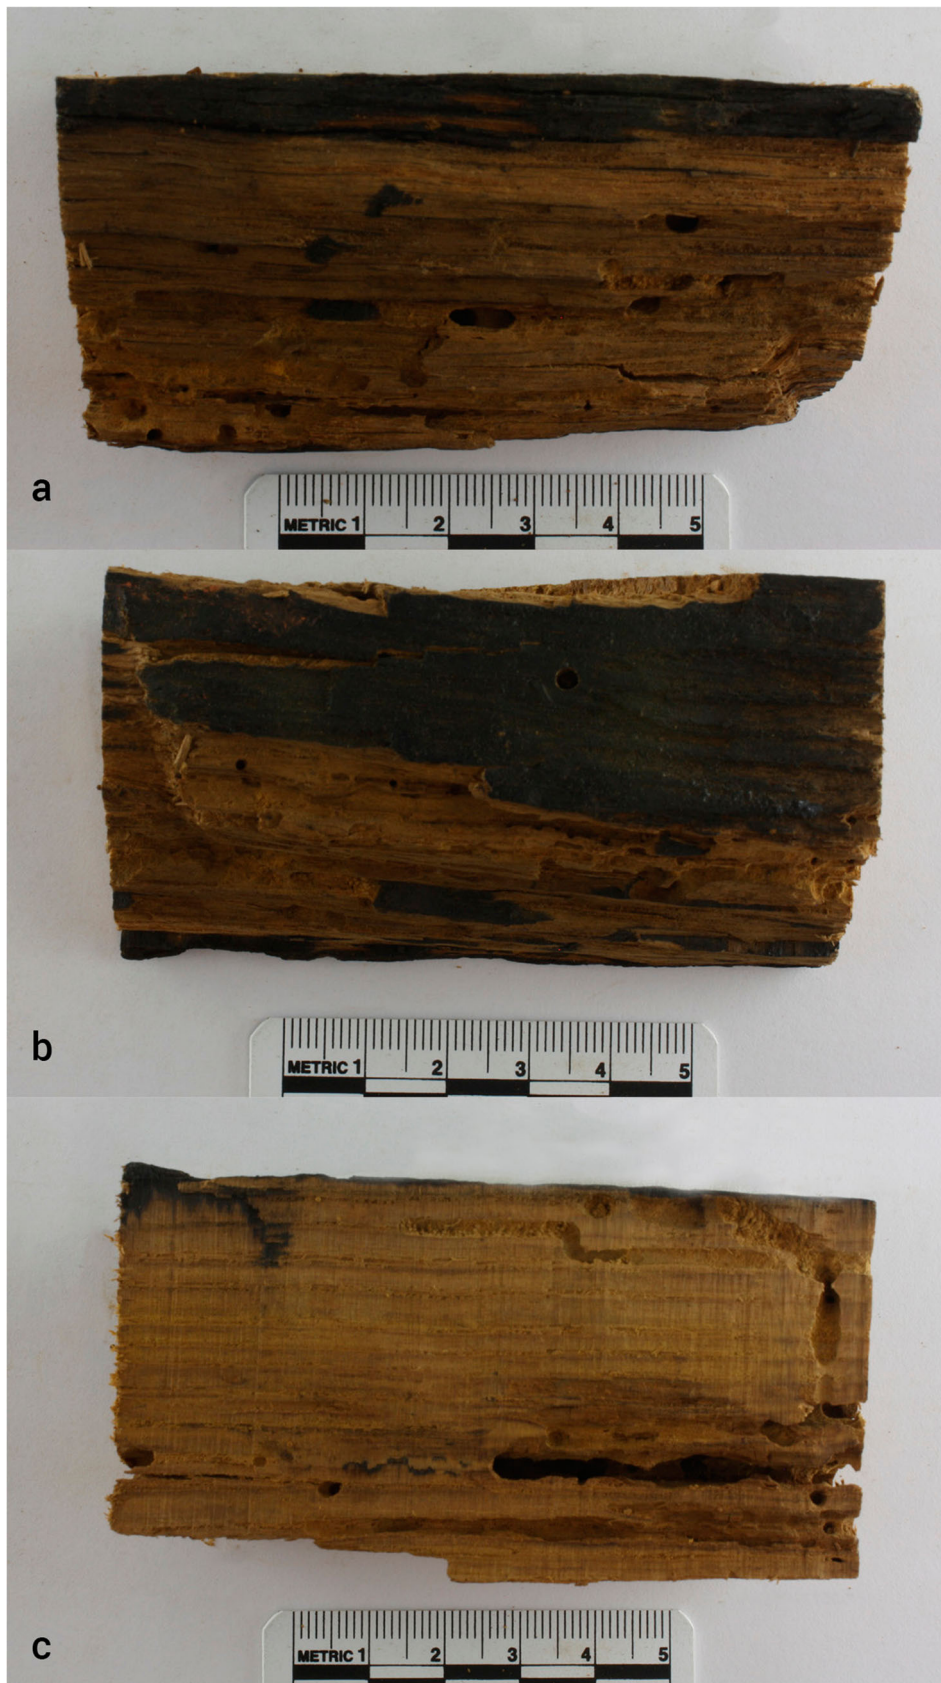
Figure 10. Block 7a (image of the fourth surface not available).

Further difficulties were experienced in calculating the total area of flight holes for samples that had significant damage resulting in uneven surfaces (e.g. Block 7a, Figure 10). Unfortunately, these difficulties could not be overcome by calculating the flight hole area from the micro-CT images using the same

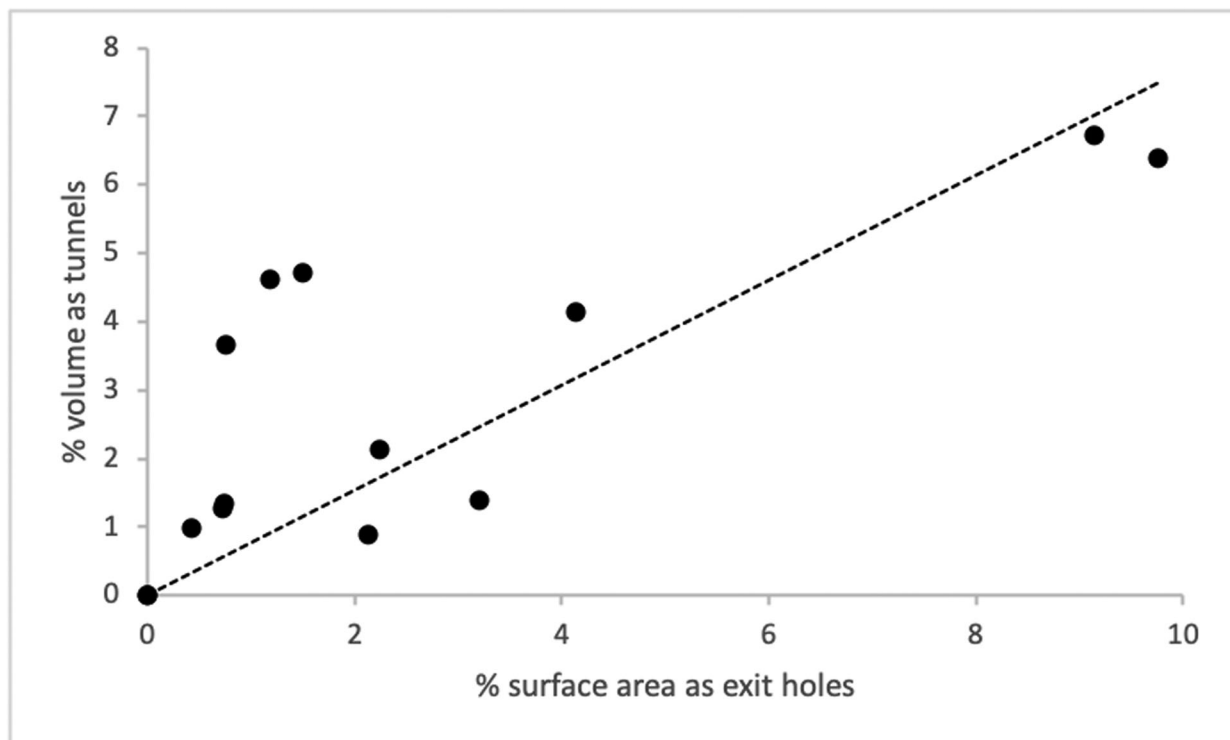
Figure 12. Plot showing % surface area as exit holes vs % total block volume as tunnels, showing broad correlation between the two measurements. The trendline is forced to pass through 0 on both axes to reflect expected values for unaffected wood.

Despite the difficulties described in measuring both the area of exit holes on the surface of, and the volume of tunnels within, each block, there appears to be a general correlation between the two values (Figure 12), indicating that the number of exit holes may be able to inform on the extent of internal damage.
