**Using Low-Cost Remote Sensing Data for Geohazard Modelling
and Analysis in Small Island Developing States (Examples of
Dominica and Cape Verdes).**

PhD Geology

**Submitted to Department of Earth and
Planetary Sciences, Birkbeck University of
London**

July 2021.

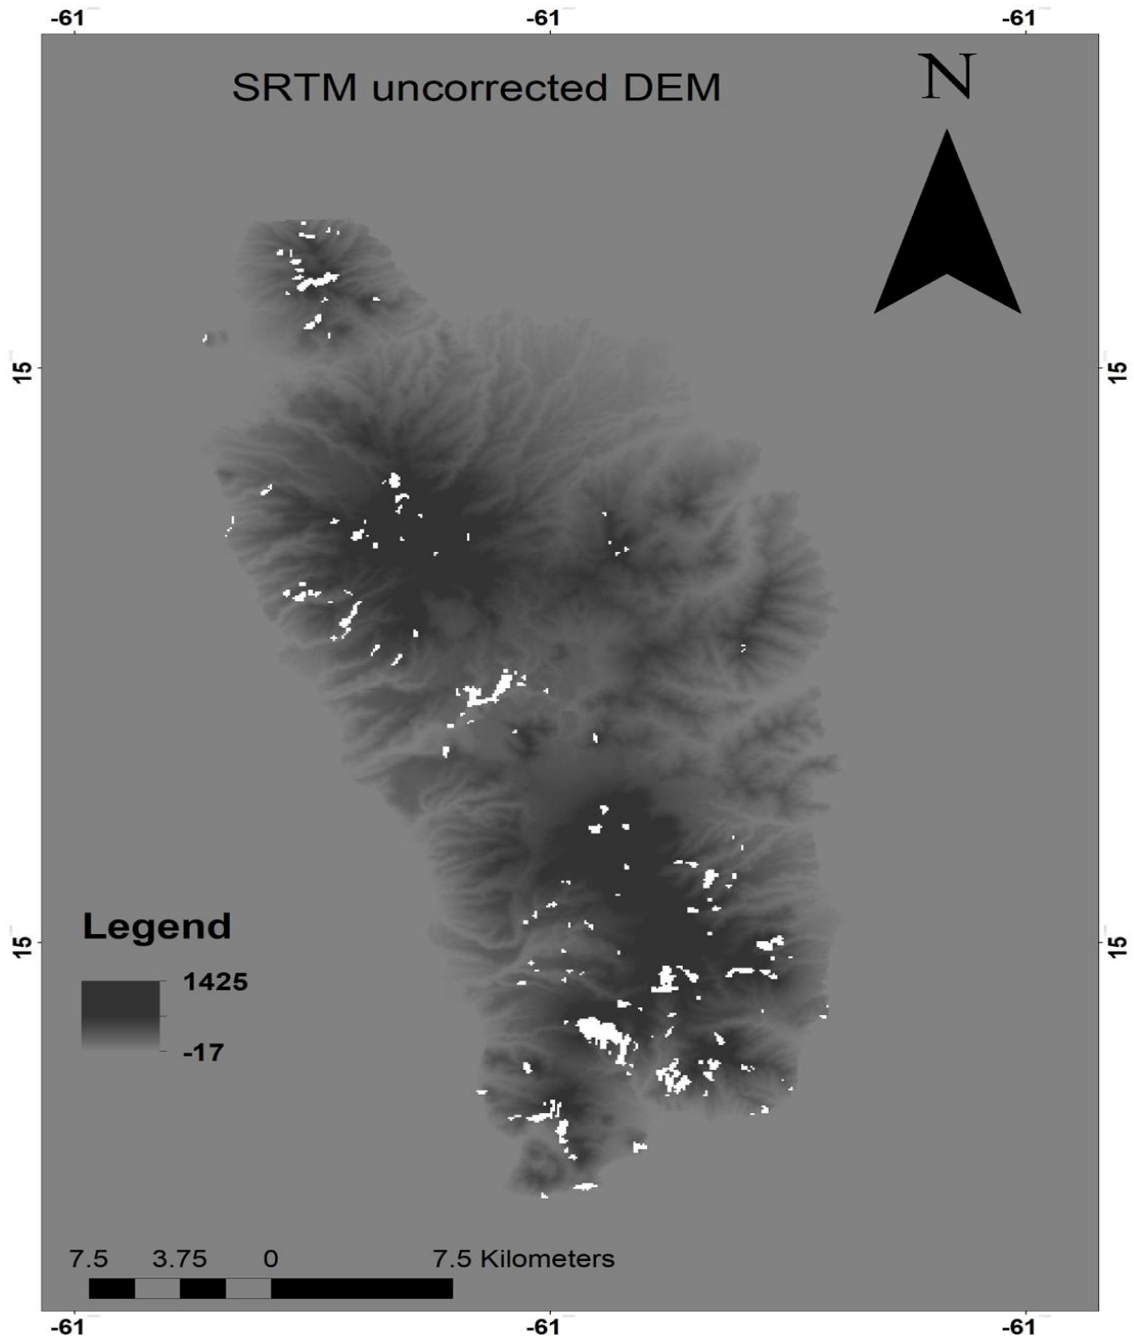
Figure 3.5: Uncorrected Shuttle Radar Topographic Mission DEM. (Researcher's image created in ArcMap 10.7)

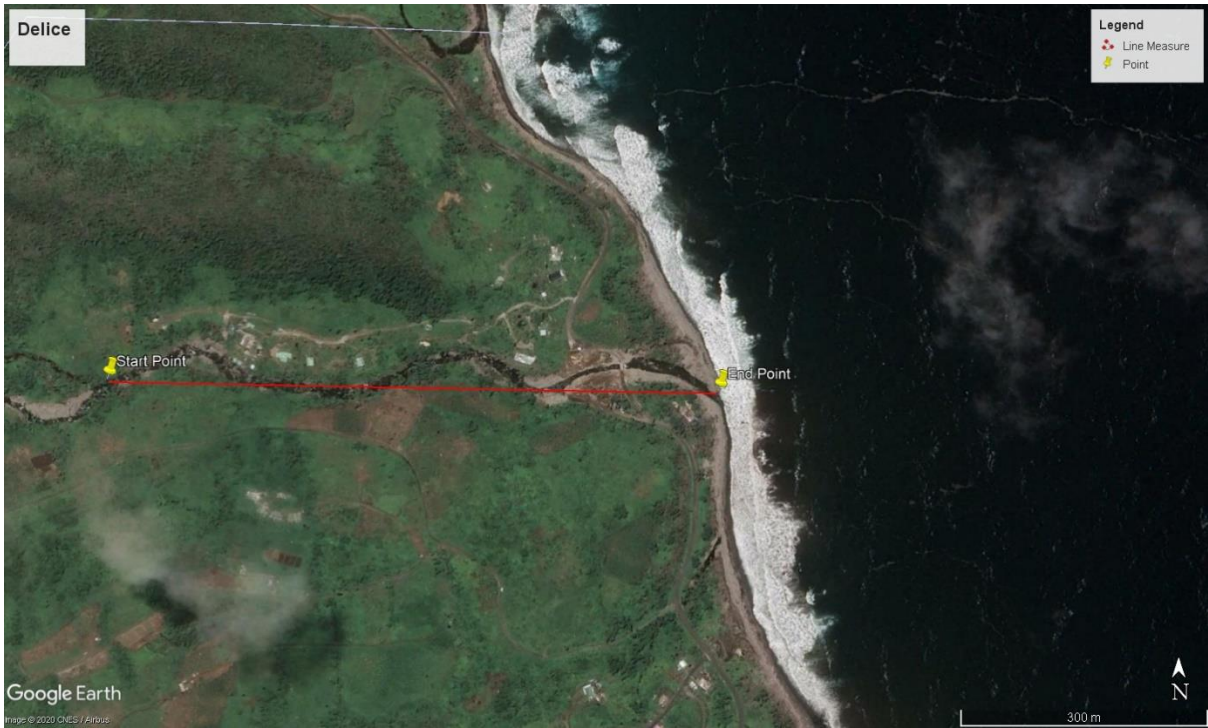
Figure 3.18: Google Earth Map of Delice area where a drone survey was conducted.

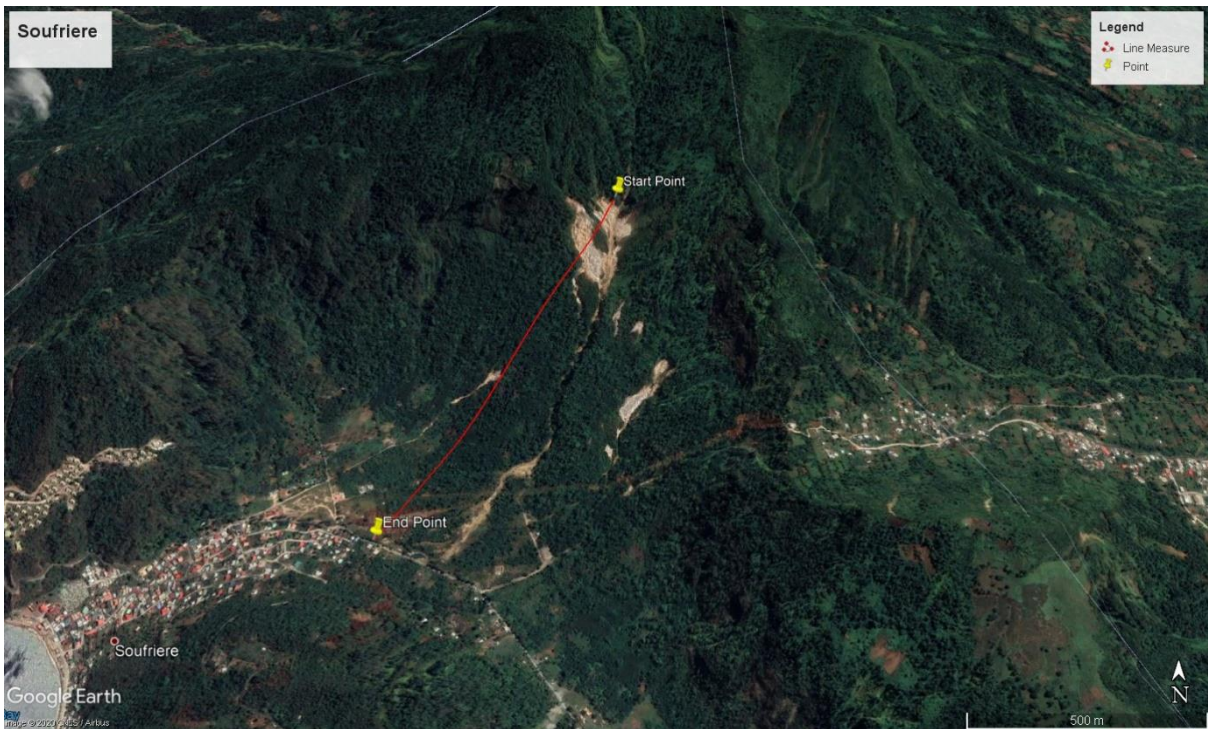
Figure 3.19: Google Earth Map of Soufriere area where a drone survey was conducted.

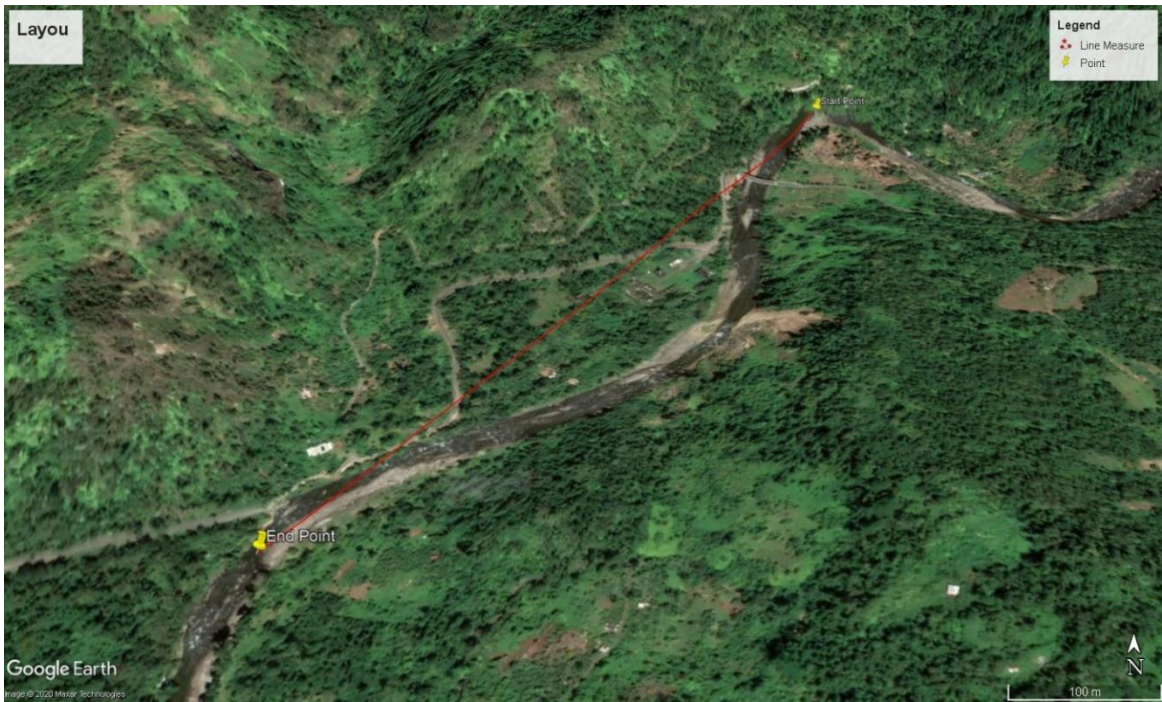
Figure 3.22: Google Earth Map of Layou area where a drone survey was conducted.

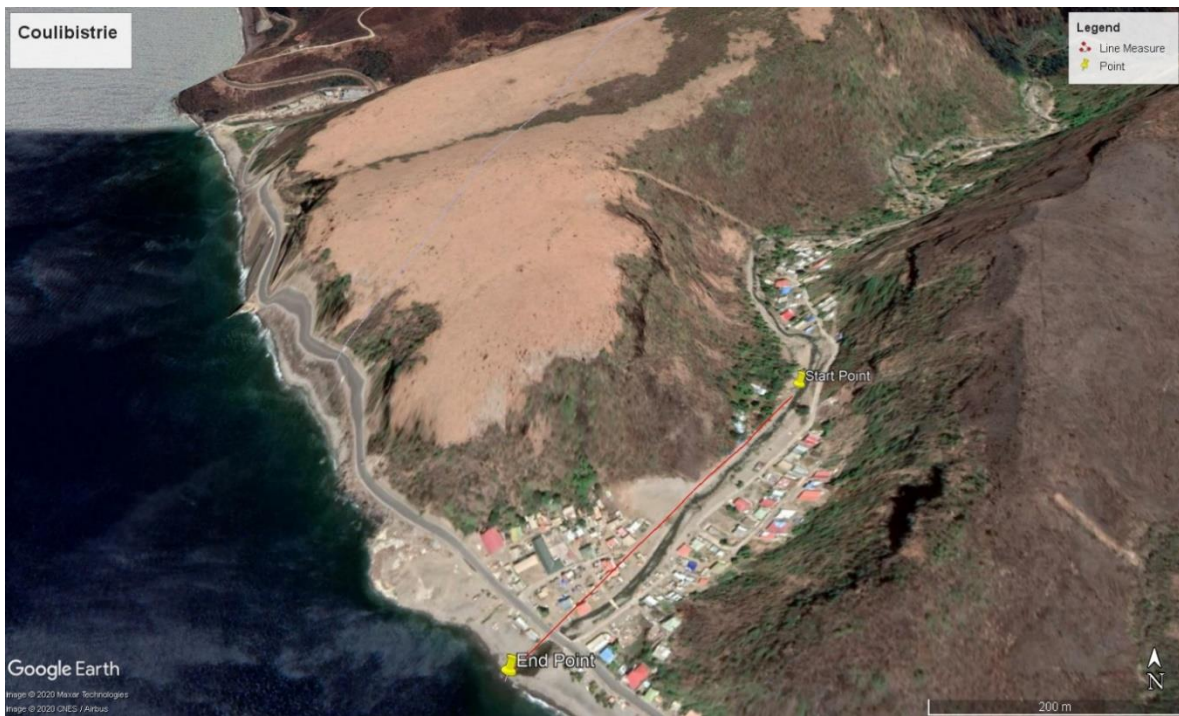
Figure 3.23: Google Earth Map of Coulibistrie area where a drone survey was conducted.

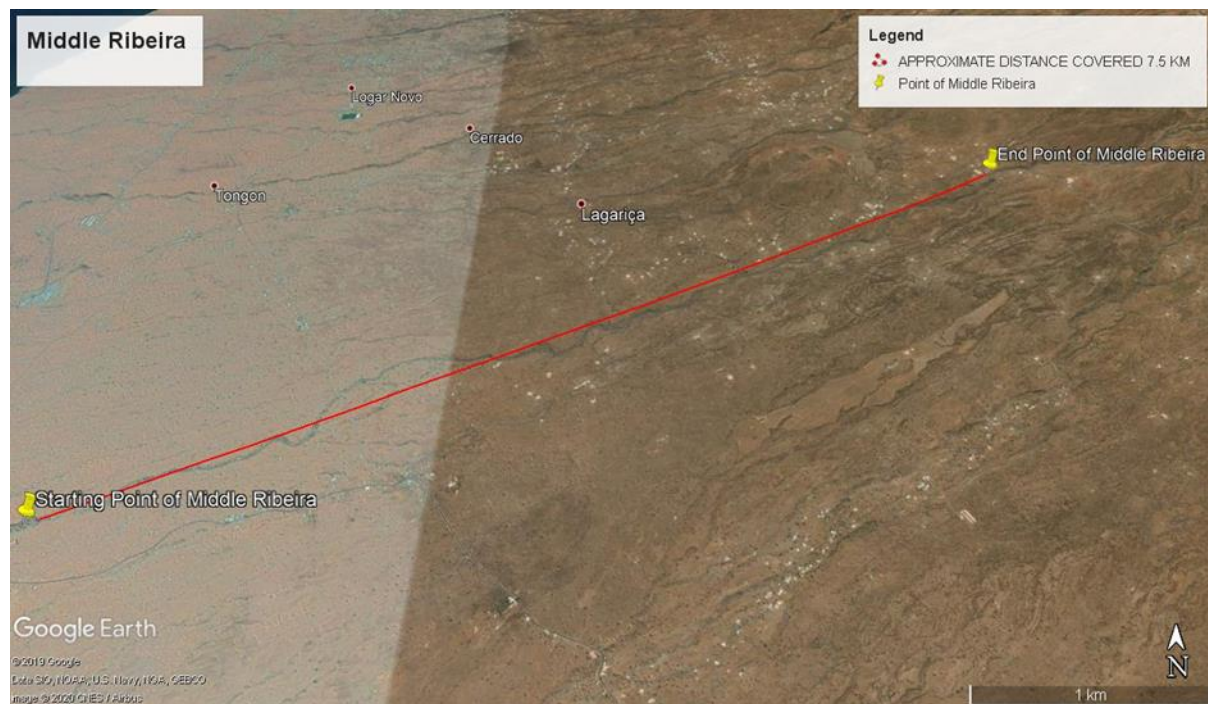
Figure 3.25: Google Earth Map of eastern Fogo showing area of Middle Ribeira.

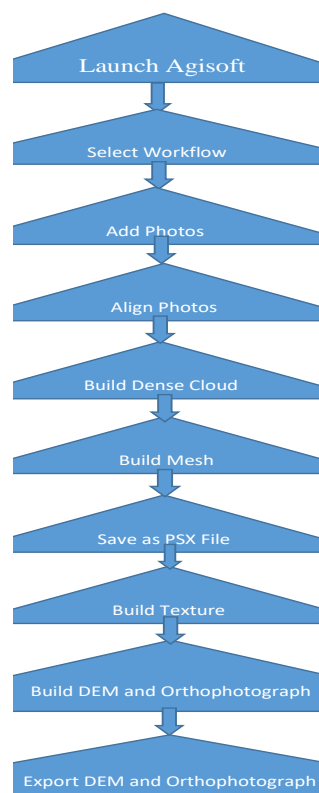
Figure 3.28: Workflow used to process drone aerial photographs in Agisoft Metashape Professional

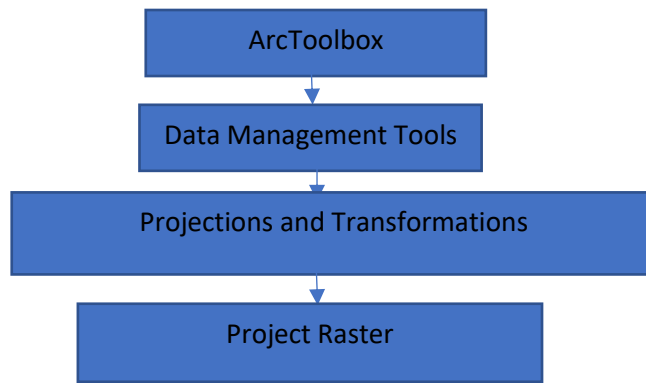
Figure 3.33 A: Raster Coordinate System Projection Workflow in ArcGIS.

Digital Elevation Model (DEM) (Digital Surface Model) (DSM) is the main input parameter required for debris flow simulation in RAMMS debris flow module. For this research work, RAMMS 1.7.20 was used for debris flow hazard simulation and analysis. All DSMs used for this study were acquired by drone survey and processed into DSMs using Agisoft Metashape Professional. RAMMS only accepts DSMs and orthophotographs in GeoTIFF and ESRI ASCII format with projected coordinate system such as Cartesian coordinate system. However, the DSMs were generated in Geographic coordinate system such as WGS 84 in Agisoft Metashape Professional. The DSMs and orthophotographs were projected from World Geodetic System (Geographic Coordinate System) to World Behrmann (Projected Coordinate System). This was done in ArcGIS using the data management tool called Projections and Transformations to project raster DSMs and orthophotographs (Figure 3.33 A and B).

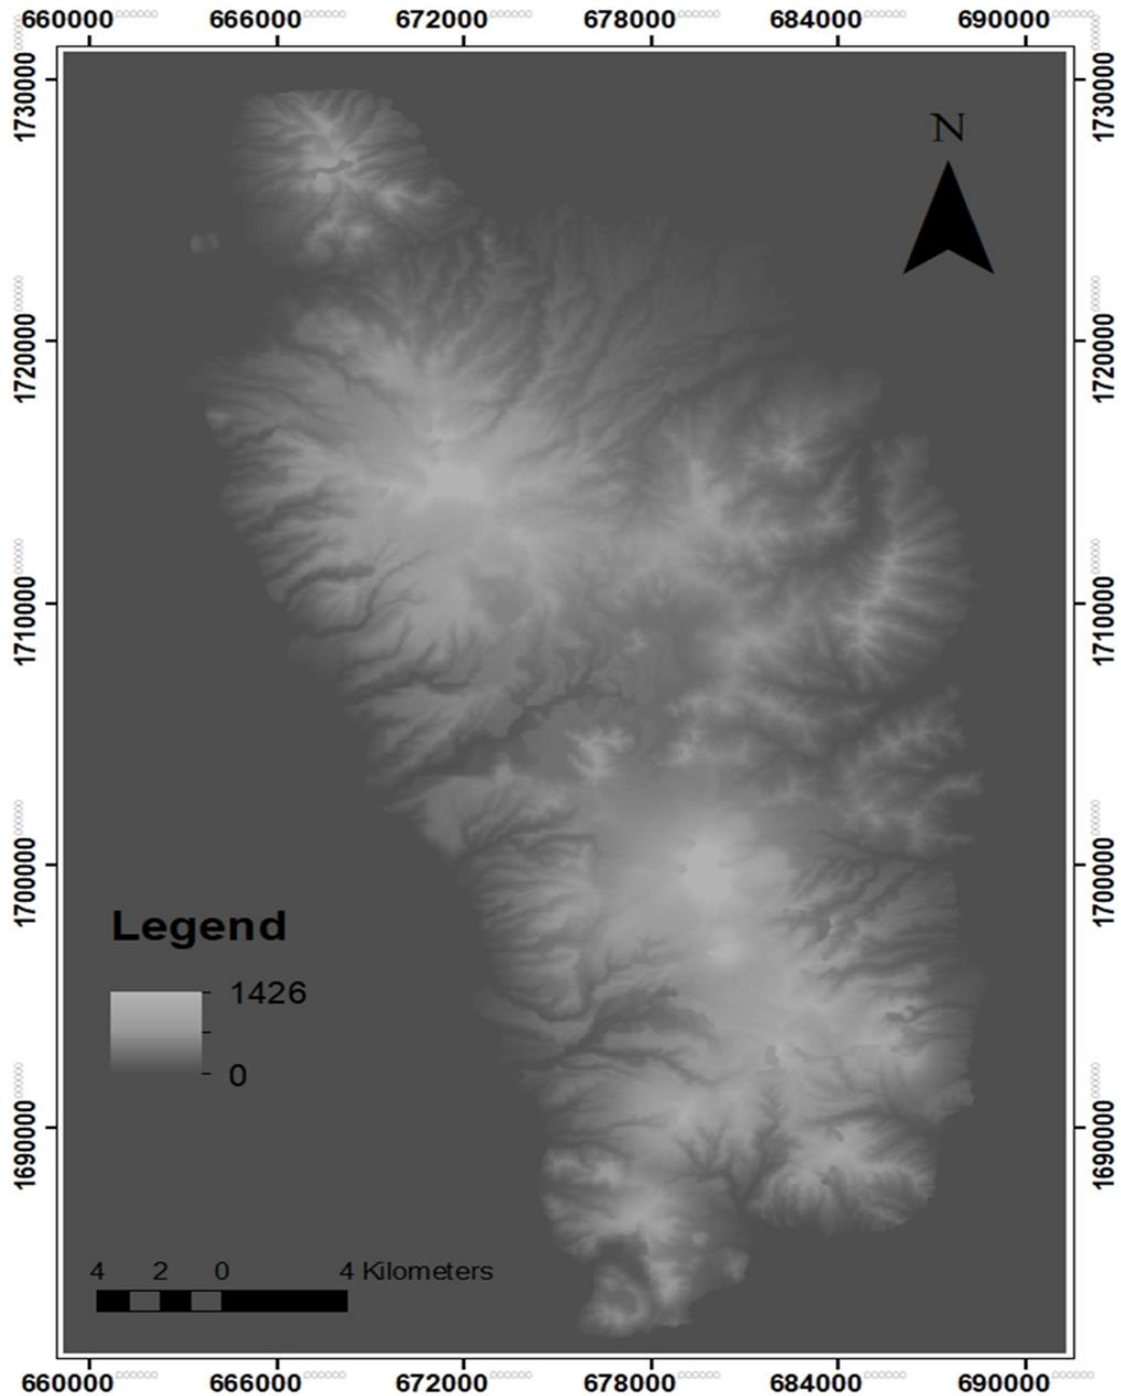
Figure: 4.1: Corrected DEM of Dominica with backscatter values. (Researcher's image created in ArcMap 10.7).

The contour map (Figure 4.5) was overlaid on the relief shaded map (Figure 4.1) to determine areas with equal elevation above sea. The contour interval used for the analysis to distinguish the distance between contours was 50 m. The contour lines are spaced further apart from each other in the central and north-western parts of the island. This indicates that there were little changes in elevation in these areas. On the other hand, contours lines in the north, north-west and south of the island are very close to each other. This indicates that these areas experience a sharp change in elevation. Comparing the slope map (Figure 4.3), hillshade map (Figure 4.2) and contour map (Figure 4.5), it is clearly visible that all steep slopes are found where there is rapid change in elevation and vice versa. In terms of hazard assessment, spacing of the contours helps to identify toe-slopes where landslide deposits had spread out to form a gentle slope (Crawford, 2011)

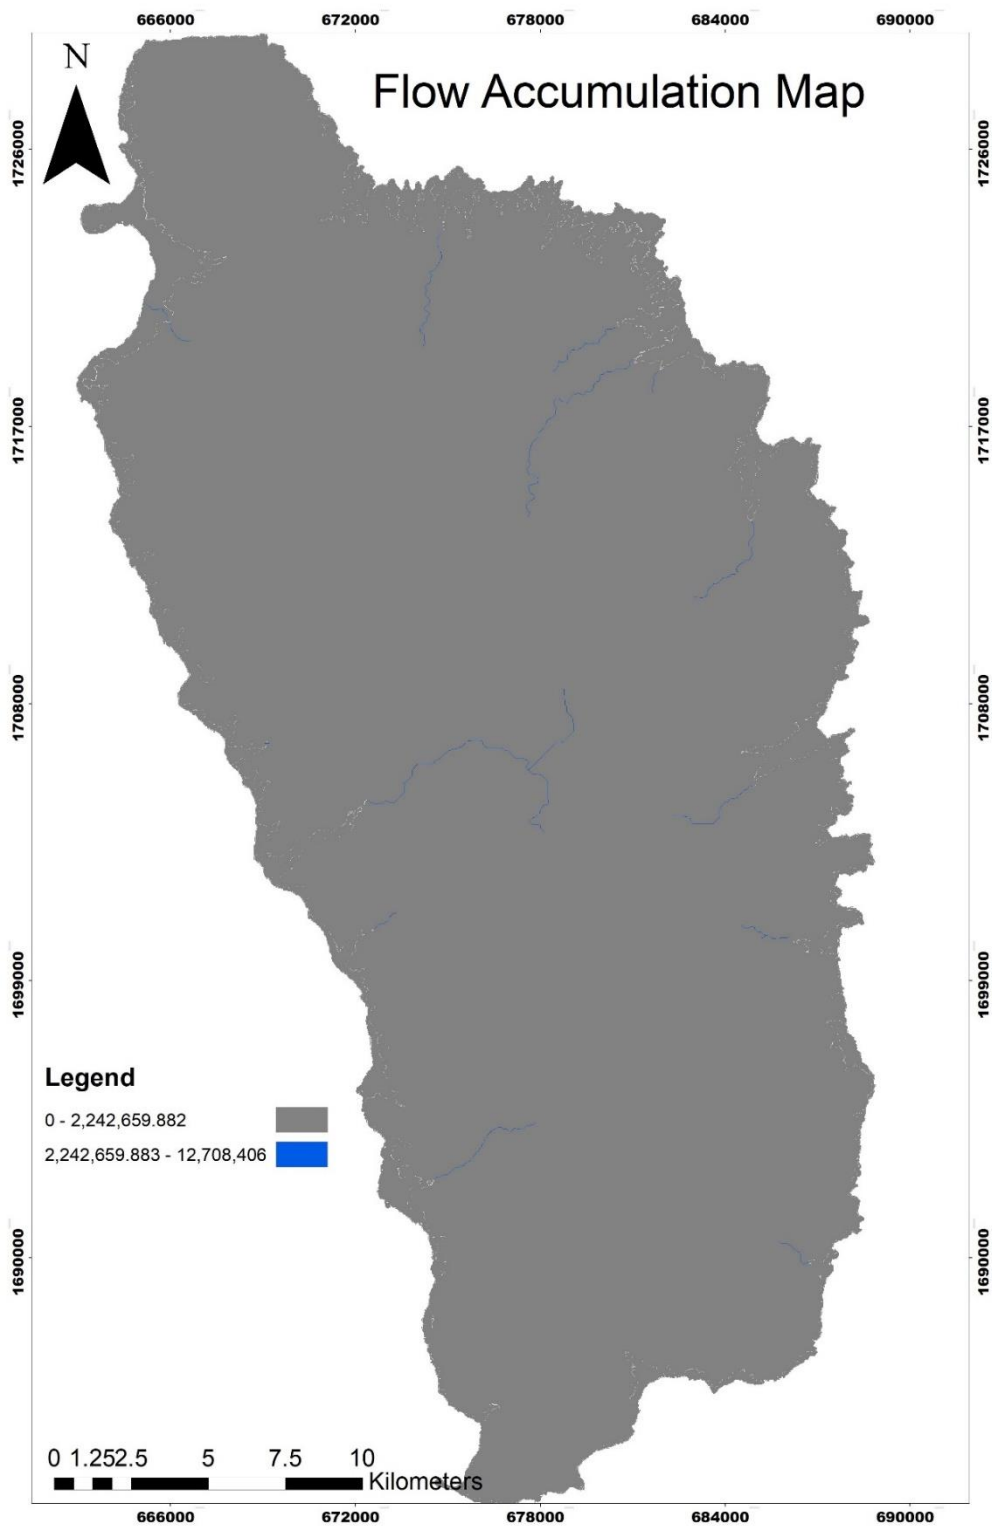
Figure: 4.7: Flow Accumulation map showing ten accumulated streams.

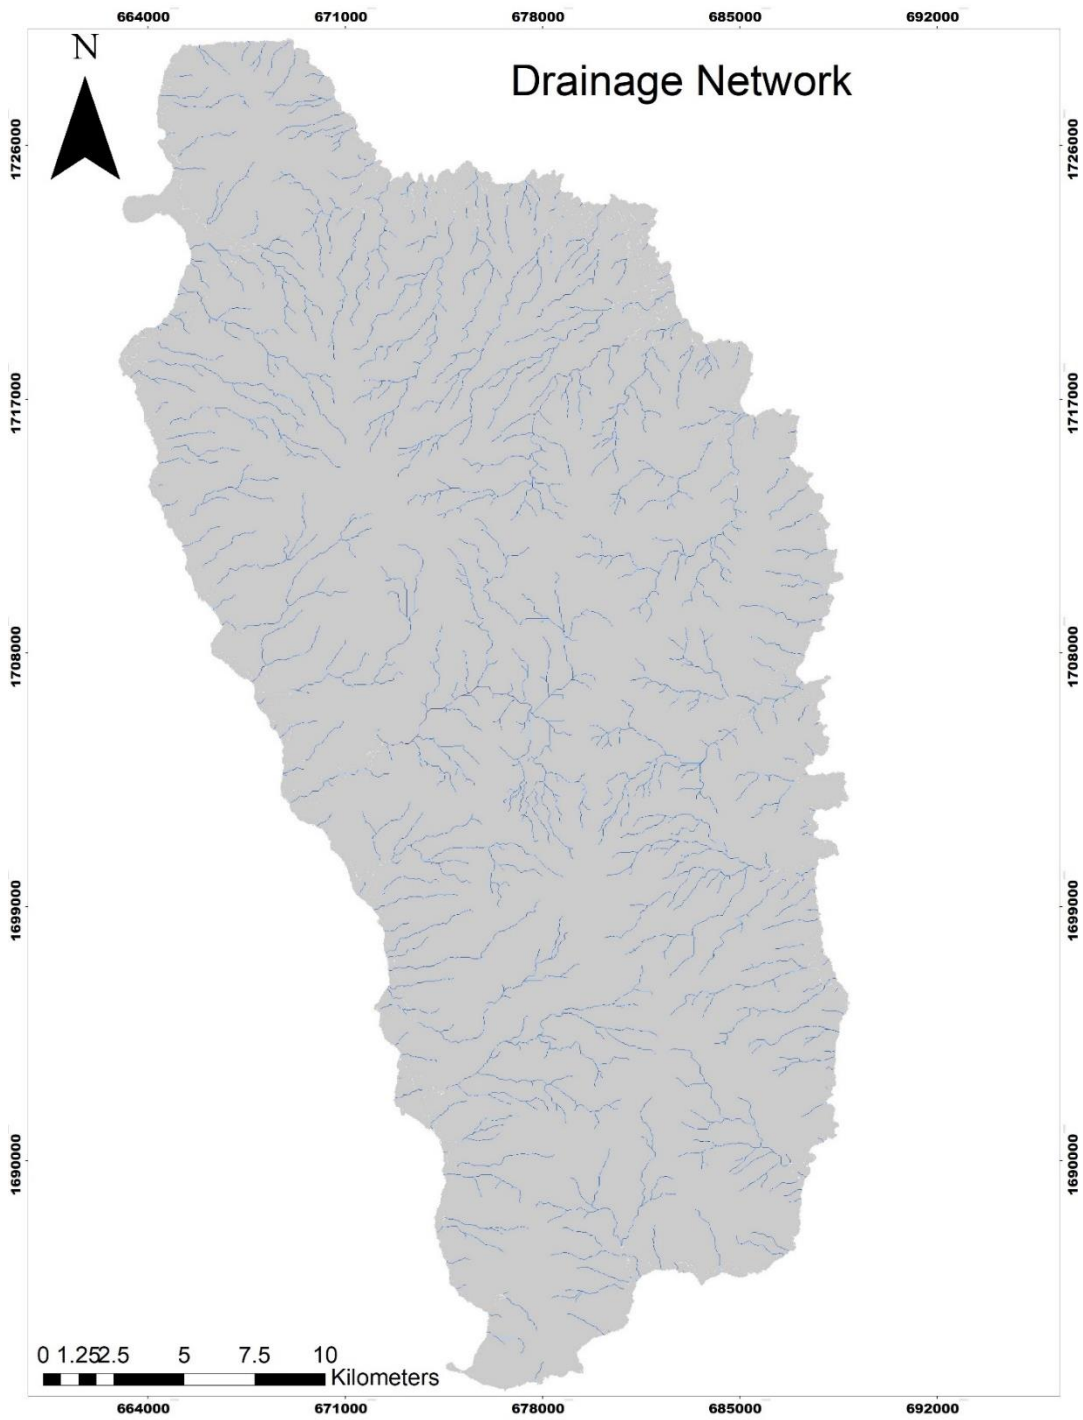
Figure: 4.8: Drainage Network map showing dendritic drainage pattern.

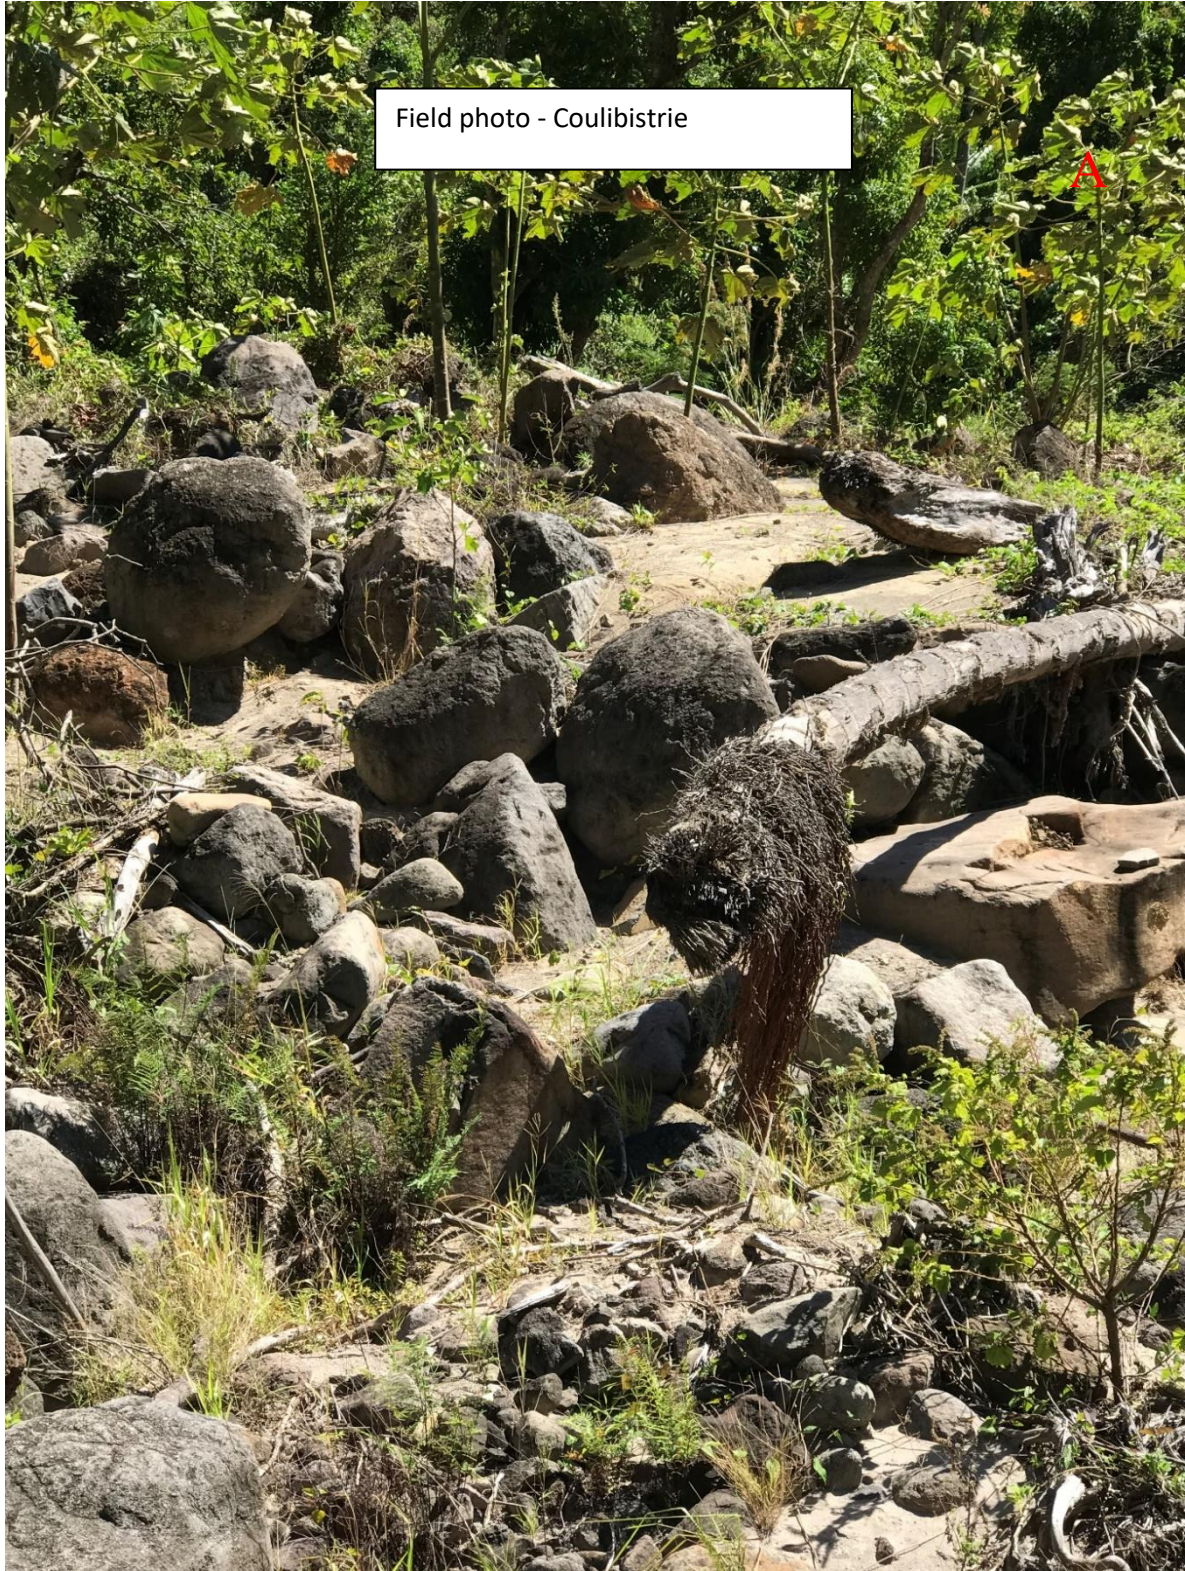
Figure 5.1 A: Field image showing cluster of boulders (0.4-1.5 m) and tree debris (1-3 m) in the channel bed at Coulibistrie (Dominica).

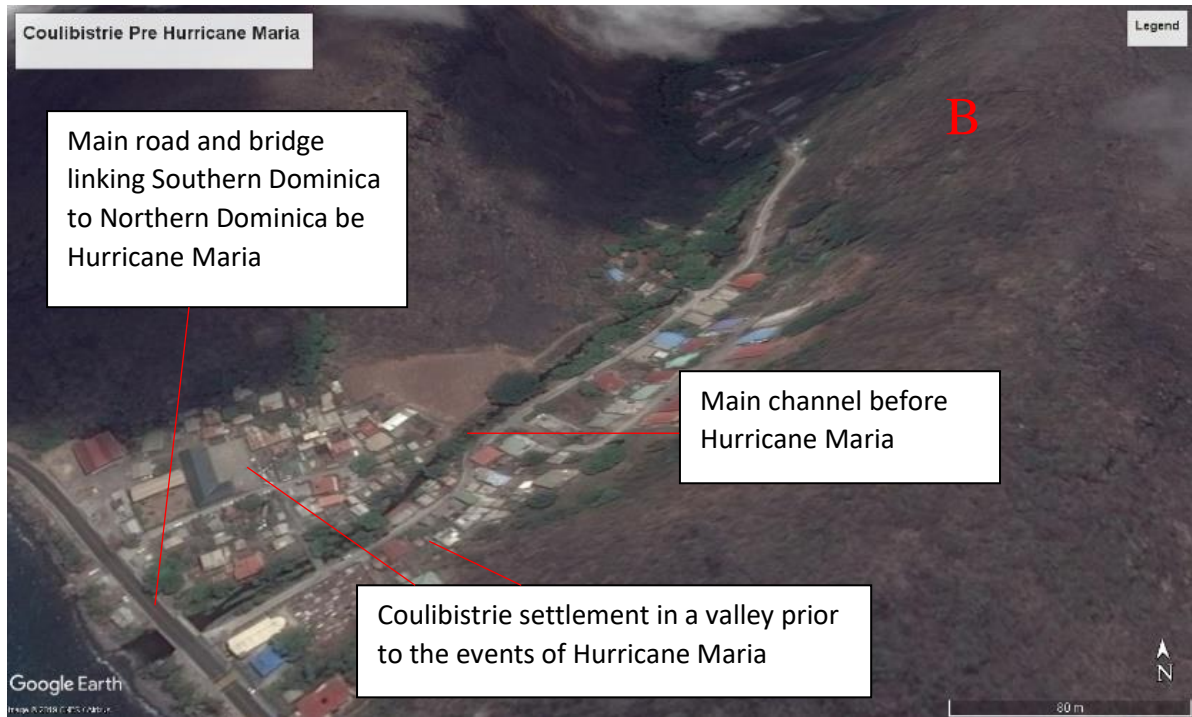
Figure 5.1 B: Google Earth image before the Hurricane Maria event for Coulibistrie (Dominica)

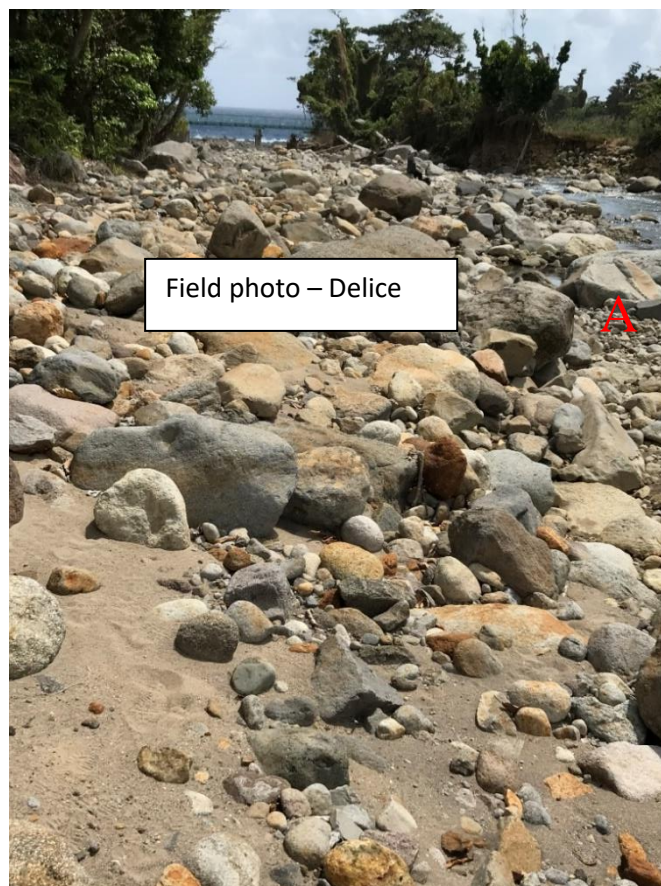
Figure 5.2 A: Field image showing cobbles (0.06-0.2 m), boulders (0.4-2 m) and tree debris (0.5-3 m) deposited laterally in the channel bed at Delice (Dominica).

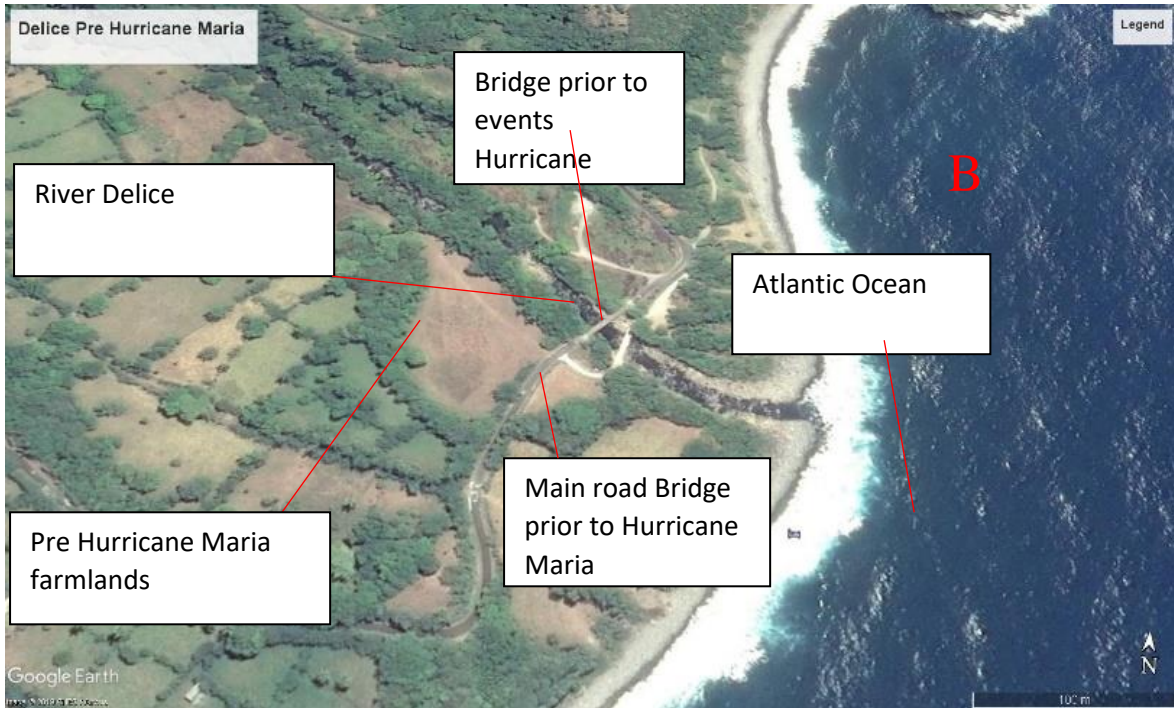
Figure 5.2 B: Pre-Hurricane Maria Google Earth images for Delice (Dominica)

Delice is less populated in comparison to Coulibistrie, however there are a lot of agricultural activities. Vegetation and farmlands were completely wiped out by strong winds, high velocity flood, landslides and debris flow (Figure 5.2 A, C and D). Figure 5.2A shows lateral debris flow deposition. Most roofs of buildings in Delice township were blown away by strong winds (Figure 5.2C). Unlike Coulibistrie, houses in Delice were not covered in sediments or submerged in flooding as the settlement is situated on high-grounds. Nevertheless, infrastructure, facilities and social amenities were damaged, leaving the town with no electricity, clean water or transport network to evacuate people to safe grounds. For example, the main bridge linking the road network in Delice to Petite Savannah and other southern towns such as Fond St. Jean, Dubuc and Berekua was damaged by boulders and covered in sediments (Figure 5.5 A, B, C and D).

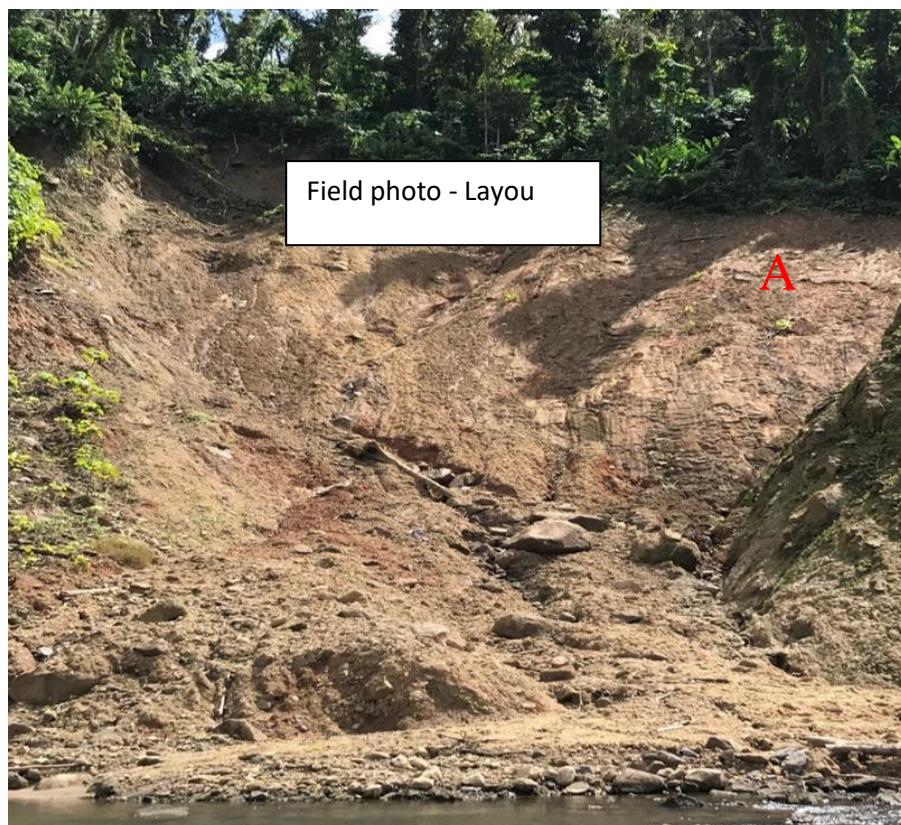
Figure 5.3 A: Field image showing deposit of mud-laden debris and hydrothermally altered boulders (0.5-1.5 m) at Layou (Dominica).

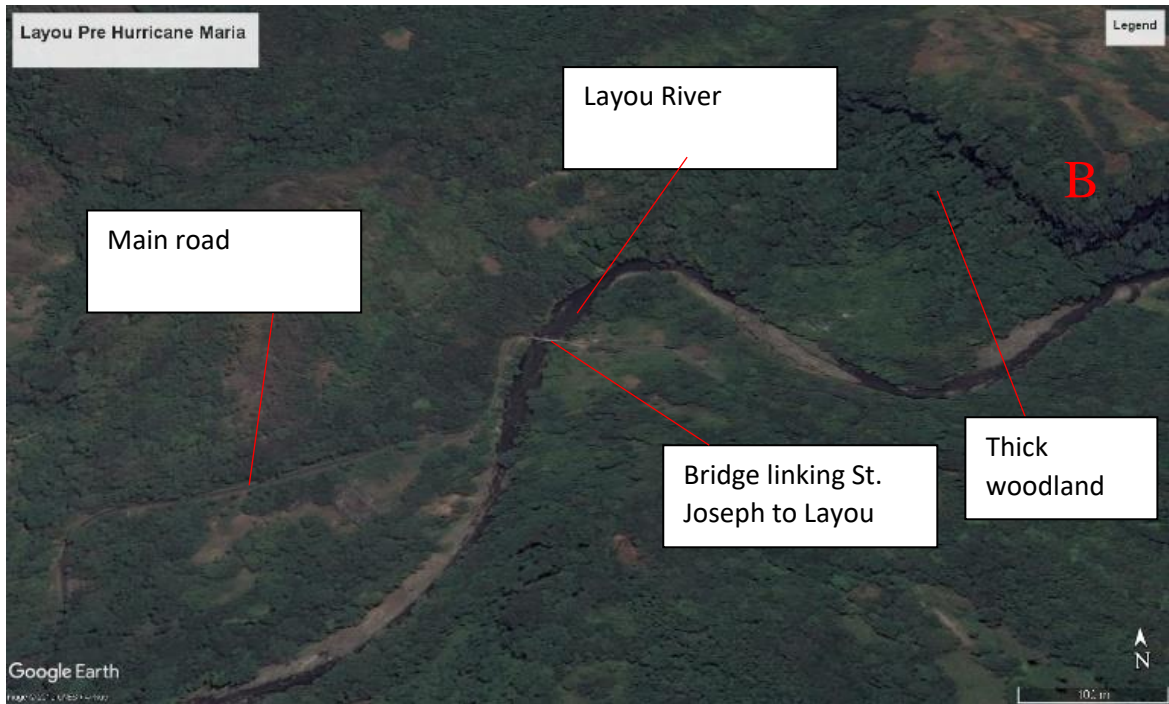
Figure 5.3 B: Google Earth images before the Hurricane Maria event for Layout (Dominica)

Layou Valley and its environs were devastated by numerous landslides, debris flow and severe flooding. Plantations such as cocoa, banana and other crops were destroyed completely, majority of livestock were killed as well. Situated in low-lying lands, Layou was always susceptible to flooding but torrential rainfall during Hurricane Maria coupled with the collapse of Matthieu Dam meant that Layou was submerged in water and debris. Layou was one the severely damaged towns as most houses were filled with water for days (Figure 5.3 A-D). Roads linking Layou with other towns such as Mero, Mahaut, Warner and St. Joseph were either eroded away or blocked by massive landslides and rockfalls (Figure 5.3 A-D). Just like Delice and Coulibistrie, there was no electricity or supply of clean water and other infrastructures were destroyed.

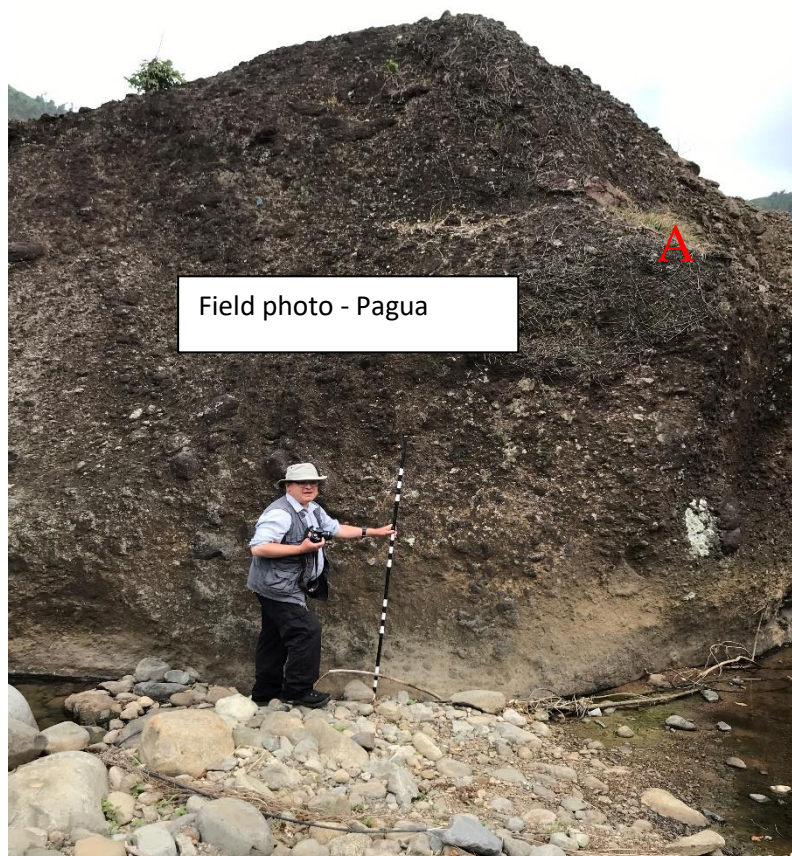
Figure 5.4 A: Field image showing deep-seated giant boulder (10 m), small to medium boulders (0.4-7 m) and supervisor with 2 m rod as scale at Pagua (Dominica).

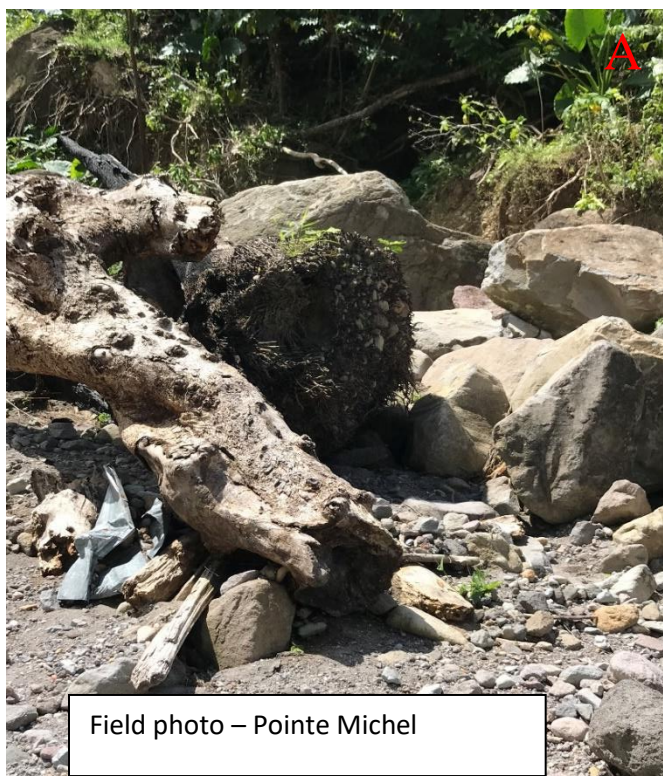
Figure 5.5 A: Field image showing deposit of tree debris (0.5-2 m) and cluster of boulders (0.5-1.5 m) at Pointe Michel (Dominica).

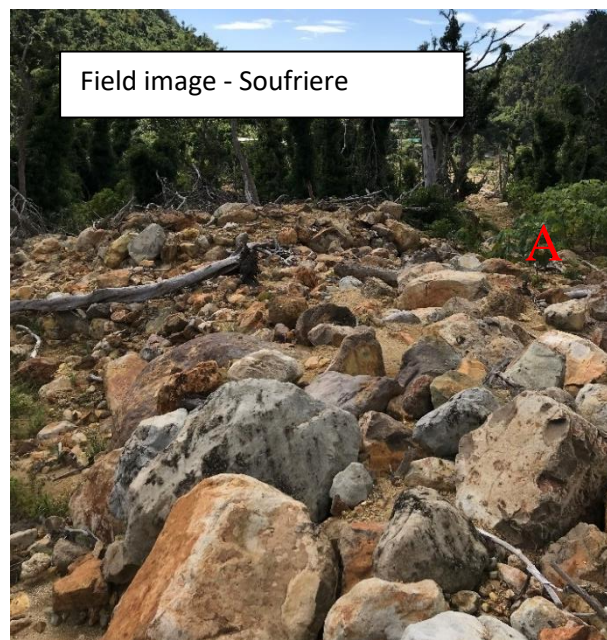
Figure 5.6 A: Field image showing deposit of tree debris (0.5-2 m) and cluster of boulders (0.5-1.5 m) at Soufriere (Dominica).

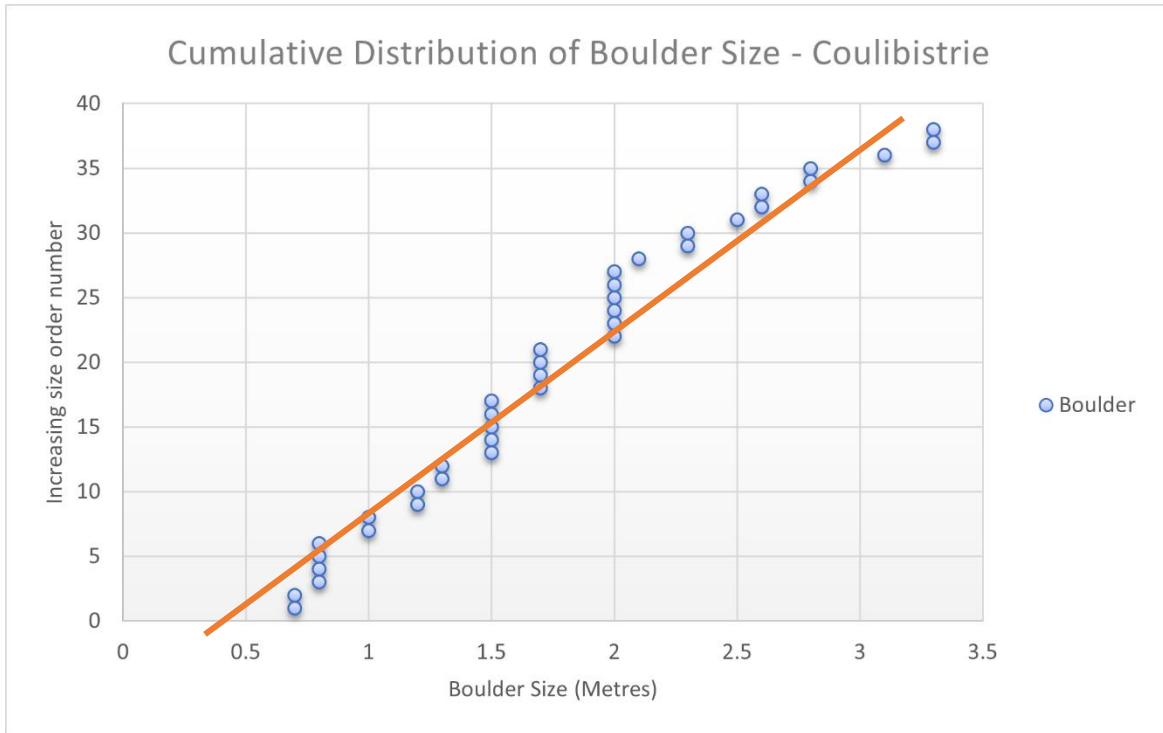
Figure 5.7: Results of ImageJ boulders analysis for Coulibistrie (Dominica) showing the sizes (m) and number of boulders.

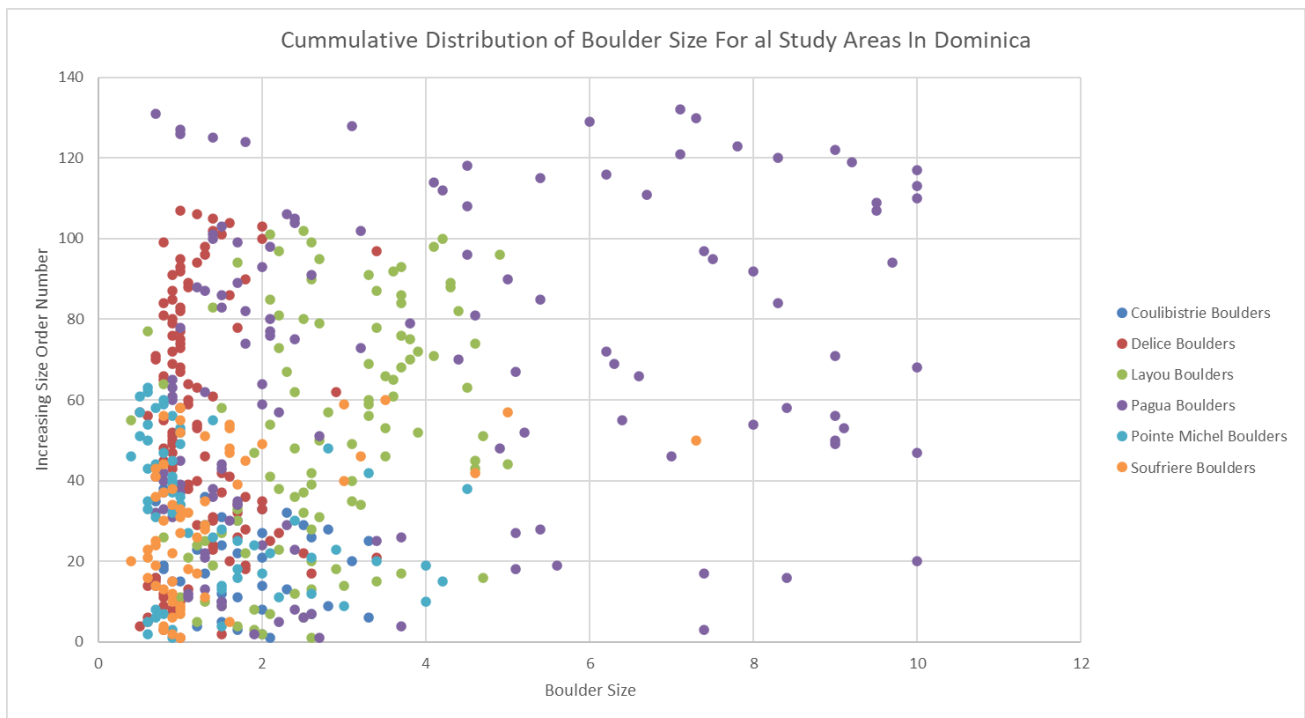
Figure 5.13: Results of ImageJ boulders analysis for all study areas in Dominica showing the sizes (m) and number of boulders.

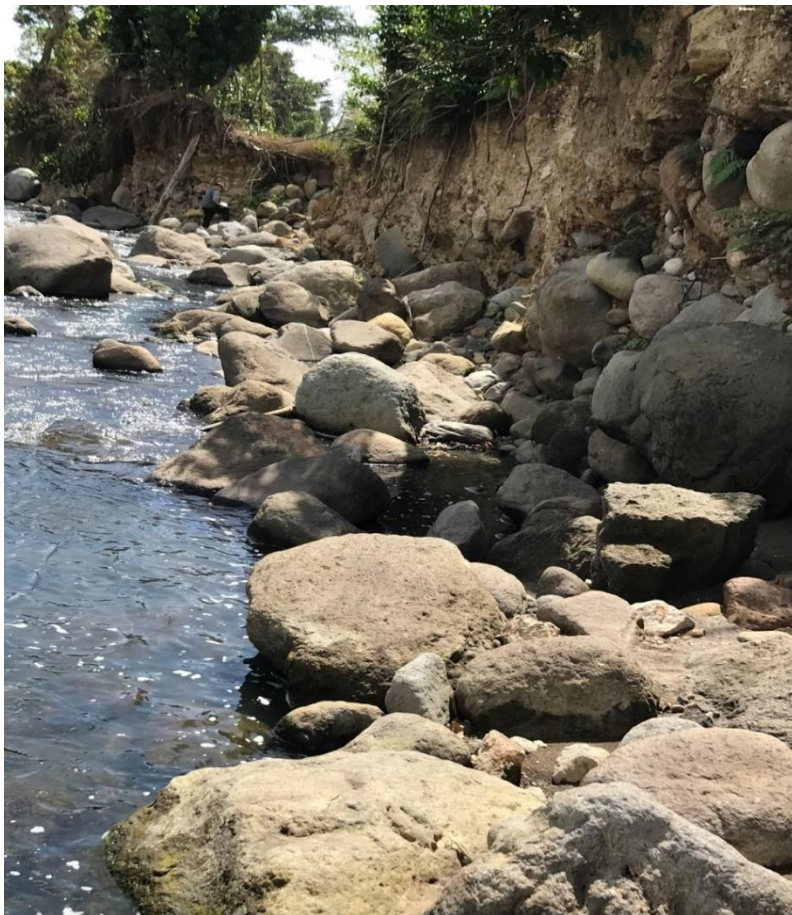
Figure 5.15: Delice River field photograph showing lateral deposition of boulders (0.5-3.4 m in diameter) from the riverbank failure caused by excessive force of the flow and hydraulic toe erosion undercutting the river-bank during Hurricane Maria. River flows from right to left from the viewer.
