**Using Low-Cost Remote Sensing Data for Geohazard Modelling
and Analysis in Small Island Developing States (Examples of
Dominica and Cape Verdes).**

PhD Geology

**Submitted to Department of Earth and
Planetary Sciences, Birkbeck University of
London**

July 2021.

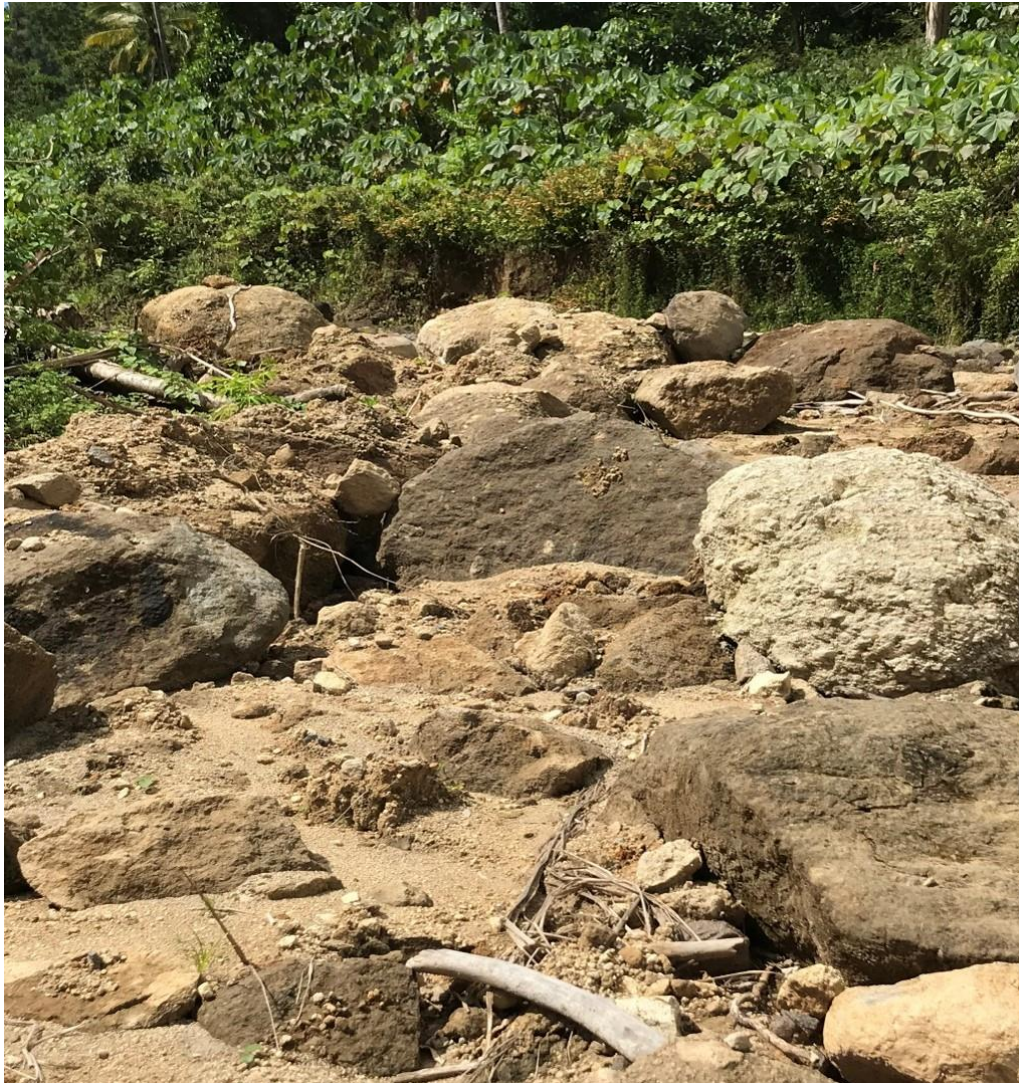
Figure 5.16: Layou River field photograph showing deposit of hydrothermally altered boulders (0.4-7.3 m diameter).

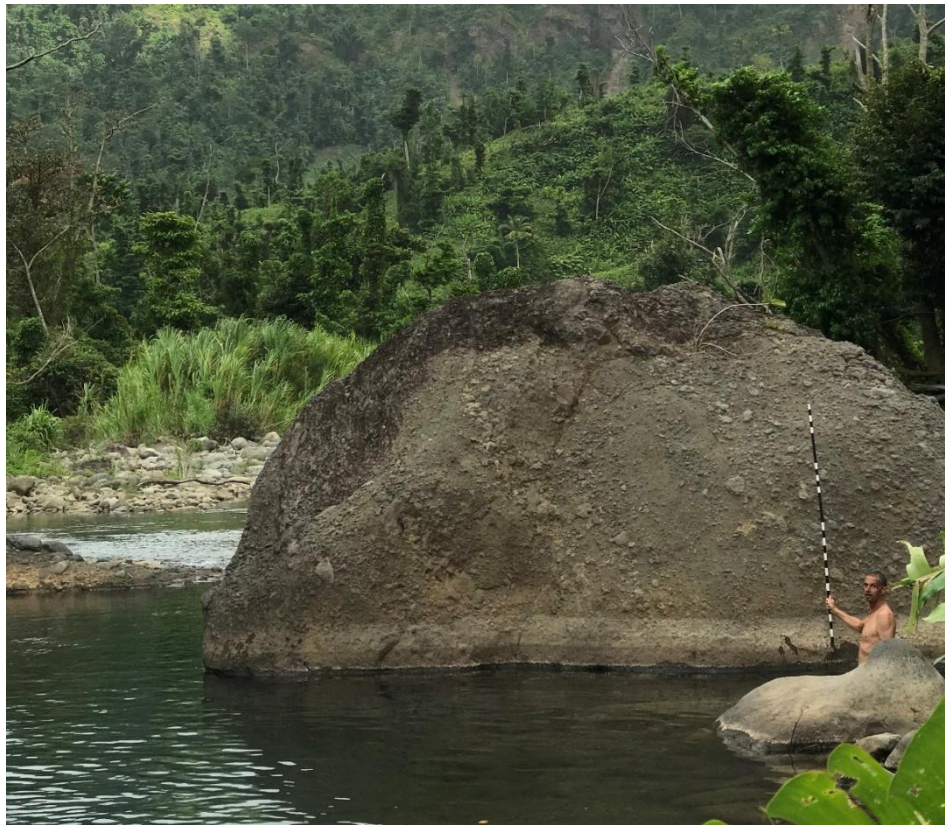
Figure 5.17: Pagua River field photograph showing deep-seated giant boulder (0.5-10 m in diameter) in the river-bed and 2 m rod as scale. The boulder is a conglomerate of pumice and volcanic clasts and river flows from left to right. The boulder pre-dated Hurricane Maria but may block the stream flow when tree debris and other sediments pile-up behind it which may result in overbank flooding.

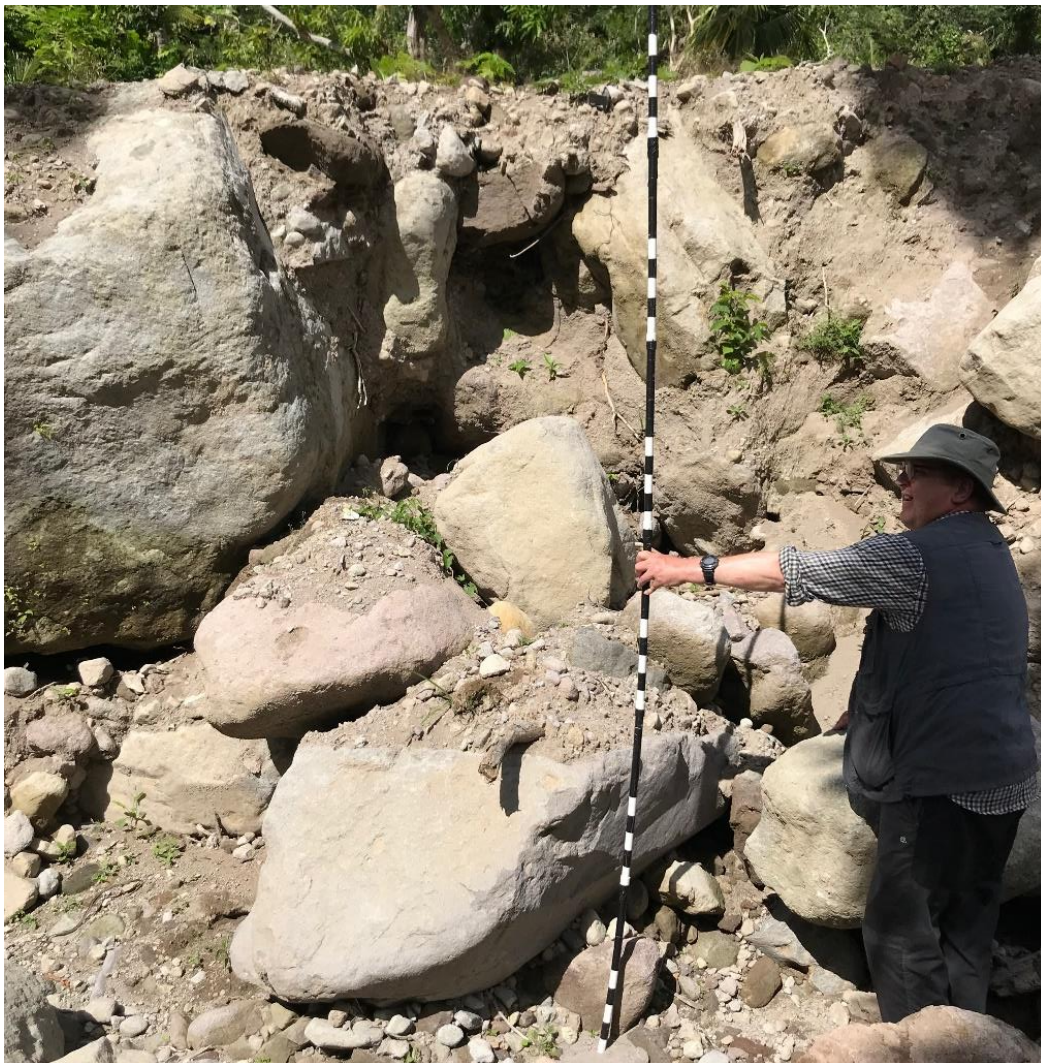
Figure 5.18: Pointe Michel field photograph showing Hurricane Maria debris flow deposit of boulders (0.4-4.5 m in diameter).

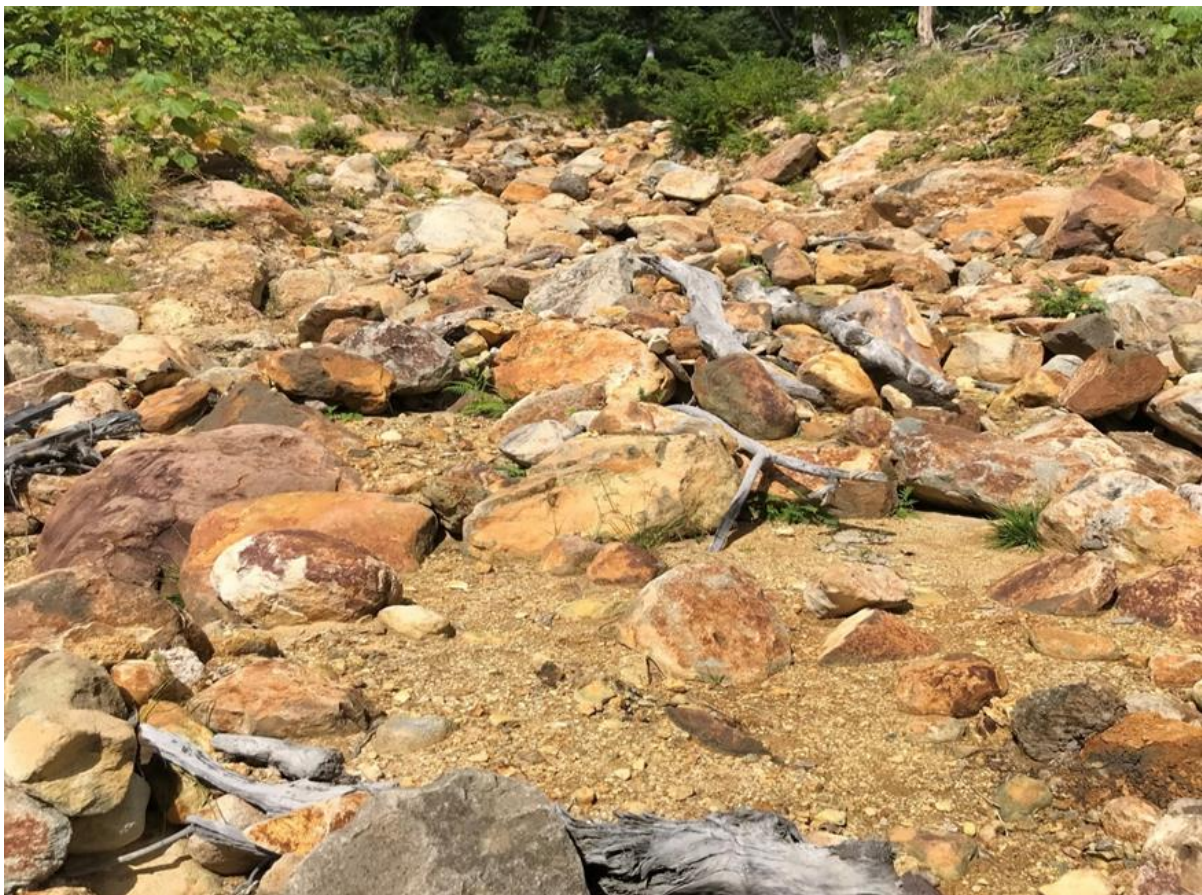
Figure: 5.19: Soufriere field photo showing Hurricane Maria debris flow deposit of cluster of hydrothermally altered boulders (0.4-7.3 m in diameter) mixed with clay, tree debris and cobbles.

Soufriere was characterised by a rainfall-induced landslide which occurred during Hurricane Maria and turned into a debris flow. The material transported by the debris flow included clay, tree debris, giant boulders, gravels and cobbles (Figure 5.19). Most of the boulders were yellowish, poorly sorted, very angular and about 0.4-7.3 m in diameter (Figure 5.19). Most of the boulders were hydrothermally altered because Soufriere is situated in an area of hot springs which is evident in the yellow colour of boulders. Some of boulders were yellowish-green which may have been altered by degassing of sulphur from fumaroles.

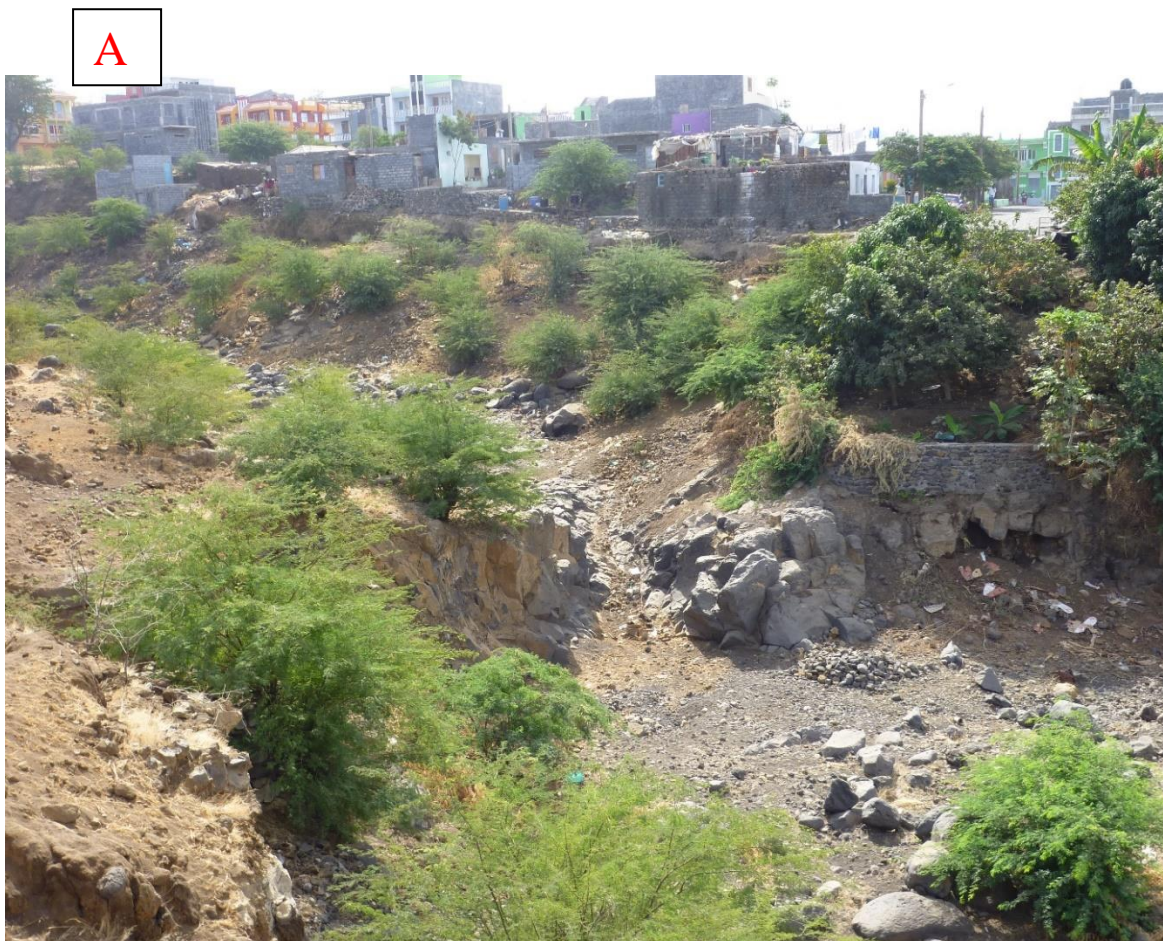
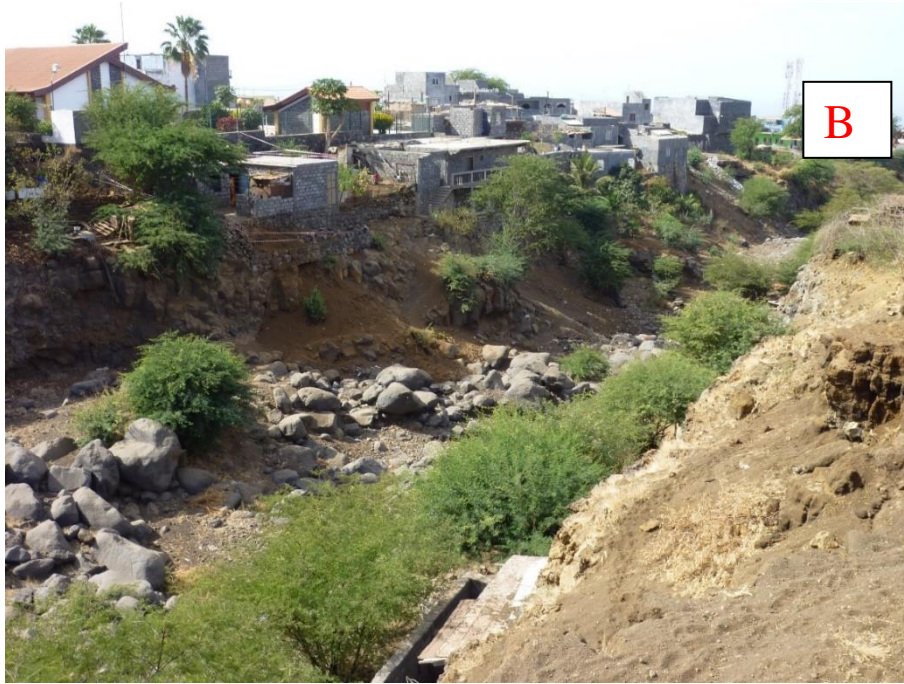
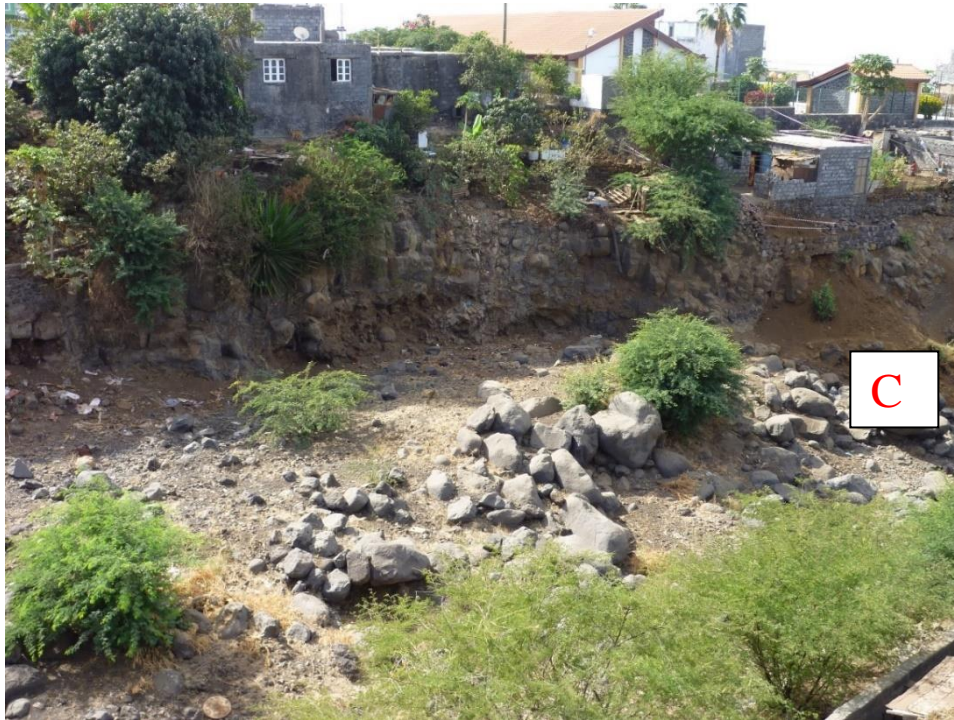
Figure 5.20 A, B and C: Field photos of the western part of Ribeira Domingo Santo (Fogo), showing settlements situated laterally on the edge of channel's left bank. The buildings are on an unstable slope made of layers of boulders (0.5-1 m) which are being eroded and deposited into the channel bed. Direction of the channel and buildings is north to south of Ribeira Santo Domingo (Cape Verde, Fogo).

Maria in Cape Verde. However, due to the large size of Ribeira Santo Domingo, the drone-derived orthophotograph data was about 2.5 Gb. This data size was too big for the capability of the image analysis software ImageJ. It was not possible to reduce the data size as it reduces the image quality and affects the accuracy of the results. However, images taken during the fieldwork indicated that livelihood, the built and natural environment of Ribeira Santo Domingo are at risk of movements of boulders should there be an event like Hurricane Maria or Tropical Storm Fran (Figure 5.20 A - C).

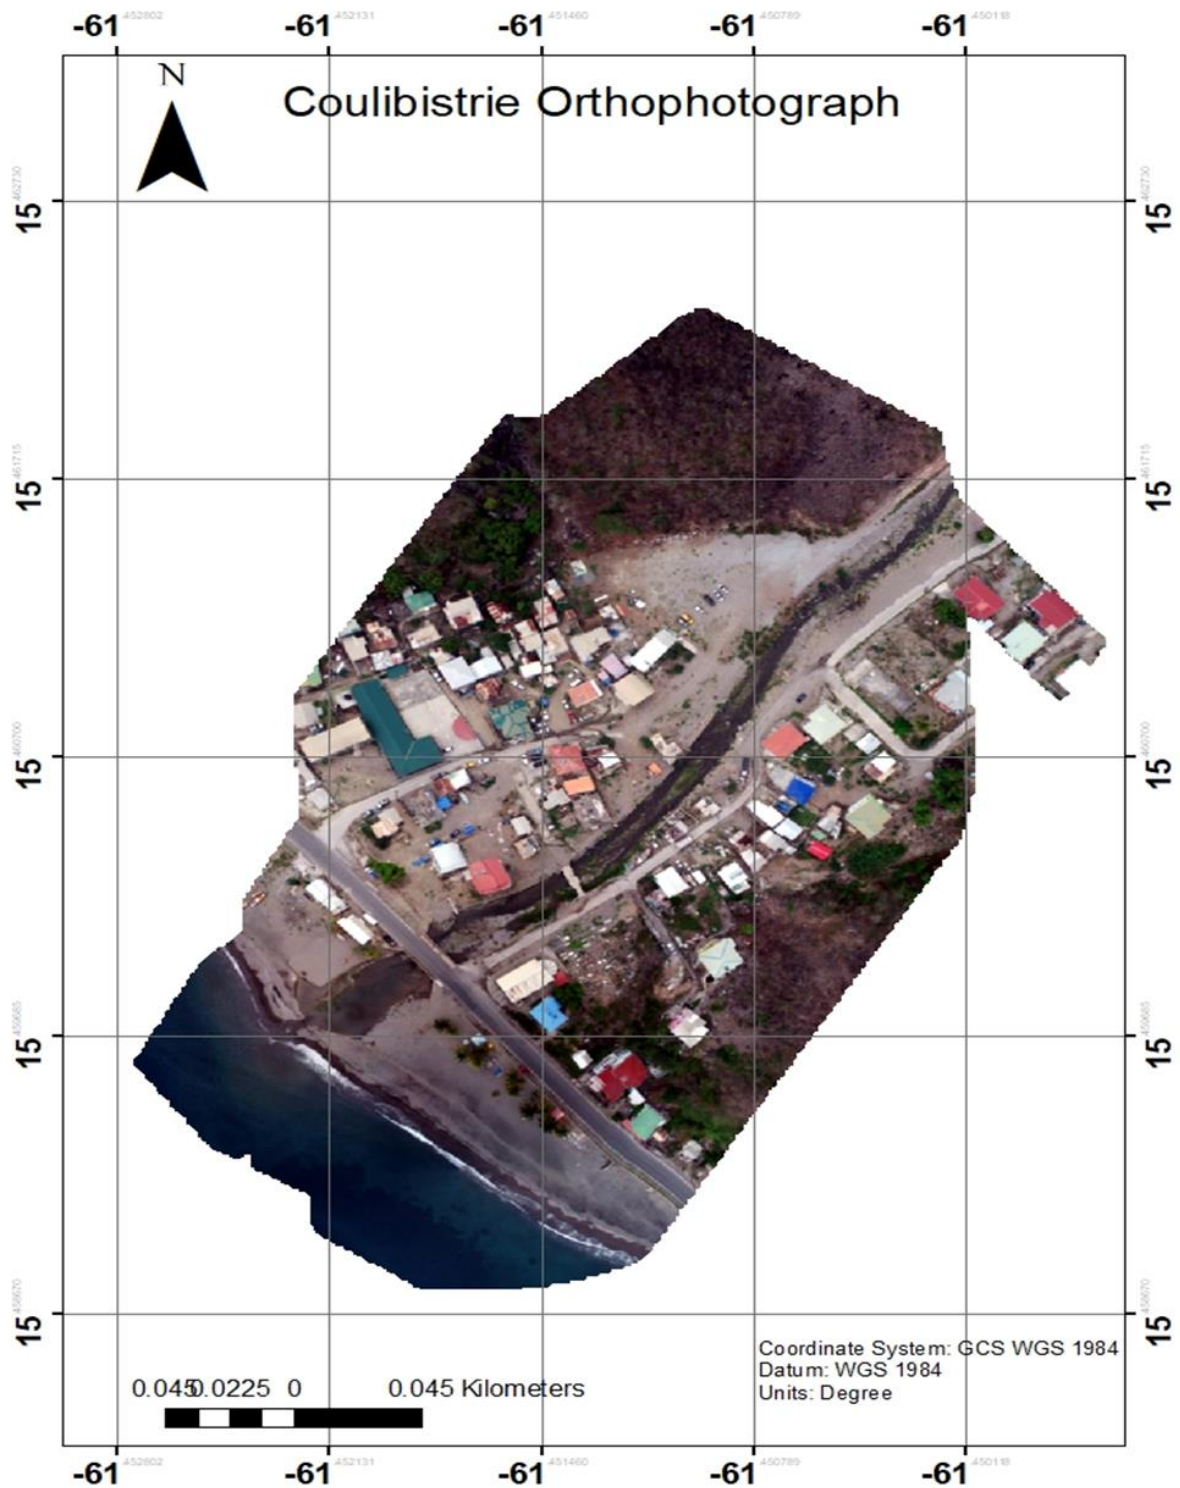
Figure 5.22: Drone-derived orthophotograph for Coulibistrie, showing destruction caused by Hurricane Maria.

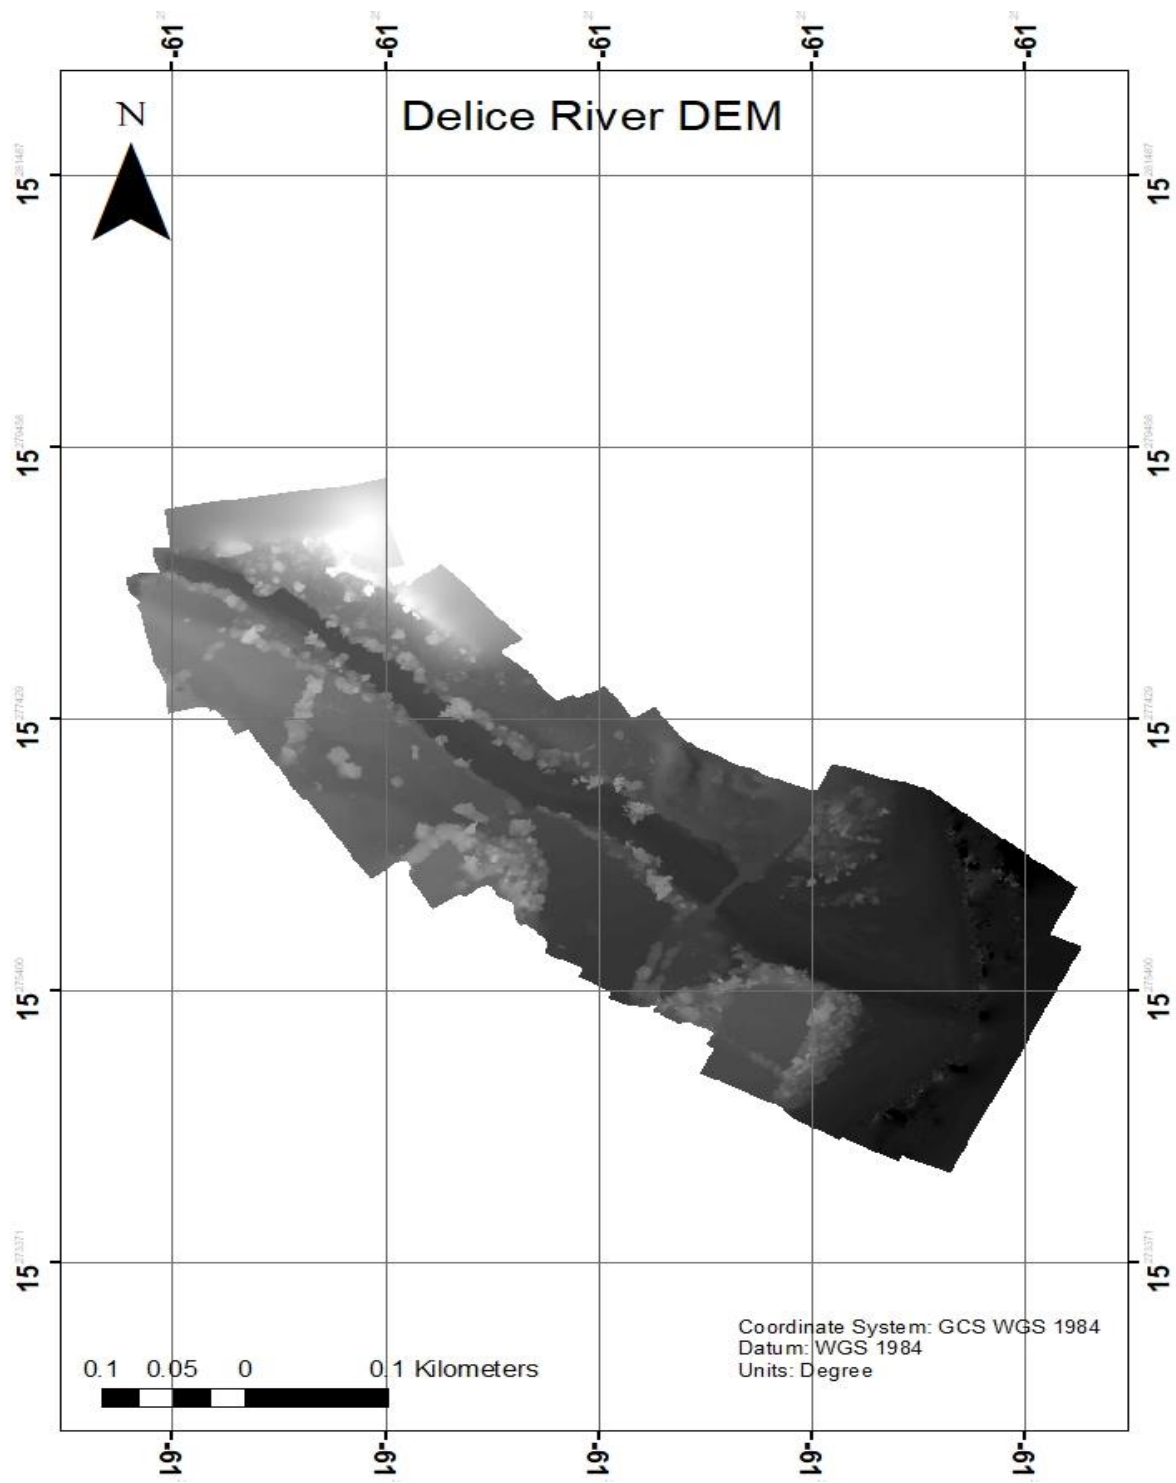
Figure 5.23: Drone-derived DSM for Delice showing areas of low elevation in dark and high elevation in grey.

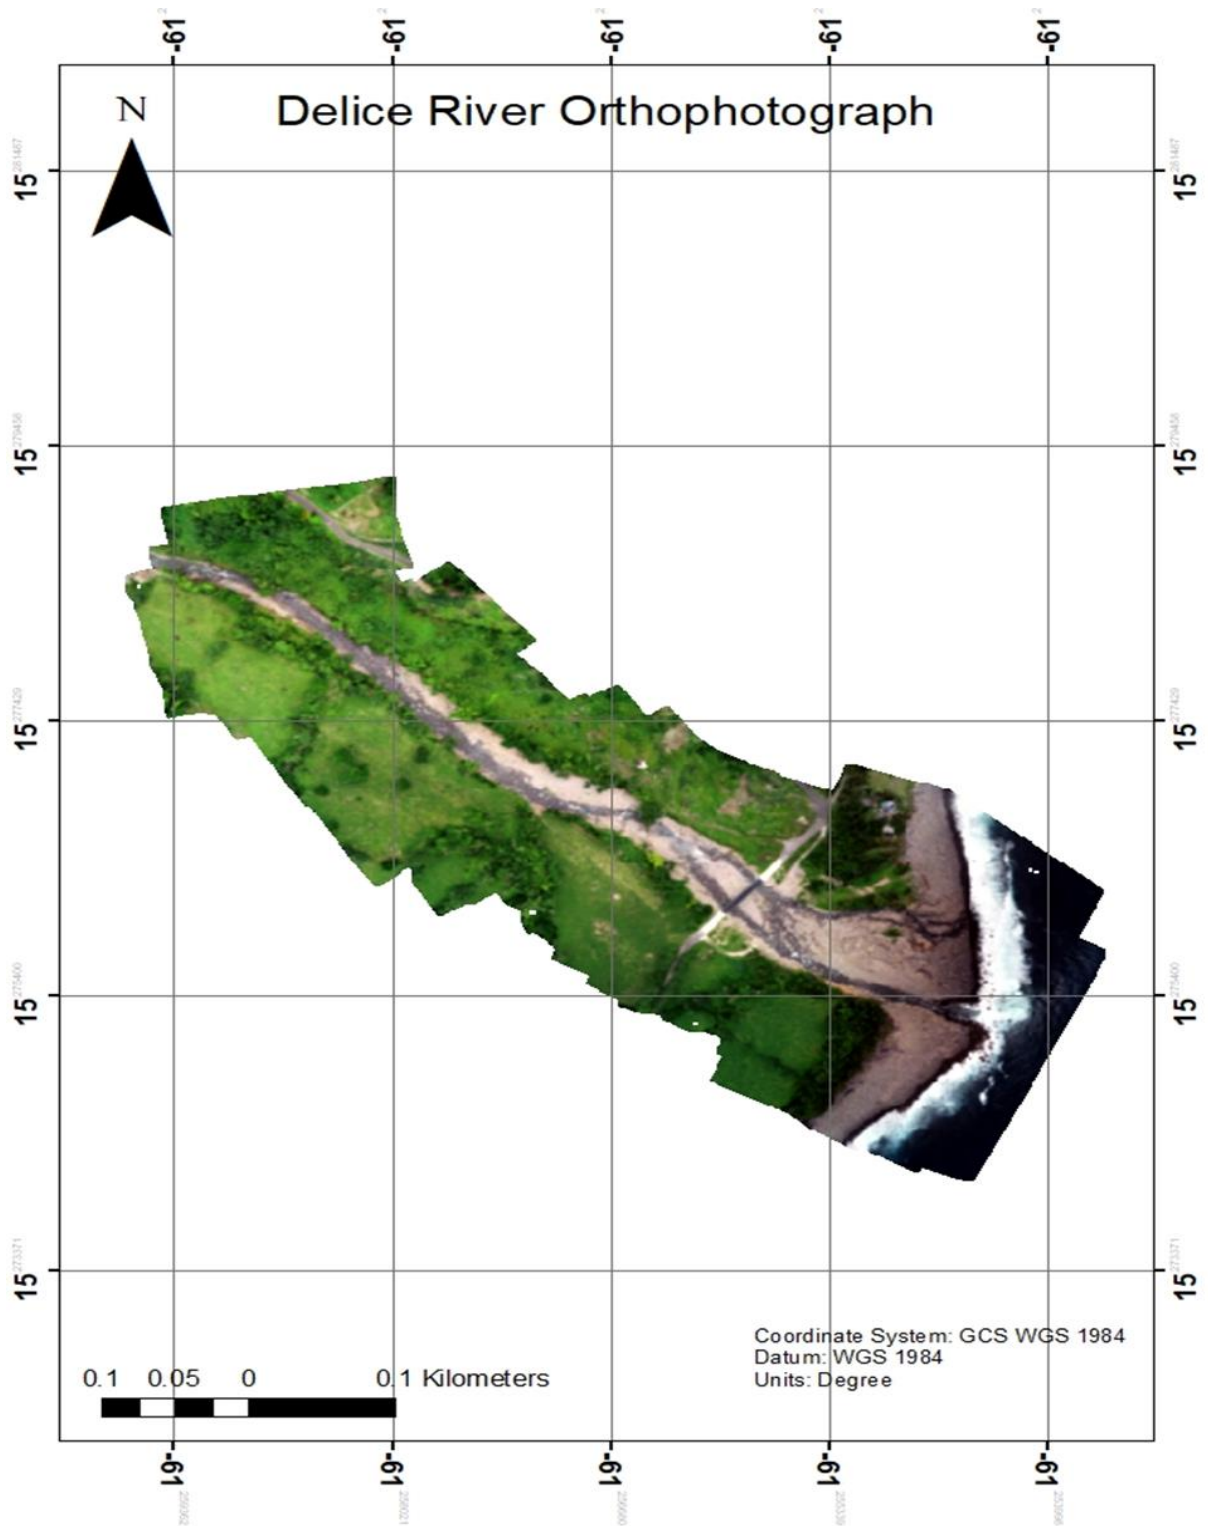
Figure 5.24: Drone-derived orthophotograph for Delice, showing devastation of Hurricane Maria on infrastructure and farmlands.

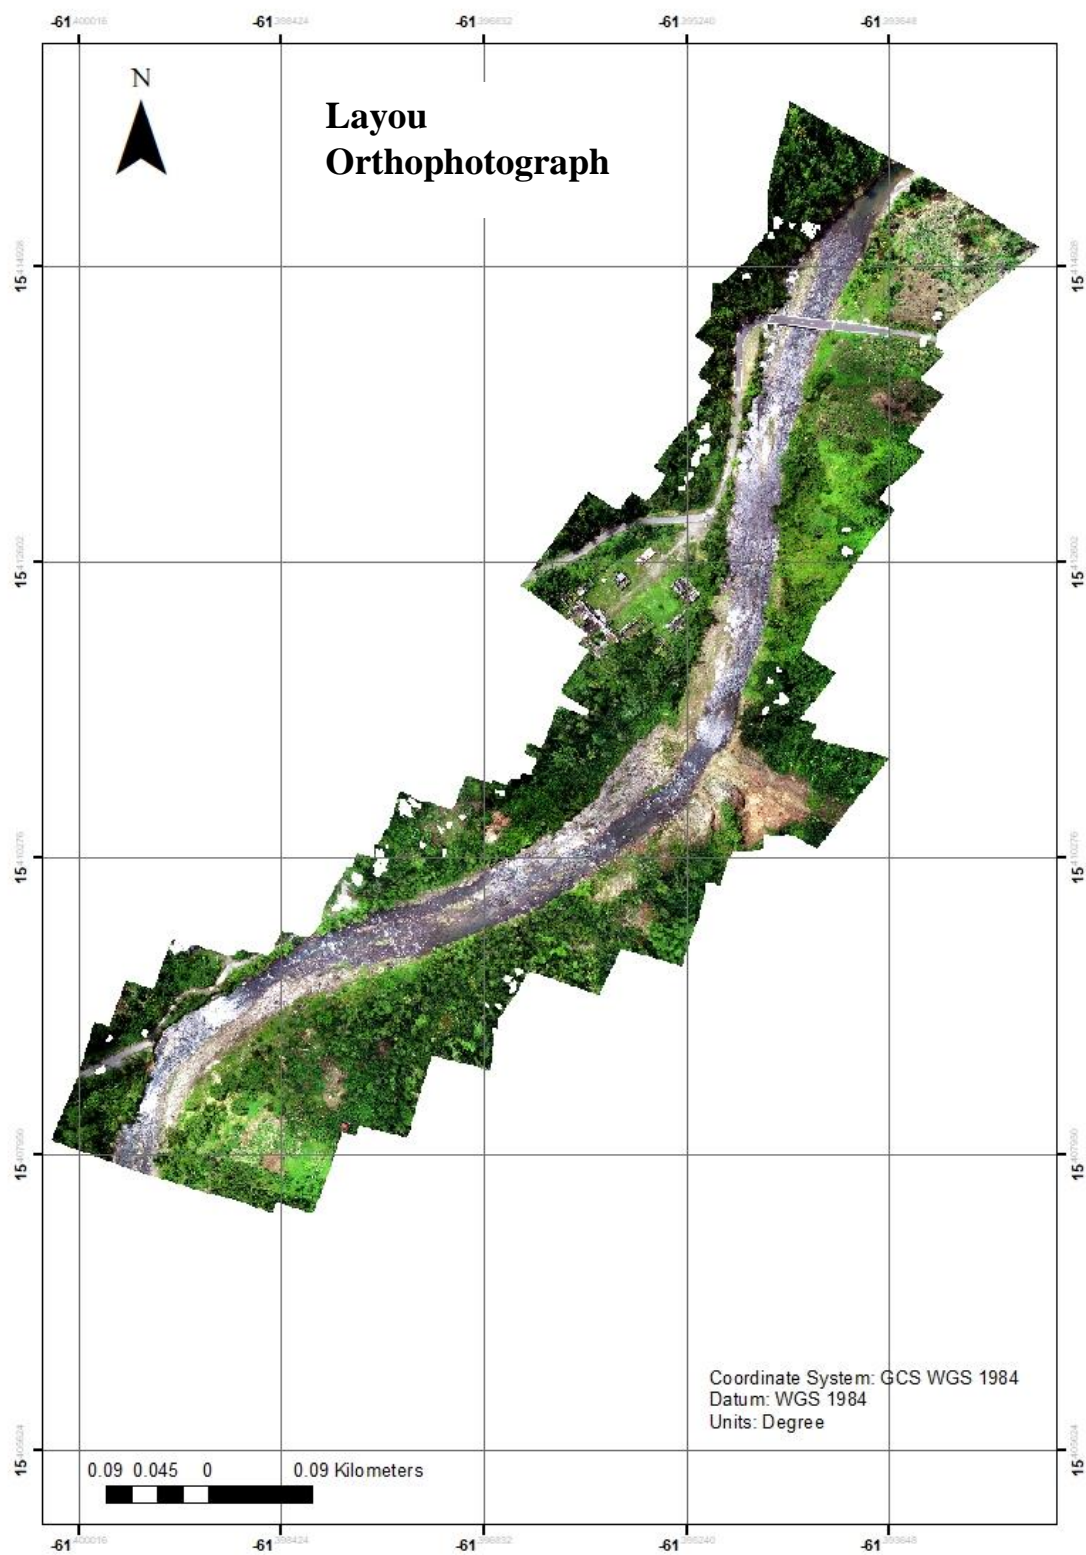
Figure 5.26: Drone-derived orthophotograph for Layou, showing post-Hurricane Maria destruction

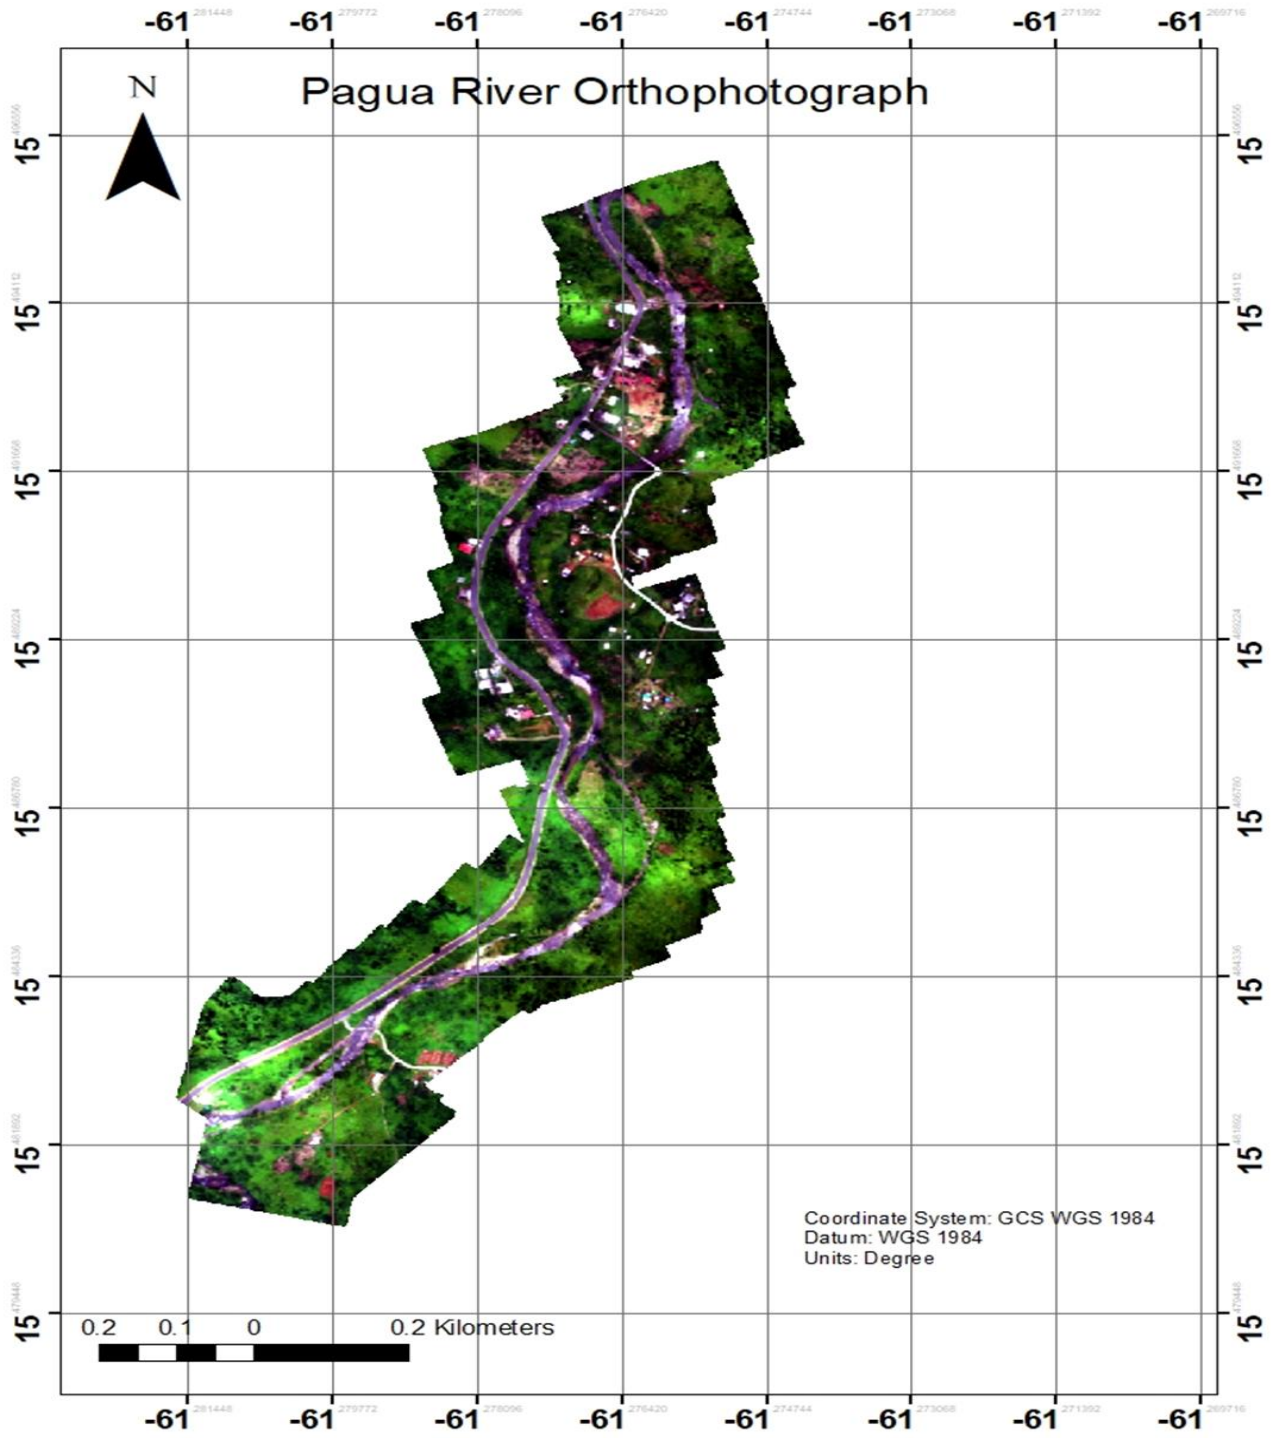
Figure 5.28: Drone-derived orthophotograph for Pagua, showing damage caused by Hurricane Maria.

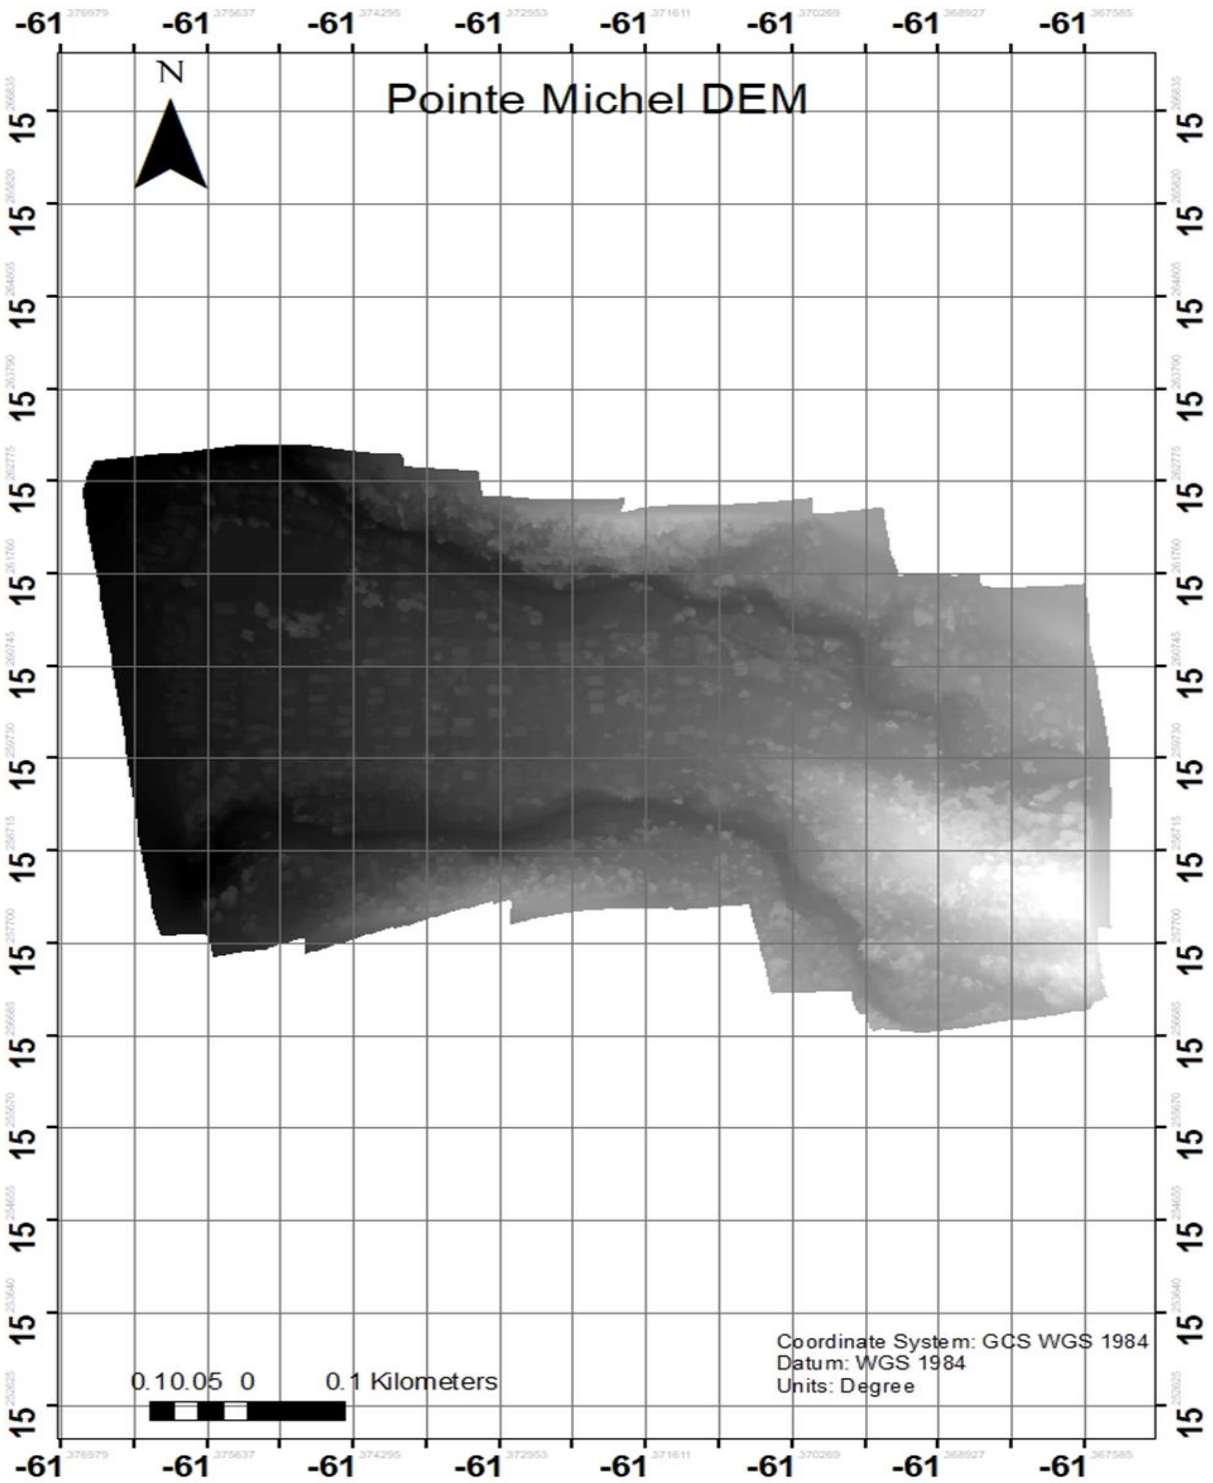
Figure 5.29: Drone-derived DSM for Pointe Michel, showing areas of low elevation in dark and high elevation in grey.

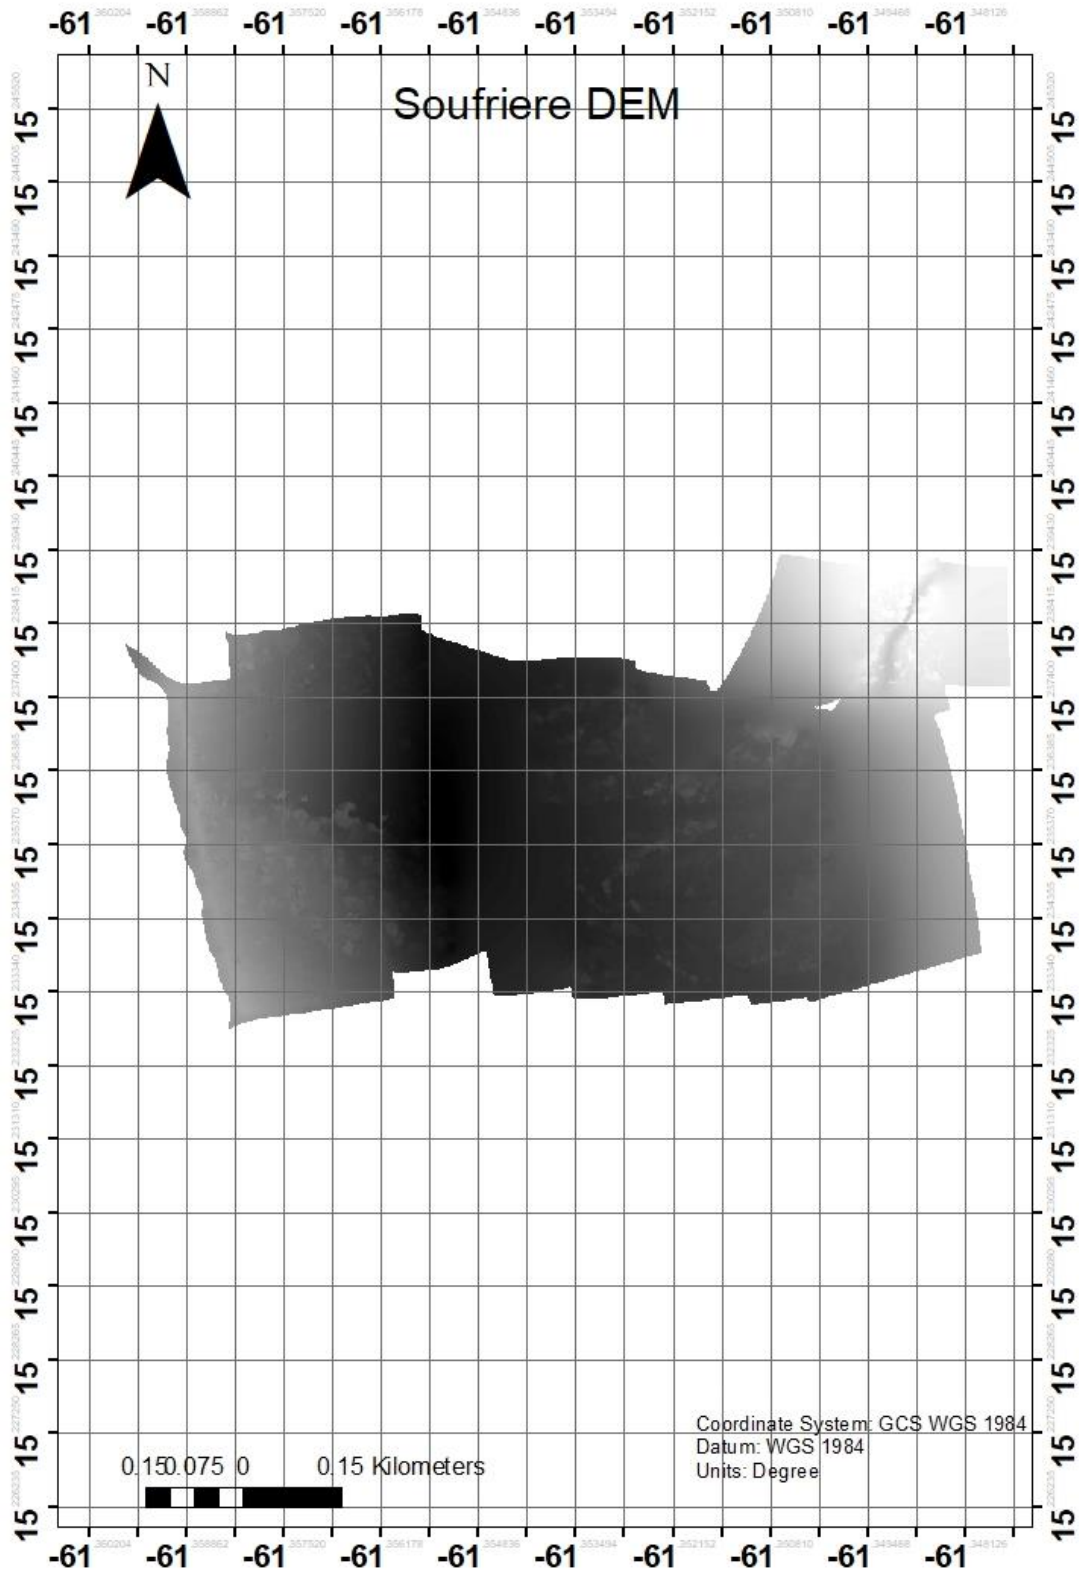
Figure 5.31: Drone-derived DSM for Soufriere showing areas of low elevation in dark and high elevation in grey.

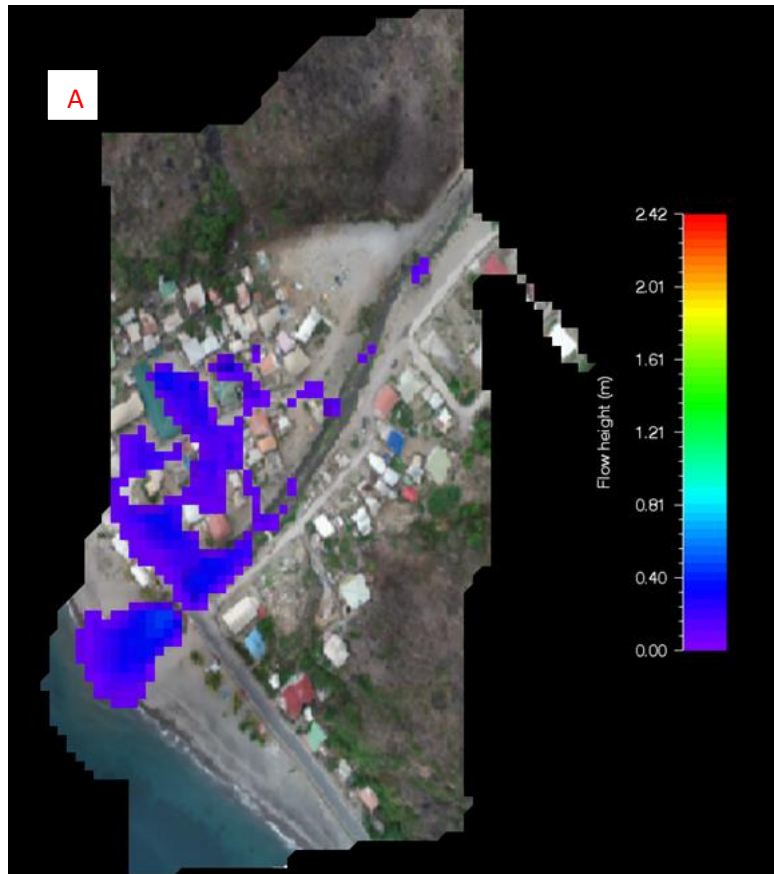
Figure 6.4: Results of RAMMS debris flow modelling for Coulibistrie (Dominica), (A) Variations in flow height (in m); (B) flow velocity (in m/s) over the whole drainage area.

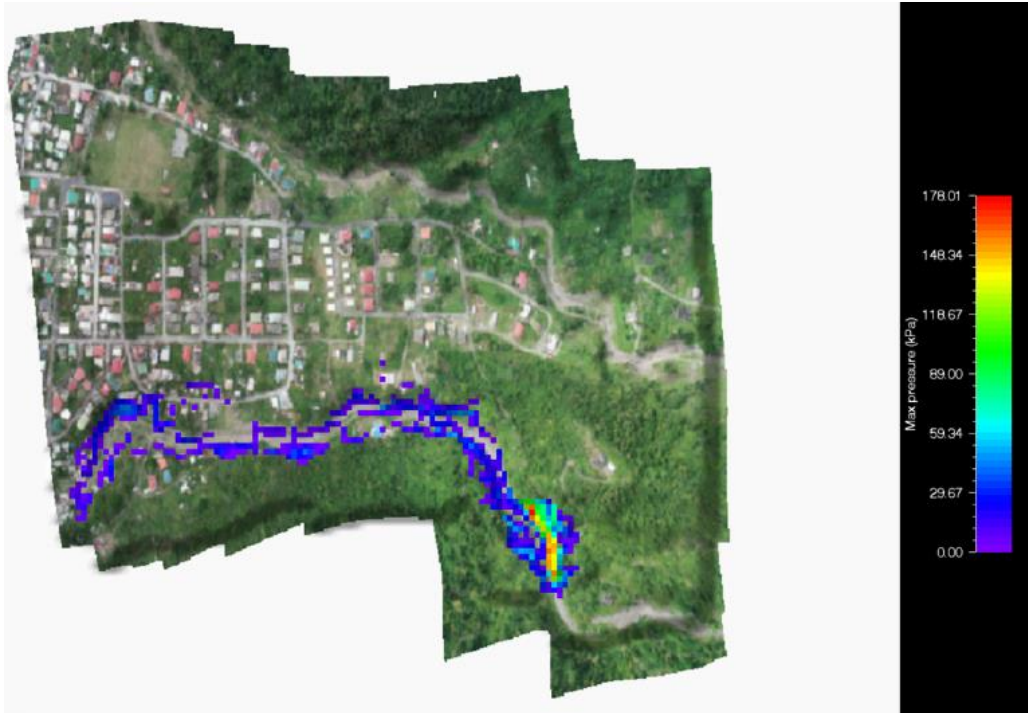
C

Figure 6.8: RAMMS debris flow simulation of Pointe Michel South

(Dominica); (C) flow pressure (in Pa), (D) flow entrainment (in m^3) over the whole drainage area.

Figure 6.8 and Table 6.10 report the results of RAMMS debris flow modelling of the point Michel South region of Dominica. Flow height of simulation was high throughout the channel, mainly within the channel-bed. Low flow heights were recorded at both channel banks and inland (Figure 6.8 A). The highest velocity was recorded at the flow release area and lowest velocity was recorded at the flow deposition area. Flow velocity direction of the velocity was north-west of the channel (Figure 6.8 B). High pressure areas were at the upper part of the channel, specifically the right bank of the channel. Most of the impact pressures were around the channel banks with some inland (Figure 6.8 C).

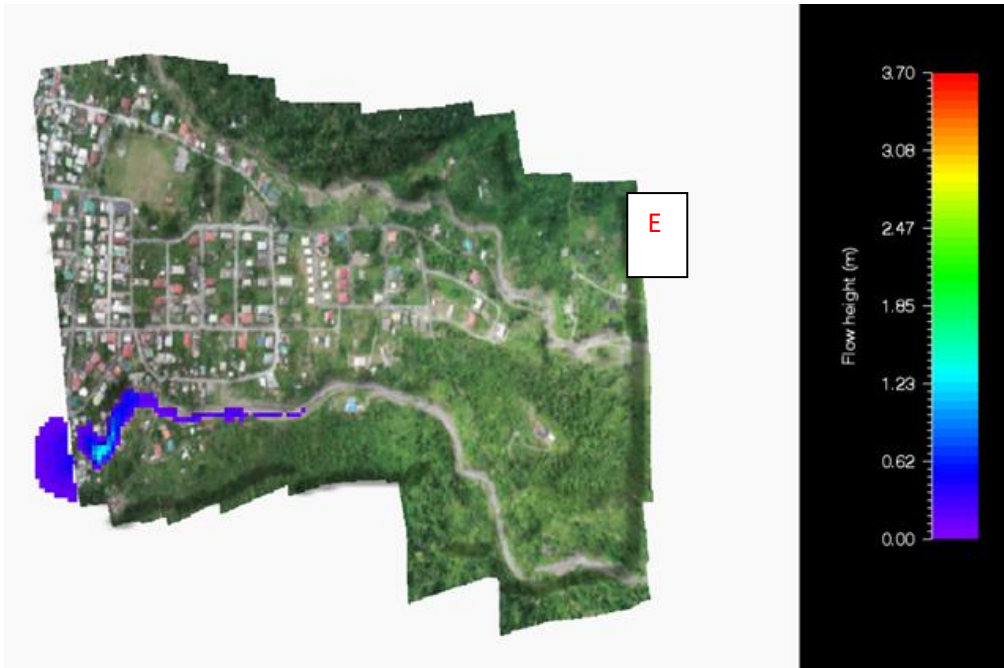
Figure 6.8: RAMMS debris flow simulation of Pointe Michel South (Dominica), (E) flow deposition (in m³) and (F) flow momentum (in m/s) over the whole drainage area.

Depositional volume of the simulation was 13737 m³ (Figure 6.8 E). That is a decrease of 3212 m³ from the total flow volume of 16948 m³ representing 82% of the flow volume. Flow direction was north-west of the channel. Most of the flow went under the bridge and deposited downstream into the Caribbean Sea. Some of the flow was deposited behind the bridge and top

There was a rise and fall of the flow momentum from the initiation area to the transition area and this decreased steadily to the deposition zone (Figure 6.8 F). Flow volume was 8158 m³ at 0.1s. Flow volume then increased rapidly from the point of initial to the transition point and relatively remaining at same level to the point of deposition.
