**Using Low-Cost Remote Sensing Data for Geohazard Modelling
and Analysis in Small Island Developing States (Examples of
Dominica and Cape Verdes).**

PhD Geology

**Submitted to Department of Earth and
Planetary Sciences, Birkbeck University of
London**

July 2021.

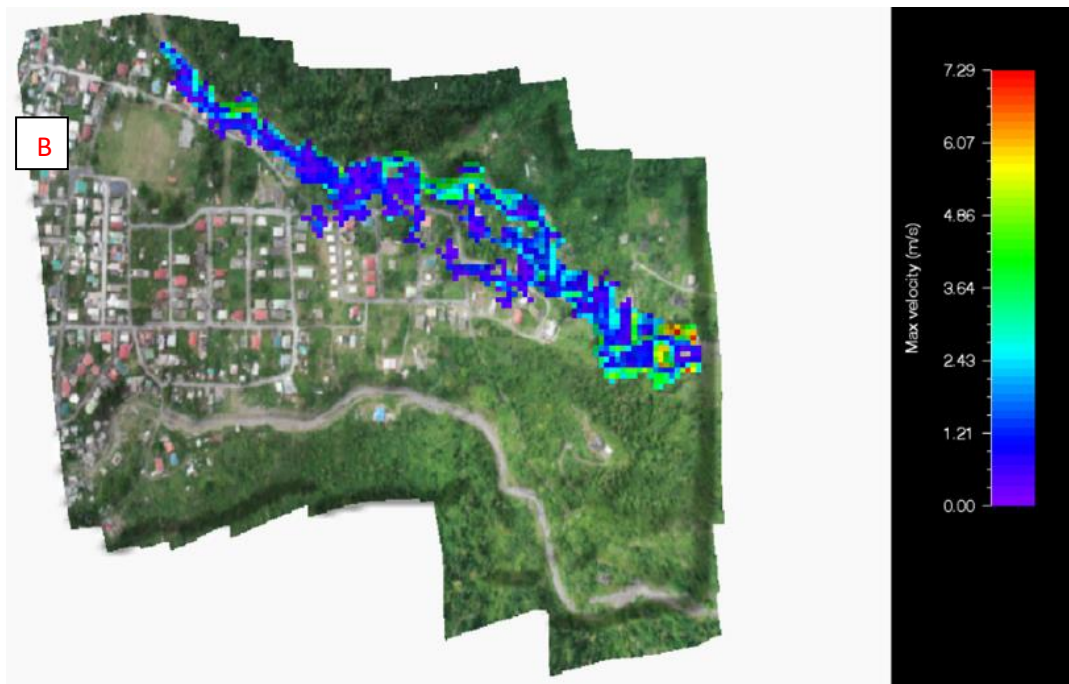
Figure 6.9: RAMMS debris flow simulation of Pointe Michel North (Dominica), (A) Variations in flow height (in m); (B) flow velocity (in m/s) over the whole drainage area.

All results for the debris flow simulation of Point Michel North are shown in Figure 6.9 and Table 6.11. Flow height of simulation was high throughout the channel, mainly within the channel-bed. Low flow heights were recorded at both channel banks and inlands (Figure 6.9 A). Highest velocity was recorded at the flow release area and lowest velocity was recorded at the flow deposition area. There was variation of flow velocities throughout the channel and velocity was mainly active within the channel-bed (Figure 6.9 B). The direction of the flow velocity was north-west of the channel (Figure 6.9 B). High pressure areas were at the upper part of the channel. The highest values of the impact pressures were within the channel bed with activities at both banks and inland (Figure 6.9 C).

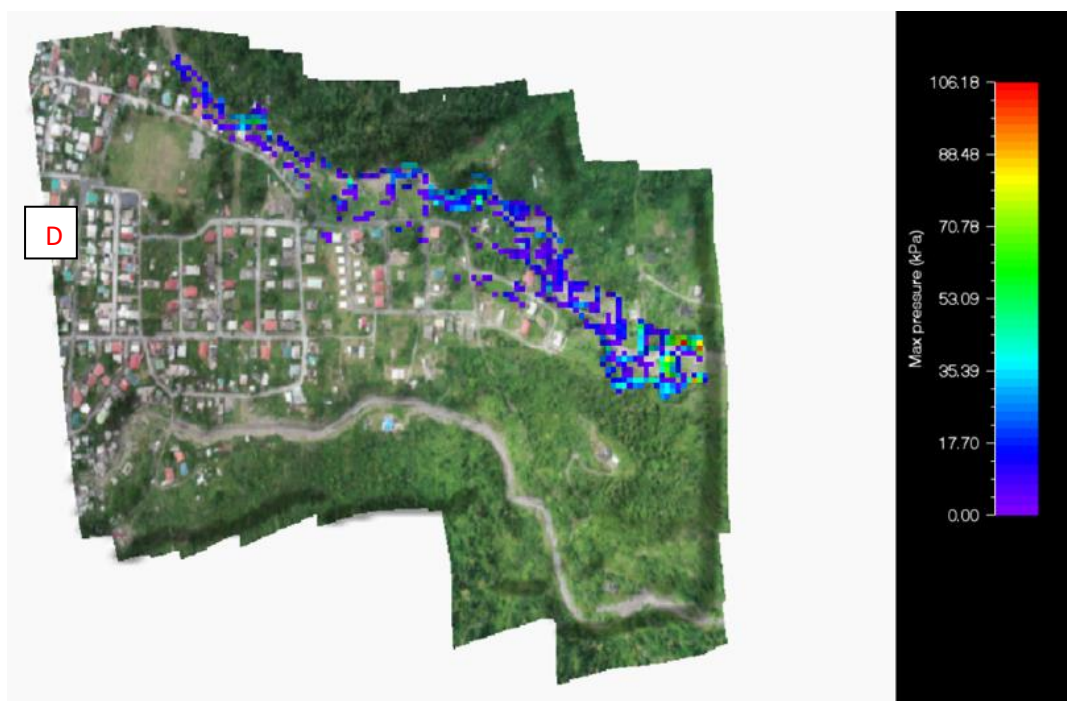
Figure 6.9: RAMMS debris flow simulation of Pointe Michel North (Dominica), (C) flow pressure (in Pa), (D) flow entrainment (in m³) over the whole drainage area.

Entrainment volume after the simulation was 6168 m³ and entrainment basically occurred throughout the channel from flow release area to flow deposition area (Figure 6.9 D). Entrainment was highest in the channel-bed from upstream to downstream. The channel contained sand, gravels, cobbles and boulders coupled with tree debris. Total depositional

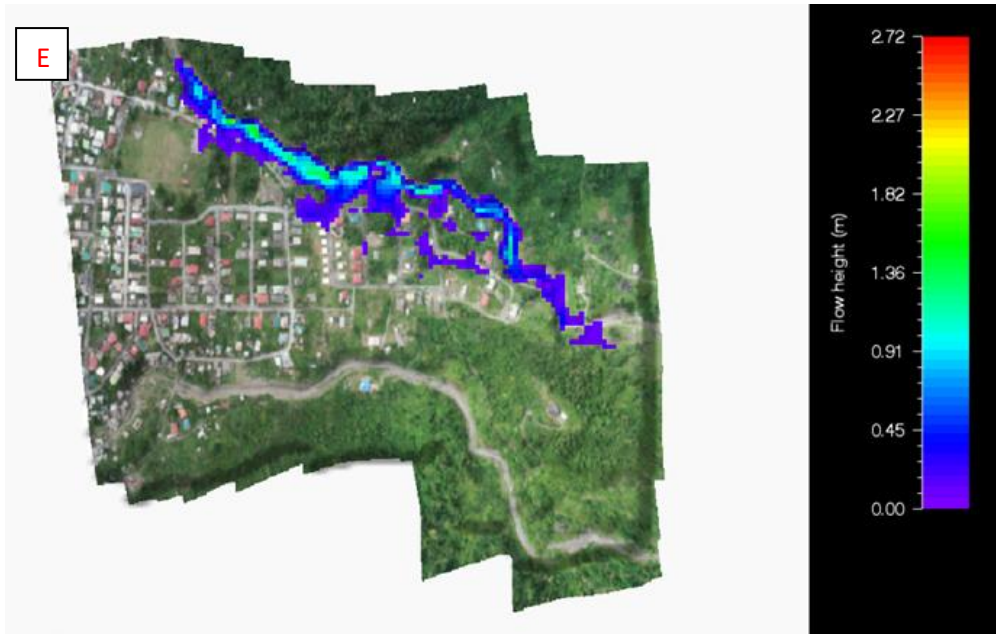
Figure 6.9: RAMMS debris flow simulation of Pointe Michel North (Dominica), (E) flow deposition (in m³) and (F) flow momentum (in m/s) over the whole drainage area.

volume of the simulation was 12932 m³ (Figure 6.9 E), thus a decrease of 1,925 m³ from the total flow volume of 14857 m³ representing 87% of the flow volume.

Flow direction was north-west of the channel. Most of the material was deposited downstream into the settlements (Figure 6.9 E). The rest of the flow was deposited around the inland buildings south-west of the channel. Momentum of the flow was approximately the same from the initiation area to the transition area and increased slightly to the deposition area (Figure 6.9 F). There was a gradual increase of flow volume from the initiation area to the deposition area.

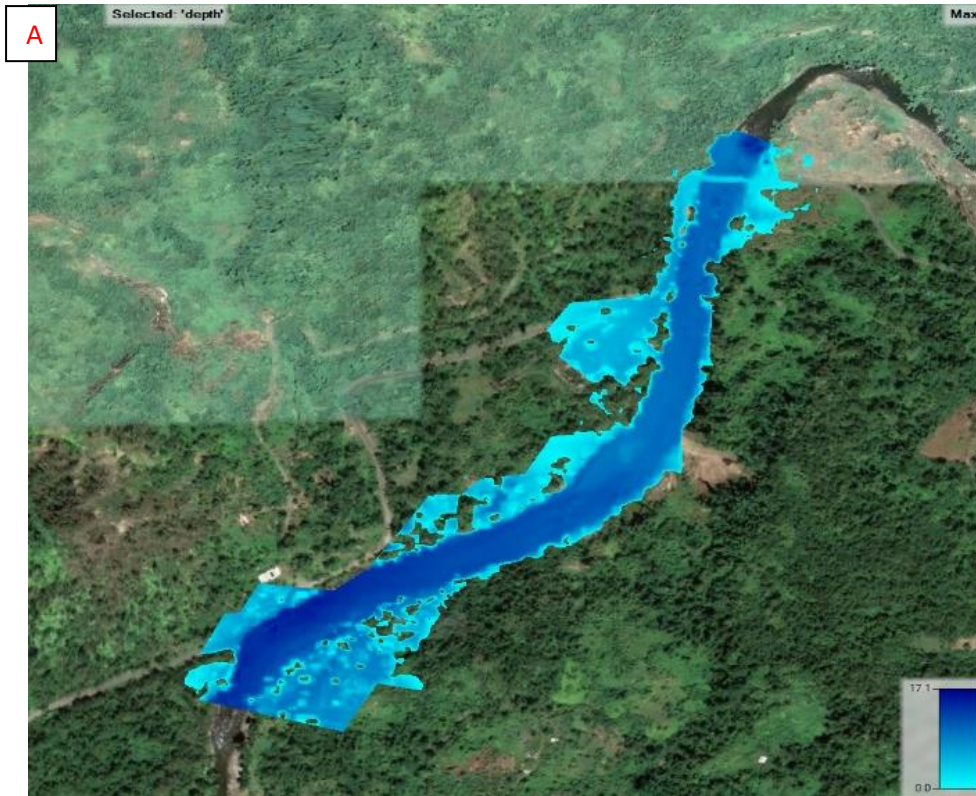
Figure 6.14 A: Results of HEC-RAS unsteady flow simulation for Delice (Dominica), showing variations in flow depth across the floodplain (in m)

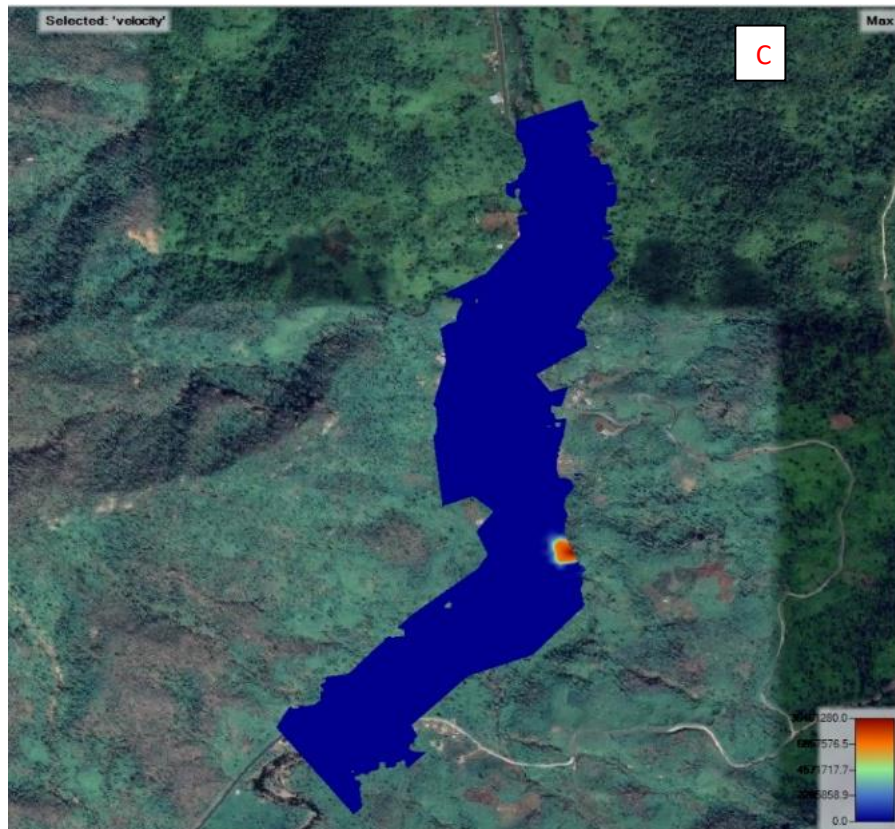
Figure 6.15 C: Results of HEC-RAS unsteady flow simulation for Pagua (Dominica), showing variations in flow velocity across the floodplain (in m/s).

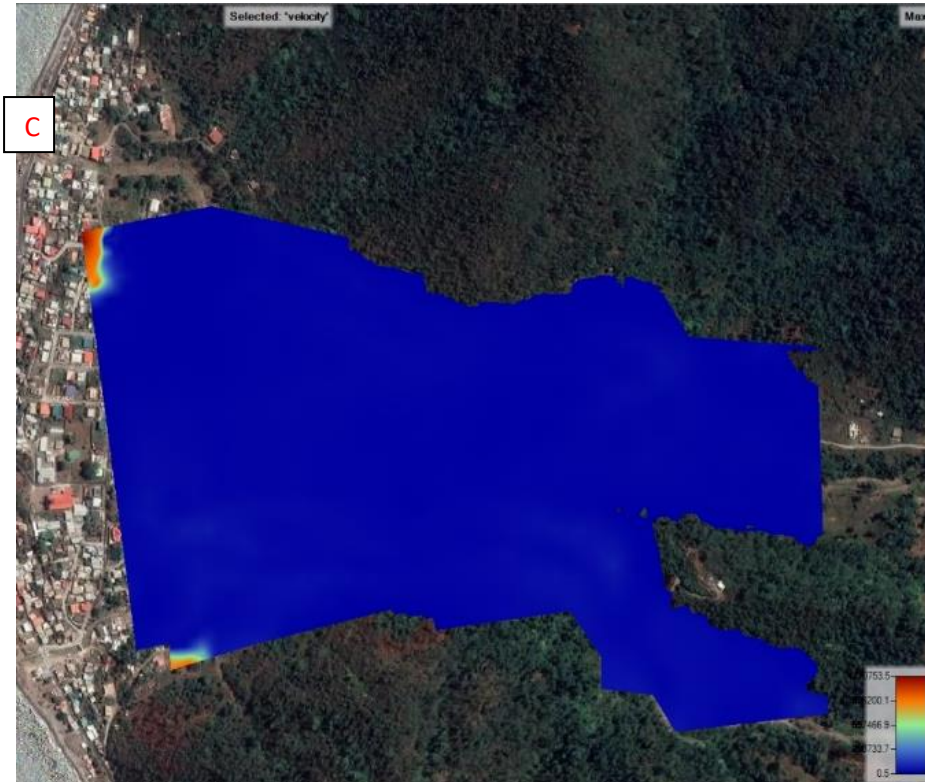
Figure 6.16 C: Results of HEC-RAS unsteady flow simulation for Pointe Michel (Dominica), showing variations in flow velocity across the floodplain (in m/s)

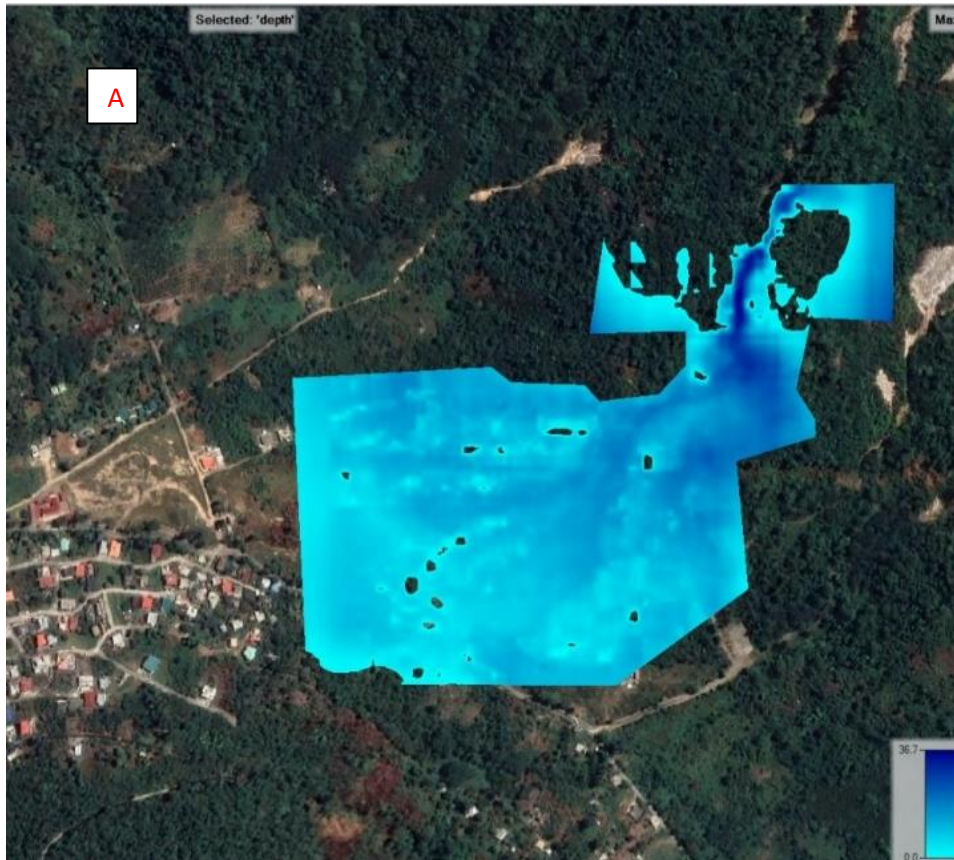
Figure 6.17 A: Results of HEC-RAS unsteady flow simulation for Soufriere (Dominica), showing variations in flow depth across the floodplain (in m).

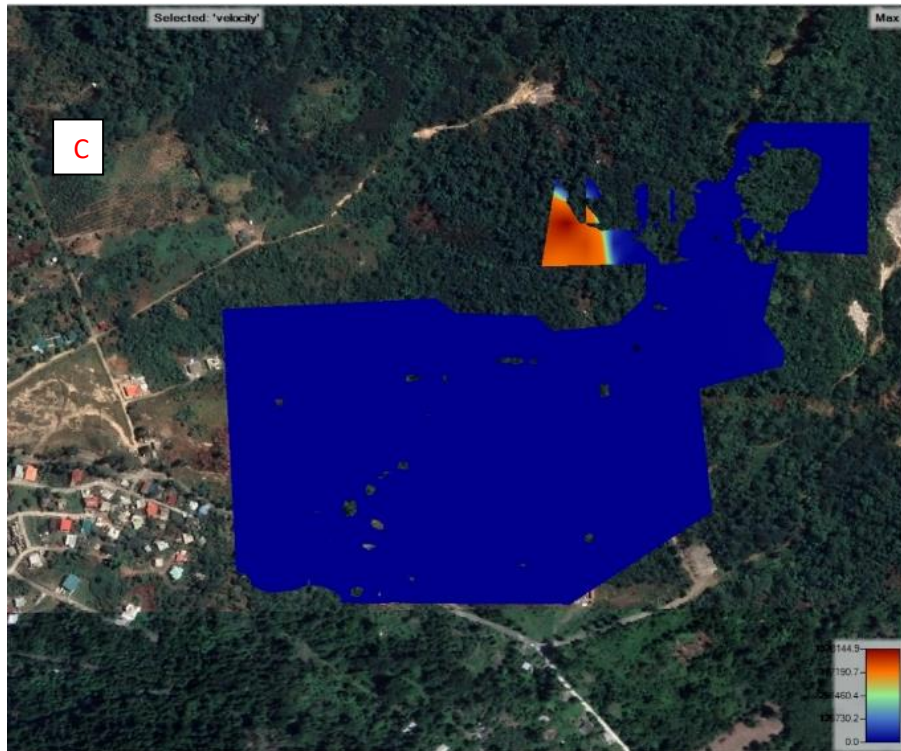
Figure 6.17 C: Results of HEC-RAS unsteady flow simulation for Soufriere (Dominica), showing variations in flow velocity across the floodplain (in m/s).

Flow velocity results are presented in figures 6.17 C and D. Flow velocity did not change across most of the study area. The maximum velocity recorded after the simulation was 1189 m/s and the minimum velocity was 30 m/s (Figures 6.17 C and D). High velocities were predominately recorded at the north-east corner of the drainage area (Figure 6.17 C). This is as a result of the sharp slopes there, causing rapid flow of water hence high velocities occurred.

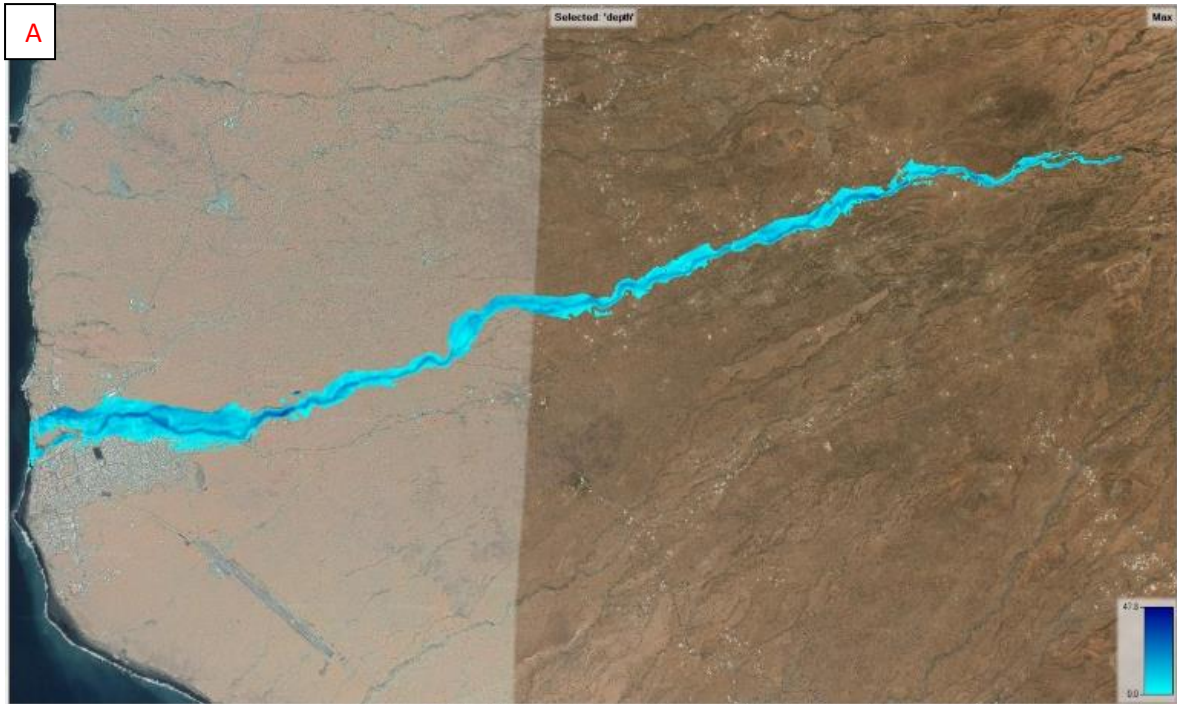
Figure 6.18 A: Results of HEC-RAS unsteady flow simulation for Ribeira Domingo Santo (Fogo), showing variations in flow depth across the floodplain (in m).

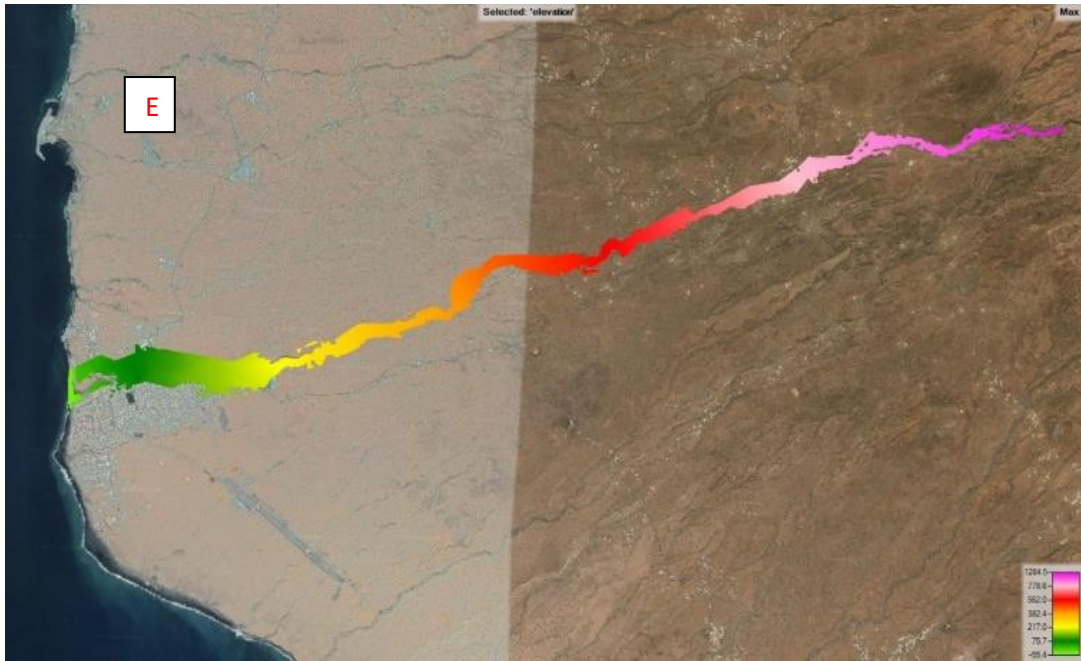
Figure 6.18 E: Results of HEC-RAS unsteady flow simulation for Ribeira Domingo Santo (Fogo), showing variations in water surface elevation across the floodplain (in m).

Water surface elevation results are presented in Figures 6.18 E and F showing the elevation at which the terrain was inundated. From the simulation results, the minimum flow and maximum water surface elevations at which the area was inundated were 64 m and 916 m, respectively (Figures 6.18 E and F). The water surface elevation was high at the upper part of the terrain, gradually decreasing down the channel into the Atlantic Ocean.

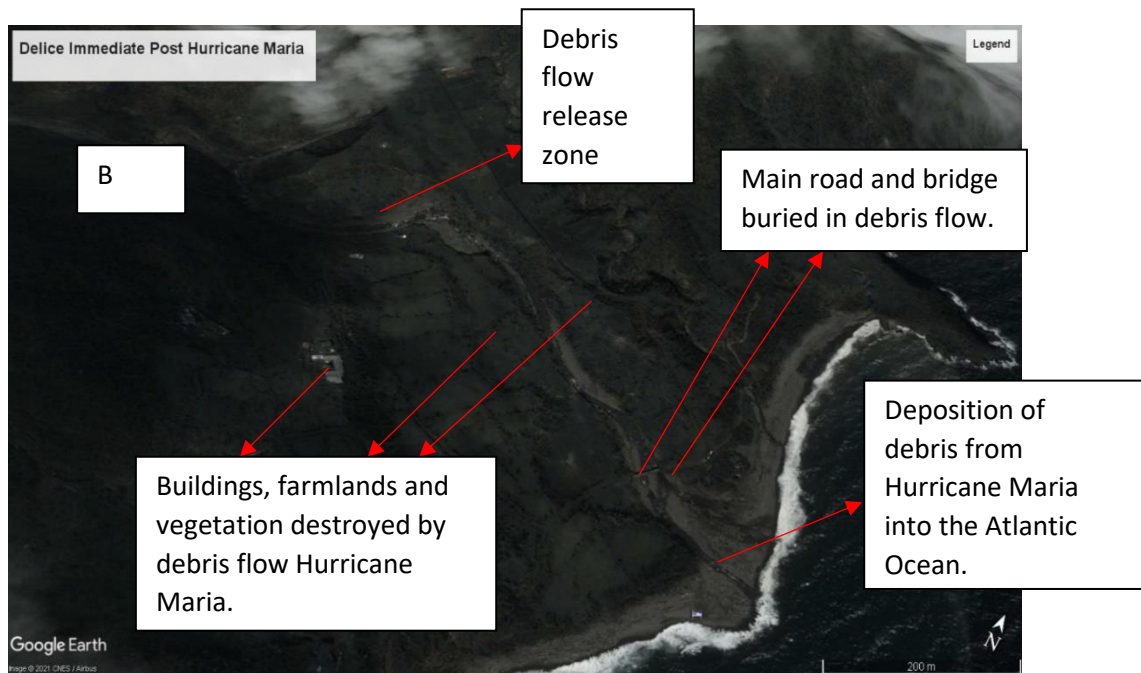
Figure 7.2 A and B: Comparison of RAMMS debris flow simulation and Google Earth image of observed debris flow event after Hurricane Maria for Delice (Dominica).

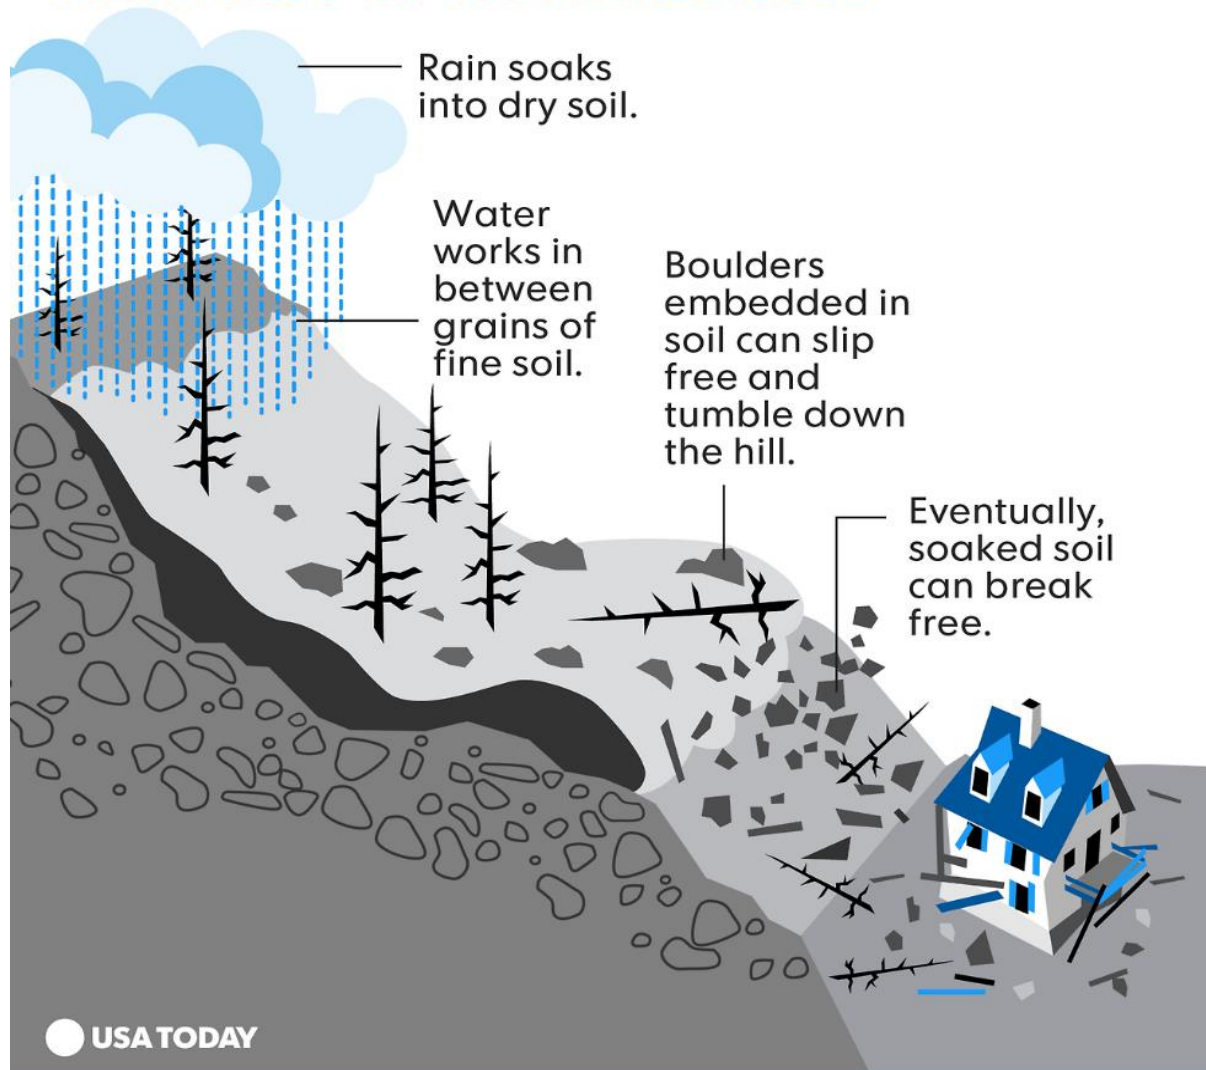
Figure 7.7: Diagrammatic presentation of factors that trigger debris flow and related hazards (USGS).

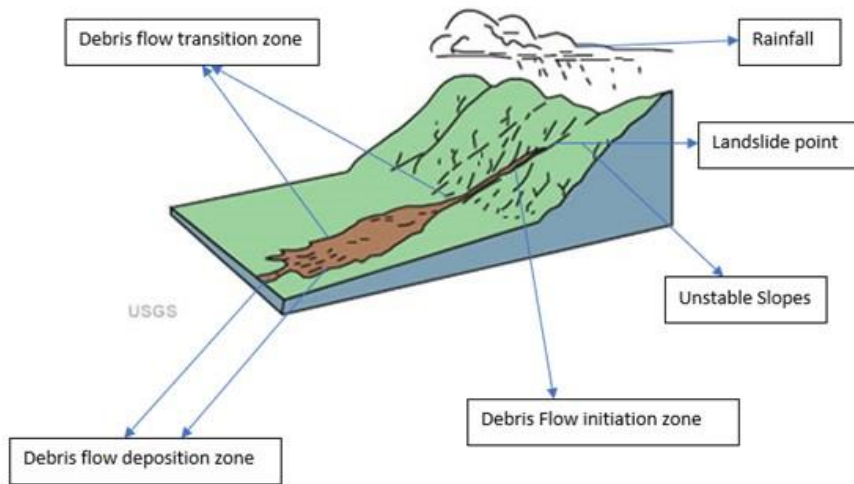
Figure 7.8: Diagrammatic presentation of rainfall-induced landslide sourced debris flow (USGS)

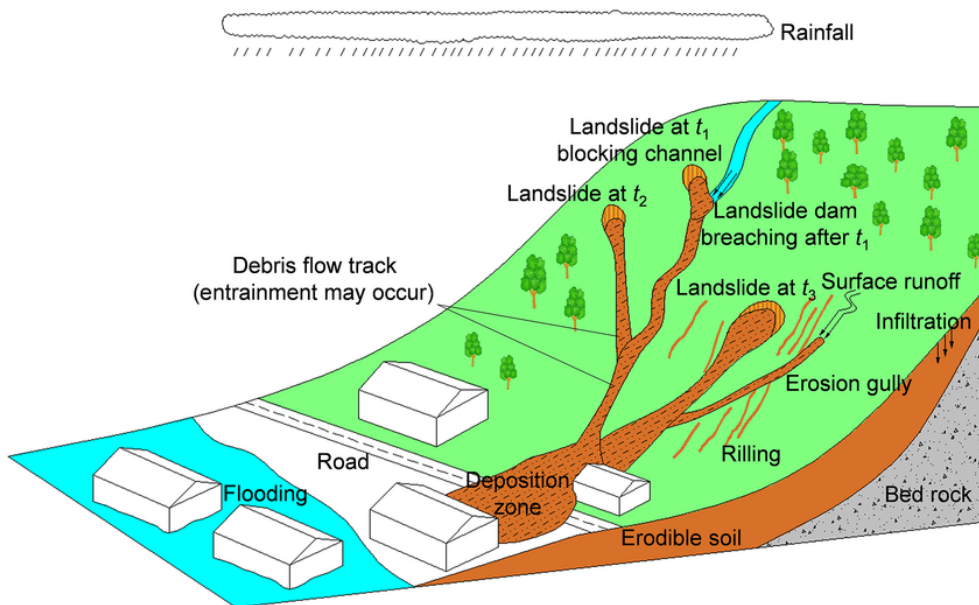
Figure 7.9: Diagrammatic presentation of landslide initiated debris flow, and channel-bed failure and erosion initiated debris flow (Shen et al, 2018).

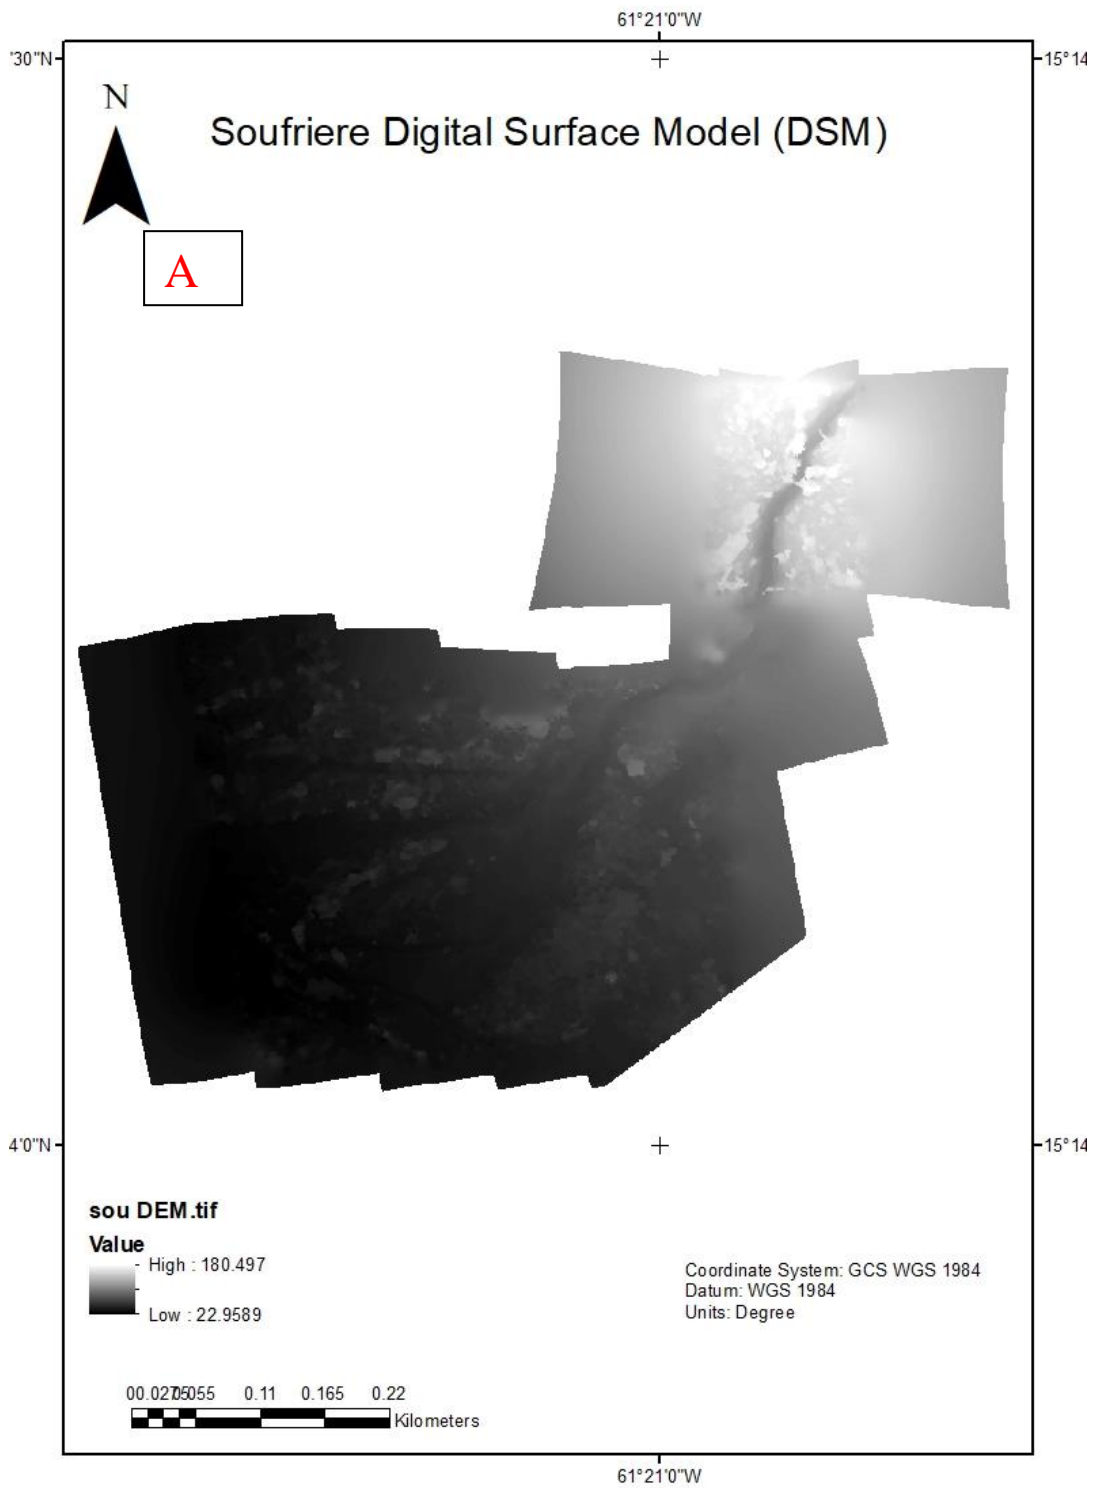
Figure 7.10 A and B: (A) Comparison of high resolution and up to date drone-derived DSM of Soufriere with (B) erroneous slow resolution and outdated SRTM DEM of Dominica.
