Power loss and hotspot analysis for photovoltaic modules affected by potential induced degradation

Mahmoud Dhimish¹✉ and Andy M. Tyrrell¹

npj Materials Degradation (2022)6:11 | <https://doi.org/10.1038/s41529-022-00221-9>

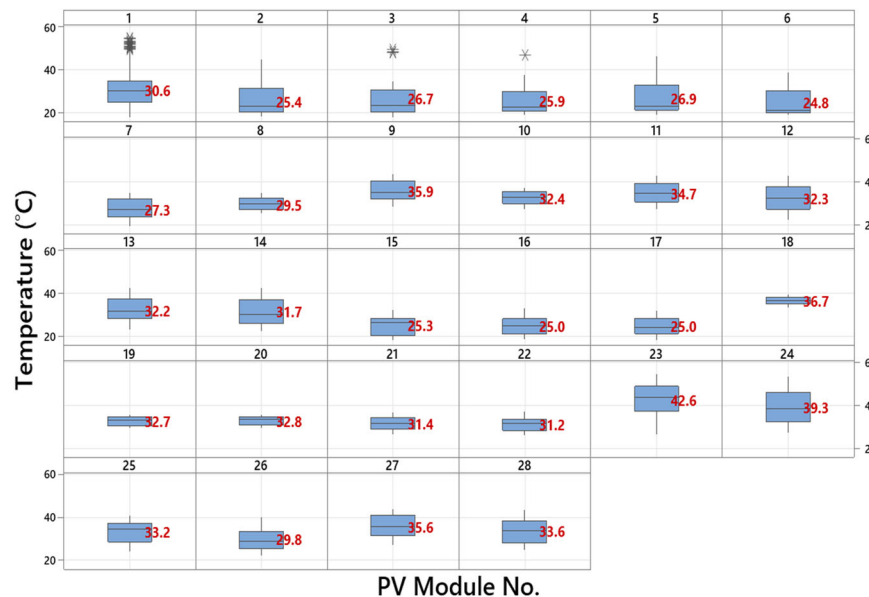
Fig. 8 Extracted PV modules temperature after PID test was performed. The error bars represent the collected data of the 28 tested PV modules after completing a single PID test (96 h).

Using FLIR software, the temperature data from all the PV modules after completing a single PID test (96 h) can be extracted; the temperature profile are presented in Fig. 8. The mean value of the PV modules temperature varies between 25 to $42\text{ }^{\circ}\text{C}$. Therefore, following the IEC61215 standard, if the average PV temperature is above $30\text{ }^{\circ}\text{C}$, it is assumed that the PV module fails the reliability test. In contrast, and according to the results

illustrated in Fig. 8, it can be recognized that 17 out of the 28 examined PV modules fail the reliability test. Therefore, these modules are likely to have severe degradation when exposed to environmental/outdoor conditions.
