Son Care Handicap Ramp and Fence

Brendan Mulholland
California Polytechnic State University
San Luis Obispo, CA

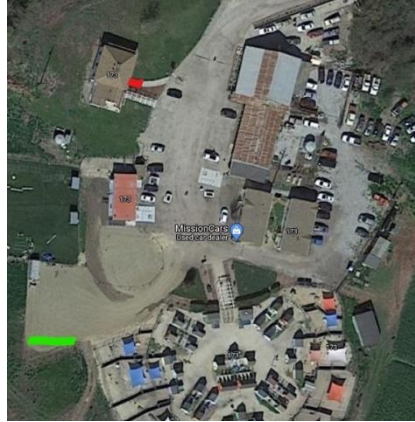
The first step to for this project was to find out what Son Care expected to have when everything was finished. To achieve this a first meeting was held. During this meeting Son Care described that they wanted to have a fence built that would separate the parking area from the field that was next to it and a handicap ramp installed in front of the front entrance of the building. Figure 1 depicts the location of the fence with a green line and the location of the handicap ramp with a red line.

*Figure 1: Property Overhead View of Buildings on the Ranch
Parking Lot Fence*

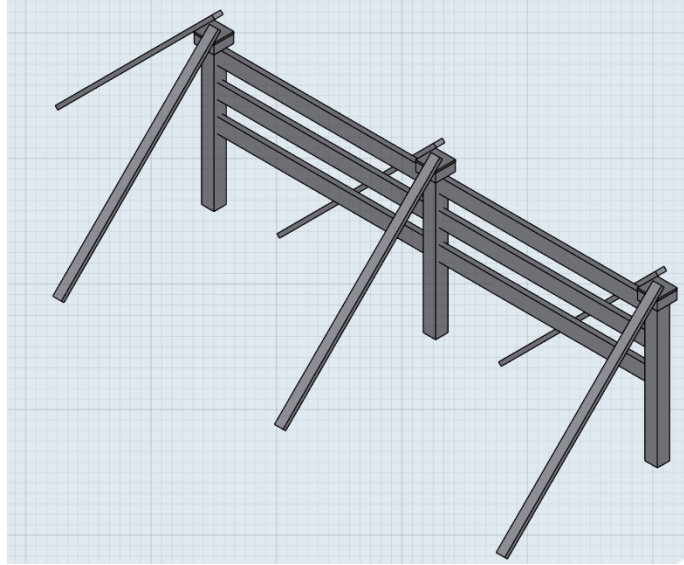
Figure 2: Fence Installation Model

decided that holding the posts from the top would provide much more stability. During the first attempt a lot of time, money, and resources were wasted. In order to prevent this mistake from happening again a model was made. The model is shown in Figure 2, and proved to be very useful when trying to envision how the post would be help up while their positions were finalized.

By creating the model, it became much easier to envision how the fence would be put together. With this new foresight and the knowledge from the previous mistake the second attempt at the installation of the fence went much smoother. Even with the extra knowledge and experience the task still took another two days to complete. With the fence finally standing and held in place, it was time to fill in the holes with concrete and finish up this part of the project. Sone Care consistently had projects being completed on the campus and many of them required the use of concrete. Because of this they already had a pallet of ready mix concrete on site. Son Care does not own a concrete mixing machine and renting one was not practical. Unfortunately, that meant the concrete had to be mixed by hand. A quick estimate suggested that about twenty bags of concrete mix would be needed to fill the holes. After three and a half hours the total number of bags used came out to eighteen. With a slight addition from a nineteenth bag the concrete was finally complete. The fence was then left for two days to make sure that it would not move as the install jigs were taken off. Once the install jigs were removed the fence was washed clean. At this point the post caps were pressed into place on the tops and outsides of the outermost posts. With one last check and approval from Dillan the fence was completed and can be seen in Figure 3.

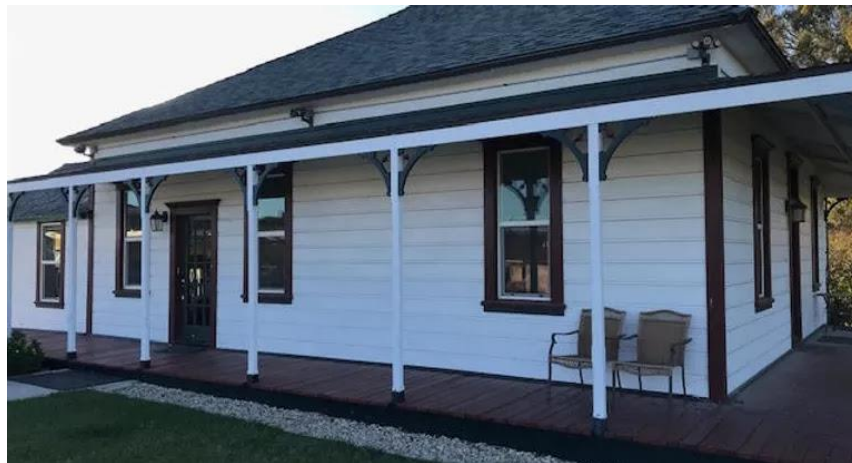
Figure 4: Son Care Foundation Front Entrance

The Son Care Foundation and some of the other non-profits that the business manages are dedicated to helping individuals who may need some extra assistance. The main entrance to the office building has a small porch in front of it. This porch creates a large step up from the concrete of the walkway and a second smaller step from the porch to the threshold. In addition to the steps, the porch is angled down and away from the side to the building. These conditions, which can be seen in Figure 4, combined to make it rather difficult for those with disabilities to enter the office. Replacing this awkward entrance with a ramp would allow the much needed ease of access that the building demanded.

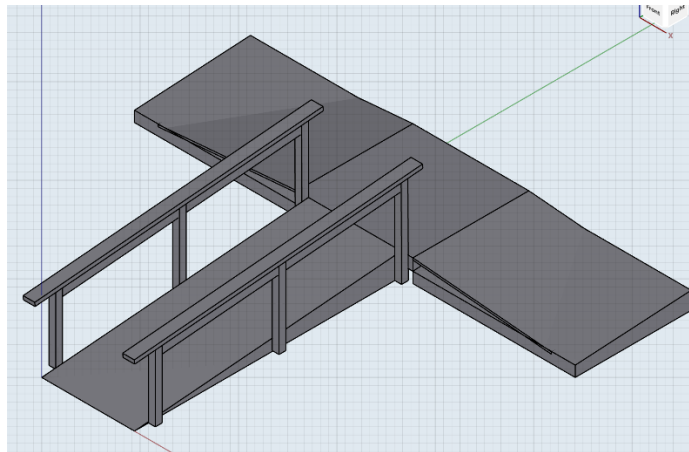
Figure 5: Model of the Accessibility Ramp to Son Care's Entrance

With a new description of the structure that Son Care wanted, and the knowledge gained from the background research a model was created. The model can be seen in Figure 5. This model was created with ideal conditions in mind. Existing conditions on site were not ideal and forced numerous field changes. However, the model still served as a useful representation of the structure.

Once the design of the ramp had been approved construction was able to begin. As helpful as the model was during conceptual design it became much less useful during construction. This was due to the fact that absolutely nothing on site was square, flat, or level. This was a fact that was only discovered after construction had begun. The fallout of this discovery was that there was no repeated cuts or measurements, so each element was made completely custom.

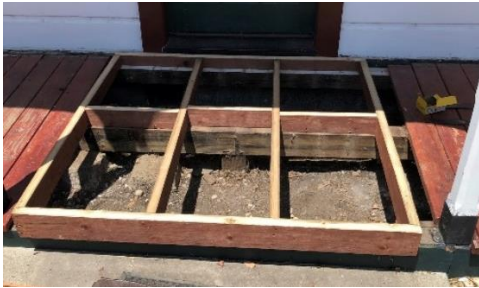
Construction began with the removal of the molding between the deck and the wall of the office on either side of the door. Next the existing deck in front of the door had to be removed. The ADA Codes called for a flat space at least five feet by five feet wide before the door so that individuals would have space to maneuver around the door. This meant that the deck had to be artificially raised, as depicted in Figures 6 and 7, to sit flush with the threshold of the entrance.

Figure 6: Framing that Supports the Landing

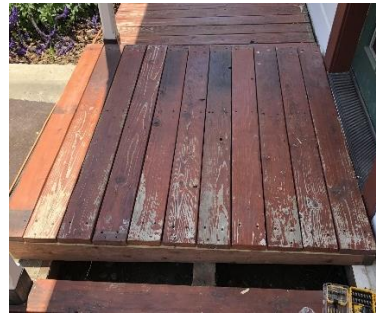
Figure 7: Completed Landing

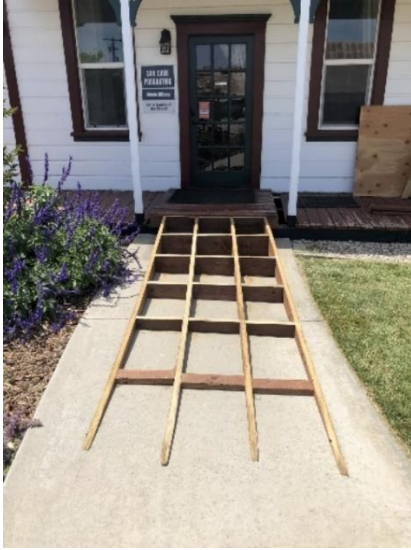
The next part of the structure to be completed was the main section of the ramp. Framing in the ramp proved to be the most difficult part of this structure. The new landing created an unappealing overhang, so the top of the ramp frame had to be notched to fill the gap. When facing the building the left side of the walkway sits higher than the right and also curves along its length. The combination of these two factors meant that each of the runners had to be cut at different angles and slightly different lengths as shown in Figure 8. Figure 8 also shows how each piece of the frame had its own measurements due to the unevenness of the concrete. With the frame complete exterior grade plywood was placed over the pressure treated frame. Figure 9 shows the unpainted stage of the finished ramp. In order to make sure that the ramp did not deteriorate or begin to creak as it aged exterior grade epoxy was applied to every joint and exposed edge.

Figure 8: Frame of the Main Ramp

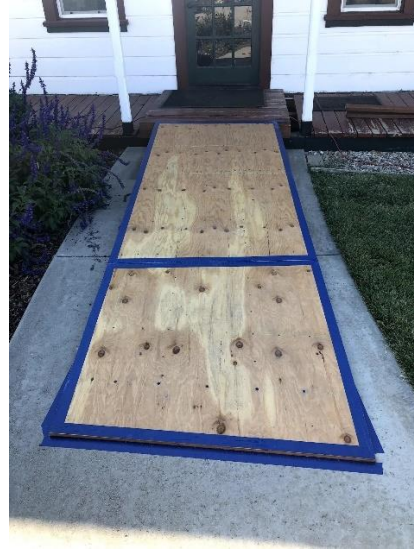
Figure 9: Constructed but Unpainted Main Ramp

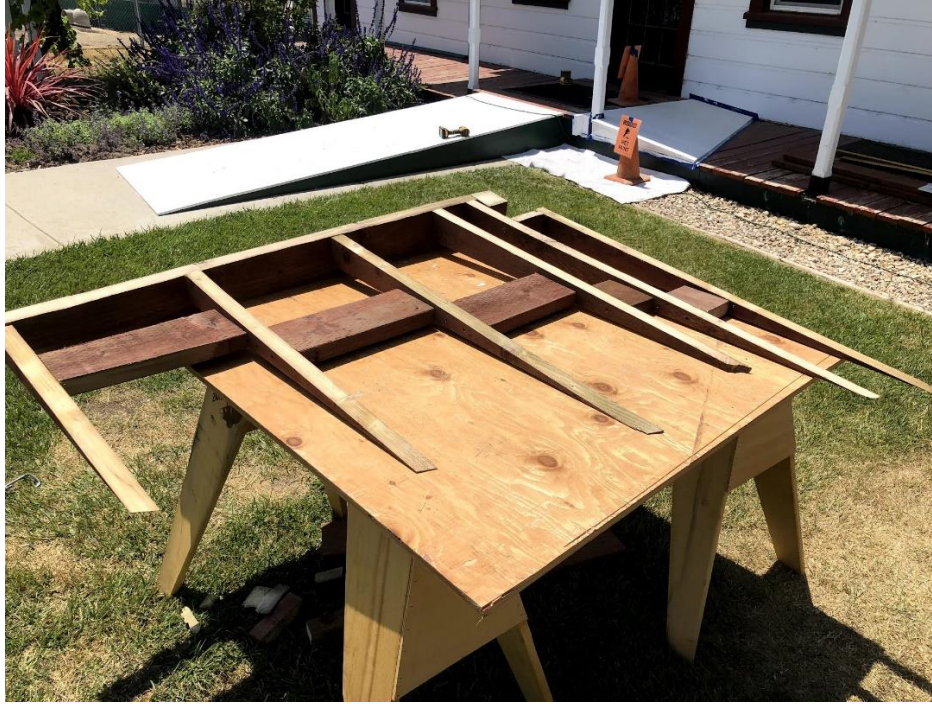
Because of COVID-19 there were a couple of issues with procuring the paint from the manufacturer. Once these problems were solved painting began. Many layers were needed to properly cover the ramp, so while each coat was drying the side ramps were constructed. When the new landing was installed, it raised the portion of the porch in front of the door a few inches above the rest of the deck. In anticipation that those who needed the main ramp would also like to walk along the porch, side ramps were designed to eliminate the step. These side ramps were not as difficult to produce as the main ramp was, but still provided a host of challenges as they had to accommodate the more drastic angle of the deck and were forced to extend around the posts that support the porch roof. Figure 10 depicts both the framing for one of the side ramps and a completed side ramp.

Figure 10: The Framing for One Side Ramp with a Completed Side ramp in the Background

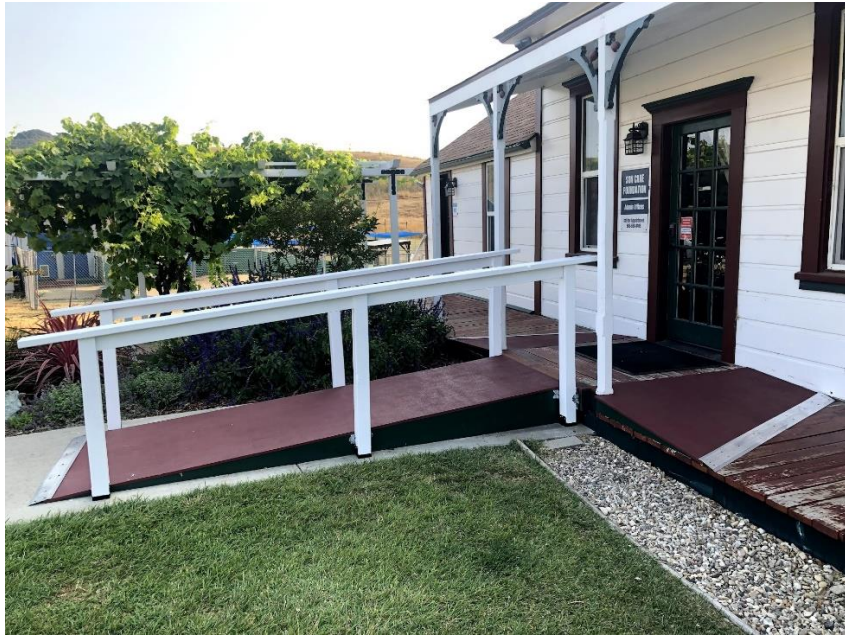
The primer coats of paint did not require much drying time which allowed for work to be done near them while the paint dried. The finish coats of paint needed a significantly longer amount of time to dry and thus prohibited work from being done during this time. In order to take advantage of this forced downtime the fence was erected while the layers of paint dried. The installation of the fence finished just as the last coat of finish paint was done drying. With the ability to work restored, the guiderails were built and installed. The posts were mounted into Simpson Strong-Tie post bases and then secured to the concrete with one half inch Tapcon concrete anchors. The guiderails were then painted white to match the siding and roof supports on the front of the office. To comply with the last piece of ADA code, aluminum six-inch-wide door thresholds were placed at the bottom of each ramp to transition the ramps to the concrete below, and eliminate the step created by the plywood. The final product is displayed in Figures 11 and 12.

Figure 11: Side View of Completed Ramp

The ADA access ramp was a beautiful addition to the entrance of the Son Care Foundation. The ramp is not so steep that it requires the use of the handrails and is sturdy enough to stand up to the years of use that lay before it. The sides of the ramps were colored green to match the underside of the porch that wraps around the office. To help the ramp blend with the color of the porch and also add some grip to the slippery plywood, a rustic red paint that was mixed with sand and painted on the top of the ramp. The last touch was the railings. While they were not needed it would have been unsafe to leave the edges exposed. The pressure treated wood was painted over with many layers of white paint so that they would blend in with the color of the office. The finished ramps do not look out of place even one bit and added to esthetic of the office.

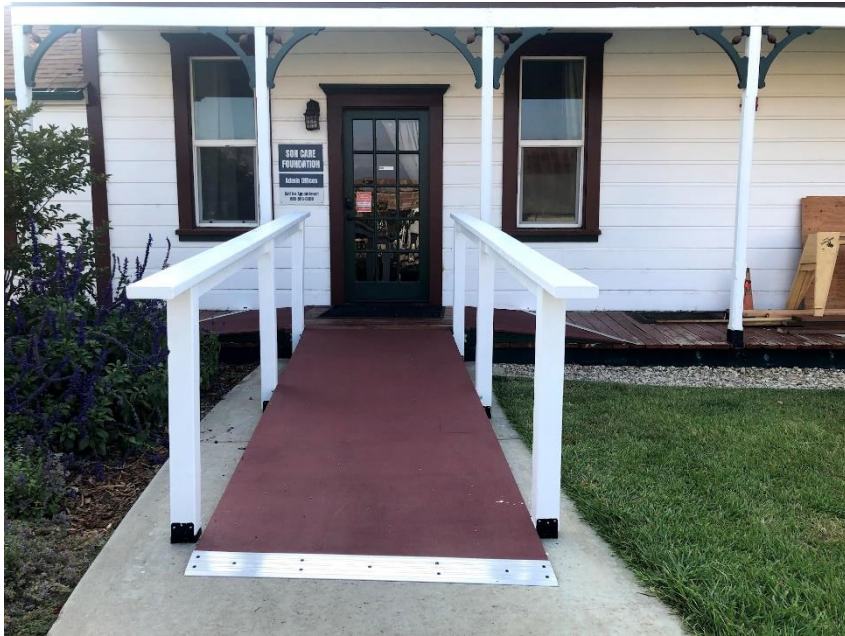
Figure 12: Front View of Completed Ramp
