## ARCHAEOLOGICAL STUDY OF THE HISTORIC TERRAZZO PAVEMENT OF PRINCE MOHAMED ALI MUSEUM, CAIRO, EGYPT

**Abstract:** This research will shed light on studying a terrazzo pavement in Prince Mohamed Ali Museum (the case study). The authors used visual inspection, stereo microscope, USB microscope, XRPD analysis, and SEM.EDX to identify its components, deterioration aspects and execution techniques. The XRPD and SEM.EDX results revealed that Portland cement was used in the three layers of terrazzo because of the detection of Hatrurite, Alite, Anorthite, Albite, Aragonite, etc. Many pigments were used in the topping terrazzo layer as; Goethite, Greenalite, Hematite, Azurite and Magnetite. The divider strips were made of brass alloy and the topping layer chips were prepared from basalt, marble and sea shells.

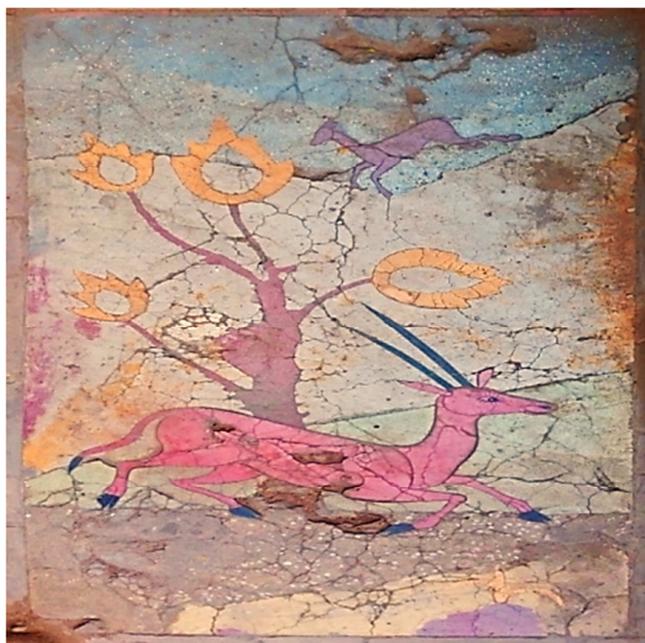
The current research represents a decorated historical terrazzo pavement in Prince Mohamed Ali museum which takes the shape of a deer in jungle *Fig. 1*.

Fig. 1. The studied terrazzo pavement of Prince Mohamed Ali Museum

The visual examination revealed the detection of many deterioration aspects; for example cracking, flaking, buckling, inappropriate filling by ordinary Portland cement, surface disfiguring by new paintings, dust wide spreading and the severe corrosion of concrete iron armatures [15], *Fig. 1* and *Fig. 2*.

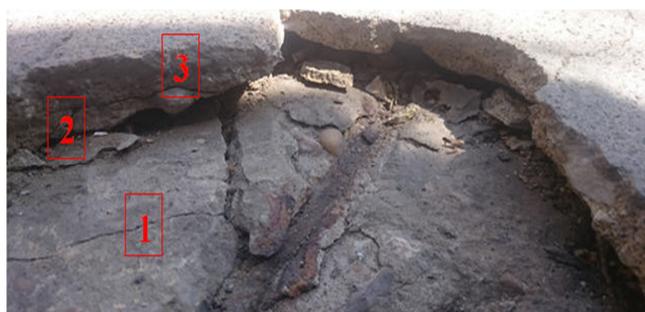
This terrazzo pavement represents the 'in site cast type'. It consists of three layers; the first layer is the concrete slab (the base course layer), which is covered by a thin layer of sand and insulation layer. The second layer is the underbed layer, which consisted of sand and cement, which poured on the concrete bed and before the complete setting of this layer; workers put divider strips, which act as control strips, *Fig. 2*, [13]. These strips should be non-corrosive material and they may be made of zinc or brass or any other suitable materials. The third layer is the topping terrazzo consisted of cement, aggregates, and pigments [7]. Before the complete dryness of terrazzo, workers used to grind and polish the surface through two stages, the first is by using carborundum block or disk and water, then the surface is washed and the voids were filled with fine slurry of cement. The second phase involves grinding by a disk or using a special stone [7], [13], [14].

Fig. 2. The stratigraphic section of terrazzo pavement of Mohamed Ali Museum, 1) the concrete layer; 2) the underbed layer; 3) the topping terrazzo layer

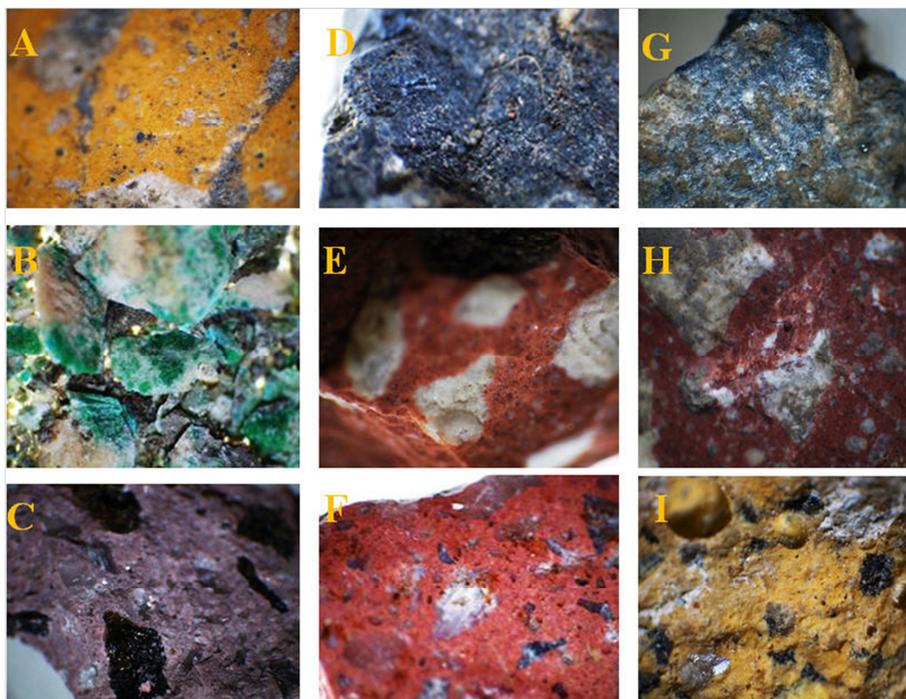
*Fig. 3.* Stereo microscope examination of some pigmented samples of the terrazzo pavement of Prince Mohamed Ali Museum

Figure	Stereo microscope and USB digital microscope results of the terrazzo pavement
Fig.3A	(Sample A - 450X) yellow mortar containing big white chips and small black ones.
Fig.3B	(Sample B1- 400X): green sample taken from the ground of the deer shape of the topping terrazzo contains some particles of green pigment mixed with white chips and small black ones.
Fig.3C	(Sample C- 450X): purple sample taken from the body of the small deer from the topping terrazzo layer contains big black gravels.
Fig.3D	(Sample D1- 450X): dark blue sample taken from the topping terrazzo, the image revealed that there are not any chips whether black or white.
Fig.3 E	(Sample E- 450X): sample of red mortar taken from the topping terrazzo reveals the detection of big white and black chips.
Fig.3F	(Sample F1- 450X): sample of red mortar taken from the body of the big deer from the topping terrazzo which contains big white and black chips.

Fig.3G	(Sample G1- 450X): sample of cyan mortar taken from the topping terrazzo layer contains small white chips.
Fig.3H	(Sample H- 450X): sample of dark red mortar taken from the tree roots of the topping terrazzo contains big white gravels and small black chips.
Fig.3I	(Sample I- 450X): sample of yellow mortar taken from the top of the topping terrazzo contains small black chips.

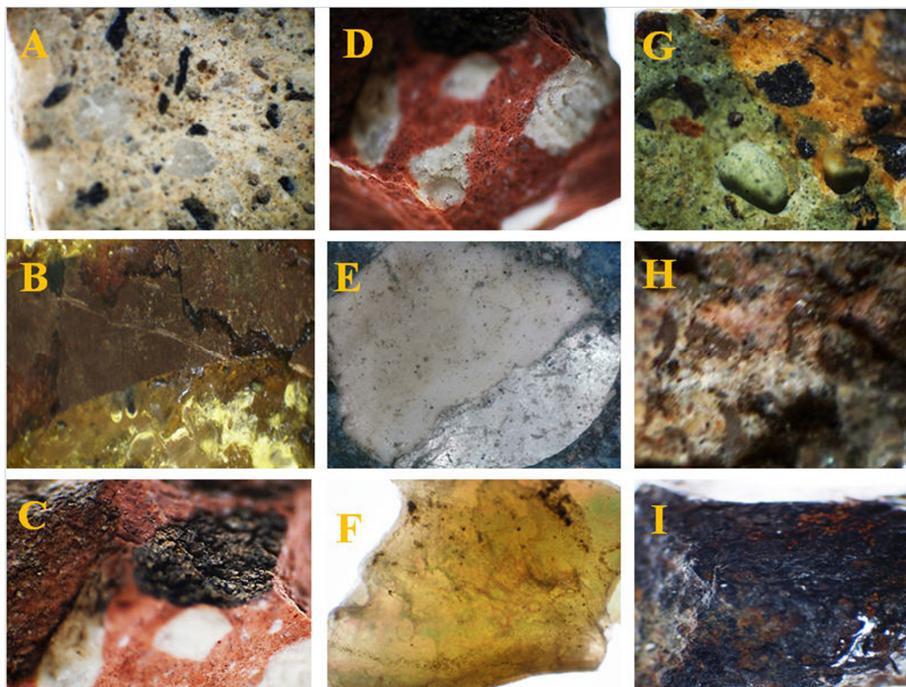
Fig. 4. A), B), C), D), F), G), H), I) stereo microscope examination of the other samples of the components of the terrazzo pavement of Prince Mohamed Ali Museum, E) the USB microscope examination of sea shells chips

Figure	Stereo microscope and USB digital microscope results of the terrazzo pavement
Fig.4A	(Sample J- 450X) sample of yellowish white mortar taken from the ground of the topping layer which was mixed with white and black chips.
Fig.4B	(Sample K- 400X): sample taken of the divider strips used in the topping terrazzo which fixed directly within the underbed layer.
Fig.4C	(Sample L- 450 X): black aggregates taken from the topping terrazzo layer.
Fig.4D	(Sample M- 400X): white chips taken from the topping terrazzo layer.
Fig.4F & E	(Sample N): sea shell aggregates sample ( <i>Fig. 4F</i> ) examined by stereo microscope 450X and ( <i>Fig. 4E</i> ) taken by USB microscope 250X. These chips were used in some parts of the topping terrazzo layer.
Fig.4G	(Sample O- 350 X) sample from the underbed layer showing the cementing material and its aggregates.
Fig.4H	(Sample P- 450 X): sample from the concrete layer.

Fig.4I	(Sample Q- (450 X): sample from concrete steel armatures showing their heavy surface corrosion.
