# Modelling, identification and structural damage investigation of the Neoria monument in Chania

Charalambidi, Barbara, Koutsianitis, Panagiotis, Motsa, Siphesihle Mpho, Tairidis, Georgios, Kasampali, Amalia, Drosopoulos, Georgios, Stavroulaki, Maria and Stavroulakis, Georgios

<https://doi.org/10.1016/j.dibe.2022.100069>

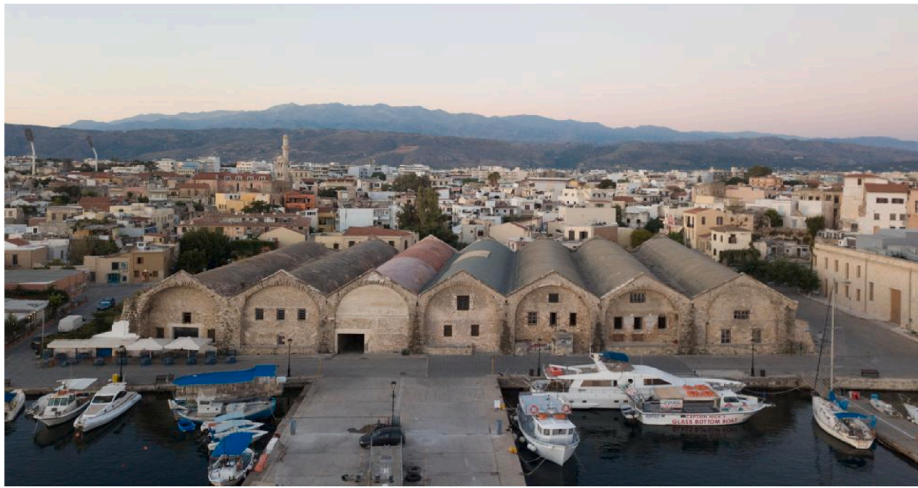
Fig. 1. The Neoria monument (Providakis, 2021).

In the present paper, the structural analysis investigation of the Neoria masonry vaulted structure at the Venetian harbor of Chania is presented (Fig. 1). Data related to the structure, the material, the damages and the foundation have been collected during a recent research project (Providakis, 2021). The accurate representation of the geometry of the vaults and the spandrels is necessary in order to model the existing condition including permanent deformations, loose material, cracks (Stavroulaki et al., 2016). This is important for the estimation of the structural strength and dynamic behavior considering the three dimensional, effects of the vaults and the stabilization role of the spandrels (Stavroulaki and Tsinarakis, 2011).

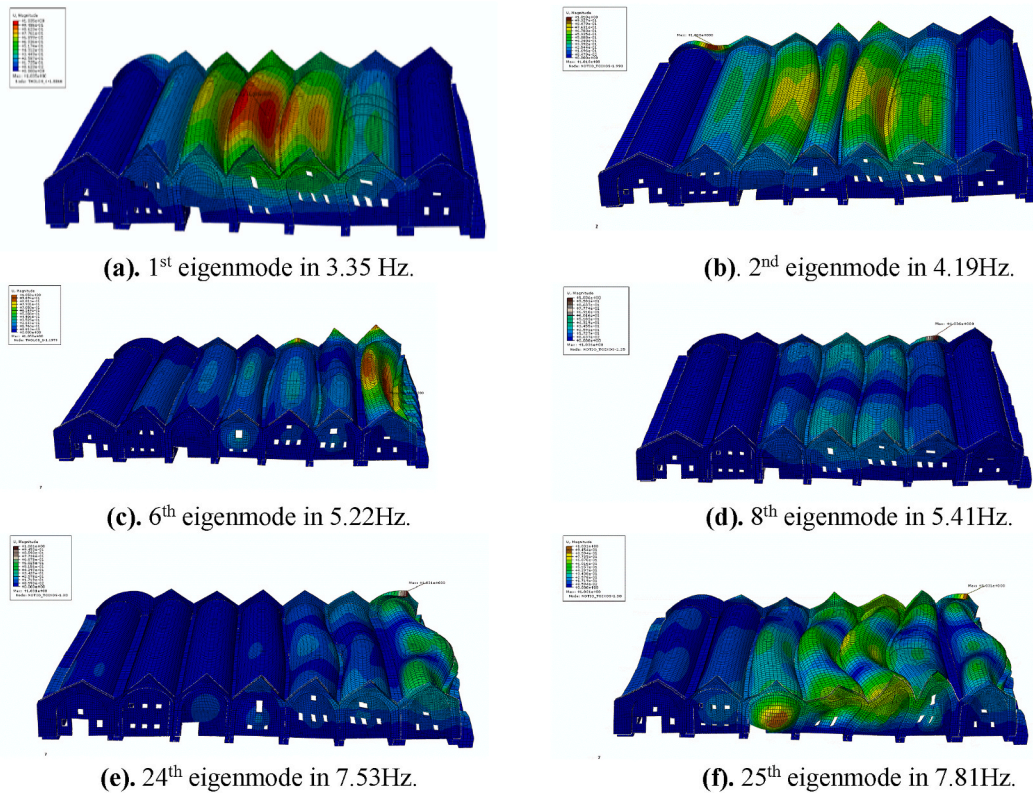
Fig. 4. Selected eigenmodes of the structure.

(a). 1<sup>st</sup> eigenmode in 3.35 Hz. (b). 2<sup>nd</sup> eigenmode in 4.19Hz.  
 (c). 6<sup>th</sup> eigenmode in 5.22Hz. (d). 8<sup>th</sup> eigenmode in 5.41Hz.  
 (e). 24<sup>th</sup> eigenmode in 7.53Hz. (f). 25<sup>th</sup> eigenmode in 7.81Hz.

Some of the calculated eigenvalues and eigenmodes of the Neoria structure are shown in Fig. 4 (a) – (f).

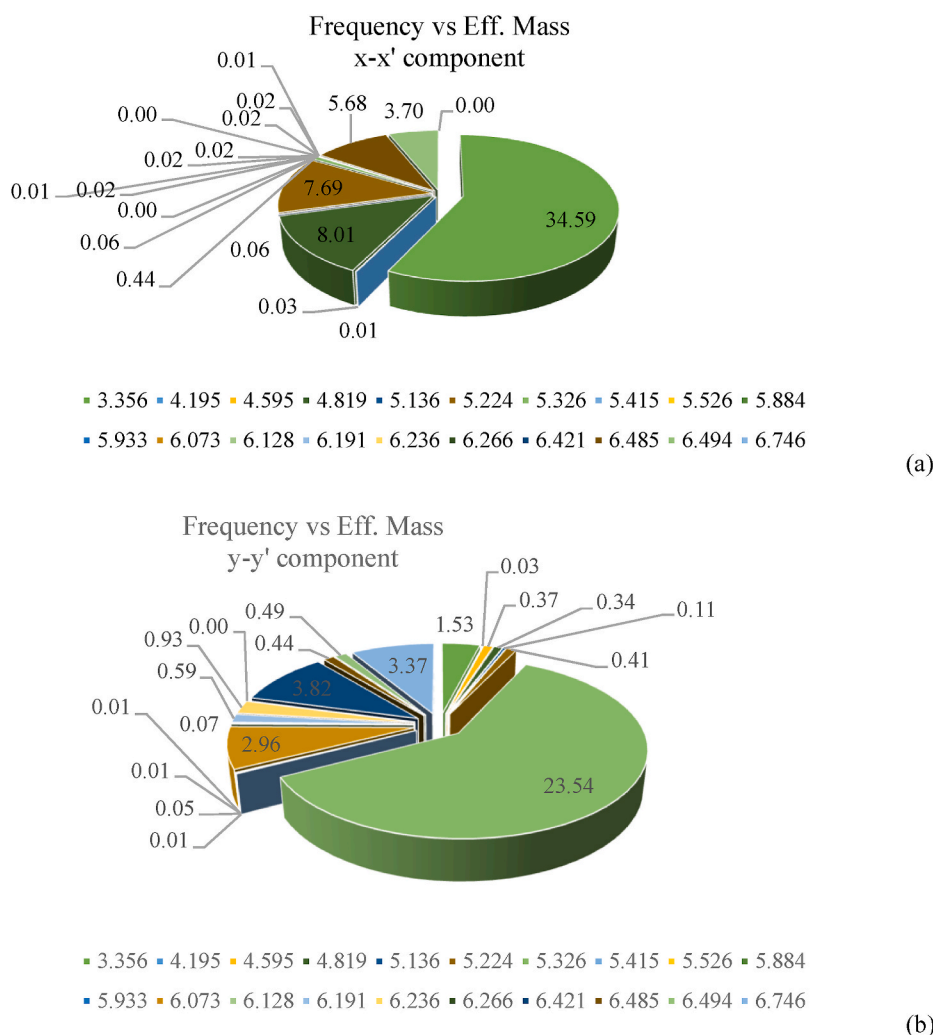
Fig. 5. Eigenmodal participation factors for earthquake in X and Y direction.

The eigenmodal participation factors are shown in Fig. 5 (a,b) in the two directions of the structure. From the modal analysis it turns out that there are frequencies where the vaults develop oscillation in the longitudinal direction and that is taken into account in a three-dimensional simulation and analysis of the structure. Specifically in Fig. 4, the oscillation of the vault of the western neorio in the 6th, 24th and 25th eigenmodes, is shown.

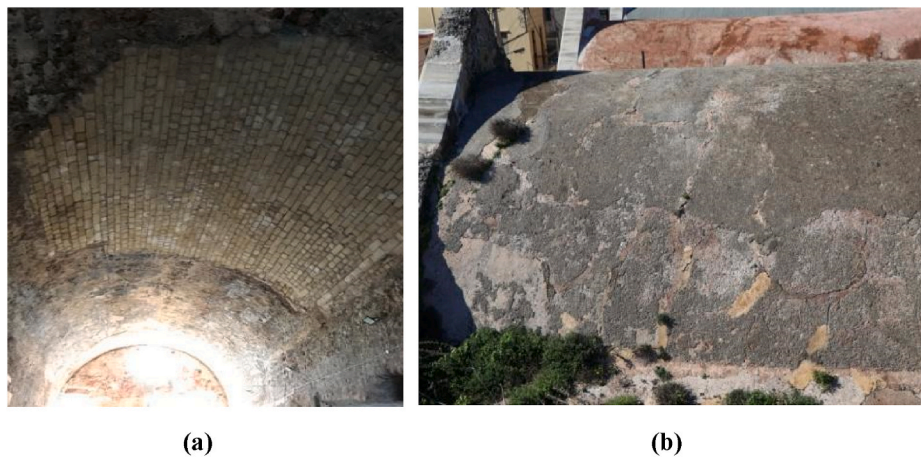
Fig. 11. Vault (a) inside and (b) outside view.

The structural conditions of the 4th and 6th vault from the west due to poor interventions are also considered as important (Fig. 11 (a)-(b)). They have been imported to the model as material with reduced strength

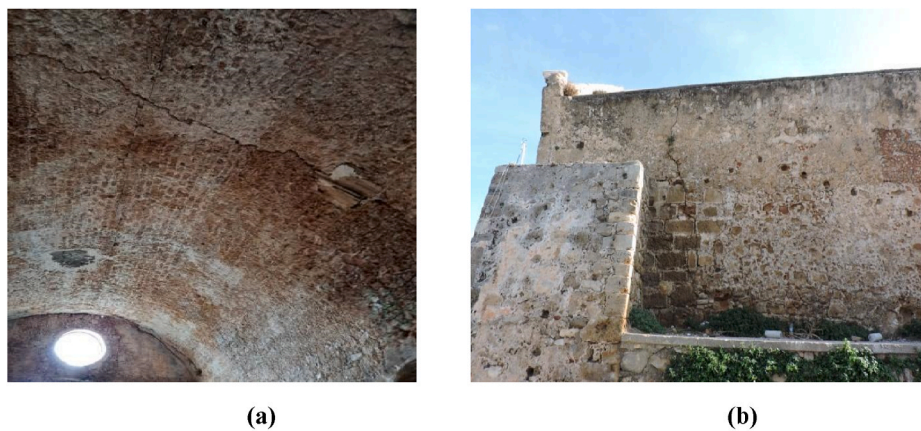
Fig. 12. Crack on vault. (a) Inside and (b) outside view. (c) Biological deterioration on the North Wall.

Large width cracks of the inside of the vaults and on the west wall are illustrated in the followed Figures (Fig. 12 (a) – (c))

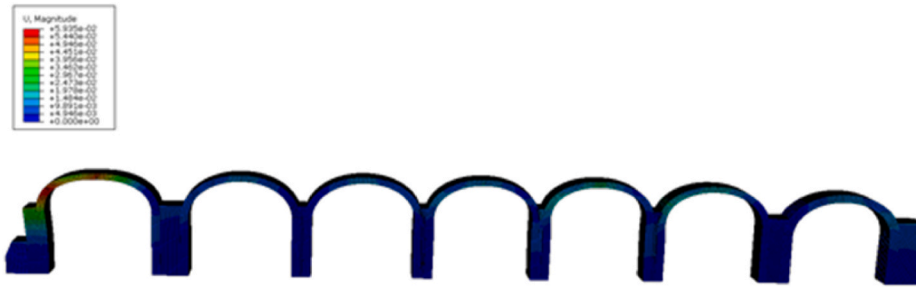
Fig. 19. The displacement contour of the whole structure under gravity loads.

closure and sticking-slipping along the masonry stone interfaces. The models were developed with a fixed support and the self-weight was incorporated in the loading condition. Two steps were used to create the models: the first step was a pure gravity load to simulate the state of inertia of the structure and to stabilize the model. The second step has an increased gravity load by 0,5g which was incrementally applied on the structure. This is used to provide a preliminary indication of the effect of the vertical component of an earthquake to the structural system. The results from these models are shown in Figs. 18–20.
