Cyclic shear-compression testing of brick masonry walls repaired and retrofitted with basalt textile reinforced mortar

Larisa Garcia-Ramonda ^{a,*}, Luca Pelà ^a, Pere Roca ^a, Guido Camata ^b

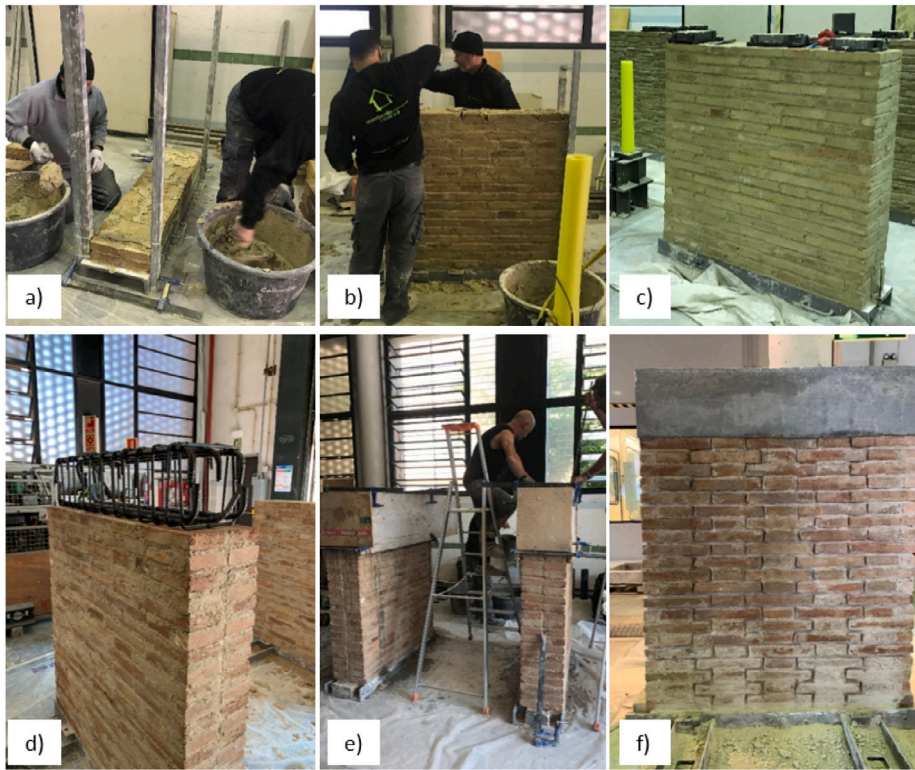
Fig. 1. Construction procedure: (a) placing of the rulers for the construction, (b–c) construction of the wall in Flemish bond, (d) rebars placing for the concrete beam located on top of the specimen, (e) cast of the concrete beam, (f) specimen finished and stored under laboratory conditions.

Four double leaf masonry walls with nominal dimensions 1270 × 1270 × 310 mm³ were built in the laboratory by professional personnel. The construction process of the specimens considered the procedure shown in Fig. 1. The specimens were built in Flemish bond with 21 courses and 15 mm thick mortar joints. Finally, a concrete beam was cast on top of the specimens to allocate the set-up device in charge of applying the reversed horizontal displacement. The finished walls were stored under laboratory conditions during the 28 days required for the curing of the mortar.

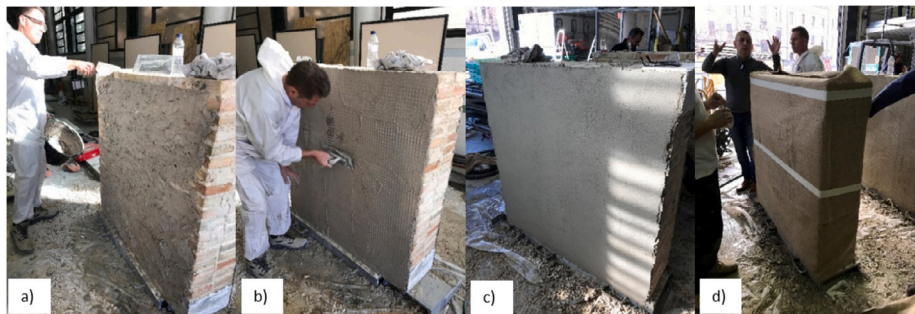
Fig. 2. Procedure for the application of the B-TRM strengthening system: (a) application of the first layer of mortar, (b) set of the basalt grid, (c) finished look of the wall retrofitted with B-TRM, (d) wrapping of the specimens with wet sackcloth fabric for curing.

The specimens were strengthened twenty-eight days after their construction by professional workers from the manufacturer company. From the four specimens built, two were left unreinforced. These URM specimens were tested, and as a result two damaged specimens were later repaired and retrofitted with Basalt Textile Reinforced Mortar (B-TRM), as described in the following subsection. The remaining two specimens were retrofitted with B-TRM strengthening systems following the procedure show in Fig. 2.

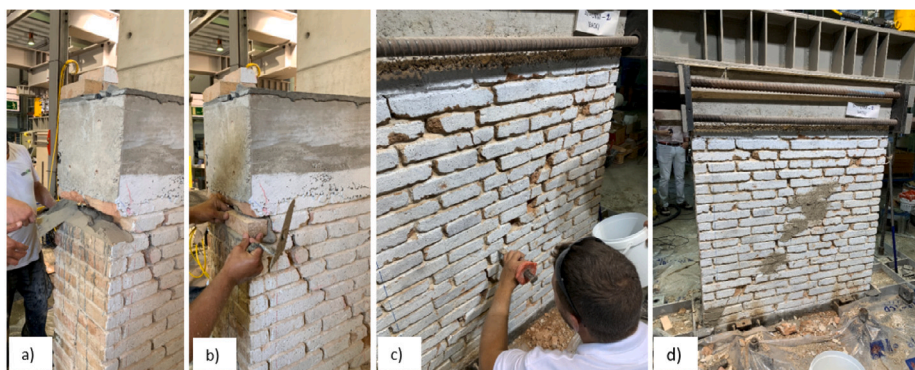
Fig. 3. *Scuci-cuci* intervention: (a) Removing of fractured units, (b) replacing of fractured units, (c) cracks opening with a hand tool, (d) filling of cracks with lime based strengthening mortar.

The two unreinforced specimens were tested under SCT. Since the specimens evidenced apparent damage after testing, they were repaired using a combination of the *Scuci-cuci* technique and lime mortar repointing, as shown in Fig. 3.

The aim of the repair was to restore the wall's structural continuity along the cracks and to recover its initial stiffness, lost at the end of the test. The restoration was achieved by substituting the fractured units, located in the corners and central part of the wall, with new ones and recovering the locally heavily damaged parts of the masonry. The material used for the restoration was the same one used for the construction in order to assure a good compatibility in terms of stiffness and resistances, which is key to a good collaboration among new and existing elements. The cracks of the specimens observed in the final crack pattern were opened using a rotary hammerdrill accessorized with a 20 mm width flat chisel, and a hand tool 30 mm width flat chisel. The fractured bricks were replaced by new ones. Afterwards, the cracks were filled with the same lime-based mortar used for the retrofitting of the walls.

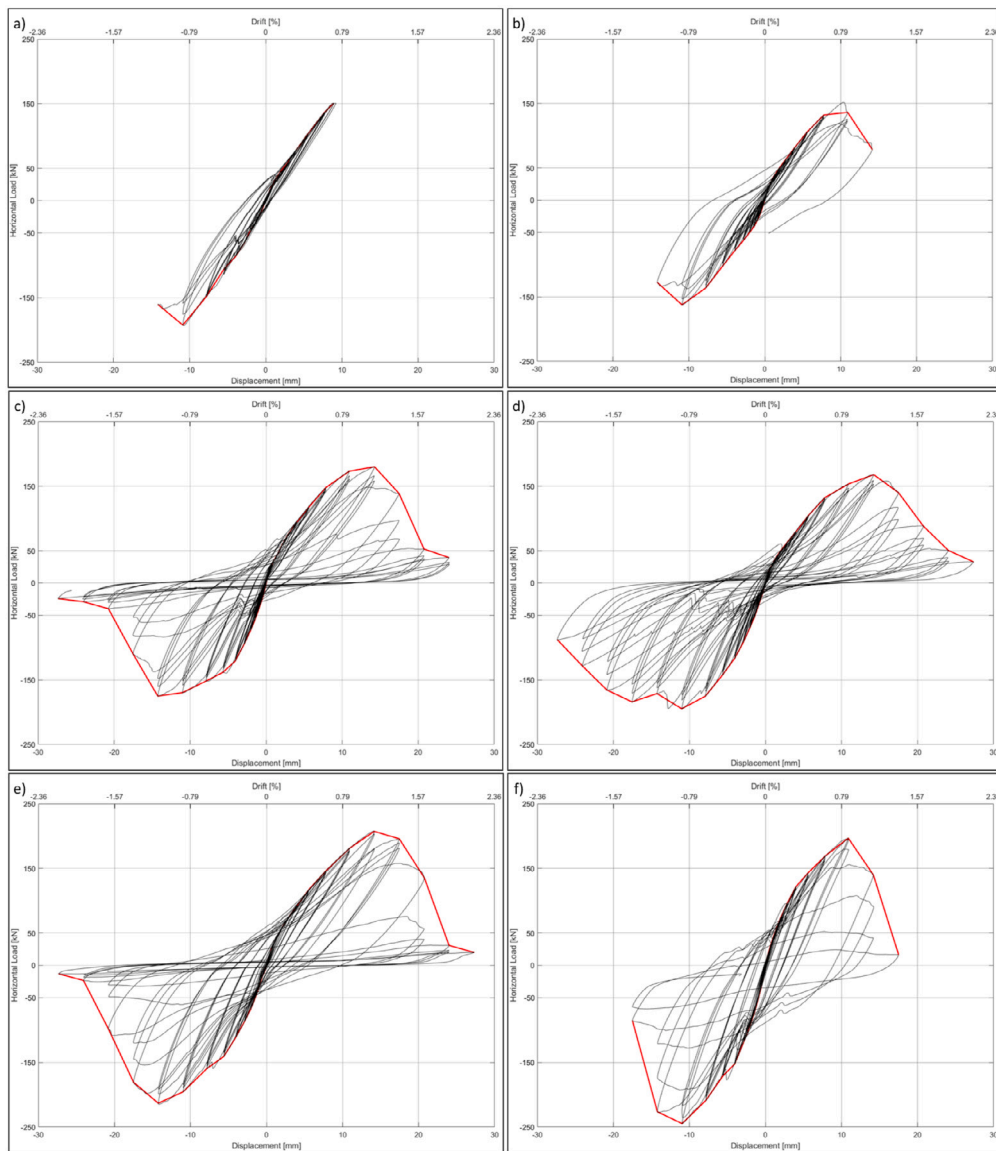
Fig. 7. Force–displacement hysteresis curves and envelope curves of tested walls: (a) URM_1, (b) URM_2, (c) walls repaired and retrofitted with B-TRM URM1_R and (d) URM2_R, (e) walls retrofitted with B-TRM LDB_1 and (f) LDB_2.

Among the unreinforced specimens, the attainment of the peak load was followed by the sudden brittle failure due to masonry's very limited tensile strength, as shown in Fig. 7 a–b. Given the brittleness of the response, the walls were unable to withstand inelastic deformation once the maximum lateral force was attained. The evolution of the damage can be related with the width of the hysteretic loops at increasing displacement amplitude. The wider the loop, the larger the damage experienced by the specimen. URM_2 evidenced wider hysteretic loops (see Fig. 7-b) which is in correspondence with the more severe damage

As aforementioned, and as a consequence of the early crack re-opening observed on the repaired and retrofitted specimens, the improvement in lateral load-bearing capacity provided by the B-TRM was moderate. On average the enhancement was of only 10%, when compared with the URM walls. This demonstrates the influence of the substrate's damaged condition on the response of the B-TRM. However, the peak load was reached at a larger displacement compared with the URM walls, showing an increment of 31%. Consequently, the specimens' global behaviour showed larger deformation capacity and ductility compared to the URM specimens, as seen in Fig. 7 c–d. The experimental response shows that specimen URM2_R exhibited a more ductile and progressive damage than its pair URM1_R. This ductile behaviour, mainly observed on the post-peak, was achieved through energy dissipation translated into larger and wider hysteretic loops, while being able to withstand damage at higher values of lateral force, before the strength degradation took place. Both specimen showed a symmetrical force–displacement response in both directions, as seen in Fig. 7 and Table 2.

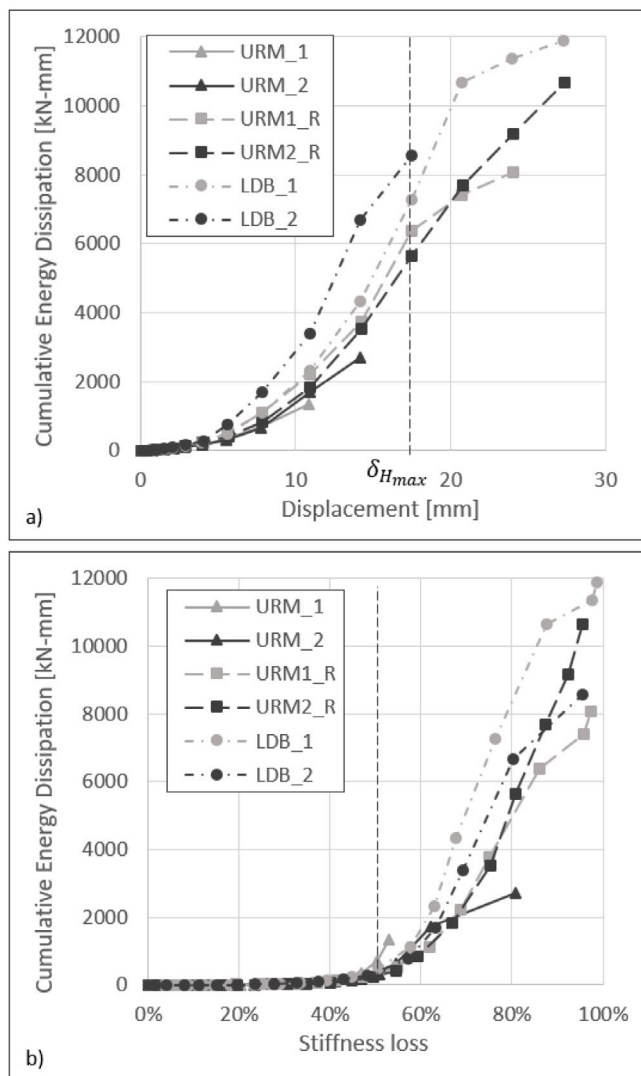
Fig. 10. Energy dissipation: (a) Cumulative energy dissipation vs. displacement, (b) Cumulative energy dissipation vs. stiffness loss.

Fig. 10-a shows the cumulative energy dissipation E_D for all the specimens tested. In general terms, all the tested specimens exhibited a similar trend, showing increasing energy dissipation capacity with increasing displacement. As expected, all the specimens retrofitted with B-TRM (URM_R, LDB) showed higher dissipation capacity than the URM walls. The combination of repairing techniques and B-TRM application provided the URM_R specimens with the ability to dissipate more energy by reaching greater displacement amplitudes in the inelastic domain. On average, these specimens increased their energy dissipation capacity by 364%. The specimens just retrofitted with B-TRM (LDB) showed even higher dissipation capacity with average increase of the total energy dissipated equal to 406%. Such increment can be attributed to the action of the TRM after the cracking of the masonry. From Fig. 10-a it can be observed that the damaged condition of the masonry substrate on specimens URM_R only influenced their dissipation capacity after the peak load. In this figure, the average value of $\delta_{H_{max}}$ is marked with a dashed line. Beyond the peak load, the energy dissipation capacity of walls URM_R decreases significantly when compared with specimens LDB, in which the B-TRM was bonded on undamaged substrate.

Fig. 10-a also shows the influence of the failure mode on the energy dissipation capacity. The specimens failing due to diagonal tensile failure (URM, URM_R and LDB_1) showed similar values of energy dissipation for the same displacement amplitudes, while the only specimen (LDB_2) failing due to shear sliding showed always higher dissipation capacity for these same displacement amplitudes and up to the failure of the specimen.

Fig. 10-b presents the relationship between the cumulative energy dissipation and the stiffness loss. The stiffness loss represents the percentage of the initial stiffness $K_{initial}$ lost in each loading cycle. Fig. 10-b shows an exponential growth of the energy dissipation capacity after the specimens lose 50% of the initial stiffness. As mentioned, this limit coincides with the onset of cracking. Such behaviour indicates that, as expected, the main mechanism for energy dissipation is cracking. Initially, the energy dissipation is produced by the cracking of masonry. Once the stress transfer from the substrate to the TRM system is completed, the dissipation capacity may be also provided by the gradual damage of the basalt textile.

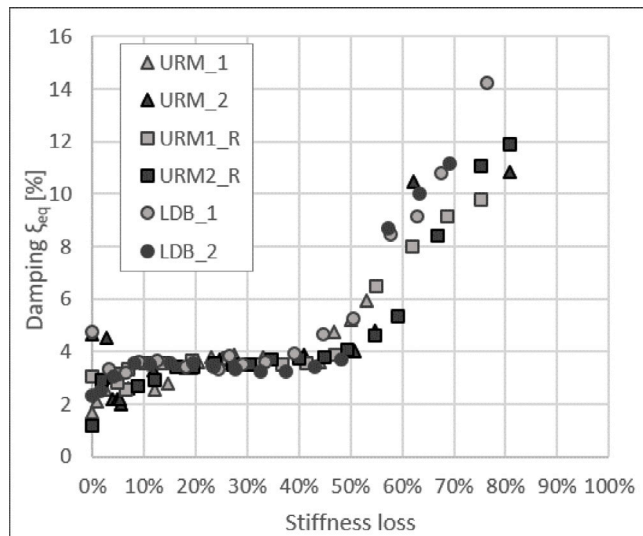
Fig. 11. Equivalent viscous damping vs. stiffness loss.

Fig. 11 shows the values of ξ_{eq} for each complete loading cycle and the corresponding stiffness loss. All the specimens showed a similar trend, in which the damping coefficient increased as damage was being accumulated. On average, up to the cracking pointing corresponding to 50% stiffness loss, the equivalent damping coefficient ξ_{eq} remained constant and with a value of almost 4%. Unlike the energy dissipation capacity, the parameter ξ_{eq} was totally independent of the damaged condition of the masonry, the presence of the reinforcement, and the failure mode. In addition, the value attained was close to the 5% proposed by EC8 [40] as the default viscous damping for the linear response analysis. After the cracking and up to 70% stiffness loss, ξ_{eq} showed a significant increase caused by the evolution of the damage. Afterwards, ξ_{eq} showed a fairly constant trend until failure. On average, this post-peak equivalent viscous damping presented a value of 11%, which is similar to the values obtained by [36] for specimens failing due to shear under cyclic testing. However, it is important to note that the equivalent viscous damping is intended to model the energy dissipation at deformation amplitudes within the linear elastic range of the overall structure. Over this range of deformations, the damping coefficient may vary with the deformation amplitude. The non-linearity observed on the damping coefficient due to increasing deformation can be handled by selecting a damping coefficient to characterise the wall associated with the linearly elastic limit of the structure. Therefore, the post-peak value of ξ_{eq} must be considered carefully since it could lead to high values which are unconservative and may not represent the real dissipation mechanism.

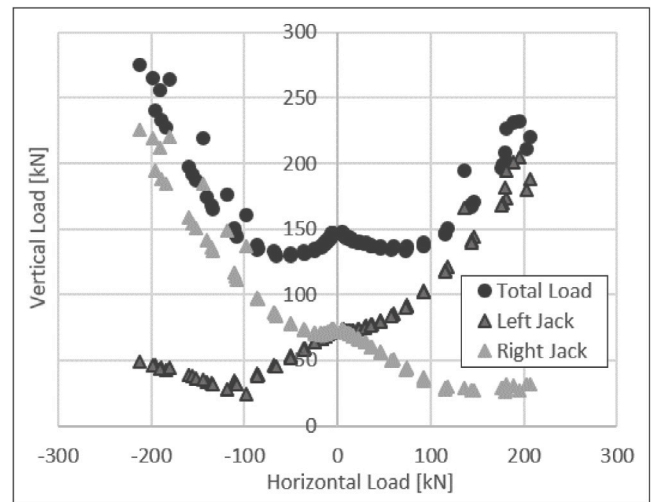
Fig. 12. Variation of the total vertical load, and the variation experienced by each jack, with increasing cyclic horizontal load.

As mentioned in Section 3.1, the testing configuration was designed to achieve a fixed–fixed boundary condition. As a results of such configuration, with the horizontal loading the vertical load increased as consequence of the dilatancy, and thus incrementing the compressive stress experienced by the wall. This increment of the vertical load was measured by means of four pressure transducers located one on each oil chamber of the two double effect jacks that applied the vertical load in the first stage of the testing. Fig. 12 shows the vertical load variation experienced by each jack (named here as left and right, see Fig. 4) during the cyclic testing, as well as the total vertical load applied on top of the wall. The total load is obtained as the sum of the vertical loads experienced by each jack and recorded by each pressure transducer for each displacement amplitude imposed in the test.

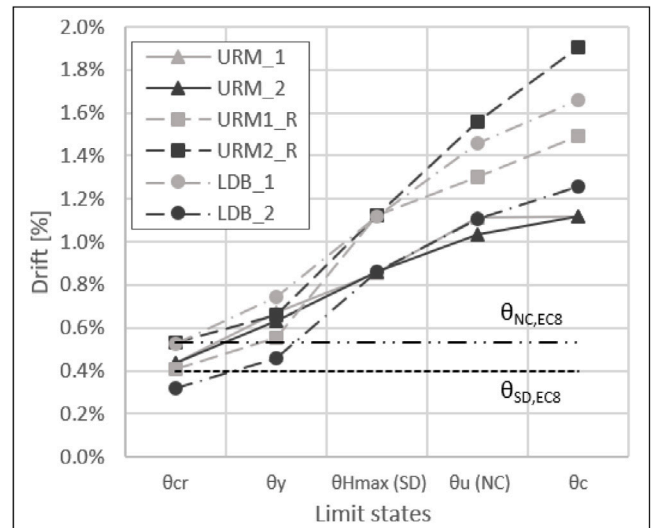
Fig. 14. Drift capacities of URM and strengthened specimens according to the limit states defined by [10] and comparison with SD and NC limit states set by EC8 [40].

with the energy dissipation. The repaired specimen URM_R attained similar values as the retrofitted specimen LDB_1 up to the drift at peak load $\theta_{H_{max}}$. After the peak load, the drift capacity of these specimens presented a broad spectrum of values. Among the retrofitted specimens, those failing in a tensile diagonal cracking (URM_R, LDB_1) showed always higher displacement capacity than the one failing due to frictional sliding (LDB_2), as evidenced in Fig. 14.
