# Experimental cyclic behaviour of shear masonry walls reinforced with single and double layered Steel Reinforced Grout

## Abstract

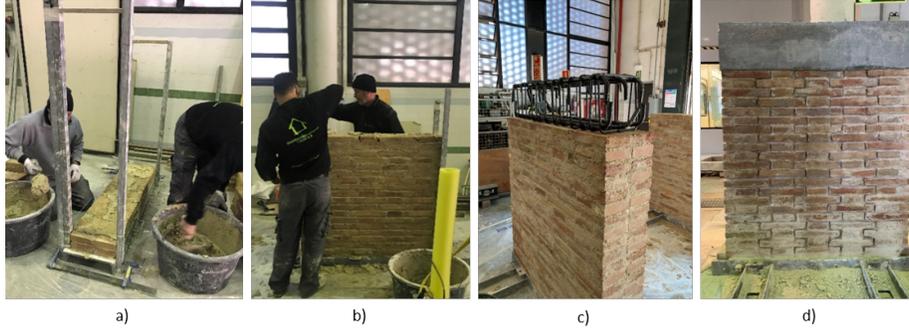
Figure 1: Procedure for construction: a) placing of the rulers for the construction, b) construction of the wall in Flemish bond, c) rebars placing for the concrete beam located on top of the specimen, d) specimen finished and stored under laboratory conditions

In order to represent a common type of historical masonry, the wall speci-  
114 mens investigated in the present research were built with fired clay bricks and  
low-strength lime masonry. Handmade solid clay bricks fired with traditional  
116 procedures were used for the assemblage of six double leaf masonry walls with  
nominal dimensions  $1270 \times 1270 \times 310 \text{ mm}^3$ . The specimens were built in Flem-  
118 ish bond with 21 courses and 15 mm thick mortar joints, see Figure 1.

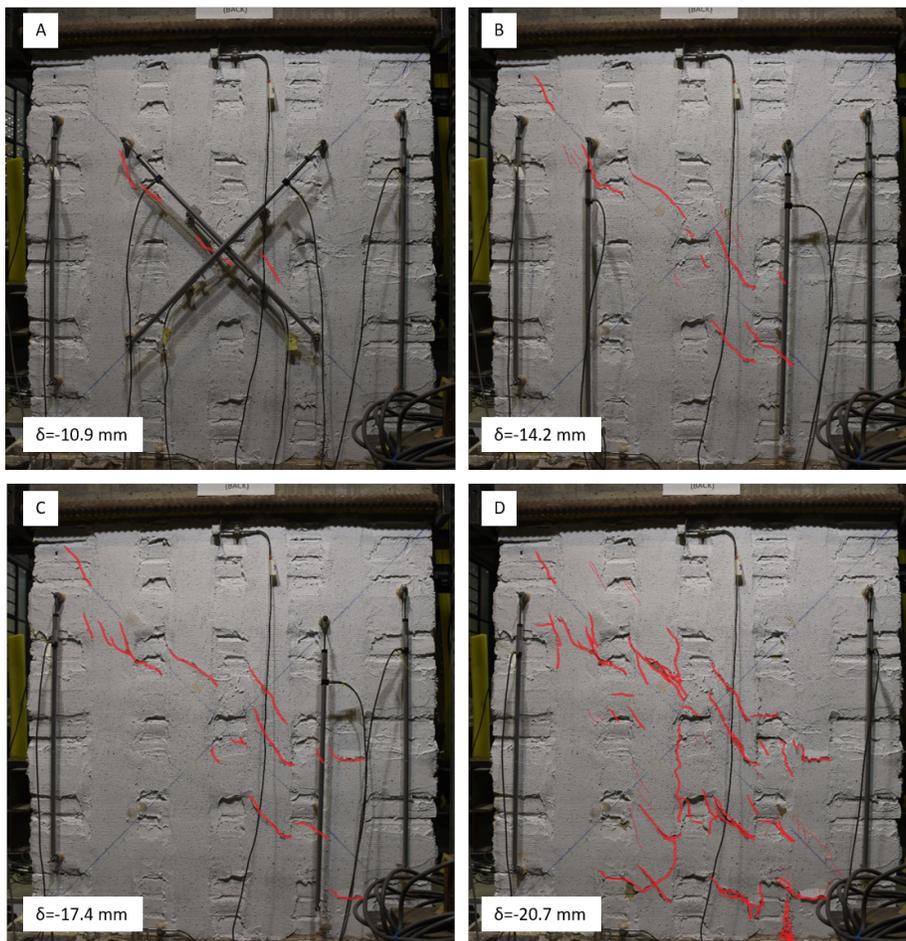
Figure 8: Crack pattern evolution in the pushing direction of specimen LDS.2
