**SILVER BOW CREEK/BUTTE AREA NPL SITE
BUTTE PRIORITY SOILS OPERABLE UNIT**

*Butte Reduction Works (BRW) Smelter Area
Mine Waste Remediation and Contaminated
Groundwater Hydraulic Control Site
Remedial Design Work Plan*

Atlantic Richfield Company

May 13, 2021

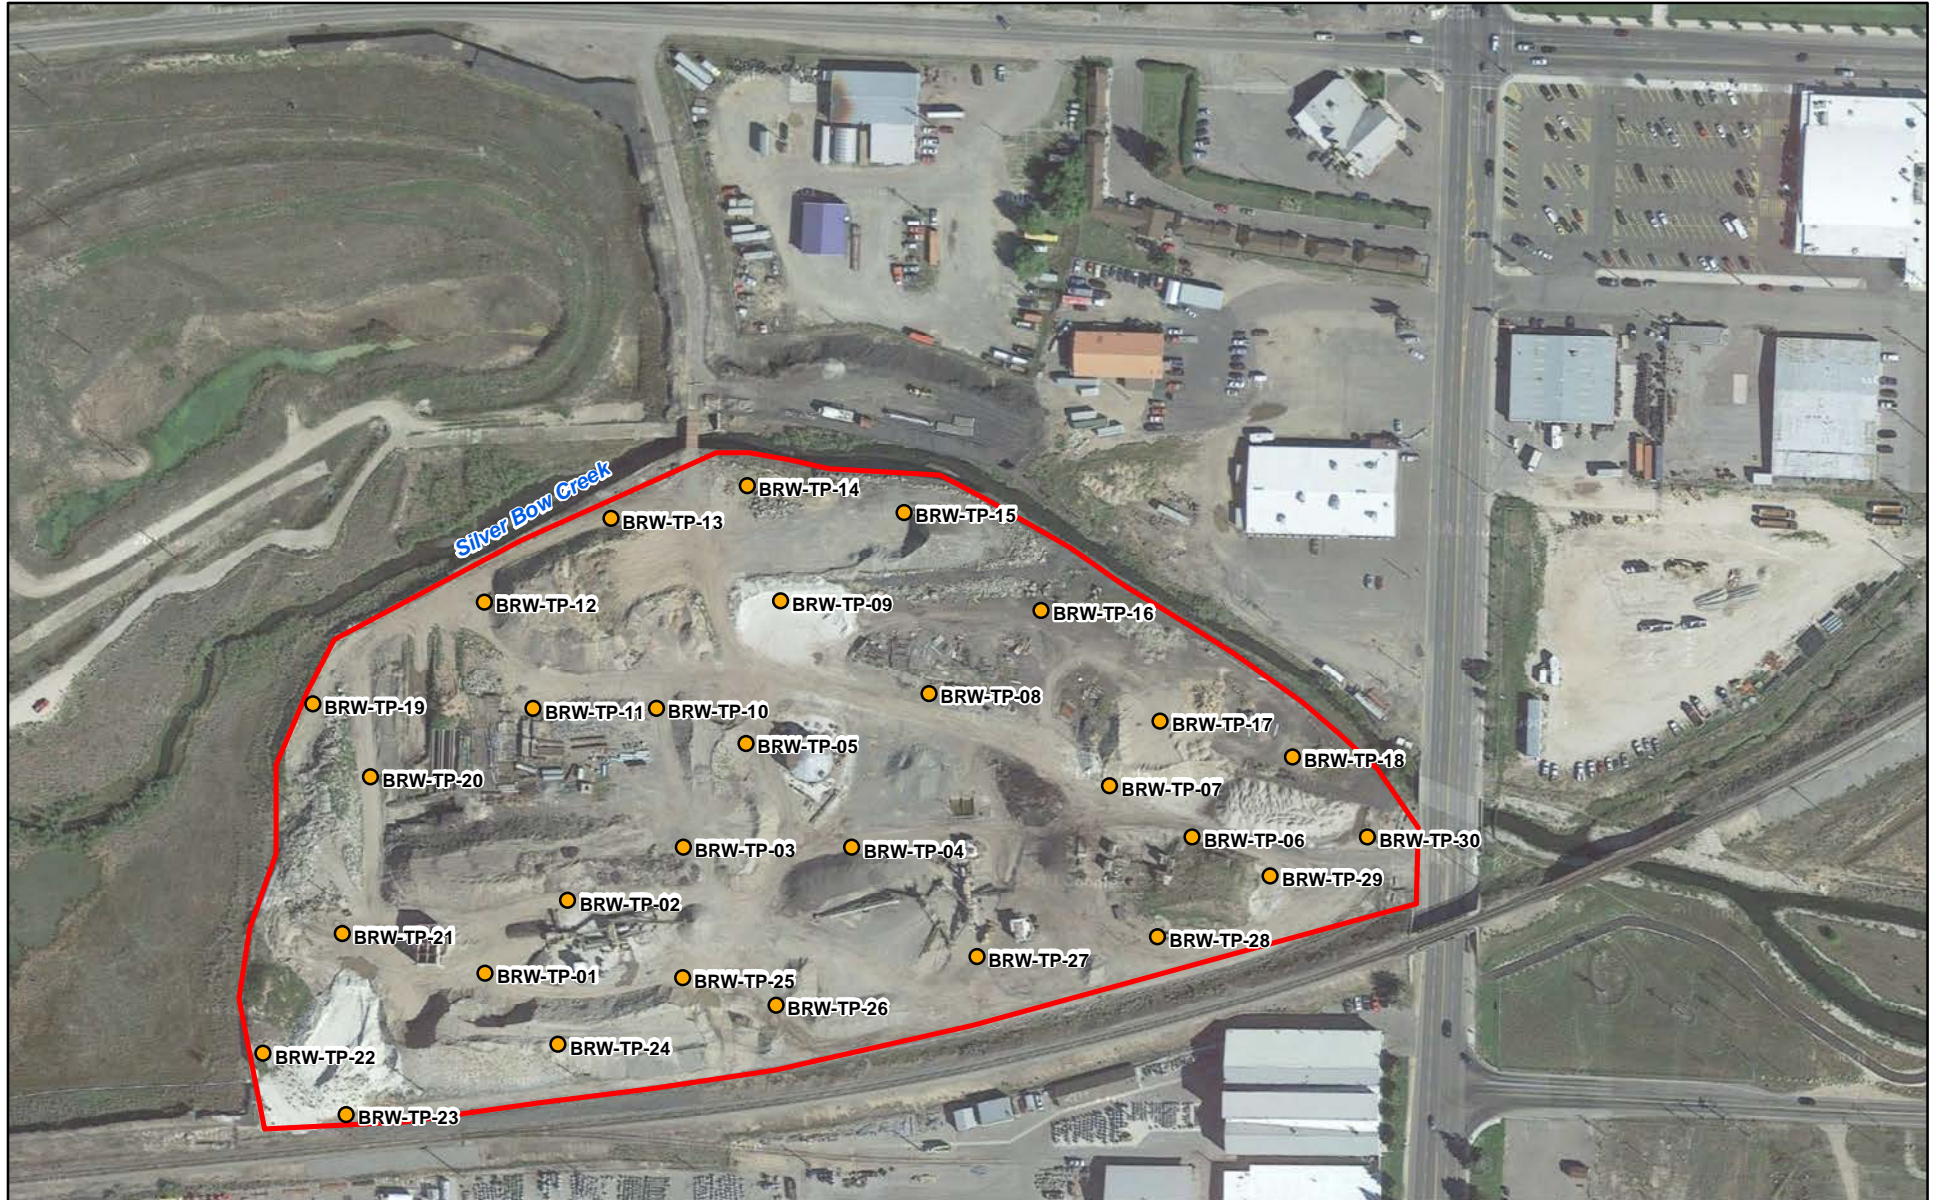
Figure 2
Test Pit Locations
Butte Reduction Works Smelter Site
Data Gaps Investigation
Lower Area One
Butte, Montana

- Test Pit
- Butte Reduction Works
