A SPATIAL ASSESSMENT OF RIPARIAN VEGETATION DENSITY
AND IMPLICATIONS FOR STREAMBANK EROSION IN
RELATION TO LAND TENURE IN THE MGWALANA
CATCHMENT, EASTERN CAPE PROVINCE, SOUTH AFRICA

Submitted in fulfilment of the requirements for the degree of
Master of Science (Geography) to be awarded at the Nelson
Mandela University

December 2021

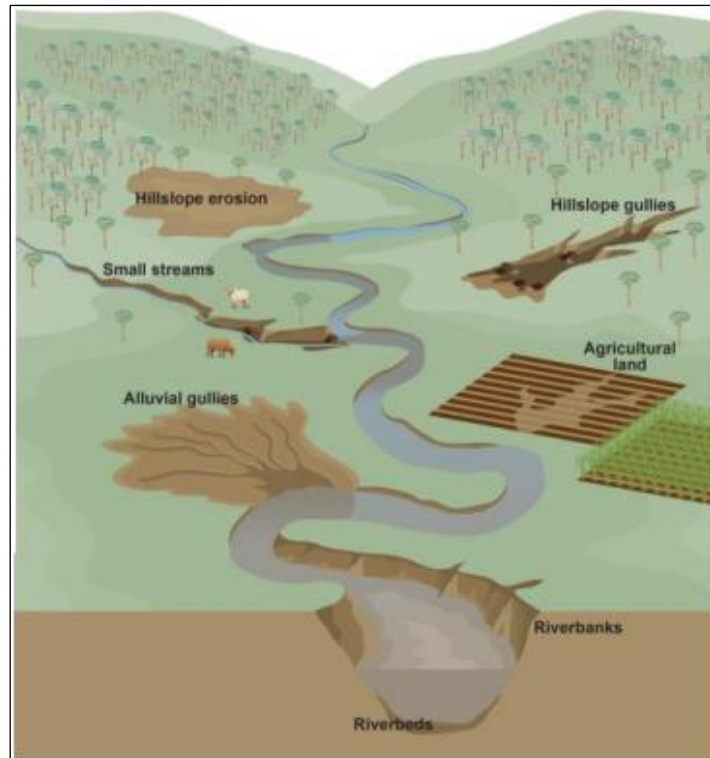
Figure 2.1. Gullies connecting into streams exacerbating erosion and sediment output (Image by Prosser, 2018).

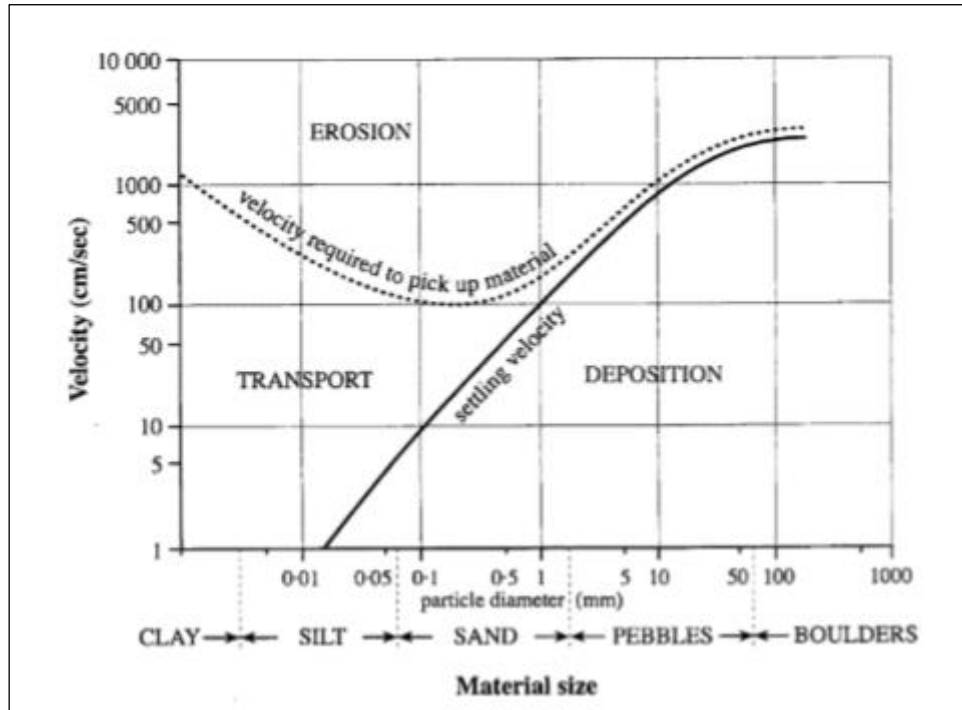
Figure 2.2. An adaptation of the Hjulström curve (Hjulström, 1939).

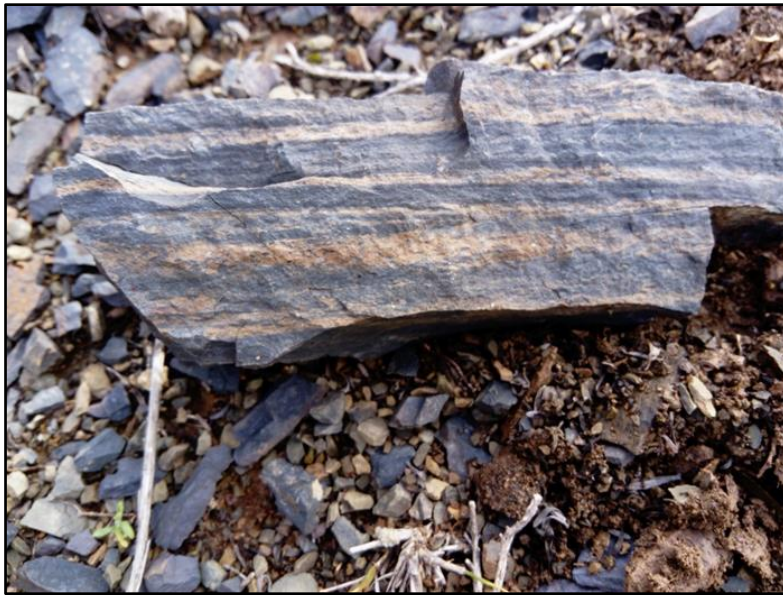
The catchment is predominantly made up of the sandstones and shales, which belong to the Eccca group and red mudstones which belong to the Karoo Supergroup (Manjoro, 2012). Sandstones characteristic of the Eccca group are dominated by feldspathic greywackes and minor quartz wackes. (De Jagers, 2015).

Figure 3.7. Shales of the Eccca group characteristic in the study area.

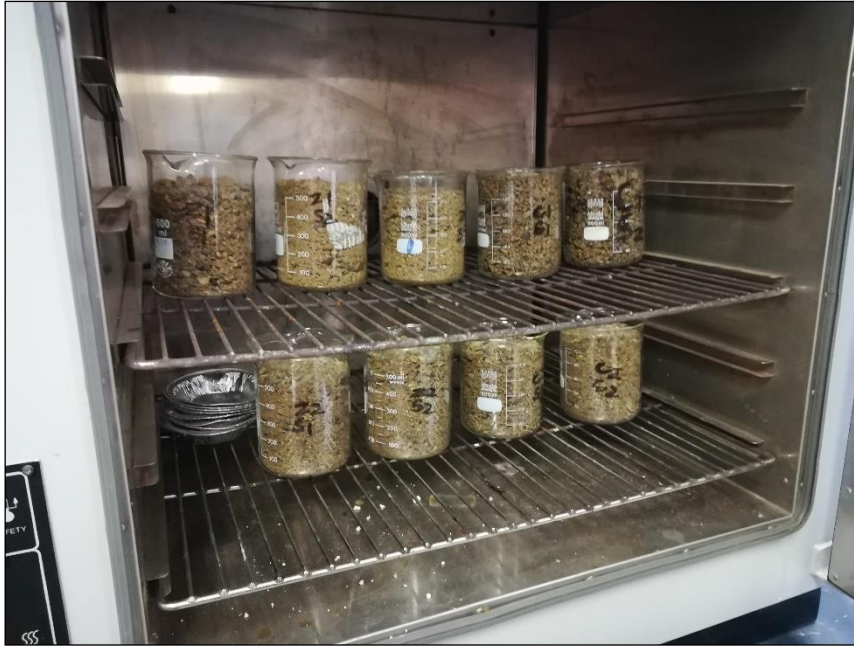
Laboratory procedures involved sediment analysis by determining the particle size distribution, bulk density and soil texture. The first part of this analysis was carried out on the soil samples collected from the sediment sinks (sediment accumulation zones). The samples were poured into beakers. They were then dried overnight in an oven at 105°C (Figure 4.3) and were taken out to cool. Soil samples were inserted in a mortar and were separated using a pestle until they were not as intact. The second part of the analysis involved samples collected from the stream reaches and channel banks.

Figure 4.3. Soil samples in beakers

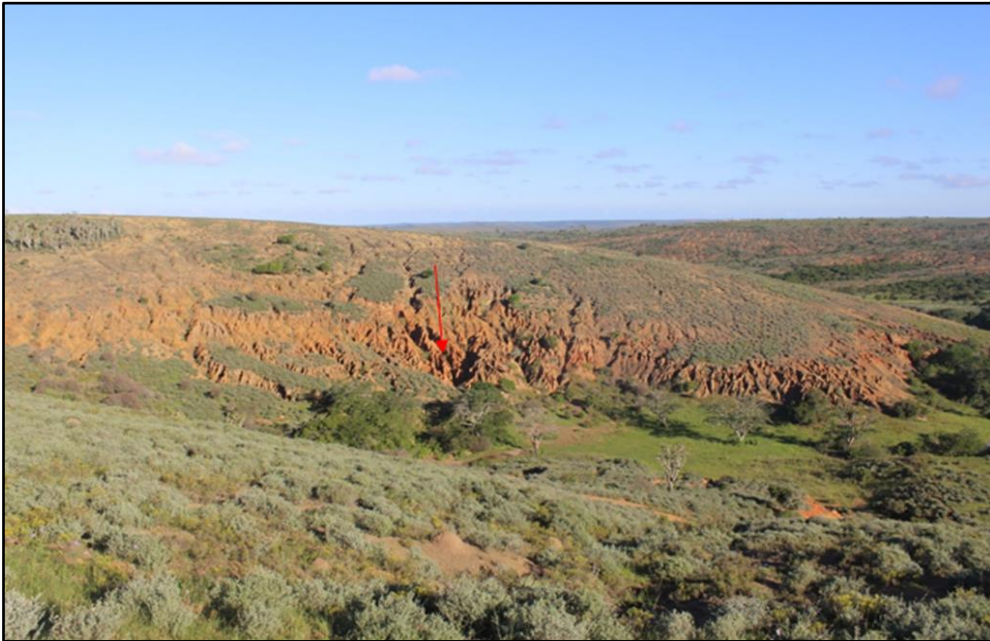
The spatial relationship between the gullies on the hillslopes and sediment sink zones as shown in (Figure 5.4) is presented below (Figure 5.5). Sediment sink zones are identified as occurring directly adjacent and coupled with extensive gullied sites (Figure 5.6), many of which were gully fan remnants. This confirmed that gullies are the main source of sediment for the sink zones as also observed in Figure 5.5.

Figure 5.5. Gullied hillslopes that directly deliver sediment into channel

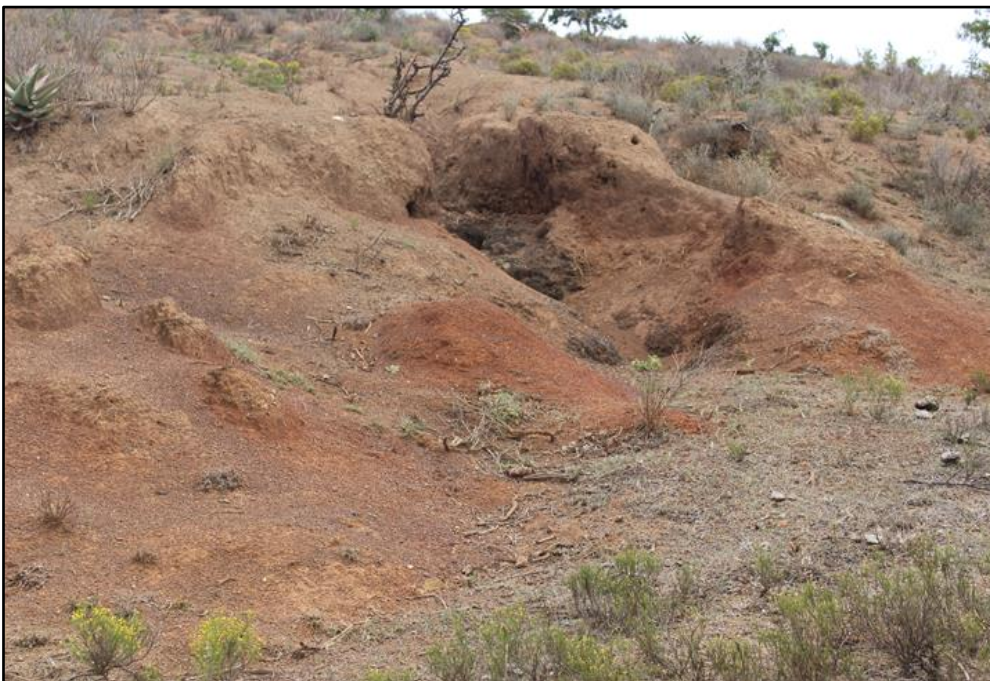
Figure 5.6. A gully that is directly connected to the stream channel in the Mgwalana catchment.

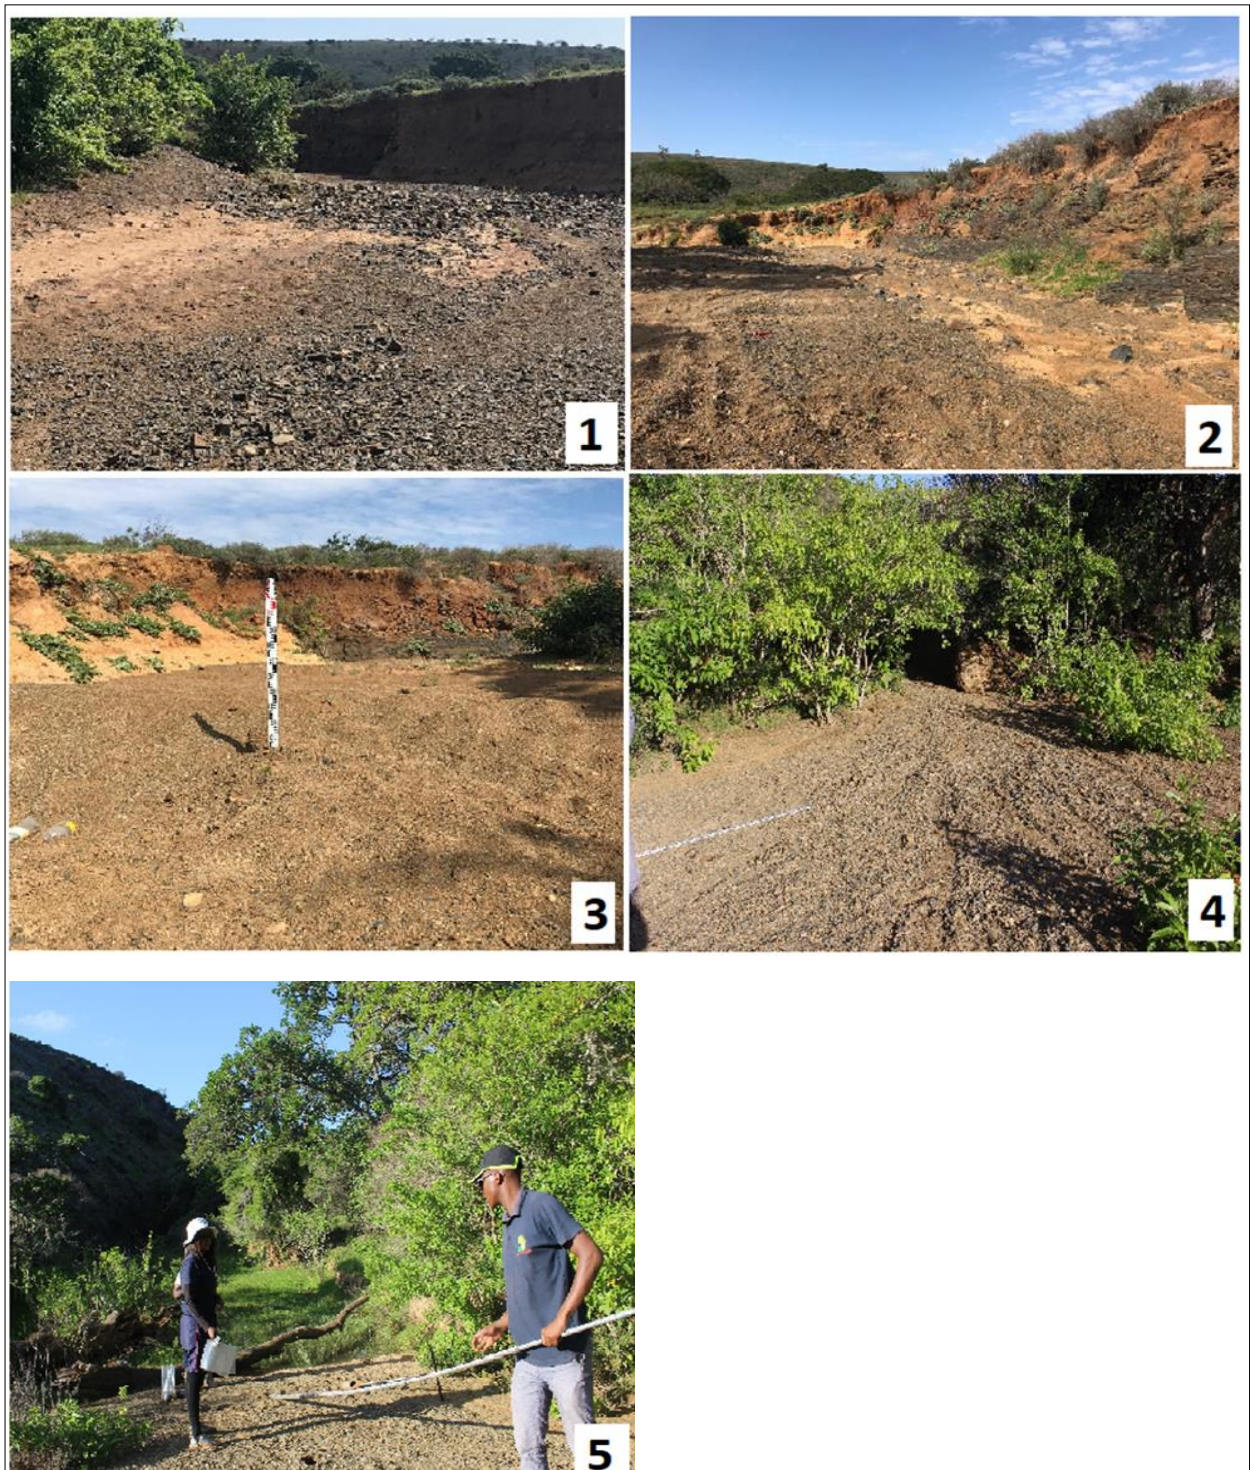
Sediment sinks (sediment accumulation zones) that were assessed in the present study are presented in Figure 5.7.

Figure 5.7. Sediment accumulation zones found in the upper catchment area (Images taken by Asakhile Maxama and Vusumzi Tsipa)

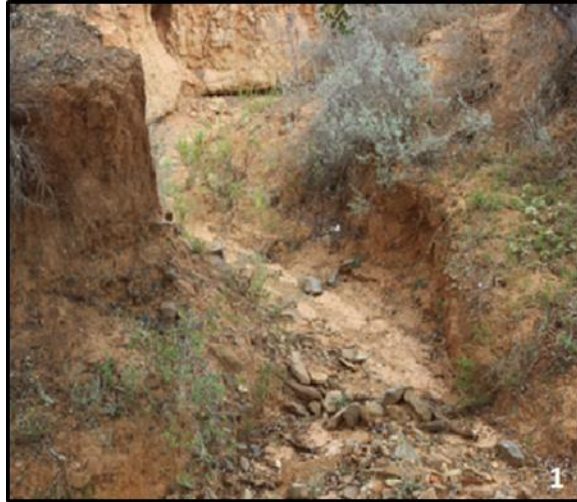
Through observations in the field, it was discovered that reach 1 was actively eroding and had minor patches of protective vegetation in the form of grass (Figure 5.10). There were gullies and rills all round and a significant invasion by the *P. incana* invader shrub was located about 5 m from the channel reach. There was visible bank undercutting, with channel walls characterized by poorly sorted pebbles and cobbles embedded in channel walls.

Figure 5.9. Scantily vegetated reach one (1) found in the upper catchment area in the communal traditional villages.

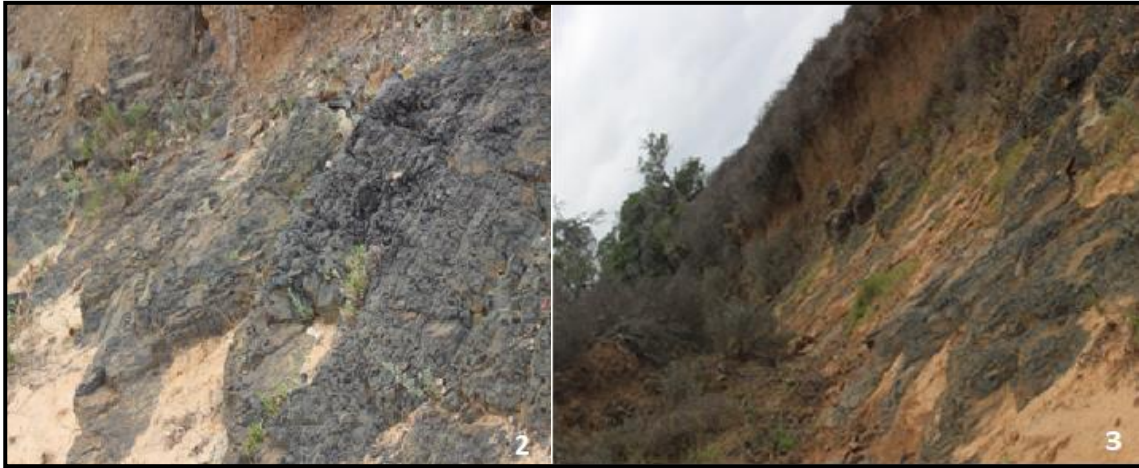
Reaches 2 and 3 showed similar trends (Figure 5.10). They were also characterized by coupling of gullies with the stream channel. Incision and bedrock exposure (Figure 5.10) were also typical of these scantily vegetated banks.

Figure 5.10. Reach two (2) and three (3) found in the upper catchment area representing unvegetated channels in the traditional village land tenure.

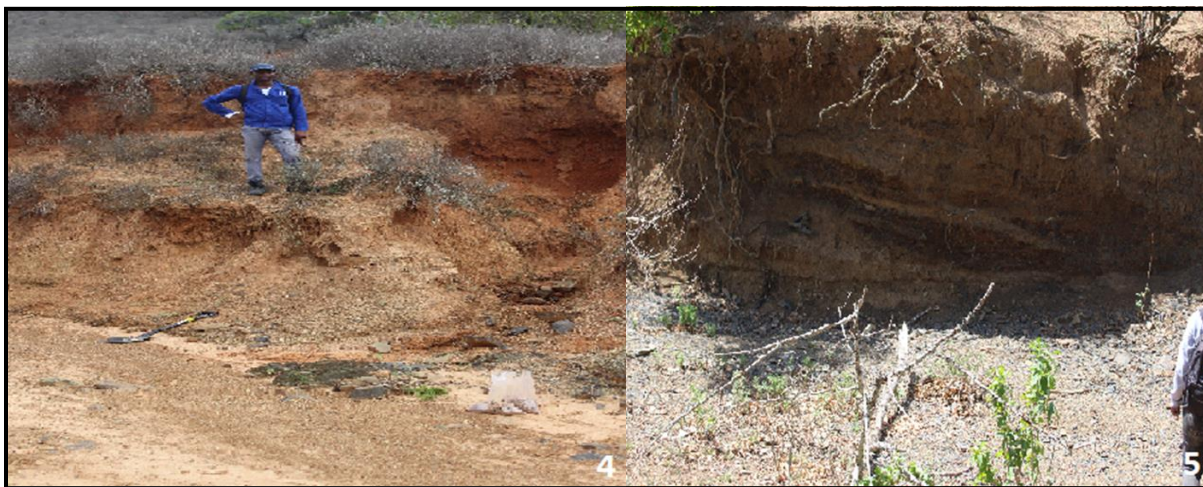
A similar pattern is also illustrated by reaches 4 and 5 (Figure 5.11). Reach 4 shows a degree of bedrock exposure and evidence of significant active erosion. Reach 5 shows minor aggradation and stable channel condition even though the riparian vegetation distribution is scanty.

Figure 5.11. Reach four (4) and five (5) found in the upper catchment area representing unvegetated channels in the traditional village land tenure.

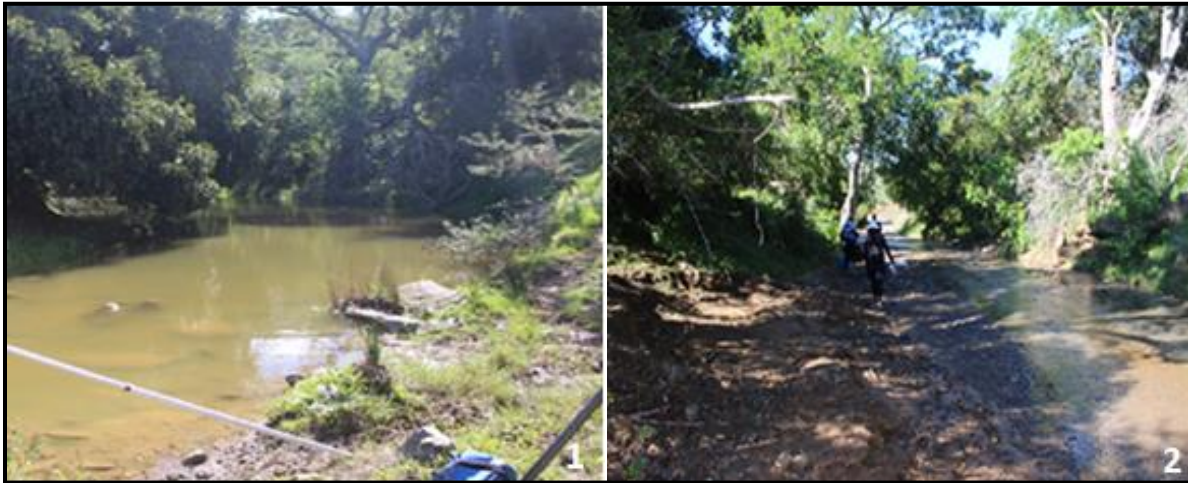
In the lower section of the catchment, reaches 1 and 2 were noted as stable and showed no signs of erosion. Vegetation cover in the form of trees (*Umnga*), grass on berms and shrubs was observed (Figure 5.12). Berm development is a clear sign of bank aggradation.

Figure 5.12. Reach one (1) and two (2) found in found in the lower catchment area representing densely vegetated channels in the former commercial farms land tenure.

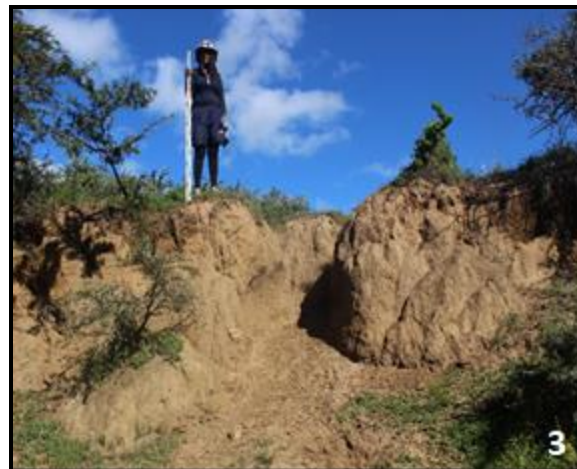
Reach 3 was the only one that showed signs of early stages of erosion, as channel walls were noted as actively eroding.

Figure 5.13. Reach three (3) found in found in the lower catchment area representing vegetated channels in the former commercial farms land tenure.

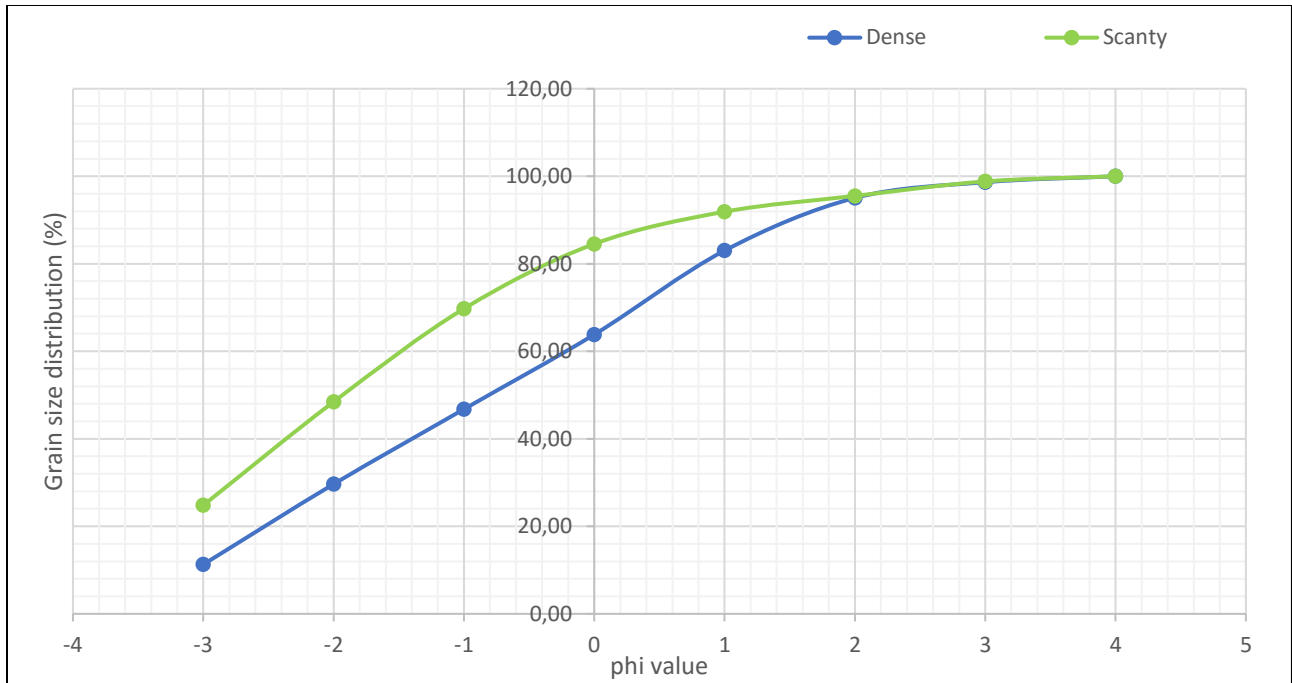
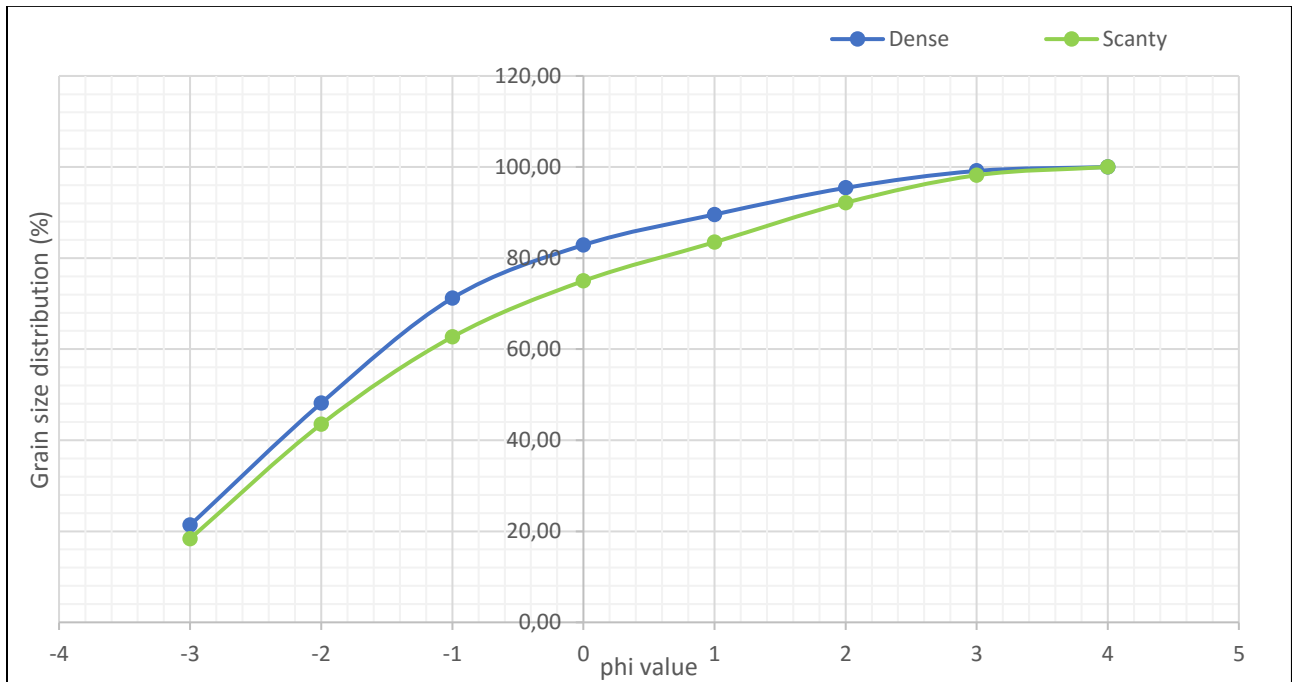
Noticeable trends from Figures 5.15 to 5.19 is that at most reaches, the scantily vegetated reaches have a greater percentage of coarser materials than the densely vegetated ones, as borne out by the curves in negative phi values zone. The trend also shows that the grain size distribution on both dense and scantily vegetated stream courses overlaps in terms of fineness of particles, between phi values 2 – 4. The grain distribution on densely vegetated stream reaches generally shows a less coarse component. The fine sediment component evidently dominates sediments collected from both the scantily and densely vegetated stream reaches.

Figure 5.15. A comparison of grain size distribution curve between a densely and scantily vegetated stream reach one (1).

Figure 5.16. A comparison of grain size distribution curve between a densely and scantily vegetated stream reach two (2).

Figure 5.17. A comparison of grain size distribution curve between a densely and scantily vegetated stream reach three (3).

Figure 5.18. A comparison of grain size distribution curve between a densely and scantily stream reach four (4).

Figure 5.19. A comparison of grain size distribution curve between a densely and scantily stream reach five (5).

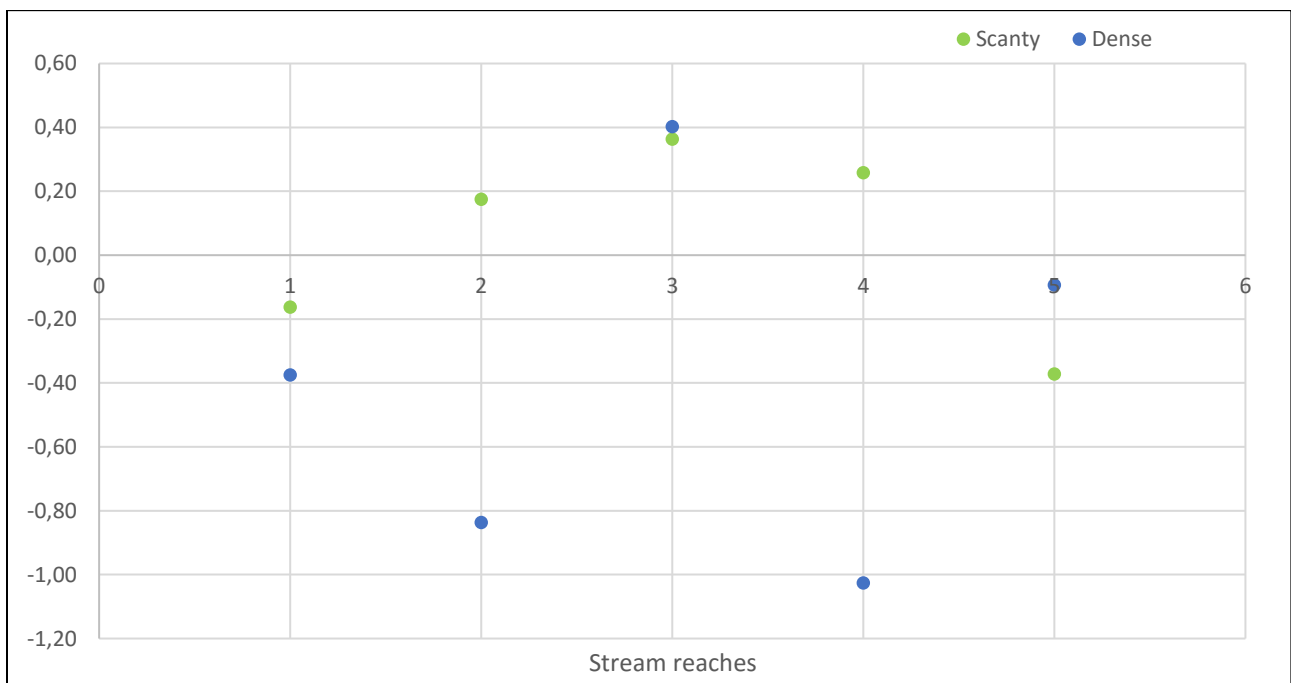
The results for particle size analysis detailing the skewness of the data are presented below (Figure 5.20). Samples along the scanty riparian vegetation distribution show a trend of being positively skewed as the values >1 . However, there are two instances where particles show a much skewed distribution and an almost symmetrical particle size. On the other hand, samples on the dense riparian vegetation distribution show a pattern that varies from very negatively skewed to negatively skewed. One sample on reach 5 is skewed symmetrically.

Figure 5.20. Characteristics of the particle size distribution in terms of skewness in scanty and densely vegetated reaches.

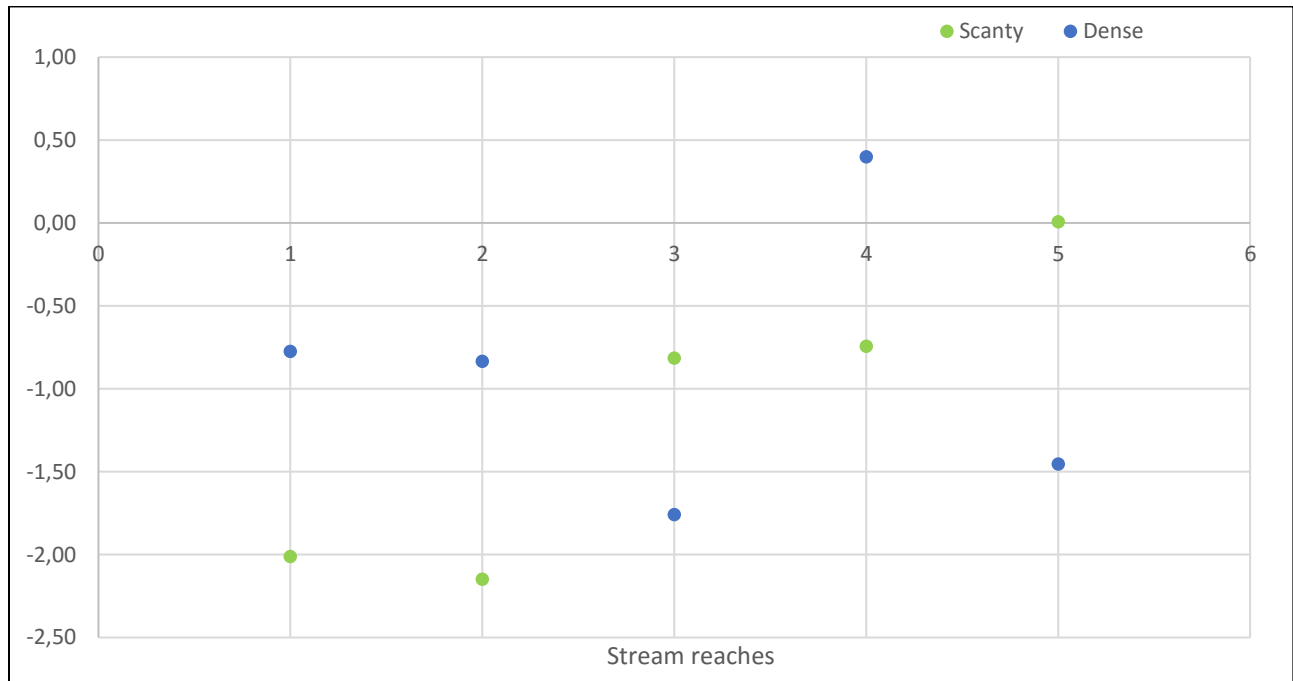
Results for kurtosis are presented below (Figure 5.21). A comparison was carried out between samples derived from scanty and dense riparian vegetation reaches. The general trend observed is that the particle size analysis for all samples is very platykurtic.

Figure 5.21. Characteristics of the particle size distribution in terms of kurtosis in scanty and densely vegetated reaches.

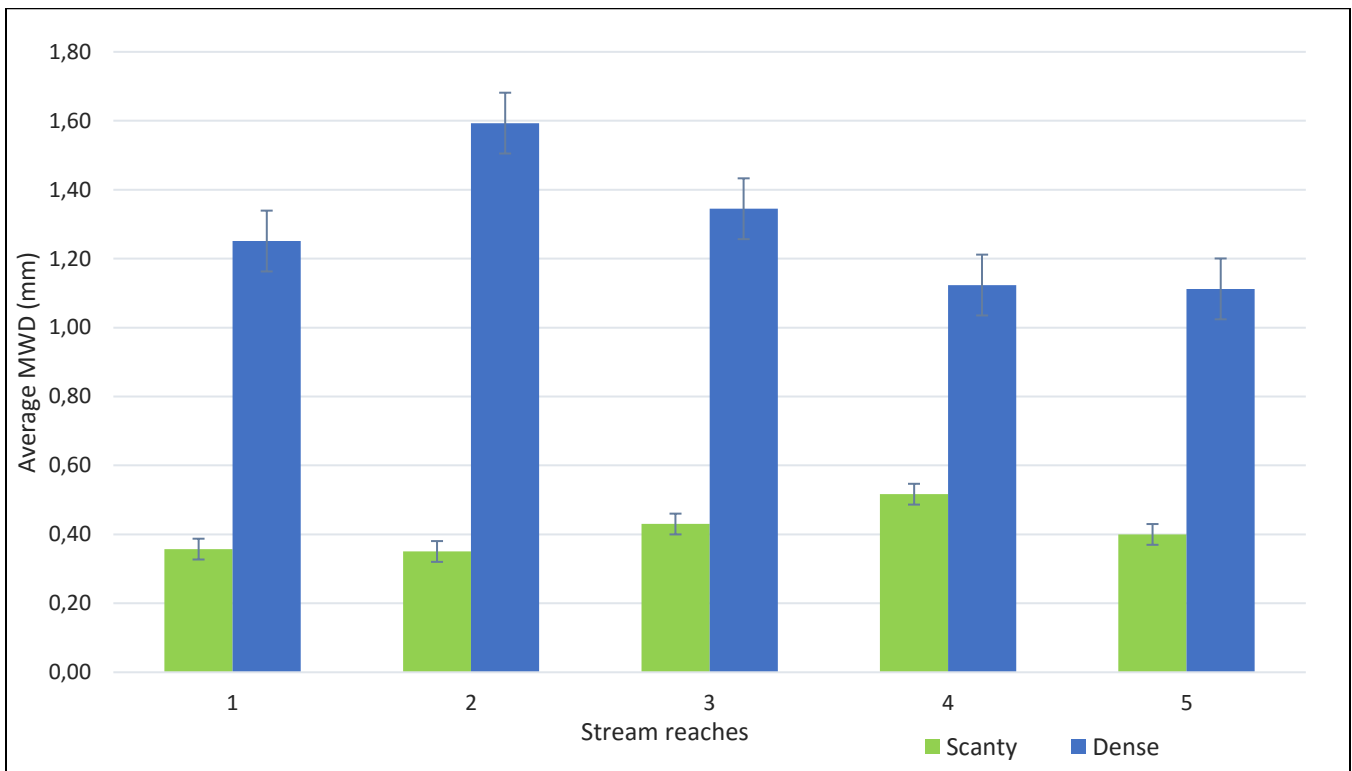
The results of the average aggregate stability of soils at densely and scantily vegetated stream reaches are presented below using MWD (Figure 5.23). MWD values for scantily vegetated stream reaches lie below 0.5 on average. By implication, the soils have a poor aggregate stability, and are unstable, susceptible crusting and erosion. On the contrary, MWD values for all samples from the densely vegetated reaches lie above 1.3. Therefore, the soils are evidently stable, and crusting is rare. A significant difference was observed between the soil aggregate stability in unvegetated and vegetated stream as $p= 1.43 \times 10^{-6}$; $p<0.05$.

Figure 5.23. Average aggregate stability on vegetated and unvegetated stream reaches
