## Experimental and numerical studies of six small-scale continuous concrete slabs subjected to travelling fires

Wang, Y, Ren, Z, Huang, Z, Gao, W, Zhong, B, Bu, Y, Huang, Y, Zhang, Y, Yuan, G & Ma, S 2021, 'Experimental and numerical studies of six small-scale continuous concrete slabs subjected to travelling fires', *Engineering Structures*, vol. 236, 112069. <https://doi.org/10.1016/j.engstruct.2021.112069>

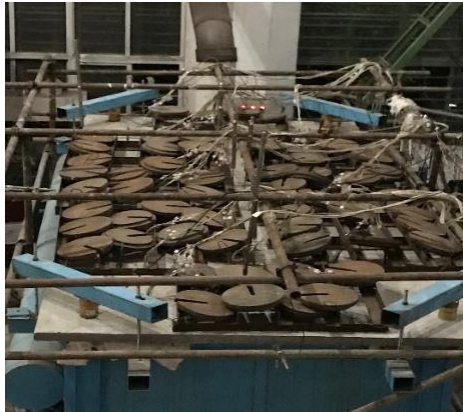
Figure 2

(a) Photos of the iron bricks and restrained beams at each corner

Fig. 2 Details of the loads and restrained beams (all dimensions in mm) (a) Photos of the iron bricks and restrained beams at each corner; (b) Loading device, supports, and corner restraints; (c) Position of the pressure sensor.

196 restrained using reaction beams, as shown in Figs. 2(a)-(c).

803 Fig. 2 Details of the loads and restrained beams (all dimensions in mm) (a) Photos of  
804 the iron bricks and restrained beams at each corner; (b) Loading device, supports, and  
805 corner restraints; (c) Position of the pressure sensor.

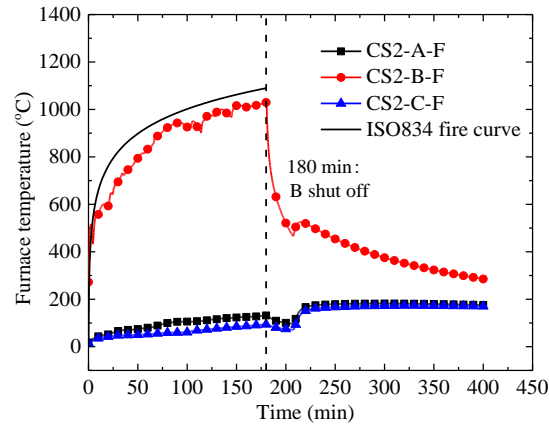
**Fig. 3** Average furnace temperature-time curves for the six slabs

229 The furnace temperature of one compartment was observed to be dependent primarily  
230 on the ignition of the nozzles and the fire duration. At shut-off, the maximum furnace  
231 temperature of the heated spans ranged from 830 °C to 1137 °C. As expected, the shorter  
232 heating duration of slabs CS3 to CS6 (90 min) resulted in maximum furnace  
233 temperatures that were slightly lower than those of the previous tests [13-14]. For  
234 instance, the maximum furnace temperatures in slabs B1 to B4 [13] ranged from 1016  
235 °C to 1299 °C, and those in slabs S1 to S5 [14] ranged from 1003 °C to 1147 °C, as shown  
236 in Table 3.

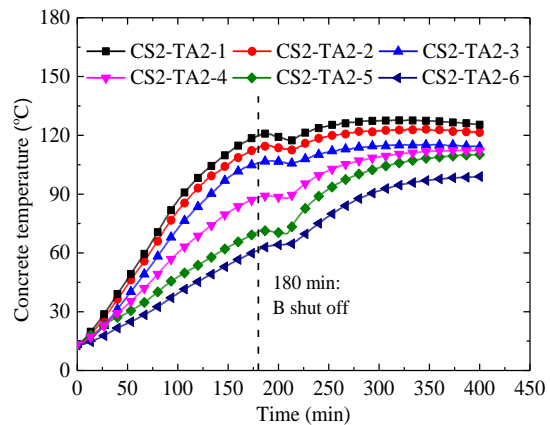
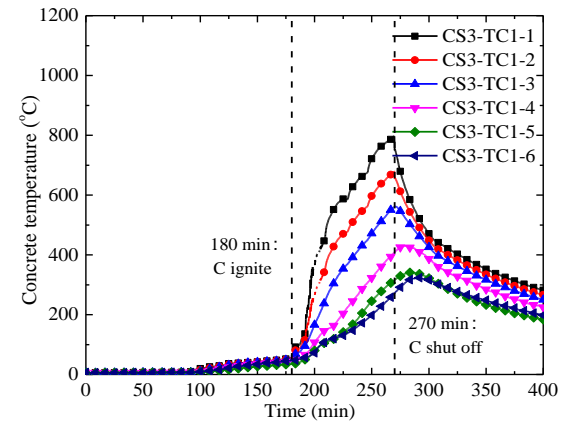
Fig. 4 Temperature distributions through the thickness of the six slabs

241 Figs. 4(a)–(f) show the concrete temperatures of the six tested slabs, and the maximum  
242 concrete and steel temperatures are shown in Table 3. It should be noted that the data  
243 for compartment CS4-B were not measured owing to a malfunction of the  
244 thermocouples. In addition, the average bottom and top steel temperatures in each span  
245 are shown in Figs. 5(a)–(f).

246 The measured results indicate that there is no temperature plateau near the top surface  
247 of the slabs created for this study; this observation is different from those of the full-  
248 scale tested slabs in references [13-14]. **As discussed above, the aggregate's dimensions  
249 (5-12 mm) were not reduced in size according to the reduction of the slab dimensions.  
250 In this case, the larger aggregates tend to increase the heat permeability and lead to the  
251 formation of concrete micro-crack [31]. Note that, concrete permeability is one of the  
252 most important characteristics controlling moisture transport. Meanwhile, micro-cracks  
253 tend to initiate in the high stress region and propagate along the weakest area to release  
254 stresses. Thus, no temperature plateau and large cracks appeared on the top surface of  
255 the tested slabs, respectively.**

278 During the cooling stage, the concrete temperatures near the top surface of most of the  
279 slabs continued to rise, and the average duration of the rise (from the shut-off time) was  
280 about 21 min. However, the durations of the temperature rise in the tested slabs in  
281 references [13] and [14] were 84 min (100 mm) and 49 min (80 mm), respectively.  
282 Clearly, the increased thickness of those slabs resulted in a longer duration. In addition,  
283 for the slab with serious spalling, no temperature increase in the top surface appeared  
284 during the cooling stage, as observed in slabs CS1-A and CS2-B. This implies that, in  
285 the numerical model, the effect of spalling should also be considered to accurately  
286 predict the temperature of the slab during the cooling phase. Thus, this behaviour  
287 should also be considered in the failure criterion, post-fire performance assessment, and

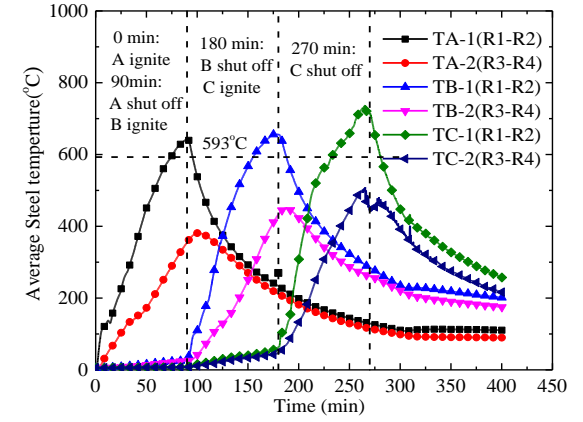
**Fig. 5 Reinforcing steel temperatures in the six slabs**

263 It was also observed that a time delay had a greater effect on the bottom steel  
264 temperature than on the concrete temperature of the later heated spans, particularly the  
265 maximum temperature during the heating stage. For slabs subjected to the same fire  
266 exposure duration, a longer time delay had no significant effect on the peak  
267 temperatures of the reinforcement compared with uniform fire scenarios. In slab CS3  
268 and CS5, for instance, the maximum temperatures of bottom reinforcement in spans A,  
269 B, and C were 644 °C, 654 °C, and 721 °C, and 626 °C, 642 °C, and 673 °C, respectively,  
270 and the average values were 673 °C and 647 °C, respectively. However, the maximum  
271 temperature of bottom reinforcement in slab CS6 was 634 °C. In this case, for the  
272 travelling fire scenario, the later heated spans failed earlier than the first heated span.  
273 Thus, travelling fire scenarios, which include parameters such as the fire spread

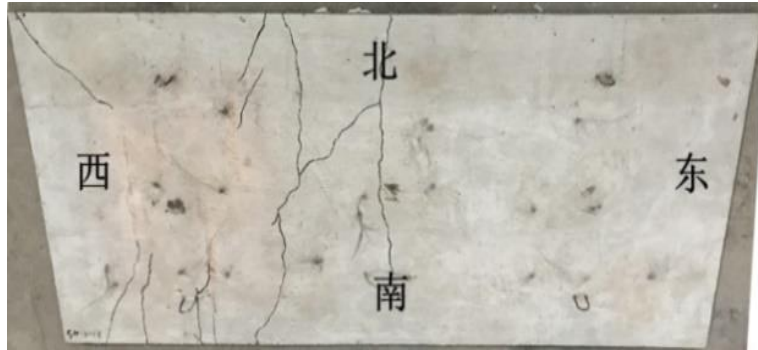
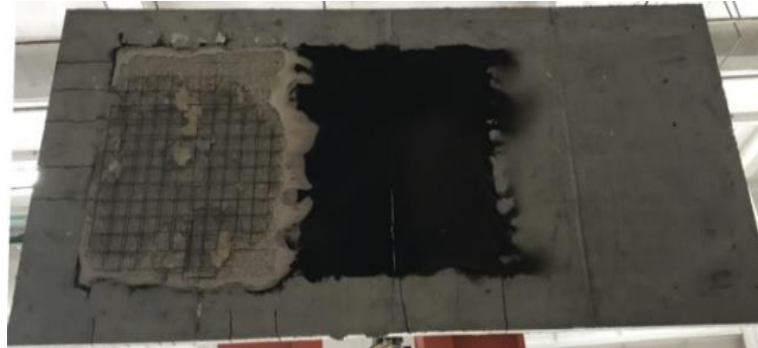
Fig. 9 Failure modes of Slab CS1: (a) cracking pattern on the top surface, (b) crack development, (c) bottom surface, and (d) cracking pattern on the bottom surface

406 After 5 min, slab CS1 experienced serious spalling accompanied by a loud sound. Then,  
407 slight spalling was heard until 37 min. At 20 min, cracks appeared on the corners of the  
408 slab and the mid-span region of the top surface. It should be noted that some steam was  
409 observed on the top surface between 45 min and 50 min. The cracking patterns and  
410 spalling are shown in Figs. 9(a)–(d). Clearly, the short corner cracks mainly appeared  
411 on heated span A owing to its upward deflection, and fewer cracks appeared near its  
412 adjacent internal support. On the bottom surface, there were fewer short edge cracks  
413 around the heated region, with a maximum spalling depth (area) of 45 mm (0.98 m<sup>2</sup>).  
414 In addition, the cracking pattern in span CS1-A was different than that of Span S1-A  
415 [14] as a result of a different deflection trend. It can be seen that the crack distribution

416 and spalling may be used to evaluate the deflection trend of the span during a fire.

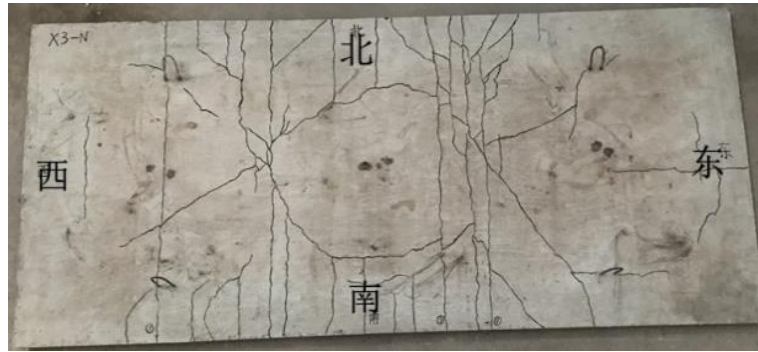
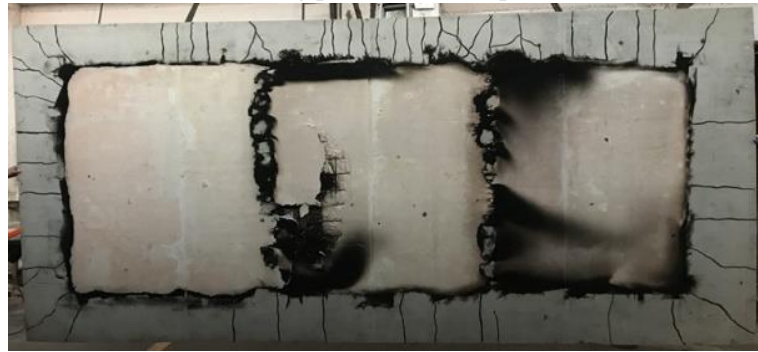
Fig. 11 Failure modes of Slab CS3: (a) cracking pattern on the top surface, (b) crack development, (c) bottom surface, and (d) cracking pattern on the bottom surface

434 Figs. 11(a)–(d) show the symmetrical cracks on the top surface of slab CS3 and many  
435 short-span (south-north) cracks concentrated at the internal supports and in span CS3-  
436 B. Different from the many short-span cracks (upward deflection) in span B3-B [13],  
437 circular cracks appeared in span CS3-B owing to the downward deflection. There were  
438 fewer cracks (i.e., larger crack spacing) in span CS3-B because of its lower  
439 reinforcement ratio.

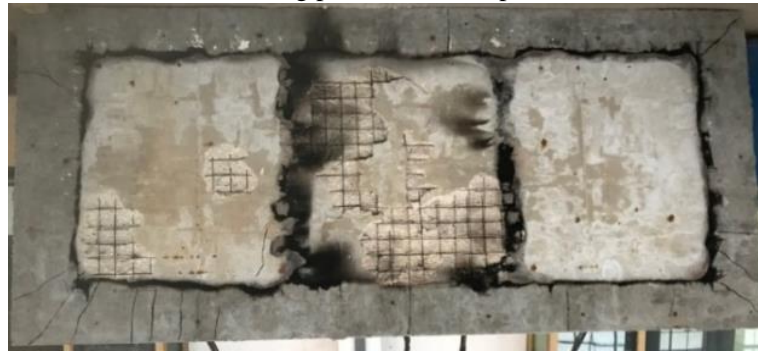
Fig. 12 Failure modes of Slab CS4: (a) cracking pattern on the top surface, (b) crack development, (c) bottom surface, and (d) cracking pattern on the bottom surface

450 As shown in Figs. 12(a)–(d), symmetrical cracks appeared on the top surface of slab  
451 CS4, with arc cracks at the two edge spans. It should be noted that no arc cracks were  
452 observed on the top surface of any edge span in references [13-14]. Thus, the span-

453 thickness ratio had a considerable effect on the appearance of edge arc cracks. In  
454 addition, spalling occurred on the bottom surface of span CS4-B (spalling area: 0.53  
455 m<sup>2</sup>; maximum depth: 36 mm), and slight spalling occurred on span CS4-A. Compared  
456 to slabs CS1 and CS2, the spalling in slab CS4 was relatively slight owing to its older  
457 concrete age (196 days).

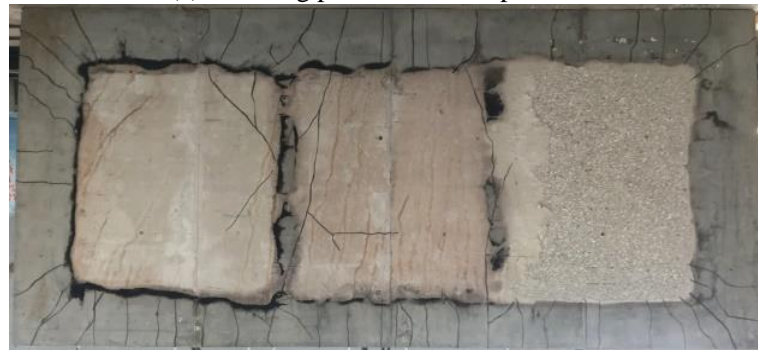
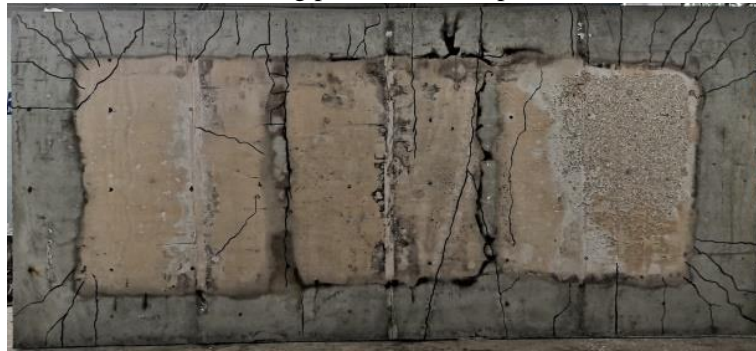
Fig. 13 Failure modes of Slab CS5: (a) cracking pattern on the top surface, (b) crack development, (c) bottom surface, and (d) cracking pattern on the bottom surface

Fig. 14 Failure modes of Slab CS6: (a) cracking pattern on the top surface, (b) crack development, (c) bottom surface, and (d) cracking pattern on the bottom surface

467 Figures 13(a)–(d) and 14(a)–(d) show the symmetrical cracking pattern on the top and  
468 bottom surfaces of slabs CS5 and CS6, respectively, including the arc or inclined cracks  
469 (top surface) and short-span bottom surface cracks (internal supports). It can clearly be  
470 seen that the internal supports became the weakest region as a result of the increasing  
471 span-thickness ratio, and integrity failure occurred owing to the short-span top and  
472 bottom cracks.
