**Redução do custo de manutenção e aumento da  
eficiência na secção de estampagem a quente**  
Maintenance cost reduction and process optimization of  
the Hot Stamping line – Gestamp Aveiro case study

Relatório de Estágio apresentado à Universidade de Aveiro para cumprimento dos requisitos necessários à obtenção do grau de Mestre em Engenharia Mecânica, realizada sob a orientação científica do Doutor Tiago Manuel Rodrigues da Silva, Investigador do Departamento de Engenharia Mecânica da Universidade de Aveiro e supervisão do Engenheiro Miguel Nunes, Diretor de Manutenção da Gestamp Aveiro.

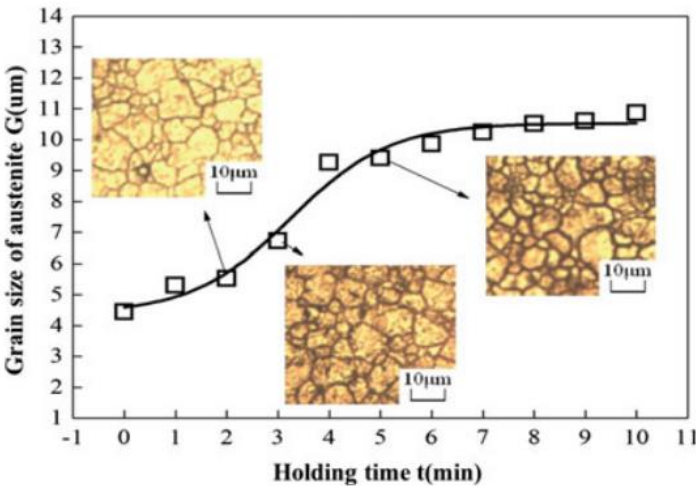
FIGURE 4: DWELL TIME IN FURNACE EFFECT ON 22MnB5'S MARTENSITIC GRAIN SIZE (Hu, Ying e He, 2016)

The dwell time inside the furnace is another variable of major importance as the size and homogeneity of the austenitic grains has a heavy influence on the final cold product. It has been considered that the most suitable dwell time is about 5min, and the acceptable range is 3 to 6min (Figure 4). Before the 3min mark, there is not enough time for the austenite to form. After 6 min the grains are too coarse. The desired dwell time causes the creation of fine, uniform austenite, which potencies the martensite formation during quenching, as well as material elongation during the forming stage, decreasing the likelihood of fractures or tearing in the blanks (Hu, Ying e He, 2016) (Figure 3 and Figure 5).

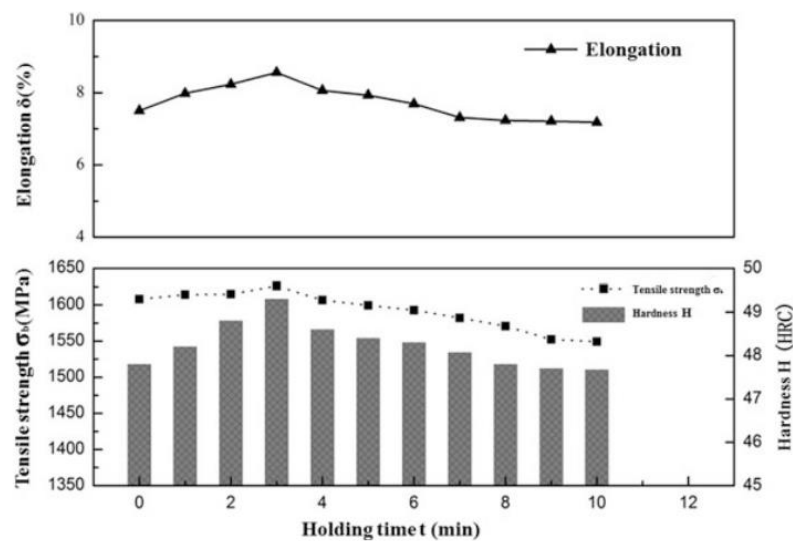
FIGURE 5: EFFECT OF DWELL TIME IN THE FURNACE ON 22MnB5'S TENSILE STRENGTH (Hu, Ying e He, 2016)

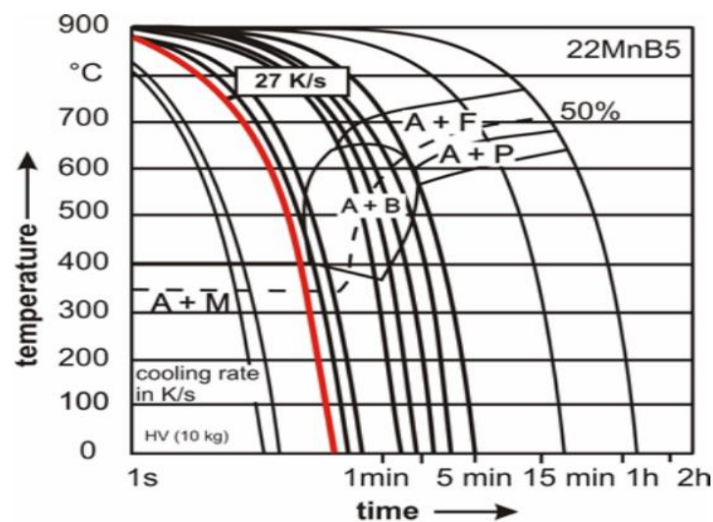
FIGURE 7: 22MNB5'S CCT DIAGRAM PROVIDED BY THE PRODUCER (ARCELOR®)

One of the most relevant and characteristic processes in HS, compared to CS, is the quenching of the blanks. This process begins once the blank enters the production line's furnace, where the blanks reach up to 920°C. During the heating, austenitic transformation occurs, changing the properties of the blanks. As soon as the heated blank is ejected from the furnace and transferred to the press, the stamping and quenching processes occurs, cooling the blank down rapidly. The dies have an integrated cooling system to lower both the die and blank's temperature down. The rapid cooling of the heated blanks will reorganize its microscopic structure, developing mostly martensite which will increase the material's strength. To develop a fully martensitic microstructure, as stated in (Merklein, Lechler e Geiger, 2006), 22MnB5 has to have a minimum cooling rate of  $27 \text{ K}\cdot\text{s}^{-1}$  to achieve the desired result, as provided by Arcelor® (Figure 7) datasheet.

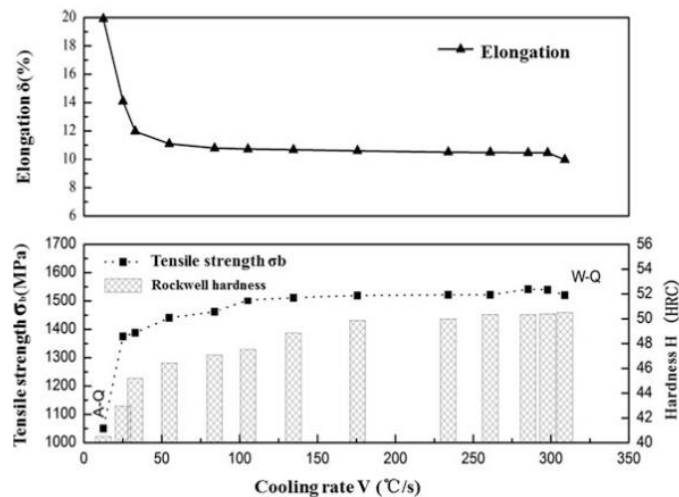
FIGURE 8: COOLING RATE EFFECT ON ELONGATION AND TENSILE STRENGTH (Hu, Ying e He, 2016)

As stated by (Hu, Ying e He, 2016), there is a relation between the cooling rate and the hardness of the formed part where an increase in cooling rates increases the hardness. However, increasing the cooling rate creates stresses in the press's tool, which can lead to fracture over time. The authors made experiments/tests to determine the optimum cooling rate. Figure 8 shows the main results obtained.

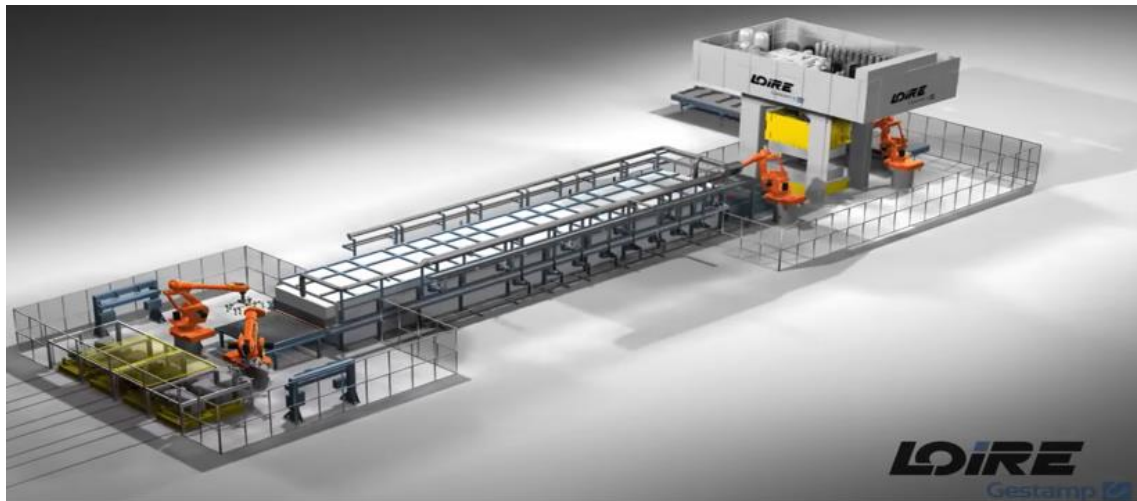
FIGURE 12: A) GESTAMP HS LINE RENDER IMAGE AND B) HS SCHEMATIC

The furnace has a total of 274 ceramic rollers, controlled by servomotors, which transports the blanks up to a maximum of 11 minutes up to 930°C, time that if surpassed will degrade the blanks mechanical properties. The batches are controlled by photo barriers inside the furnace. After the heating process, the blanks are expelled from the furnace into the centring bed (3). The centring bed is responsible for aligning the blanks with the assistance of linear rail, servo-controlled claws

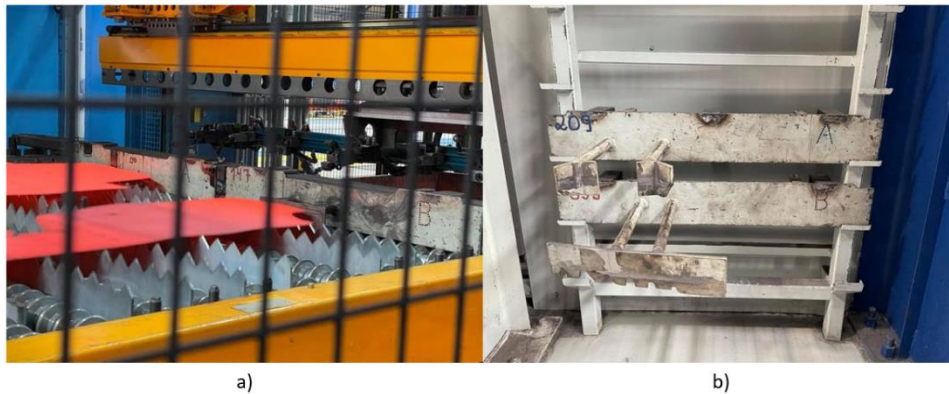
FIGURE 13: A) BLANK HITTING A STOPPER AND B) STORED STOPPERS

If there is any reject from a faulty blank because of over-exposure to temperature, a "stopper" plate is lifted, causing the faulty blank to leave the system immediately to a scarp container. Despite their simplicity, the stoppers have a very important function. Once the blank leaves the furnace, the rollers move the blanks until they hit the stoppers. The special format the stoppers have allows the blanks to be semi-aligned and prevents more delicate contours of the blank from warping/bending due to the impact. Stoppers are shown in Figure 13.

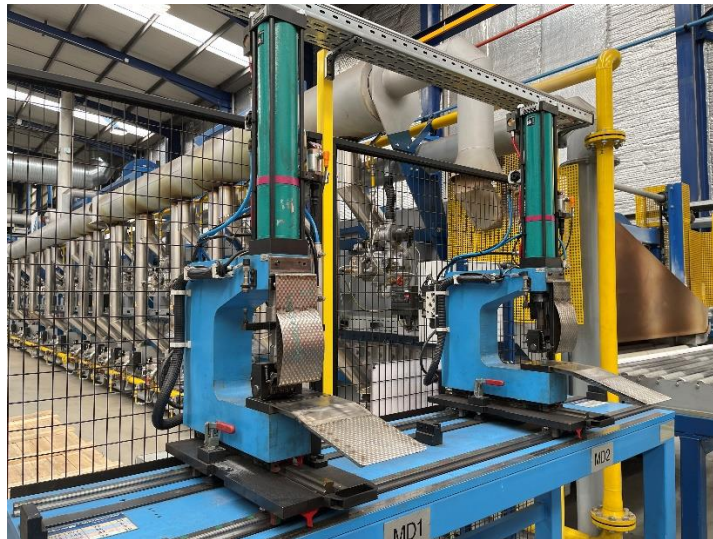
FIGURE 15: TOX HYDRO-PNEUMATIC REFERENCING PRESS

In the early stages of the production line, the small "C" shaped hydro-pneumatic press (Figure 15) responsible for the referencing and thickness verification of the blanks breaks repeatedly. When maintenance is being performed, to enter the destaker area, a safety gate cuts the pressurized system once open. At this point, the press starts losing pressure and its tool head drops, often abruptly.

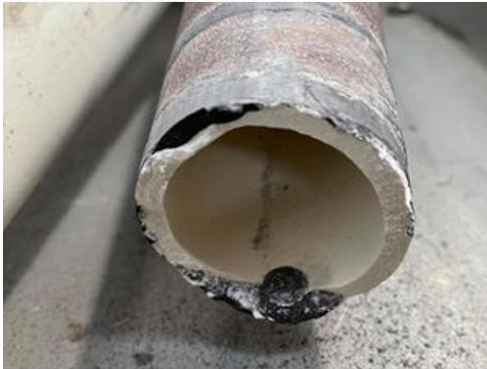
b) Aluminium encrustations

These aluminium encrustations can as well infiltrate the rollers deep inside. It is in these places where the breakage usually occurs, so the encrustations, simultaneously with the high-temperature gradient when being replaced, are thought to be the breakage cause (Figure 16 b). The breakage makes refurbishing the rollers impossible, meaning that for each roller that breaks a new one must be used.

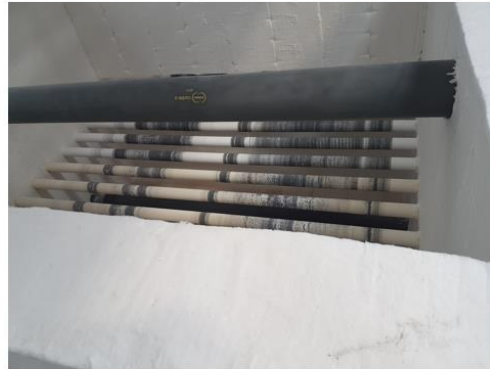
c) Contaminated rollers inside the furnace

One of the major problems of the production line is the premature wear and break of the ceramic rollers. The periodic maintenance associated with the replacement of the ceramic rollers is one of the biggest expenses, rounding about 100.000 €/year. There are a total of 274 rollers in the furnace, which are divided into several heating areas. There are two types of rollers: massive (used at the beginning and end of the furnace) and hollow as shown in Figure 16 a). It is known that the blanks leak aluminium and contaminate the ceramic rollers which are very porous, evidenced in Figure 16 c). The presence of aluminium in the rollers causes the blanks to start deviating and possibly getting stuck in the furnace, leading to a clog in the furnace. Another consequence is that the blanks travel slower inside the furnace, due to skidding in the aluminium contaminations.

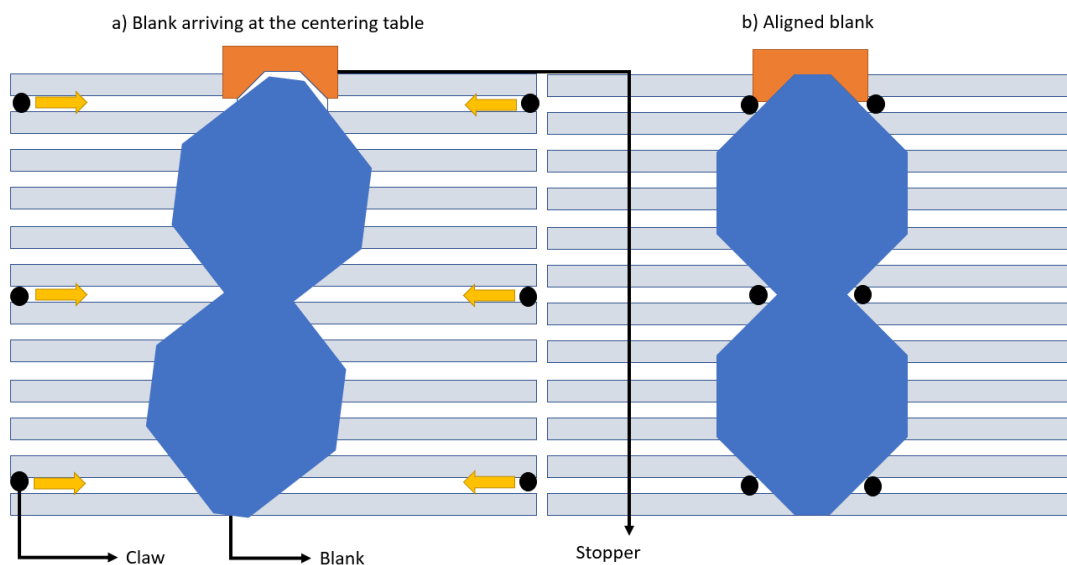
FIGURE 17: BLANK ALIGNMENT IN CENTRING TABLE SCHEME

After the austenitization process, the blanks leave the furnace and are expelled to the centring bed to be properly positioned. The centring process consists of the "claws", which are linear rail-guided by metal cylinders. Moving towards the blank from each side, and locking in place, aligned with the transfer leading arms. Then, geared plates elevate the blanks to ease the grabbing process by the transfer leading arms. The centring and elevation process is demonstrated in Figure 17 and Figure 18.

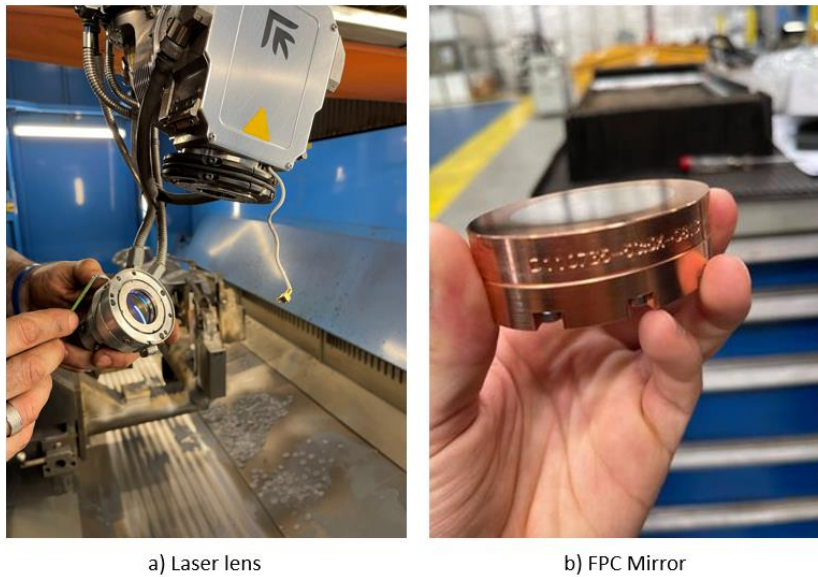
FIGURE 19: LASER TOOL HEAD COMPONENTS.

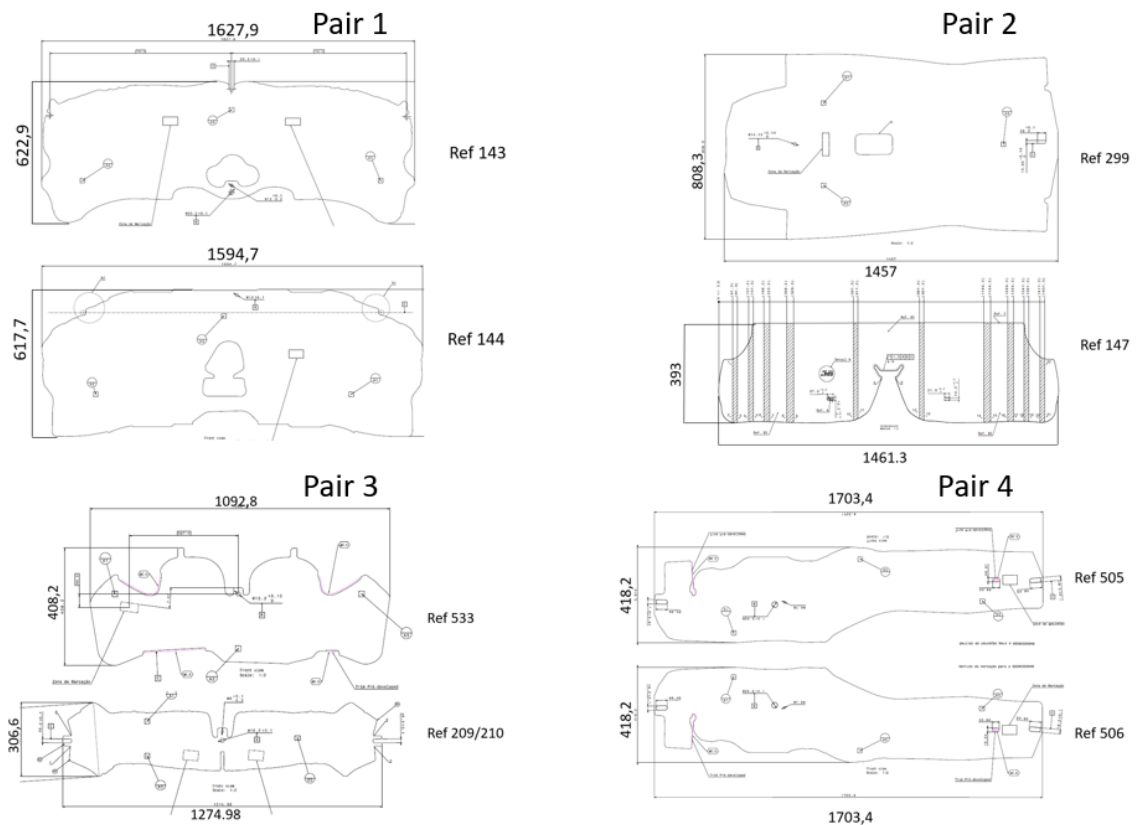
FIGURE 27: WORKING PAIRS AND BLANK DIMENSIONS

To understand what is possible to execute, let us first focus on the overall dimensions of the blanks formed. As mentioned previously, the Loire medium forming press has 2 individual carriages, which means it can produce 2 different components at the same time. Having this, the HS line operates with blank pairs. Both the blank dimensions in millimetres and working pairs are shown in Figure 27.

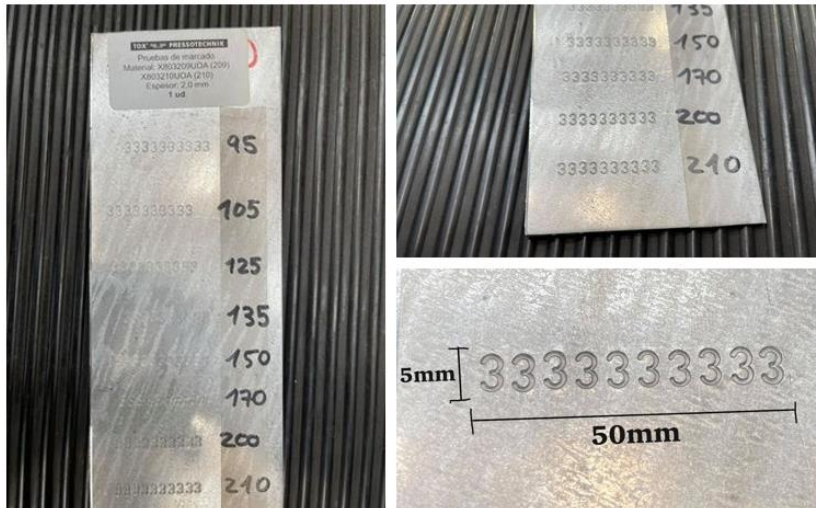
FIGURE 34: REFERENCING TEST SAMPLES FROM BY TOX®

To understand the consequences of altering the working pressure of the TOX® referencing presses, several samples, representative of the various blanks were studied. The test consisted of stamping the references at various working pressures, as shown in Figure 34.

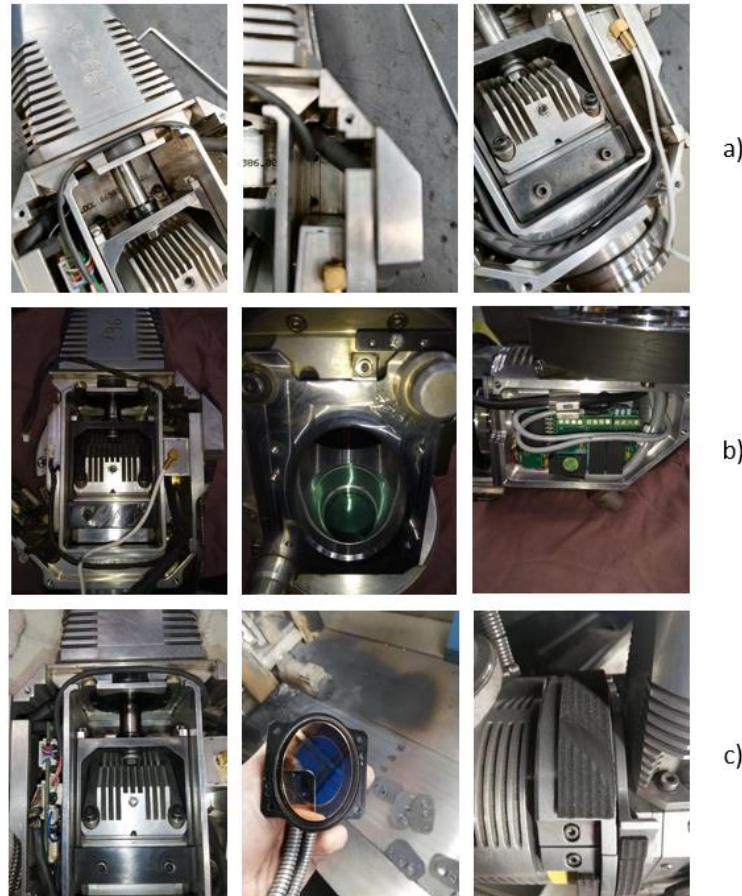
FIGURE 39: COMPARISON BETWEEN AN UNMAGNETIZED TOOL HEAD A) AND 2 MAGNETIZED TOOL HEADS B) AND C)

Once the magnetic bands were applied, the laser machines went through their normal working cycle of 1 week, before another cleaning intervention. When intervening in the machine's tool head, images were captured to both laser machines whose tool head had been magnetized and not magnetized, for comparison purposes, as shown in Figure 39.

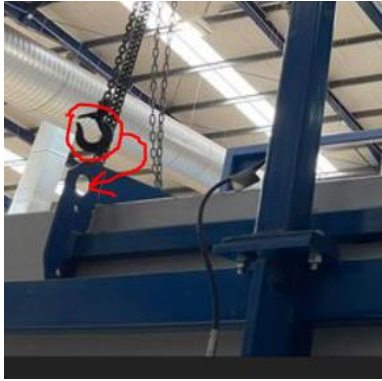
4	To correctly hoist the furnace's cover, 4 collaborators (on the floor) must synchronously pull the chains from the crane, so that the cover lifts in equilibrium. The cover must be lifted until it is above the safety locking system.	
5	Activate the 4 safety locking bars, present in the crane's support beams.	
6	Lower the cover until it has its weight supported by the safety locking mechanism. The chains must be tensioned so that the safety locking mechanisms do not support all the weight of the cover.

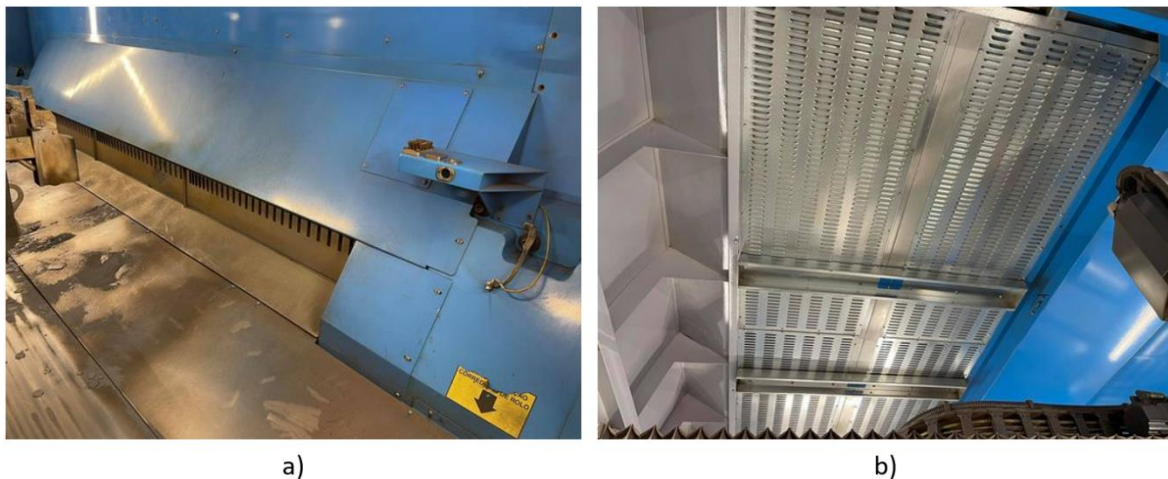
FIGURE 46: LASER MACHINE'S VENT POSITIONING

There are 2 evident problems related to the machine. The first is the positioning of the vents inside the machine as shown in Figure 46.
