## Development of the Maryland Shoreline Inventory Methods and Guidelines for Somerset County

# Development of the Maryland Shoreline Inventory Methods and Guidelines for Somerset County

October, 2004

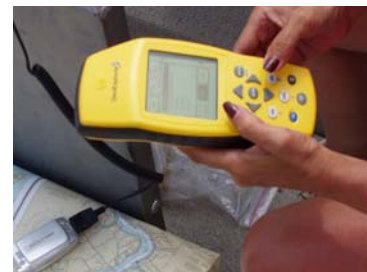
Data collection is performed in the field, from a small, shoal draft vessel, navigating at slow speeds parallel to the shoreline. To the extent possible, surveys take place on a rising tide, allowing the boat to be as close to shore as possible. The field crew consists of a boat operator, and one surveyor. The boat operator navigates the boat to follow the shoreline geometry. The boat operator logs information relevant to shoreline structures. The surveyor collects information pertinent to land use and bank condition. Data is logged using either the handheld Trimble GeoExplorer, GeoExplorer 3, or GeoXT GPS unit. These units are accurate to within 4 inches of true position with extended observations, and differential correction. This level of accuracy has not been achieved in this project due to the observation requirements. Both static and kinematic data collection is performed.

Kinematic data collection is a collection technique where data is collected continuously along a pathway (in this case along the waterway). GPS units are programmed to collect information at a rate sufficient to compute a position anywhere along the course. Features are collected at a rate of one observation every five seconds. Land use, bank condition, and linear shoreline structures are collected using this technique.

Static surveys pin-point fixed locations that occur at very short intervals. The boat actually stops to collect these data, and the boat operator must hold the boat against tidal current, and surface wind waves. Static surveys log 10 GPS observations at a rate of one observation per second at the fixed station. The GPS receiver uses an averaging technique to compute one position based on the 10 static observations. Static surveys are used to position point features like piers, boat ramps, and boat houses.

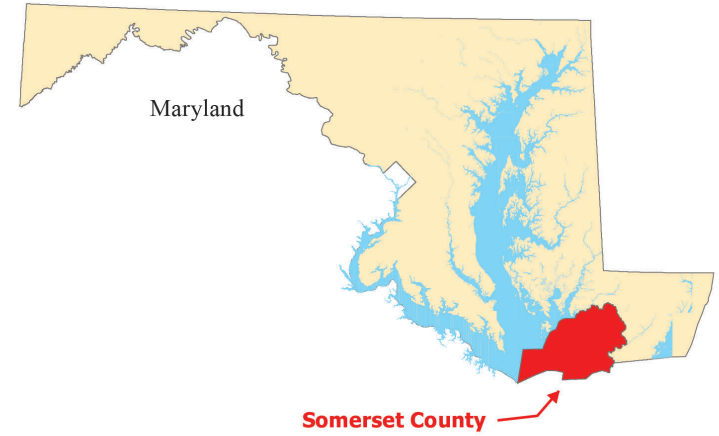
## Somerset County, Maryland Index Map

For publication purposes the county and city is divided into a series of plates. Plates are scaled at 1:12,000 for publication at 11x17. Publications scale will vary if printed at a different size. The number of plates was determined by the geographic size and shape of Somerset County. An index is provided on the website that illustrates the orientation of plates to each other. The county was divided into 39 plates (plate 1a, 1b, 1c, etc.), for a total of 117 map compositions. The index can be used to locate the plate containing an area of interest. Each plate must be individually selected and viewed from the list on the web page.

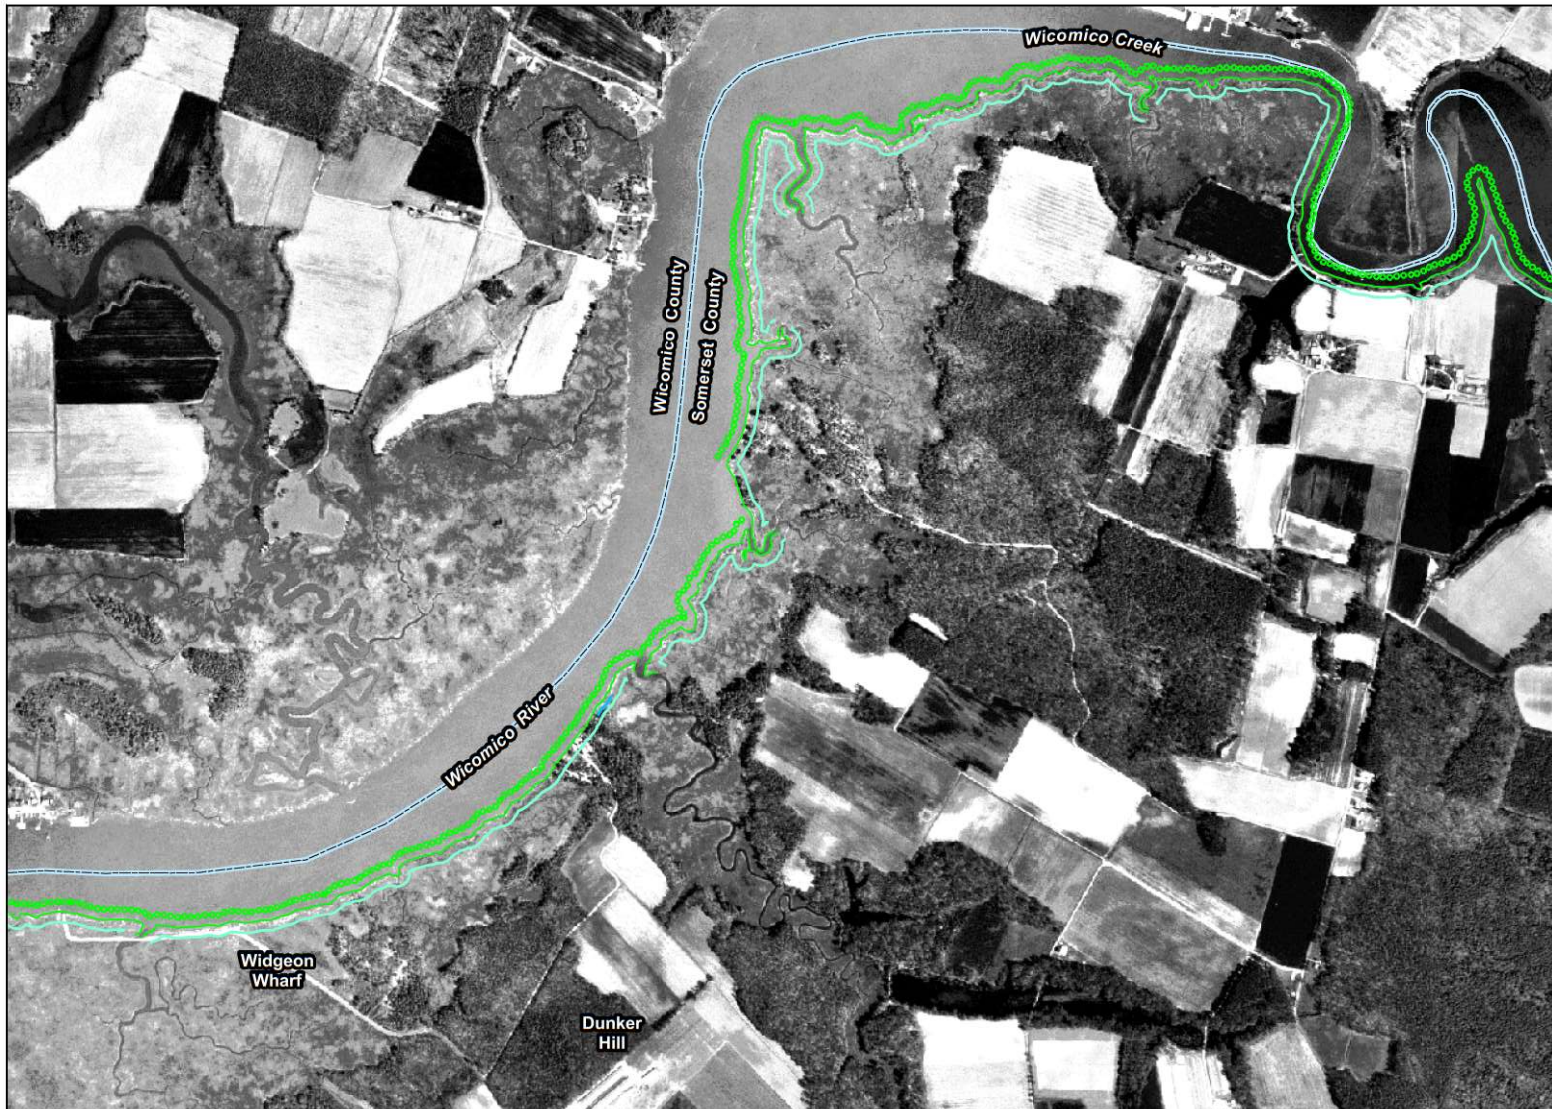
## Somerset County Plate 1b

### Bank and Buffer Conditions

Plate B depicts the condition of the bank and any natural buffers present. Four lines, and a combination of color and pattern symbology gives rise to a vast amount of bank and natural buffer information. Depending on the conditions between 2-4 lines may be illustrated. The length of the symbology along the shore reflects the length alongshore that the features persist. The symbology changes as conditions change.

Bank height and stability is plotted directly on the land/water interface (shoreline). Bank height varies with the thickness of the line; where the thinnest lines designate the lowest banks (0-5 ft), and thickest lines designate the highest banks (> 30 feet). If conditions along the bank were classified as “high erosion” the line will be red. If conditions were classified as “low erosion” the line will be green. Yellow is used if the bank is only undercut.

Natural buffers, when present, are described by small circles parallel and channelward of the shoreline. Open circles indicate a natural fringe marsh along the base of the bank. Solid circles indicate a sand beach buffer at the base of the bank. It is possible to have both. If condition of the buffer is considered highly erosional the circles are red. If conditions do not

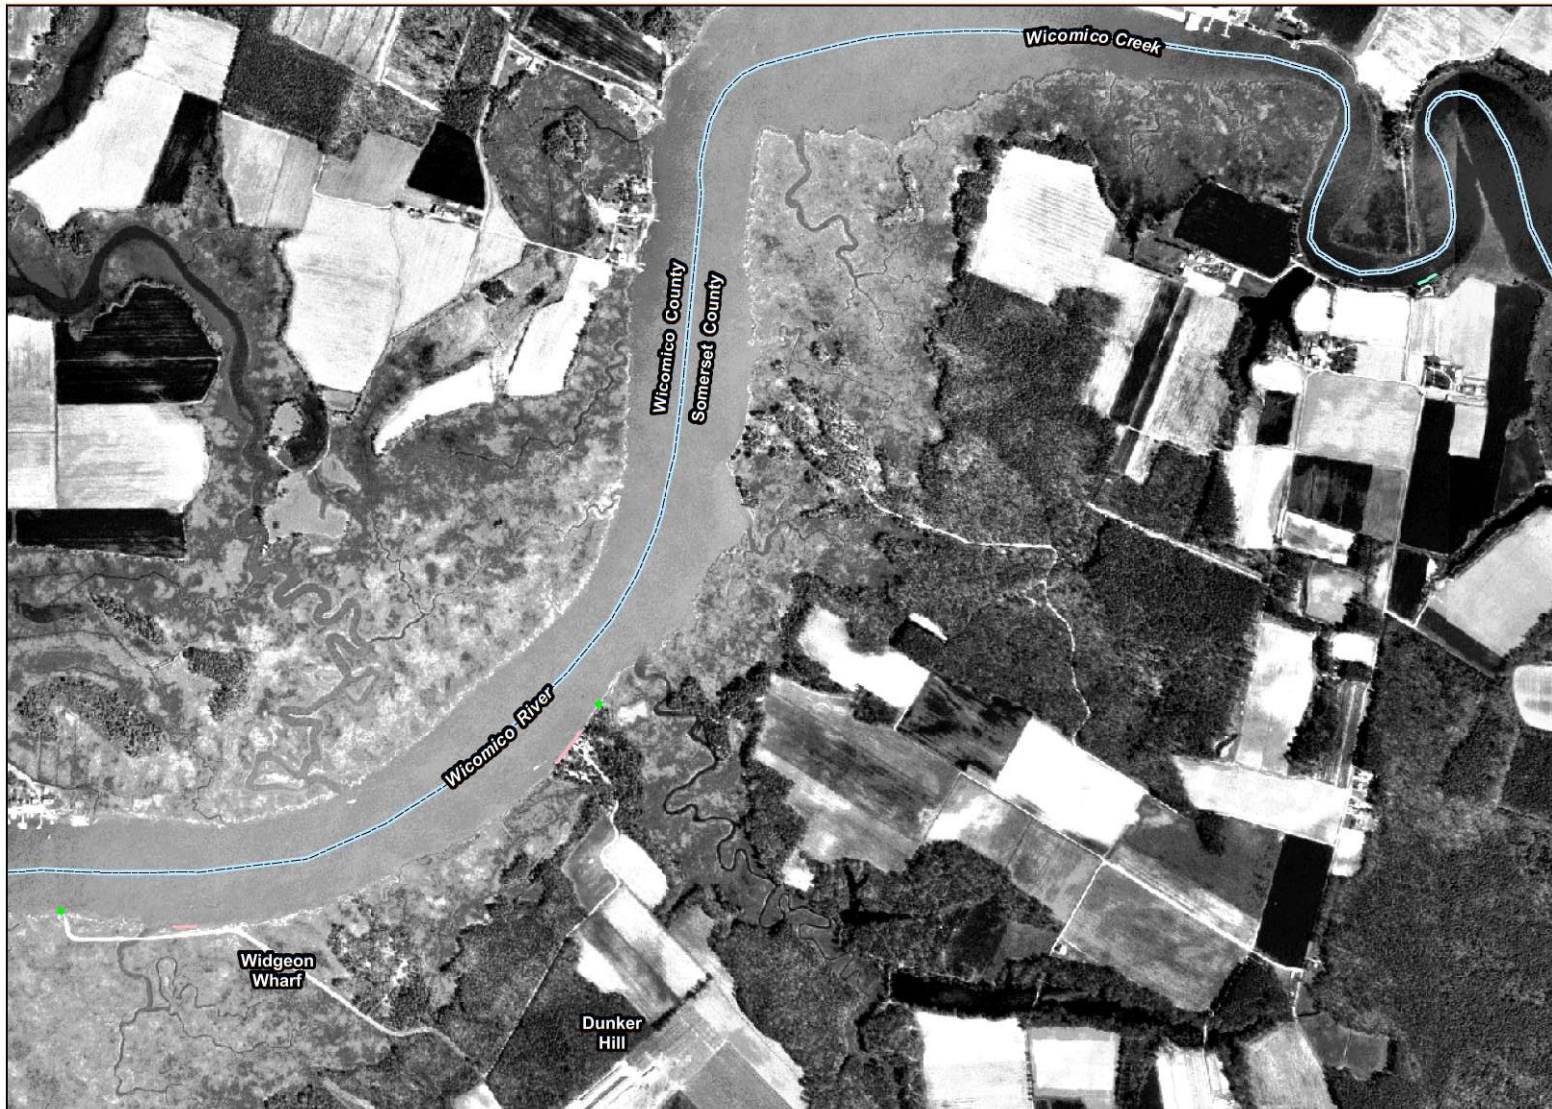
## Somerset County Plate 1c

### Shoreline Features

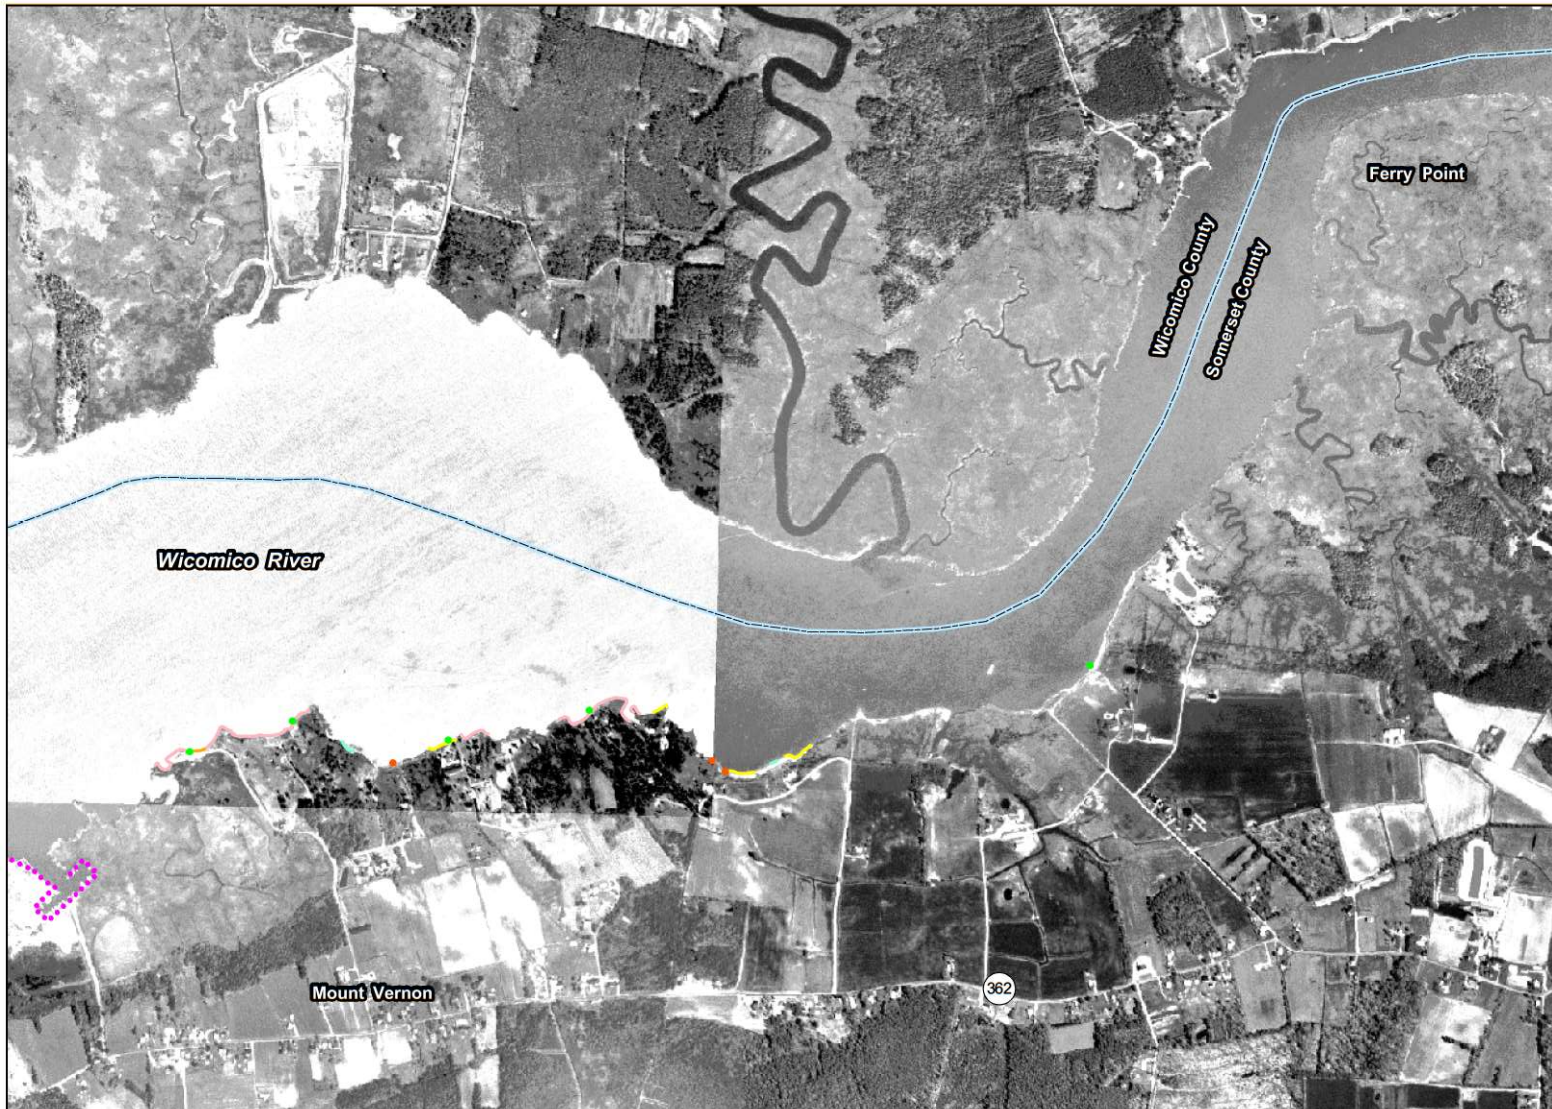
# Somerset County Plate 3a

## Riparian Land Use

Plate A defines the land use adjacent to the shoreline. To the extent that land use directs the type of management practices found, these maps can predict shoreline strategies which may be expected in the future. Residential areas are prone to shoreline alterations. Commercial areas may require structures along the shore for their daily operations. Others frequently seek structural alternatives to address shoreline stability problems. Forested riparian zones, and large

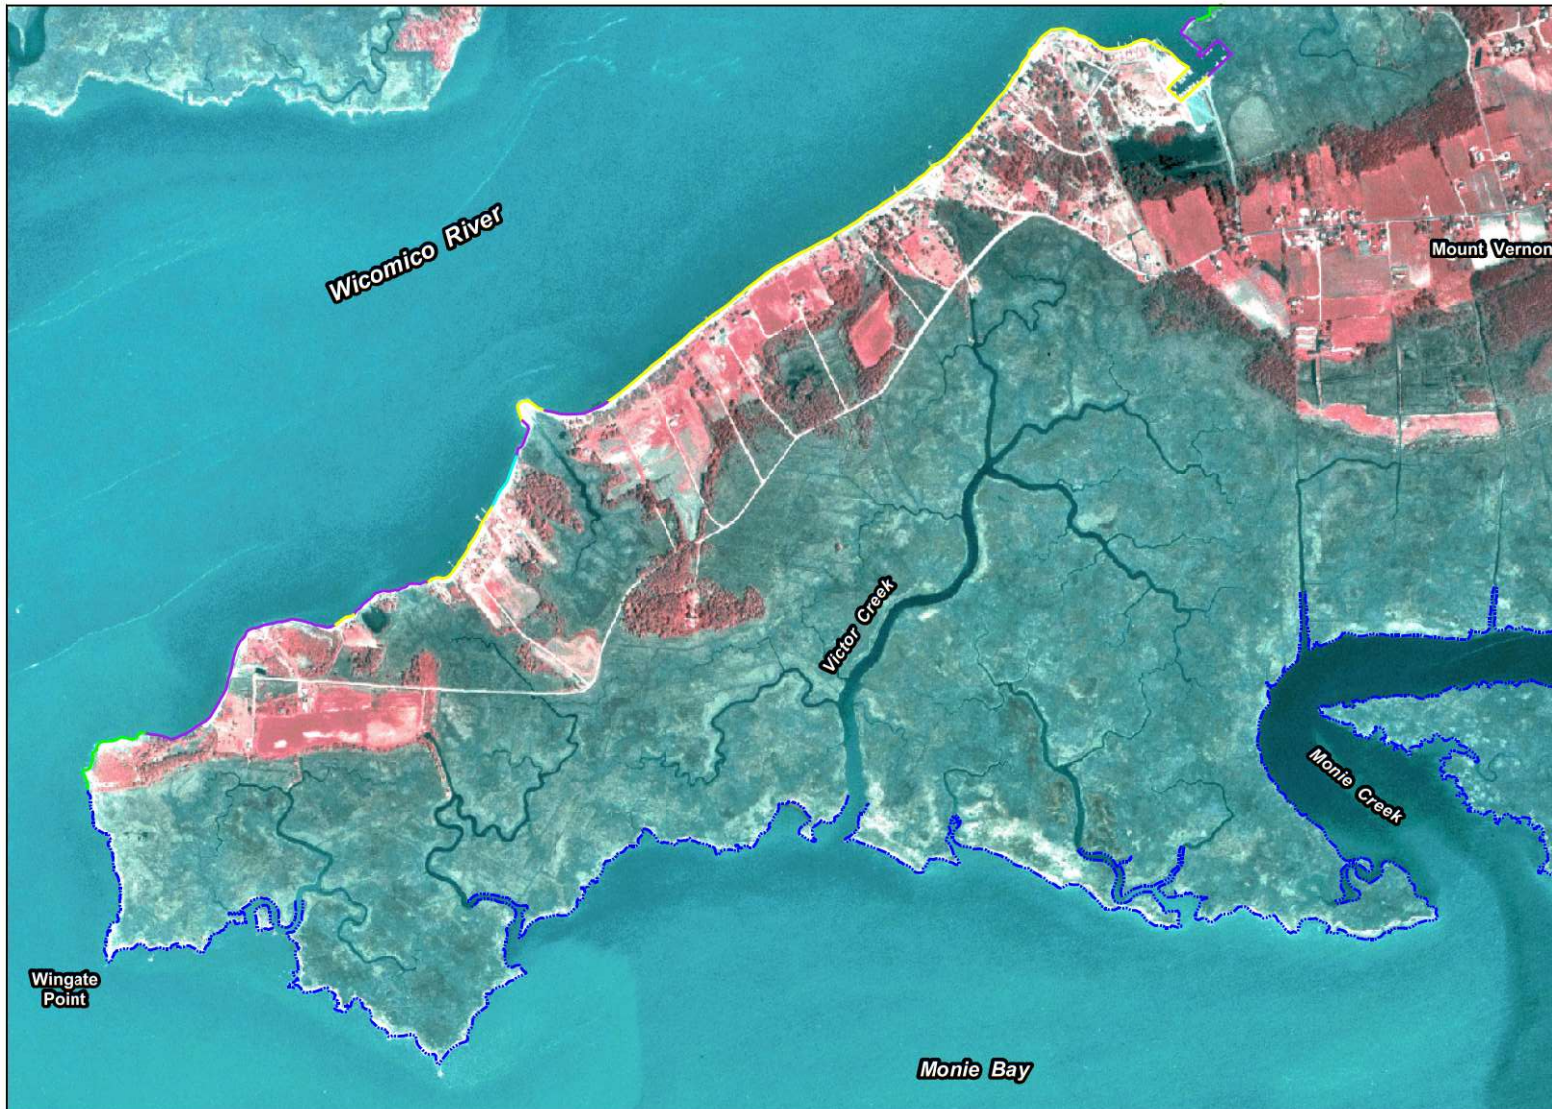
Somerset County  
Plate 3b

Bank and Buffer Conditions
