## Development of the Maryland Shoreline Inventory Methods and Guidelines for Baltimore County and the City of Baltimore

Prepared by the Comprehensive Coastal Inventory Program,  
Center for Coastal Resources Management, Virginia Institute of Marine Science,  
College of William and Mary, Gloucester Point, Virginia.

October, 2004

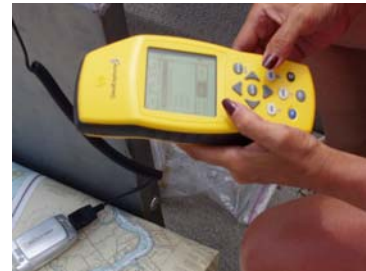
Data collection is performed in the field, from a small, shoal draft vessel, navigating at slow speeds parallel to the shoreline. To the extent possible, surveys take place on a rising tide, allowing the boat to be as close to shore as possible. The field crew consists of a boat operator, and one surveyor. The boat operator navigates the boat to follow the shoreline geometry. The boat operator logs information relevant to shoreline structures. The surveyor collects information pertinent to land use and bank condition. Data is logged using either the handheld Trimble GeoExplorer, GeoExplorer 3, or GeoXT GPS unit. These units are accurate to within 4 inches of true position with extended observations, and differential correction. This level of accuracy has not been achieved in this project due to the observation requirements. Both static and kinematic data collection is performed.

Kinematic data collection is a collection technique where data is collected continuously along a pathway (in this case along the waterway). GPS units are programmed to collect information at a rate sufficient to compute a position anywhere along the course. Features are collected at a rate of one observation every five seconds. Land use, bank condition, and linear shoreline structures are collected using this technique.

Static surveys pin-point fixed locations that occur at very short intervals. The boat actually stops to collect these data, and the boat operator must hold the boat against tidal current, and surface wind waves. Static surveys log 10 GPS observations at a rate of one observation per second at the fixed station. The GPS receiver uses an averaging technique to compute one position based on the 10 static observations. Static surveys are used to position point features like piers, boat ramps, and boat houses.

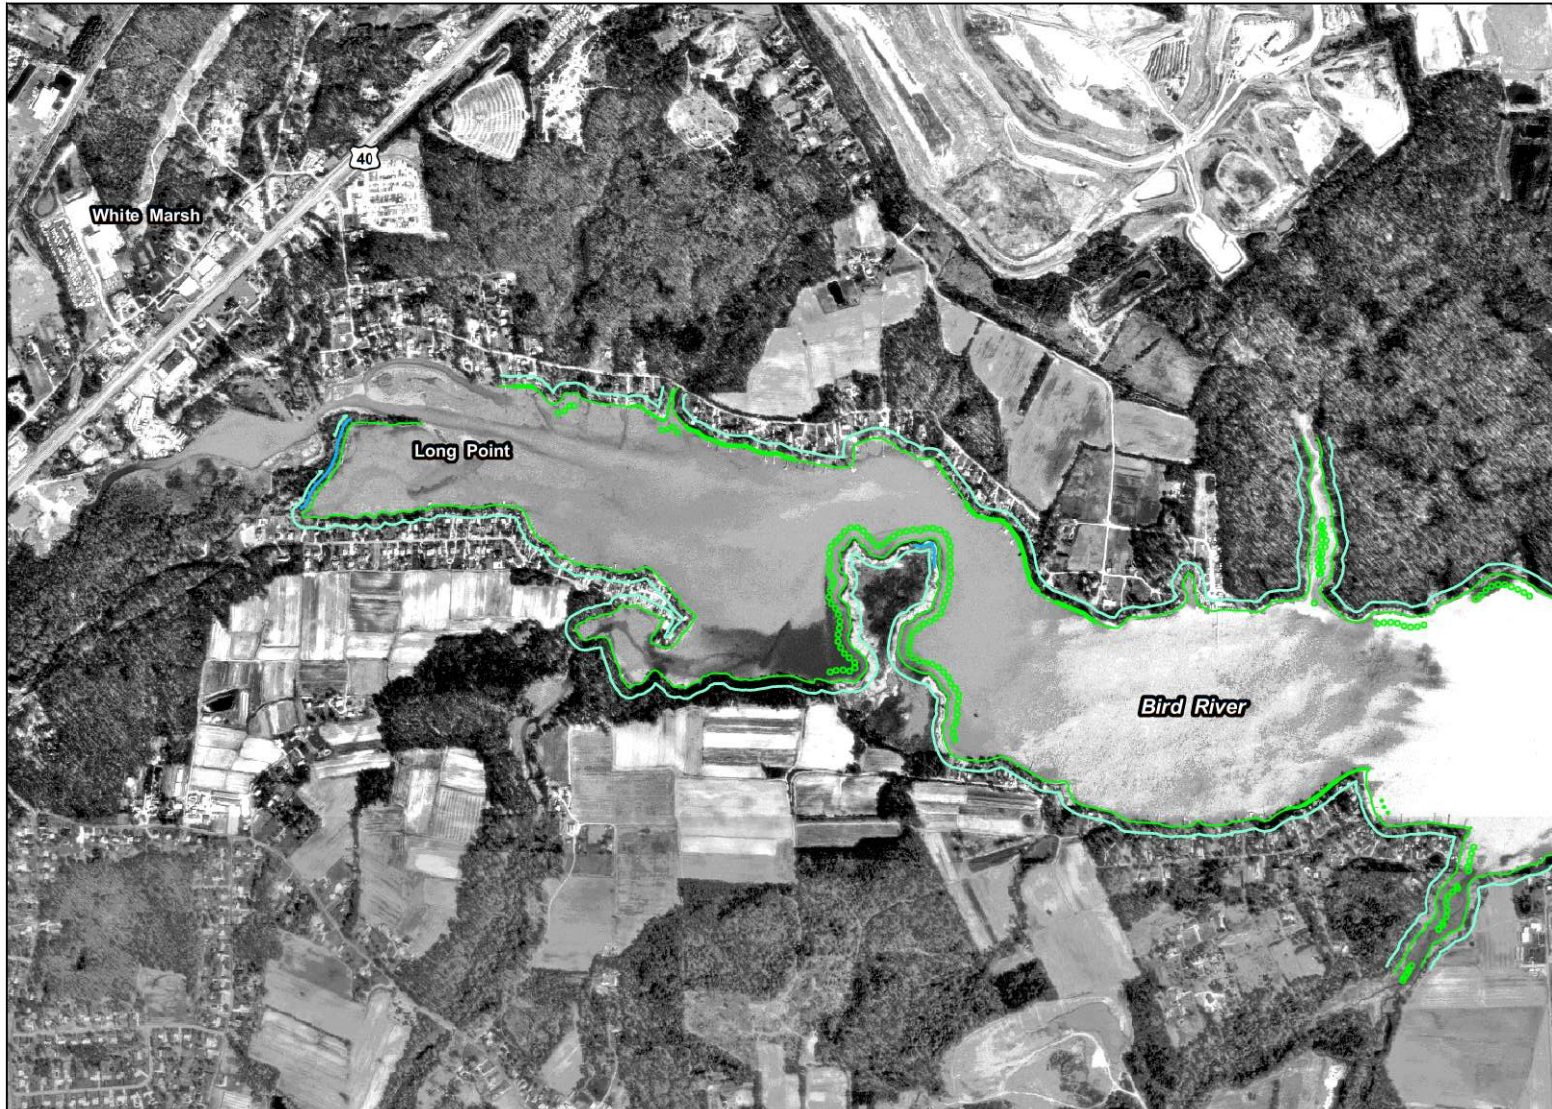
## Baltimore County Plate 1b

### Bank and Buffer Conditions

Plate B depicts the condition of the bank and any natural buffers present. Four lines, and a combination of color and pattern symbology gives rise to a vast amount of bank and natural buffer information. Depending on the conditions between 2-4 lines may be illustrated. The length of the symbology along the shore reflects the length alongshore that the features persist. The symbology changes as conditions change.

Bank height and stability is plotted directly on the land/water interface (shoreline). Bank height varies with the thickness of the line; where the thinnest lines designate the lowest banks (0-5 ft), and thickest lines designate the highest banks (> 30 feet). If conditions along the bank were classified as “high erosion” the line will be red. If conditions were classified as “low erosion” the line will be green. Yellow is used if the bank is only undercut.

Natural buffers, when present, are described by small circles parallel and channelward of the shoreline. Open circles indicate a natural fringe marsh along the base of the bank. Solid circles indicate a sand beach buffer at the base of the bank. It is possible to have both. If condition of the buffer is considered highly erosional the circles are red. If conditions do not

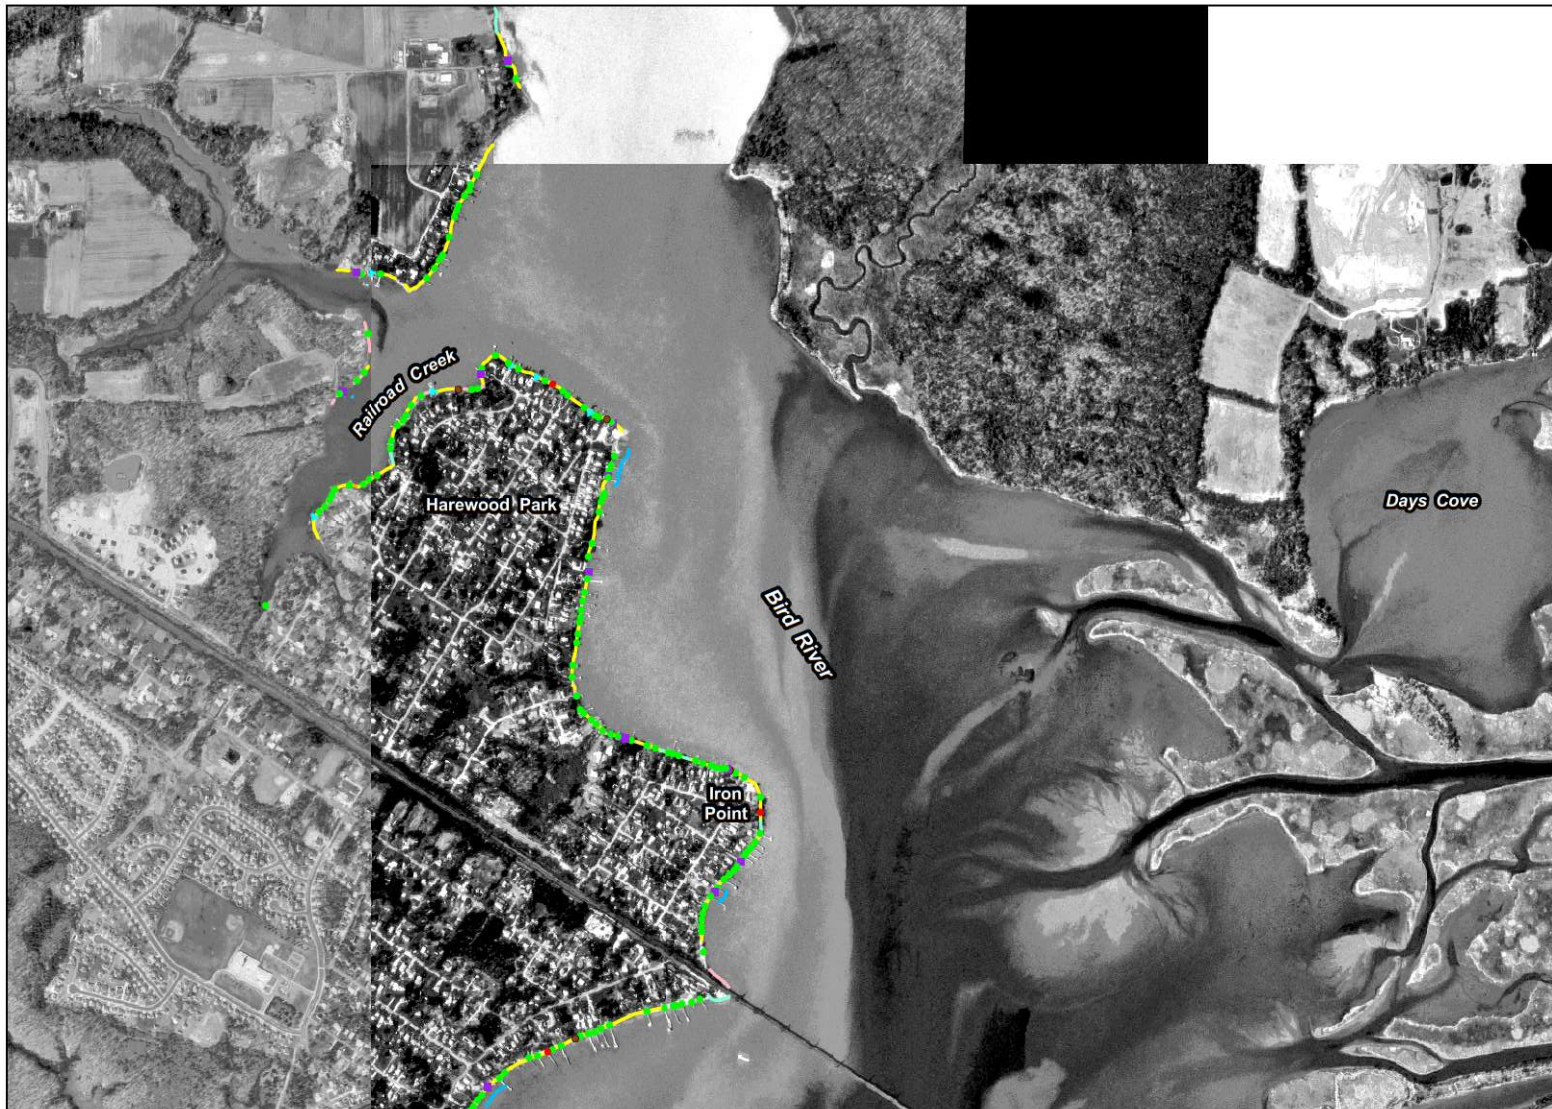
# Baltimore County Plate 3a

## Riparian Land Use

Plate A defines the land use adjacent to the shoreline. To the extent that land use directs the type of management practices found, these maps can predict shoreline strategies which may be expected in the future. Residential areas are prone to shoreline alterations. Commercial areas may require structures along the shore for their daily operations. Others frequently seek structural alternatives to address shoreline stability problems. Forested riparian zones, and large

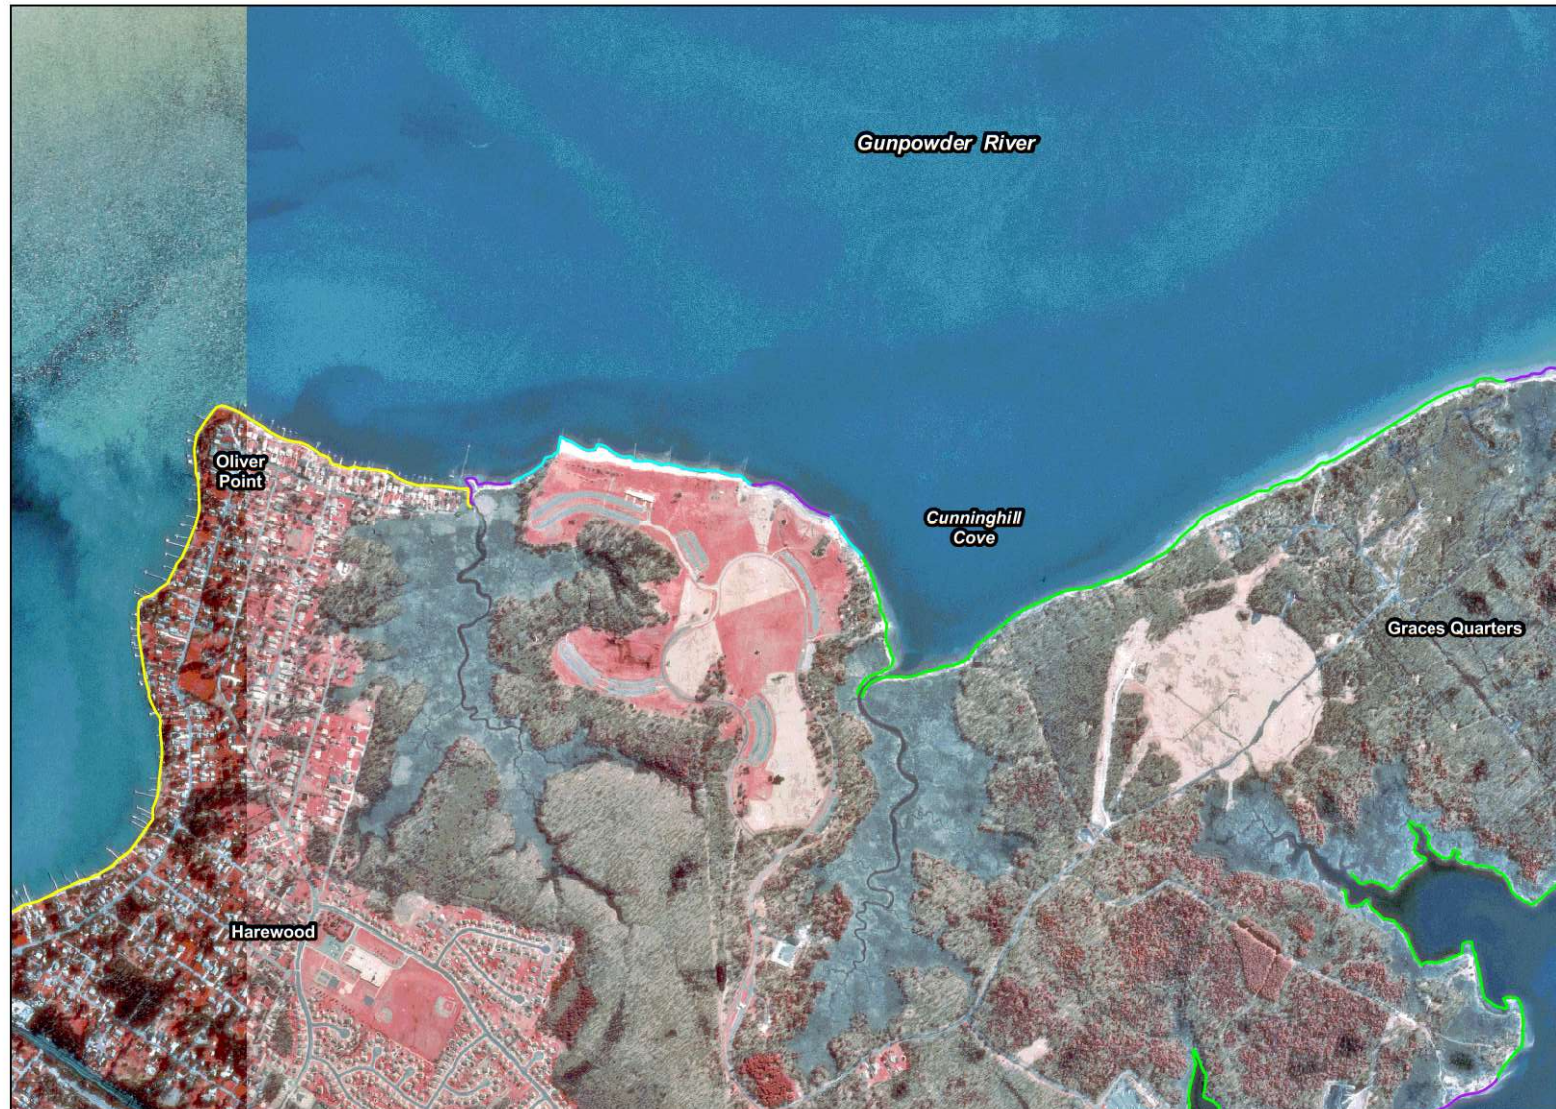
**Baltimore County  
Plate 3b**

**Bank and Buffer Conditions**

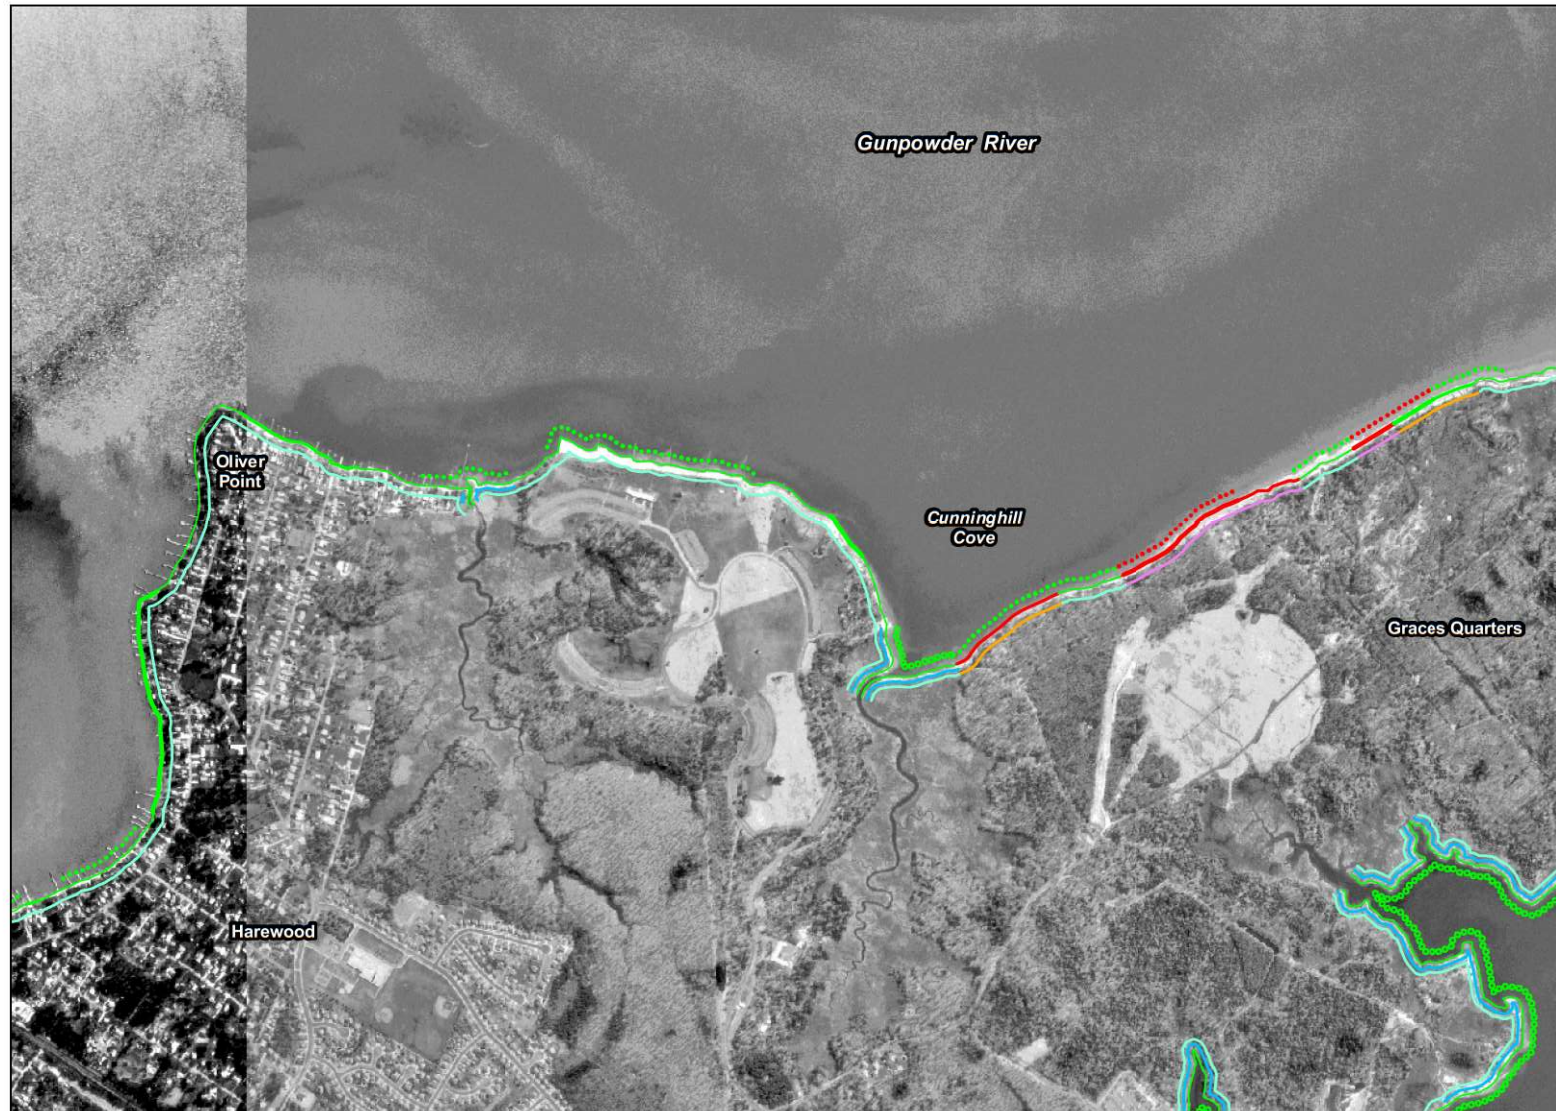
# Baltimore County Plate 3c

## Shoreline Features
