Hole in the Wall Dredge Channel Data Report

**Shoreline Studies Program
Virginia Institute of Marine Science
William & Mary**

December 2020

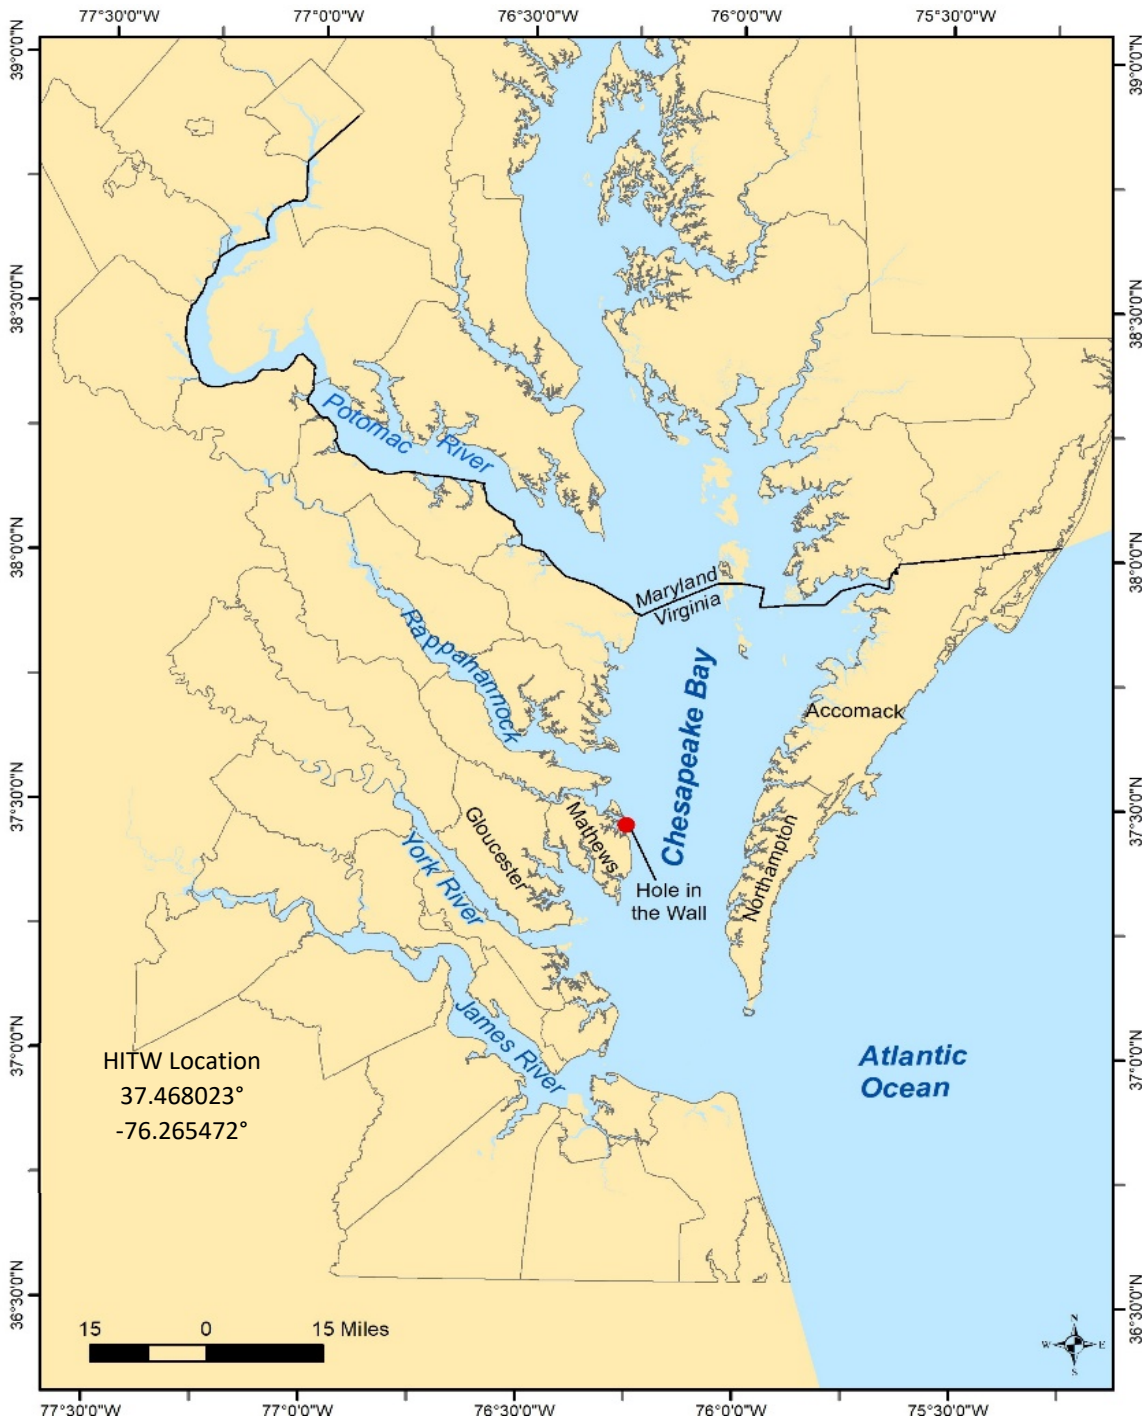
Figure 1. Location of Hole in the Wall channel.

Hole in the Wall (HITW) is located in Mathews County, Virginia (Figure 1). It is a natural channel between fetch-limited barrier islands that provides access from Chesapeake Bay to Milford Haven and Gwynn Island. Milford Haven is a unique tidal creek watershed occurring between Chesapeake Bay and the Piankatank River and consists of numerous lateral tidal creeks entering from Gwynn Island to the north and others entering from the south including Lanes Creek, Stutts Creek, Billups Creek, Stoakes Creek and Whites Creek (Figure 2). Presently, the barrier between Milford Haven and Chesapeake Bay includes the northern barrier and Rigby Island. Another tidal inlet ebbs and flows between Milford and Hills Bay. This inlet on the western side of Milford Haven is recognized as a federal navigation channel.

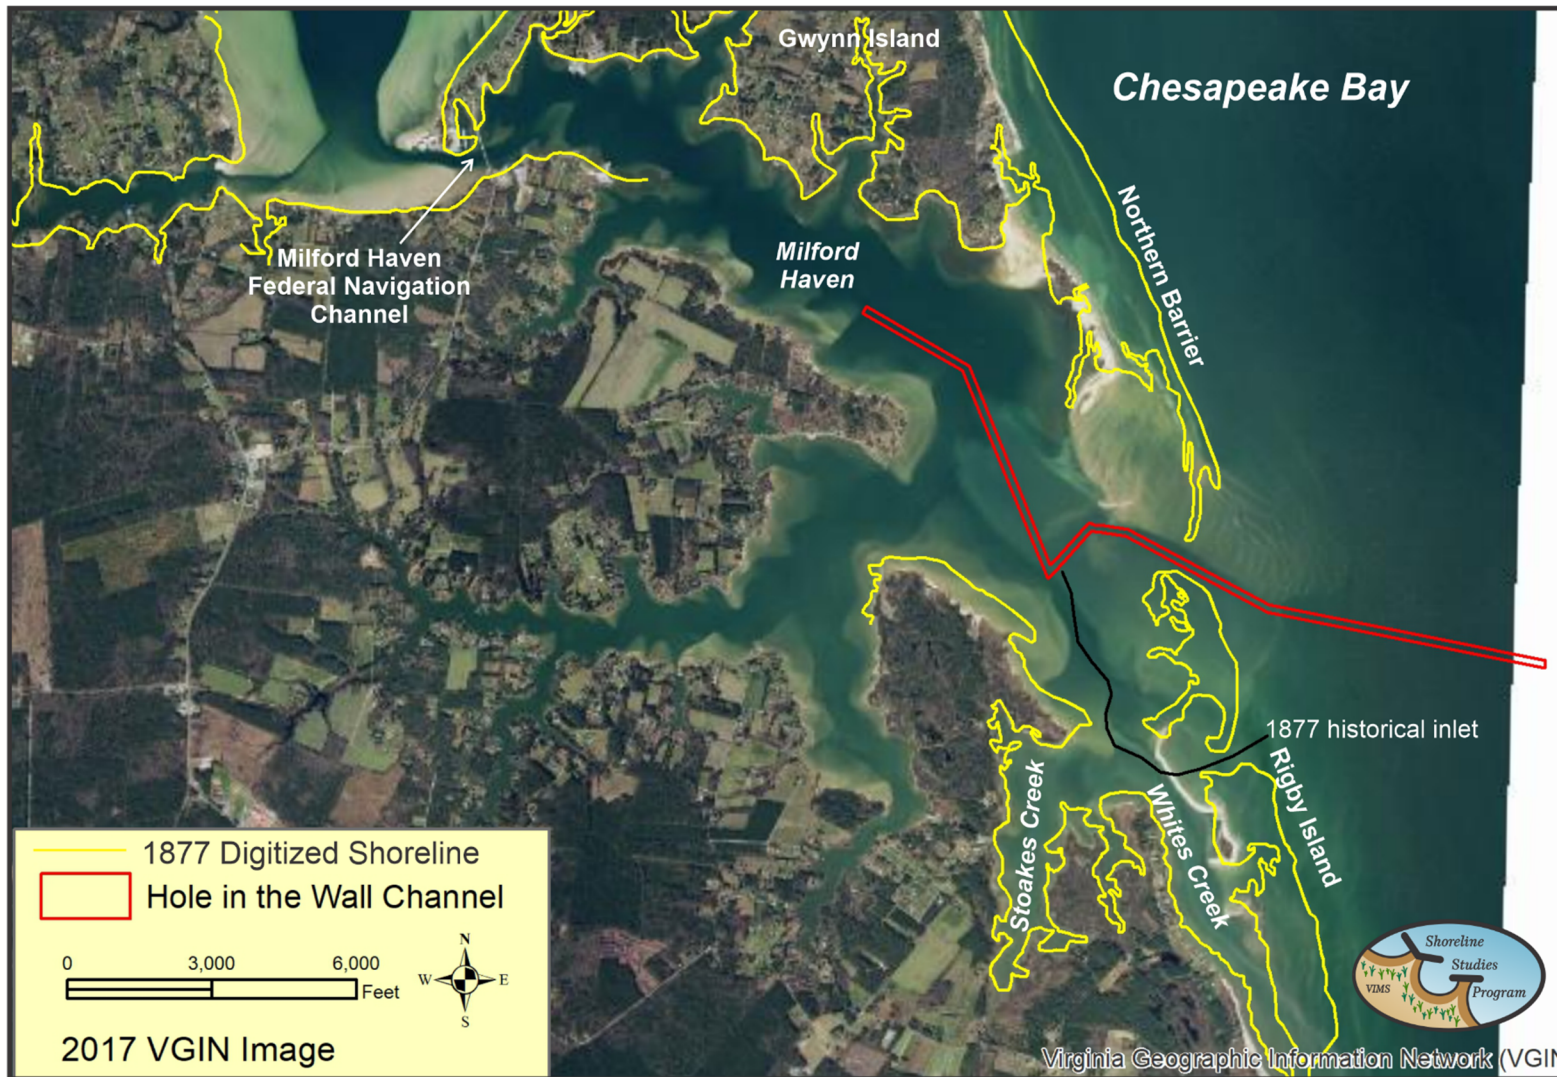
Figure 11. VGIN photo taken in 2017 showing Hole in the Wall and the barrier islands fronting Milford Haven. Also shown is the 1877 digitized shoreline.

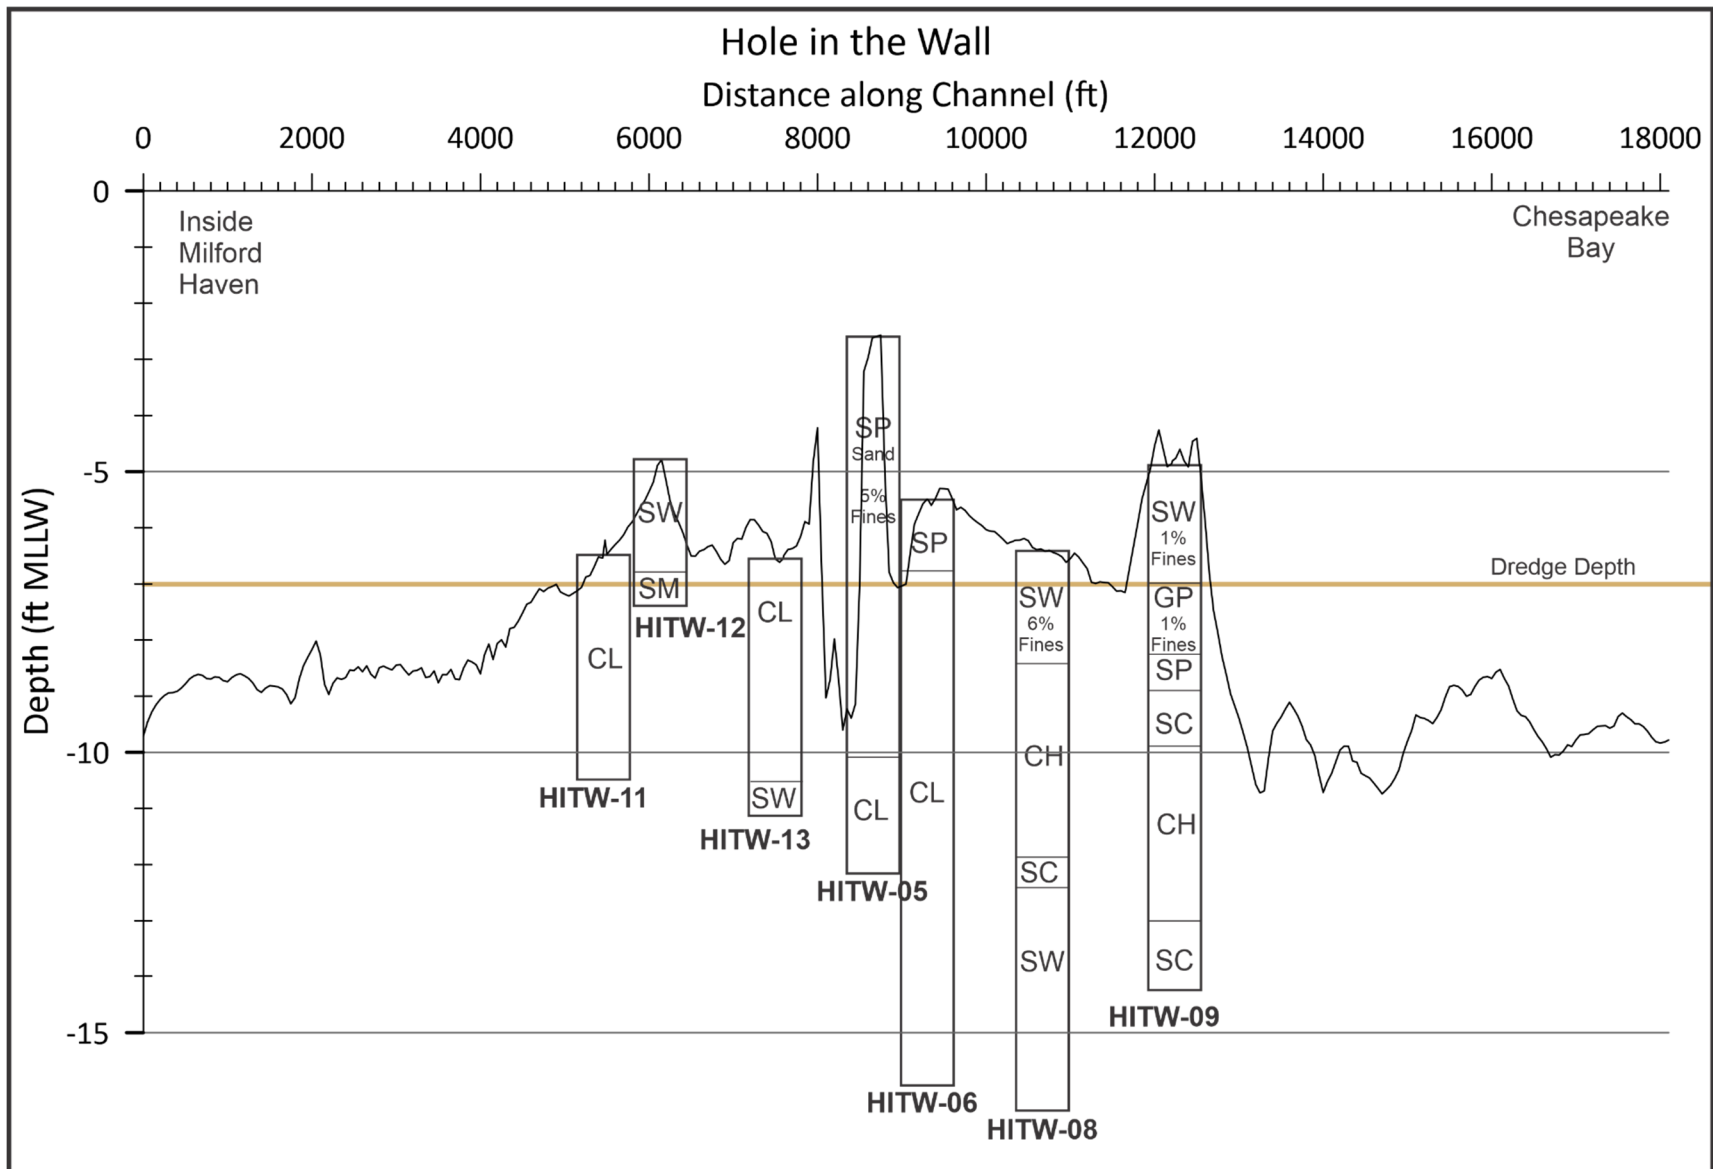
Figure 18. Along-channel cross-section showing the position of the cores and the type of material in the core. The dredge depth is -7 ft MLLW.

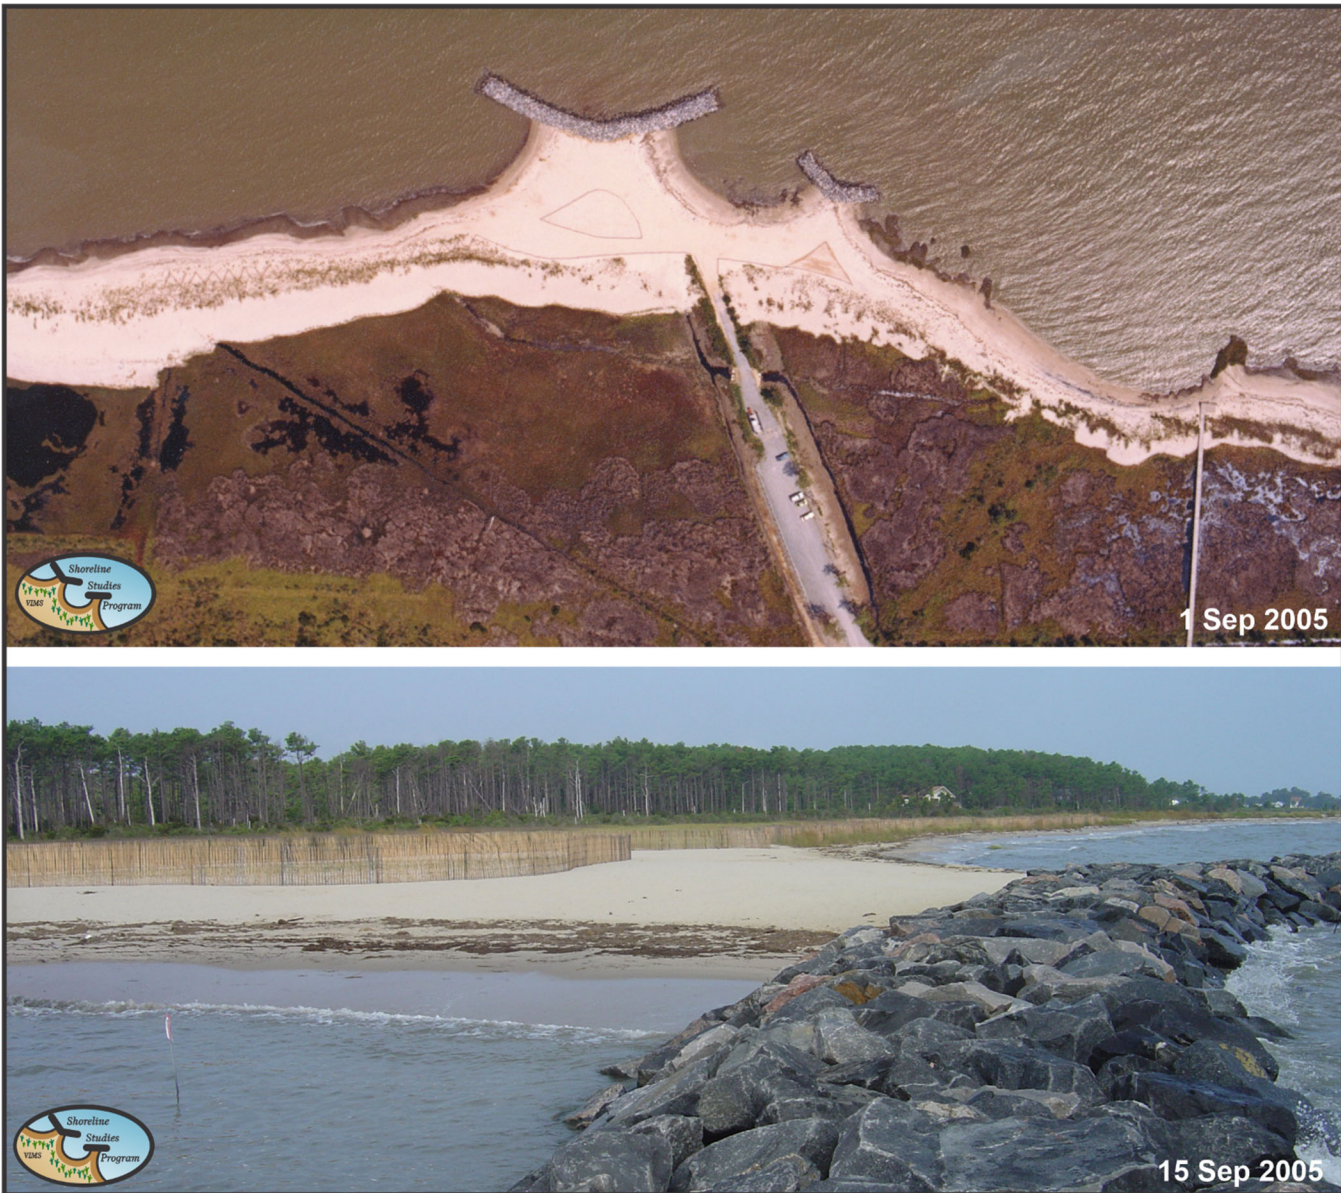
Figure 22. Aerial photo (top) and ground photo (bottom) taken at Haven Beach after breakwater and beach fill installation.

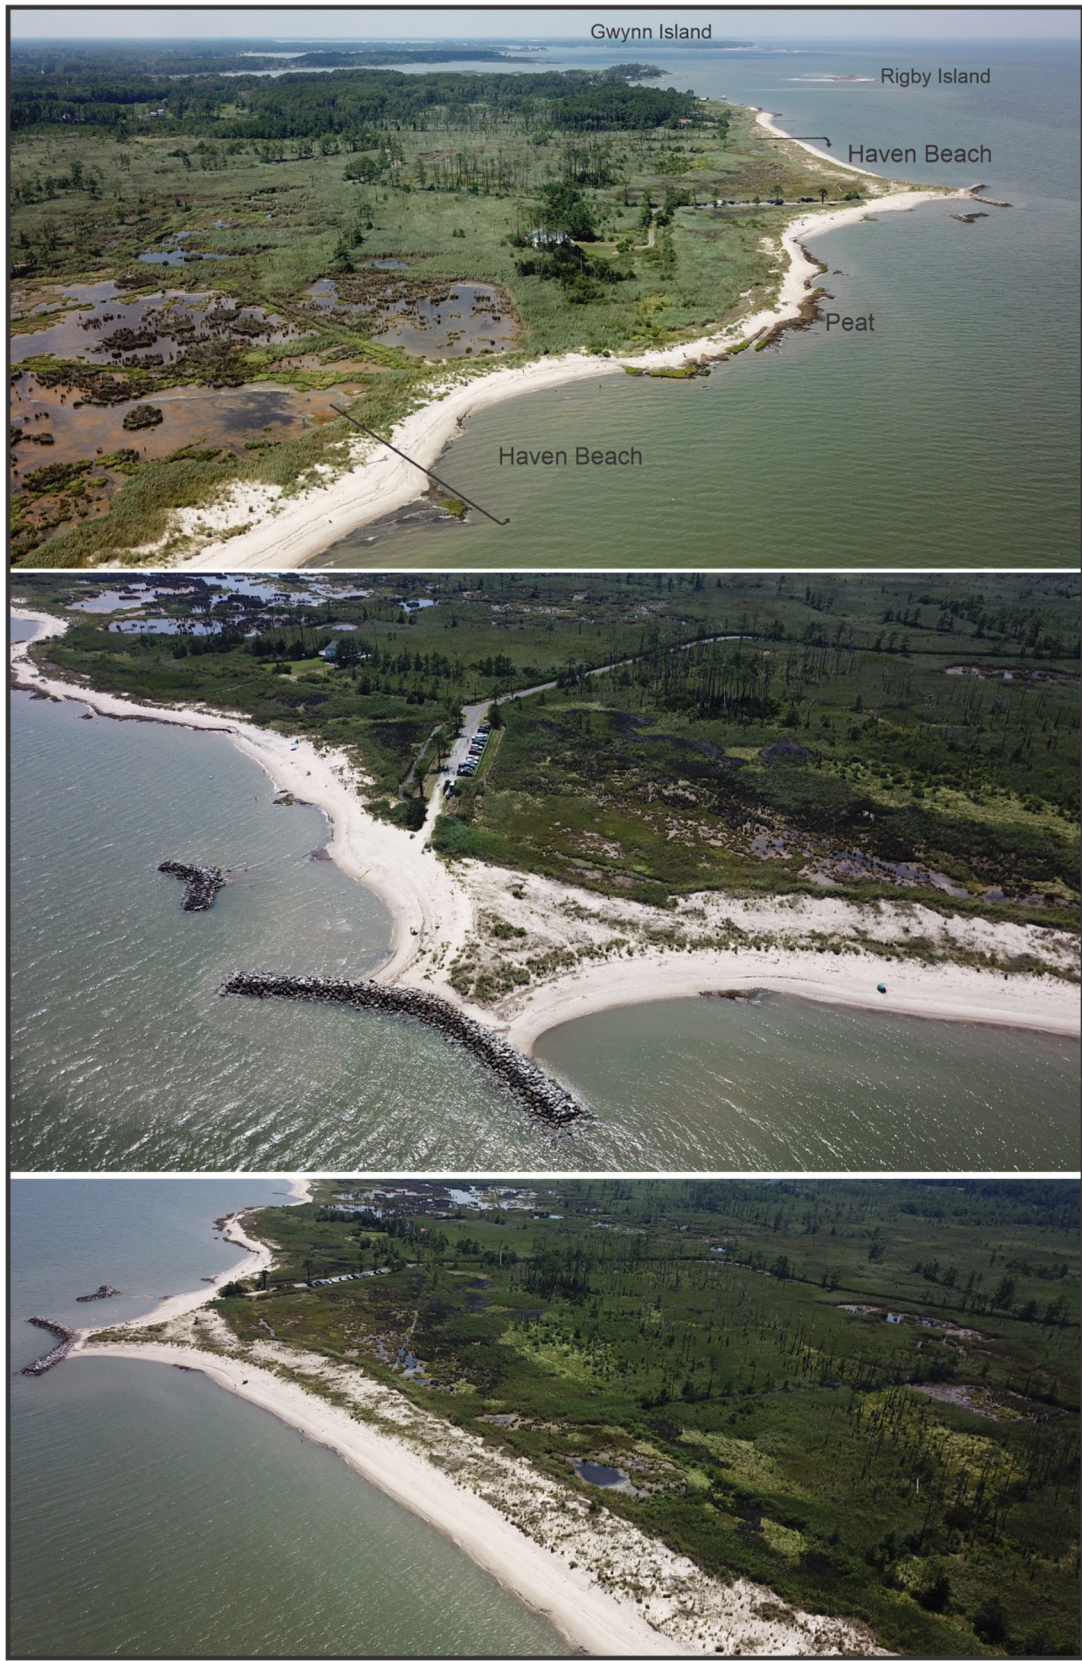
Figure 24. Drone imagery taken July 30, 2020 at Haven Beach.

In 2017, Rigby Island had broken into two sections, and, as a result, Whites Creek experienced a much greater level of exposure to the Chesapeake Bay (Figure 23). The small, southern, Rigby Island remnant, just barely above water level in 2017, is completely eroded by July 2020. At Haven Beach, no sand occurs behind the small breakwater. Drone imagery taken 30 July 2020 and rectified in GIS was used to provide a baseline of existing conditions for the plan. It shows the habitats along the shoreline (Figure 24), and the peat outcrops that occur along the shoreline south of the breakwaters. Along the shoreline, sandy beaches front washover dunes and vegetated and non-vegetated wetlands. The tombolo behind the large breakwater is heavily vegetated.

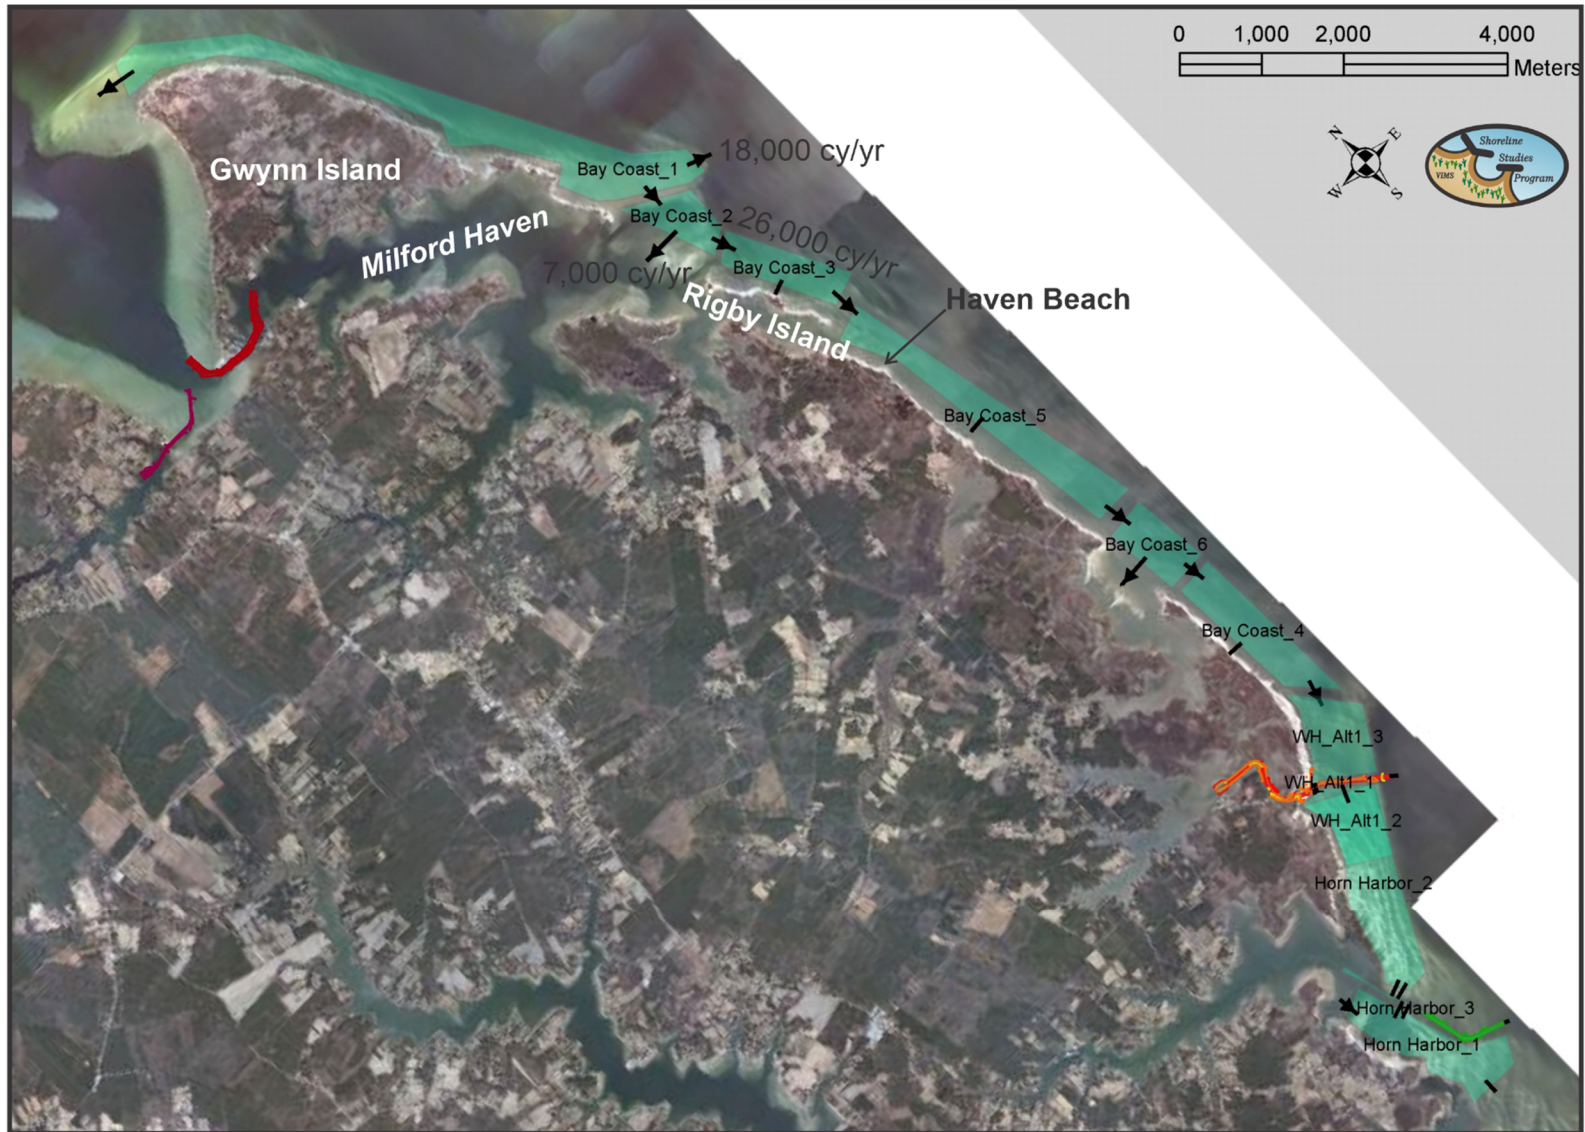
Figure 29. Unpublished sediment budget for the Mathews County Bay coast. VIMS, Shoreline Studies Program.

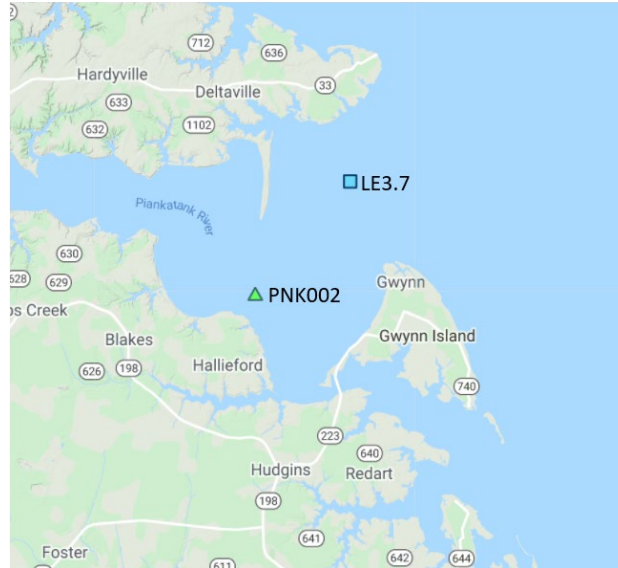
Fig. 3 Observation stations used in this report. Site LE3.7 includes salinity and temperature data from Chesapeake Bay Program; Site PNK002 includes elevation, salinity, and temperature data from Virginia Estuarine and Coastal Observing System (VECOS).

For model calibration, we utilize available observational data from Virginia Estuarine and Coastal Observing System (VECOS, <http://vecos.vims.edu/>) and EPA’s Chesapeake Bay Program (https://www.chesapeakebay.net/what/downloads/cbp_water_quality_database_1984_present). Fig. 3 shows the names and locations of these stations, where basic hydrodynamic variables (elevation, salinity, and temperature) are measured. The year 2006 was chosen as the simulation period because of the availability of most observational data.

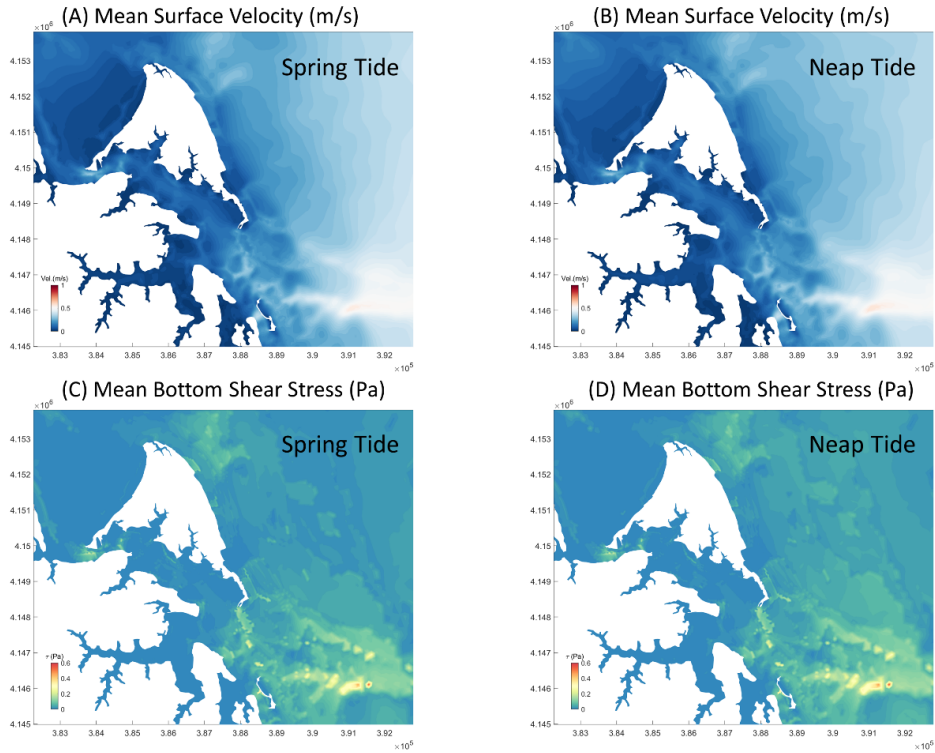
Fig. 6. Mean surface velocity and mean bottom shear stress over a spring tide (A, C) and a neap tide (B, D) in July.
