PAY QUANTITIES IN HIGHWAY CONSTRUCTION

R. R. JOHNSON
&
R. D. MILES

Joint
Highway
Research
Project

PHOTOGAMMETRIC MEASUREMENT OF FINAL PAY
QUANTITIES IN HIGHWAY CONSTRUCTION

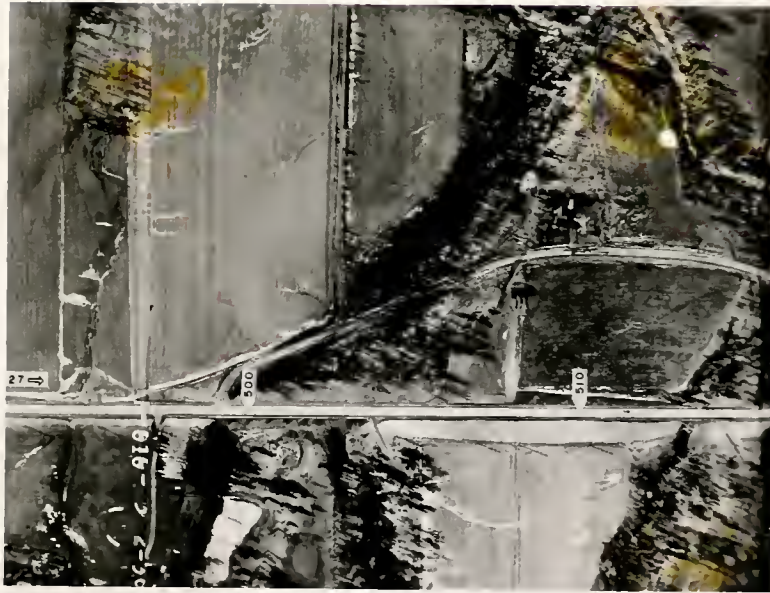
Figure 1. A section of recently constructed highway used in the investigation

A newly constructed section of State Road 27 beginning at Liberty, Indiana and extending northward about five miles was selected as a suitable location for the study. A portion of the study area showing the overall terrain is illustrated in Figure 1.

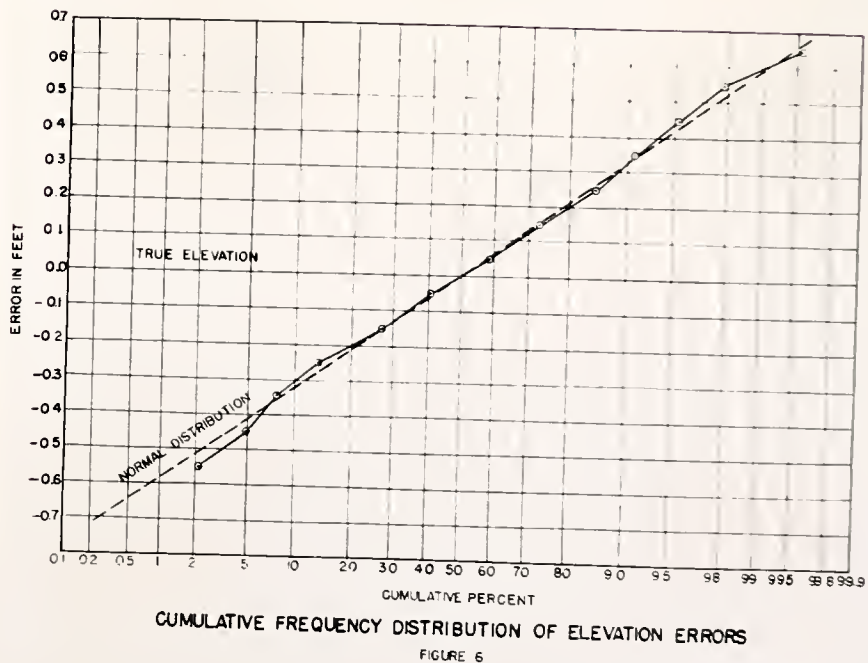
Figure 6. Cumulative frequency distribution of photogrammetric elevations compared with field base line and center line elevation.

Figure 6 shows the frequency distribution plotted in cumulative form with the abscissa scale graduated according to the area under a normal distribution curve. The points were plotted on the basis of cumulative per cent less than the class boundaries of the errors starting with the minus values. The distribution of the elevation errors is in close agreement with the normal distribution function which is shown by a broken straight line. The importance of this distribution is emphasized by the fact that such a distribution will have a compensating effect on the total error.

Approximately 90 per cent of the points tested fall within the error range of $\pm .45$ feet as estimated from the cumulative frequency distribution of Figure 6. According to the National Map Accuracy Standards, this would allow a usable contour interval of 0.9 feet. At a flying height of 1500 feet, the calculated C-factor is approximately 1670.
