**FHWA/IN/JTRP-2001/10-I-1**

FATIGUE BEHAVIOR OF BEAM DIAPHRAGM CONNECTIONS  
WITH INTERMITTENT FILLET WELDS (PART I):  
VOLUME 1 – FIELD EVALUATION

Purdue University  
School of Civil Engineering

Purdue University  
West Lafayette, IN 47907  
July 2001

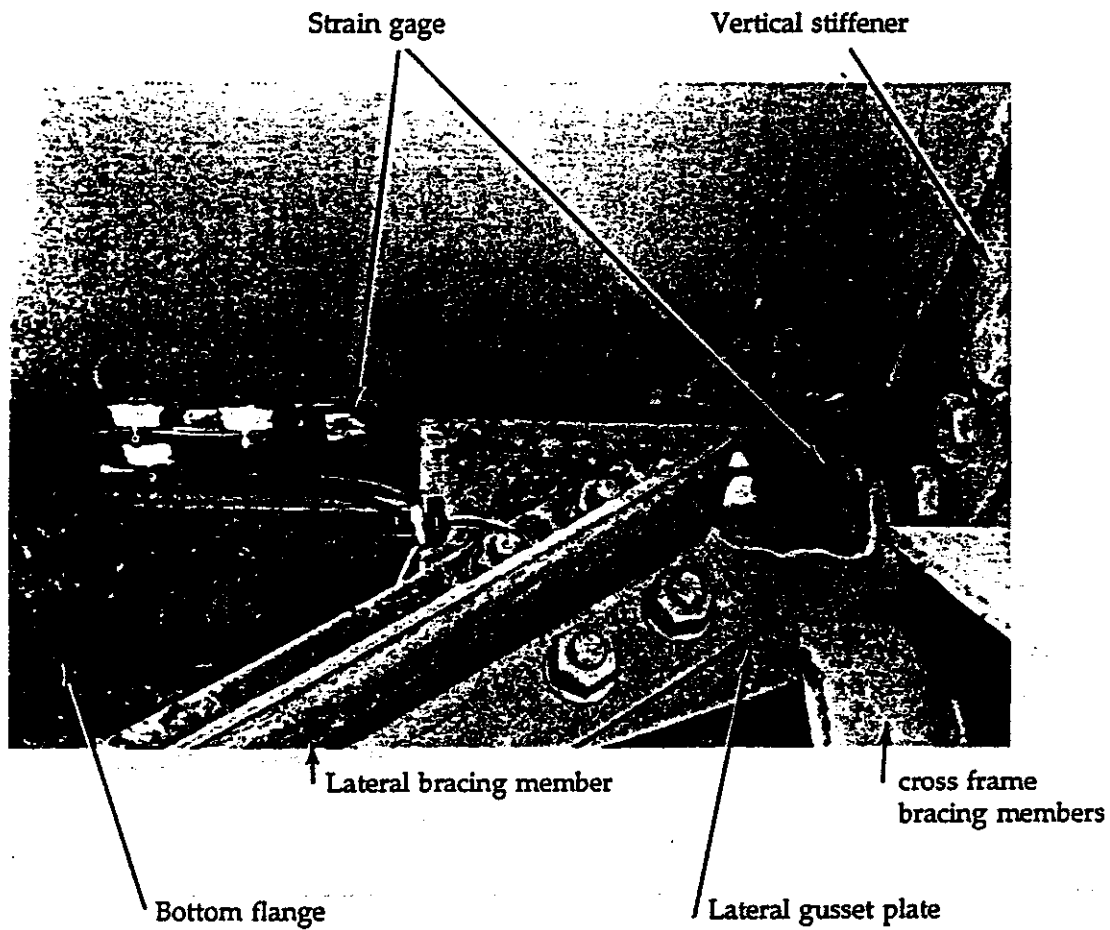
Figure 2.1.1.1 - Gerald Desmond Bridge - Strain Gages Installed at Lateral Gusset Plate Connection (Koob and Walther, 1993)

As part of a fatigue evaluation of the Gerald Desmond Bridge in Long Beach, California, the bridge was instrumented and field tested by Wiss, Janney, Elstner Associates, Inc. to determine the live load stresses and the response of the structure under normal traffic conditions (Koob and Walther, 1993). The approach spans consist of nine plate girders connected by angle cross frames at a spacing of about 6000 mm (20 ft.) on center. Objectives of field testing were to measure the stress ranges adjacent to fatigue sensitive details and compare stress levels with and verify the structural analysis. To provide information about live load stress ranges at locations of maximum moment, 6 mm ( $1/4$  in.), 350 ohm strain gages were placed on the girder webs and flanges at midspan. Strain gages were also installed at lateral gusset plate connections (Figure 2.1.1.1). Instrumentation was generally positioned beneath the right lane which is used by most truck traffic.

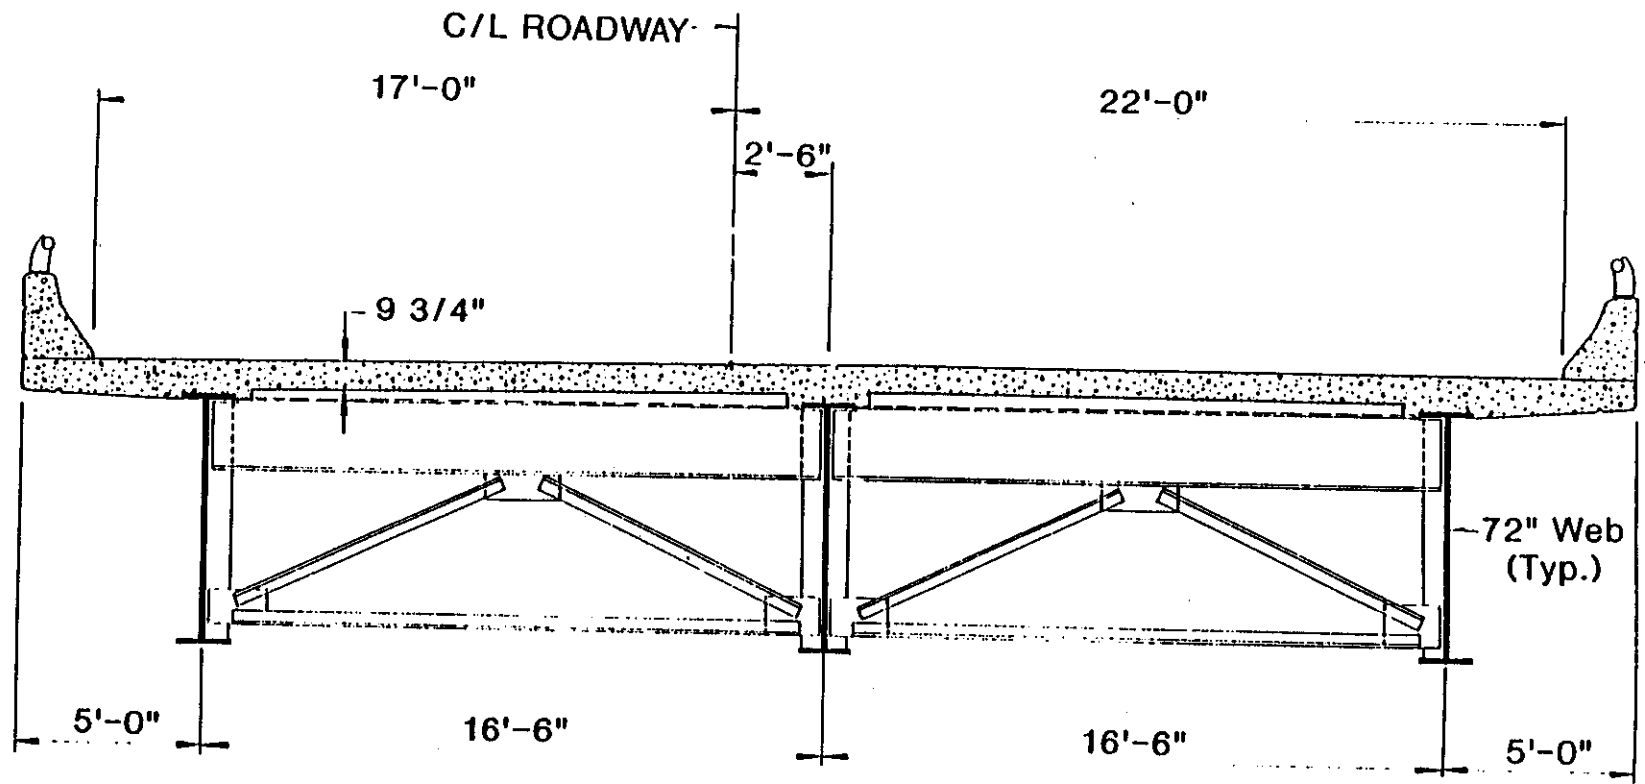
Figure 2.1.2.1 - I-64 Bridge - Typical Cross Section (Albrecht et al., 1991)

During an inspection in 1991, cracks were discovered in the I-64 bridges over Maury River and Kerr's Creek in Virginia (Albrecht et al., 1991). The two bridges are identical. Each is a seven span, continuous bridge consisting of three, 1,829 mm (6 ft.) deep girders, spaced at 5,029 mm (16 ft. - 6 in.) (Figure 2.1.2.1). The girders are joined together by floor beams and diaphragms at a 6,096 mm (20 ft.) spacing and lateral bracing every 12,192 mm (40 ft.). The first crack was found in the exterior girder where the diaphragm and lateral bracing members are connected. Three additional cracks were later discovered in web gaps between connection plates for the diaphragms and gusset plates for the lateral bracing (Figure 2.1.2.2).

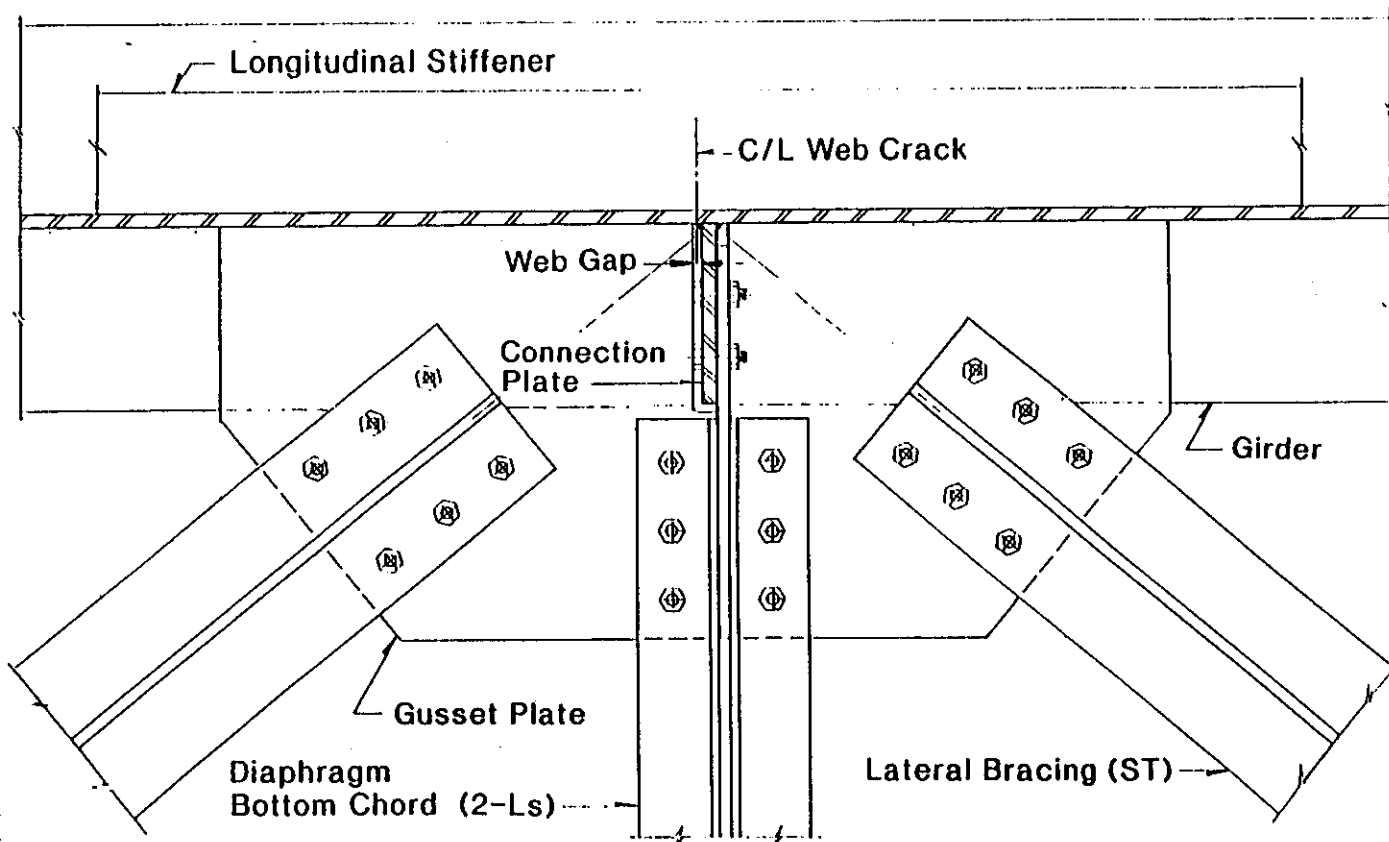
**PLAN OF JOINT J1**

Figure 2.1.2.2 - I-64 Bridge - Plan View of Joint (Albrecht et al., 1991)

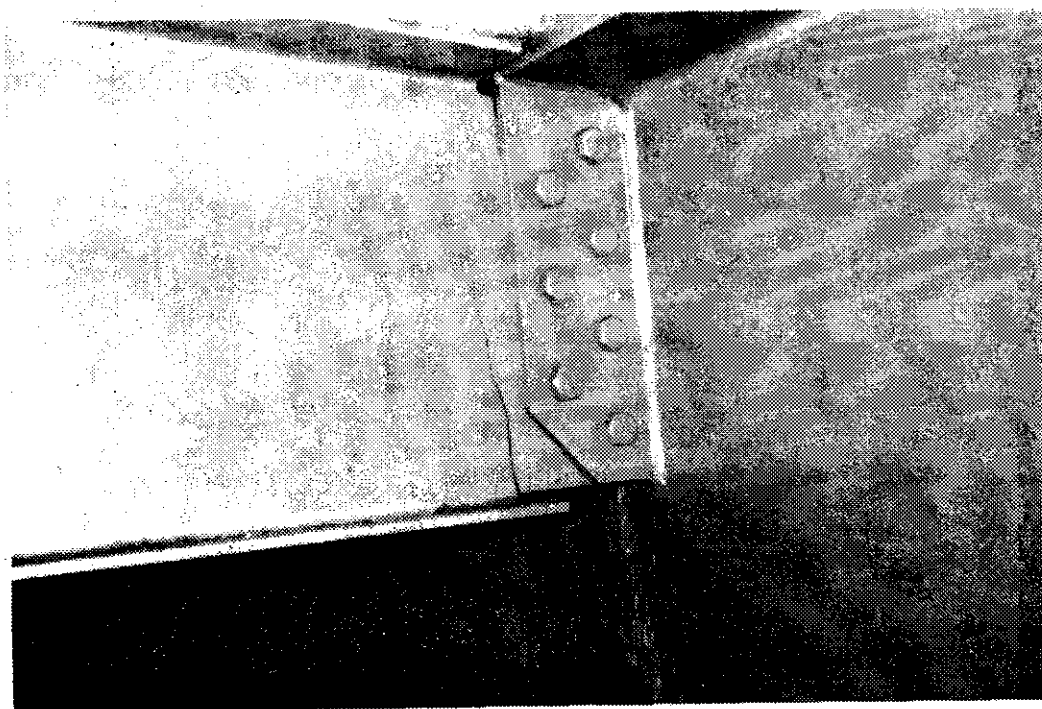
Figure 2.1.3.1 - Oklahoma Highway Bridge - Example of Cracked Diaphragm  
(Zwerneman et al., 1989)

Researchers at Oklahoma State University (Zwerneman et al., 1989) conducted a study on a steel girder bridge to identify the cause of diaphragm cracking. Hot rolled sections were used as diaphragm members, with the diaphragms bolted to a connection plate that is welded to the top flange and web of the girder. Both the top and bottom of the diaphragm are coped at each end. Cracks were found to initiate at the cope in the tension flange and propagate through the member toward the compression flange (Figure 2.1.3.1).

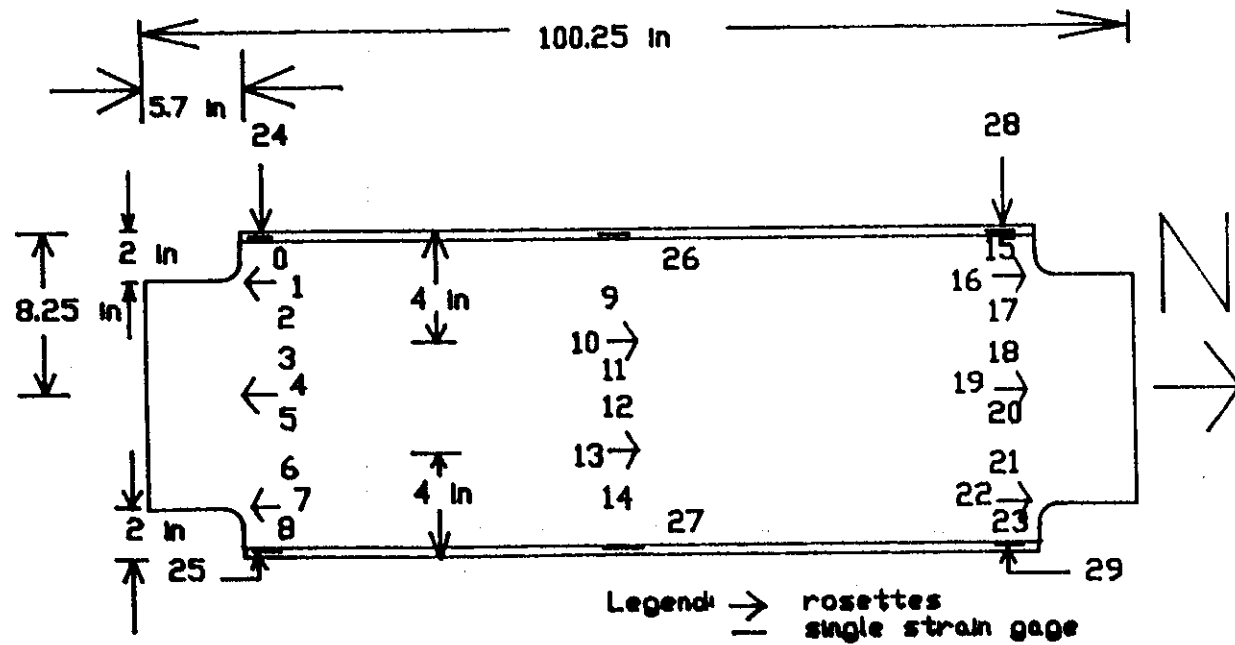
Figure 2.1.3.2 - Oklahoma Highway Bridge - Strain Gage Locations on Fabricated Diaphragm (Zwerneman et al., 1989)

Before load testing began, a diaphragm was fabricated to match existing diaphragms as closely as possible. This new diaphragm, which replaced one that had been cracked, and

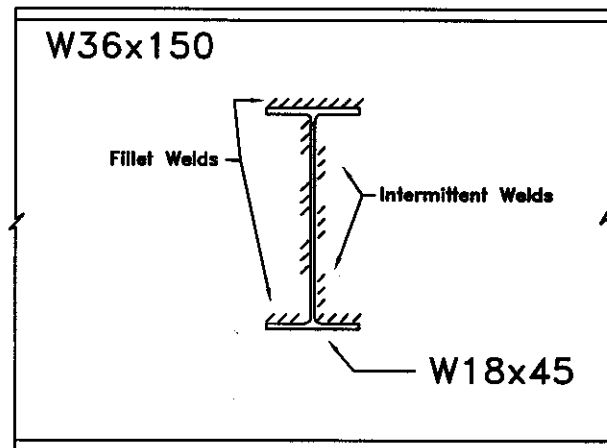
Figure 3.1.1 - Welded Diaphragm-to-Beam Connection

In several Indiana steel bridges, cracks have been observed in a frequently used diaphragm-to-beam connection. This detail involves a hot-rolled W-shape which is welded directly to the web of the longitudinal member. Intermittent fillet welds are used to attach the web of the diaphragm to the beam web. Diaphragm flanges are connected to the beam web using fillet welds along the top side of each flange. Cracks have been detected in both the intermittent web welds as well as the bottom flange fillet welds. The possibility of these cracks propagating into the beam web raises serious questions about the structural integrity of these longitudinal members in the future.

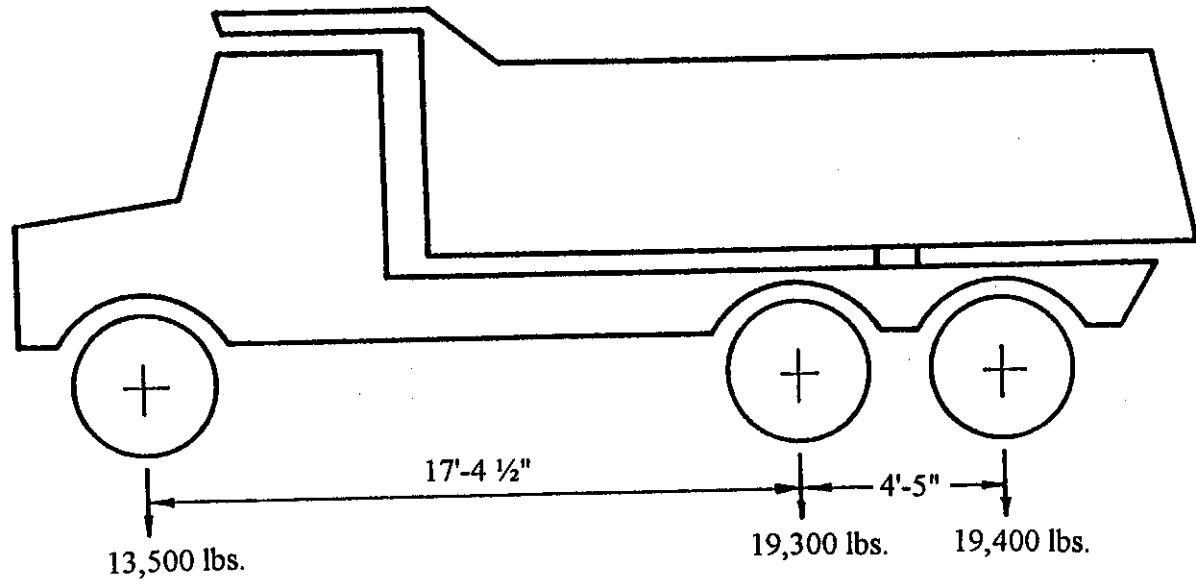
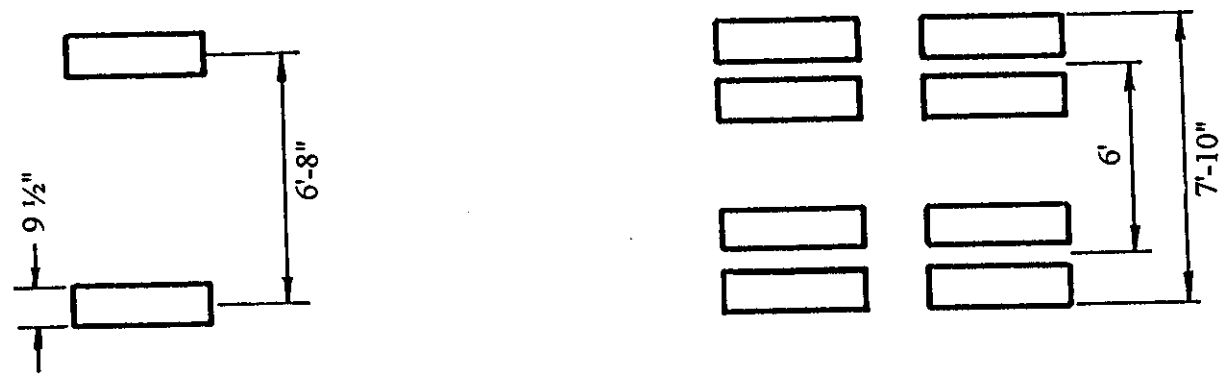
Figure 3.2.2.1 - US 52 - Tandem Axle Dump Truck

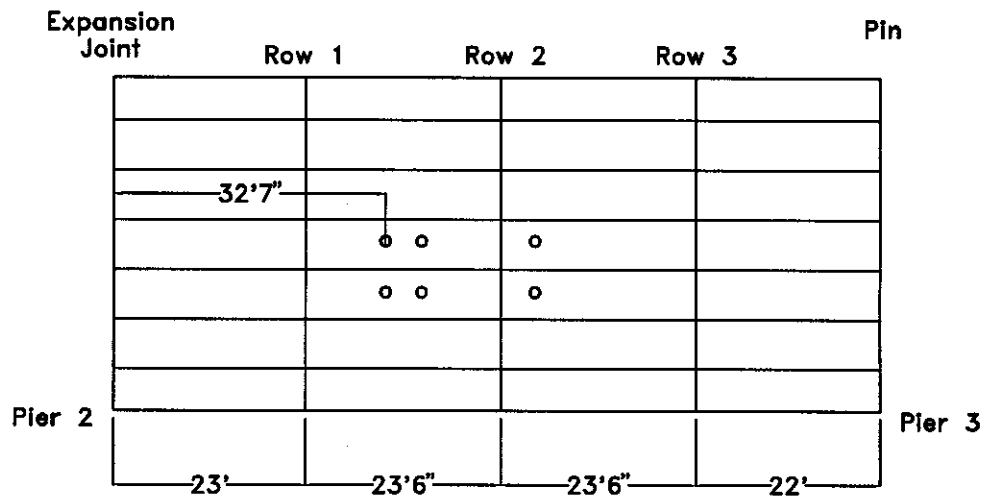
## Longitudinal Static Loading Condition #1

(Rear Axles Centered Between Diaphragm Rows 1 & 2)

Figure 3.2.2.2 - US 52 - Static Loading Condition #1 (LC #1)

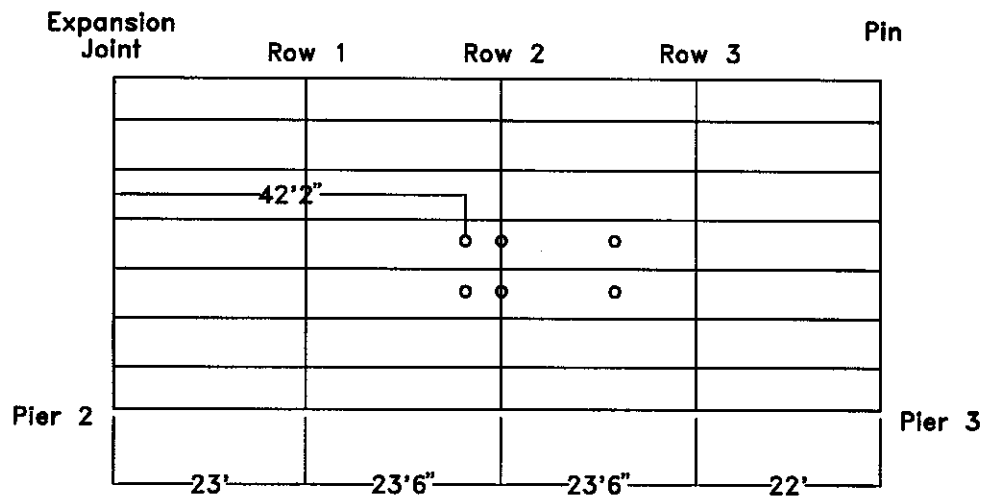
## Longitudinal Static Loading Condition #2 (Front Rear Axle Over Instrumented Diaphragms)

Figure 3.2.2.3 - US 52 - Static Loading Condition #2 (LC #2)

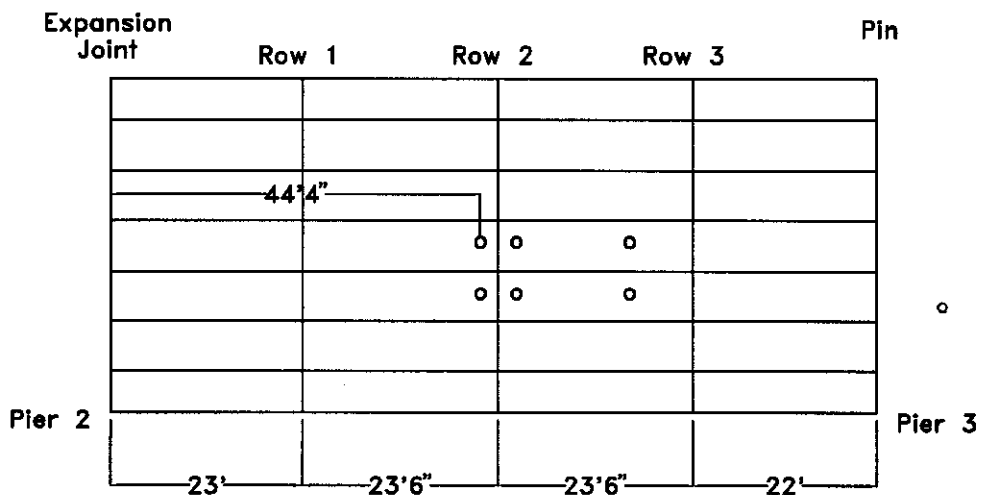
## Longitudinal Static Loading Condition #3

(Rear Axles Centered Over Instrumented Diaphragms)

Figure 3.2.2.4 - US 52 - Static Loading Condition #3 (LC #3)

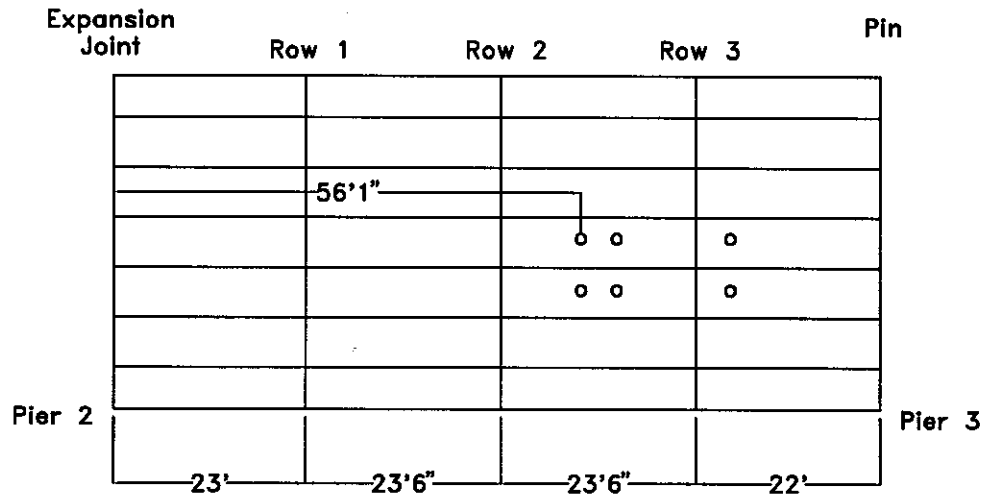
# Longitudinal Static Loading Condition #4

(Rear Axles Centered Between Diaphragm Rows 2 & 3)

Figure 3.2.2.5 - US 52 - Static Loading Condition #4 (LC #4)

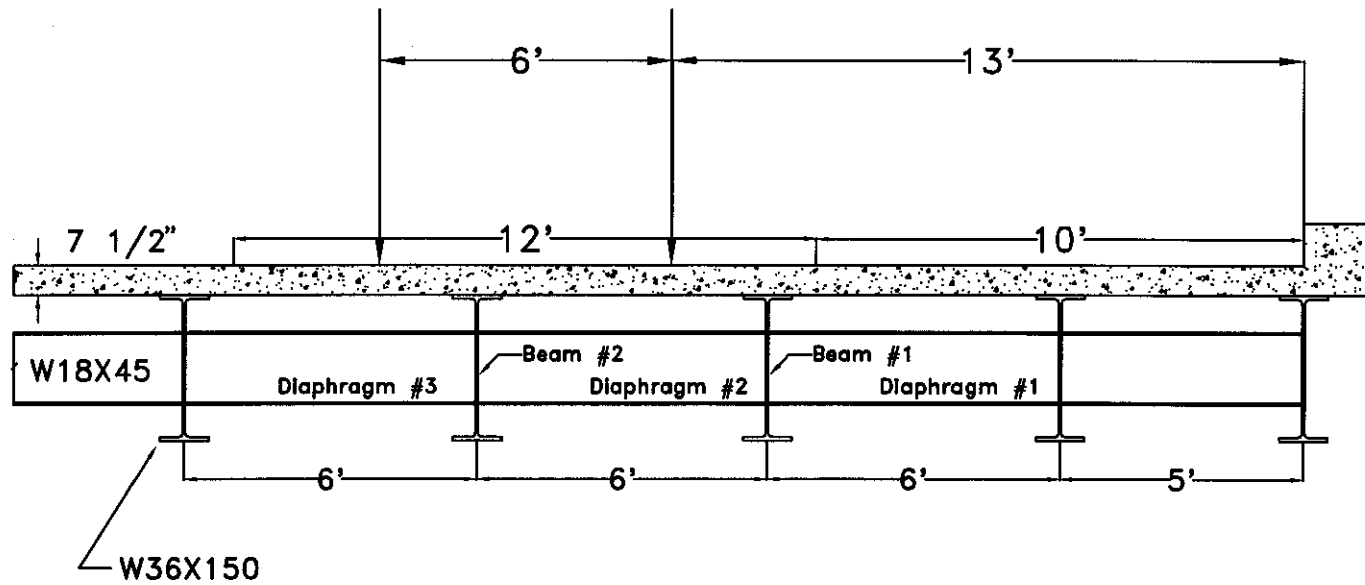
**Transverse Static Loading Condition A**  
 (Truck Centered in Right Lane)  
 US 52

Figure 3.2.2.6 - US 52 - Static Loading Condition A

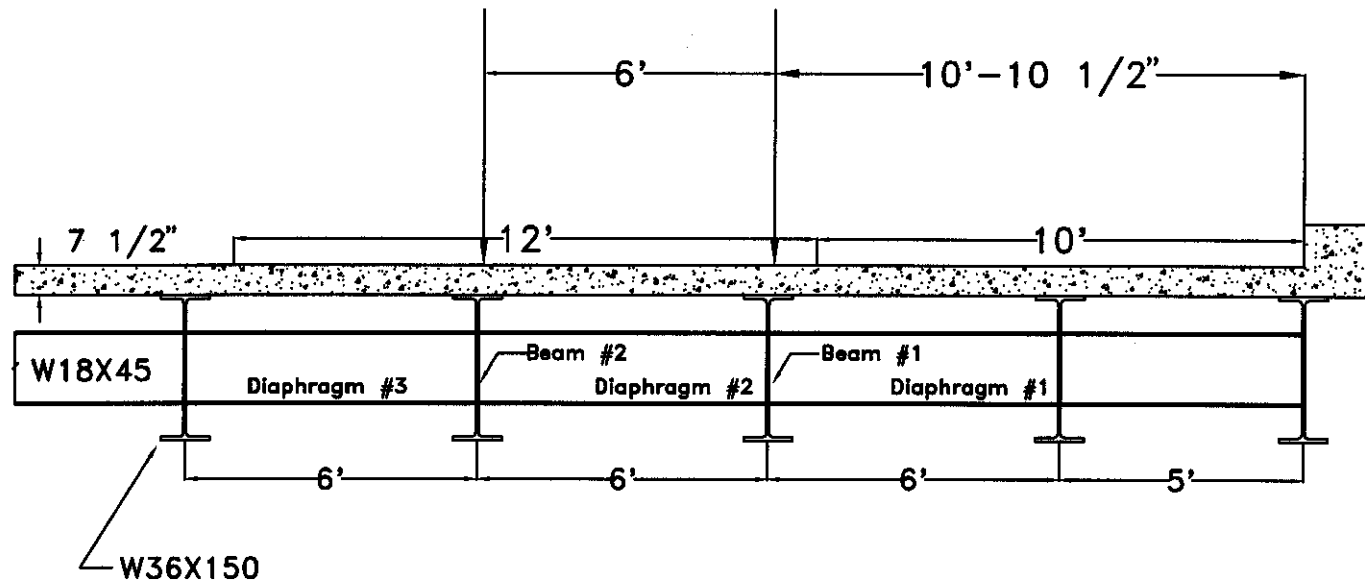
# Transverse Static Loading Condition B

(Right Rear Wheels Along Shoulder Line)

Figure 3.2.2.7 - US 52 - Static Loading Condition B

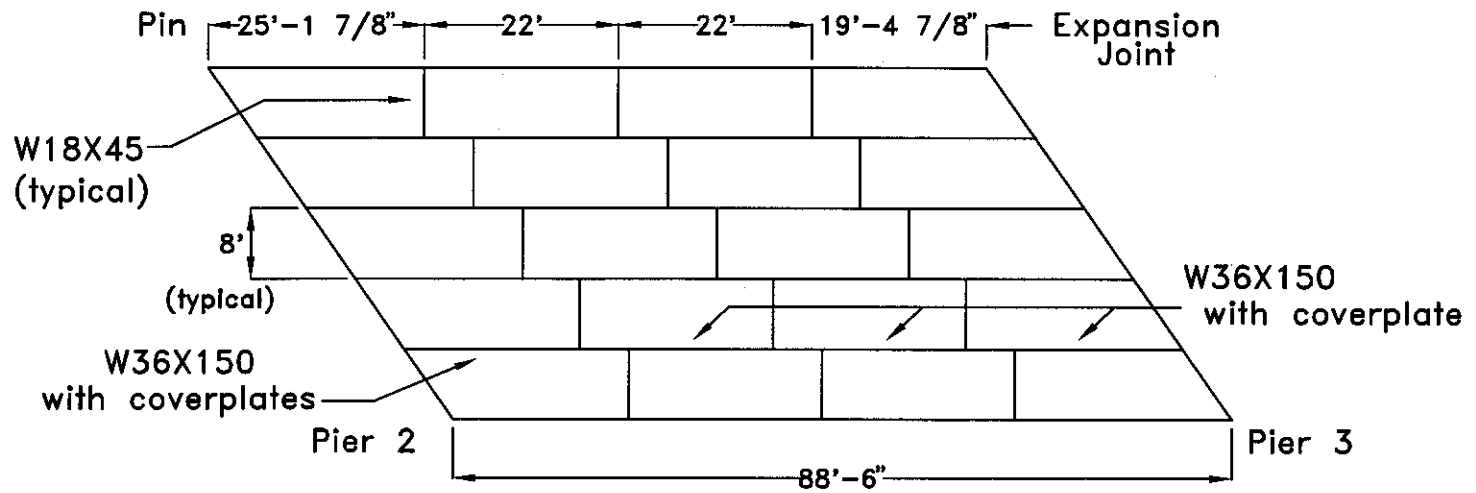
Figure 3.3.1 - I 65 - Plan View of Instrumented Span

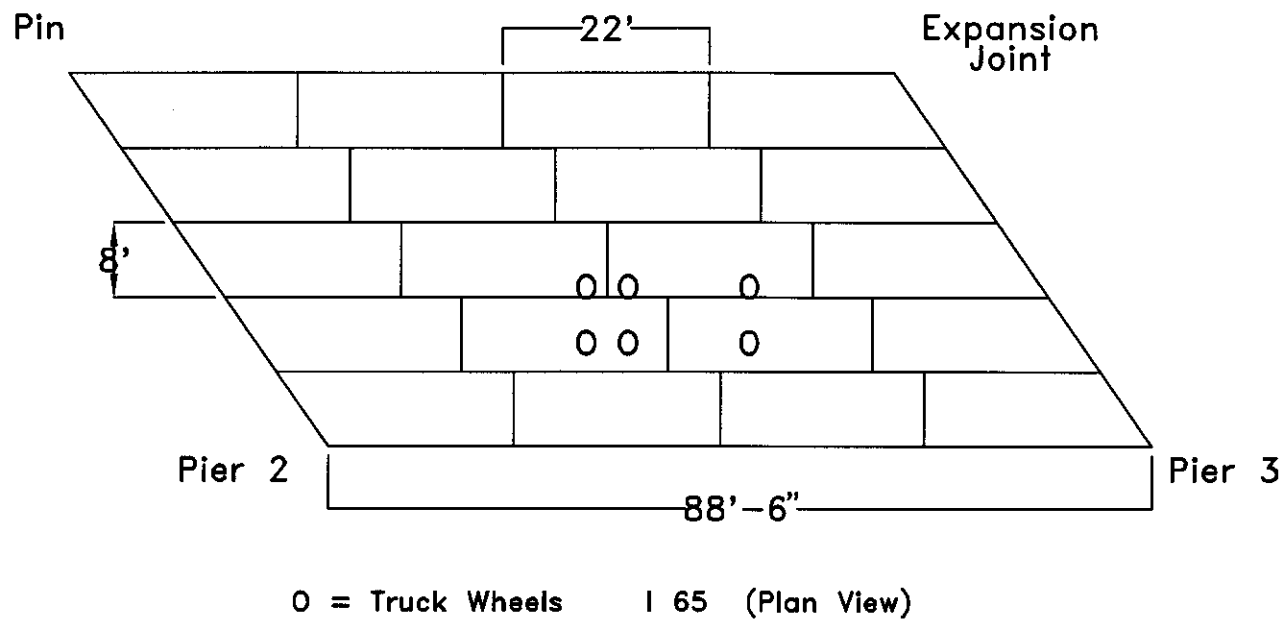
# Longitudinal Static Loading Condition #1

(Rear Axles Centered Over Diaphragm #2)

Figure 3.3.2.2 - I 65 - Static Loading Condition #1 (LC #1)

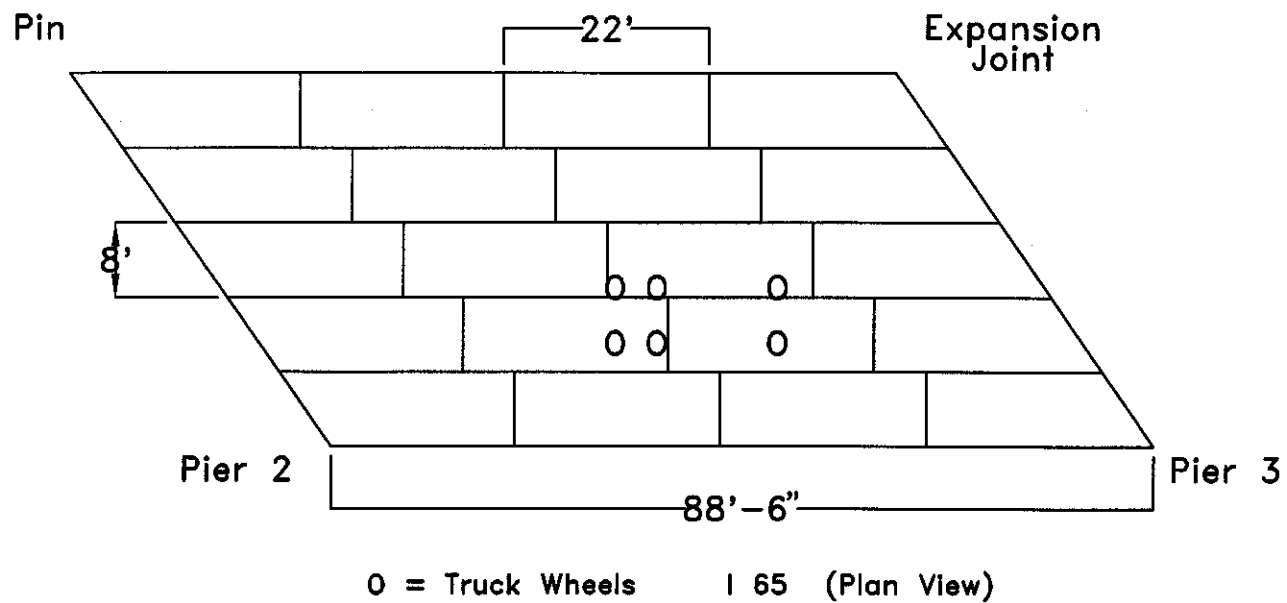
# Longitudinal Static Loading Condition #2

(Rear Axles Centered Between Instrumented Diaphragms)

Figure 3.3.2.3 - I 65 - Static Loading Condition #2 (LC #2)

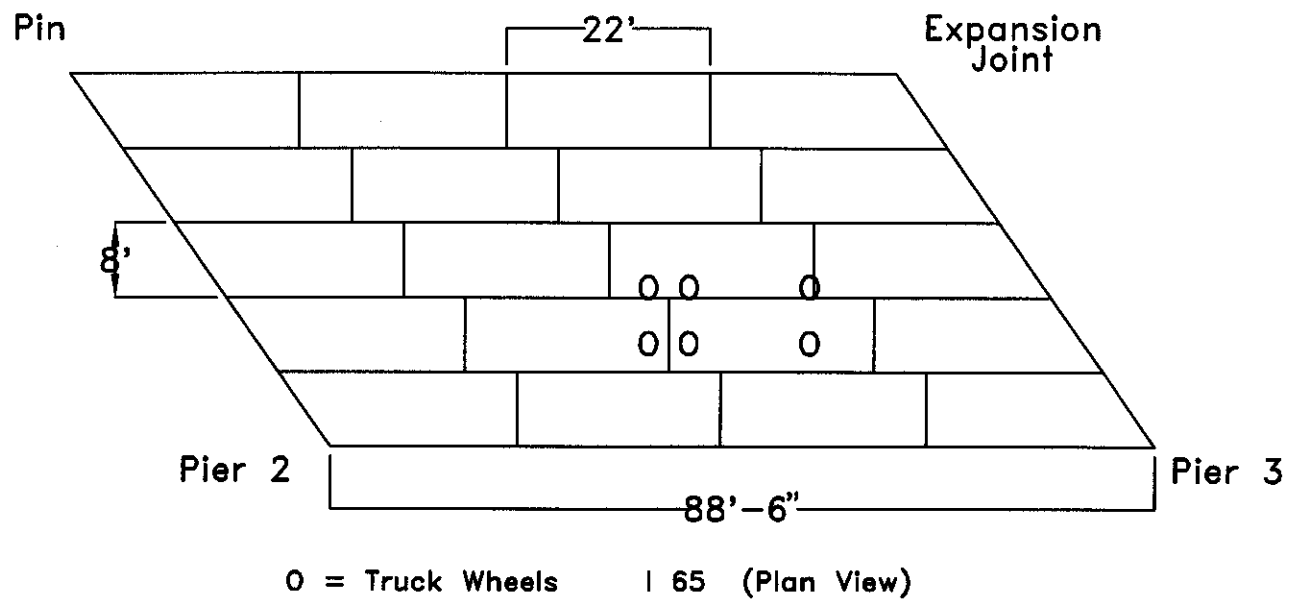
# Longitudinal Static Loading Condition #3

(Rear Axles Centered Over Diaphragm #1)

Figure 3.3.2.4 - I 65 - Static Loading Condition #3 (LC #3)

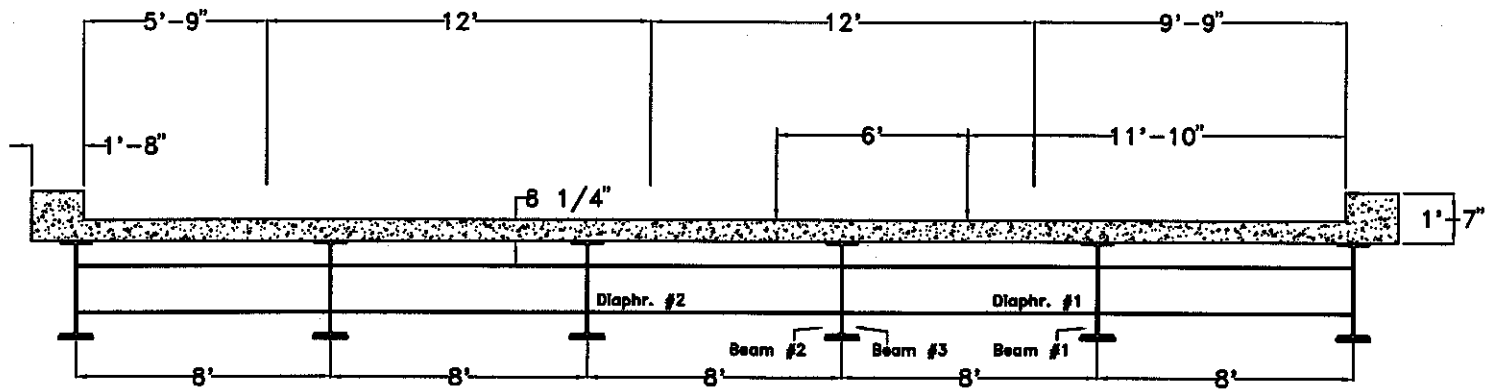
**Transverse Loading Condition A**  
 (Truck Centered in Right Lane)  
 I 65 Bridge

Figure 3.3.2.5 - I 65 - Static Loading Condition A

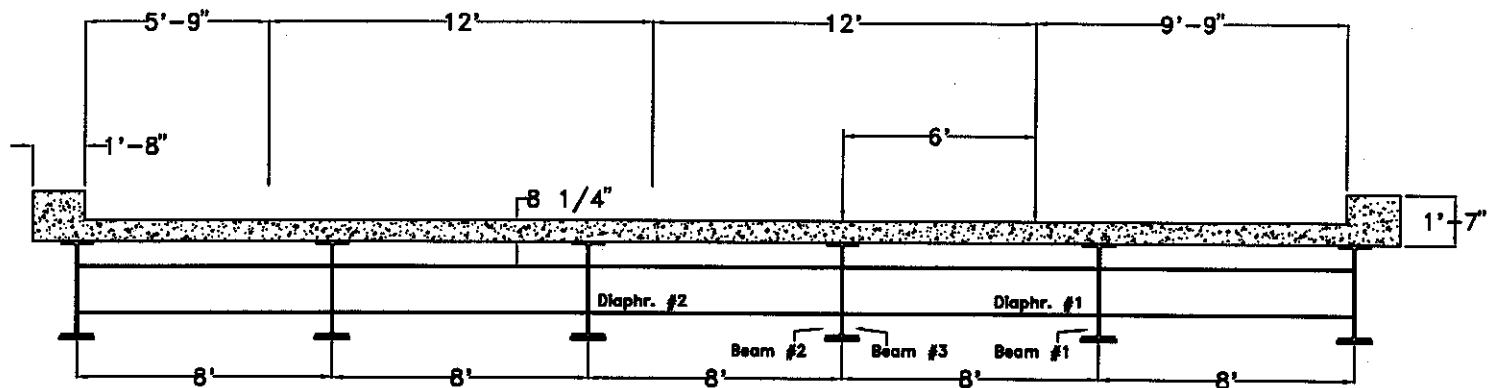
**Transverse Loading Condition B**  
 (Right Rear Wheels Along Shoulder Line)  
 I 65 Bridge

Figure 3.3.2.6 - I 65 - Static Loading Condition B

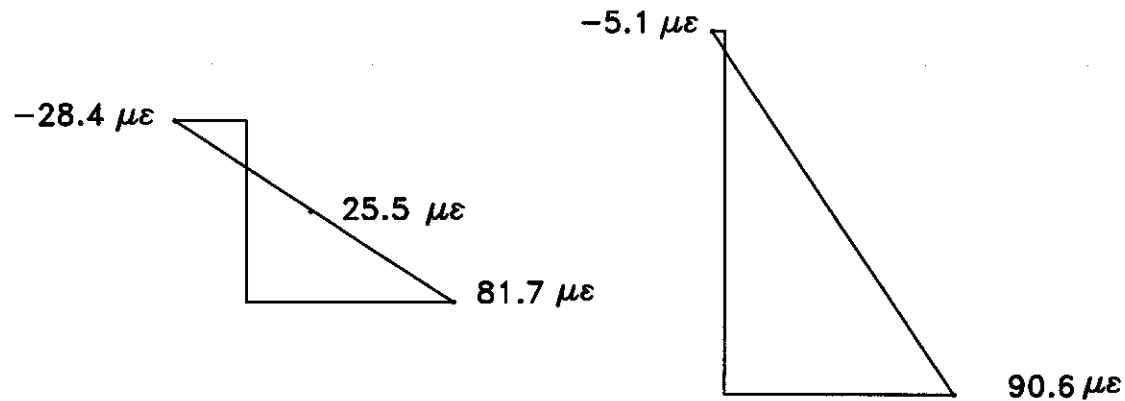
# Strain Distributions for US 52 Static Loading Condition #3A

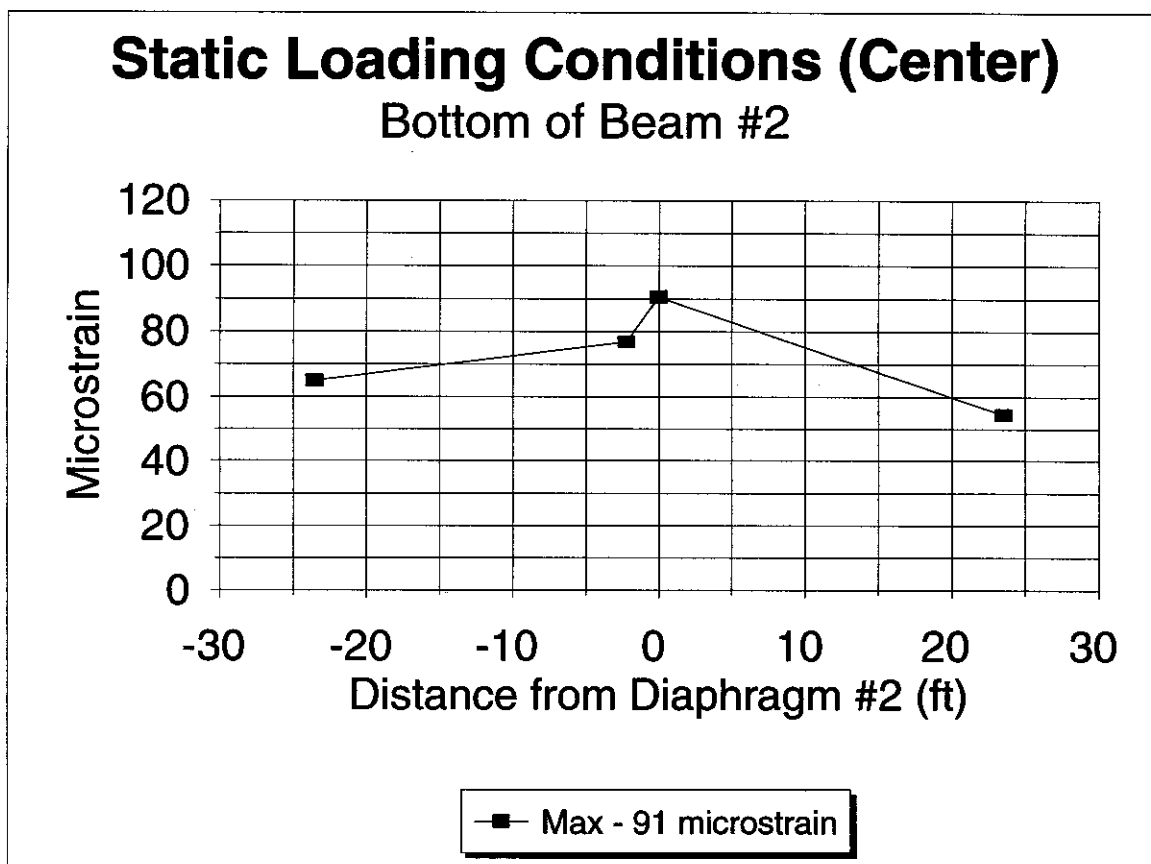
Figure 4.2.1.1 - US 52 - Strains at Bottom of Beam #2 - Loading Condition A

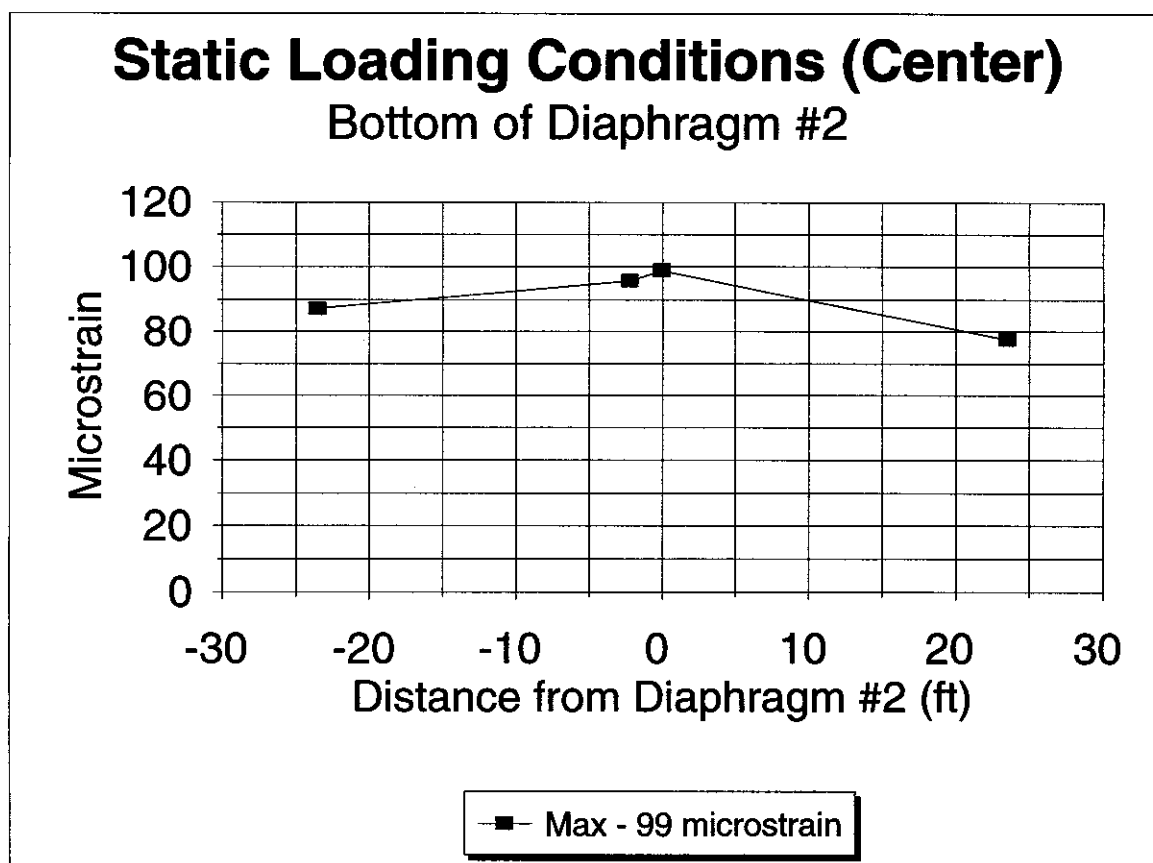
Figure 4.2.2.1 - US 52 - Strains at Bottom of Diaphragm #2 - Static Loading Condition A

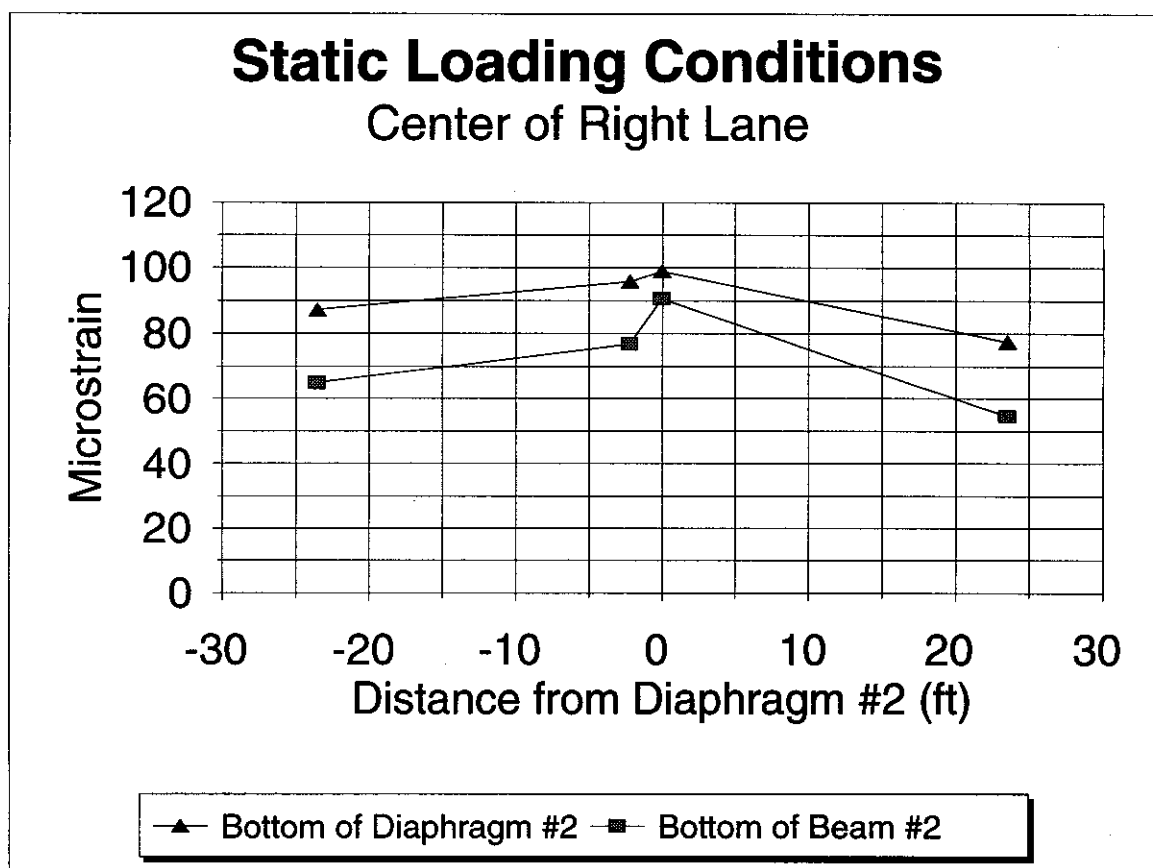
Figure 4.2.2.11 - US 52 - Behavioral Comparison of Beams to Diaphragms

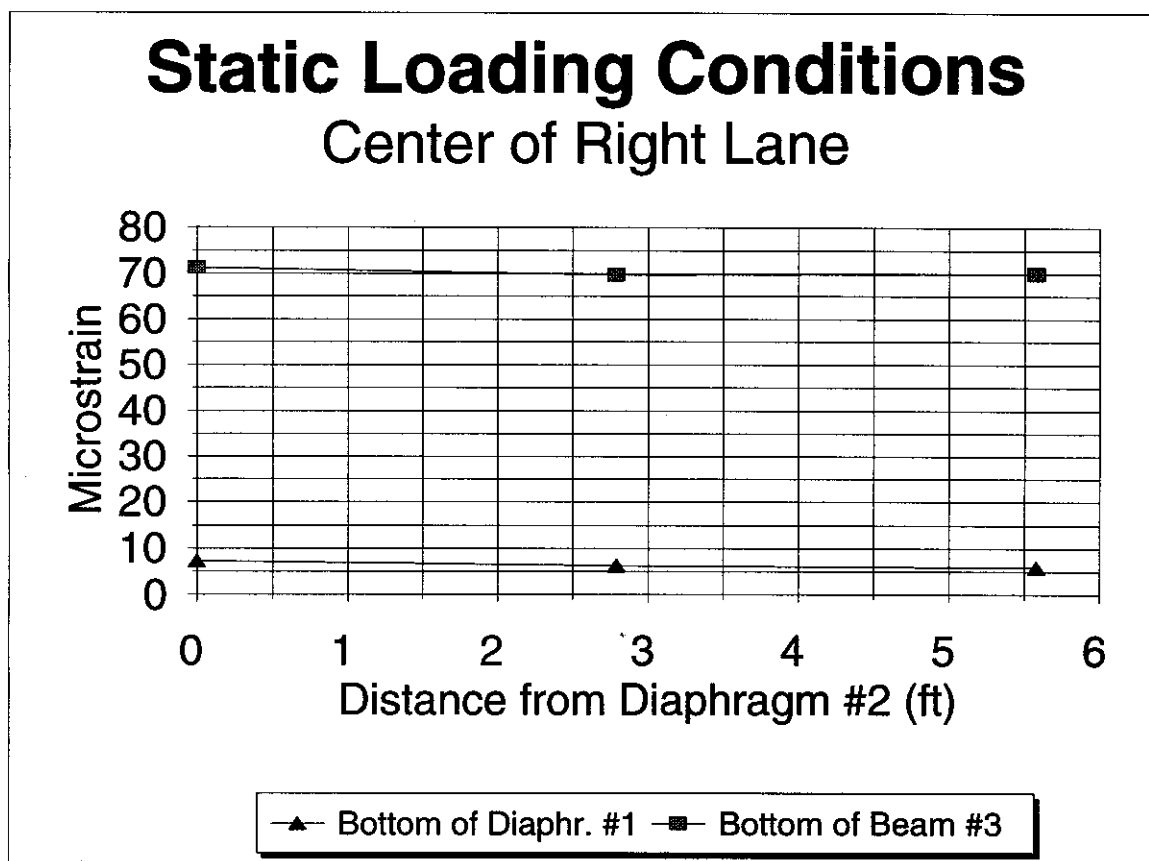
Figure 4.3.2.3 - I 65 - Behavioral Comparison of Beams to Diaphragms

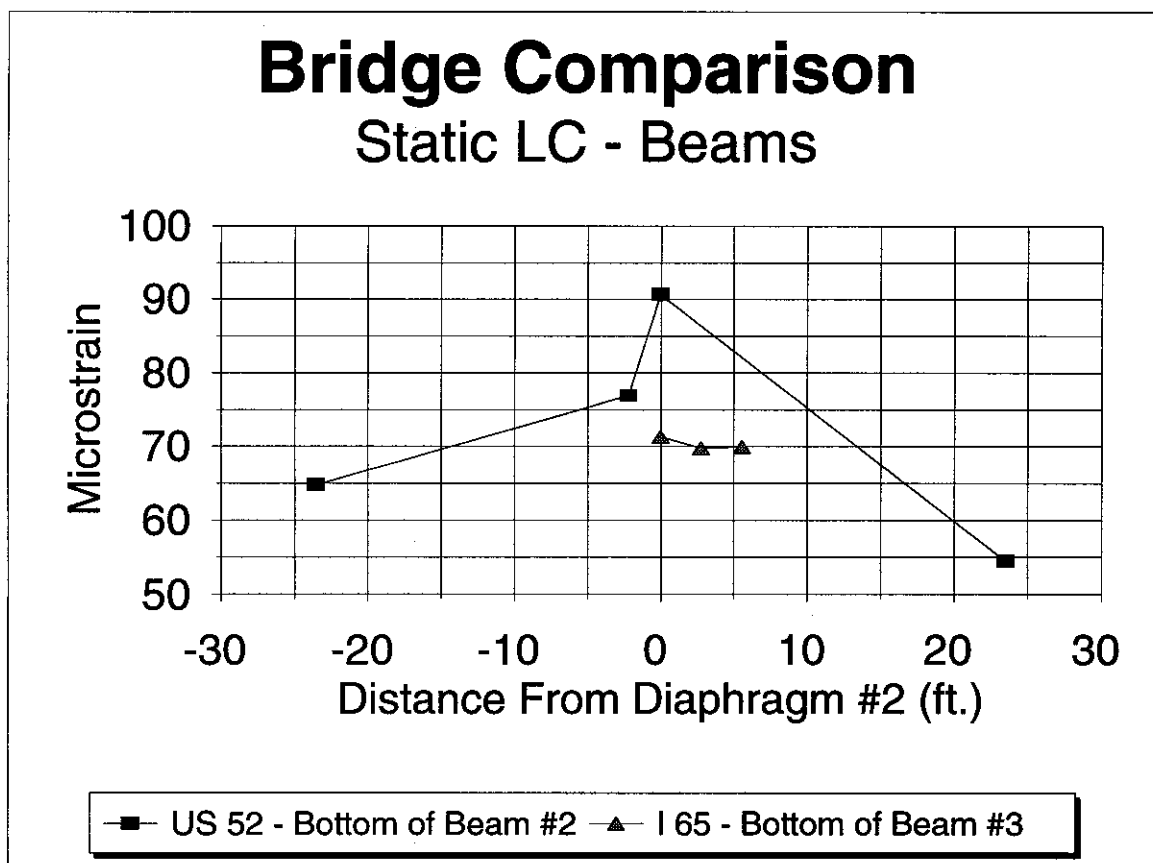
Figure 5.1.1 - Bridge Comparison - Strains at Bottom of Beams for Static Loading Conditions

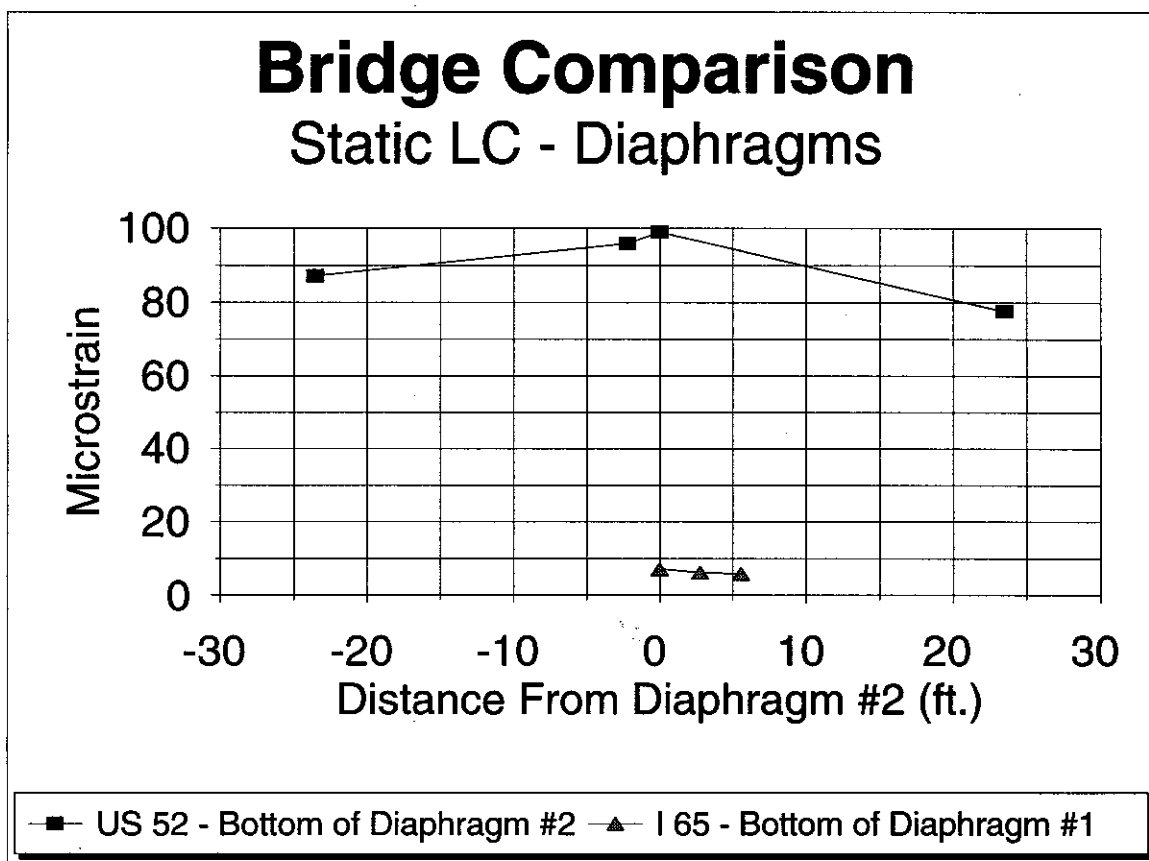
Figure 5.2.1 - Bridge Comparison - Diaphragm Strains for Static Loading Conditions
