**FHWA/IN/JTRP-2001/10-I-1**

FATIGUE BEHAVIOR OF BEAM DIAPHRAGM CONNECTIONS  
WITH INTERMITTENT FILLET WELDS (PART I):  
VOLUME 1 – FIELD EVALUATION

Purdue University  
School of Civil Engineering

Purdue University  
West Lafayette, IN 47907  
July 2001

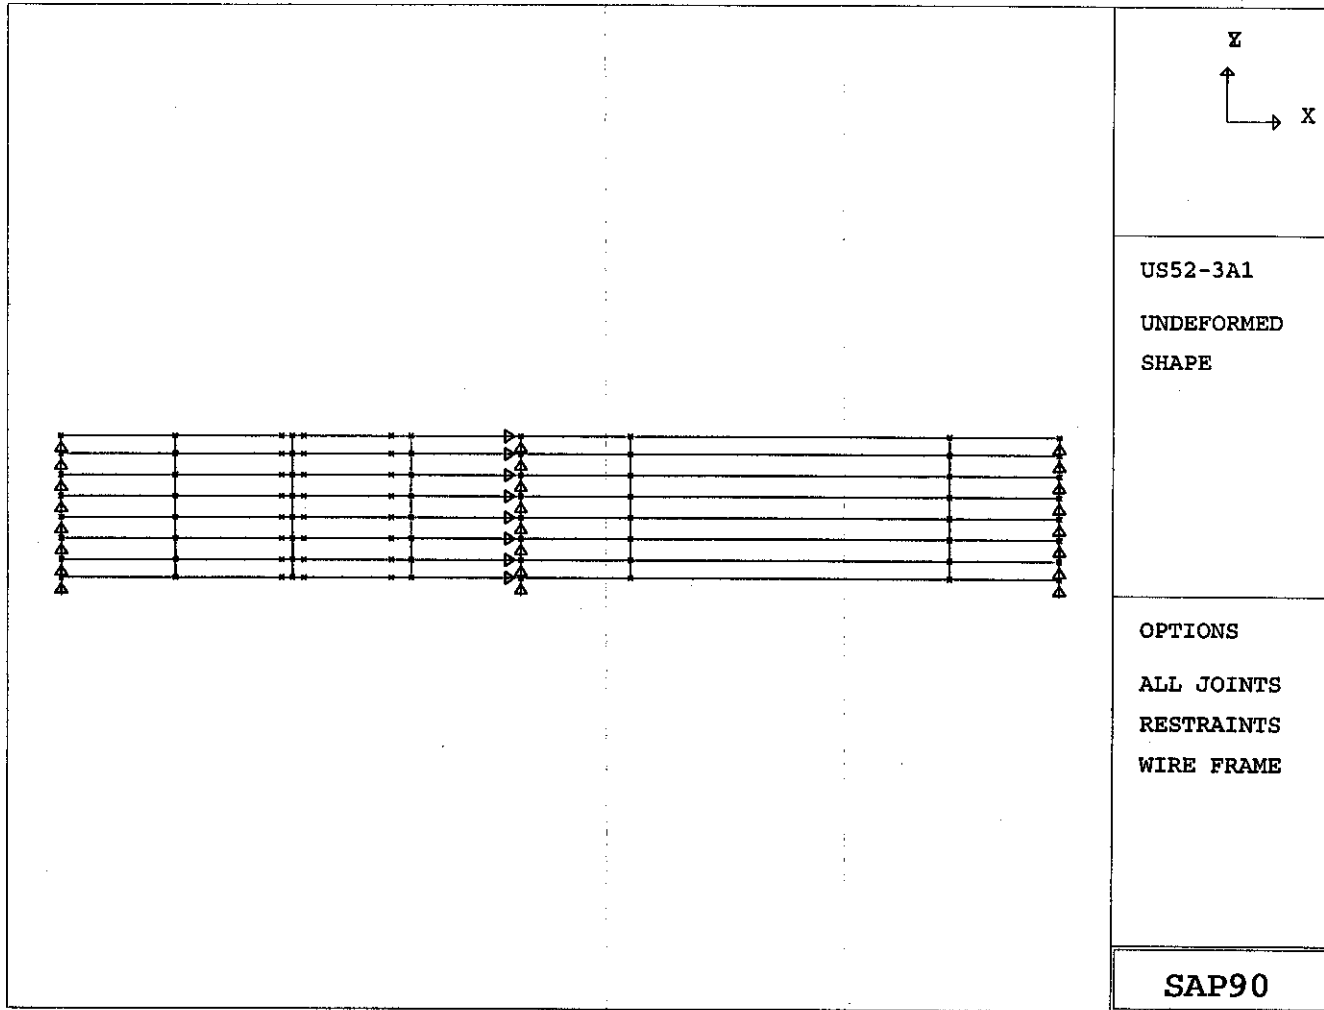
Figure 6.1.1 - US 52 - Plan View of Bridge Model

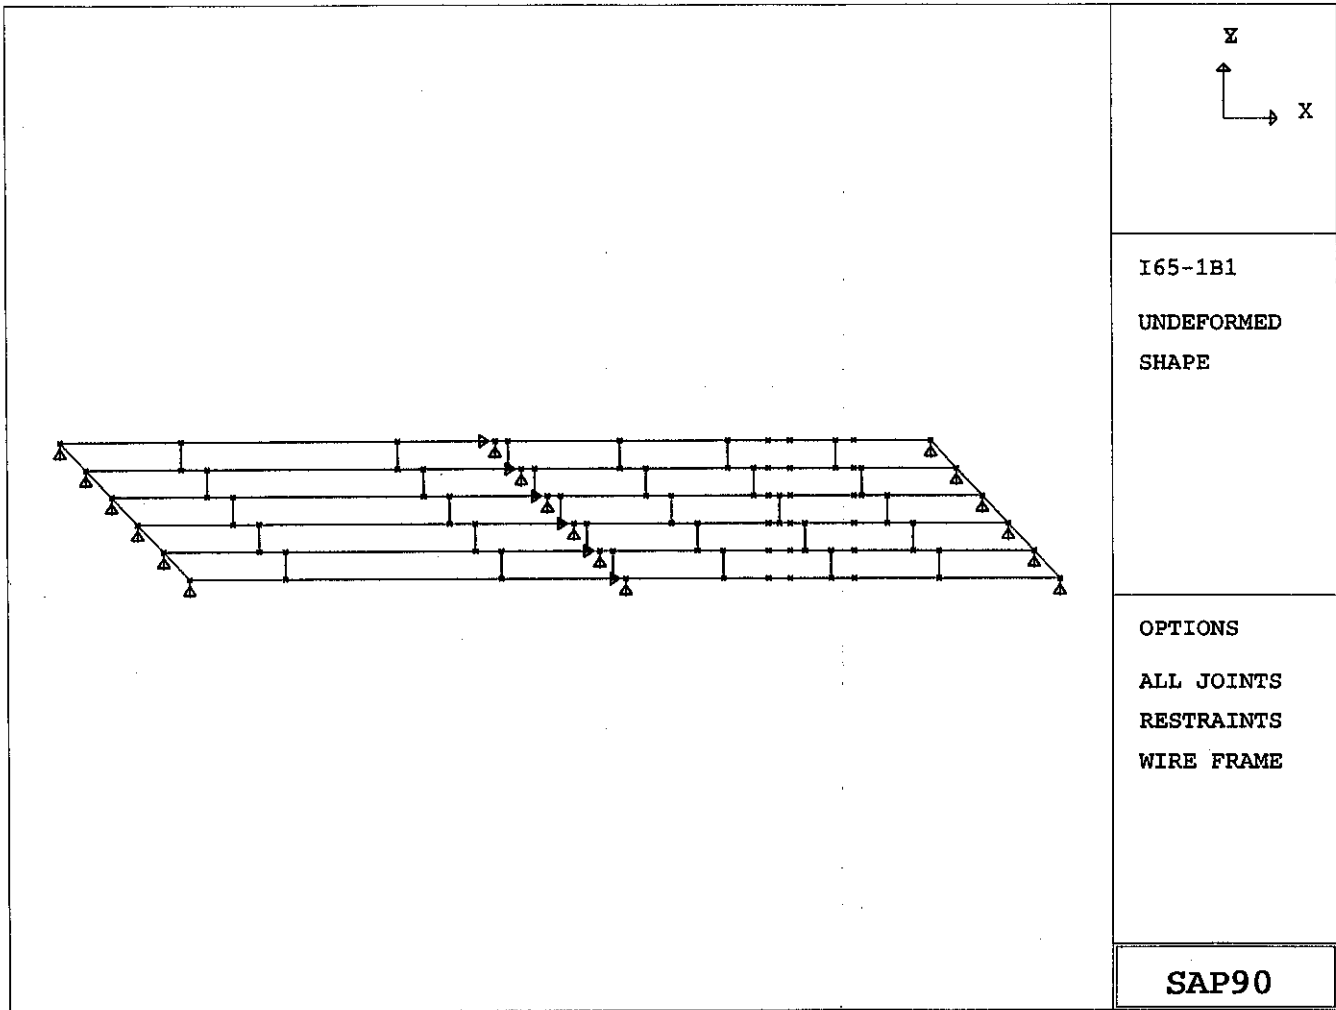
Figure 6.1.2 - I 65 - Plan View of Bridge Model

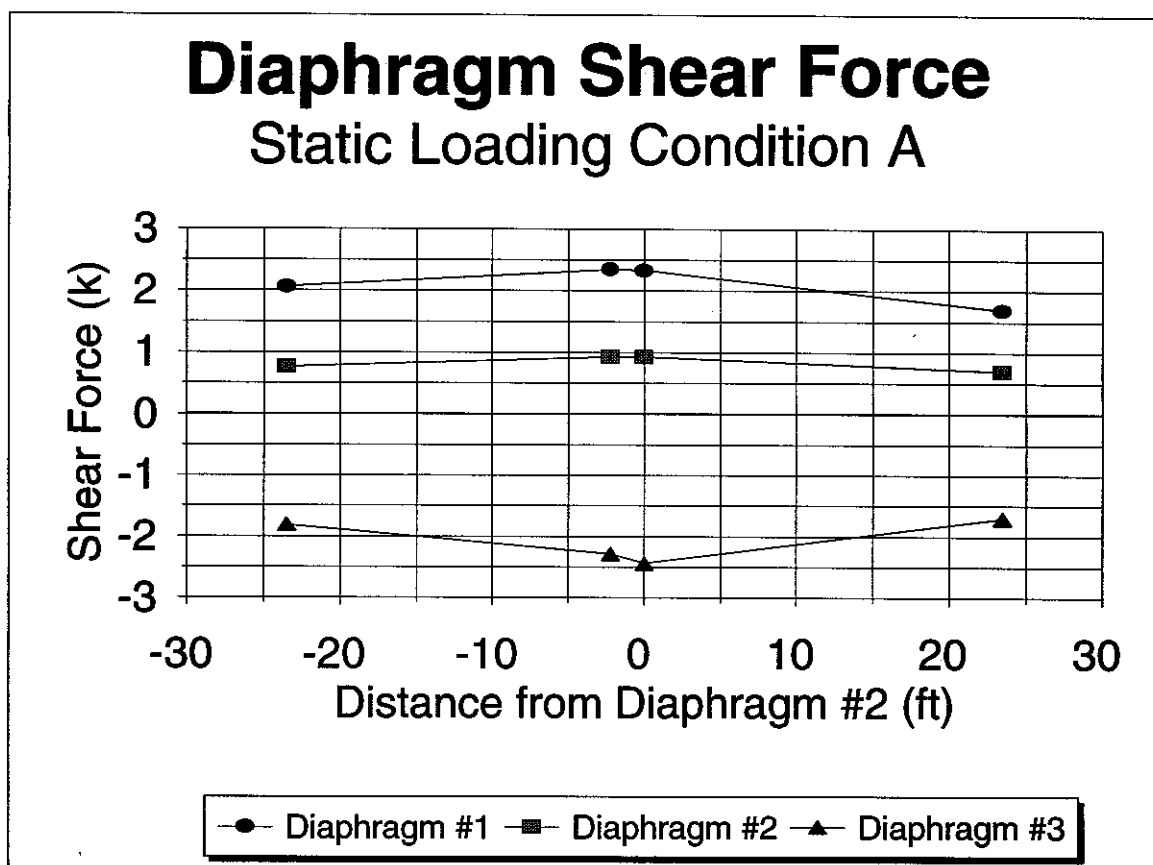
Figure C.1 - US 52 - Diaphragm Shear Forces for Static Loading Condition A

Appendix C includes additional experimental data not presented in the main text. The relationship between shear force and truck position for static loading conditions is presented here.
