JOINT TRANSPORTATION RESEARCH PROGRAM

FIBER REINFORCED POLYMER BRIDGE DECKS

Report Number: FHWA/IN/JTRP-2011/04

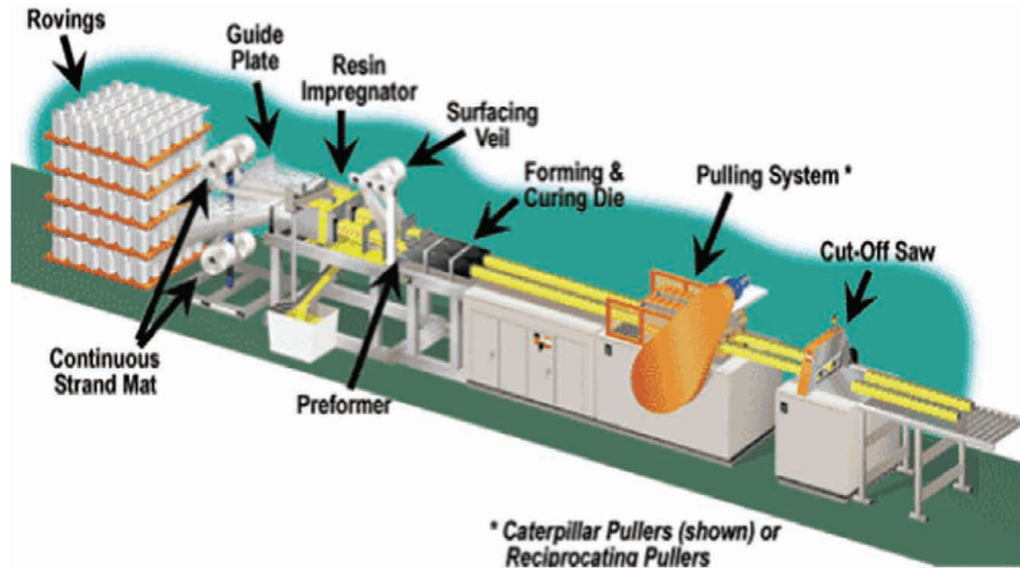
Figure 2.1: Pultrusion Process (<http://www.afpiberglass.com/images/pultrusionProcess.jpg>)

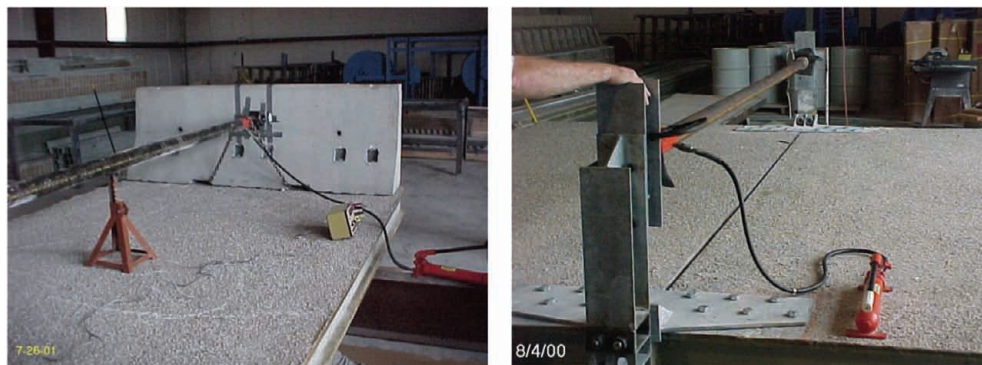
Figure 2.13: Test of Concrete Barrier (left) and Steel Rail (right) (Toillion, 2001)

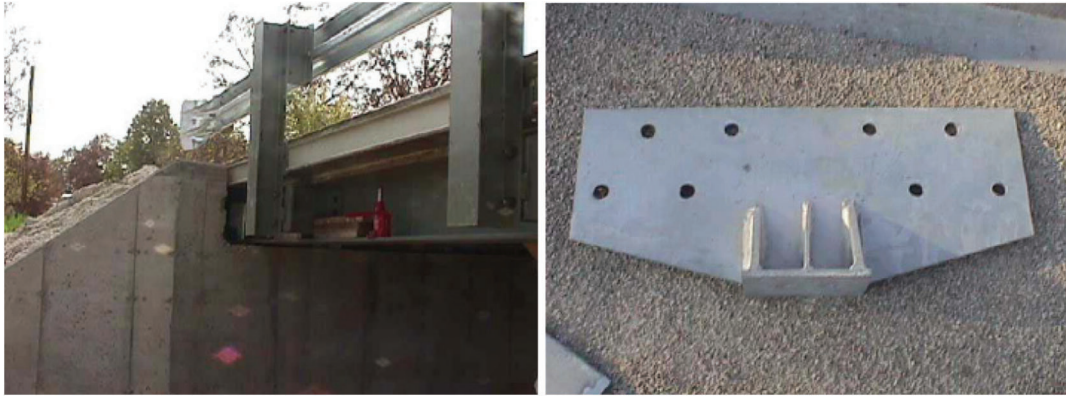
Figure 2.14: Guide rail and Connection to Deck (Nystrom, et al., 2002)

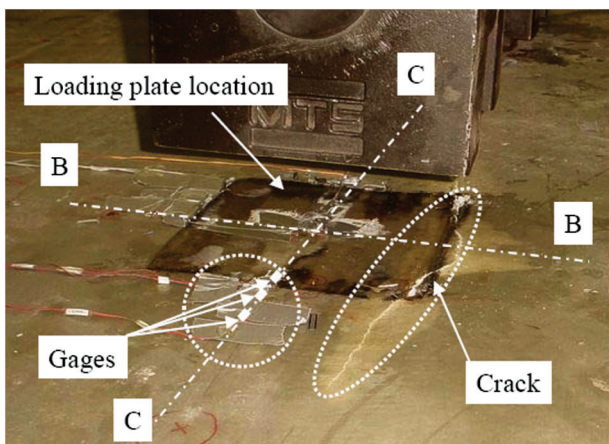
Figure 2.15: Failure of FRP Face at Loading Plate (Camata and Shing, 2004)

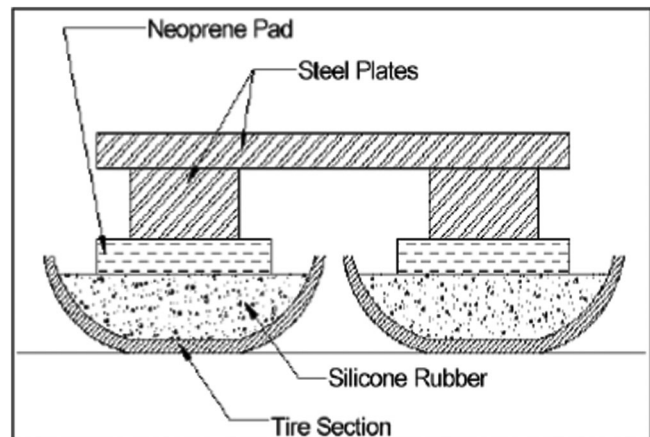
Figure 2.16: Simulated Tire Patch (Cousins and Lesko, 2004)

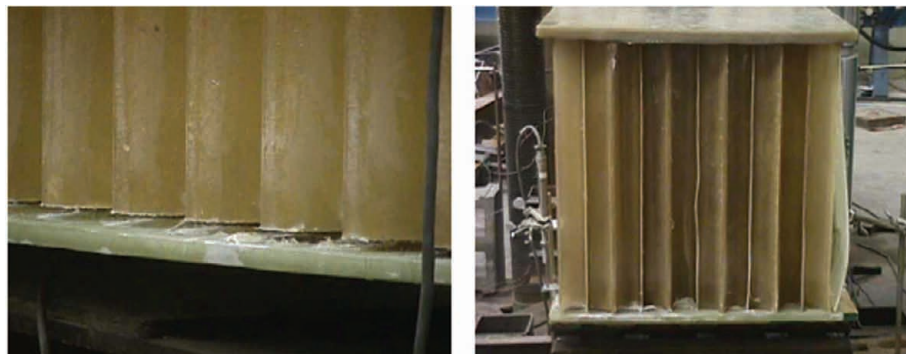
Figure 2.18: Delamination (a) and Buckling of Core (b) for honeycomb sandwich panel (Nystrom, et al., 2002)

observed included delamination of the face from the core and buckling of the core (Figure 2.18).

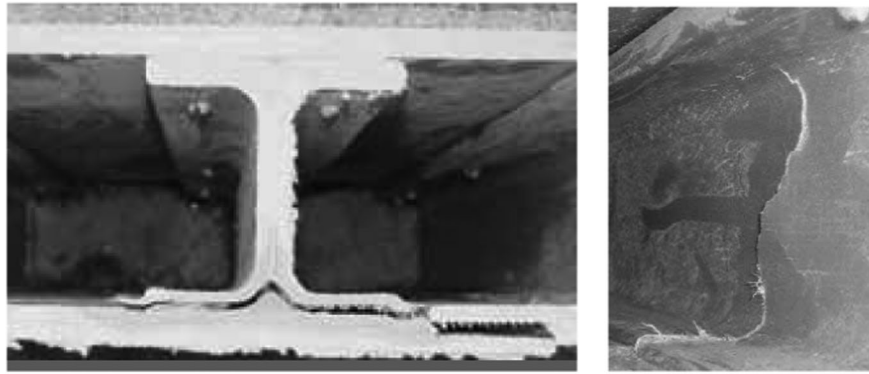
Figure 2.22: Delamination of Bottom Flange (left) and Web Failure (right) for Zellcomp Deck (Zhao, 2006)

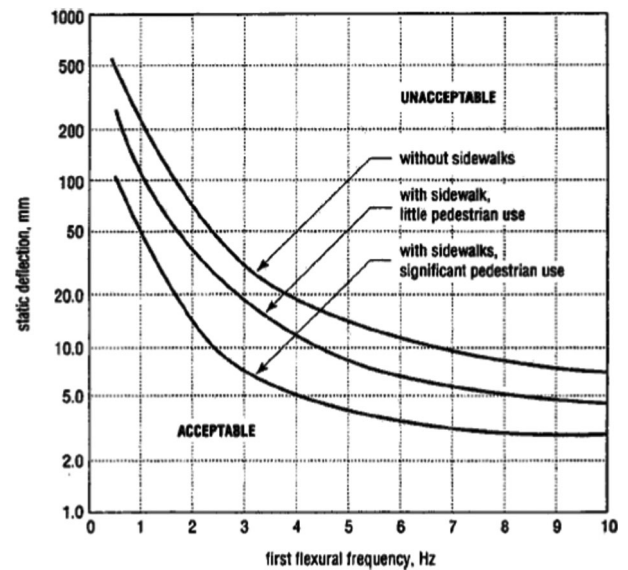
Figure 3.2: Service Deflection criteria per Ontario code (Ministry 1992)

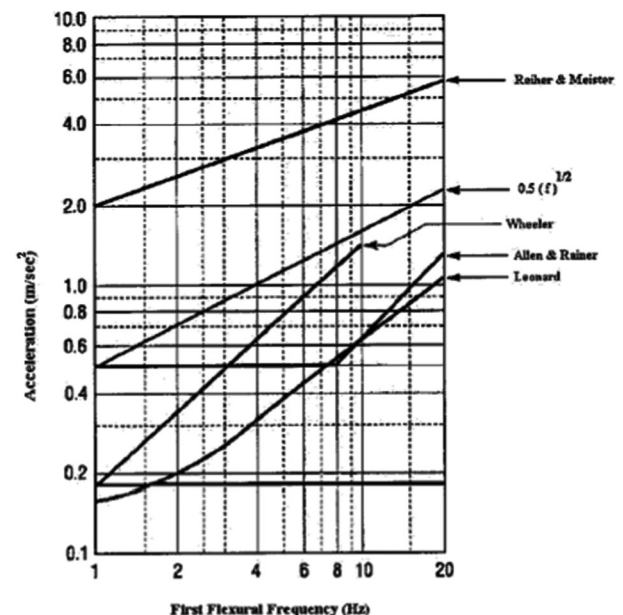
Figure 3.3: Criteria for human response to acceleration (Ministry 1995)

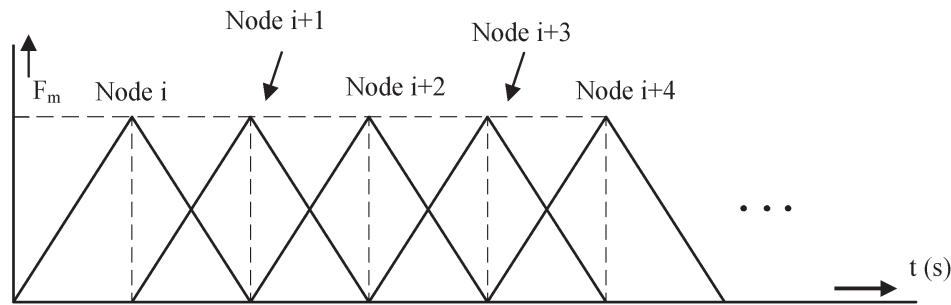
Figure 3.8: Schematic of the applied moving load model

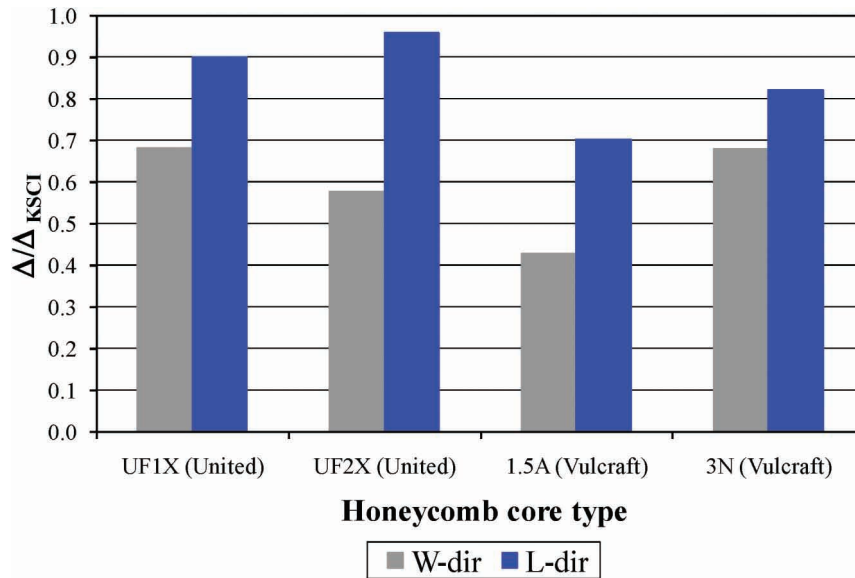
Figure 3.15: Steel deck core FE model comparison

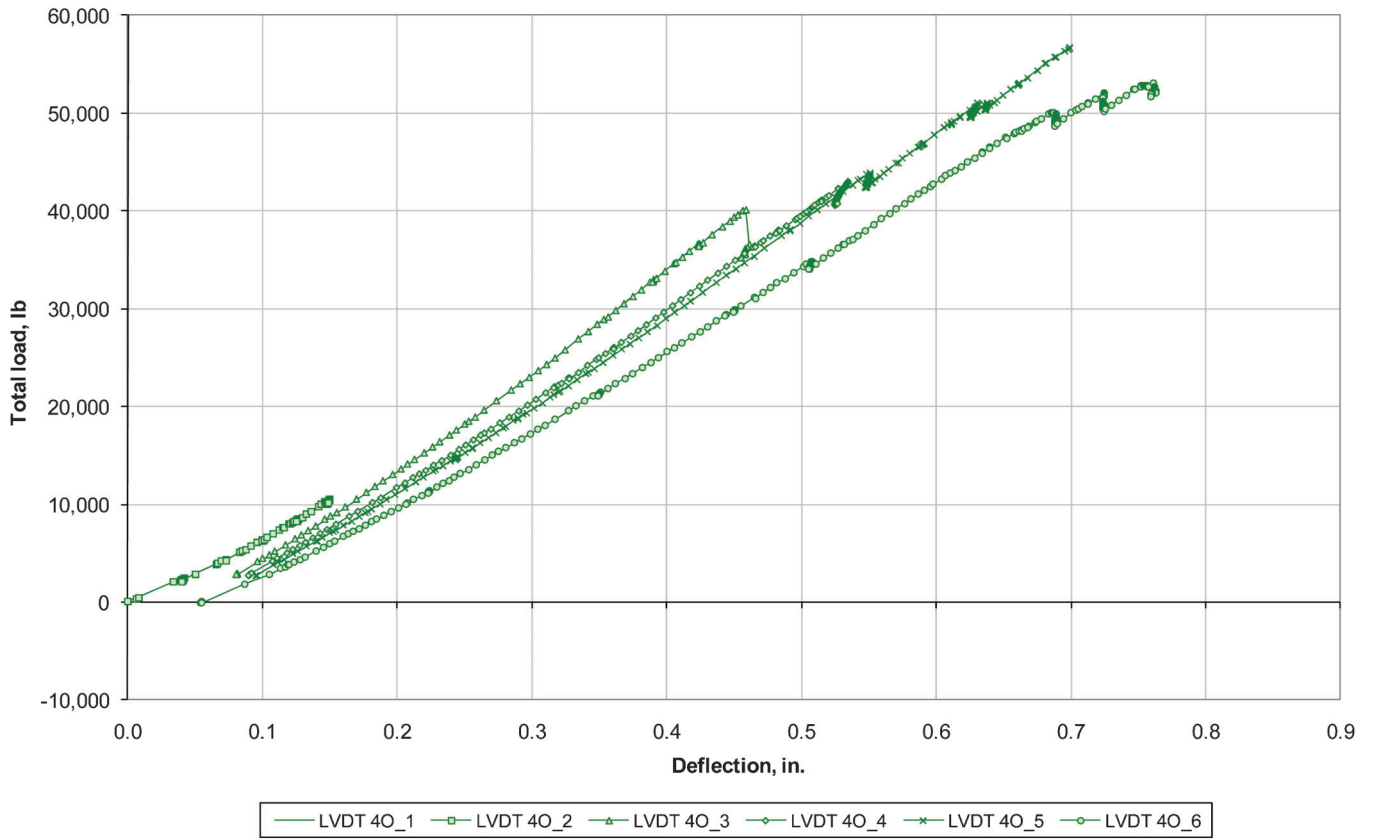
Figure 4.12: Total Load vs. Overhang Deflection near Joint (LVDT 4O) – KSCI #P1a Test

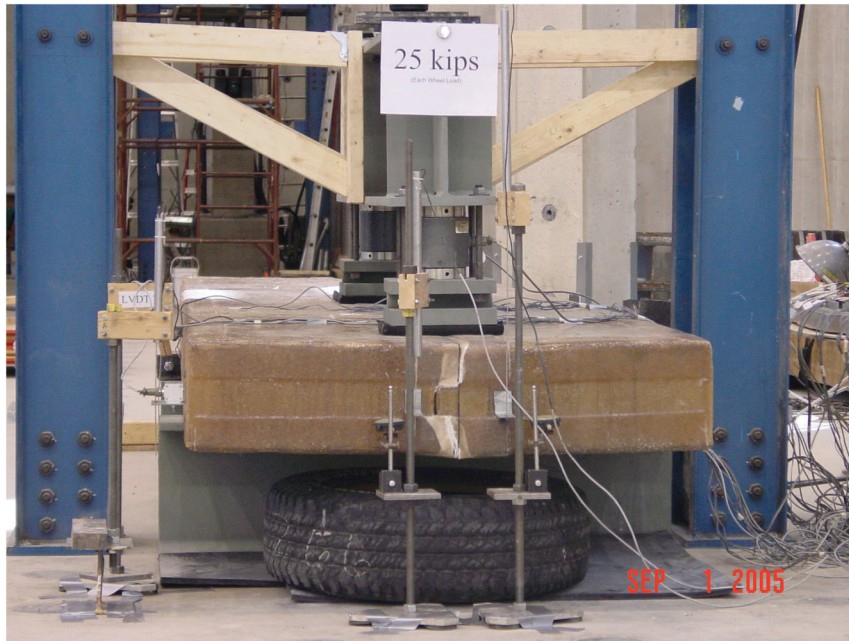
Figure 4.14: Longitudinal Joint Damage at Overhang at 50-kips Total Load – KSCI #P1a Test

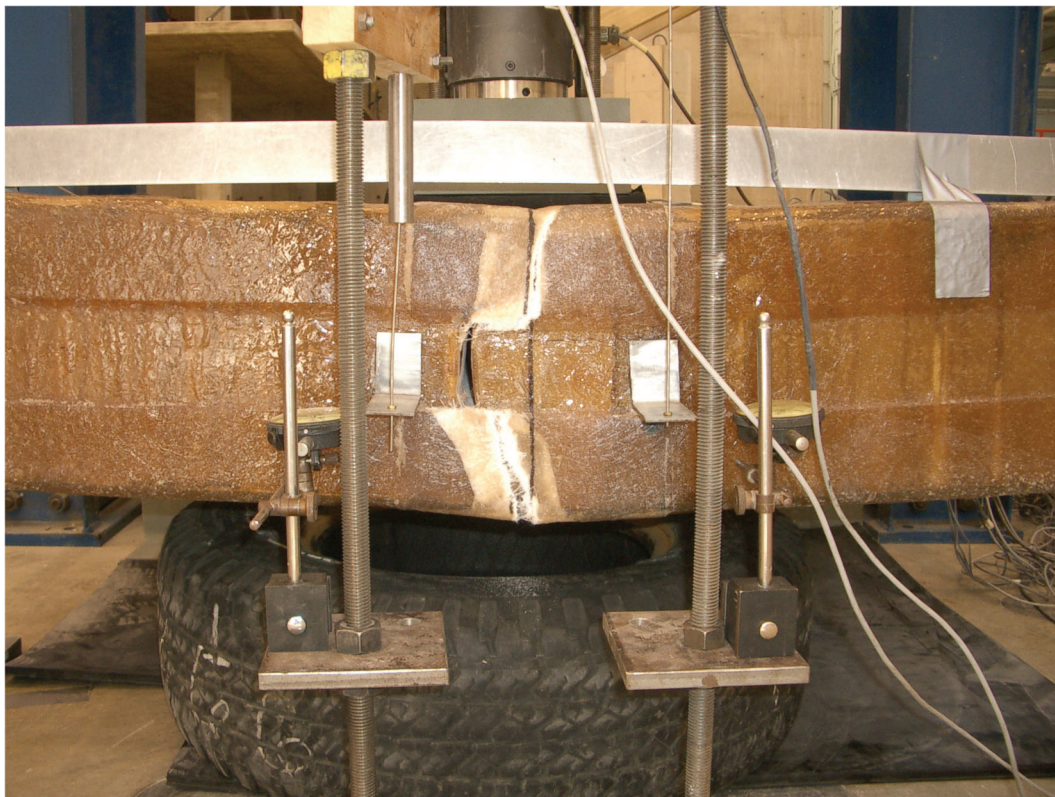
Figure 4.15: View of Longitudinal Joint Damage at Overhang – KSCI #P1a Test

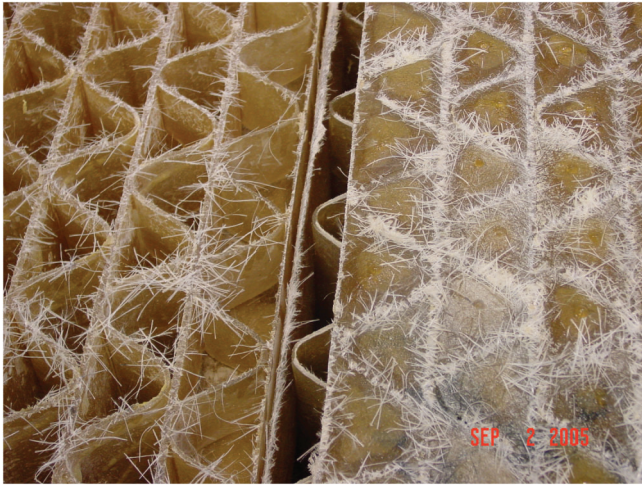
Figure 4.16: View of Longitudinal Joint; Top Plate Removed – KSCI #P1a Test

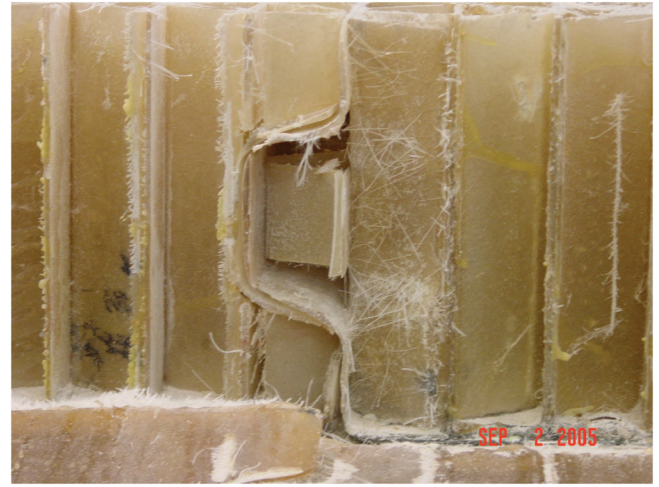
Figure 4.17: View of Longitudinal Joint; Side Removed, Showing Voids – KSCI #P1a Test

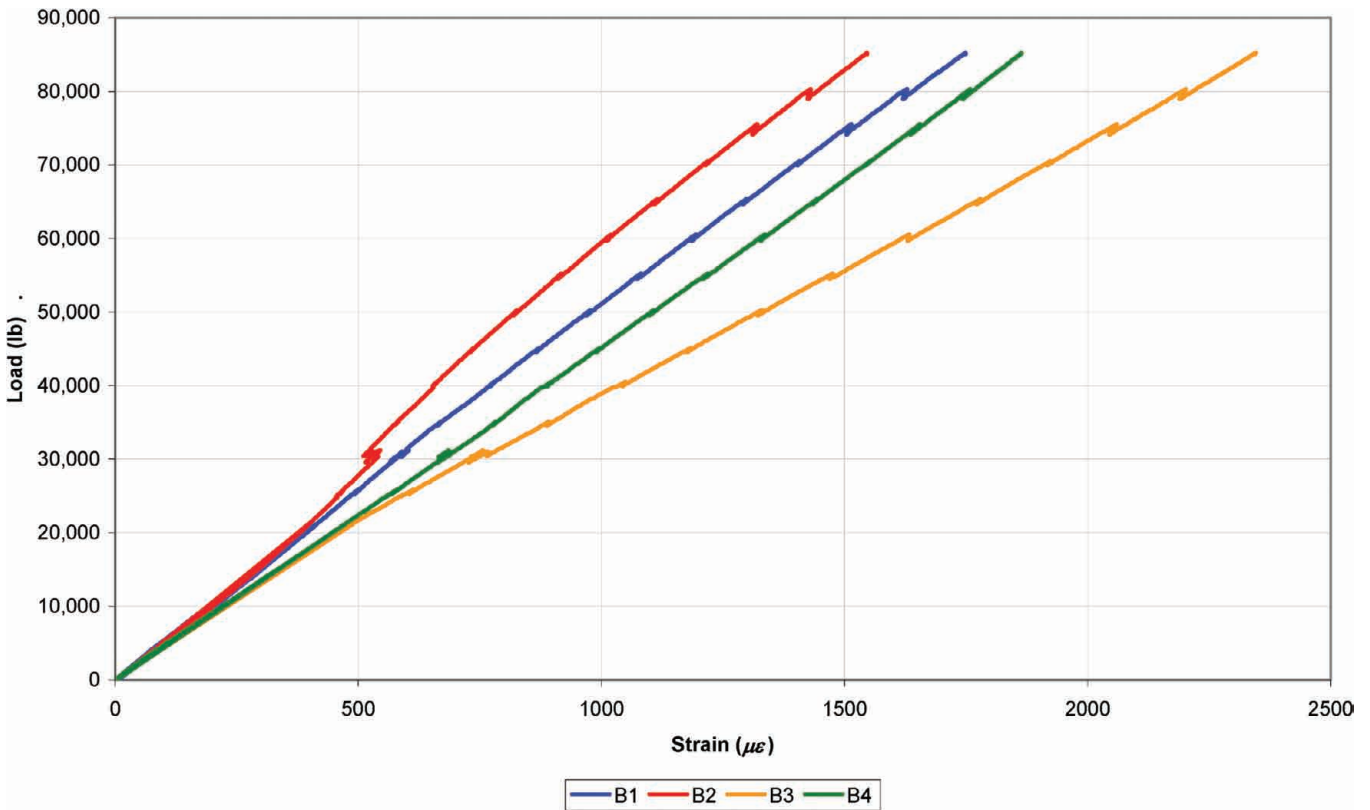
Figure 4.18: Bottom Panel Longitudinal Strains – KSCI #P1b Test

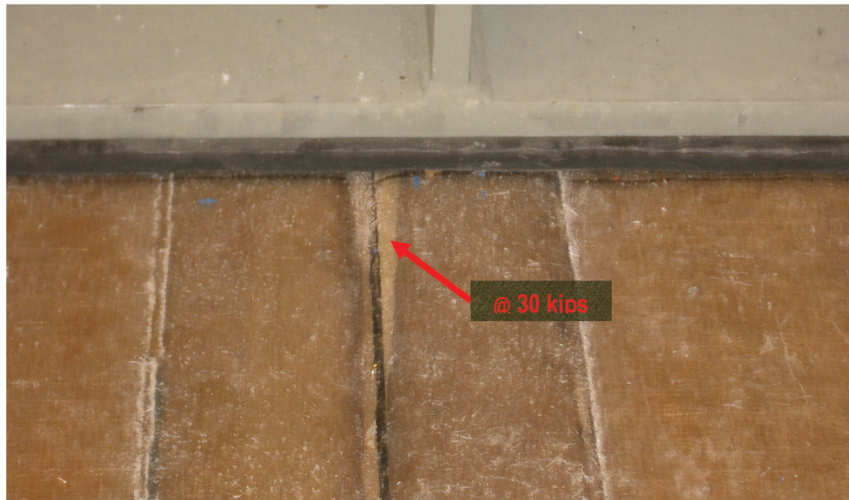
Figure 4.19: KSCI #P1b Test Specimen Damage at Longitudinal Joint Under Loading Beam

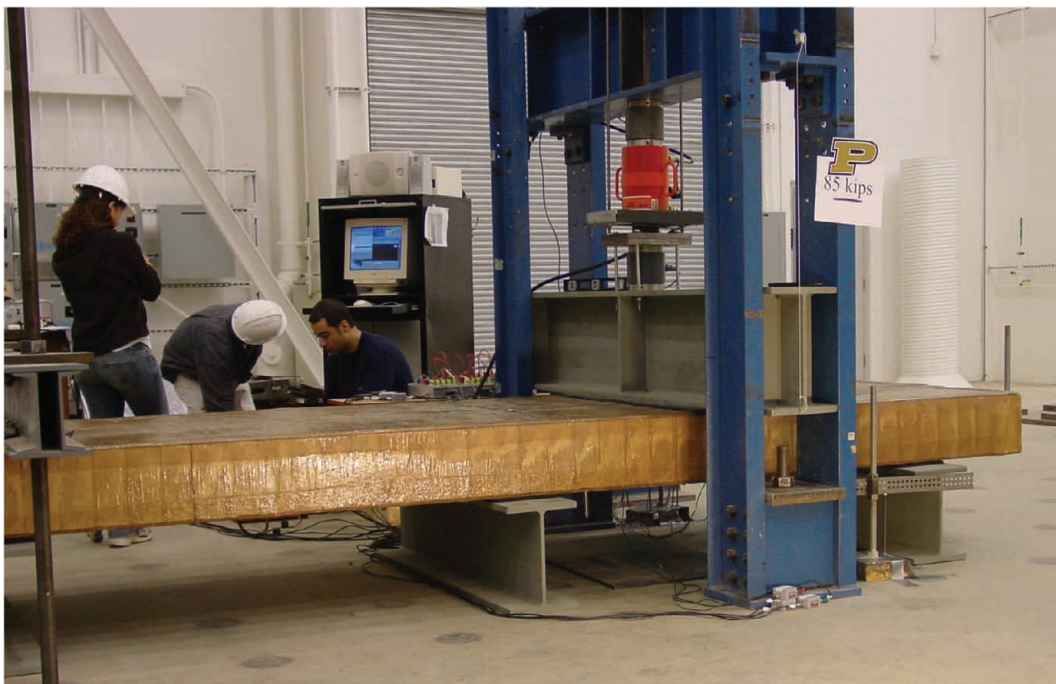
Figure 4.20: KSCI #P1b Test Specimen at Maximum Applied Load

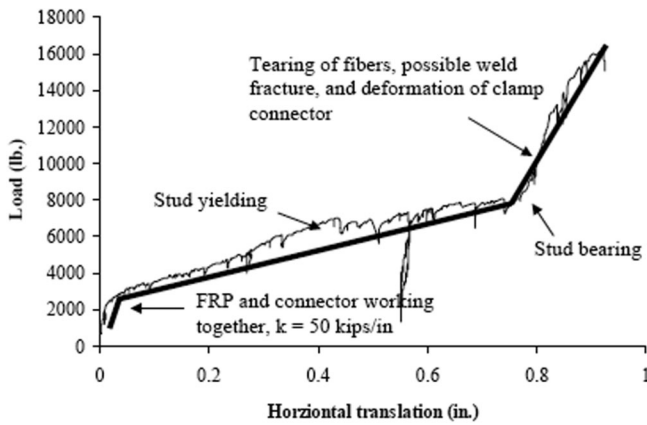
Figure 4.24: Experimental Load-Horizontal Translation

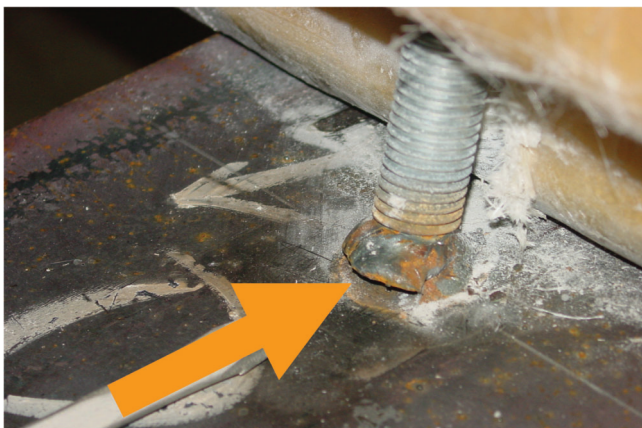
Figure 4.25: Detail of the Stud Connector After Test

indicates that the connection had infinite stiffness until it started taking the load. Then, the shear stud started bending elastically, indicating that both FRP specimen and connector were working together. After this stage, the stud started yielding, followed by the bearing of the stud and possibly the clamp plate, causing tearing of FRP fibers, possible rupture of the base weld, and deformation of clamp plate. This last stage indicated failure of the deck-to-girder connection, although the specimen continued to take load. Figure 4.25 shows a

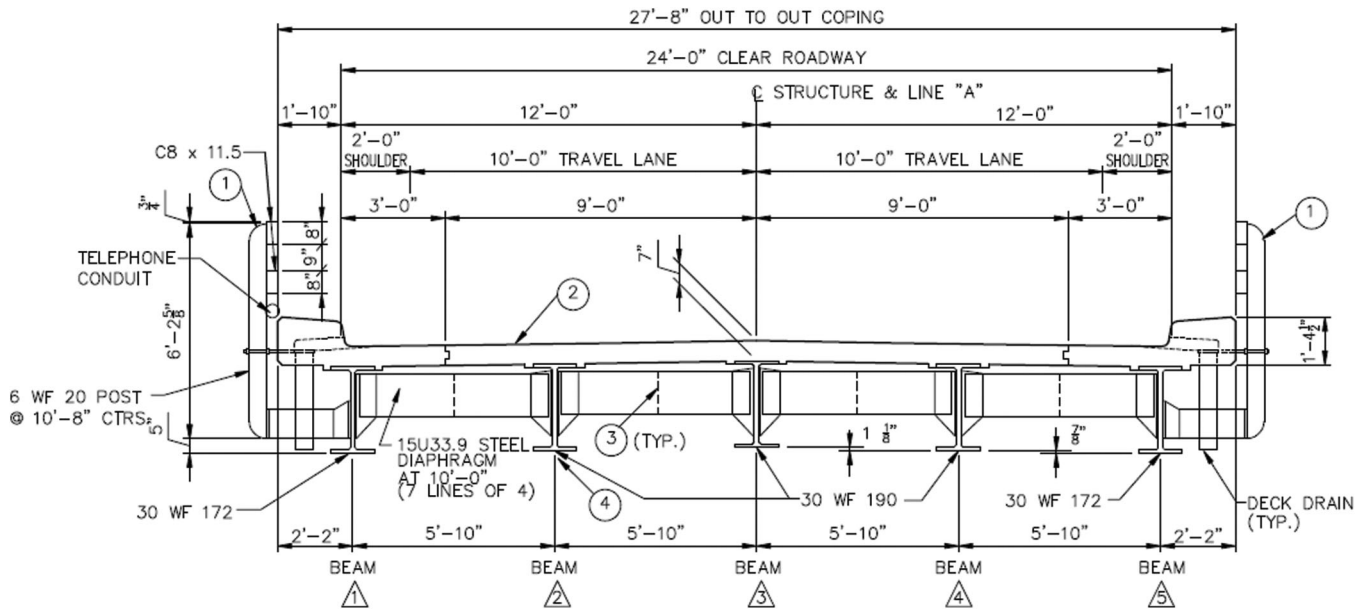
Figure 5.1: Existing Sugar Creek Bridge Cross Section

The deck rehabilitation maintained the existing 2% cross-slope. This cross-slope presented a unique challenge in that the structure required a crown connection in the ZellComp deck that had never been used before. This cross-slope was achieved with grouted haunches at each of the girders (Figure 5.3). The FRP deck panels were to be laid across those haunches; shear studs in grouted pockets secured the panels to the girders

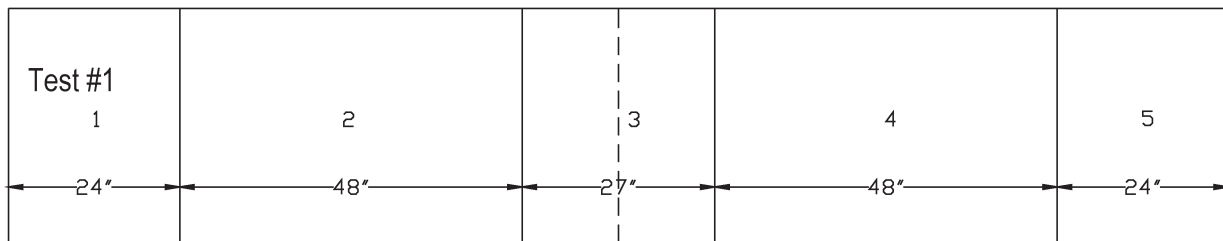
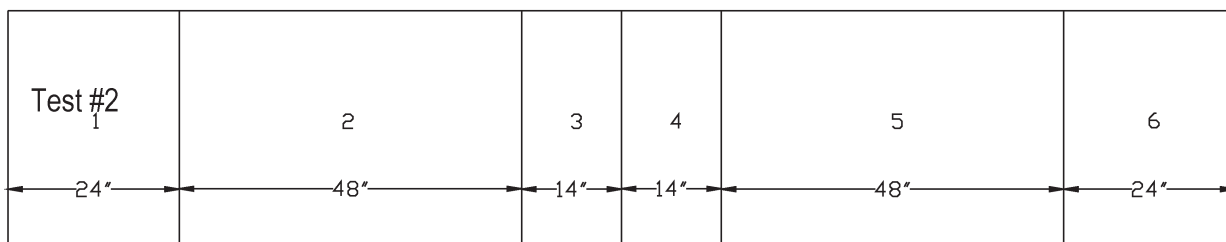
Figure 5.11: Layout of Top Plates

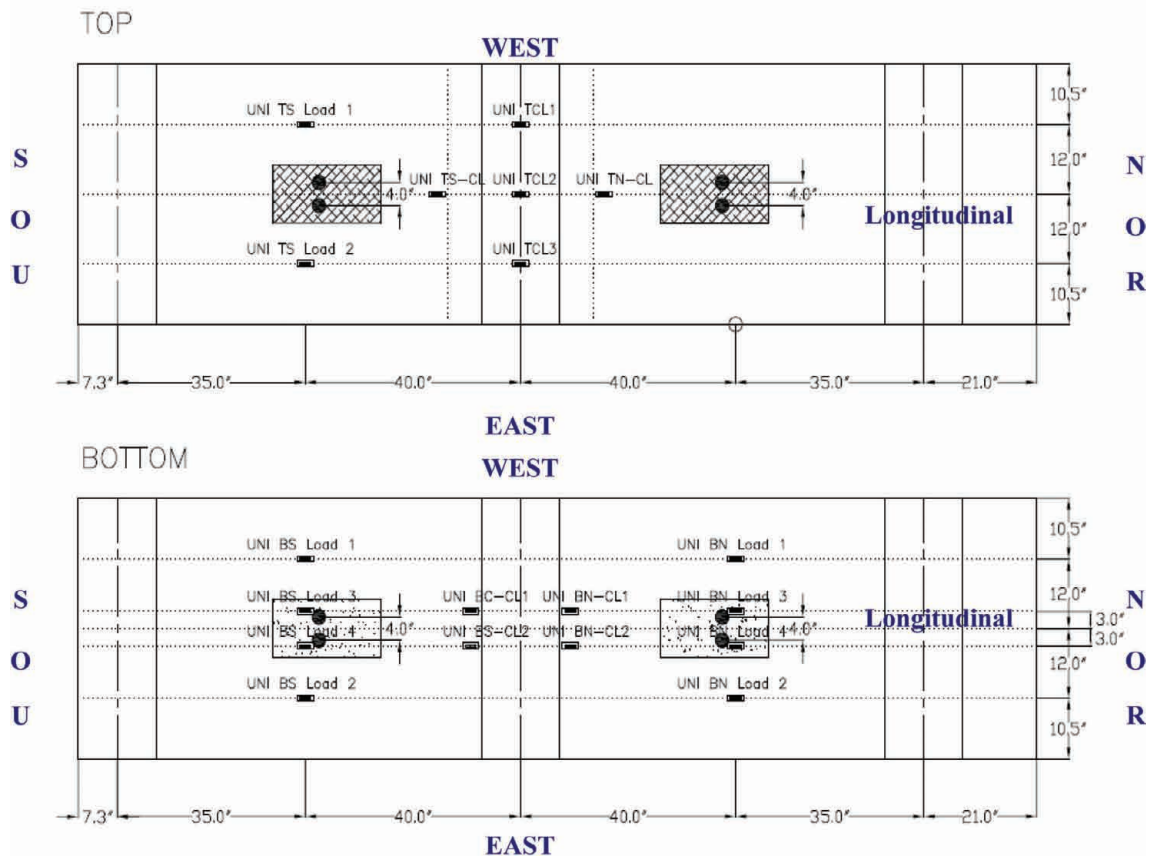
Figure 5.15: Instrumentation Plan

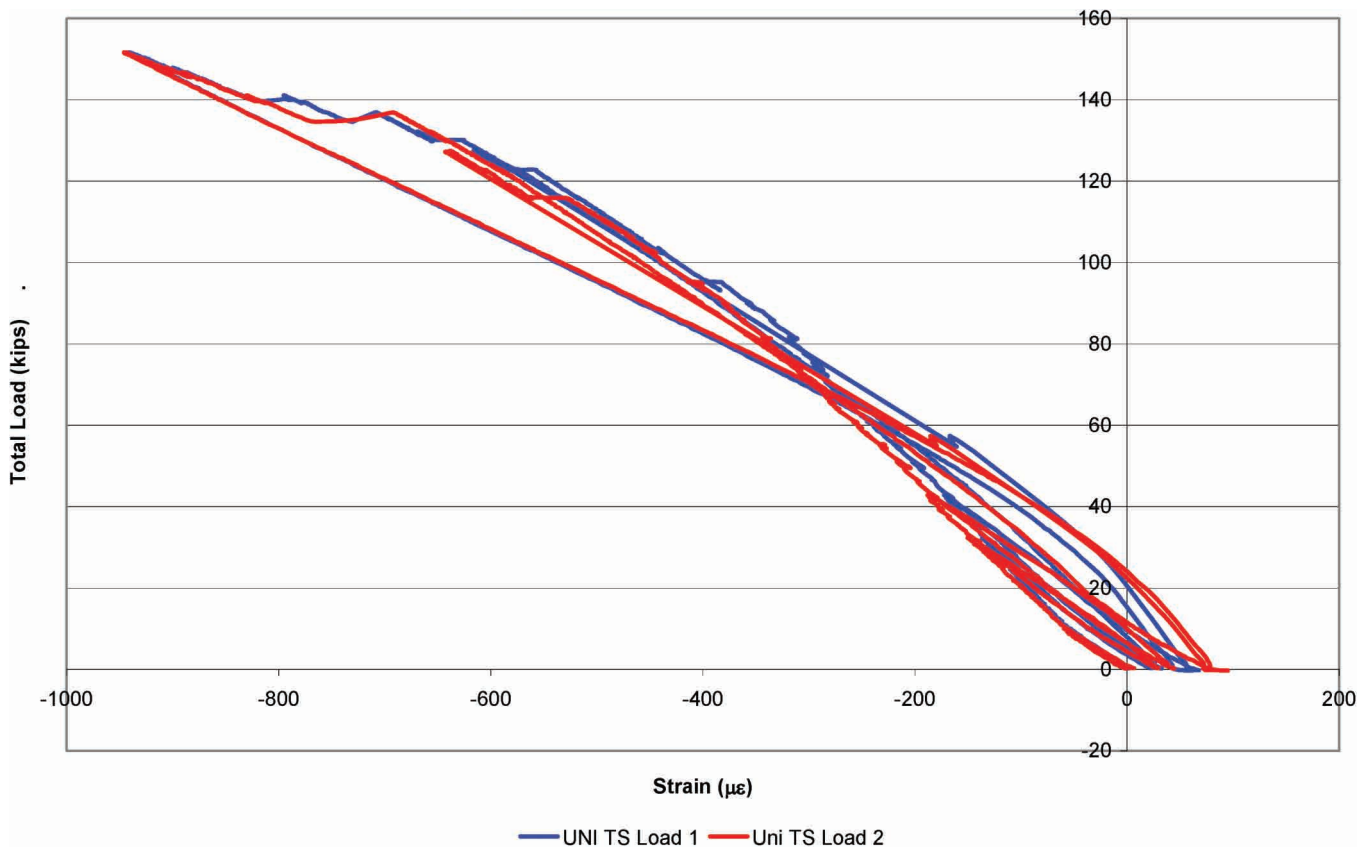
Figure 5.17: TS Load 1 & TS Load 2 vs Total Load

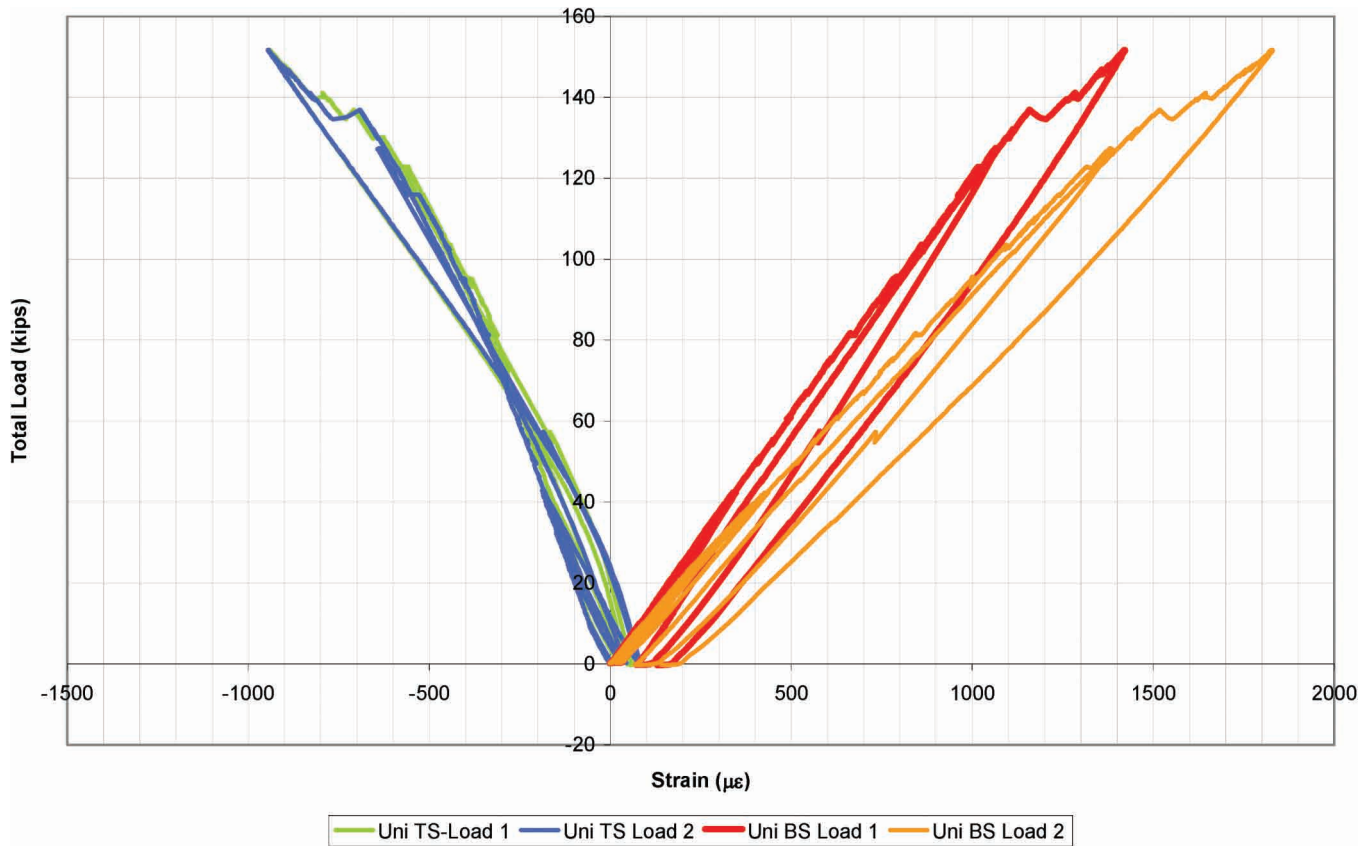
Figure 5.21: TS Load 1,2 & BS Load 1,2 vs Total Load

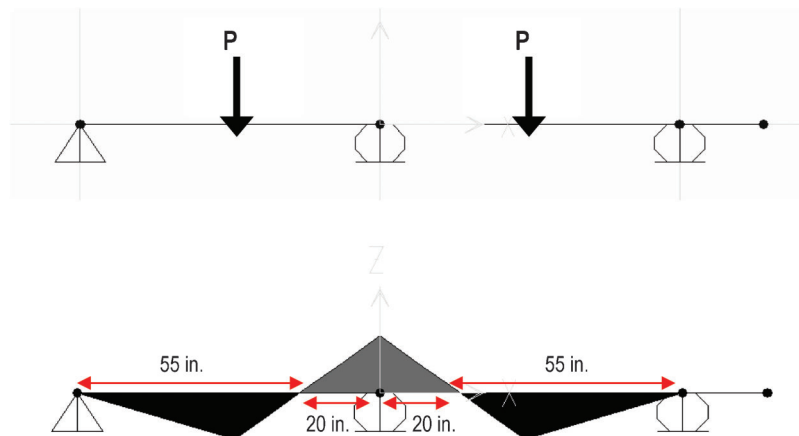
Figure 5.22: SAP 2000 Inflection Point Analysis

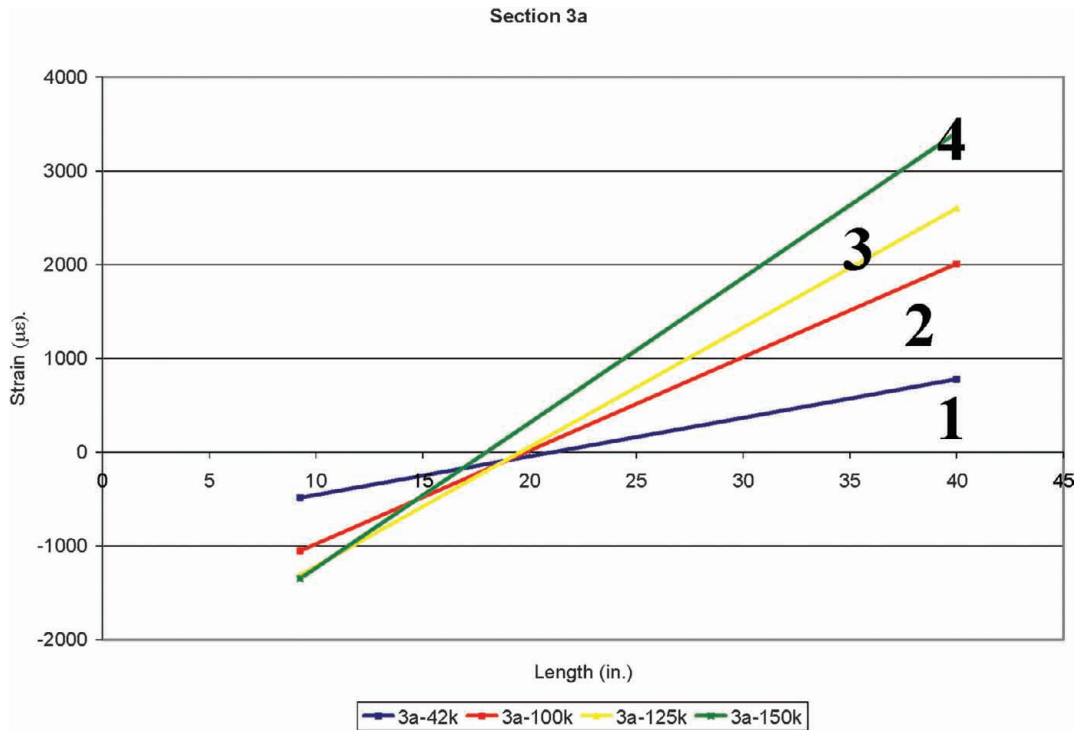
Figure 5.24: Strain vs. Length (Section 3a)

Figure 5.24 through Figure 5.27 show the plots that detail the measured strain vs. length (or locations along the deck) for each of the sections described above. Four different lines represent the strain measured at each load cycle, and their intercept in y-axis is the location of the inflection point at the respective load cycle. In other words, where all gages measure close to zero strain corresponds to the location of zero moment. Line #1 represents the load cycle with a total load of 42 kips, line #2 the one with a total load of 100 kips, line #3 the cycle with a maximum total load of 125 kips, and line #4 is the one that represents the strains during the cycle that had a maximum total load of 150 kips. All plots showed that the inflection point did not change much as higher loads were applied, and that it did not move after the top plate cracked. The average inflection point

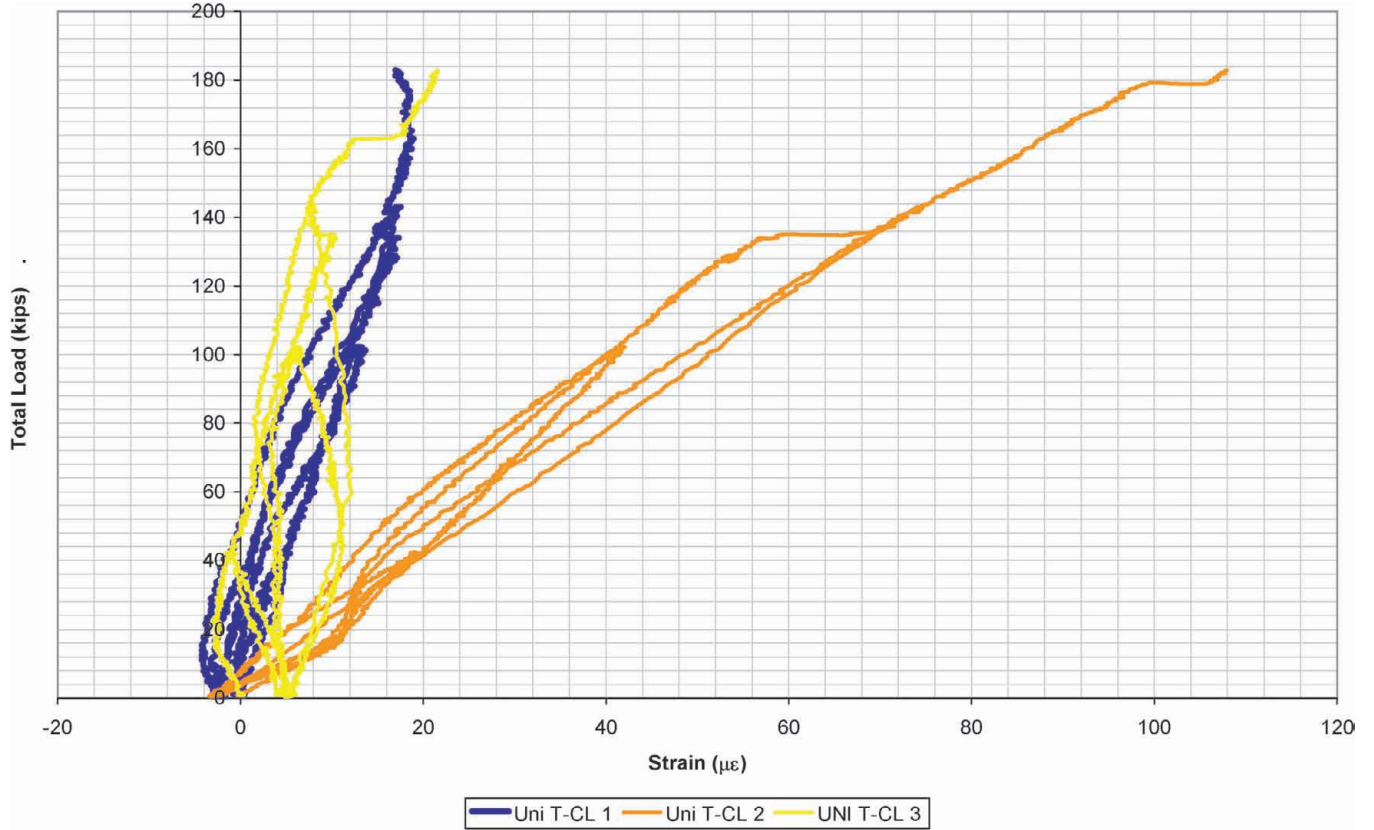
Figure 5.30: T-CL 1, T-CL 2 & T-CL 3 vs Total Load

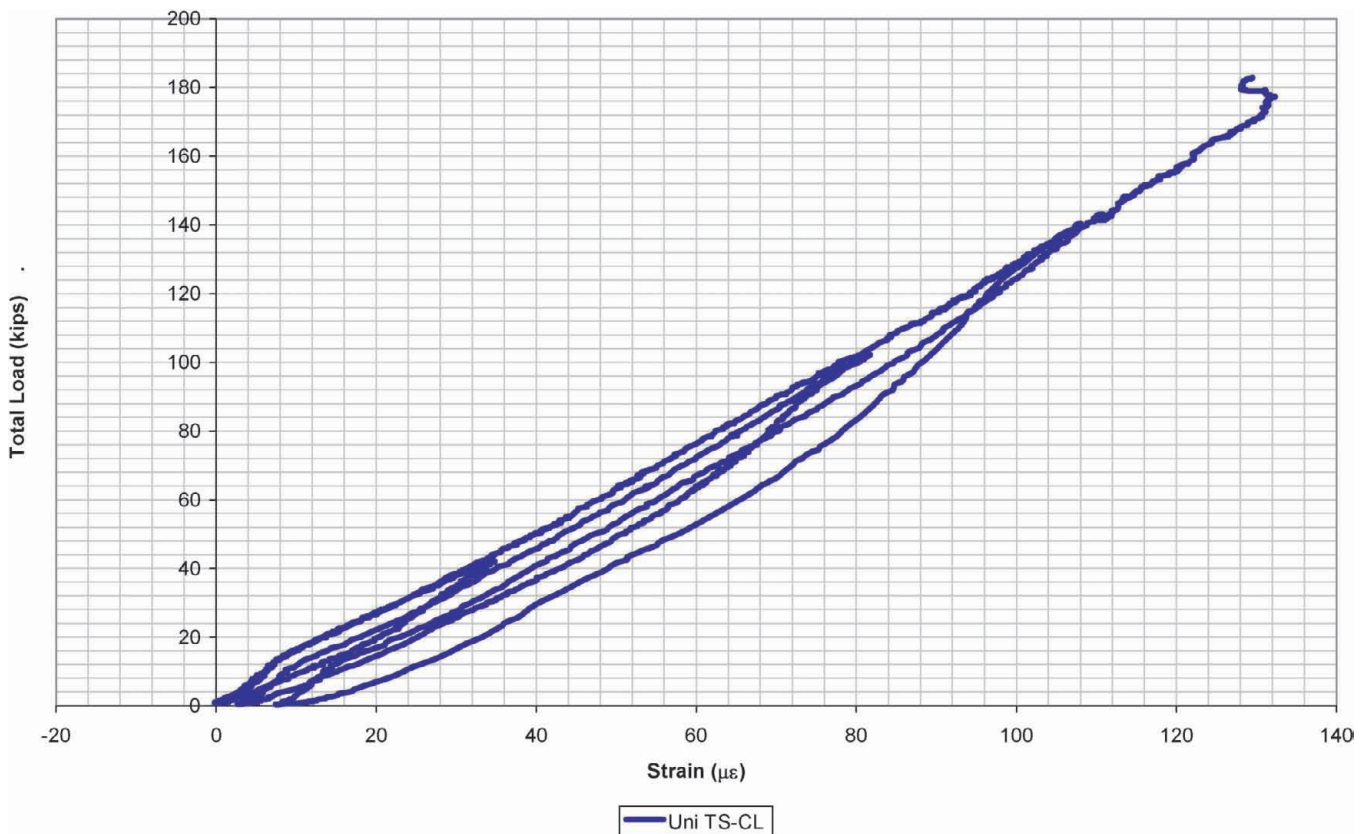
Figure 5.31: TS-CL & TN-CL vs Total Load

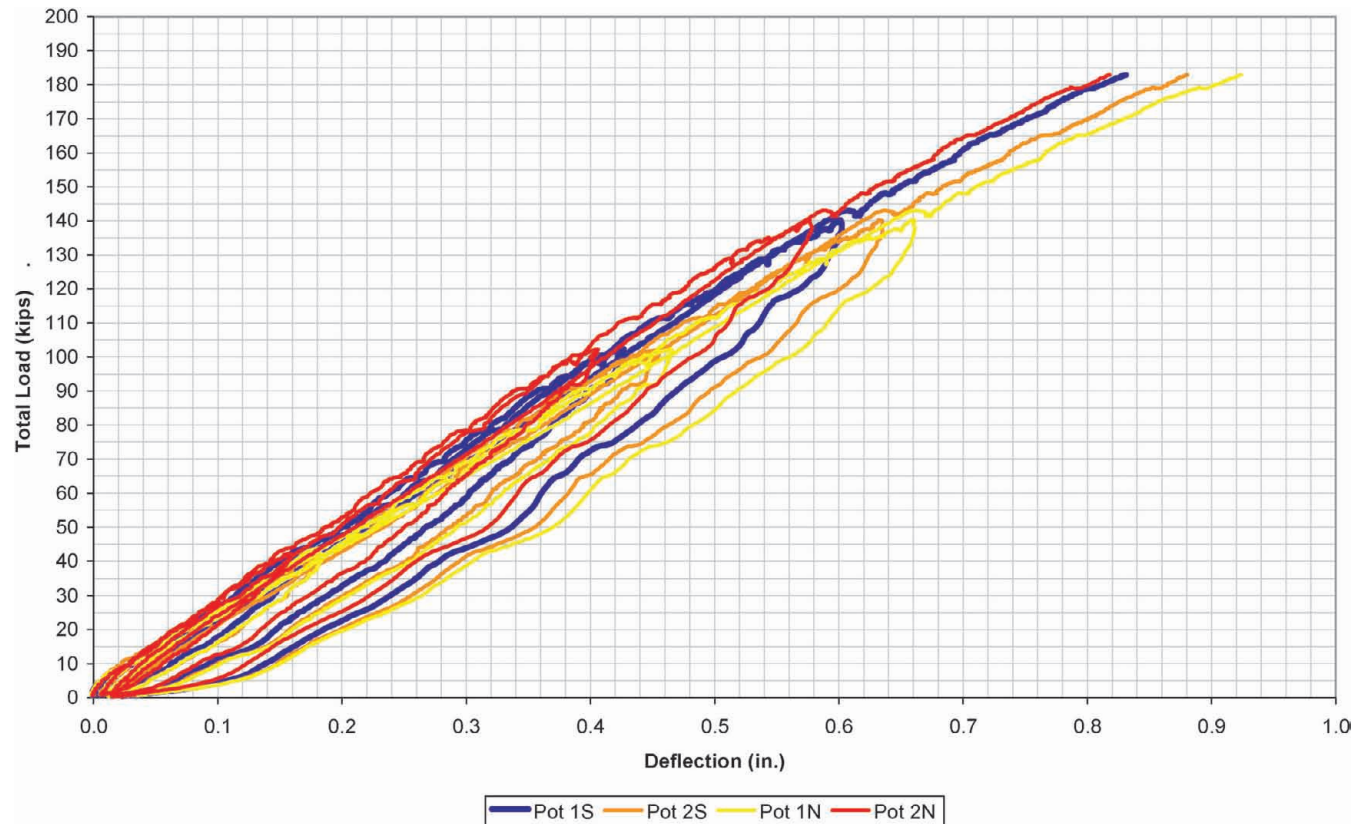
Figure 5.36: Deflection vs. Total Load

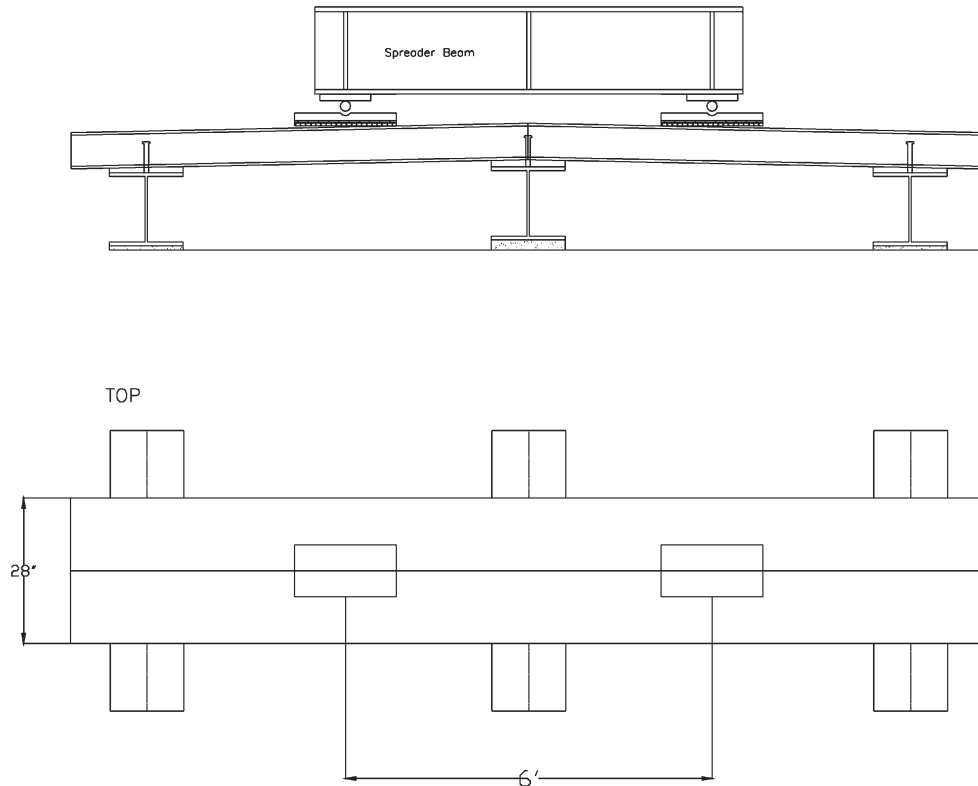
Figure 5.37: Loading for Wearing Surface Test

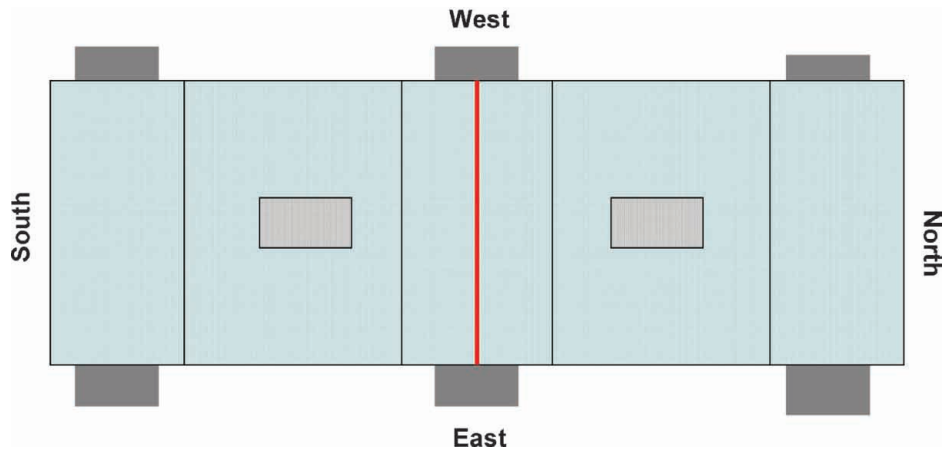
Figure 5.38: Placement of Top Plates in Wearing Surface Specimen

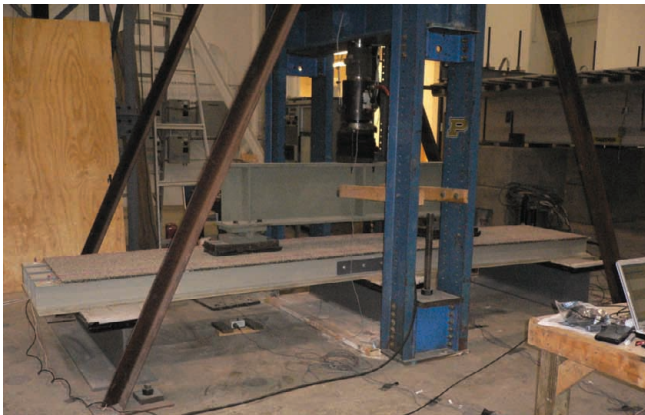
Figure 5.39: Wearing Surface Specimen in Loading Frame

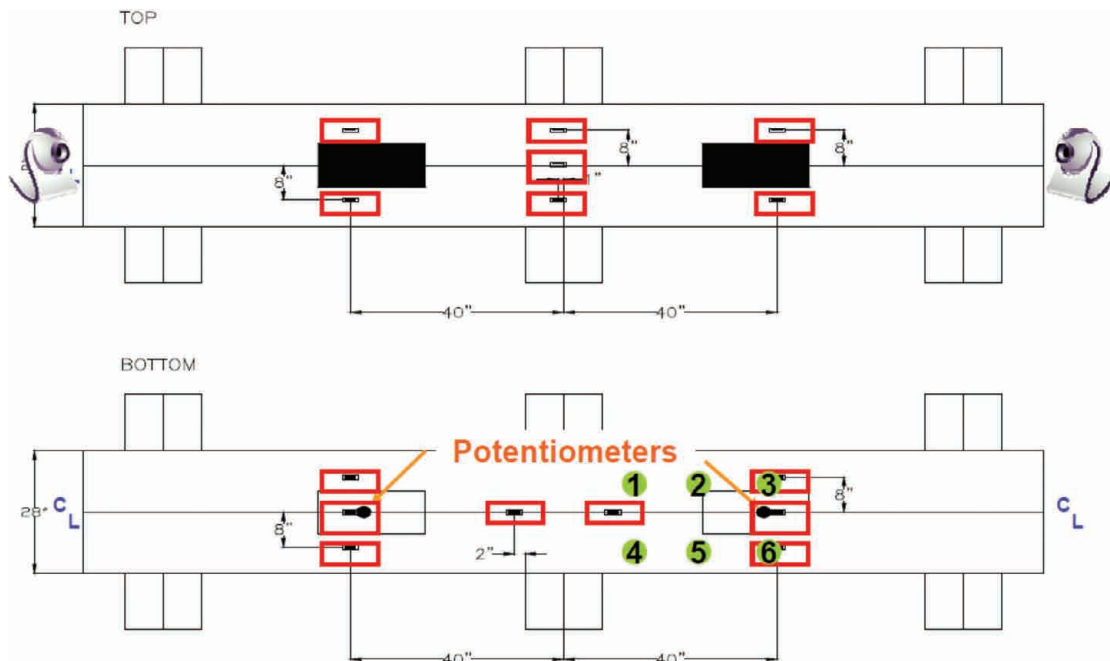
Figure 5.40: Instrumentation of Wearing Surface Specimen

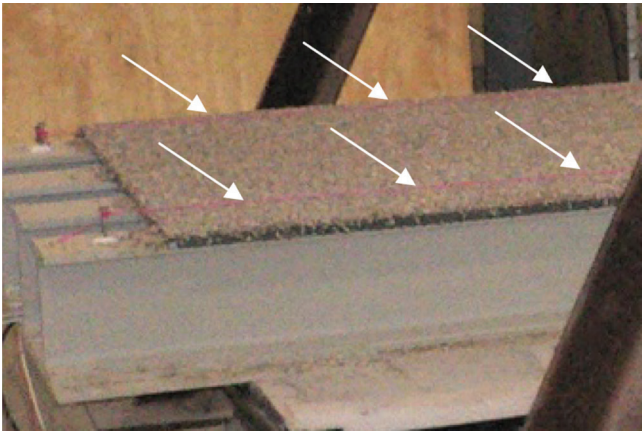
Figure 5.41: Reference String Lines on Both Sides of Wearing Surface Specimen

Also, string lines were attached to each side of the deck, following the 2% cross-slope, so that any vertical ‘dishing’ deformations of the deck would be more easily identified and compared to the original,
