JOINT TRANSPORTATION RESEARCH PROGRAM

FIBER REINFORCED POLYMER BRIDGE DECKS

Report Number: FHWA/IN/JTRP-2011/04

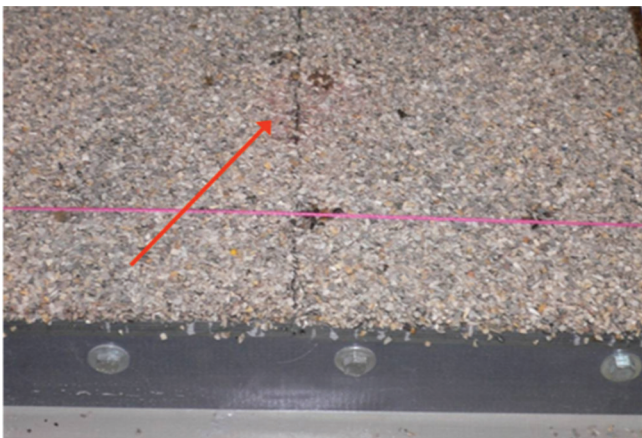
Figure 5.42: Crown Connection Crack in Wearing Surface

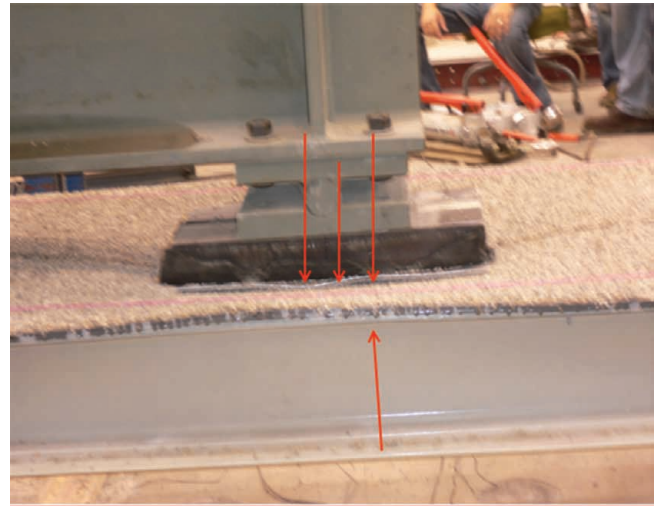
Figure 5.43: Dishing Deformation at the Load Patch

Meanwhile, despite severe deformations and dishing of the wearing surface at the load patches and top plates, the deck top plates performed well, and no cracks were observed at any other locations in the wearing surface. An example of the severe dishing at the load patches is shown in Figure 5.43; the dishing was so severe that an upwards deformation was observed at the edge of the deck specimen. The upwards deformation of the top plate at the edge was believed to be a result of the boundary conditions for this specimen,

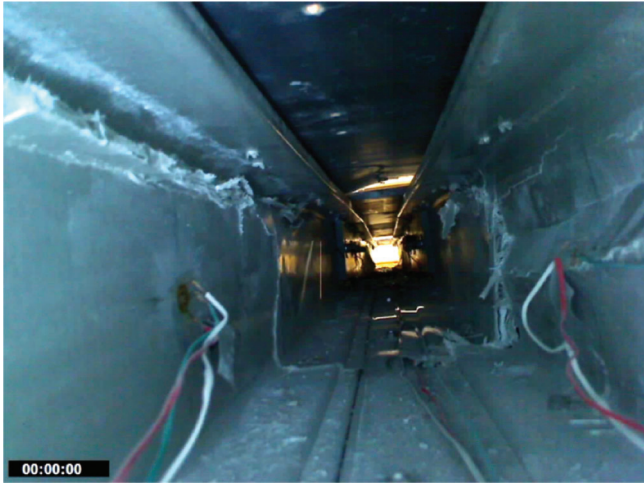
Figure 5.45: Damage to Deck Webs Under Load Patch

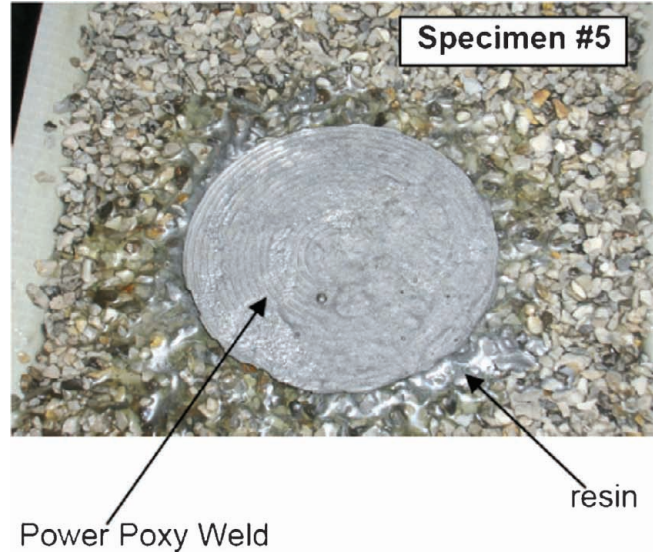
Figure 5.47: Failure of Steel Disk to Wearing Surface in Test Specimen #5

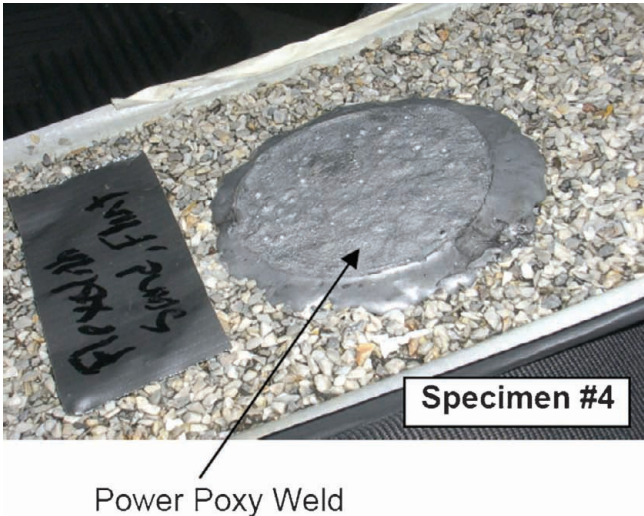
Figure 5.46: Failure of Steel Disk to Wearing Surface in Test Specimen #4

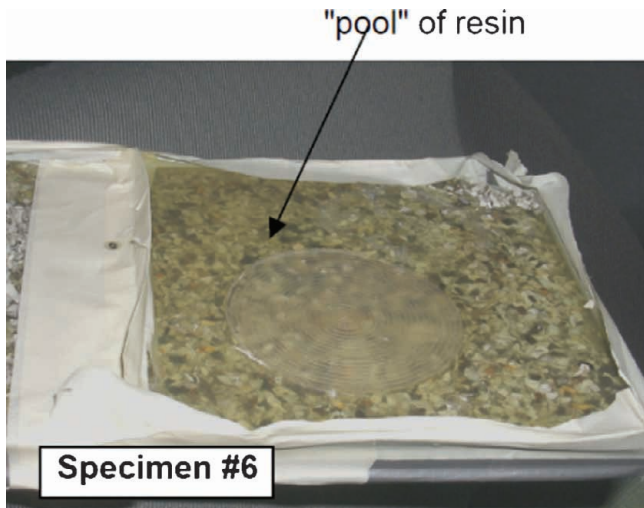
Figure 5.48: Failure of Steel Disk to Wearing Surface in Test Specimen #6

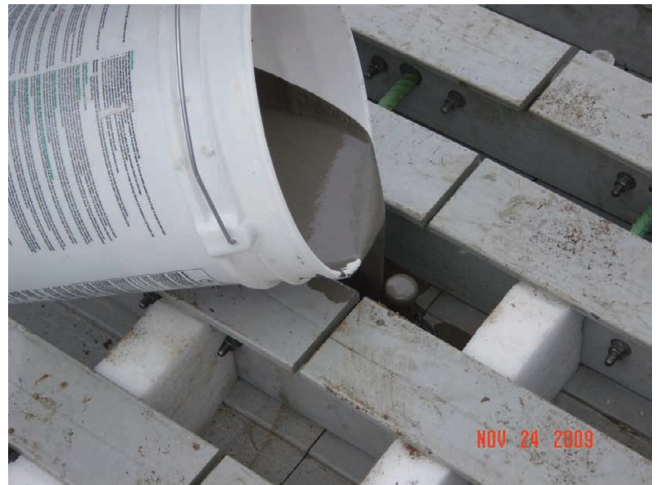
Figure 5.60: Placement of Grout in Shear Stud Grout Pocket

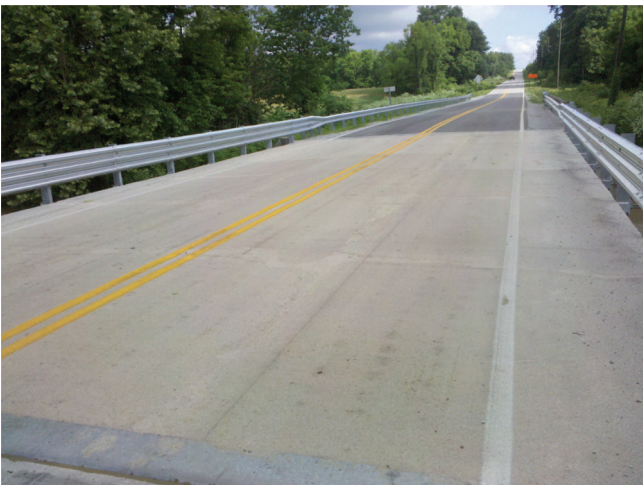
Figure 5.64: Finished Bridge with Wearing Surface and Guardrails

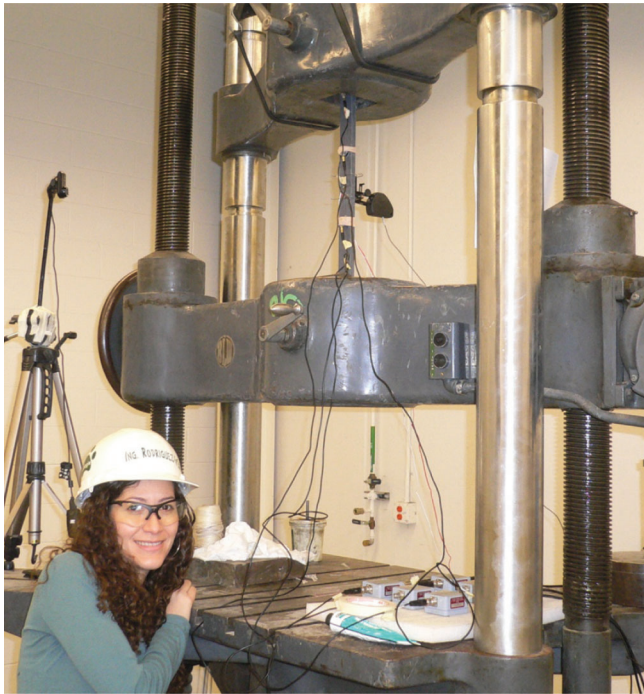
Figure 6.6: Acoustic Emission Test on Tension Coupon

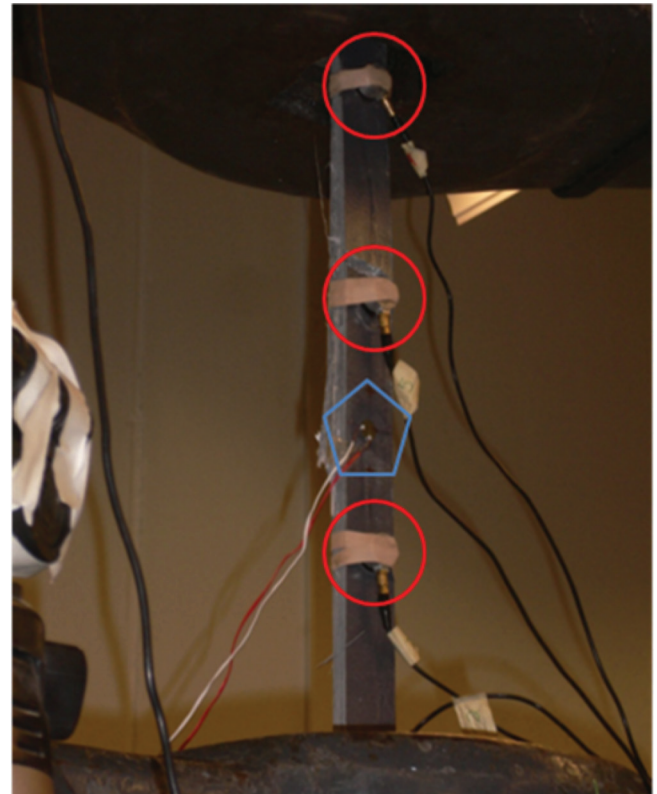
Figure 6.7: Acoustic Emission Sensor Locations (Circles) on Tension Coupon

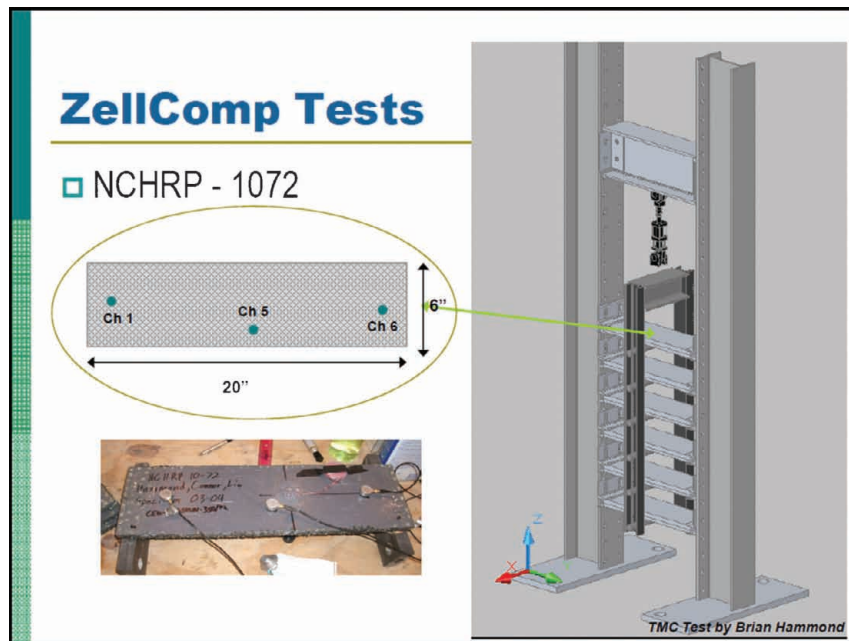
Figure 6.13: Acoustic Emission Sensors on NCHRP Wearing Surface Specimens

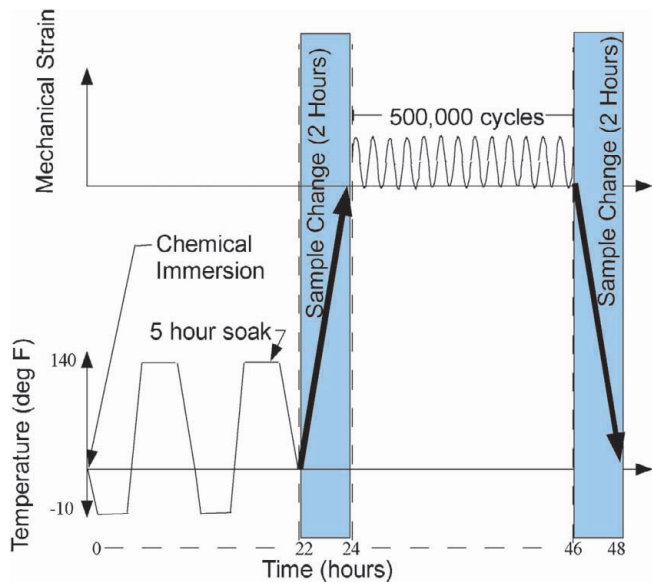
Figure 6.14: NCHRP Wearing Surface Specimen Load Cycle

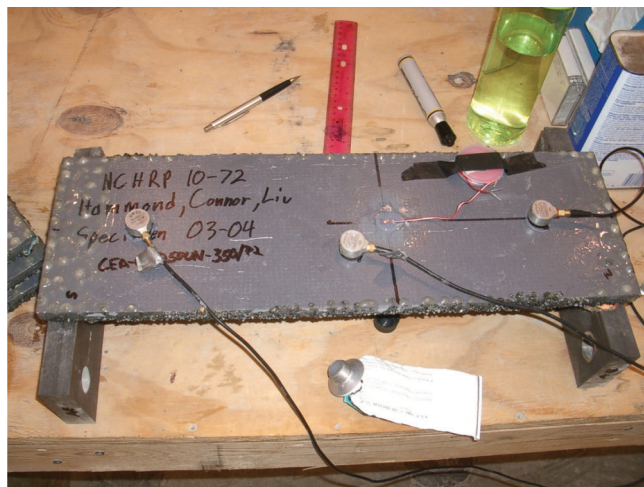
Figure 6.15: NCHRP Wearing Surface Specimen With Acoustic Emission Sensors

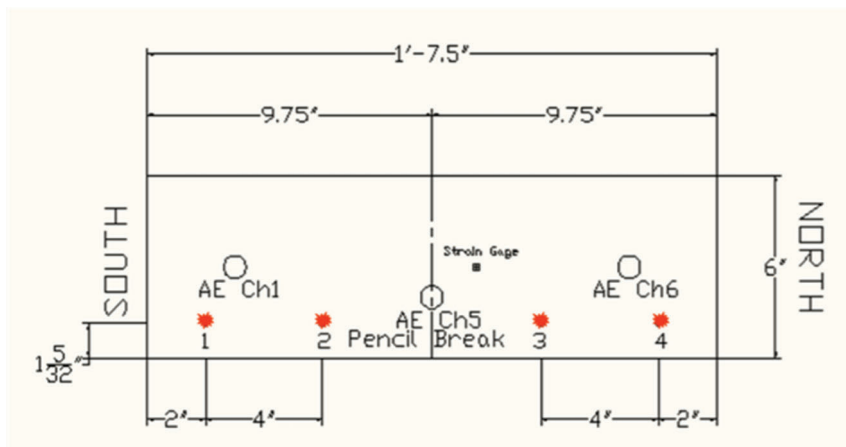
Figure 6.16: NCHRP Wearing Surface Specimen With Acoustic Emission Sensor Locations and Pencil Break Locations

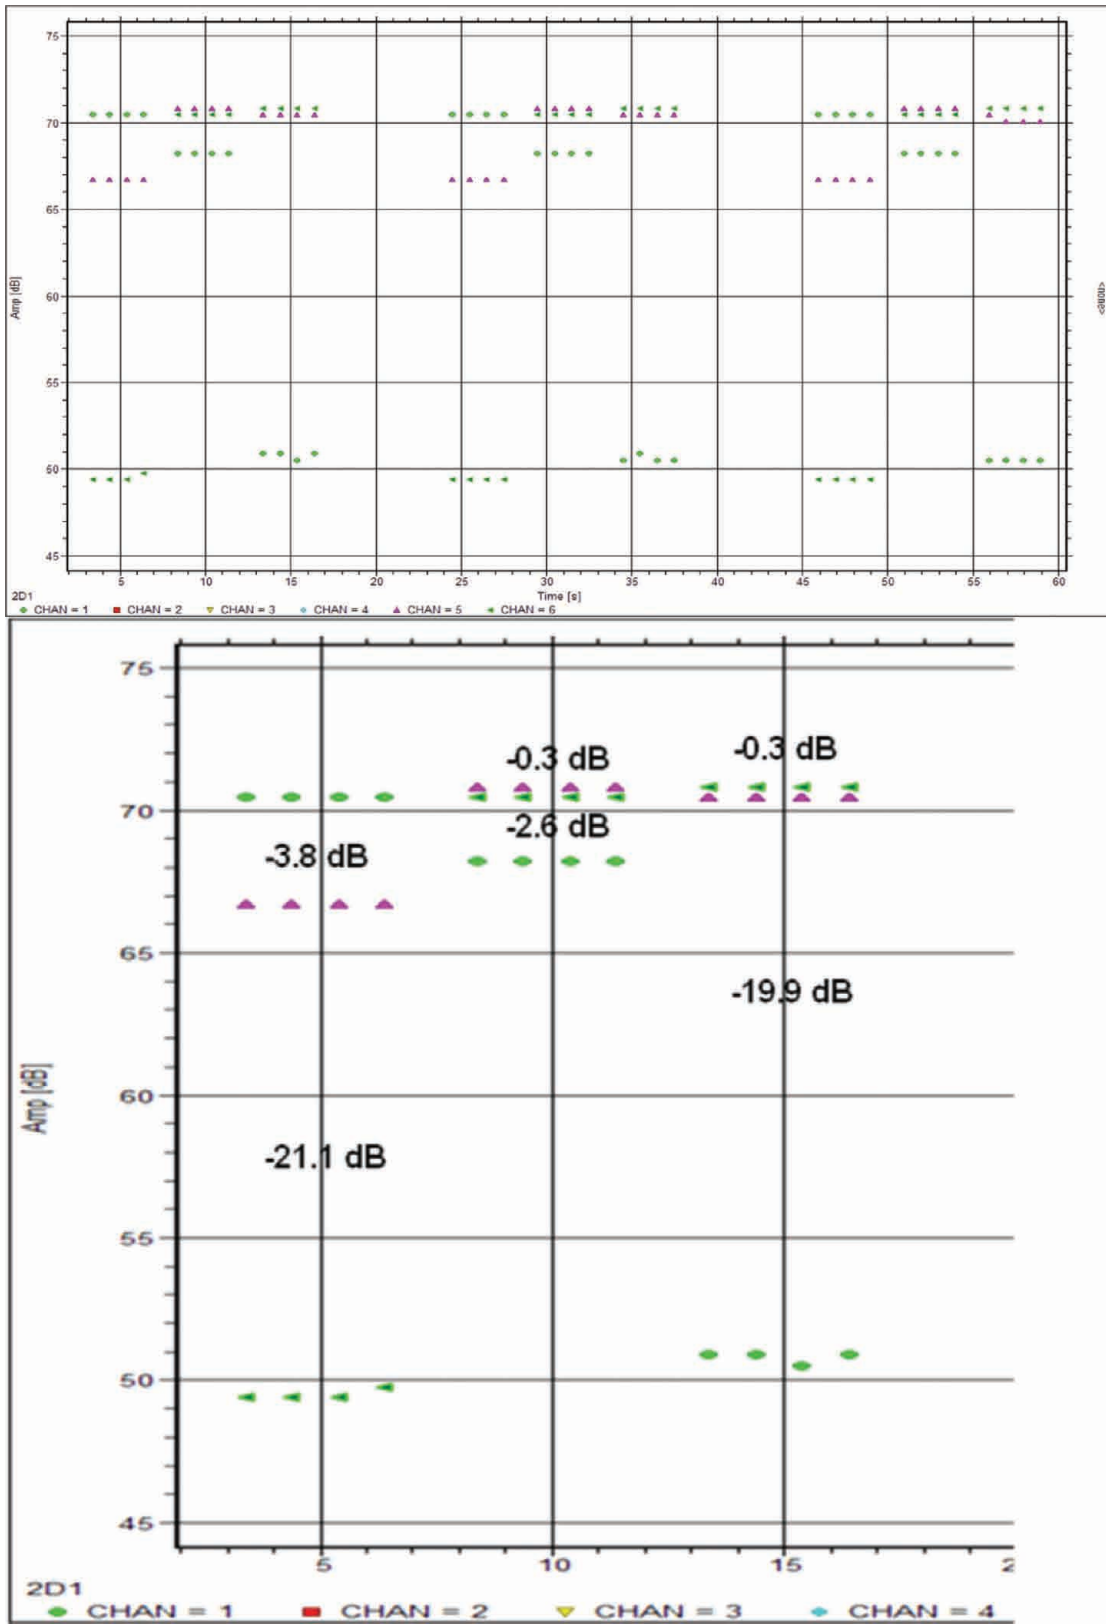
Figure 6.17: NCHRP Wearing Surface Specimen Acoustic Emission Amplitudes After 12 Load Cycles

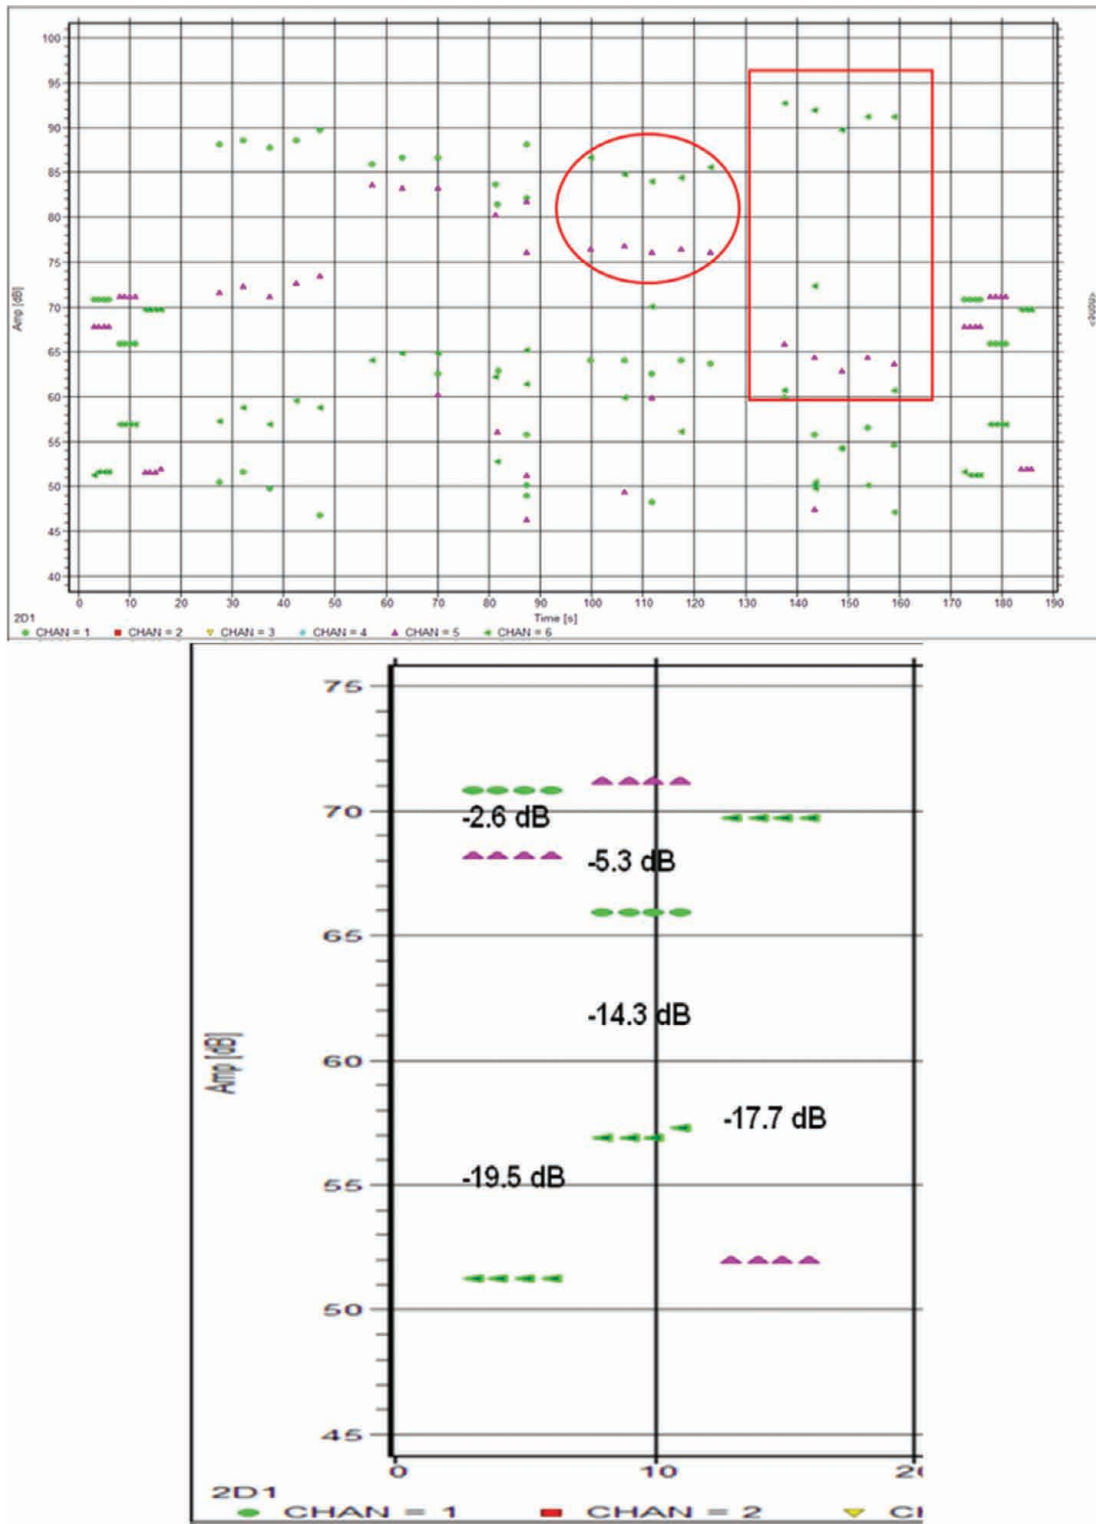
Figure 6.18: NCHRP Wearing Surface Specimen Acoustic Emission Amplitudes After 23 Load Cycles

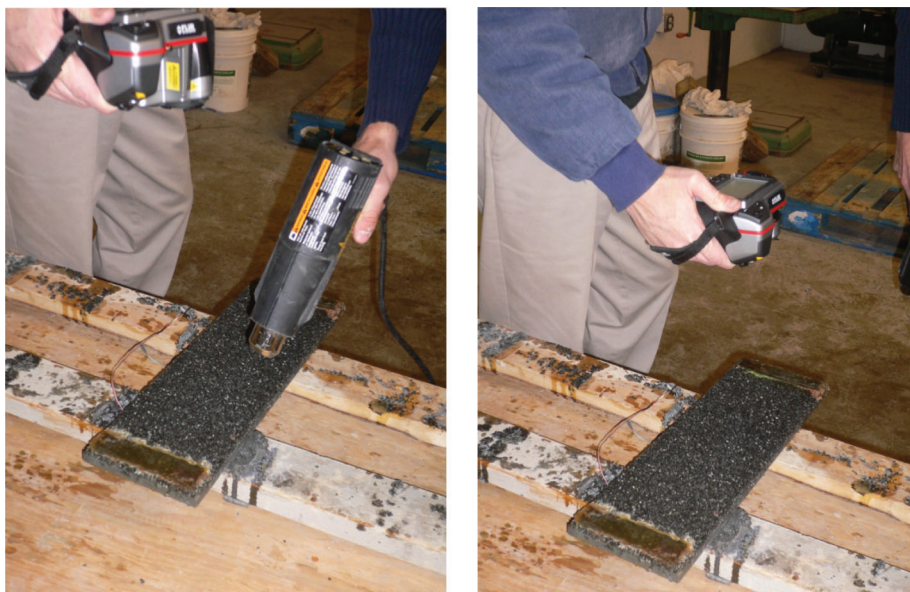
Figure 6.19: Heating Specimen (Left) and Taking Image with Thermographic Camera (Right)

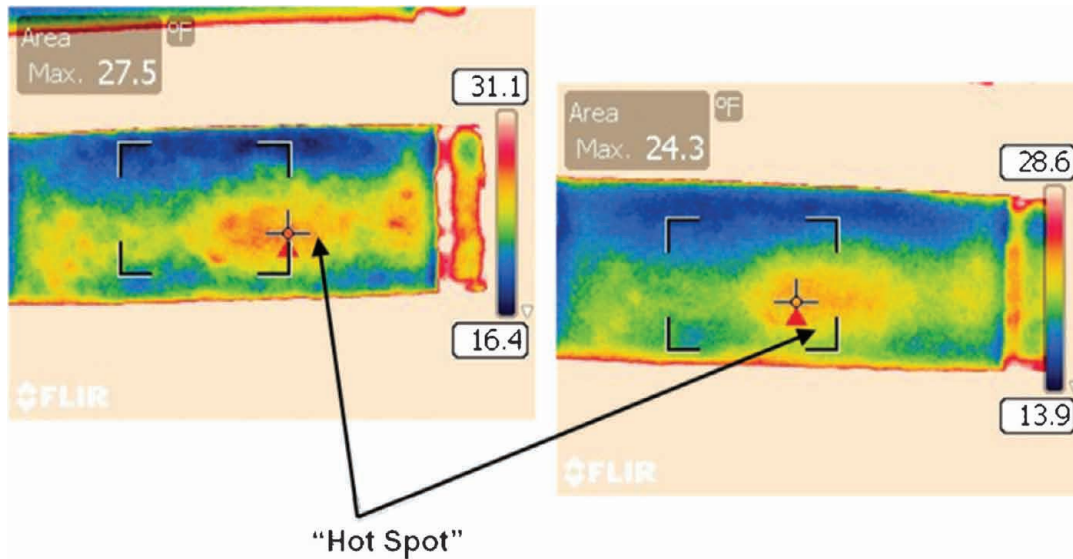
Figure 6.20: “Hot Spot” at Delamination Captured by Thermographic Camera

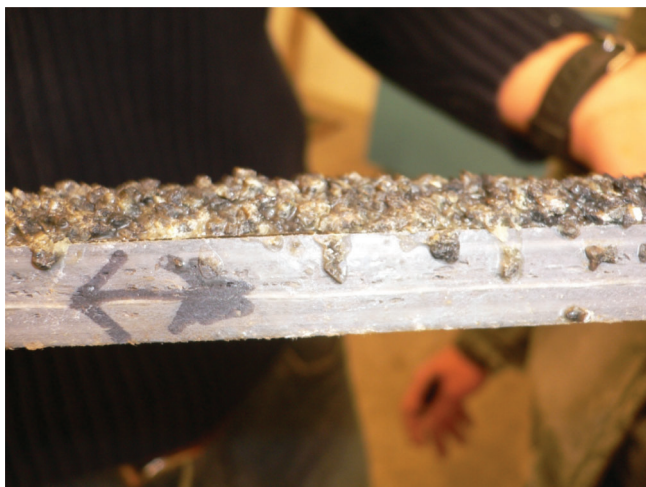
Figure 6.21: Delamination Between Wearing Surface and FRP Plate

- Infrared thermography also appeared to be promising for identifying delamination between the wearing surface and the FRP top plate. However, use of the infrared thermographic camera would also be labor intensive, requiring heating of small sections of deck at a time and then quickly taking the thermographic image. Furthermore, results would show variability with amount of heating and cooling before the image is acquired.

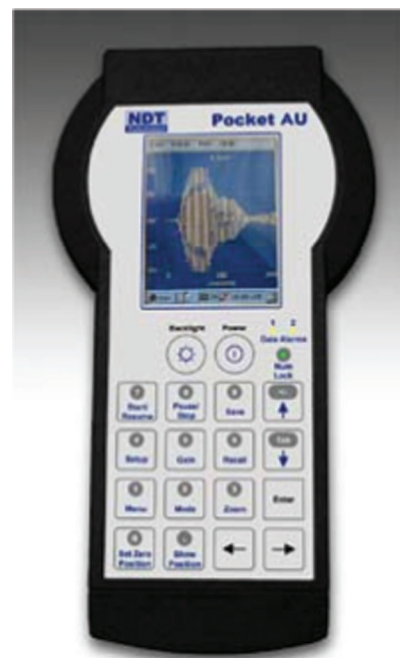
Figure 6.22: Pocket Acousto-Ultrasonic Device

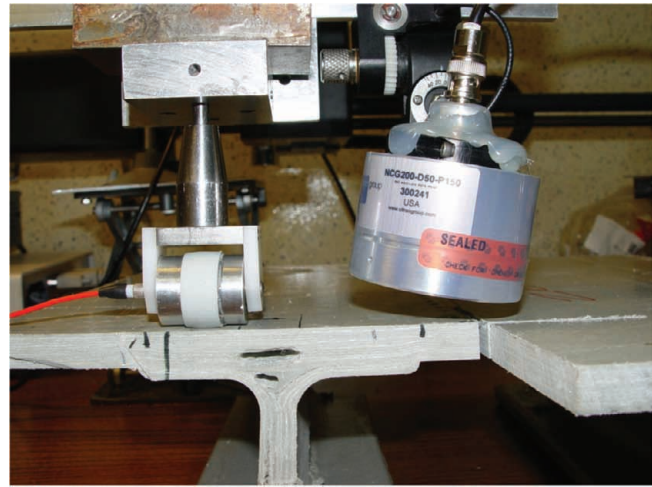
Figure 6.27: Acoustic-Ultrasonic Pulsar and Receiver Set-Up To Test Detection of Simulated Delamination in Flange of ZellComp Deck Section

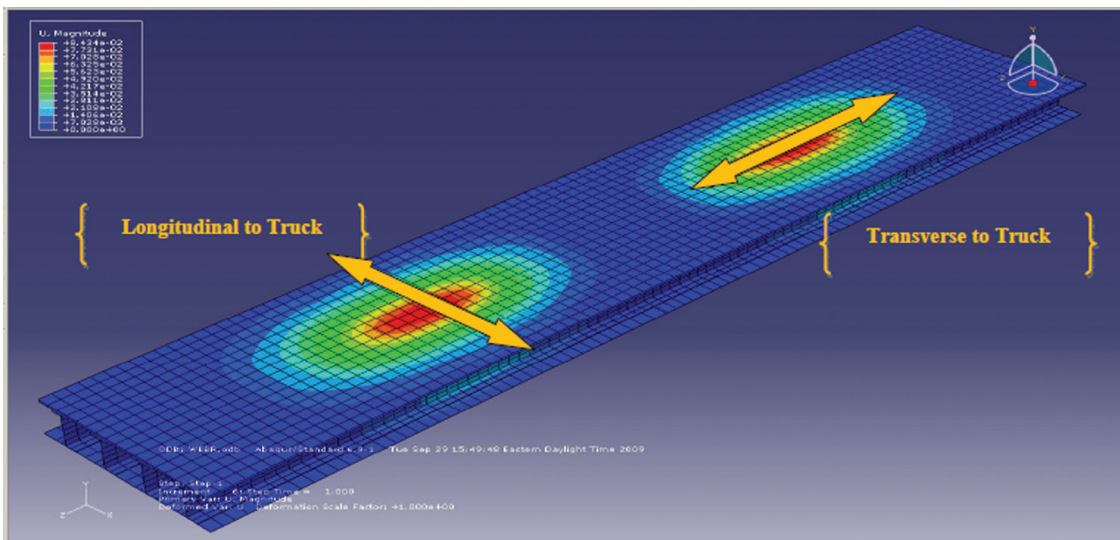
Figure 6.28: ABAQUS Analysis of FRP Top Plate Deflections Longitudinal and Transverse to Truck Travel Direction

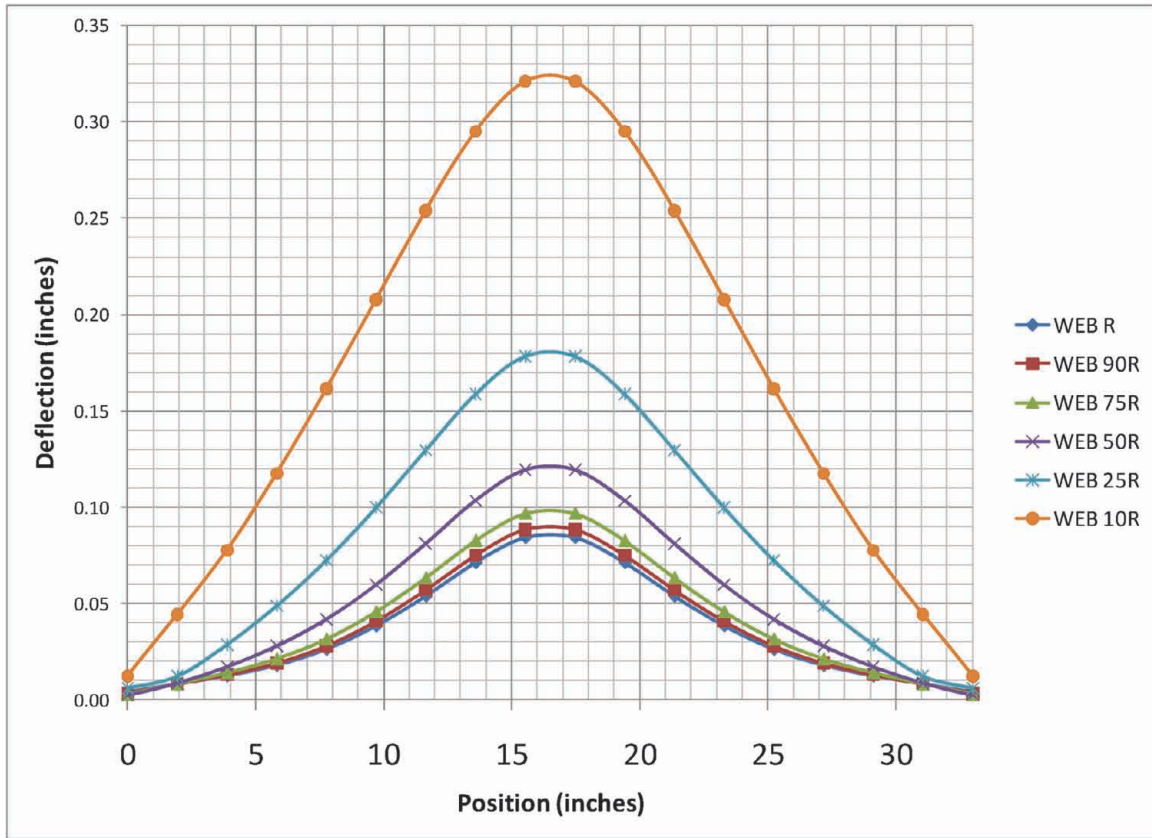
Figure 6.29: ABAQUS Results of FRP Top Plate Deflections Longitudinal to Truck Travel Direction for Reductions in Web Stiffness

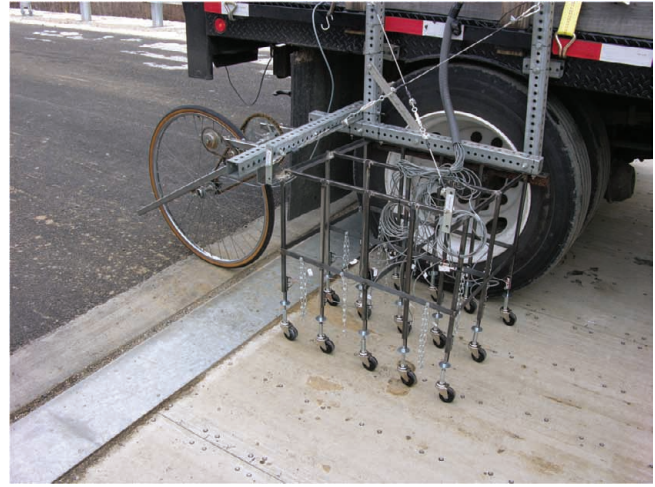
Figure 6.32: Truck with Deflection Frame Attached at Rear Wheel, Stopped at End of Bridge

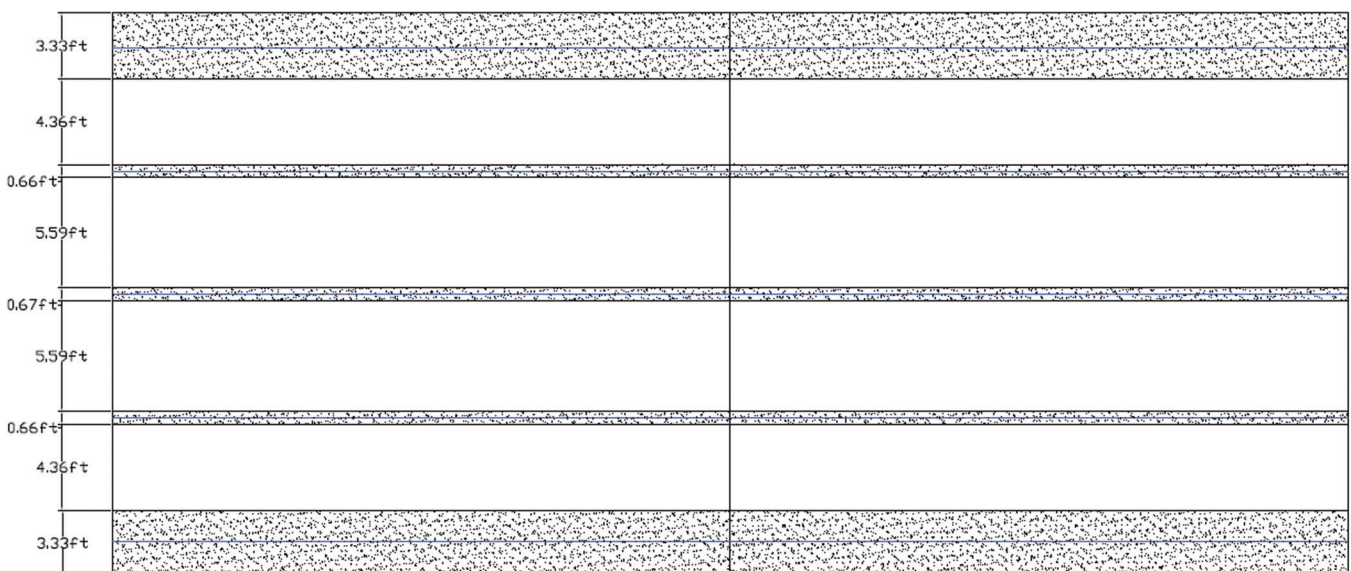
Figure 6.35: Plan View of Bridge Deck with Grouted Sections Shaded
