FHWA/IN/JHRP-94/11  
Final Report

STAY-IN-PLACE DECK PANELS -  
PART 1

Freezing-and-Thawing Durability of Concrete Bridge  
Deck Overlays with Corrugated Steel Deck Forms

September 1, 1995

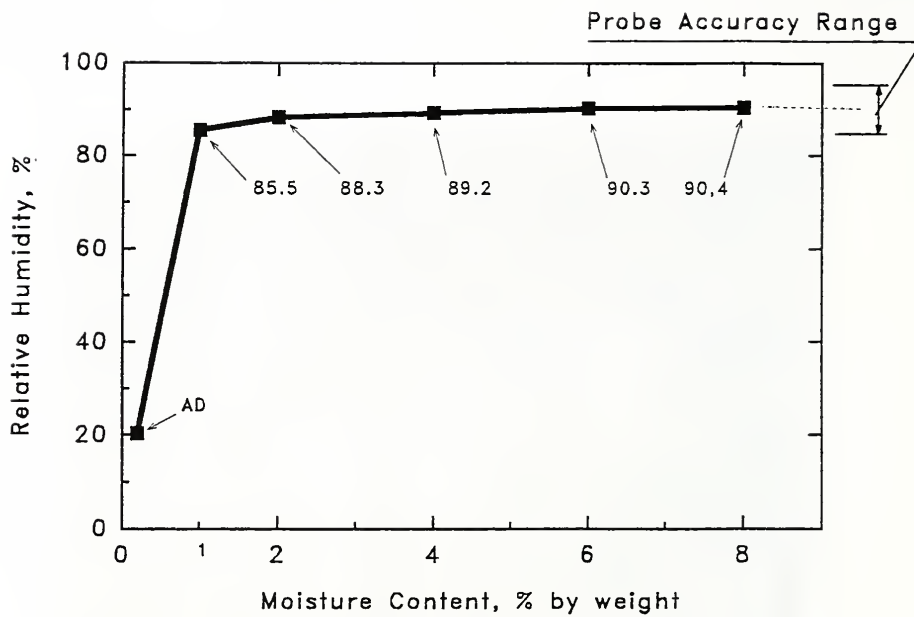
Fig. 2.7 Correlation between %RH and typical moisture contents of concrete

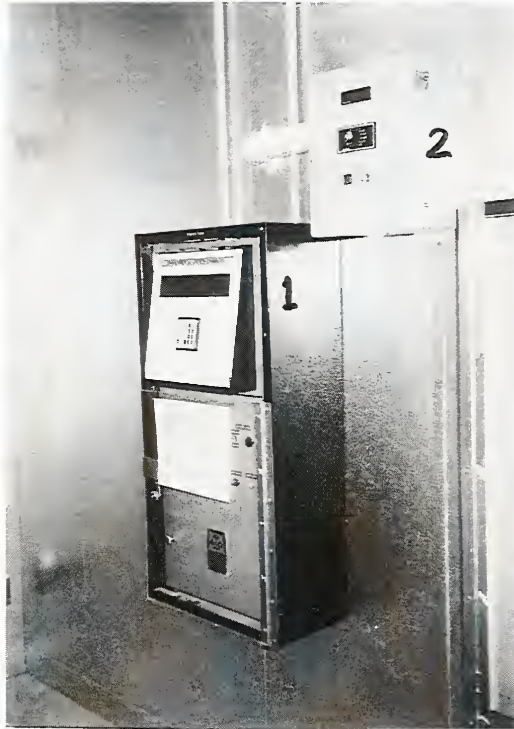
Fig. 3.4 Freezing-and-thawing chamber operating post:  
1 - computer;  
2 - commutator box with temperature indicator connected  
to the 12 thermocouples.

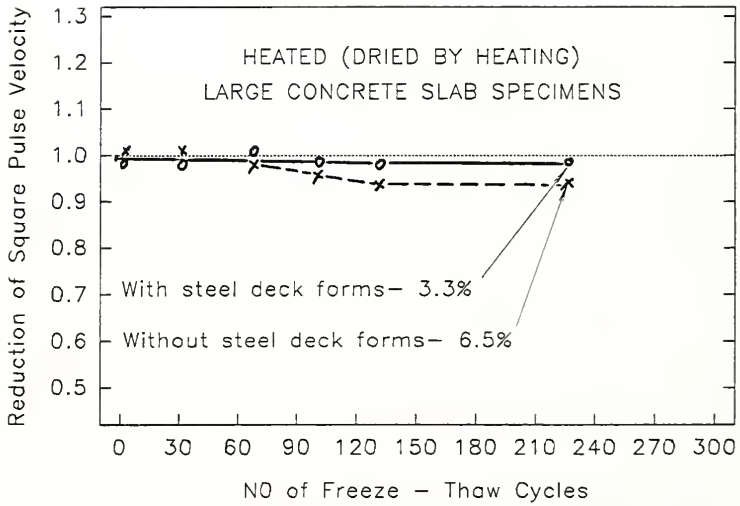
Fig. 3.9 The reduction of relative square pulse velocity in heated (dried by heating) large concrete slab specimens after 221 freeze-thaw cycles.

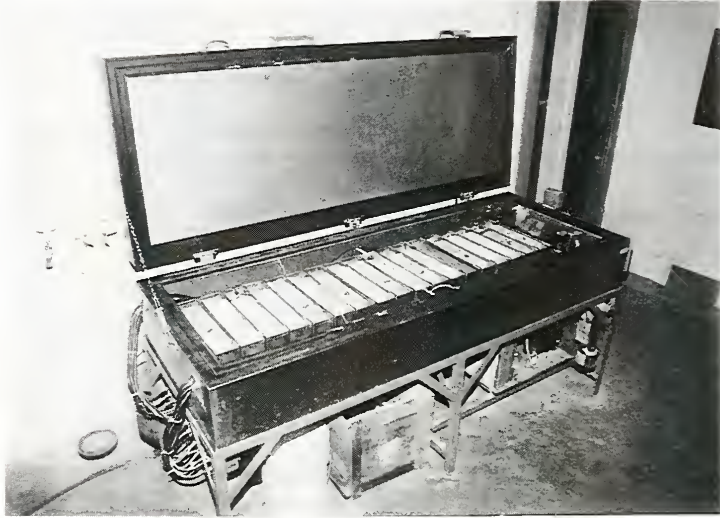
Fig. 4.10 Positioning of 3"x4"x12" specimens in the freezing-and-thawing machine

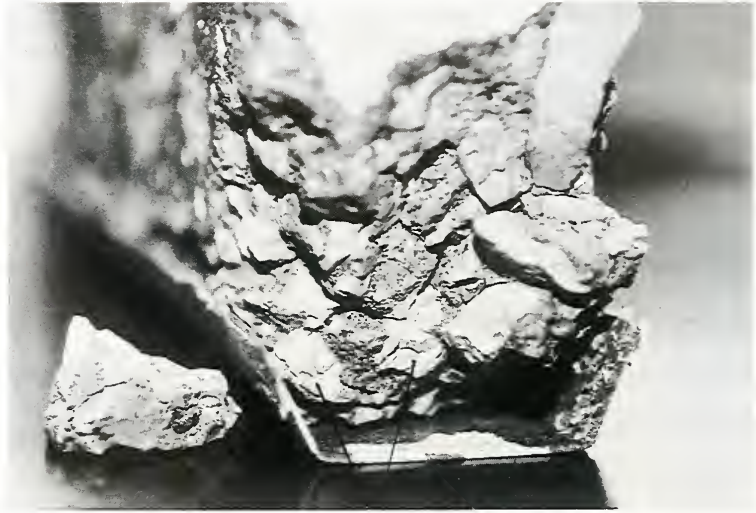
Fig. 5.1 Typical view of a deteriorated water saturated 3"x4"x12 concrete specimen:

1 - failure of aggregate grains

The deterioration has occurred only in water saturated concrete specimens, along with the extensive drop in relative pulse velocity and expansion. These imply that considerable deterioration is likely to occur when the moisture content in concrete is high, i.e. is up to 4-8%, and when the absorption capacity of the coarse aggregate is also high.

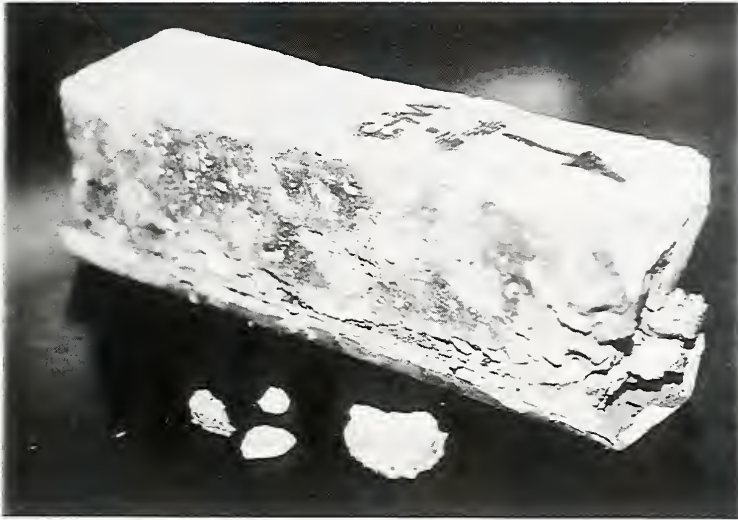
Fig. 5.2 Popouts at the surface of a deteriorated water saturated 3"x4"x12" concrete specimen
