**FHWA/IN/JTRP-2006/40**

**IMPLEMENTATION OF HEALTH  
MONITORING PROCEDURES FOR  
ITS SENSORS**

*Volume 1: Research Report*

## **Health Monitoring Procedures for Freeway Traffic Sensors Volume 1: Research Report**

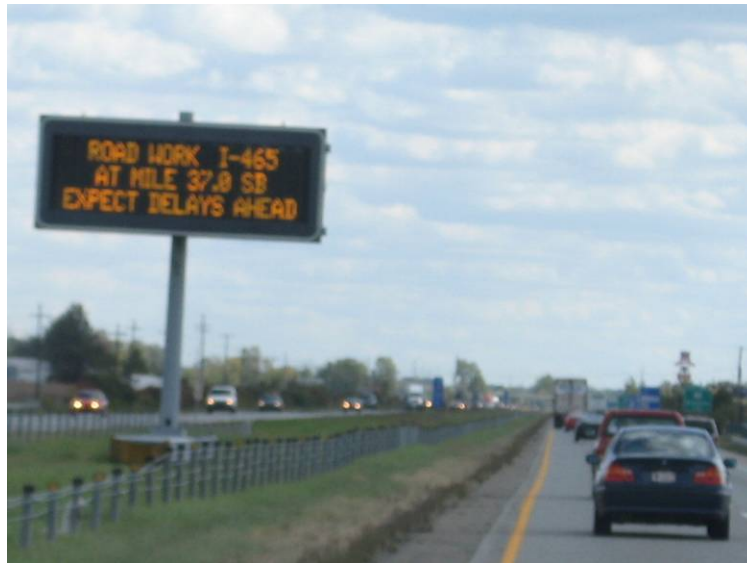
An example of a Dynamic Message Sign (DMS) is shown in Figure 1.1. Dynamic Message Signs are used to provide relevant information to motorists with respect to downstream roadway restrictions thus providing the opportunity for re-routing vehicles and decreasing motorist delay and user cost.

Figure 1.1 I-65 Example of Dynamic Message Sign on I-65 north of Zionsville, IN

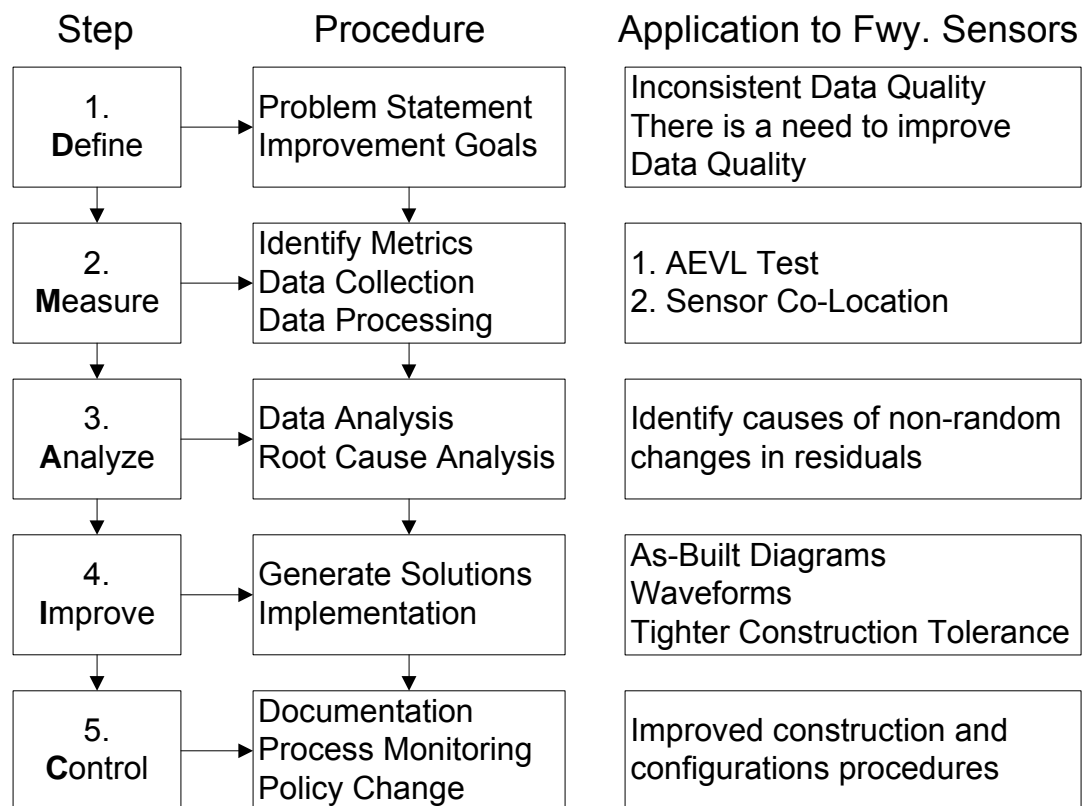
The Six-Sigma process control model has been successfully used by companies interested in improving the repeatability of production and reducing customer complaints. A systematic approach to implementing Six-Sigma is the DMAIC model (2,3,4), which provides a step by step procedural context for determining the root cause of defects and preventing them in the future. This model, applied to the context of freeway sensor data is shown in Figure 1.2 (5). Decreased

Figure 1.2 DMAIC Performance Improvement Model (5)

This procedure was developed by implementing the steps 2 through 5 of the DMAIC model (Figure 1.2). The data collection and analysis was conducted by co-locating sensors at a test location and analyzing the data to determine questionable data occurrences. The Average Effective Vehicle Length test was found to be an important tool for determining potential error occurrence; however it is somewhat limited due to factors such as traffic composition, and occupancy reporting precision. Heuristic knowledge of site characteristics however can improve the AEVL test's effectiveness by narrowing the test upper and lower limits by using archived sensor data from the same location.

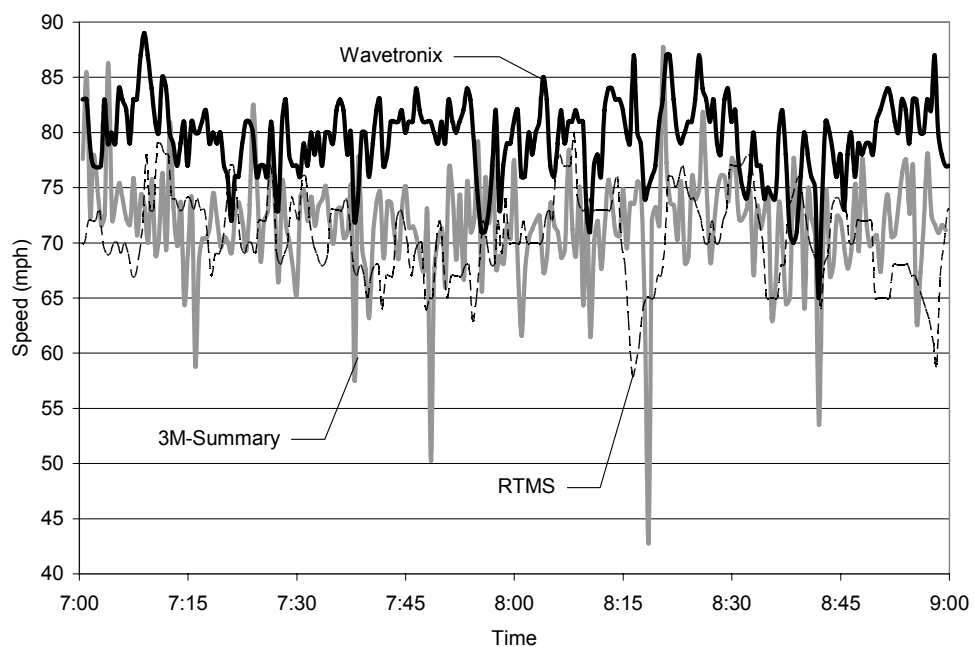
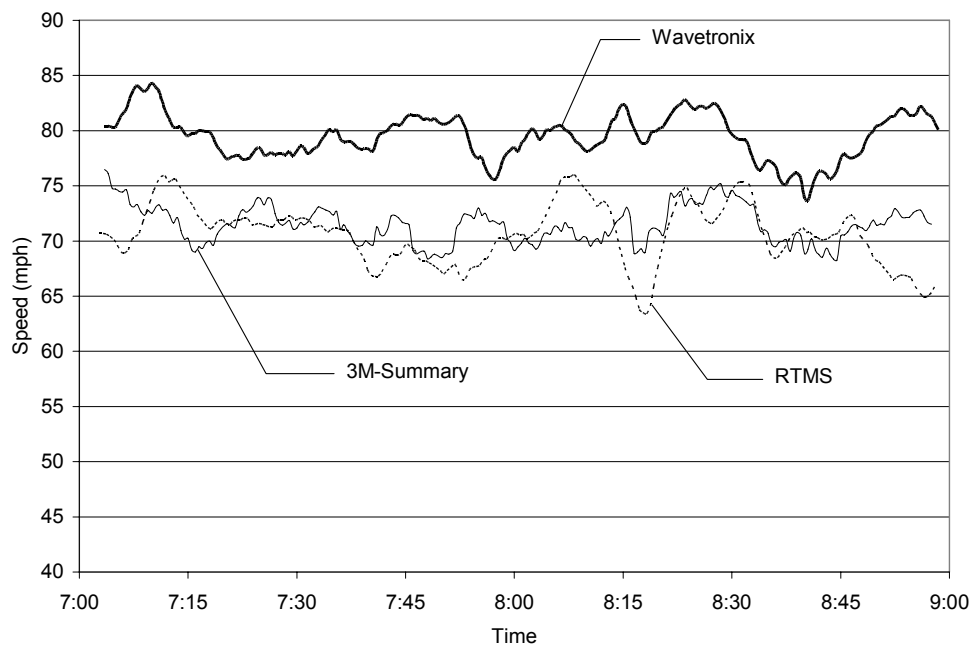
The comparison of sensor speeds with respect to time is another performance metric which can be used to assess the quality of the data being provided by ITS sensors. The interval speeds are plotted vs. time and visually compared to each other. Significant variations in speed over time are indicative of a problem worthy of further investigation. Data aggregation can be used to remove “sensor noise” from the plots. For example a 5 minute moving average speed plot vs. time is easier to visually inspect than a 30 second interval speed vs. time plot. Such an example difference is shown in Figure 3.3.

a) 30 second interval speed vs. time

b) 5 Min. moving average speed vs. time plot

Figure 3.3 Example of Average Speed vs. Time Plots

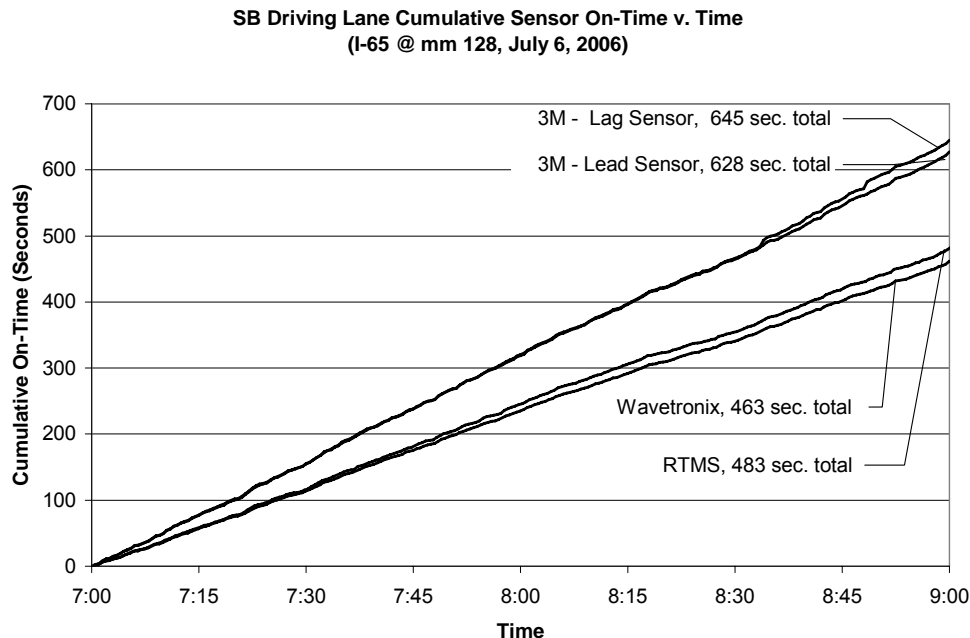
Evaluation of the occupancy metric is accomplished by visually comparing the traces of the various sensors with respect to each other. Significant divergence of the traces is indicative of a potential sensor data issue. An example of the cumulative 'on-time' vs. time plot is shown in Figure 3.4

Figure 3.4 Example of Cumulative Sensor 'On-Time' vs. Time

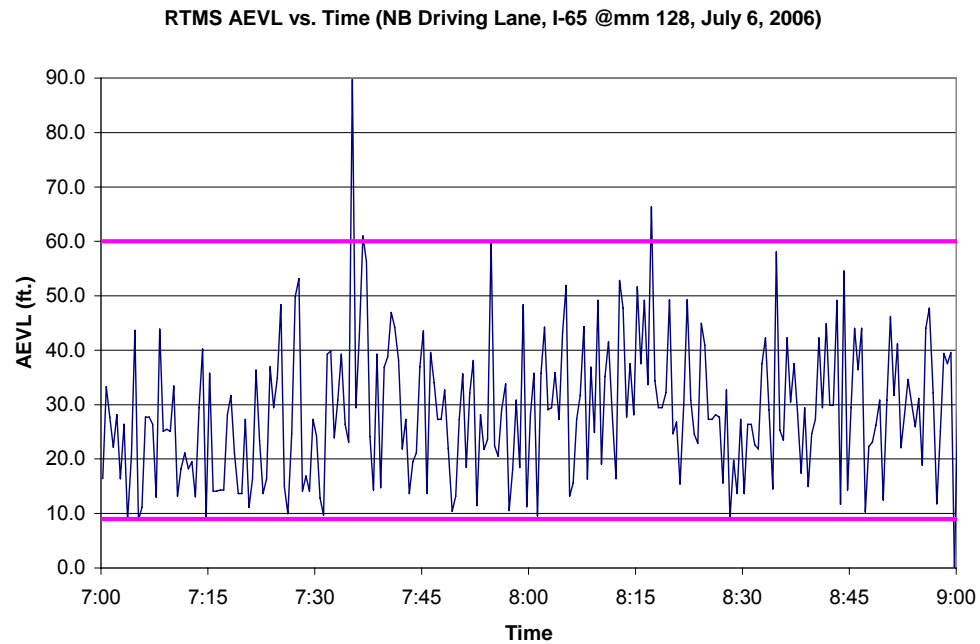
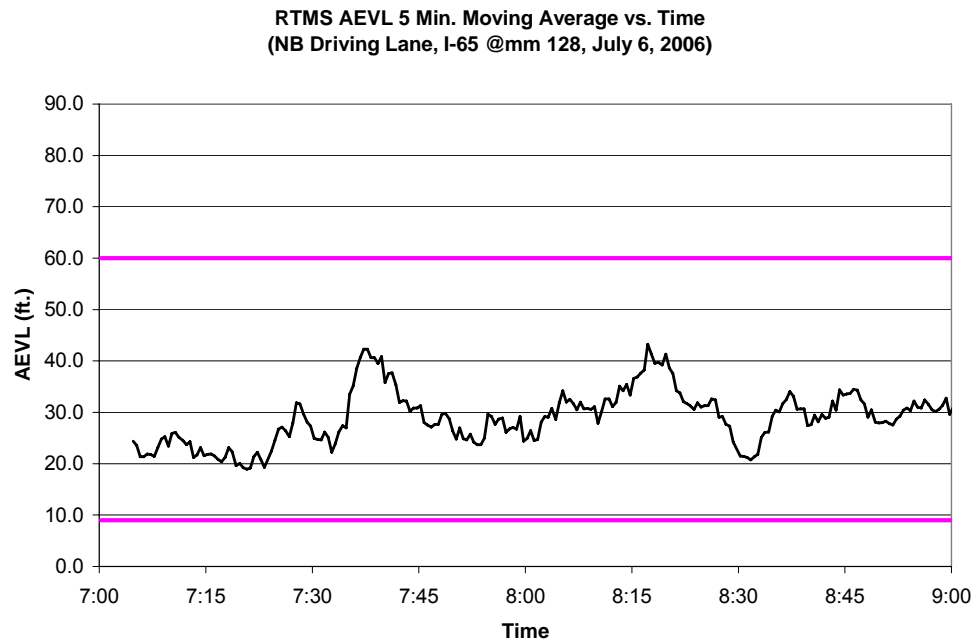
The interval AEVL values can then be plotted and compared to previously set upper and lower limits (8), as shown in Figure 3.5. The use of AEVL as a performance metric is subject to several limitations (5), such as vehicle lengths and speeds being fairly uniform and occupancy values being lower than 20%. The advantage to this metric lies in the ability to use the AEVL for screening ITS sensor sites based on a predetermined percentage of AEVL test results falling outside the acceptable limits, without the need for plotting and analyzing graphs.

a) 30 second interval AEVL vs. Time

b) 5 Min. Moving Average AEVL vs. Time

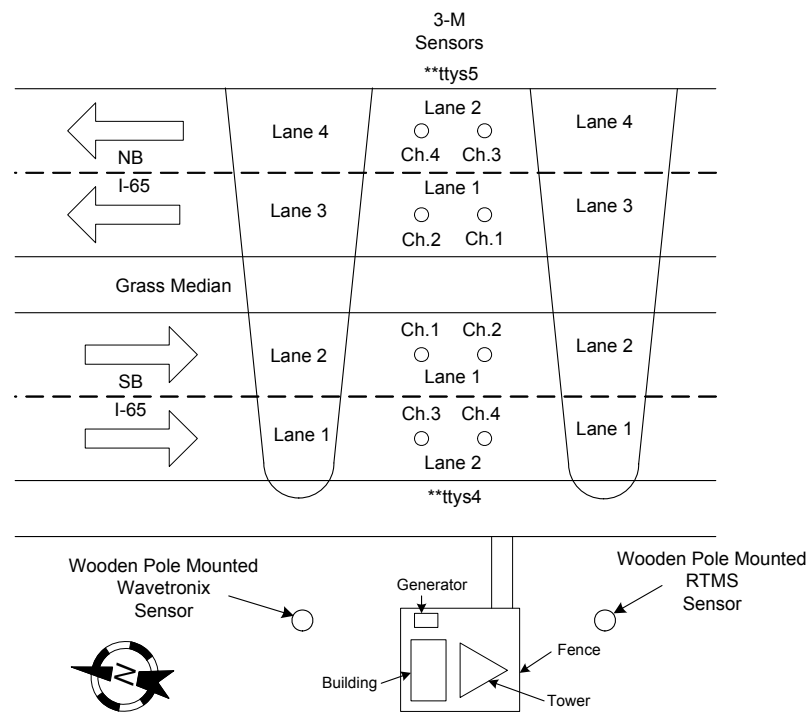
a) Outside Image of MM 128 site

b) Layout of mm 128 ITS Sensor Site

Figure 4.2 Milemarker 128 site on I-65, Hendricks Co., IN

- Pole Mounted Sidefire Radar Unit (RTMS (point a in Figure 4.2, or Wavetronix Smartsensor (point b in Figure 4.2))
- Proprietary Sensor Communication Module (Figure 4.8 & Figure 4.9)
- AFP (Figure 4.6)
- Internet Switch (Figure 4.10)
- PC for Data Processing/Analysis

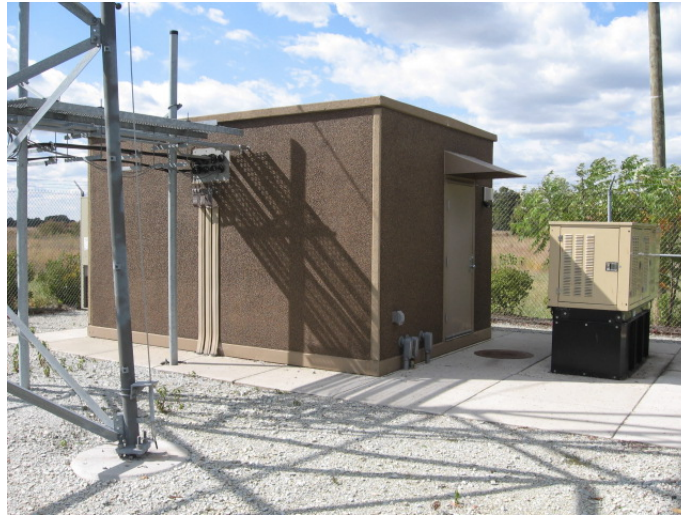
The communications shed and generator are shown in Figure 4.3.

Figure 4.3 ATMS Communications Shed @ mm 128 on I-65

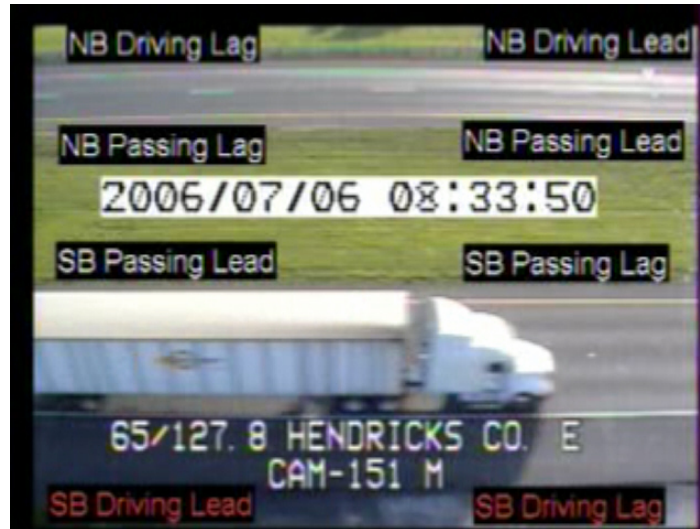
The existence of video capability at the mm 128 site provided the ability to groundtruth sensor data. The groundtruthing analysis was facilitated by overlaying the existing video from one of the mm 128 PTZ cameras with a time/date stamp and dynamic detector states. An example of the dynamic overlay is shown in Figure 4.4. This was done using an Autoscope 2020 (Figure 4.5). The label detectors are set to change color when the Canoga detector card senses a vehicle. An example of the video screen including the Autoscope overlay is shown in Figure 4.4.

Figure 4.4 View from PTZ Camera showing Autoscope 2020 Overlay and Dynamic Label Detectors

There is one label detector corresponding to each Microloop sensor. The image in Figure 4.4 shows that there was detection by the Microloops in the SB Passing Lane at 08:33:50 on July 6, 2006. The Autoscope input channels, 3M Microloop channels and label detectors are identified with respect to each other in Table 4.1. Use of the Autoscope 2020 system time overlay also made the synchronization between the time stamps of the Microloop vehicle detection occurrences and the video time much easier.

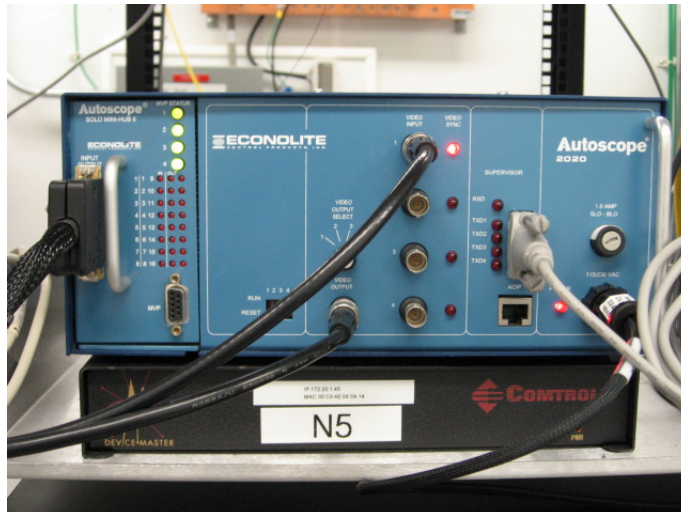
Figure 4.5 Autoscope 2020 Device in I-65 mm128 communications hut

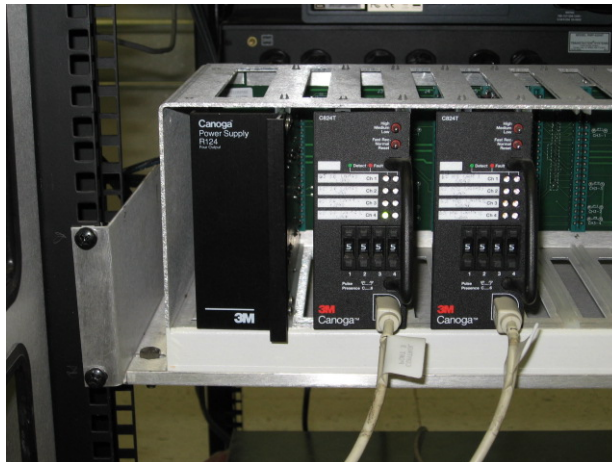
Figure 4.13 Canoga Detector Cards at mm128 Site

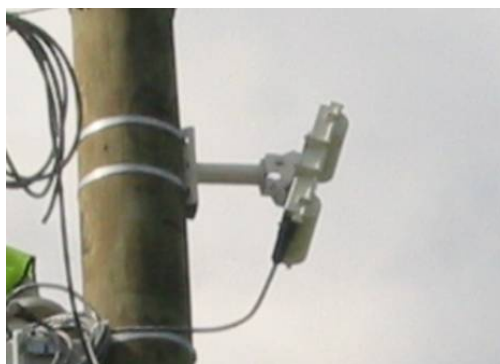
Figure 4.17 Wavetronix Smartsensor 105 at I-65 @ mm 128 ITS Site

The Wavetronix Smartsensor 105 is installed approximately 30 feet north of the Microloop sensor speedtrap, as point b in Figure 4.2 (a) and in Figure 4.2 (b). The sensor is mounted to a standard wooden utility pole, with vendor supplied hardware, approximately 17 feet above the adjacent ground elevation. The Wavetronix Smartsensor 105 is shown in Figure 4.17.

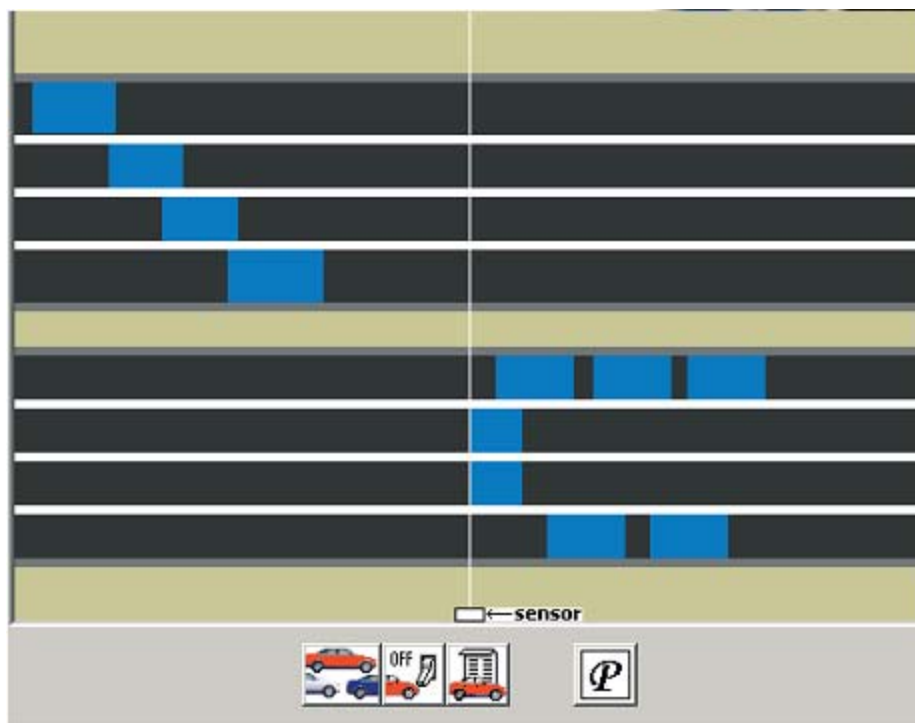
Figure 4.18 Example of Wavetronix SmartSensor Manager Lane Configuration GUI, showing four lanes in each direction of travel

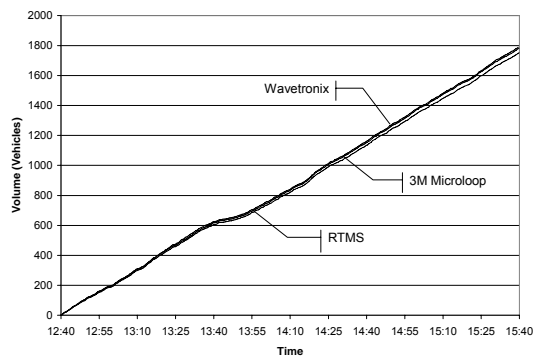
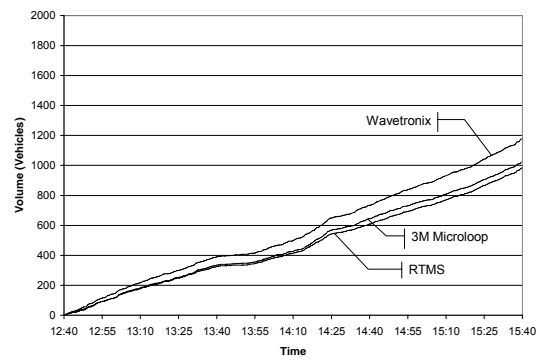
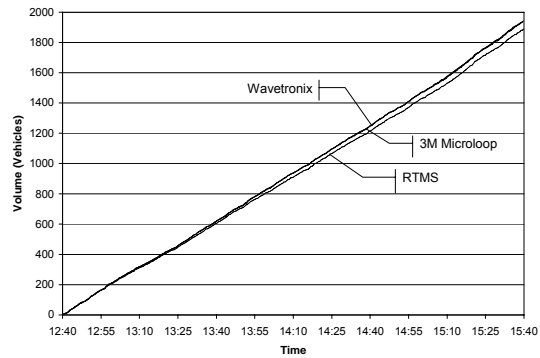
Initial Video collection occurred on February 14, 2006 for three hours. The subsequent analysis of the data showed the need for an overlay on the video in order to determine the time offset between the AFP time and video time. It was also determined that the dynamic labels from the Autoscope 2020 would assist in determining the time offset interval. Initially the analysis from early data collections involved analysis of the summary data files and cumulative volume comparison. The results of this data collection are show in Figure 5.1. A qualitative interpretation of the results indicates that the least agreement between sensors occurs in SB Passing lane (Figure 5.1, b), however no groundtruthing was performed to determine the actual volume. All other lanes indicated excellent cumulative volume vs. time agreement Figure 5.1, a,c,d).

a) SB Driving Lane

b) SB Passing Lane

d) NB Driving Lane

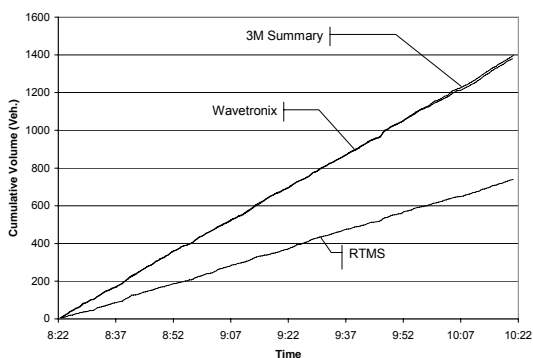
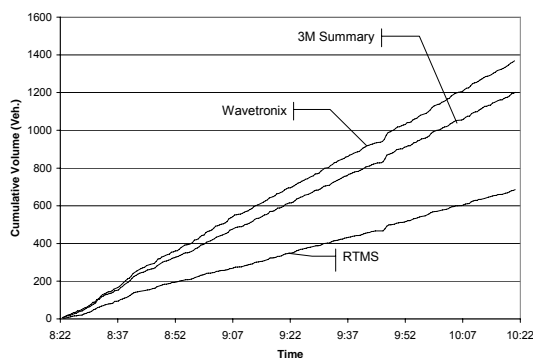
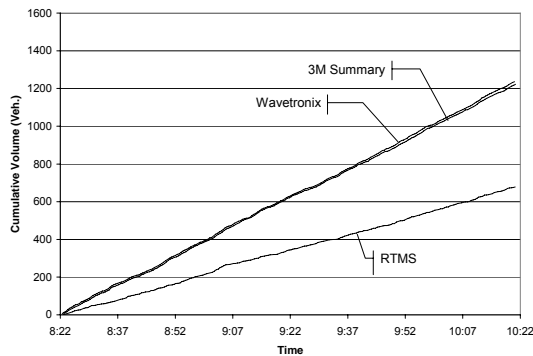
Data was collected on May 12, 2006 for two hours and analyzed using the cumulative volume metric. The resulting cumulative volume vs. time plots are shown in Figure 5.2, and clearly indicate that the RTMS unit data is suspect, as all lanes are indicating serious underreporting of volume. This analysis prompted contact with EIS for assistance in troubleshooting the unit and its ultimate replacement on the May 17, 2006.

a) SB Driving Lane

b) SB Passing Lane

d) NB Driving Lane

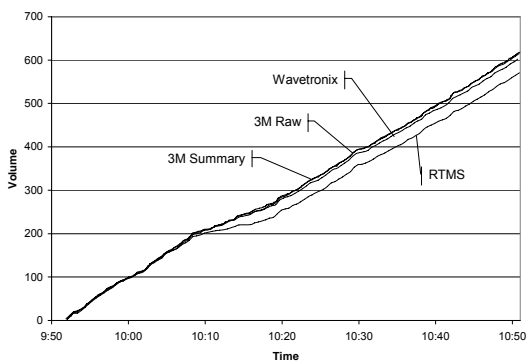
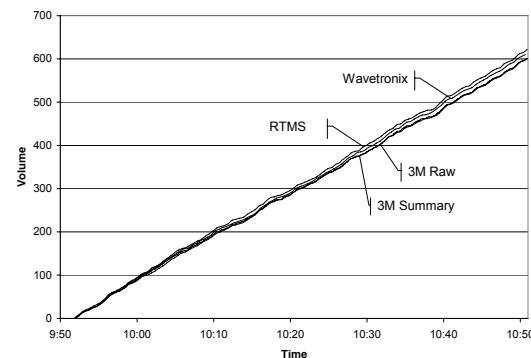
The data set taken on May 17, 2006 was a one hour set. Initially it was to be used to determine if the RTMS unit replacement had been successful. The data was analyzed using the volume and cumulative sensor 'on-time' metrics. The cumulative volume graphs, shown in Figure 5.3 indicate generally good agreement between all the sensors, with the exceptions being a slight undercounting by the RTMS unit in the SB Driving Lane (Figure 5.3,a) and the Wavetronix Smartsensor exception being a slight over counting in the SB Passing Lane (Figure 5.3,b).

a) SB Driving Lane

d) NB Driving Lane

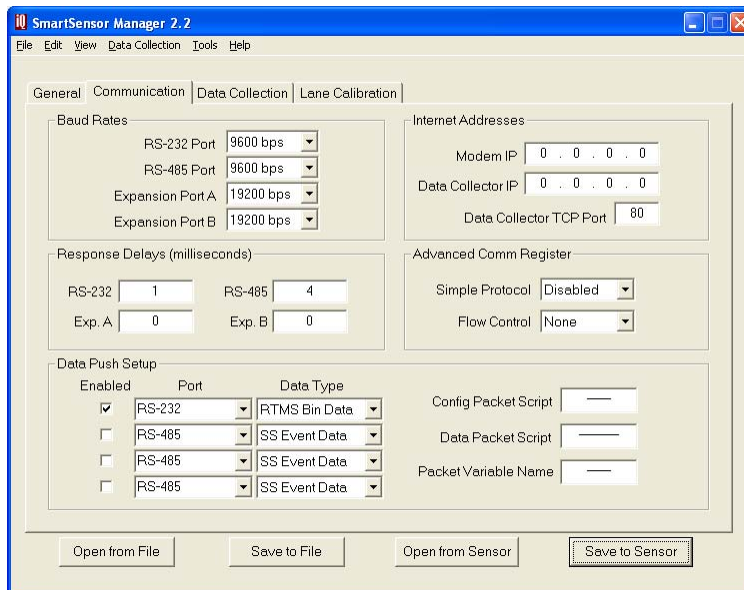
Table 5.2 Wavetronix Smartsensor Setting Changes Made on May 26, 2006

a) Changed “Simple Protocol” enable to disable

b) Changed FFFF to 0004 on “Speed Avg. Val”

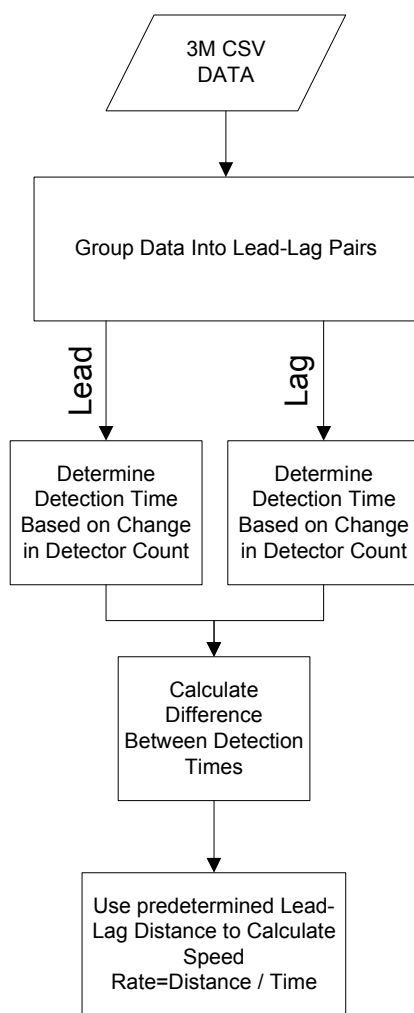
Figure 6.2 Microloop CSV file speed processing algorithm

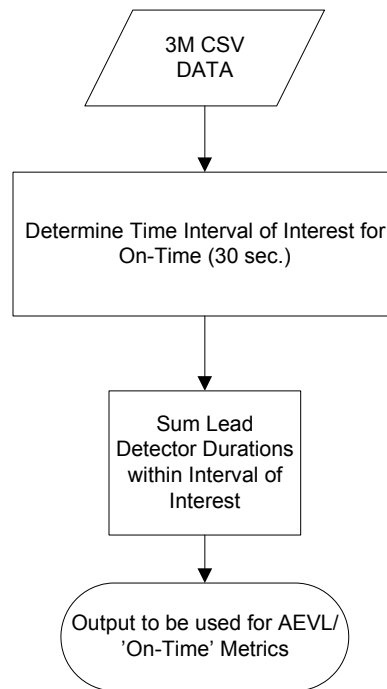
Figure 6.3 Microloop CSV file 'On-Time' and AEVL input processing algorithm

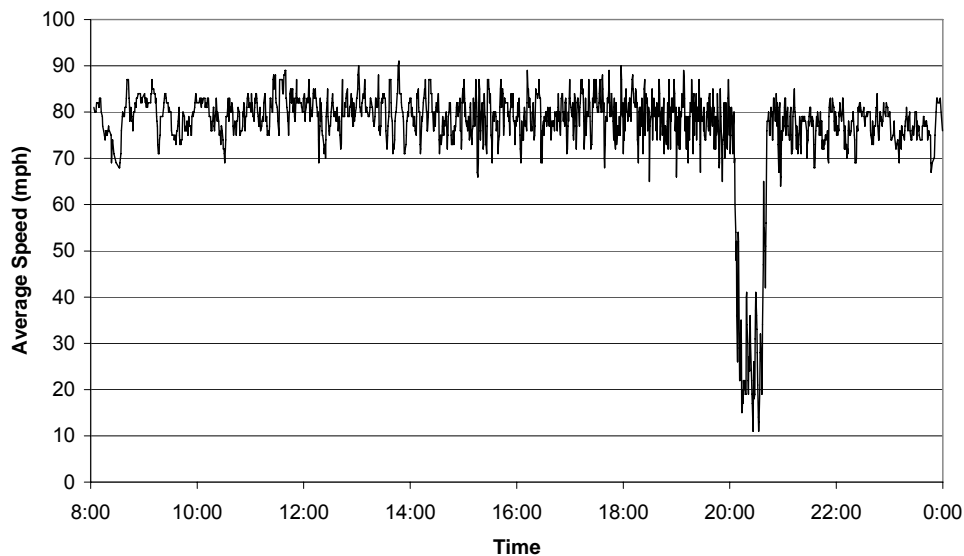
**NB Passing Lane Wavetronix Sensor Average Speed vs. Time**  
(I-65 @ mm 128, August 6, 2006)

a) NB Passing Lane Speed vs. Time

**NB Driving Lane Wavetronix Sensor Average Speed vs. Time**  
(I-65 @ mm 128, August 6, 2006)

b) NB Driving Lane Speed vs. Time

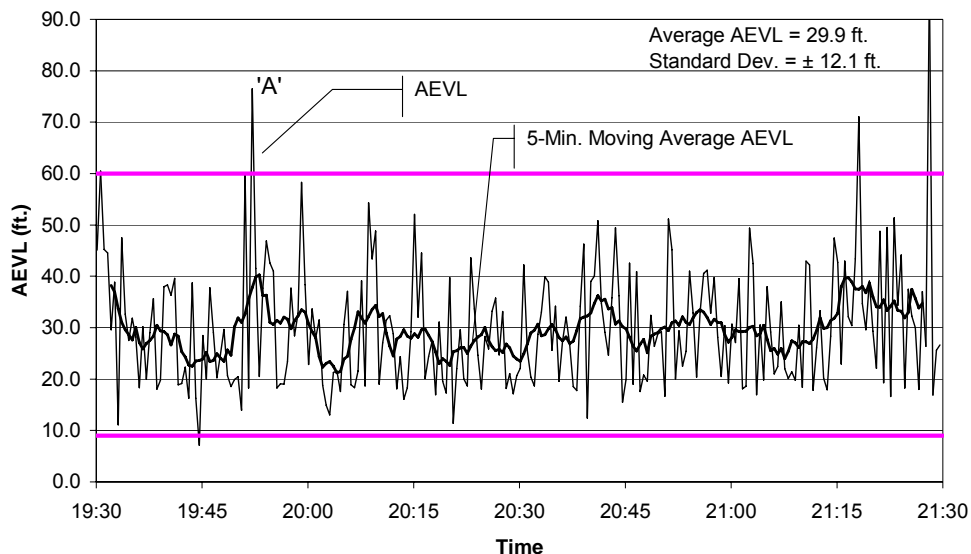
**SB Driving Lead 3M Microloop Sensor Average Effective Vehicle Length vs. Time  
(I-65 @ mm128, August 6, 2006)**

**a) SB Driving Lane Lead Microloop Sensor**

**SB Driving Lag 3M Microloop Sensor Average Effective Vehicle Length vs. Time  
(I-65 @ mm128, August 6, 2006)**

**b) SB Driving Lane Lag Microloop Sensor**

The point analyzed for the Southbound lane is noted as 'A' in Figure 7.2 and Figure 7.3. The interval values reported by the sensors, video groundtruthing and resulting calculated AEVL values are shown in Table 7.1.

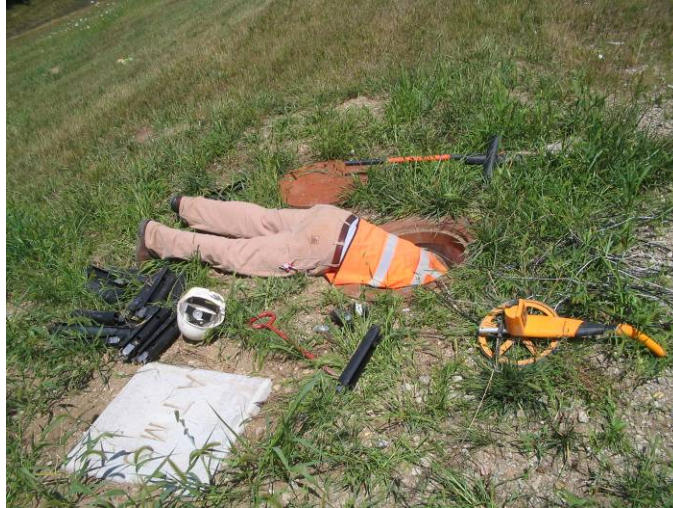
Figure 8.3 3M Microloop Sensors Placed Too Deep Below Pavement

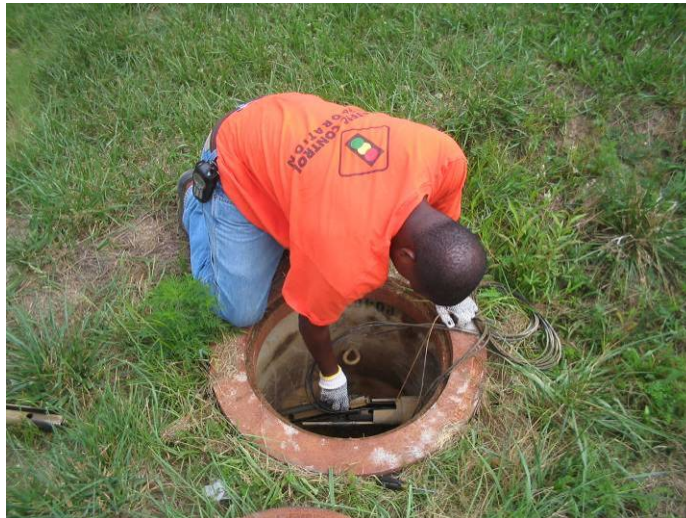
Figure 8.4 3M Microloop Sensors Placed at correct depth for ease of maintenance access

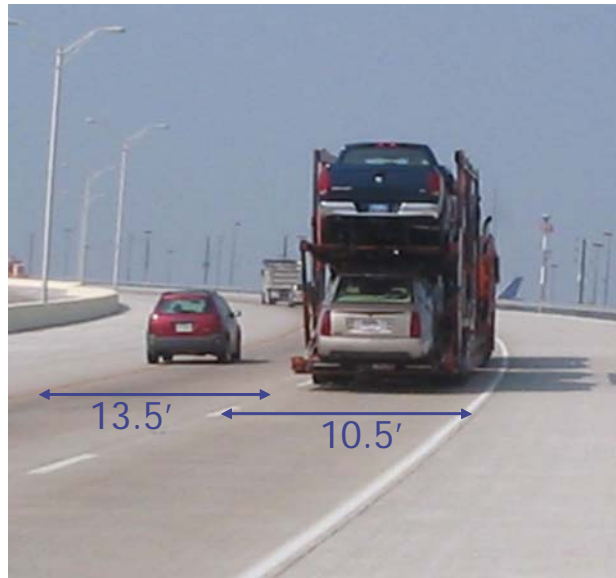
Figure 8.5 Constant lane width assumption proven false

- Construct a portable side-fire sensor device with data collection capabilities [Figure 4.4, 4.5, Table 6.3] for identifying conditions [Figure 8.5] that are causing sensor errors.

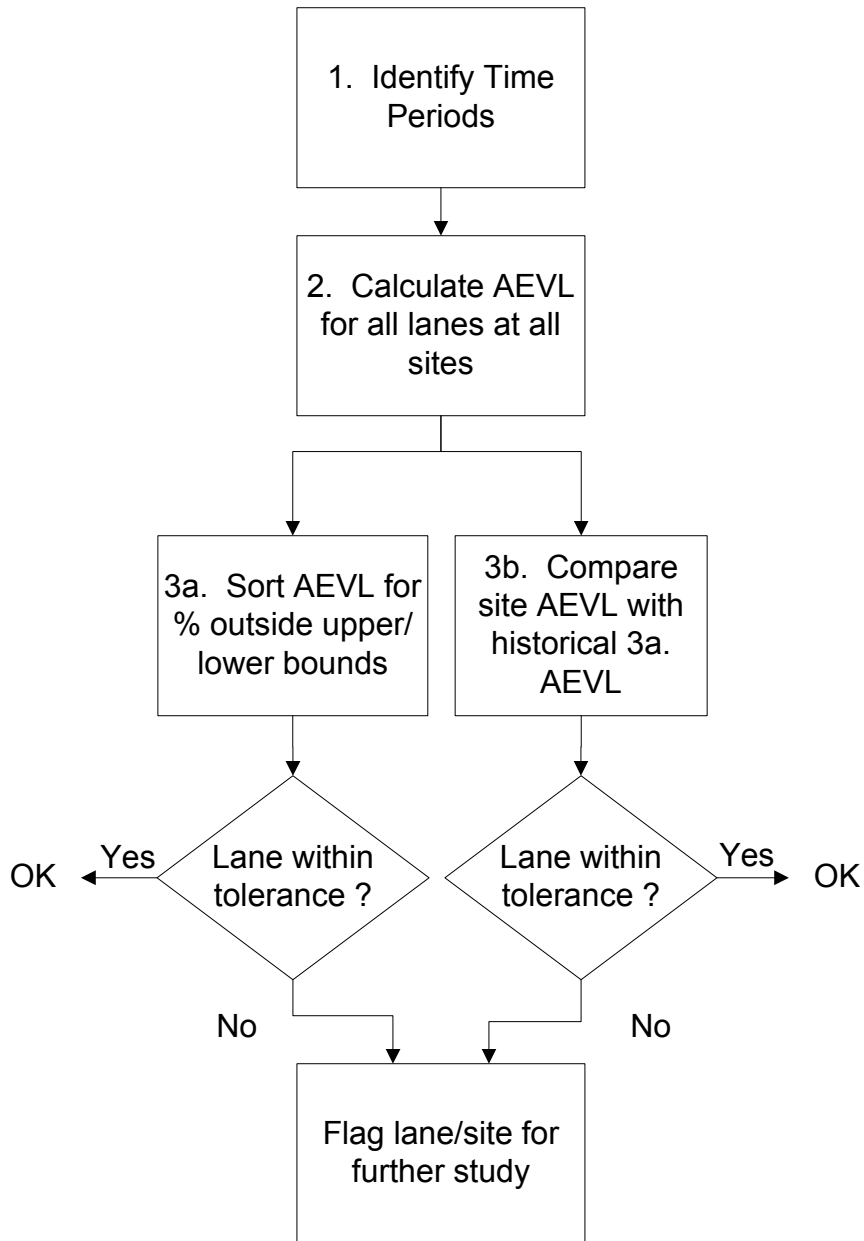
Figure 9.2 Process Monitoring Procedure for ITS Sensors

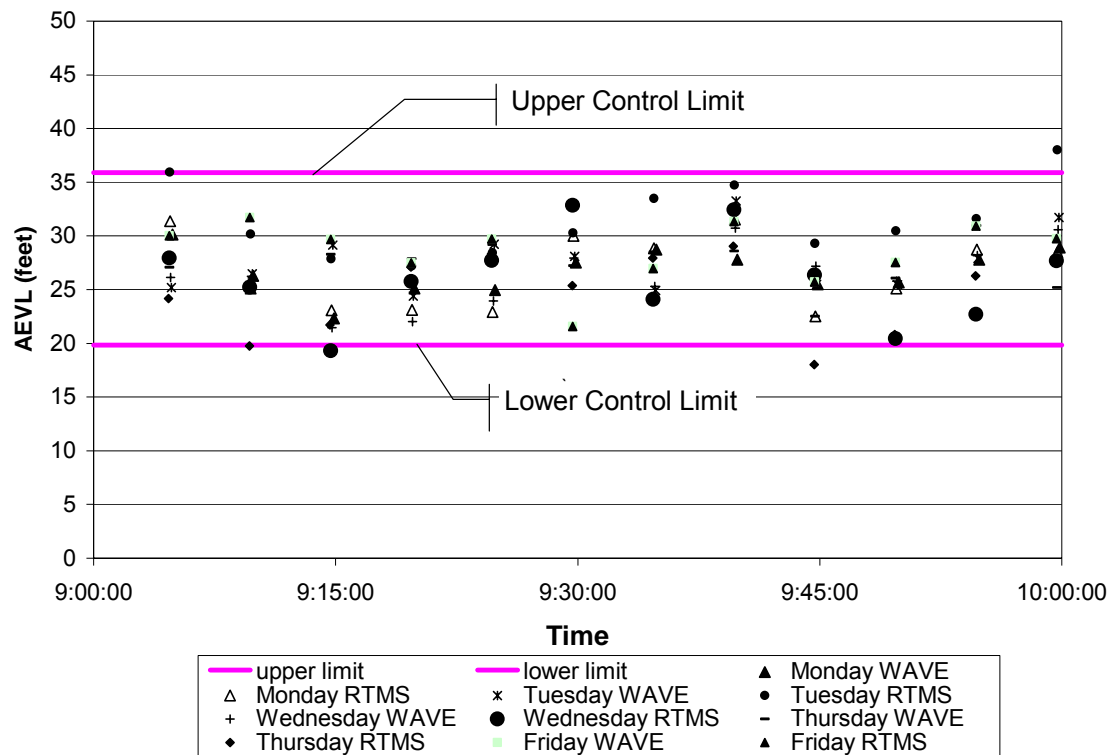
Figure 9.4 Example of Control Chart for SB Driving Lane @ I-65 mm 128 site
