The Impact of Typhoon Pamela (1976) on Guam's Coral Reefs and Beaches¹

JAMES G. OGG² and J. ANTHONY KOSLOW²

Part 1. The Impact of Typhoon Pamela on Guam's Coral Reefs

Part 2. The Impact of Typhoon Pamela on Guam's Beaches

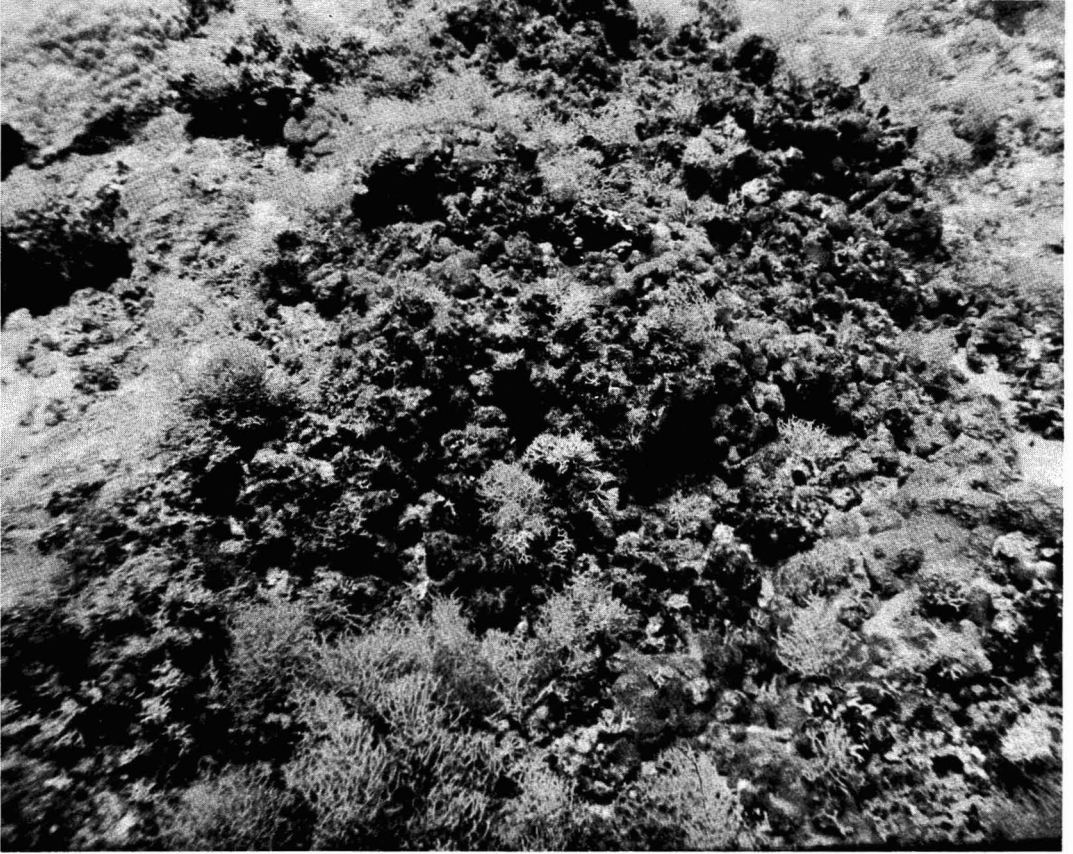
Six weeks following Typhoon Pamela, the reef at 5 to 10 meters depth, previously noted for its well-developed coral colonies, was covered by profuse growth of a red alga (Figure 5). A transect was made from 6 to

20 meters depth, and two 1 m² quadrats were placed at 6, 13, and 20 meters depth. Destruction to the coral cover was greater than 50 percent generally and approached 90 percent in patches. Branching corals were generally found broken to 20 meters depth.

FIGURE 5. Typical bottom configuration at 6 meters depth, Pago Bay 6 weeks after Typhoon Pamela. Prior to the typhoon, the community composition was similar to that found at Tarague Beach. Hard corals are extensively damaged; most knobs are broken at their base. The area is extensively colonized by the red algae in foreground.

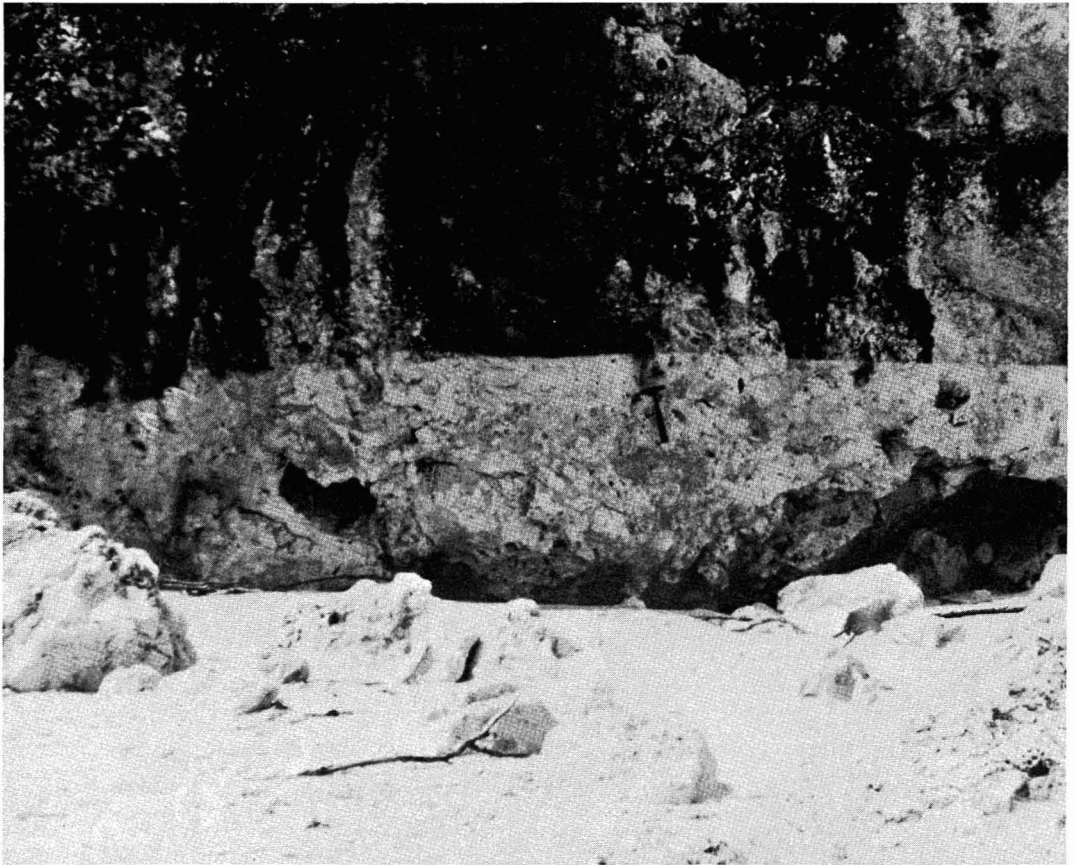
Fourteen beaches were examined on the northern, eastern, and southeastern coasts of Guam (Figure 1) to determine beach profile alteration, longshore sediment transport, and maximum height of wave surge. The leeward western coastline was protected from the typhoon waves. Transects were surveyed on seven of the beaches and less detailed profiles were made on the rest. Pretyphoon photographs taken by local residents were useful at three of the locations. Recently exposed tree roots, buried vegetation, and blankets of sand swept over shore roads and structures were surveyed. Valuable records of pretyphoon beach profiles were obtained from upraised reef limestone blocks and headlands on or bordering the beaches. The limestone is discolored to a dark gray by algal growth on all exposed surfaces over a period of time, whereas the covered or newly exposed limestone is the original white color. The dark gray-to-white transition indicates the prior beach level and the extent of sand removal or burial (Figure 6).

FIGURE 6. Recently exposed limestone at Jinapsan Beach, indicating extent of beach sand removal. Pretyphoon sand level was at contact between algal-discolored, dark gray surface and newly exposed white surface. Hammer in center for scale.

band at the base of the limestone cliff, recorded the removal of a 28-meter-long and 1.2-meter-wide lens of sand (Figure 6), a net removal of about 20 m^3 per meter of beach face. We assume a similar amount of sand was involved in accelerated longshore transport on the east end of Tarague Beach (access prohibited, Strategic Air Command munitions disposal area).

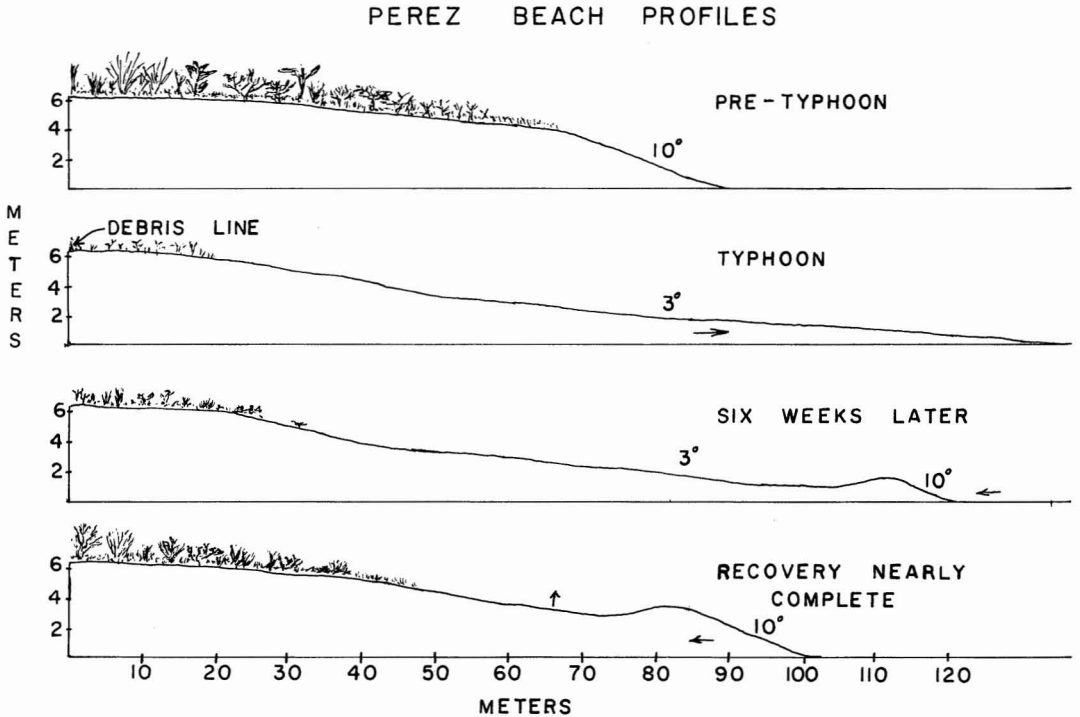
FIGURE 7. Typhoon modification and stages of recovery of typical beach profile. The typhoon waves swept sand seaward to form a wide, gently sloping beach. Surf and wind action had begun to move the displaced sand landward at the time of the survey, creating a beach ridge. This landward transport will continue until the beach regains its pretyphoon profile.

The profiles of Perez Beach on the eastern coast illustrate the process of typhoon wave modification and later recovery (Figure 7). The pretyphoon beach profile, as indicated by newly exposed white limestone of the bordering headlands, had a steep face about 1½ to 2 meters high, with perhaps a 10° slope, followed by a gently sloping-to-level, vegetated terrace. The typhoon waves cut back the terrace and shifted sand onto the reef flat. A featureless, 3° to 3½° slope resulted, ex-

tending about 130 meters from the high water debris line. The profile, as surveyed 6 weeks later, had a 10-meter-wide, ocean-bordering, coarse coral sand ridge, rising from the MLLW level with a 15° slope to 1.5 meters elevation, and then dropping 0.5 meter to the main beach slope. This beach ridge probably originated from posttyphoon, landward transport of sand by the waves and wind. Six months later, this beach ridge had migrated another 10 to 15 meters inland. The beach ridge should continue to migrate inland, while vegetation reclaims the upper beach, until the profile is again stabilized.

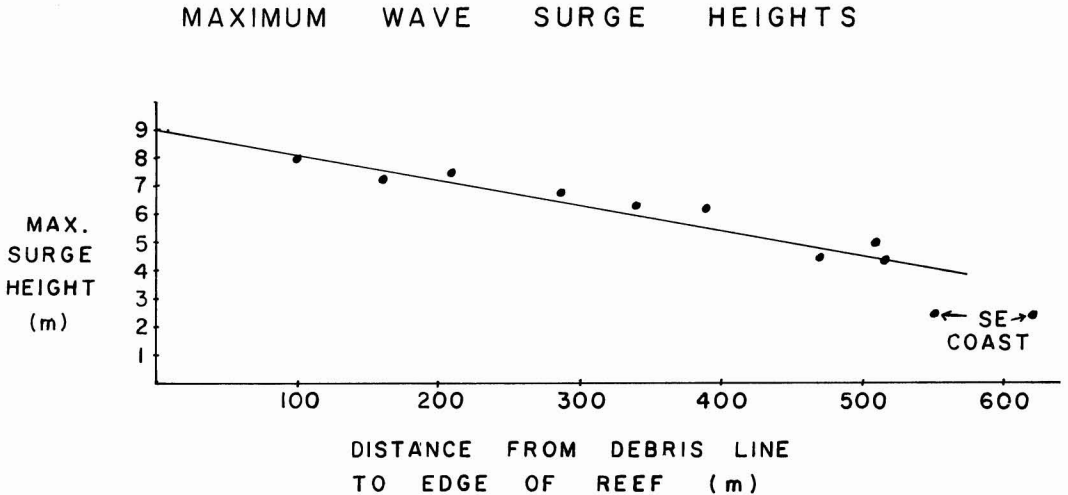
reef edge. The data indicate a linear relationship between the heights of the maximum wave surge and the distance it traveled (Figure 9). This relationship may be explained by using a simple model of waves losing energy as they travel across the reef flat and beach.

A breaking wave at the reef edge has an initial potential hydrostatic head equal to its height plus forward momentum. Suppose this potential head were equal to 9 meters as projected from the graph; this is also consistent to the estimated breaker heights of 8 meters. Then, if there were no energy loss, the wave would be expected to surge to an elevation of 9 meters on the shore regardless of how far it travels. However, energy loss occurs as the wave travels inland due to turbulence, bottom friction, return flow, and other factors. The potential head is steadily reduced, resulting in a lower height of maximum surge. The empirical value as given by the slope of the line fit to the data is a 1-meter reduction of head or run-up height per 115 ± 20 meters of landward travel. The southeastern beaches probably received indirect waves, and a lower initial potential head is indicated.

FIGURE 9. Maximum wave surge height versus distance from the highest debris line to the seaward edge of the reef. Data are given in Table 1. The linear fit is a 1-meter height decrease per 115 meters of distance.

This empirical model may be useful for predicting storm wave damage from future typhoons. Intersection of the reef flat-beach profile with the 1:115 slope projected landward from the estimated potential head of waves breaking on the reef edge will yield the approximate level of maximum wave surge on the beach.
