# The Tsunami of April 1, 1946, in the Hawaiian Islands

G. A. MACDONALD, F. P. SHEPARD, and D. C. COX<sup>1</sup>

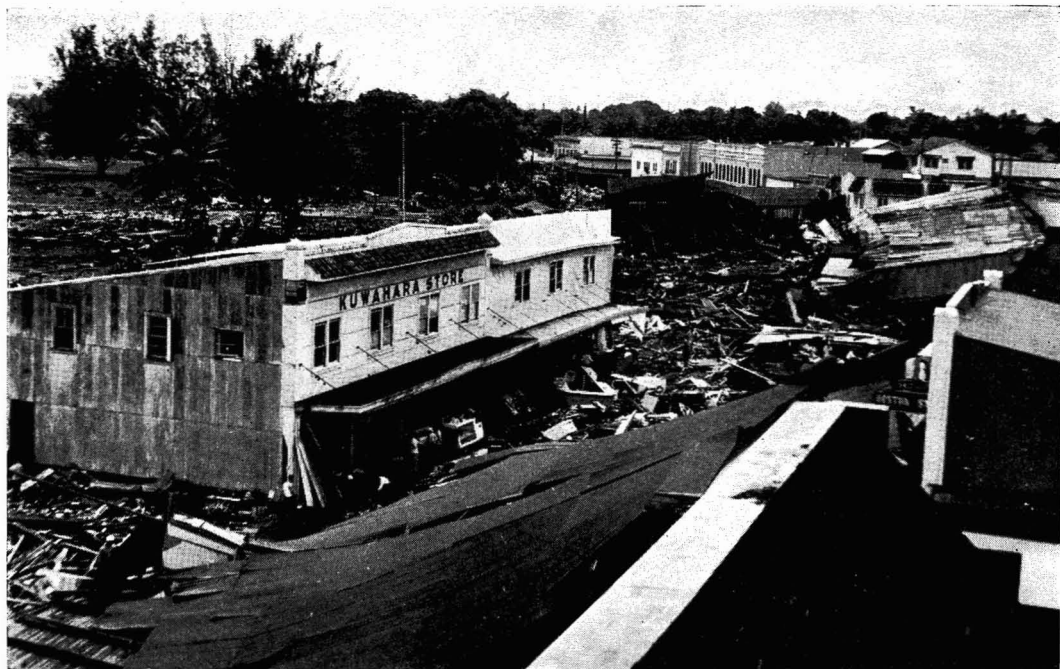
PLATE 3A. Wreckage left by the tsunami along Kamehameha Avenue, Hilo. Buildings on the left-hand (seaward) side of the street have been pushed into the street, some more or less intact, others as heaps of debris. Photo by Francis Lyman.

Structural damage includes damage to buildings, roads, railroads, bridges, piers, breakwaters, fishpond walls, and ships. Frame buildings at low altitudes along Hawaiian shores suffered extensive damage. Some were knocked over, by the force of the waves, by cutting away of the sand on which they stood, or by destruction of the foundations. Others were bodily washed away from their foundations. Some had walls pushed in by the force of the water, and in a few residences the water went on through the house and took out the opposite wall. As with earthquakes, there was a tendency to reduce the few two-story buildings to a single story, by destruction of the lower story. It is noteworthy that houses which were well built and tied together internally could be moved for considerable distances without suffering severe damage. Even more striking was the fact that houses elevated on stilts a foot to several feet above the ground survived the waves much more effectively than did those built directly on the ground. Apparently the water was able to pass under such houses without greatly disturbing them, unless it was deep enough actually to float

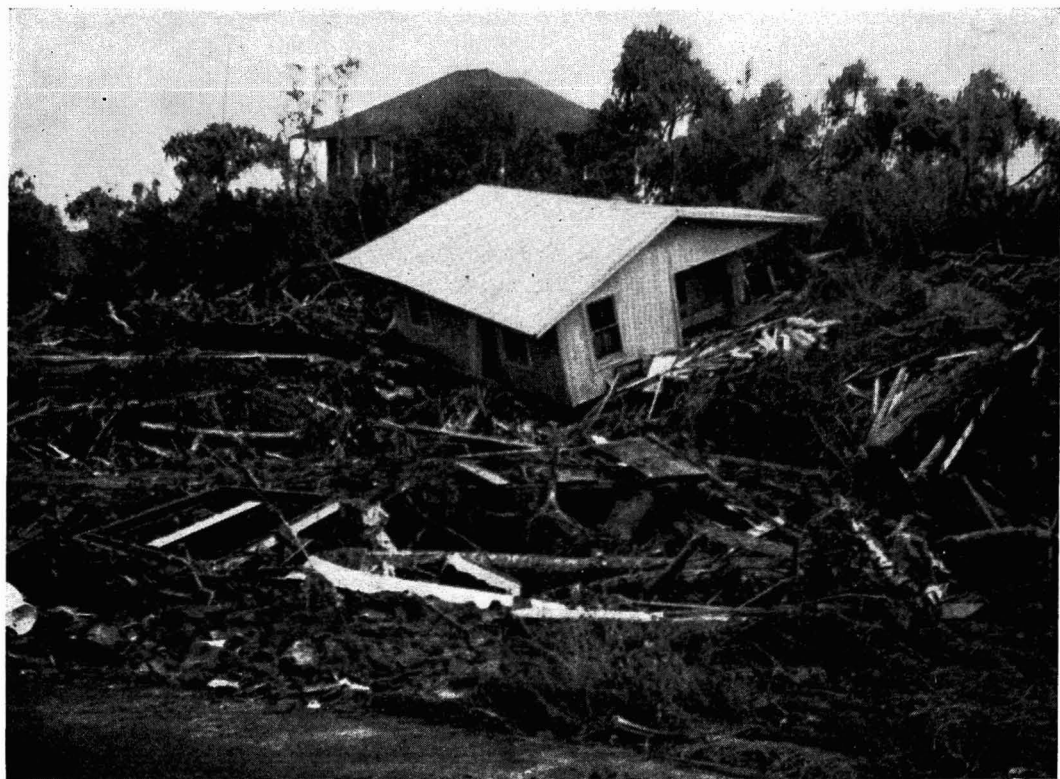
PLATE 3B. House in Keaukaha, east of Hilo, carried inland about 100 feet by the waves. The house in the background was above the reach of the water. Photo by G. A. Macdonald.

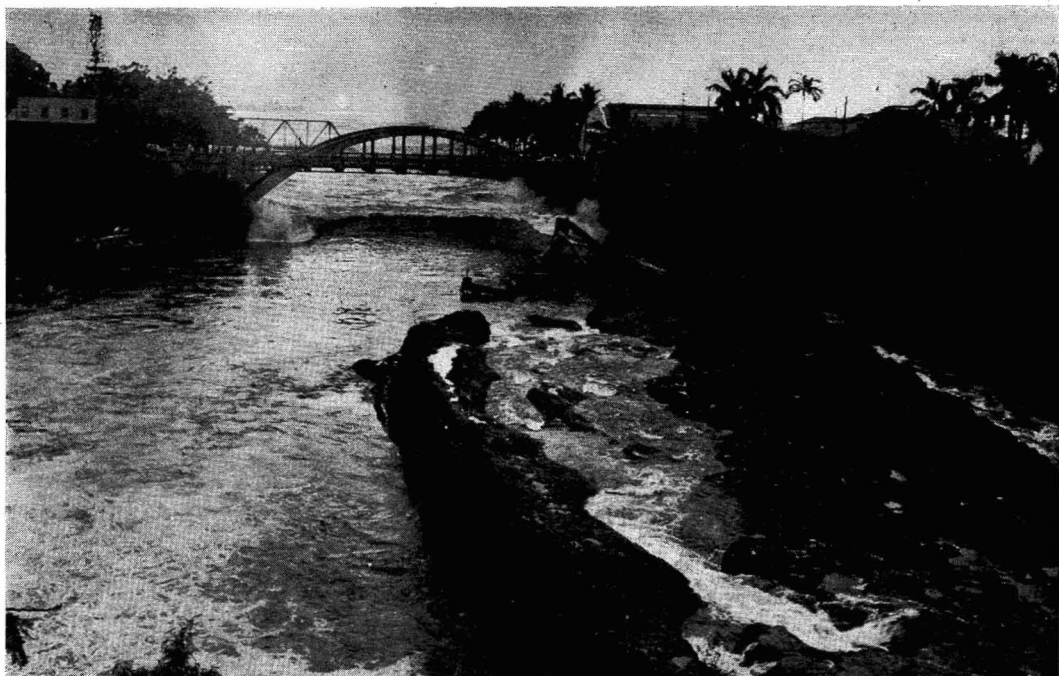
PLATE 4A. Mouth of the Wailuku River at Hilo, showing the advance of one of the later waves into the river mouth. Photo taken near the trough between two waves, showing very low water, and the waves starting up the river as the next crest approaches. The steel span from the distant railroad bridge is visible in the middle distance. Photo by Francis Lyman.

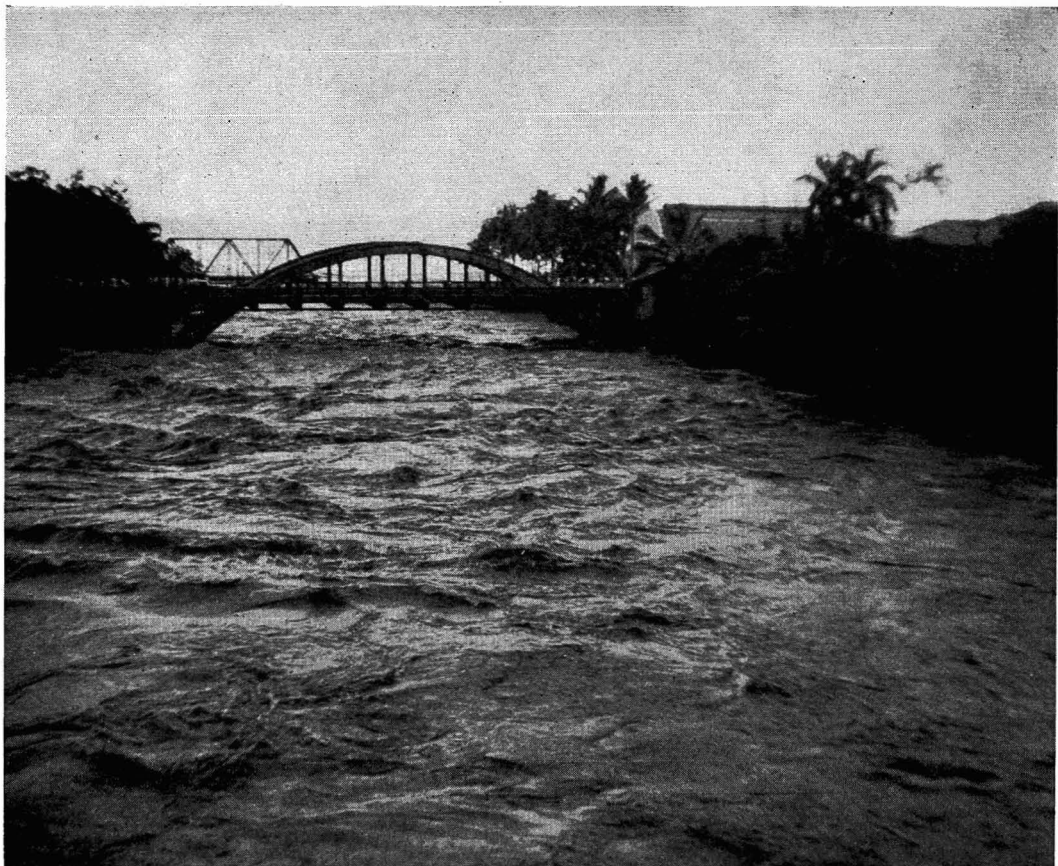
PLATE 5A. The very high stage of the water, in Wailuku River at Hilo, reached 3 or 4 minutes later than the stage shown in Plate 4B. Photo by Warren Flagg.

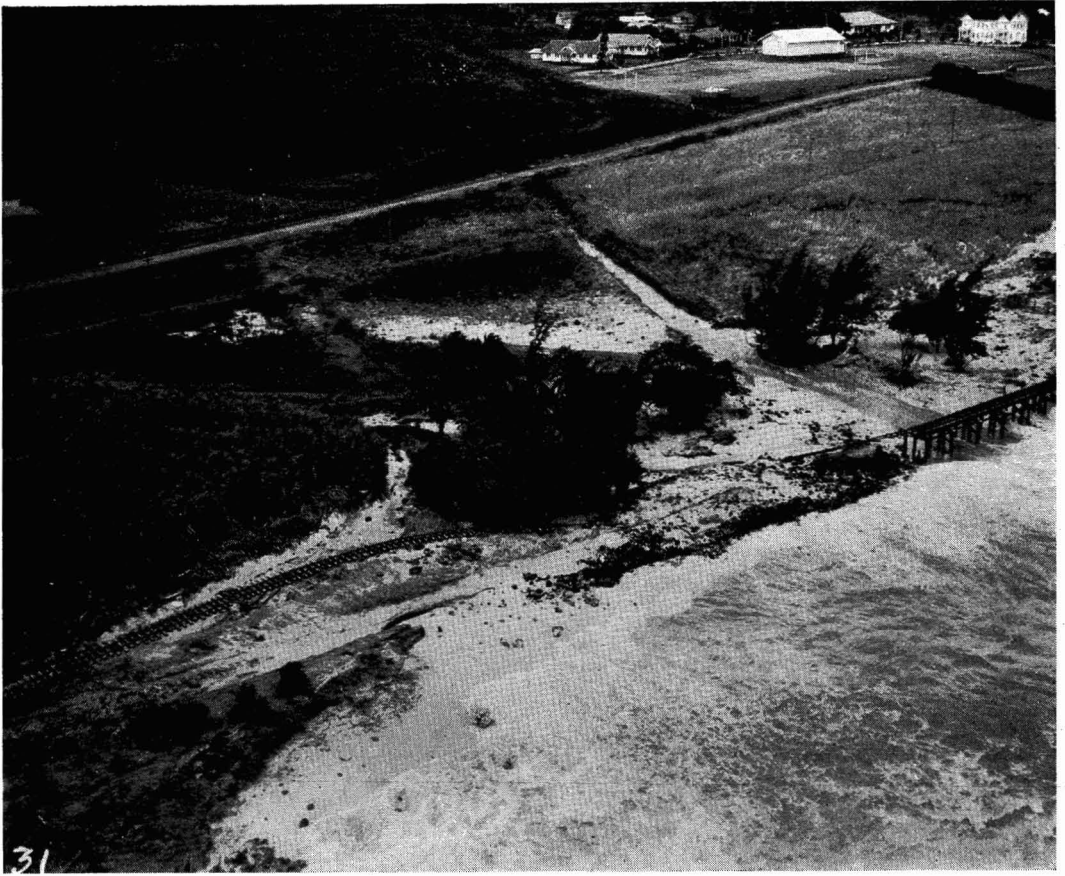
PLATE 6A. Railroad track swept inland from its bed at Waialeale, Oahu. Photo by U. S. Navy.

The railroads along the northern coast of Oahu and in Hilo were wrecked, partly through destruction of the roadbed, but largely because the tracks were shifted off the roadbed, either inland or shoreward. Locally rails were torn loose, but more generally the track was moved *en masse*, a motion probably aided by the buoyancy of the ties. Coastal highways also were partly destroyed, largely by undercutting as the water returned seaward, but partly by the direct force of the waves. Several highway and railway bridges were destroyed. Most appear to have been partly or entirely lifted from their foundations by the rising of the water under them. The head of the pier at Waianae, Oahu, was damaged in the same manner. At the Wailuku River, in Hilo, an entire span of the steel railroad bridge was torn loose and carried 750 feet upstream, passing under but not damaging a highway bridge. At Kolekole Stream, 11 miles farther north, an entire leg of the high steel railroad trestle was removed and carried upstream about 500 feet.

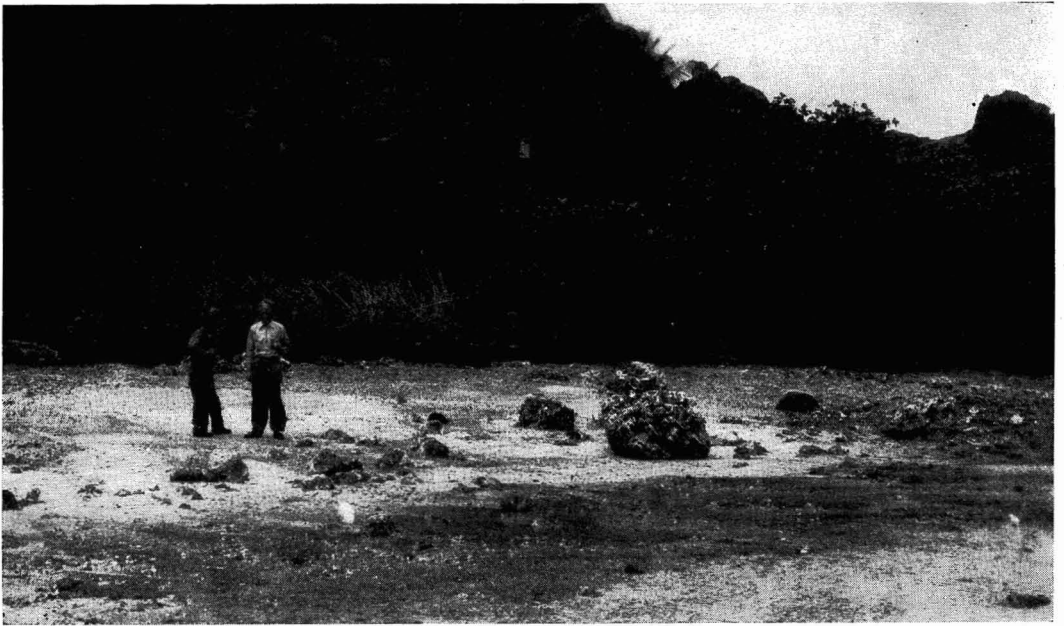
PLATE 6B. Coral heads thrown up on the beach at Kaaawa, Oahu, by the tsunami. Photo by G. A. Macdonald.

At many places the violence of the waves moving shoreward was sufficiently great to tear loose heads of coral and algae, up to 4 feet across, and toss them onto the beach as much as 15 feet above sea level. Locally, blocks of reef rock weighing several tons were quarried at the outer edge of the reef and thrown onto the reef surface.

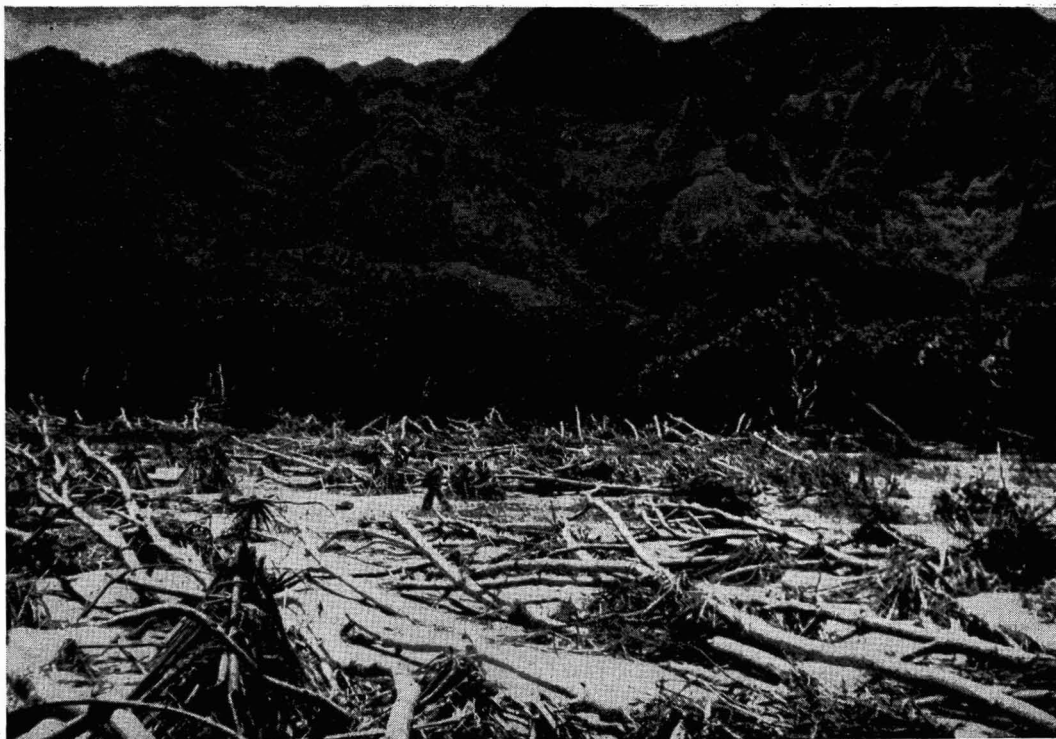
PLATE 7A. Grove of pandanus trees pushed over, and blocks of coral thrown up on the shore platform by the tsunami near Haena, Kauai. Photo by F. P. Shepard.

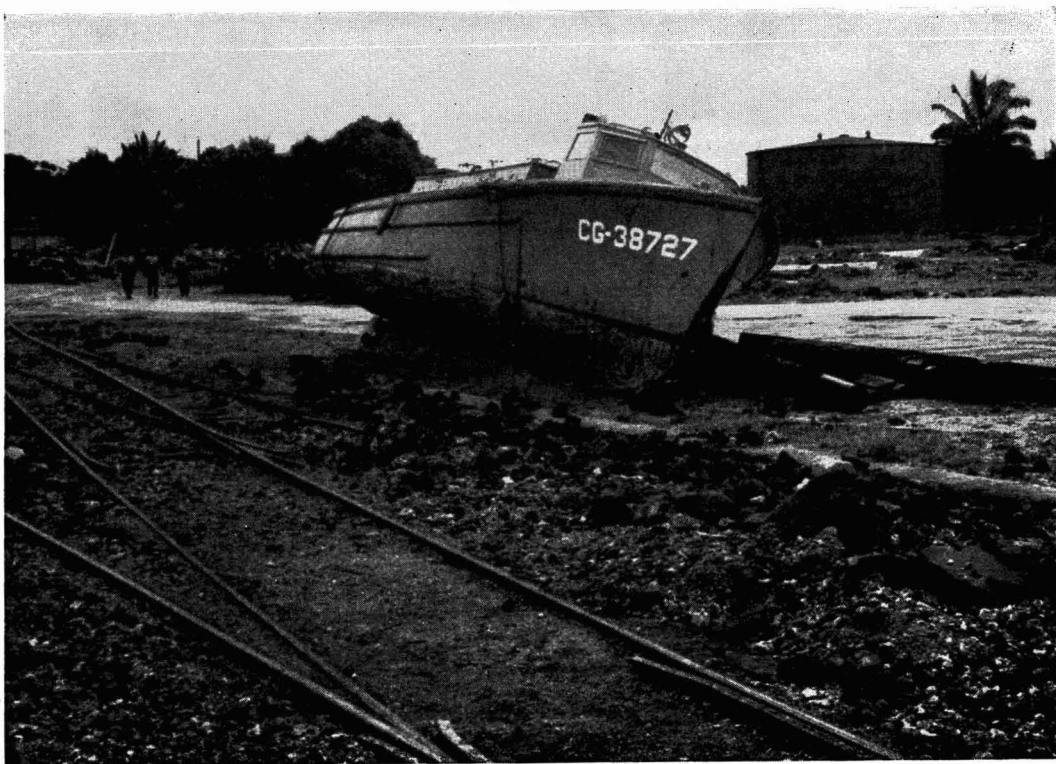
PLATE 7B. Small boat washed inland and left stranded by the tsunami near Pier 1, Hilo. Photo by G. A. Macdonald.

Many small boats were washed ashore and damaged. Railroad cars were overturned on Oahu, Maui, and Hawaii. Many automobiles were wrecked. The loose stone walls of fishponds along the southern coast of Molokai were partly thrown down. The mill of the Hakalau Sugar Company, situated only about 10 feet above sea level at the mouth of Hakalau Gulch on the island of Hawaii, suffered severe damage.
