Master's Project: Assessing Unpaved Road Runoff in the Mad River Watershed of Central Vermont

Assessing Unpaved Road Runoff in the Mad River Watershed of Central Vermont

A Master's Project Paper written by:

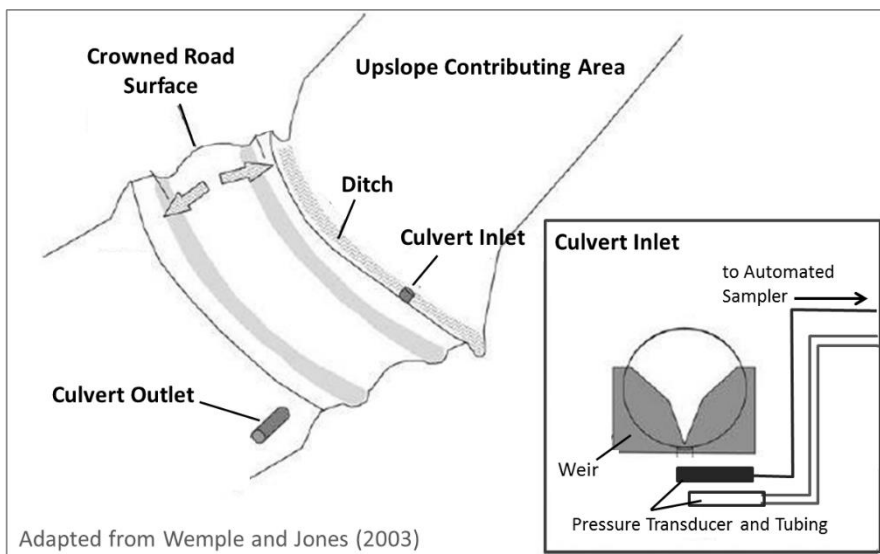
Figure 2. Schematic illustrating an example of an instrumented road site and the corresponding weir placement on a culvert inlet.

Between July 2011 and June 2012, the selected road segments were monitored to develop continuous records of runoff in response to measured storm events. Using an ISCO 6712 Automated Water Sampling Unit, and an attached pressure transducer, stage data were measured at culvert inlets of these 12 sites every 5 to 10 minutes. In order to aid in resolution of water level entering the culvert inlet, aluminum weirs (Figure 2), were attached to each of the 12 inlets. Each weir was marked with lines indicating centimeters of water flowing over the weir. During the summer and fall of 2011, hand measurements of flow rates and stage were taken to develop rating curves for the purpose of deriving calculated discharge measurements for all ISCO recorded stages. Two rating curves were developed, one for stages of ≤ 10 cm and one for stages of > 10 cm (Figure 3). At 5 selected sites, a HOBO rain gauge was installed to monitor precipitation. The precipitation data from these 5 sites were used for all

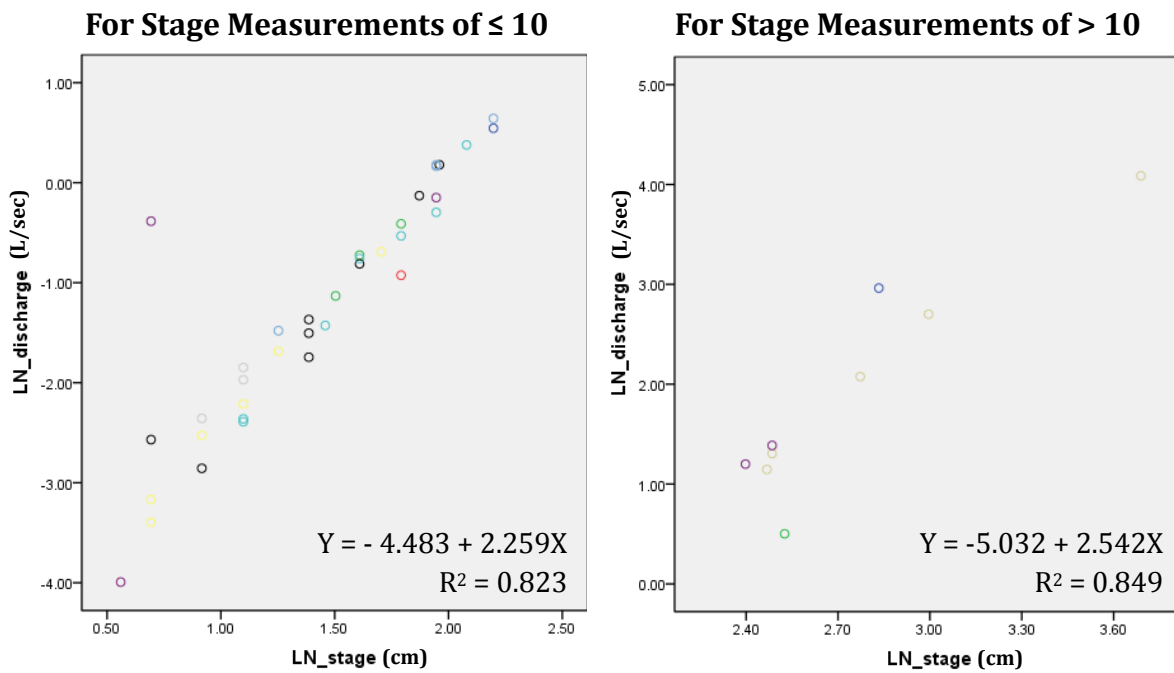
Figure 3. Rating curves correlating stage (cm) and discharge (L/sec) for stage measurements of ≤ 10 cm and > 10 cm.

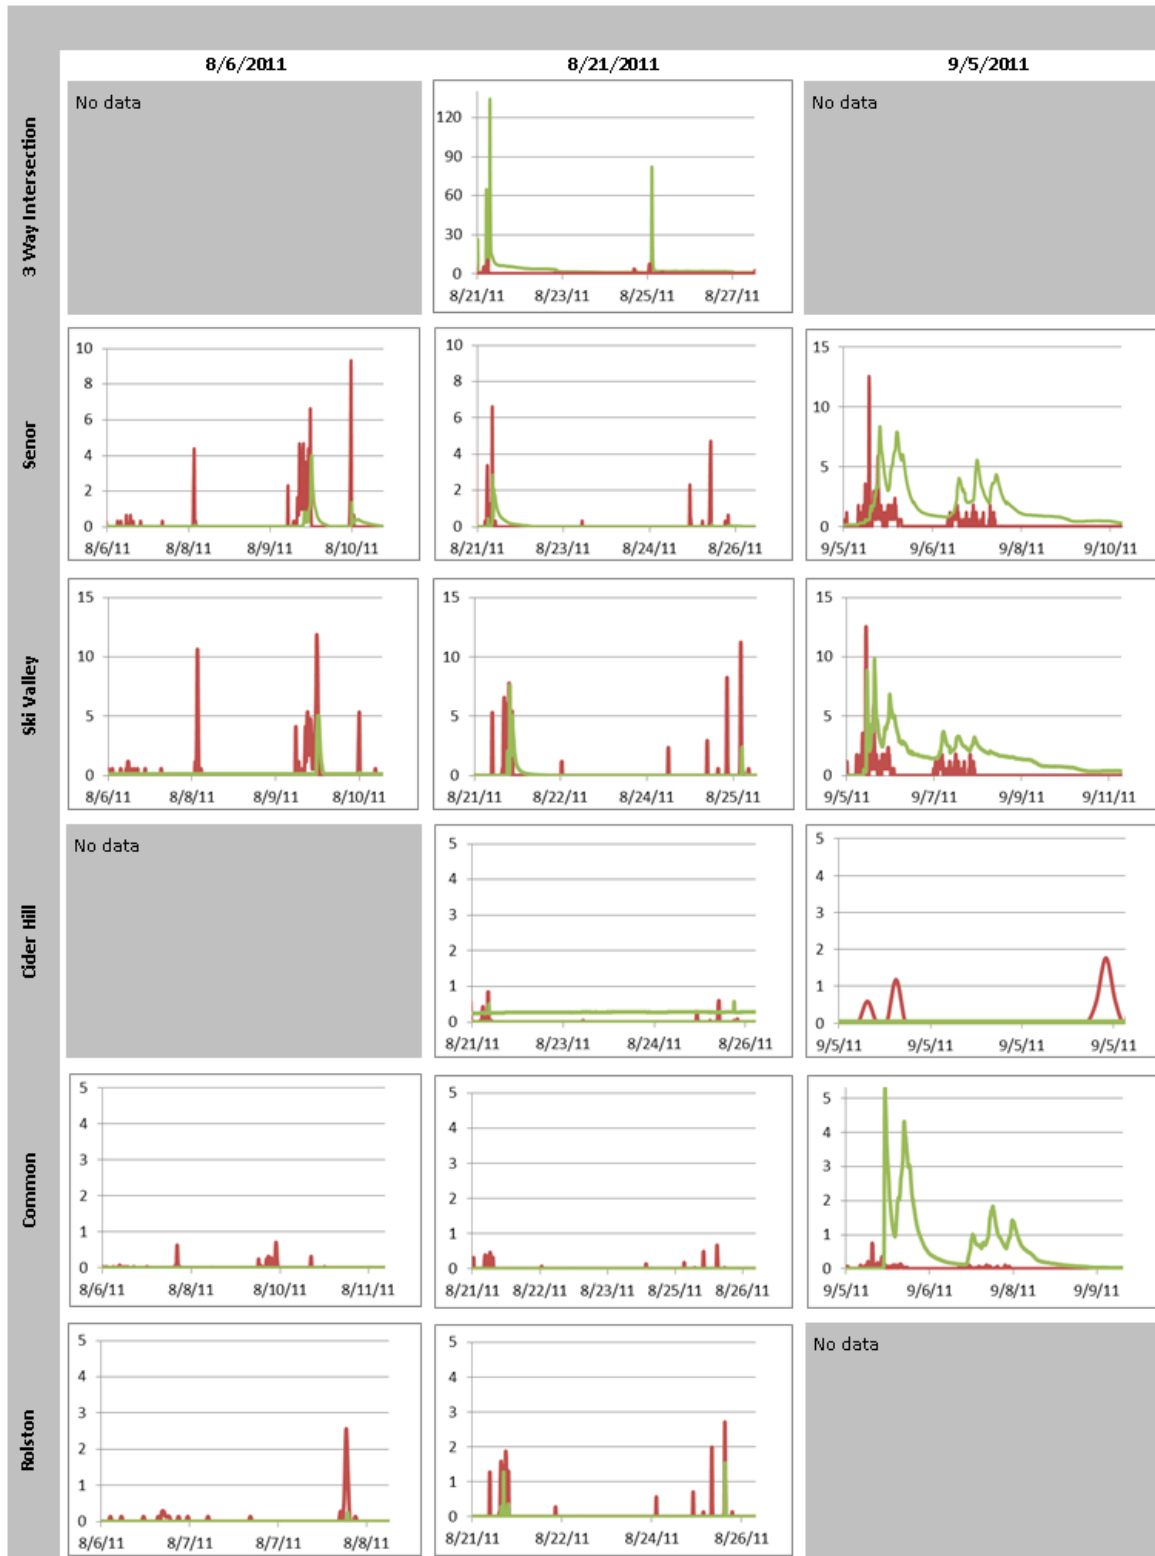
Figure 4: Graphs illustrating total measured runoff (L/sec) in green lines and simulated road surface runoff (L/sec) in red lines using the rational method for selected storms and sites monitored during Summer 2011.

The evaluated sites displayed diverse responses to individual storm events ranging from 0.74 to 6.38 centimeters (Figure 4, 5; Note that Randell was removed from these figures as data was not available for the storm dates used here). Figures 4 and 5 represent a sampling of the storms measured in 2011 and 2012 and display the results of a comparison of measured versus simulated runoff. While it is difficult to draw conclusions from this limited sampling, some possible trends can be seen upon a visual examination of the plots in Figures 4 and 5.

Five of the 11 sites for which modeled and measured runoff were compared (Senor, Ski Valley, Common, Rolston, and Barton) displayed modeled runoff responses that were consistently greater than the measured runoff during summer months, but lower than measured runoff during fall months. Four of these five sites (all but Rolston) were observed to have seepage or overland flow inputs coming from adjacent land. Since there were known flow inputs from adjacent lands, it seems reasonable to conclude that the antecedent moisture of the adjacent land may have resulted in these seasonal variations. During the summer, when there was low antecedent moisture, more rainfall was absorbed by the adjacent land, and therefore, less seeped into their neighboring roadside ditches. In the fall, when antecedent moisture was greater, the land was able to reach a saturation level, above which water was available to flow to the roadside ditches. Cider Hill, Mansfield, Sharpshooter, Bragg Hill, and North Fayston all displayed similar measured and modeled runoff curves. Of these five sites, four (Cider Hill, Mansfield, Sharpshooter, and North Fayston) were not observed to have any seepage points, although Cider Hill and Sharpshooter had a regular low volume baseflow. At the Bragg Hill site, minor seepage was possible through a drainage pipe, which was directed to the ditch from the upland residential property. Although some seepage was observed, the inputs at these five sites appeared to be relatively minor compared to those at the sites with seasonal variations cited above.

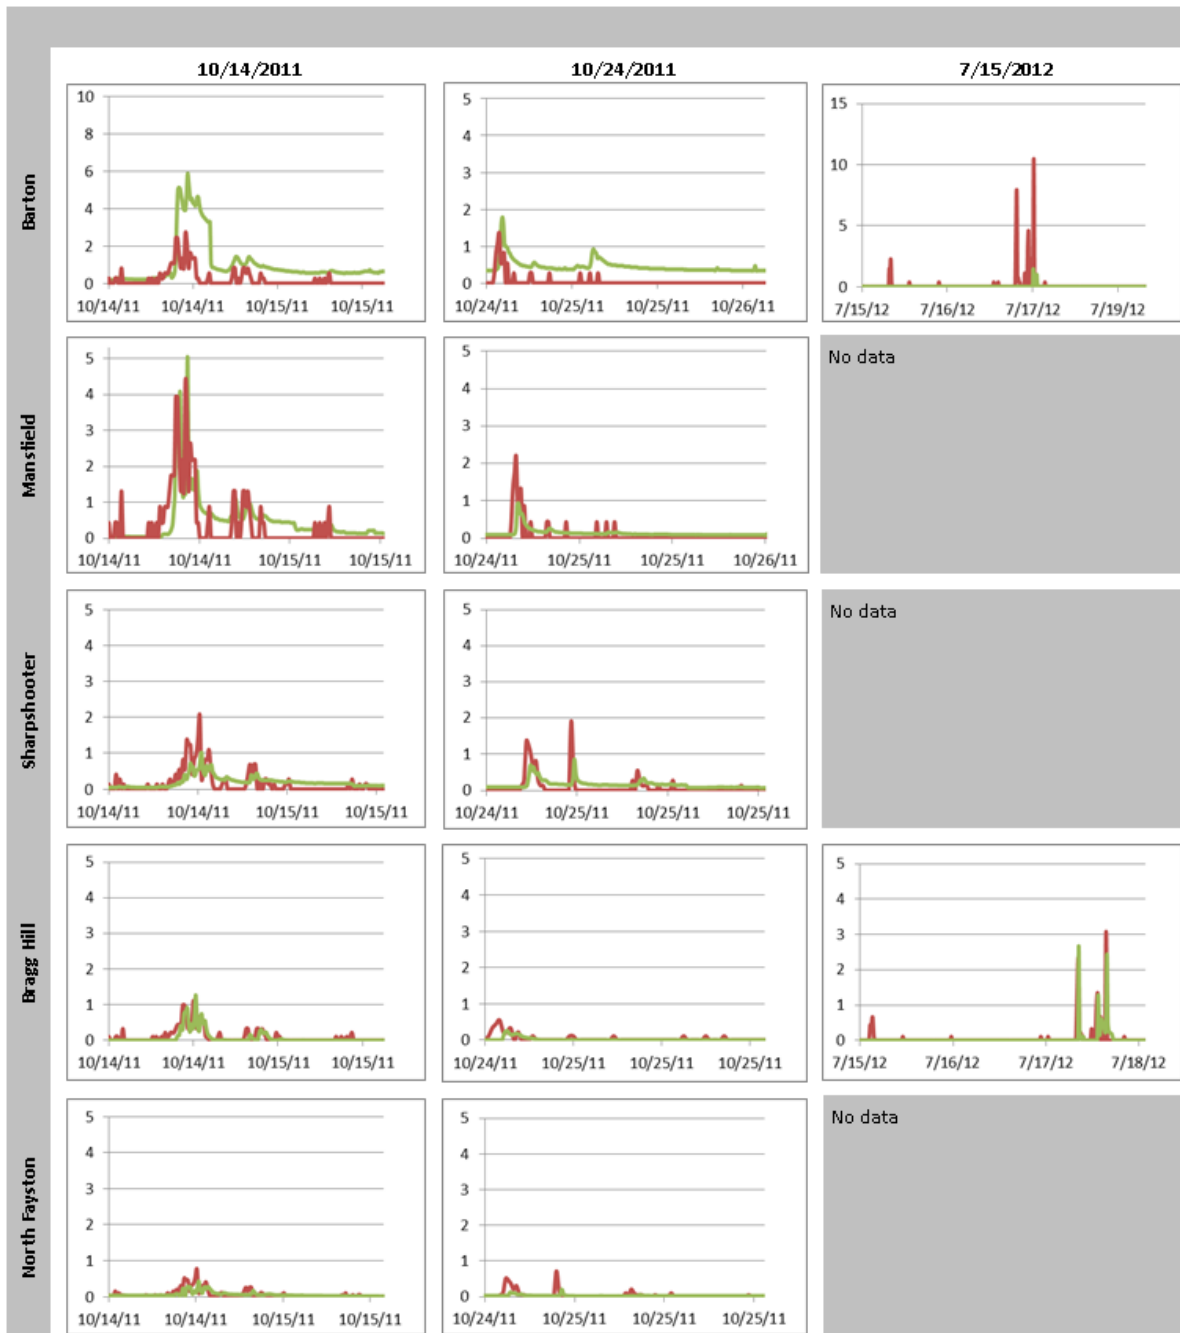
Figure 5: Graphs illustrating total measured runoff (L/sec) in green lines and simulated road surface runoff in red lines using the rational method for selected storms and sites monitored during Fall 2011 and Summer 2012.

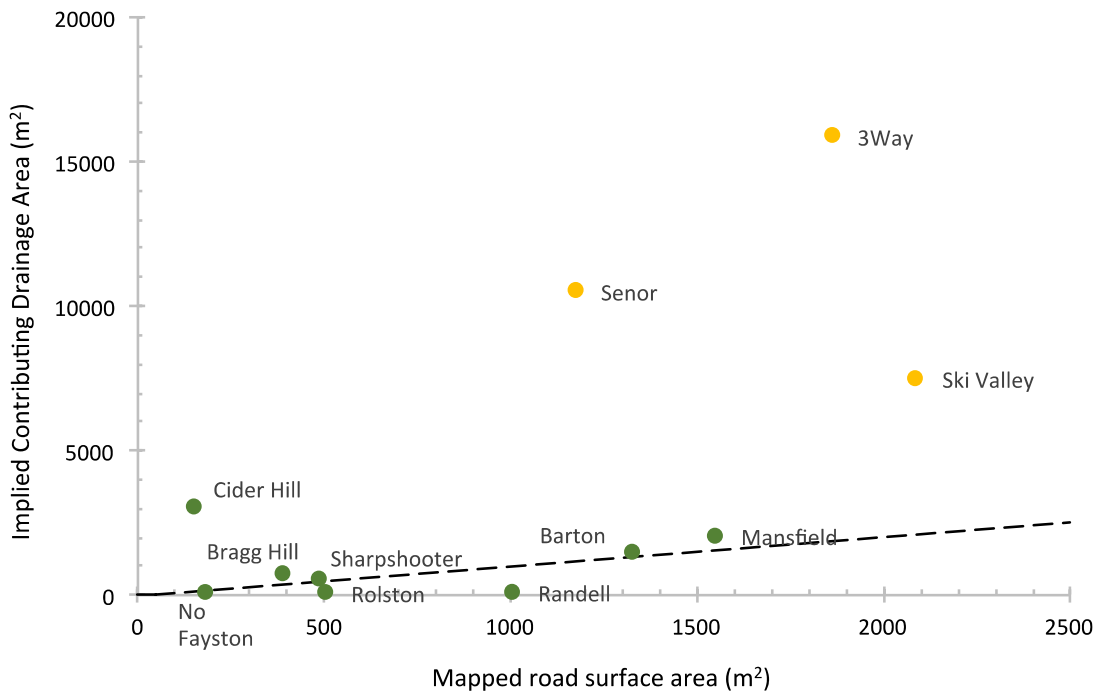
Figure 7: Plot of mapped road surface area (m²) versus “implied contributing drainage area” derived from the linear regression slopes of Figure 6. Units of the y-axis are inferred to be in m² based on units used in the linear regression described with Equation (2). Yellow points have agricultural adjacent land cover or have significant cleared portions of adjacent land; green points have forested adjacent land cover (see Table 3). Common Road is not displayed. Dotted line is 1:1.

Collectively, observations from the monitored sites show that road surface contributing area is often, but not always a good predictor of the rainfall-runoff relationship on roads examined for this study (Figure 7). Seven of the eleven sites studied exhibited rainfall-runoff relationships that were predicted rather closely by the mapped surface area of the road draining to the measured culvert, indicating that the impervious surfaces of the road are the primary source of runoff measured. Four of the sites (3-Way Intersection, Ski Valley, Senor, and Cider Hill) had runoff volumes that far exceeded contributions from the road surface alone, indicating the importance of seepage from the cutbank or drainage from the adjacent hillslope to measured runoff on road sites. Three of these four sites had adjacent land uses that were agricultural or predominantly cleared (3-Way Intersection, Senor, and Ski Valley). In addition to the unique land uses adjacent to these sites, each were observed to have obvious seepage inputs. It is not clear why Cider Hill's linear regression slope, at 3,060.2 is greater than one order of magnitude more than the mapped drainage area of 149.78 square meters, as no seepage points were directly observed at this site, however it is possible that groundwater inputs drew from a greater drainage area as a low-level baseflow was regularly observed at this site. One site, Common Road, yielded little runoff throughout the study period, except during tropical Storm Irene, and during the storm that occurred on 9/5/2011, when a veritable stream broke through from the ditch on the road located on the upper side of a hayfield, connecting an entirely new drainage area to the original mapped road surface drainage area (Appendix 1).

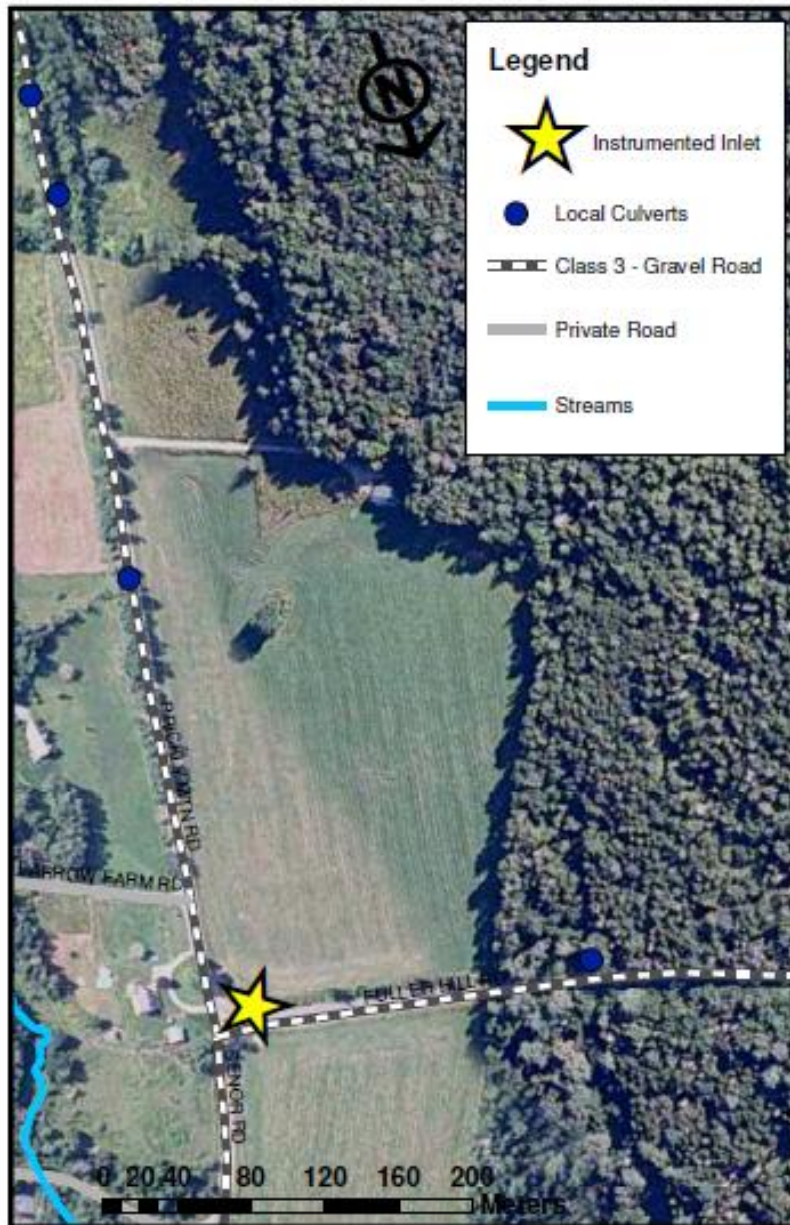
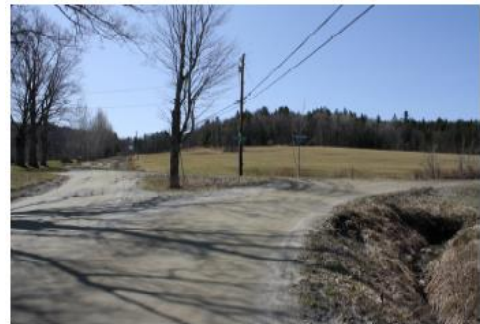
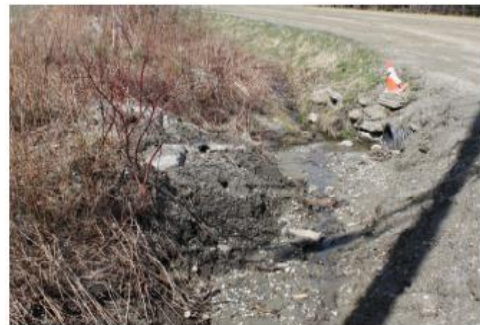
The monitoring station at the **3-Way** intersection of Prickly Mountain, Fuller Hill, and Senor Road is located in the Freeman Brook subbasin in the town of Warren, Vermont. These three roads are all Class 3, gravel roads, maintained by the town of Warren. The instrumented inlet sits just below an agricultural field, approximately 14 acres in size, with a residential home at the far upper side of the field. The drainage area for this site extends from an elevation of 1398 feet at the inlet, to 1478 feet at the uphill culvert to cross Prickly Mountain Road (elevations derived from a 30 m DEM). Prickly Mountain Road, the inlets primary channel for runoff, averages 7.9 meters wide and is crowned, resulting in approximately 3.95 m of road width draining to the inboard ditch. Fuller Hill Road averages 7.8 meters in width, and is also crowned, resulting in 3.9 m of road width draining to the inboard ditch. The monitored culvert drains runoff along a 238.5 m segment of Prickly Mountain Road and a 138.5 segment of Fuller Hill Road; the former having a roadside ditch averaging 0.2 m in width and the latter roadside ditch averaging 2.4 m in width. Together the road surface and ditch drainage area total 1862.3 m². A farm pullout from the field to Prickly Mountain Road may contribute runoff from the field during intense storm events, and seepage was observed directly from the field near the inlet point during several storm events in the summer and fall of 2011. The road grade is 8% along Prickly Mountain Road leading to rapid transmission of runoff and minor incising of the ditch, and 1% along Fuller Hill Road. At the culvert outlet, runoff is discharged into a wide bare ditch which eventually discharges to a stream which discharges to Freeman Brook. Automated monitoring on this site took place from July 7, 2011 to August 2, 2011, August 18, 2011 to September 9, 2011, and from April 22, 2012 to July 26, 2012.

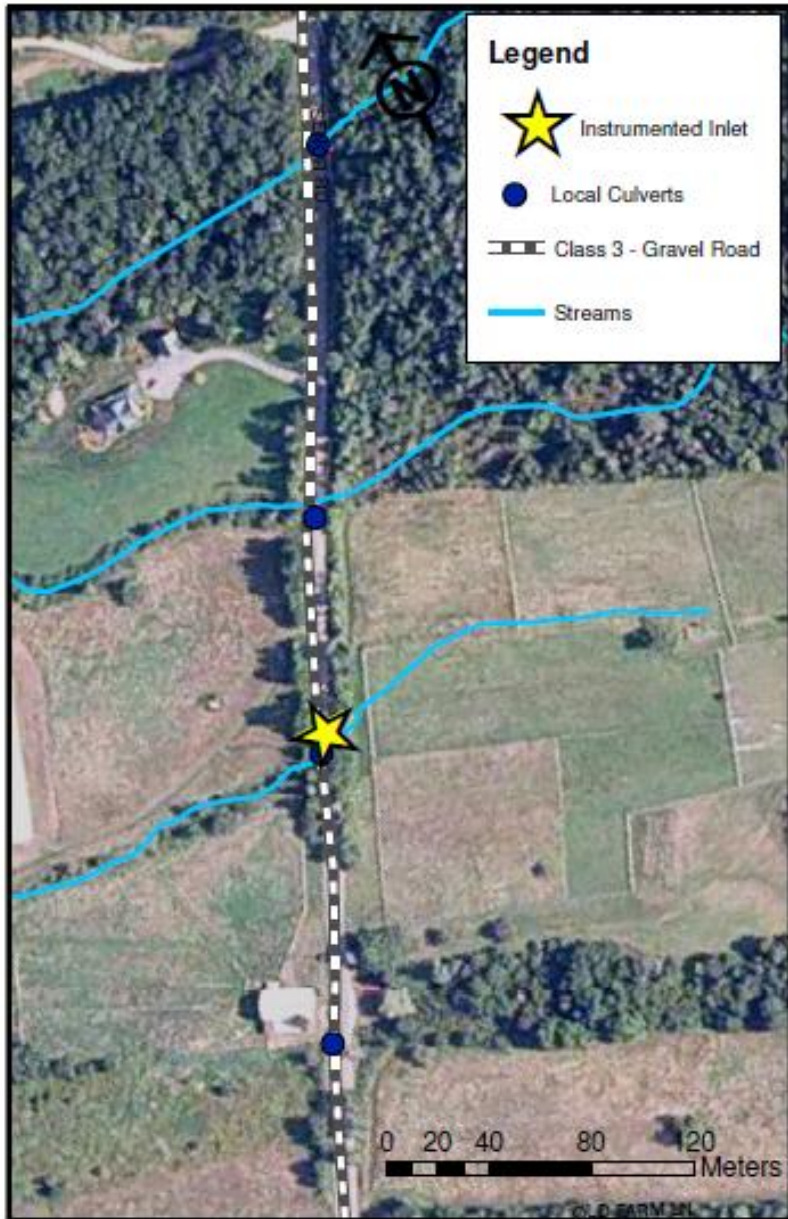
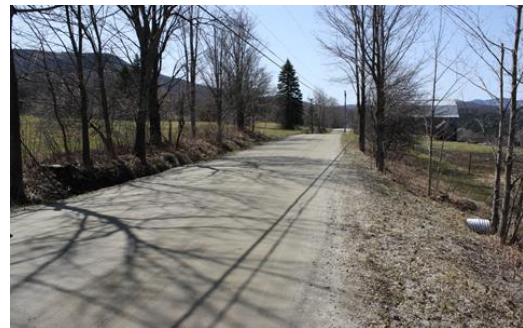
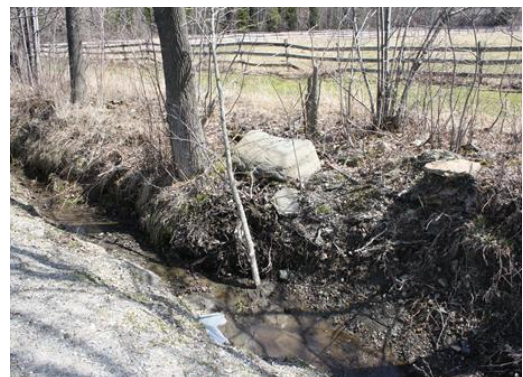
The monitoring station on **Senor Road** is located in the Freeman Brook drainage in the town of Warren, Vermont. The monitored segment of Senor Road is a relatively flat, Class 3, gravel road, the majority of which transects two agricultural fields with a 50 m segment passing through a forested patch of land on the inlet side, and with a 10 m forested buffer on either side of the agricultural segment. The instrumented inlet is at a low point, at an elevation of 1472 feet, where it receives runoff from both the north and south sides which rise with gentle slopes to 1478 feet in the northern direction and to 1472 to the south (an undetectable elevation difference in the 30 m DEM). The road averages 7.3 meters in width and is slightly crowned, resulting in 3.65 meters of the road width draining to the inboard ditch. The monitored culvert drains runoff along a 149.5 m segment to the north and a 49.5 m segment to the south. The adjacent roadside ditch for the north and south segments average 2.2 meters and 2.4 meters in width, respectively. The total contributing road surface and ditch drainage area is 1174.05 m². At least five seepage points were observed, one originating from overland flow, in the fall of 2011 during a minor storm event under wet conditions indicating an additional unmeasured contributing drainage area directly adjacent to the road. Little to no seepage was observed during drier summer condition of 2011. The road grade is 2.5% in the northern direction and 0.5% in the southern direction. At the culvert outlet, runoff is discharged into another agricultural field along a tree-lined ditch, and appears in the Vermont Hydrography Dataset Streams layer to eventually discharge to Freeman Brook. Automated monitoring on this site took place between July 7, 2011 and September 24, 2011.

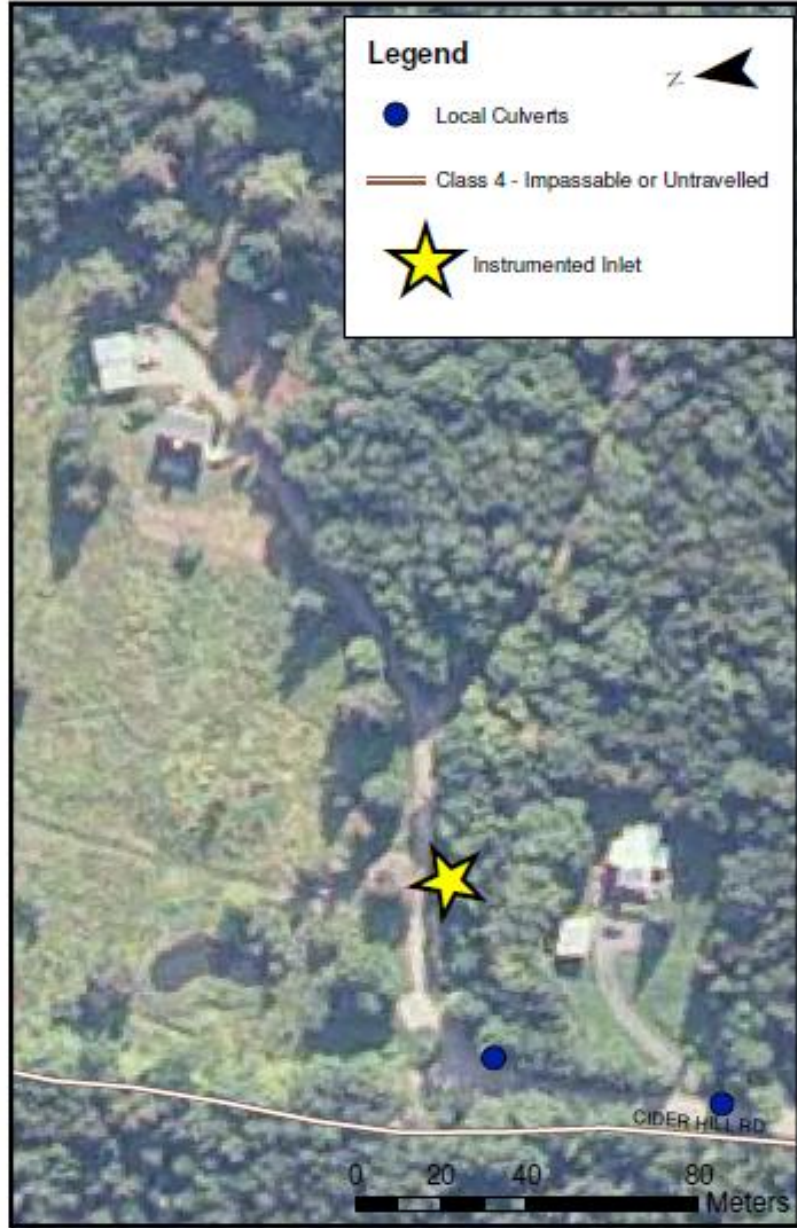
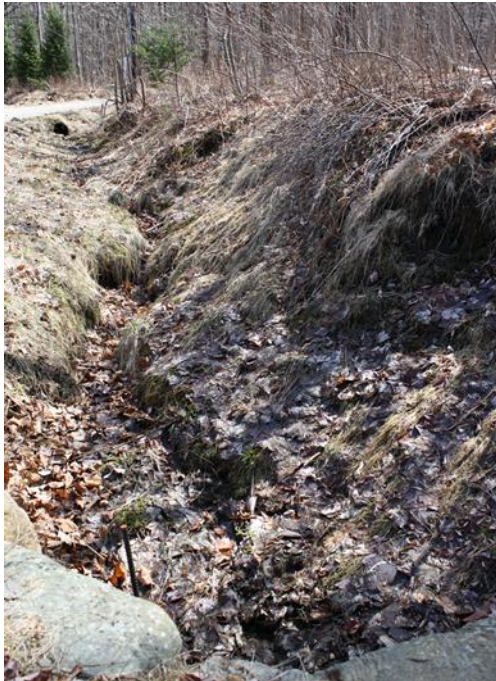
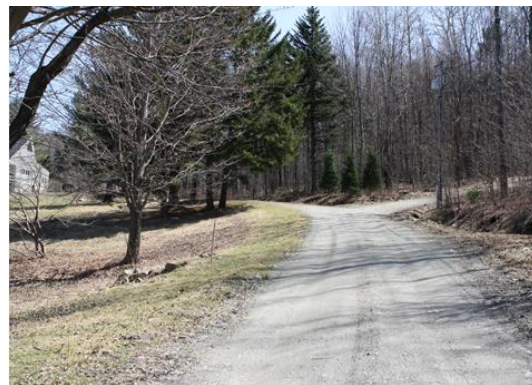
The monitoring station on **Cider Hill Road** is located in the Folsom Brook drainage in the town of Warren, Vermont. The road is a private, Class 4, gravel road which transverses a forested area to the south and a field to the north. Just east of the instrumented inlet, the road splits with a driveway leading to a residential building used as a second home to the northeast and an extension of the private road to the southeast. The elevation rises from 1592 ft. at the inlet to 1624 at the highest drainage point in the northeast direction and 1617 ft. at the highest drainage point in the southeast direction. The upper northeast and southeast roads are both slightly crowned and average 4.3 m and 3.8 meters in width, respectively, resulting in 2.15 m and 1.9 m of road width draining to the instrumented inlet, with respective drainage lengths of 43.3 m and 6.8 meters. The northeast road also has a grassy roadside ditch averaging 1 meter in width above the side road, and 1.3 meters below the side road, leading to a total ditch and road surface drainage area of roughly 149.8 m². A source of seepage was not observed at this site, but a minor amount of groundwater did lead to a moist inlet area even during dry seasons. The road grade is 10% on the northern road and 16% on the eastern, resulting in significant rills on both. At the culvert outlet, runoff is discharged into a field from which it flows to a pond. Automated monitoring on this site took place from August 18, 2011 to October 7, 2011 and from April 23, 2012 to June 28, 2012.

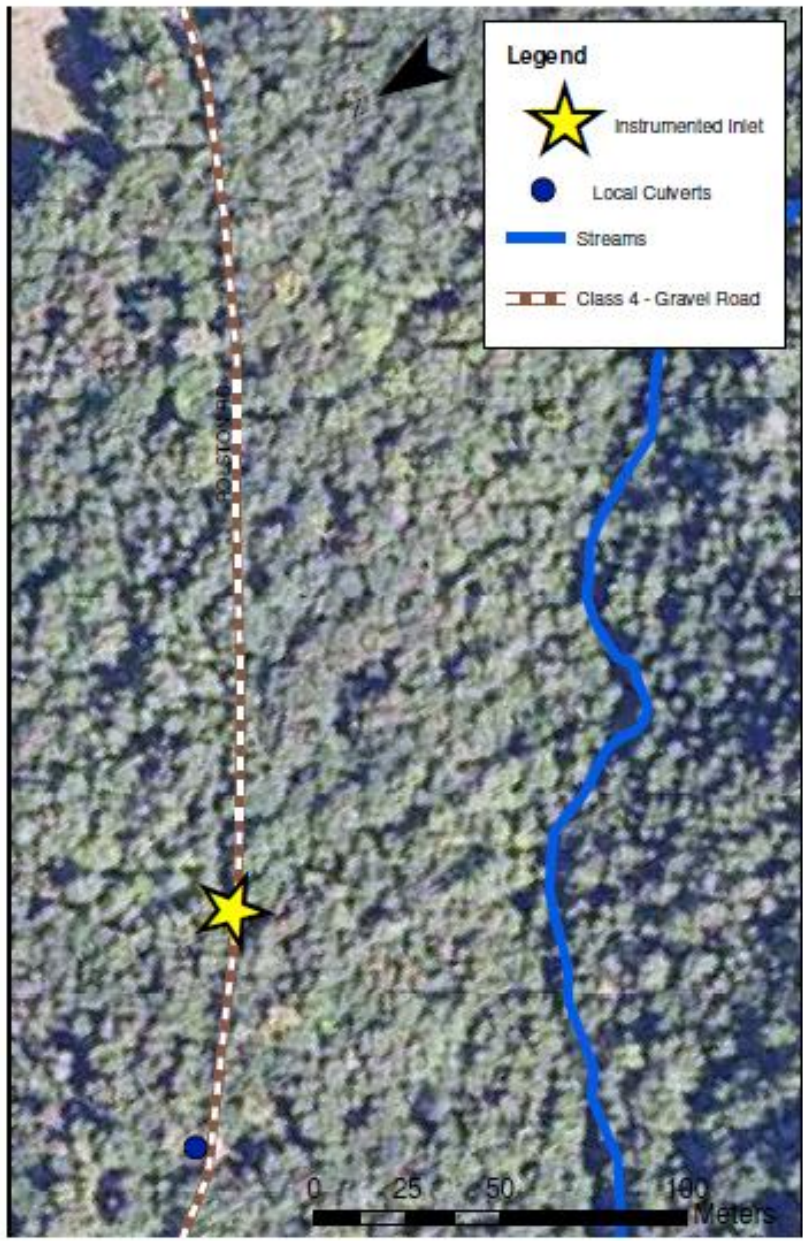
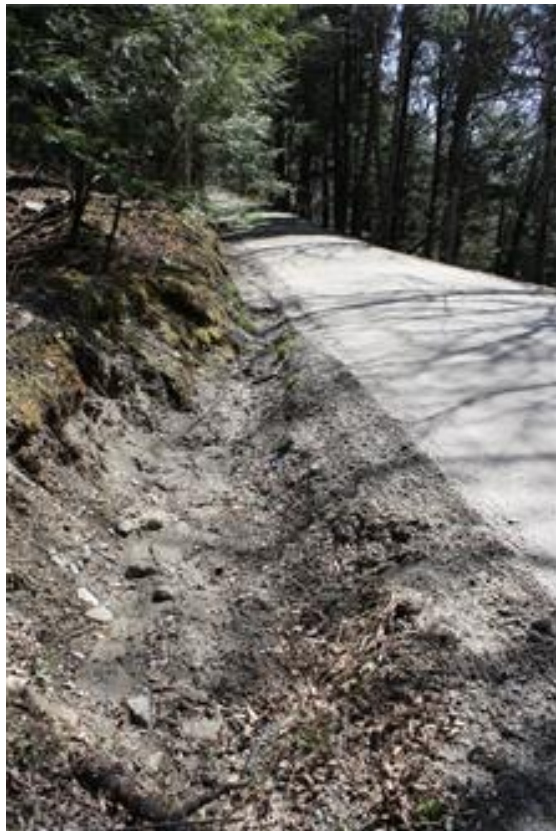
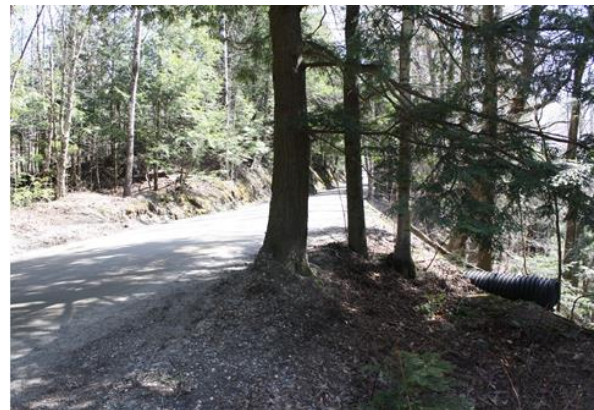
Rolston Road is a steep, Class 4, gravel road. This monitoring station is located in the Folsom Brook watershed in the town of Waitsfield, Vermont. Rolston Road is a cutslope road which is located on the side of a steep hill with a densely forested area to the north and a very steep forested area to the south. The road segment draining to this site rises from an elevation of 981 feet to 1029 feet, 138 meters upslope where drainage to the monitored inlet begins. The road averages 5.9 meters in width and is crowned resulting in roughly 2.95 meters of road width draining to the inboard ditch with a weighted average width of roughly 0.7 meters. The resulting total drainage area including ditch and road surface area is 503.9 m². For much of the 138 meter road segment the upper road bank is largely bare or moss-covered, leaving much of it very susceptible to erosion. The road grade is 12% along the monitored segment, resulting in rapid transmission of runoff from the road surface and ditch to the inlet and sedimentation was so prevalent at this site that are equipment was regularly clogged and/or buried between site visits in the summer of 2011. At the culvert outlet, runoff is discharged onto a steep forested bank where runoff may, during intense storm events, flow directly to Folsom Brook, approximately 90 meters below. No seepage was observed over the one-month period of automated and manual monitoring that took place between August 1, 2011 and September 1, 2011.

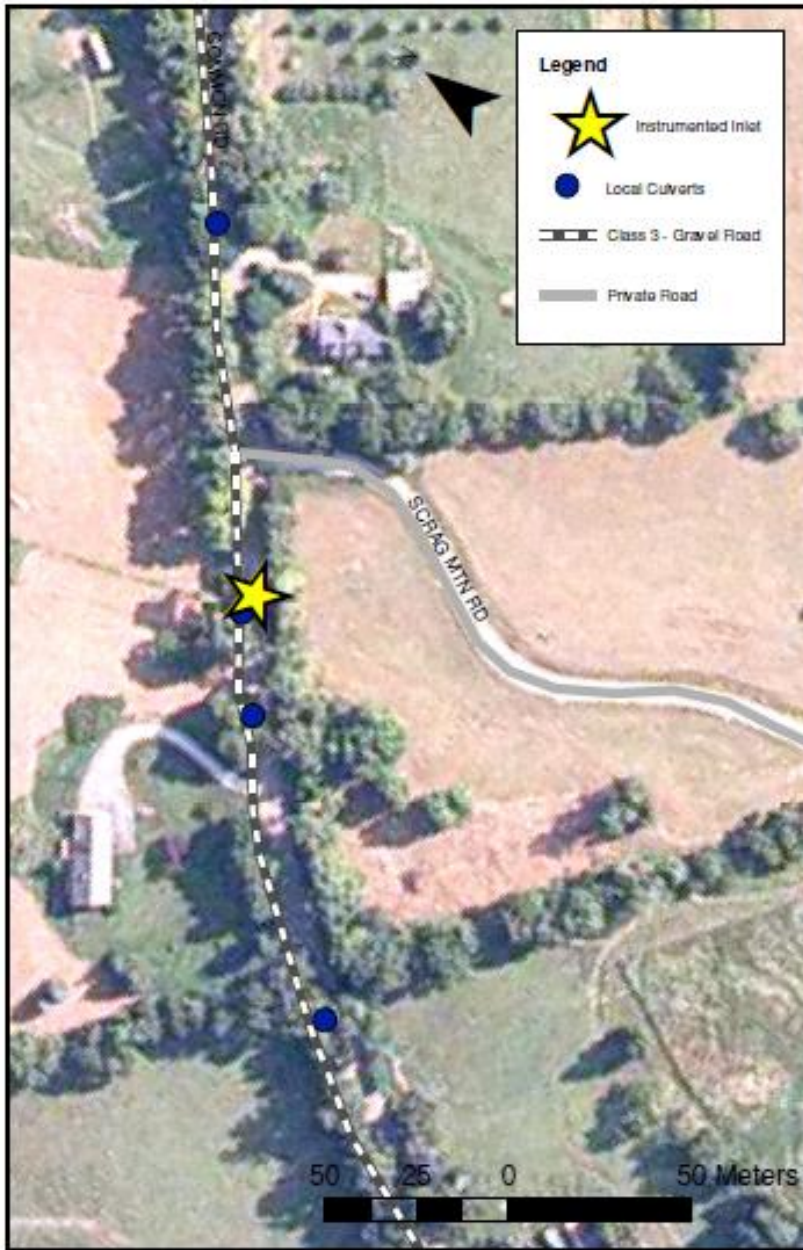
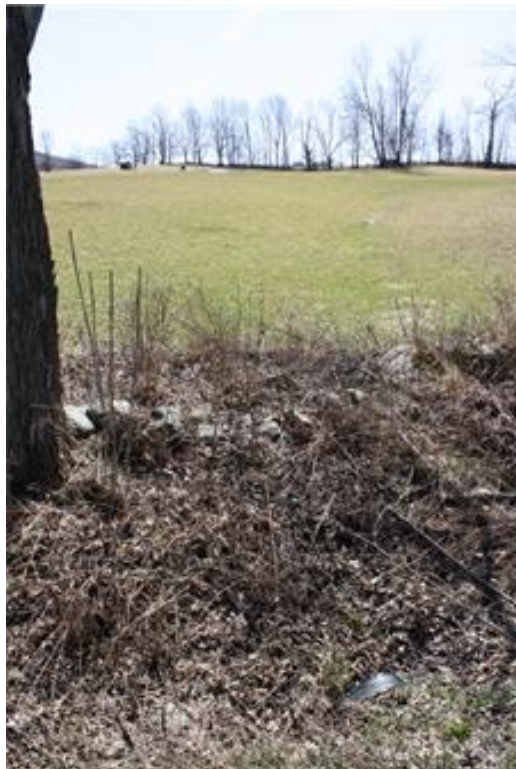
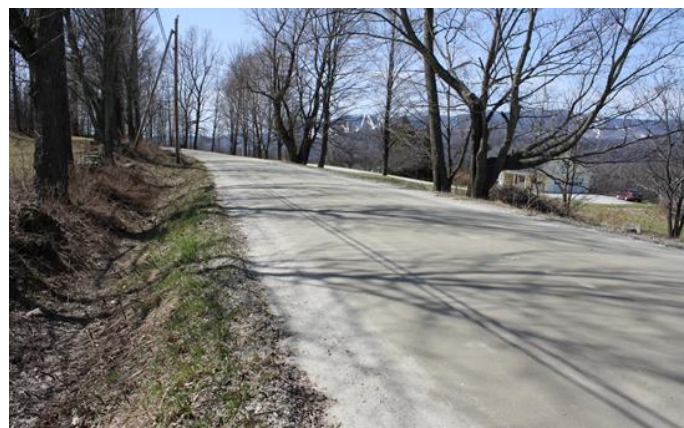
Common Road is a relatively flat, Class 3, gravel road. The monitoring station is located in the High Bridge Brook drainage in the town of Waitsfield, Vermont. This segment of road, mimics Senor Road in that it transects two fields with an approximately 10 meter tree-line roadside buffer. The inlet rests at 1227 feet and rises to 1244 feet at the height of the southeastern end of the road segment. The road averages 7.7 meters in width, and is crowned, resulting in roughly 3.85 meters of road width draining to the inboard ditch. The monitored culvert drains runoff along a 15.5 m stretch of road, and the adjacent roadside ditch averages 4.2 m in width, giving an estimated road surface and ditch drainage area of roughly 124.8 m². The wide vegetated ditch, short contributing road segment, and low road grade of 1.5% leads to little to no observed or measured runoff during medium to low intensity storms. High intensity storm events, however, create an entirely different, larger, unmeasured drainage area, as an intermittent stream develops from Scrag Mountain Road to the ditch (a 12% grade) which leads to the instrumented inlet. At the culvert outlet, runoff is discharged into a field with no visible connection to a stream. Automated monitoring on this site took place from August 1, 2011 to September 15, 2011 and from September 24, 2011 to September 30, 2011.

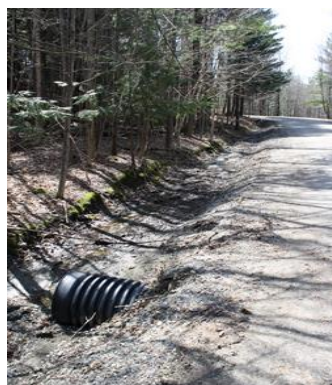
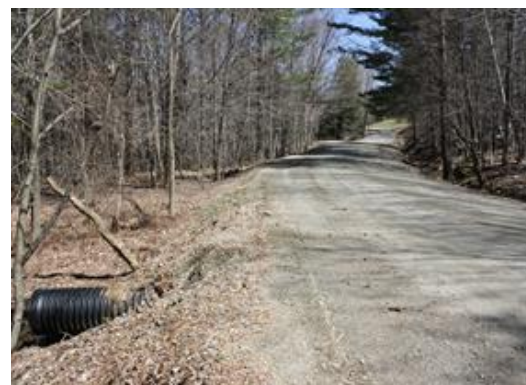
Ski Valley Road is comprised of two varieties of Class 3 roads: gravel and graded earth. The monitoring station is located in the High Bridge Brook drainage in Waitsfield, Vermont. The graded earth portion of the road passes through a densely forested area to the northwest (outlet side) and approximately 40 m of dense forest to the southeastern, upland side of the inlet. Roughly 158 m of the graded earth road that extends to either side of the inlet is relatively flat, before rising to the east for another 107 meters. At the southwest end of the flat extend of the graded earth road, the road shifts to the south and rises more steeply for another 125 meters. The elevation ranges from 1335 feet at the inlet to 1373 to the east and up to 1392 to the south. The road is crowned, and has a weighted average of 5.88 m, resulting in roughly 2.94 m of road width draining to the inboard ditch. The ditch itself has an overall weighted average of roughly 2.4 meters in width, resulting in an estimated total road surface and ditch drainage area of 2087.9 m². During storms of medium to high intensity, overland flow was observed coming through the forested area during the summer and fall of 2011. This may originate from the residential properties and roads above the inlet, on the eastern side of the 40 meter densely forested area above the inlet, but this was not visually confirmed. This overland flow indicates that there is, during medium to high intensity storm events, and larger, unmeasured drainage area beyond the road and ditch surfaces. The road grade is 5% across the 158 m flatter portion, and 10% and 12.5% at the northern and southeastern extents of the road drainage extent, respectively. The ditch surface ranges from bare gravel, to slight grassy vegetation. At the culvert outlet, runoff is discharged into a forested area where it becomes its own tributary which, after meeting with several other unnamed channels, it reaches High Bridge Brook. Automated monitoring on this site took place from August 1, 2011 to September 30, 2011.

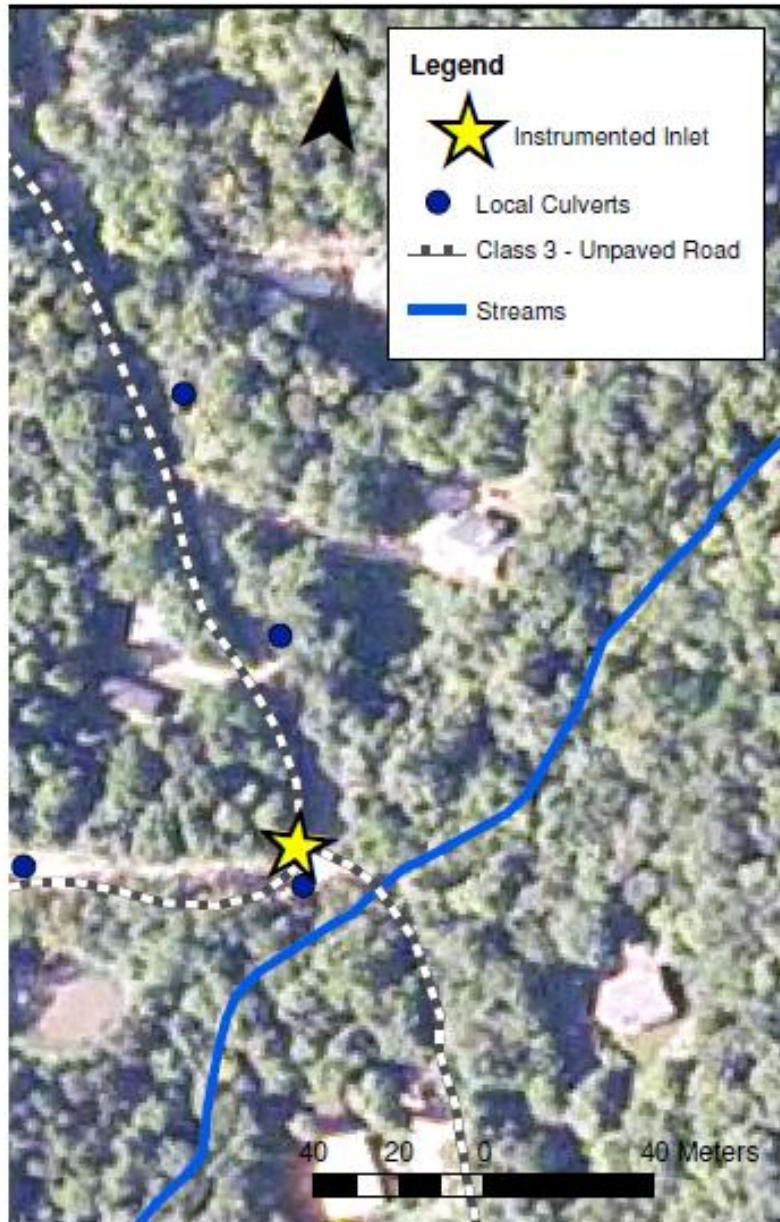
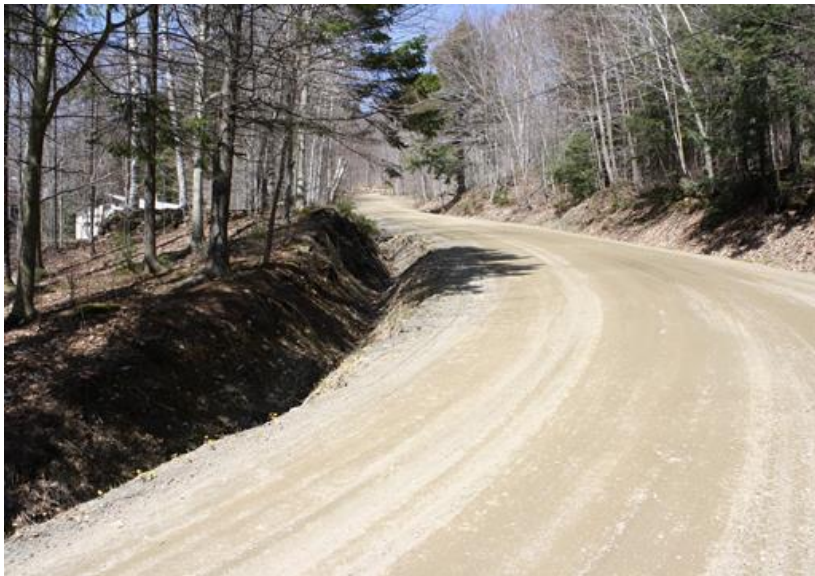
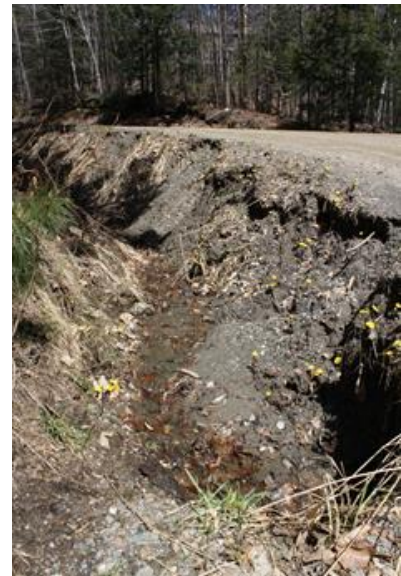
Mansfield Road is a Class 3, unpaved road located in the Mill Brook drainage in Fayston, Vermont. The road rises steeply (12% grade), through a forested area with a series of small (< 0.2 acre) clearings accommodating residential building sites, from an elevation of 1149 feet at the instrumented inlet to an elevation of 1200 feet north of a driveway to the east. The monitored inlet receives runoff directly from the western side of the road for an 89 meter length, and from the eastern side of the road for a 76 meter length due to a culvert which crosses under the road at 36 meters above the inlet. The ditch averages 2.1 meters wide on the western side and 2.0 meters wide on the eastern side. Two driveways, one on the eastern side and one on the western side, also contribute to the runoff drainage area, leading to a total ditch and road surface drainage area of roughly 1549.65 m². Automated monitoring took place between October 18, 2011 and November 11, 2011.

During this time, no seepage was observed, although researchers were not often on site during significant storm events. At the culvert outlet, runoff discharges onto a forested bank which slopes directly to a tributary of Mill Brook.

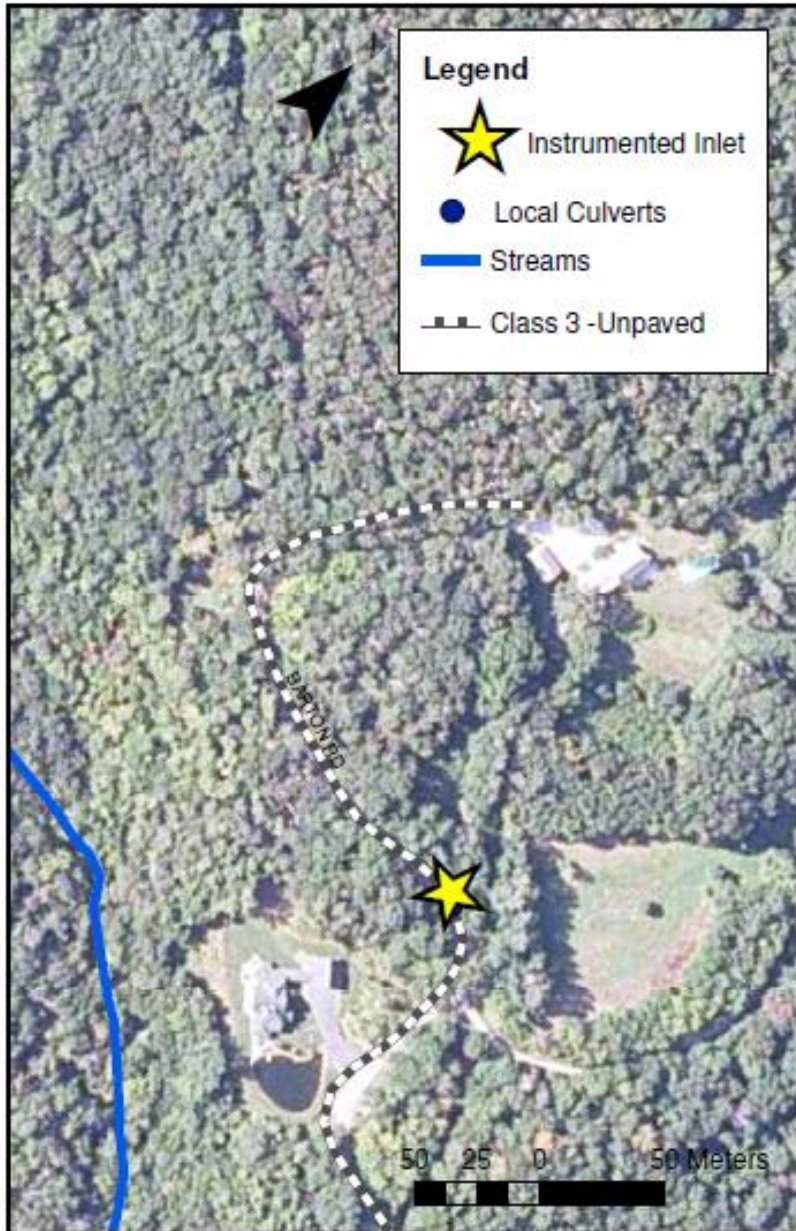
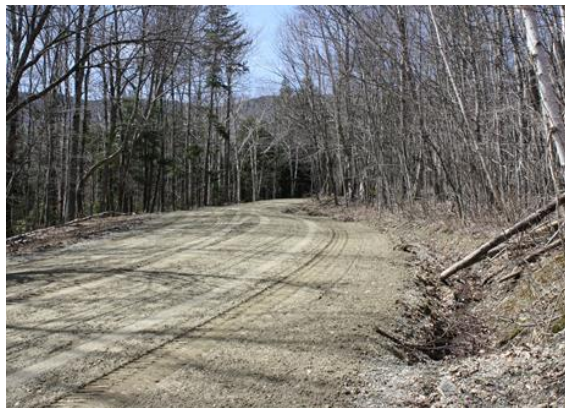
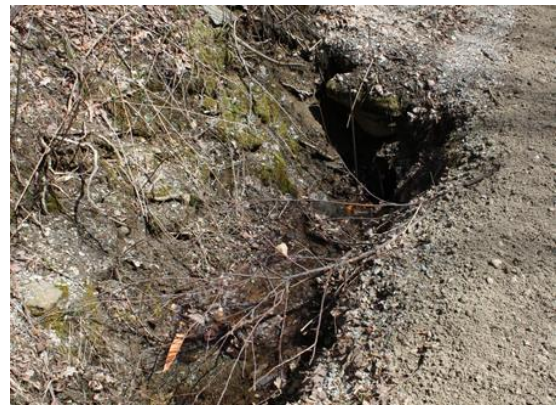
The monitoring station on **Barton Road** is located on a Class 3, unpaved road, located in the Mill brook drainage in the town of Fayston, Vermont. The road traverses a densely forested area, with a series of small (< 3.2 acre) clearings where residential buildings reside, and climbs from 1465 feet at the instrumented inlet to 1541 feet at the highest extent of the road surface drainage area, to just below a cul-de-sac driveway. The road averages 7.1 meters in width over the course of the lower 77.4 meters, and 6.3 meters in width for the upper 163 meters. The road primarily slightly crowned, with the exception of an 80 meter stretch around a corner over which the entire road surface drains to the inboard ditch. The ditch averages 2.4 meters in width over the lower 77.4 meters and 1.4 meters in width in the upper 80 meters, with no ditch along the corner or upper reaches of the road just below the cul-de-sac. This results in a total ditch and road surface drainage area of roughly 1325.4 m². One seepage point was observed during a light intensity storm under saturated conditions in December, indicating that there is a larger, unmeasured drainage area that contributes to the measured runoff at least intermittently. The road grade is 8-11% along the monitored segment, most likely leading to moderately rapid transmission of runoff from the road surface to the inlet. At the culvert outlet, runoff is discharged into a 40 meter wide forested area with no visible connection to a stream though Chase Brook is approximately 140 meters downhill of the culvert, and theoretically may be accessible by runoff during very large storm events. Automated monitoring on this site took place from October 7, 2011 to November 9, 2011 and between July 3, 2012 and July 26, 2012.
