Master's Project: Assessing Unpaved Road Runoff in the Mad River Watershed of Central Vermont

Assessing Unpaved Road Runoff in the Mad River Watershed of Central Vermont

A Master's Project Paper written by:

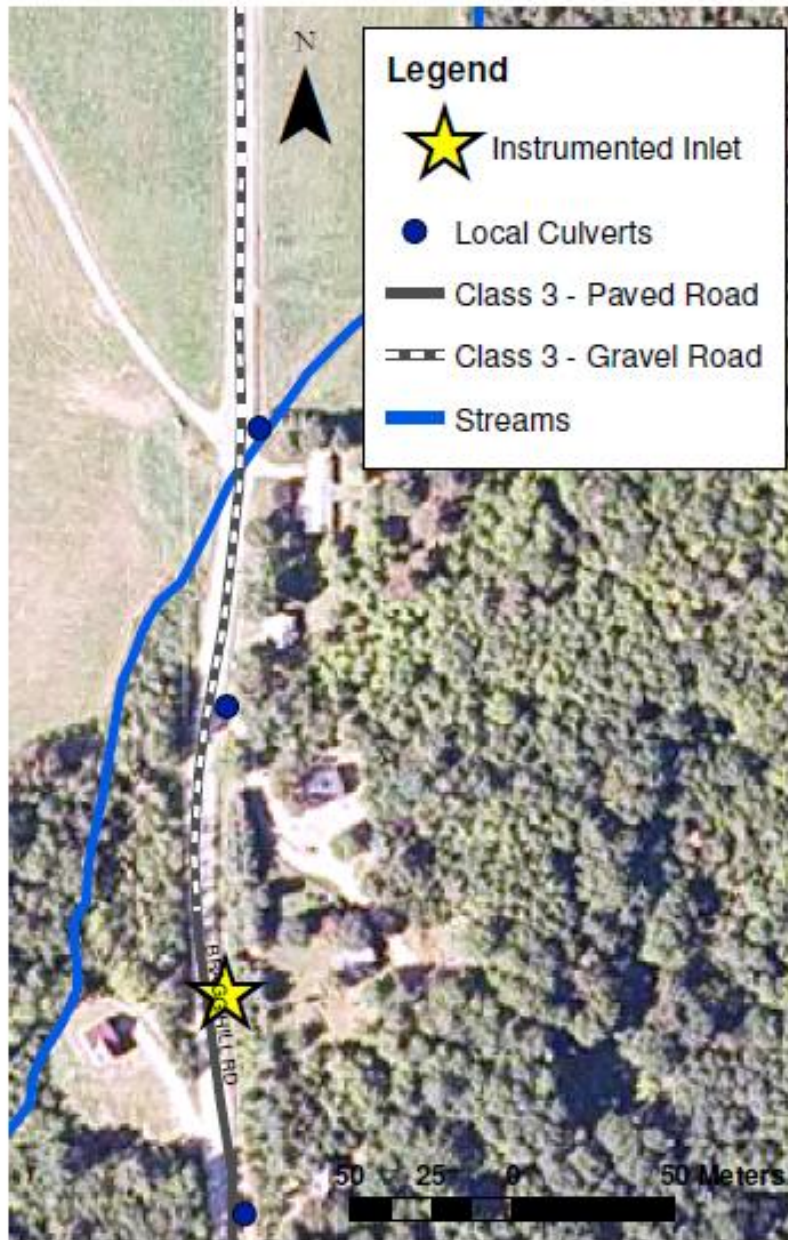
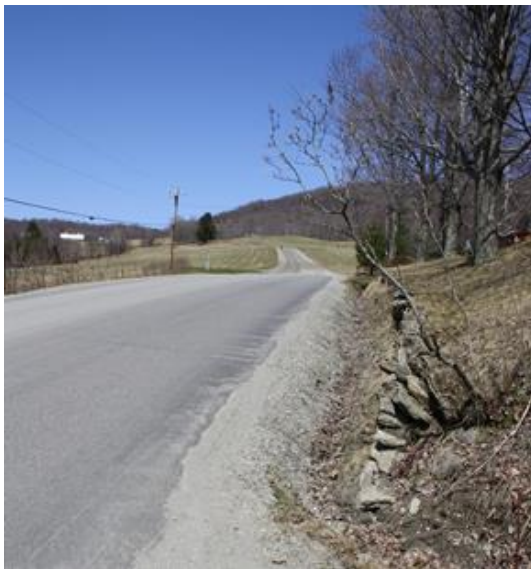
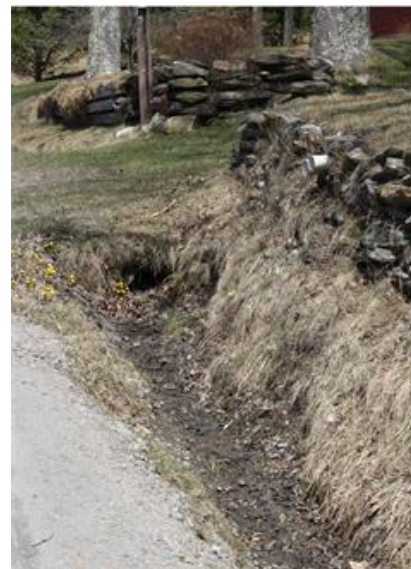
Bragg Hill Road is the one primarily paved road segment that was monitored in the fall of 2011. The monitoring station is located in the Mill Brook drainage in the town of Fayston, Vermont. The monitored road segment traverses two densely forested areas with a series of small (< 0.4 acre) clearings where residential buildings reside. The short road segment climbs from 1437 feet to 1476 feet with the paved segment extending 65 meters north before become unpaved for an additional 4 meters of the extent of the road drainage length. The road averages 8.3 meters in width, and is crowned, resulting in roughly 4.15 m of road width draining to the inboard ditch, which averages 1.5 meters in width, resulting in a total road surface and ditch drainage area of approximately 389.9 m². Under saturated conditions an average storm can lead to seepage through a buried drainage pipe located under the yard of a house on the eastern side of the road, which discharges to the monitored ditch. The road grade is 9% along the monitored segment. Automated monitoring on this site took place from October 1, 2011 to November 11, 2011.

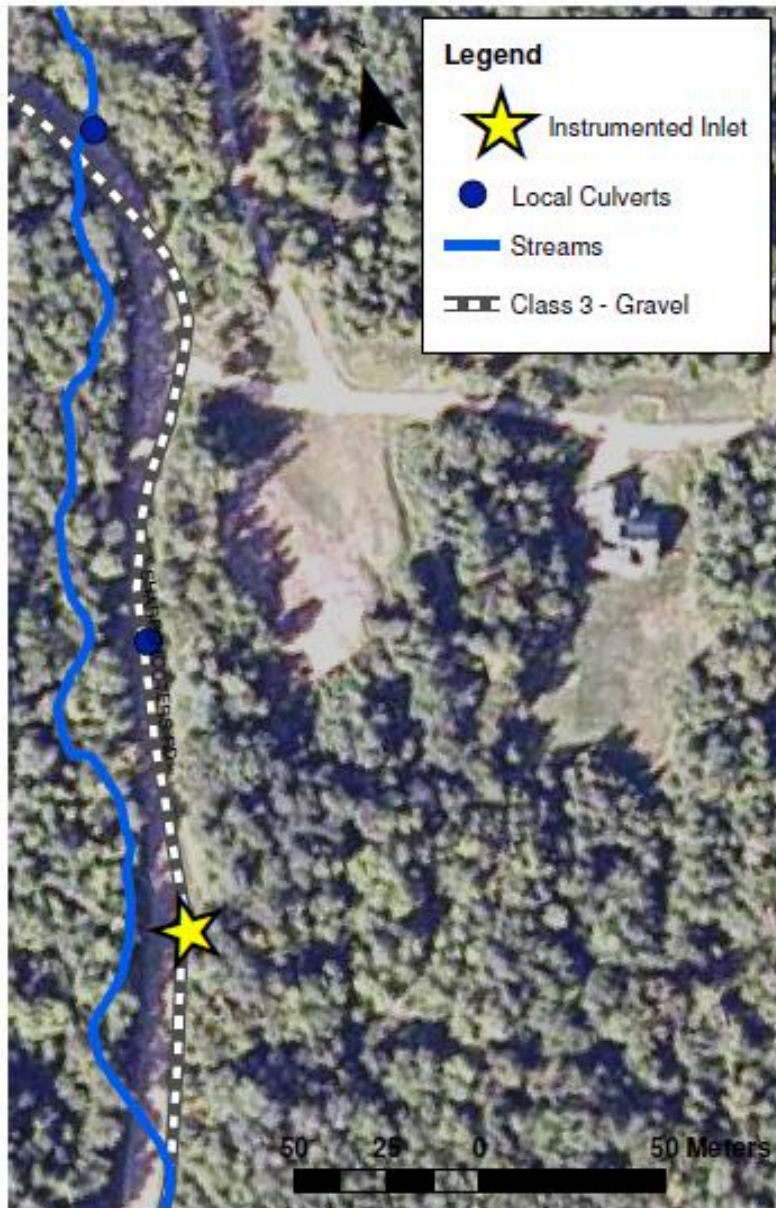
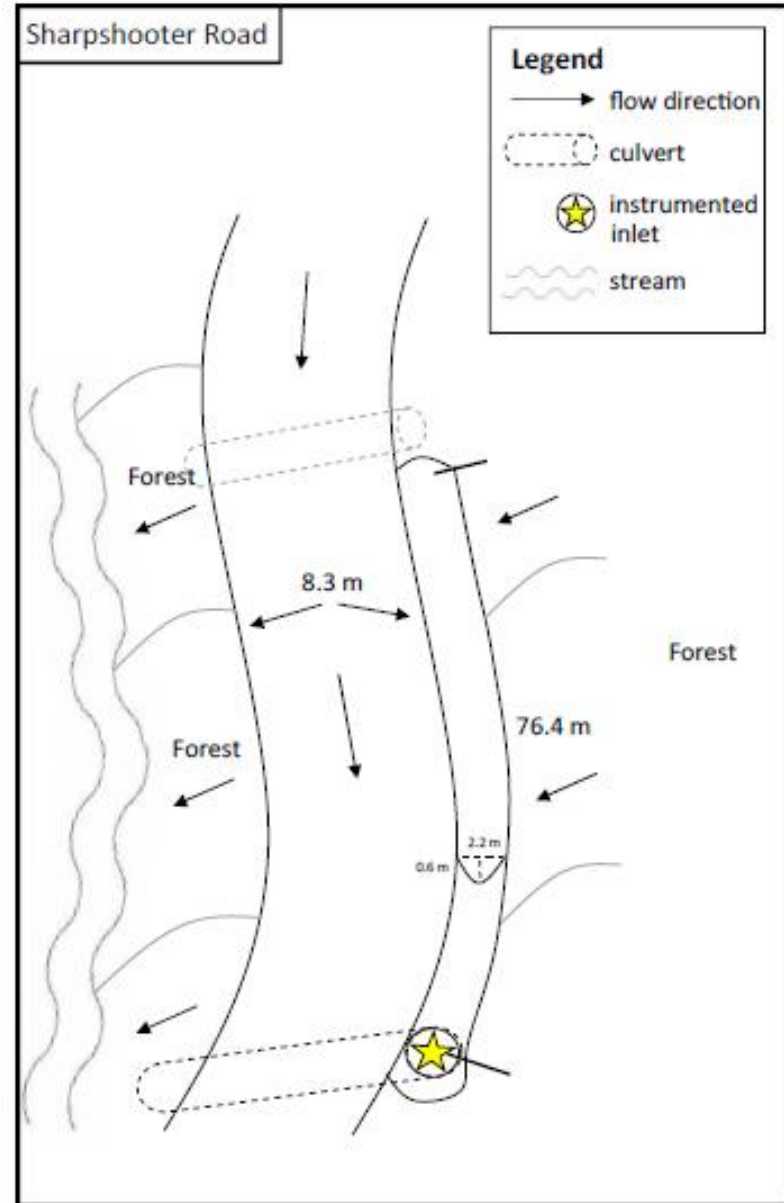
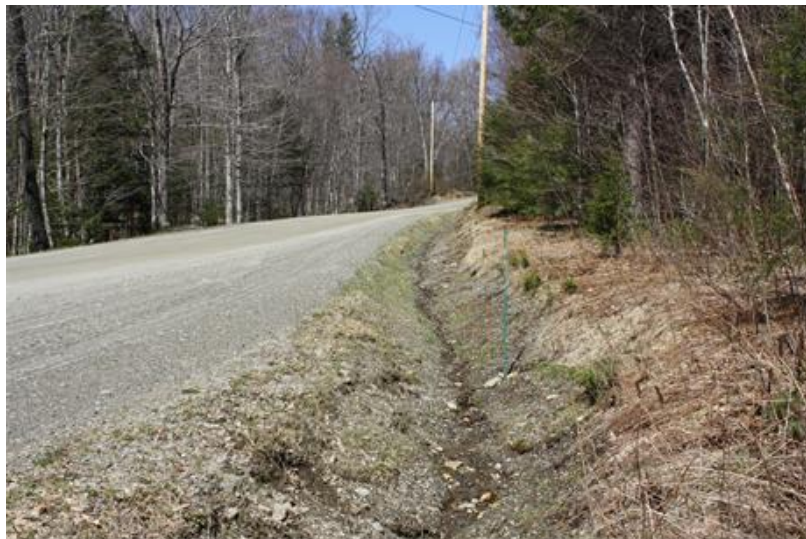
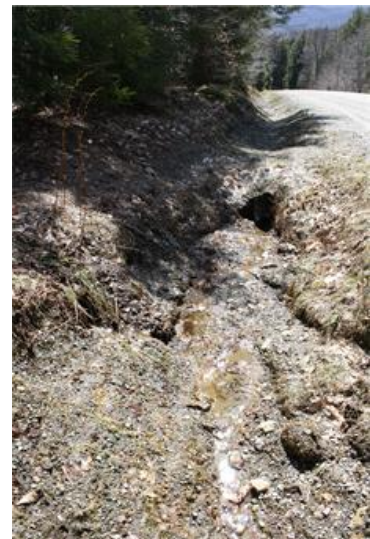
Sharpshooter Road is a Class 3, gravel road located in the Shepard Brook drainage in the town of Fayston, Vermont. The monitored segment of the road traverses a densely forested area with a few small (< 2.7 acres) clearings accommodating what appear to be residential buildings. The site climbs relatively steeply (road grade of 9%) from 1417 feet at the instrumented inlet to 1441 feet at the upper extent of the road drainage segment, 76.4 meters upslope. The road averages 8.3 meters in width, and is crowned, resulting in roughly 4.15 meters of the road width draining to the inboard ditch. The roadside ditch averages 2.2 meters in width, resulting in a total road and ditch surface drainage area of 485.1 m². The ditch is primarily bare gravel, with some slight vegetation along some segments. No seepage points were directly observed along the ditch, but a low level baseflow was frequently present during site visits throughout the fall of 2011, indicating an additional, unmeasured source of drainage beyond the road and ditch surface. At the culvert outlet, runoff is discharged onto a short (~15 meter) bank before reaching a tributary of Shepard Brook. Automated monitoring on this site took place from October 1, 2011 to November 11, 2011.

No seepage points were directly observed along the ditch, but a low level baseflow was frequently present during site visits throughout the fall of 2011, indicating an additional, unmeasured source of drainage beyond the road and ditch surface. At the culvert outlet, runoff is discharged onto a short (~15 meter) bank before reaching a tributary of Shepard Brook. Automated monitoring on this site took place from October 1, 2011 to November 11, 2011.

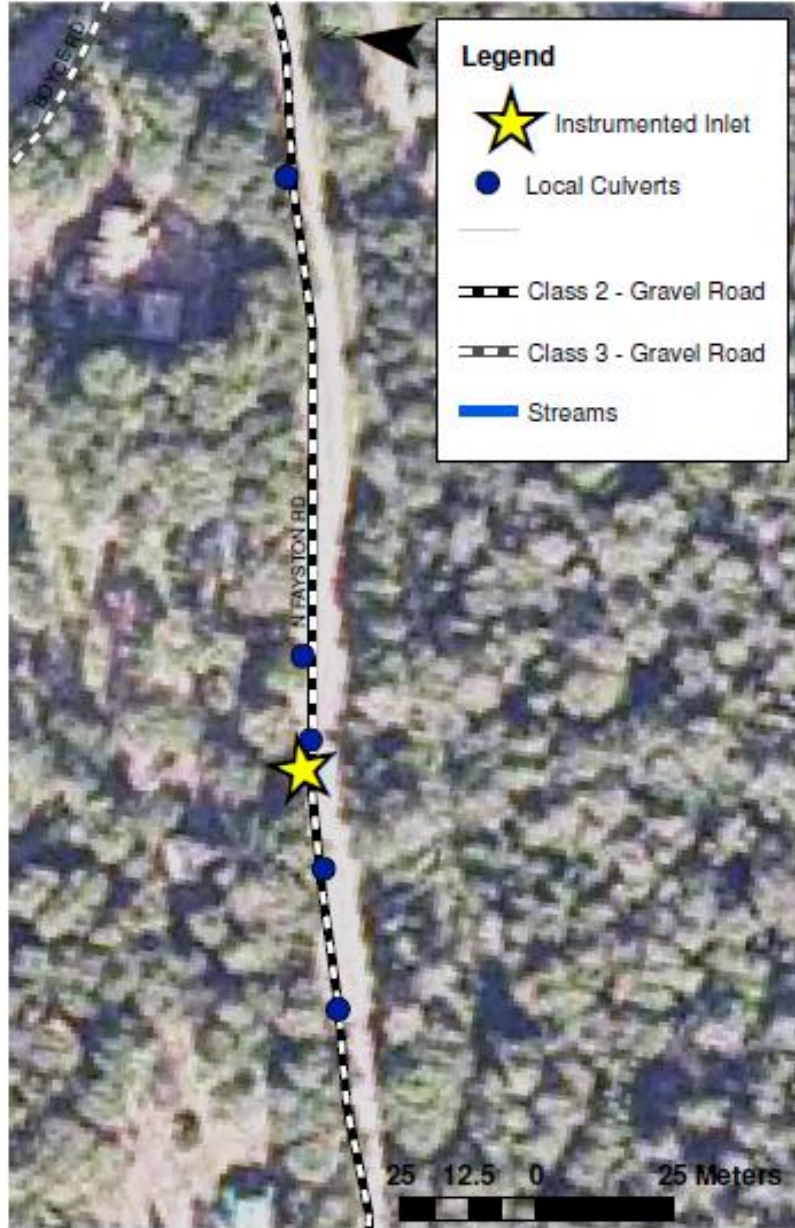
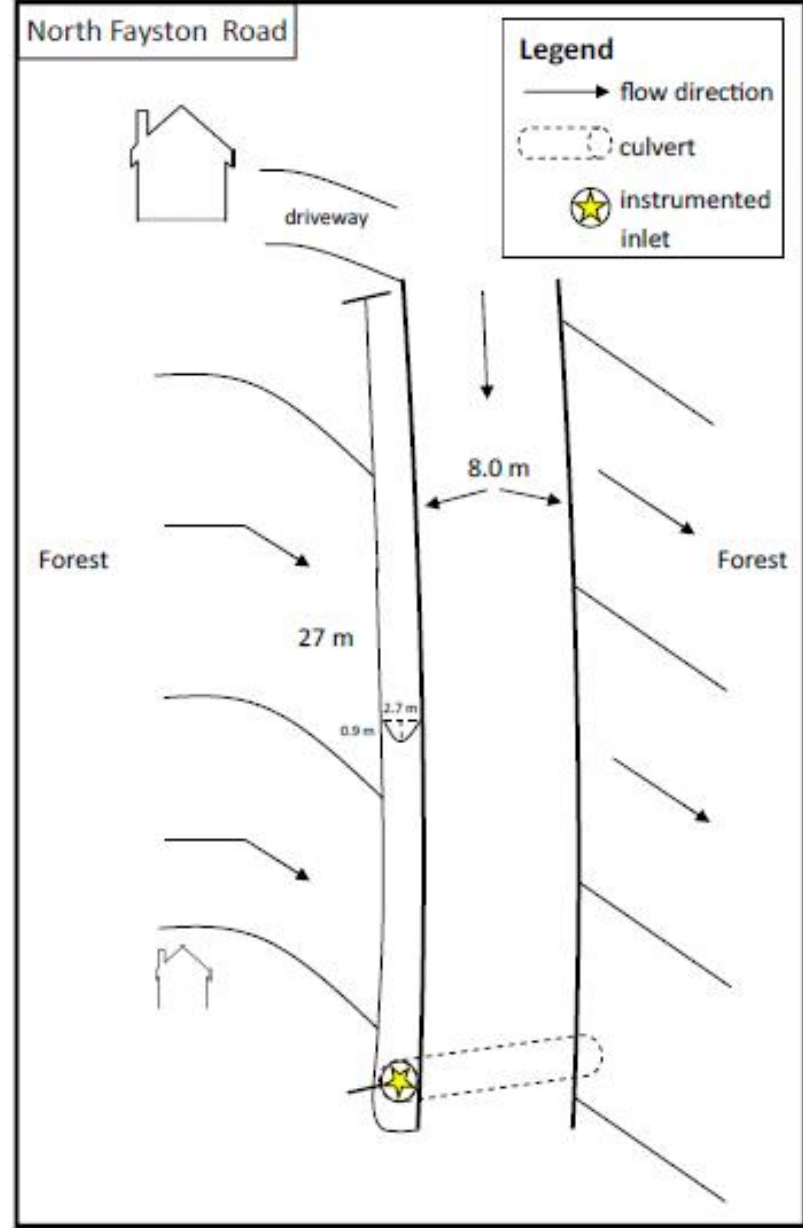
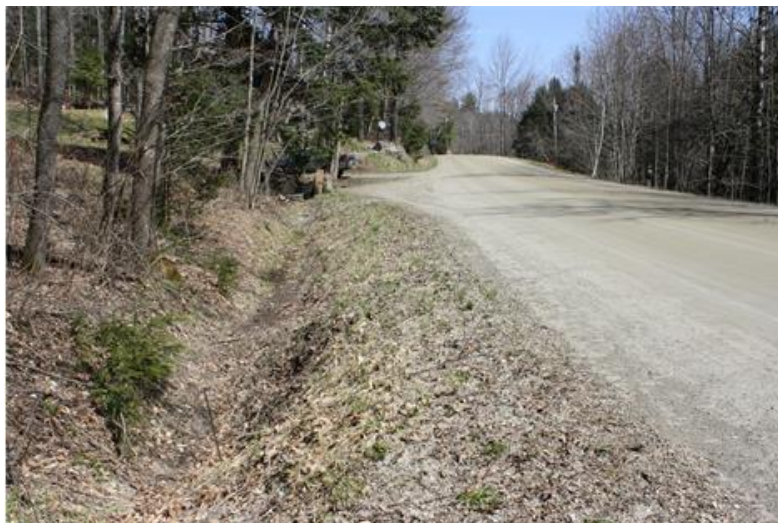
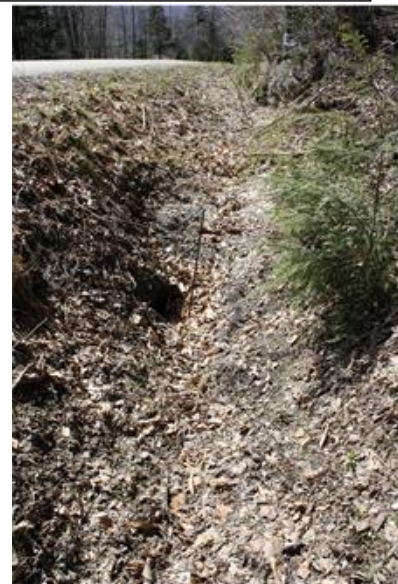
North Fayston Road is a Class 2 gravel road located in the Shepard Brook drainage in the town of Fayston, VT. The monitored road segment traverses a densely forested area, before reaching a public spring and small clearing for residential building just outside and to the east of the road surface drainage area. The road segment is quite flat (road grade of 2.5%) and stretches just 27 meters without a measurable elevation change (using a 30 m DEM). The road averages 8.0 m in width, and is slightly crowned, resulting in roughly 4 meters of road width draining to the inboard ditch. The ditch is slightly vegetated, and averages 2.7 meters in width, leading to a total road and ditch drainage surface area of approximately 180.9 m². No seepage sources and little to no baseflow was observed at this site during the fall of 2011 and spring of 2012. At the culvert outlet, runoff is discharged down a bank into a forested area, with no visible connection to a stream. Automated monitoring on this site took place from October 1, 2011 to November 11, 2011.

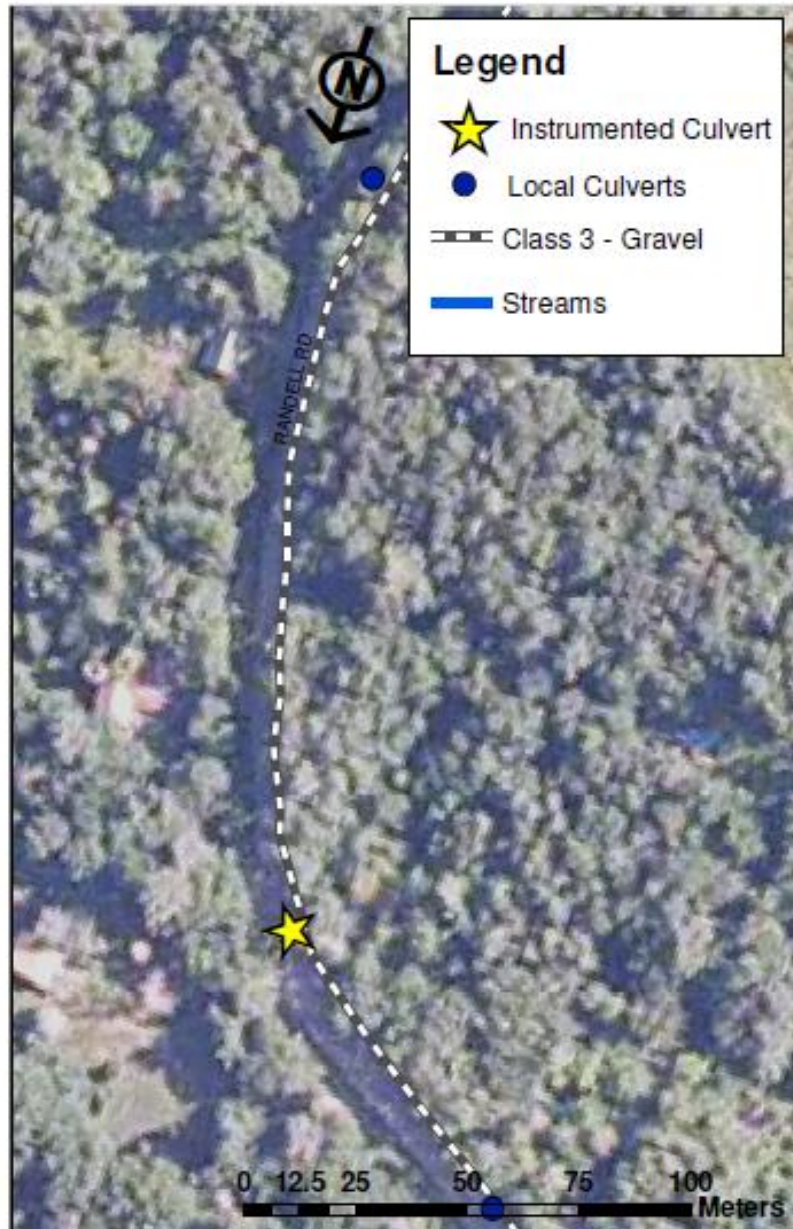
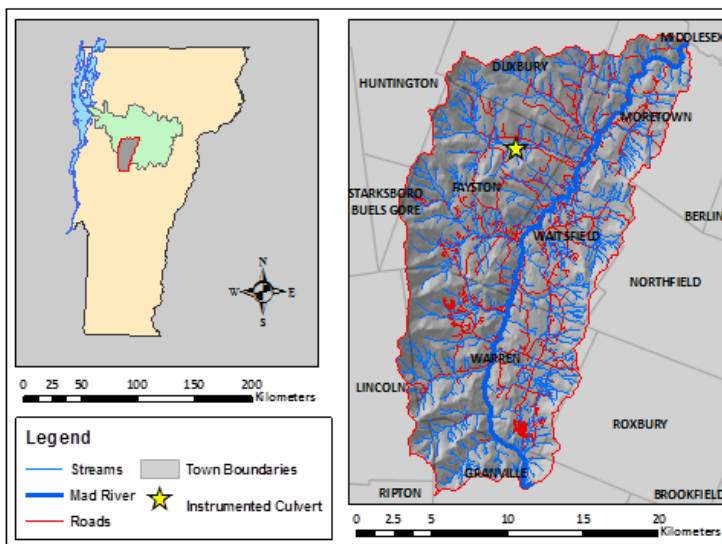
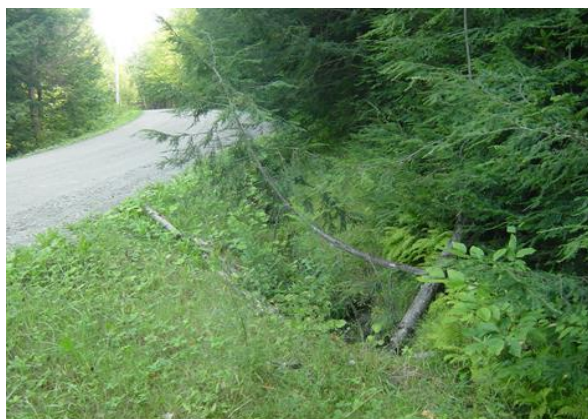
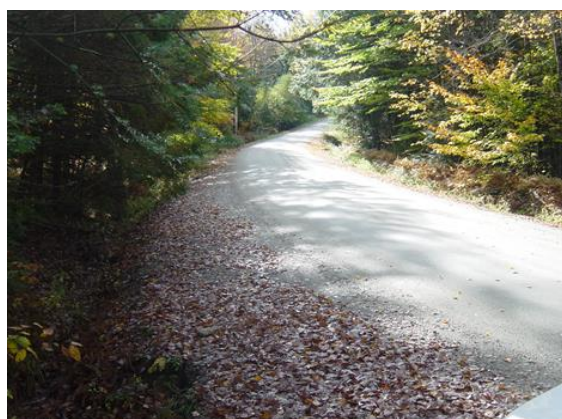
The monitoring station on **Randell Road** is located in the Shepard Brook drainage in the town of Fayston, Vermont. Randall Road traverses a densely forested area, with a series of small (< 2.2 ha, 5.5 acres) clearings accommodating residential home sites, climbing from an elevation of 325 m (1066 ft) at its intersection with North Fayston Road to an elevation of 426 m (1397 feet) at its intersection with Center Fayston Road. The road is on average 7.8 meters wide and crowned, resulting in roughly 3.9 meters of the road width draining to the inboard ditch. The monitored culvert drains runoff along a 164.8 meter segment of the road. The adjacent roadside ditch is 2.2 meters wide. A driveway approximately 30 meters long and 5 meters wide drains to the road and contributes runoff to the monitoring station during storms, giving an estimated road surface, driveway, and ditch drainage area of 1155 m². An excavated road cut is not present along the monitored segment, but during intense storm events in June and July 2012, intermittent seepage was observed along the ditch, adding an additional unmapped source from the area directly proximal to the road. Little to no seepage was observed during low precipitation intensity storms in September 2012. The road grade is 15% along the monitored segment, resulting in rapid transmission of runoff from the road surface to the ditch and culvert and visible erosion of the ditch. At the culvert outlet, runoff is discharged into a forested area with no visible connection to a stream. Automated monitoring on this site took place between June 13 and July 26, 2012, with storms sampled on 6/27, 7/4, 7/17 and 7/23-24/2012.
