WRRC-2002-02

**Assessment and Protection Plan for the Nawiliwili Watershed:
Phase 1—Validation and Documentation of Existing Environmental Data**

PREPARED FOR
State of Hawai'i
Department of Health
Clean Water Branch

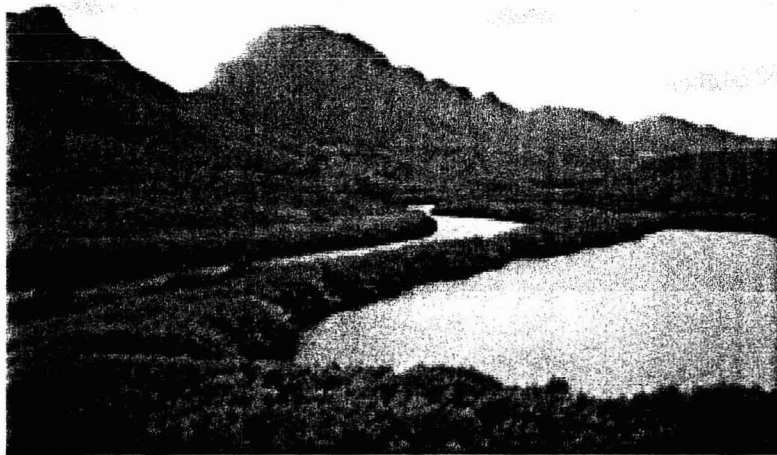
Figure 1. Alekoko Fish Pond on Hulē'ia River with significant growth of mangrove.

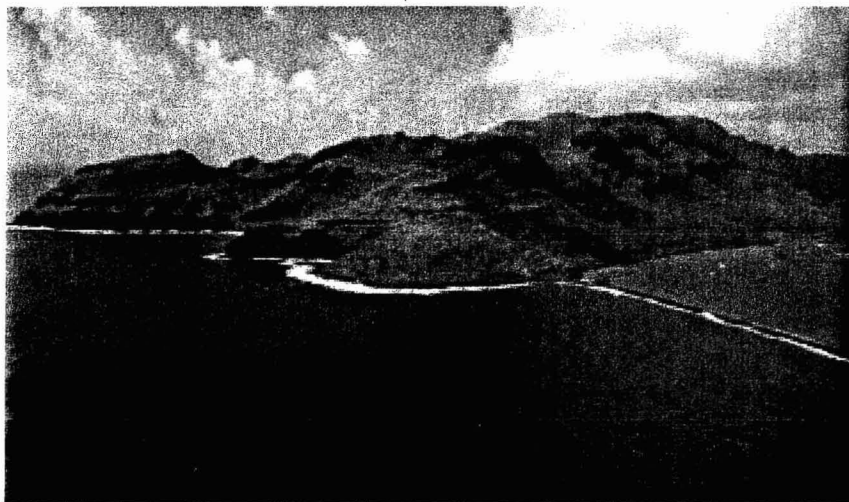
Figure 2*. The construction of the harbor at Nawiliwili has interrupted the flow of sediment out to sea, thus sediment is deposited in the harbor and on the reefs. When large surf arrives, this sediment is reintroduced into the water. Notice the difference in the color of the ocean and harbor water. Without the breakwater, the sediment would move out into the long shore flow. (Photo by David Boynton, Casey Riemer pilot - Jack Harter Helicopters.)

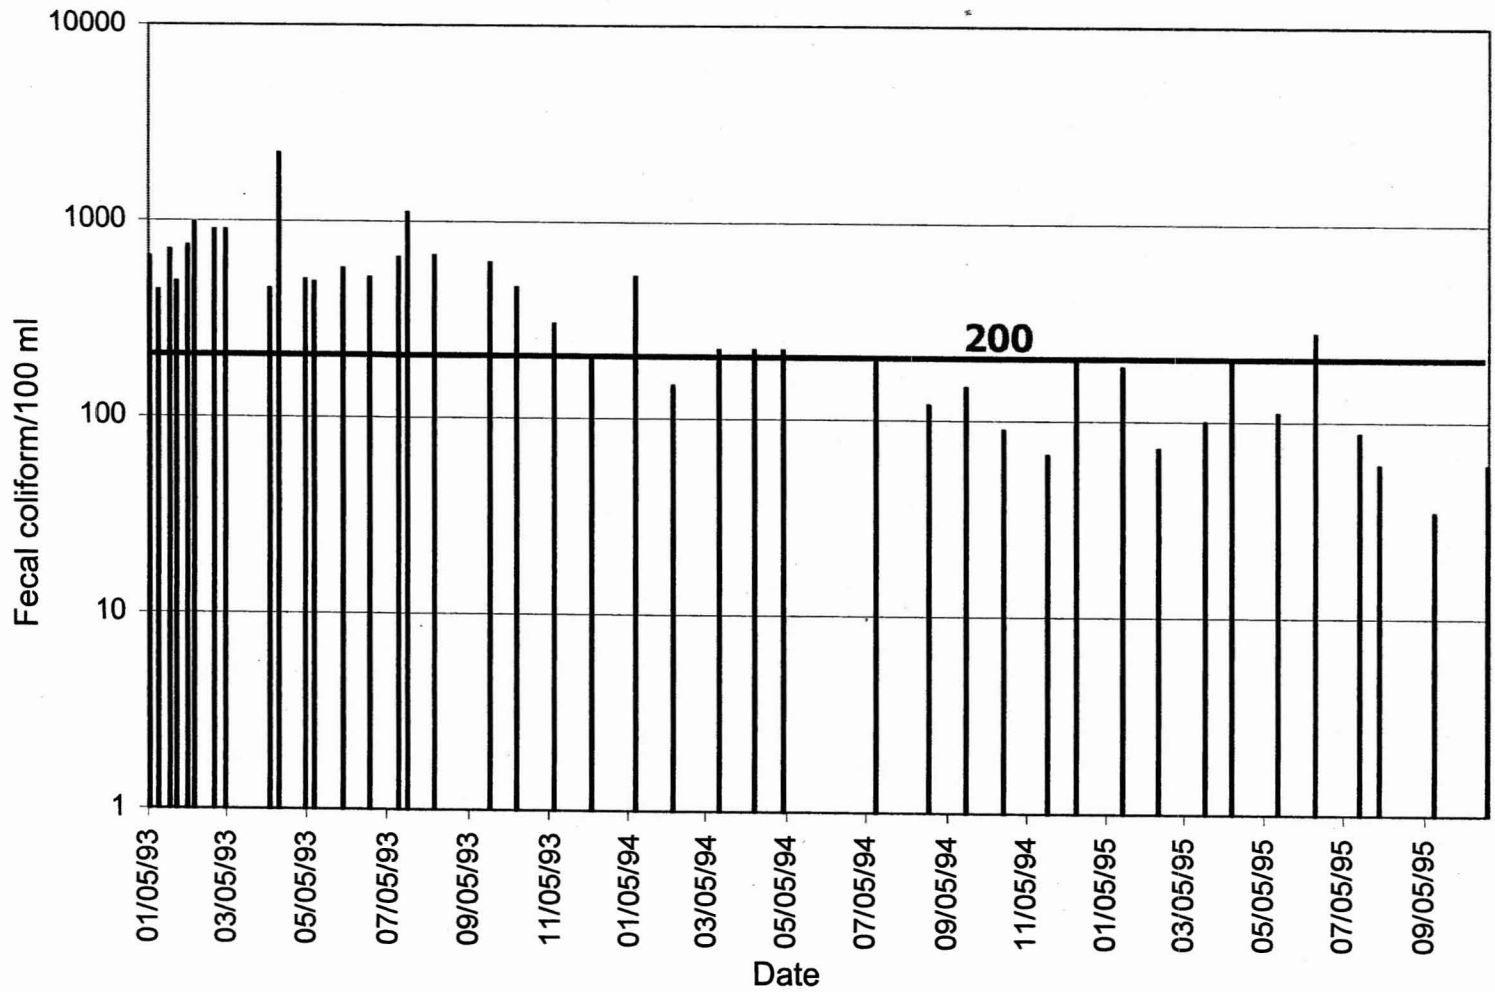
Figure 5. Fecal coliform at Hanamā'ulu River site. The heavy horizontal line indicates the fecal coliform standard for the State of Hawaii.

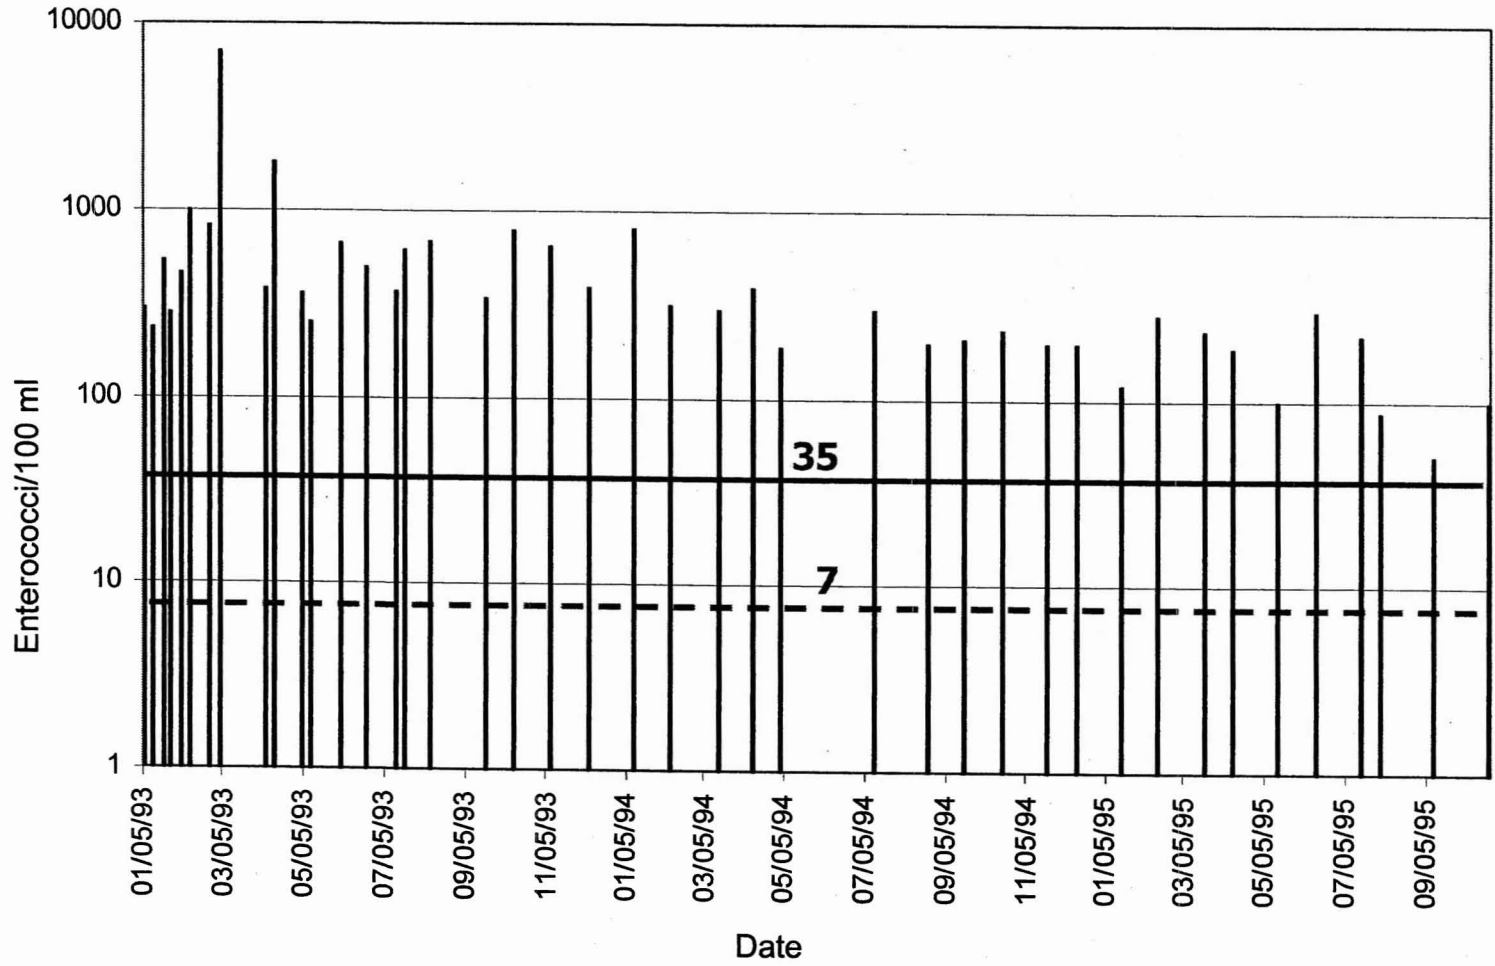
Figure 6. Enterococci in Hanamā'ulu River site. The heavy horizontal lines indicates the Federal (solid line) and State (dashed line) standards.

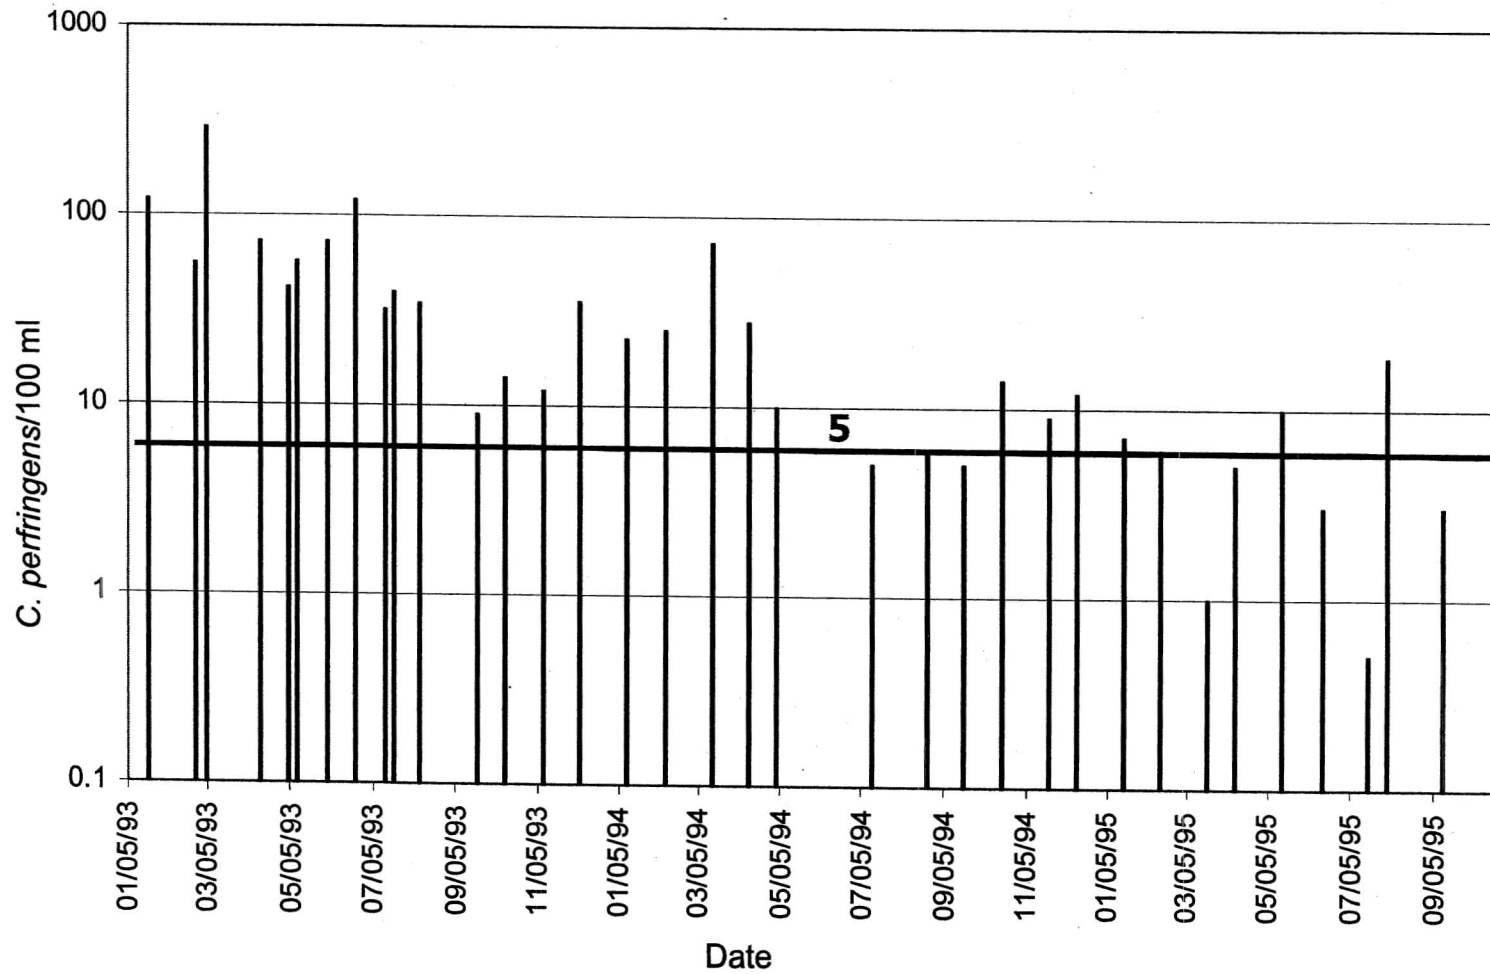
Figure 7. *C. perfringens* at Hanamā'ulu River site. The heavy horizontal line indicates the State's *C. perfringens* standard.

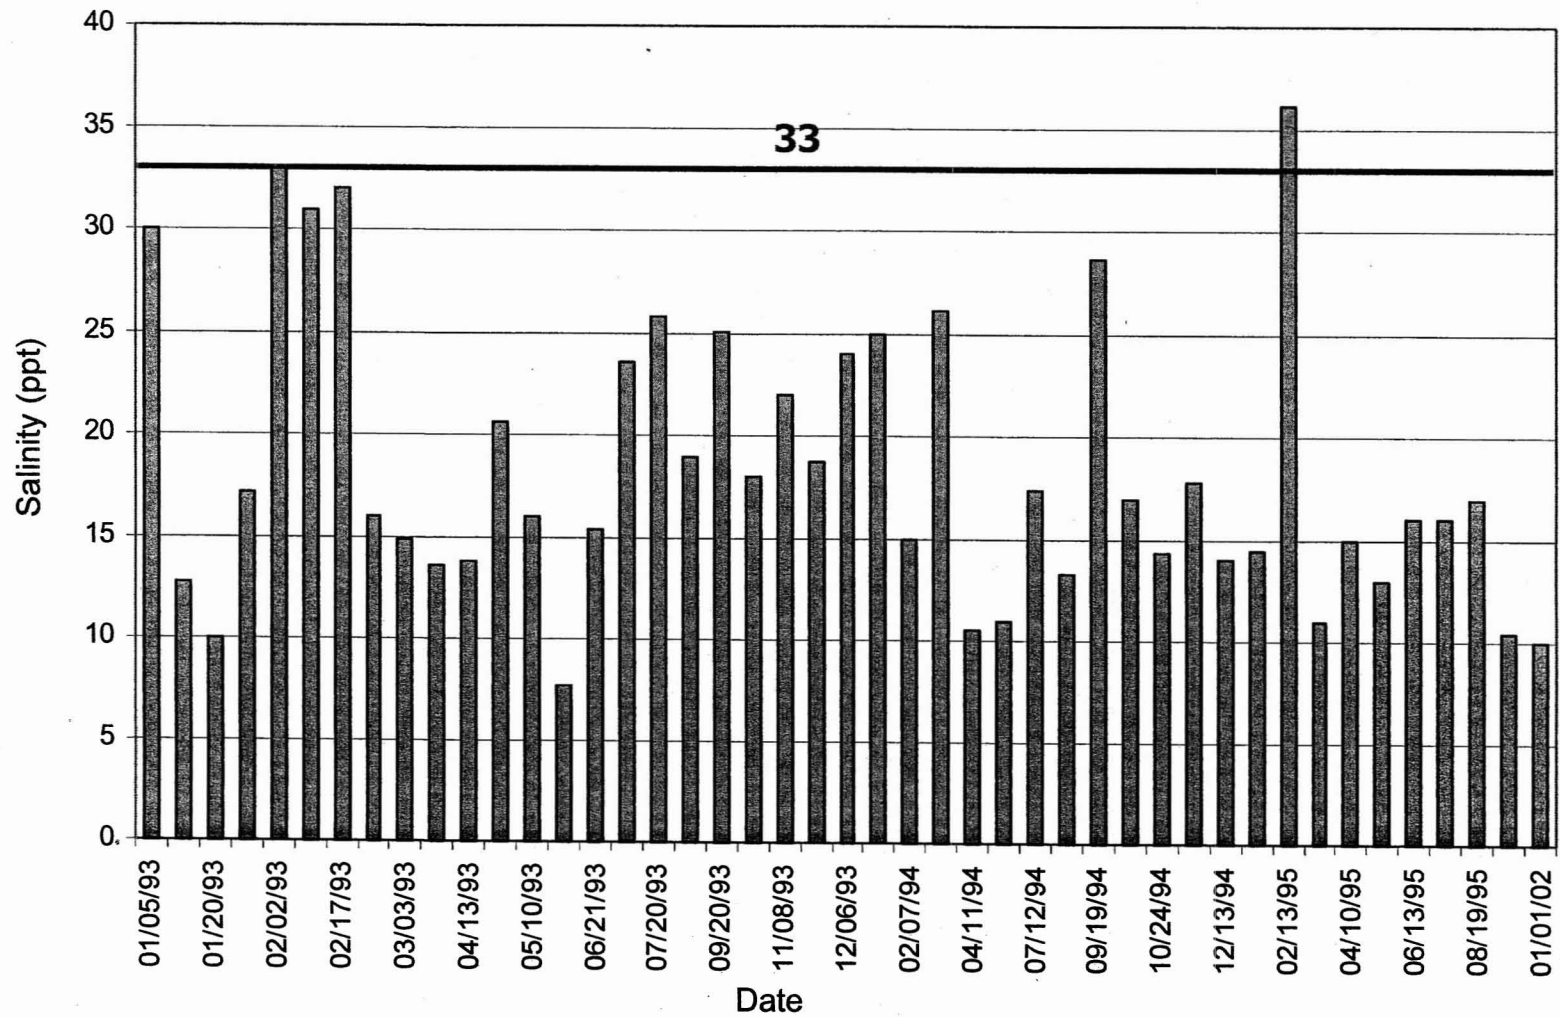
Figure 8. Salinity at Hanamā'ulu Beach site. The heavy horizontal line indicates the state's salinity standard.

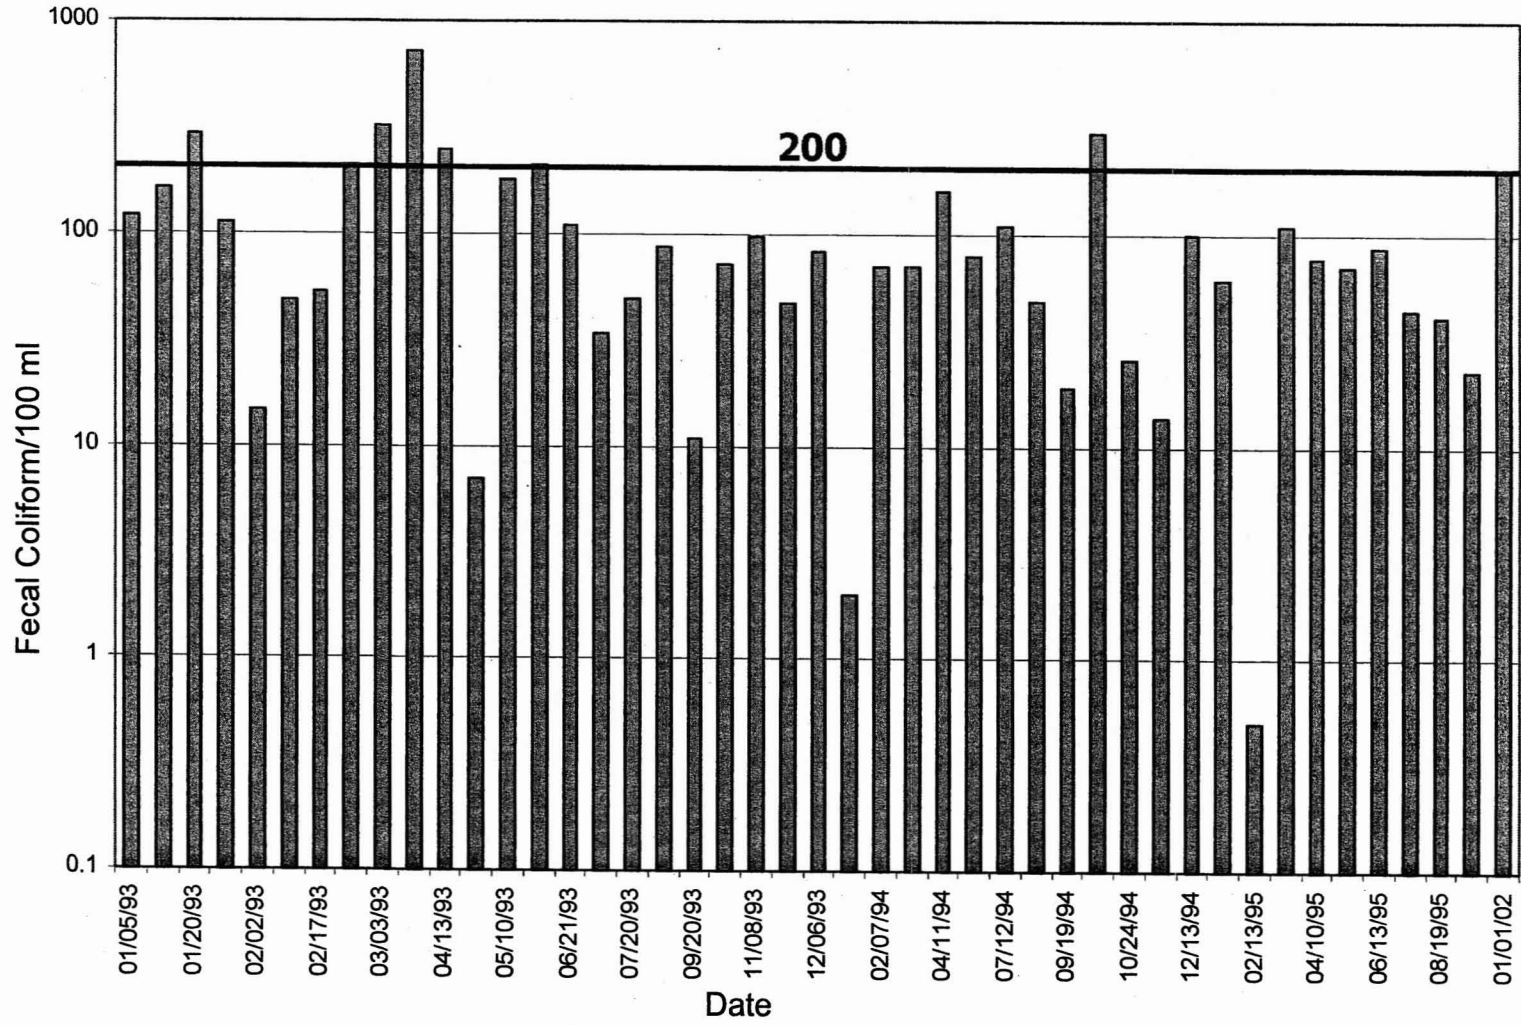
Figure 9. Fecal coliform at Hanamā'ulu Beach site. The heavy horizontal line indicates the State's fecal coliform standard.

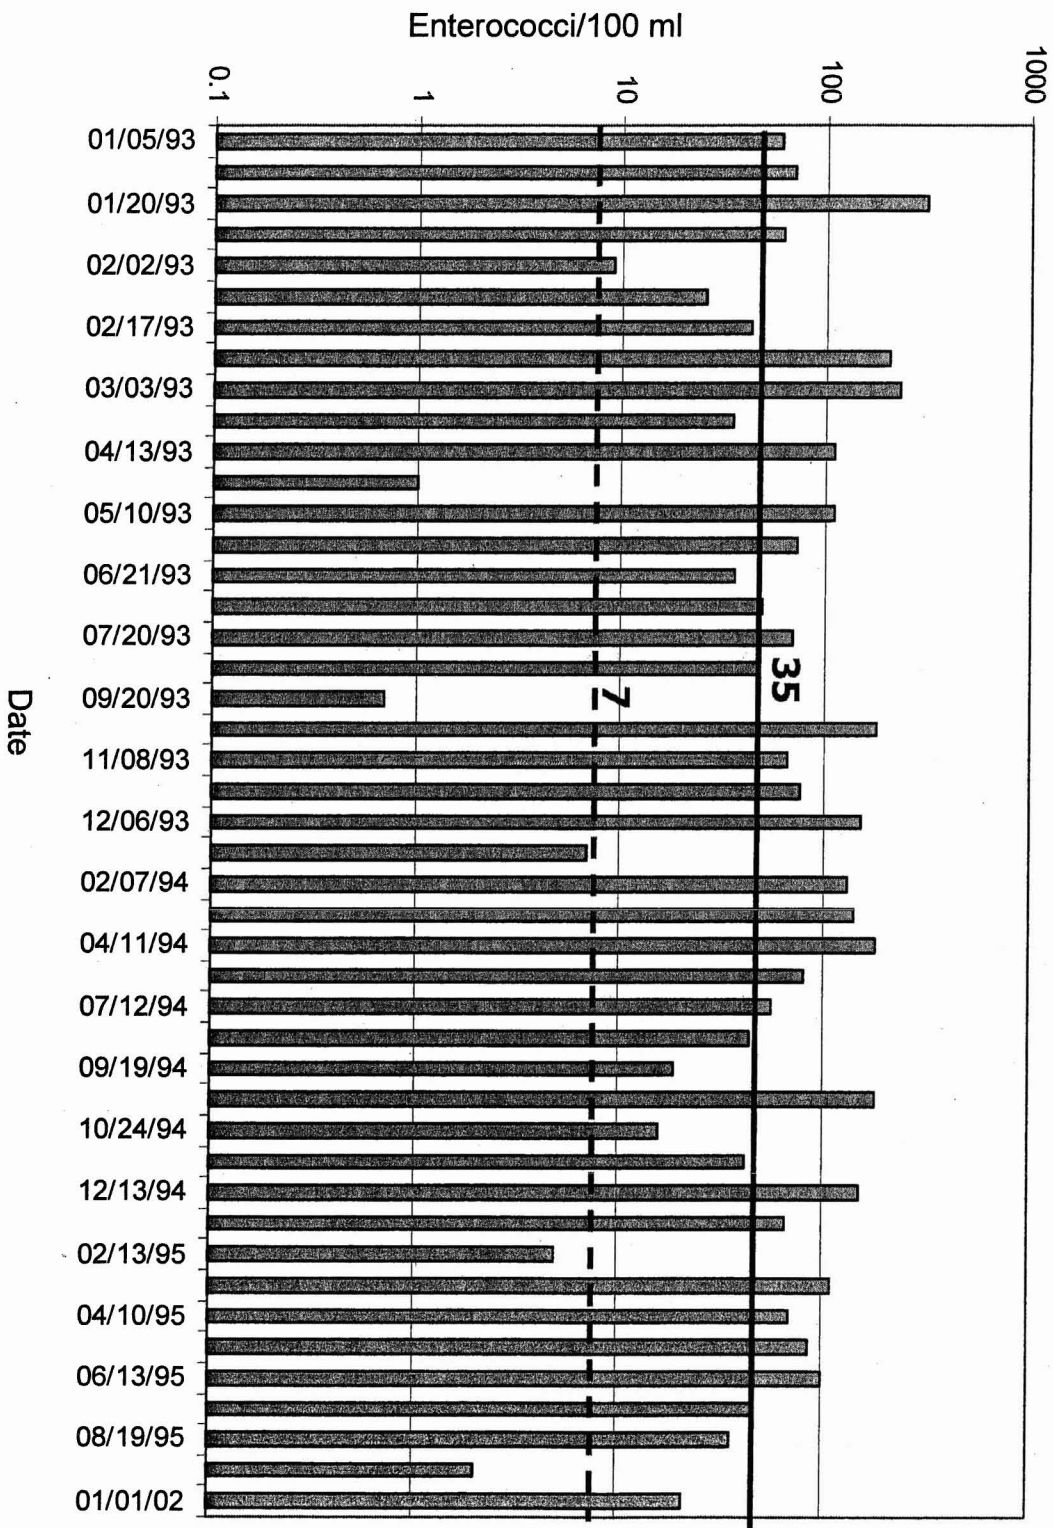
Figure 10. Enterococci at Hanama'ulu Beach site. The heavy horizontal lines indicates the Federal (solid line) and State (dashed line) standards.

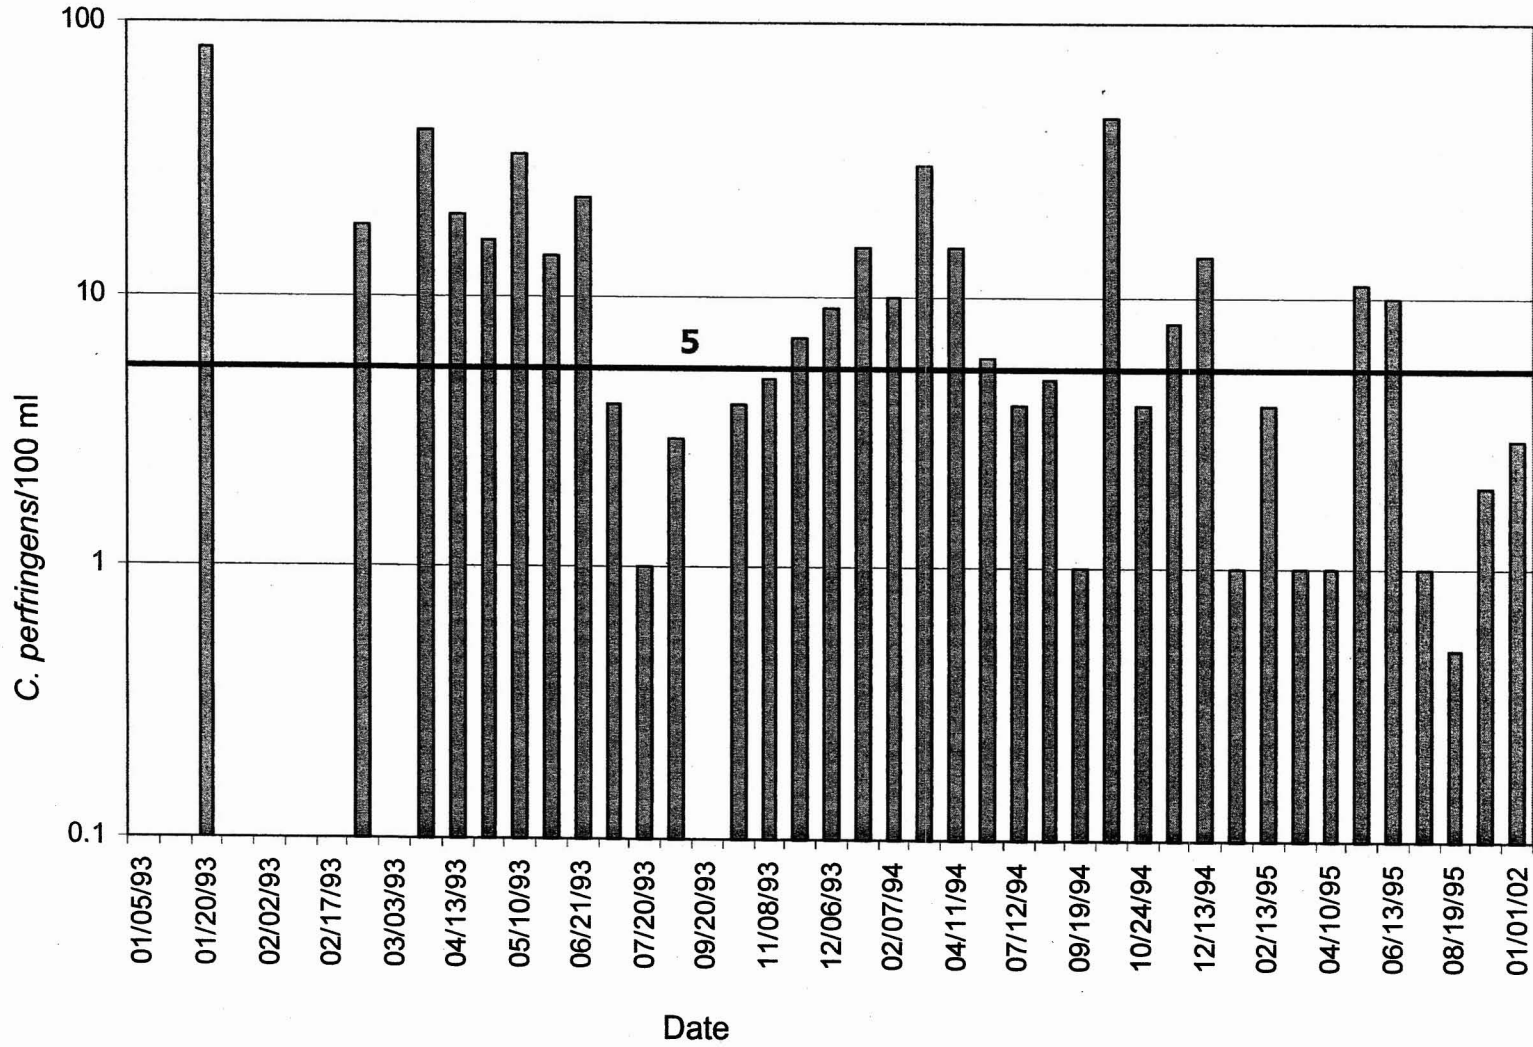
Figure 11. *C. perfringens* at Hanamā'ulu Beach site. The heavy horizontal line identifies the State's *C. perfringens* standard.

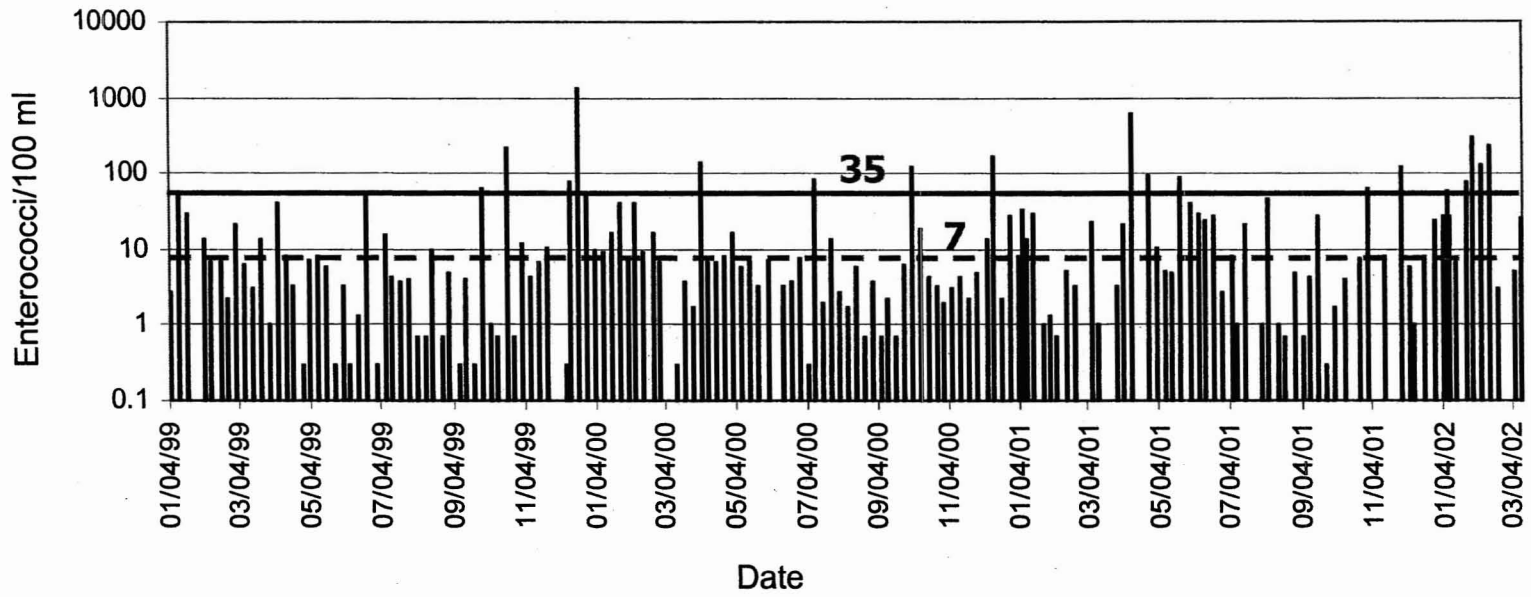
Figure 12. Enterococci at Kalapaki Beach site. The heavy horizontal lines indicate the Federal (solid line) and State (dashed line) standards.

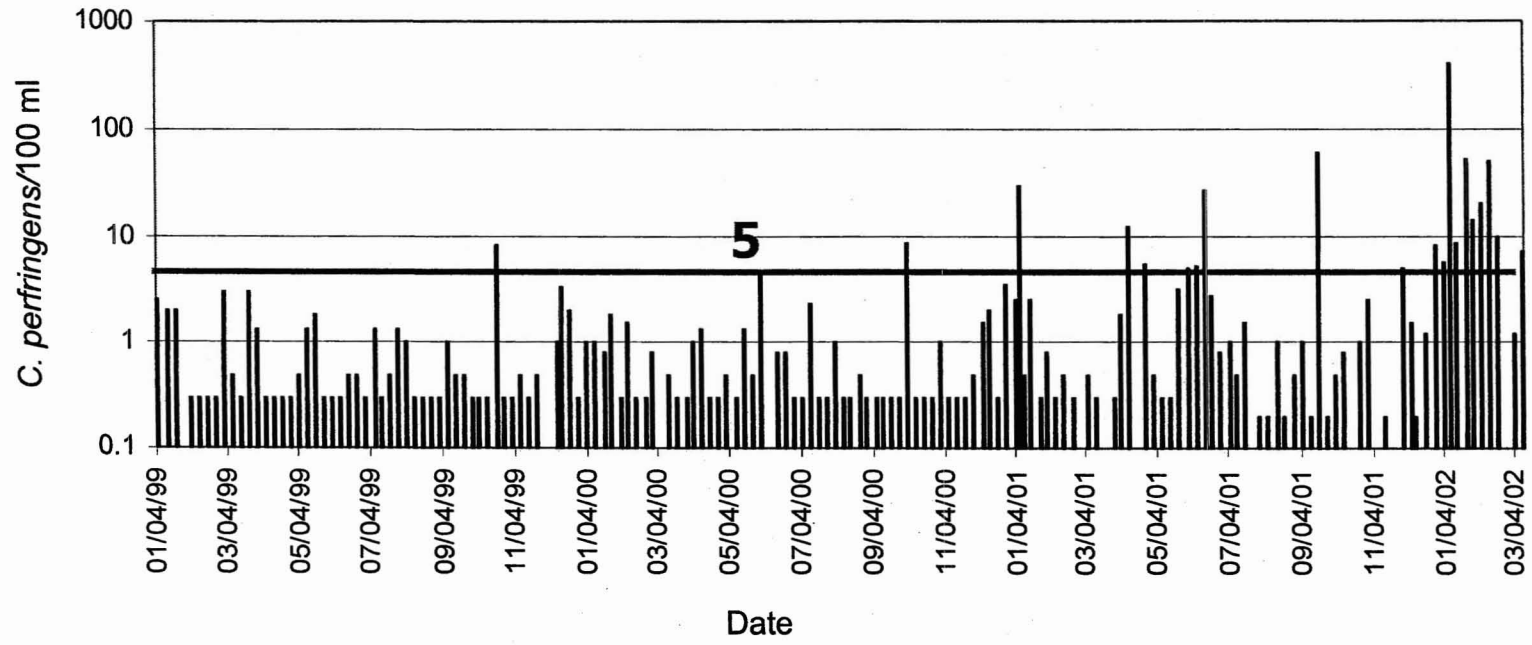
Figure 13. *C. perfringens* at Kalapaki Beach site. The heavy horizontal line indicates the State's *C. perfringens* standard.

observed during 1999 and 2000. However, during 2001 more samples (13%) had elevated levels of *C. perfringens* than the 2% observed during 1999 and 2000. The elevated concentrations of *C. perfringens* in water samples from Kalapaki Beach in 2001 provide evidence that this beach site was contaminated with sewage for some period of time.

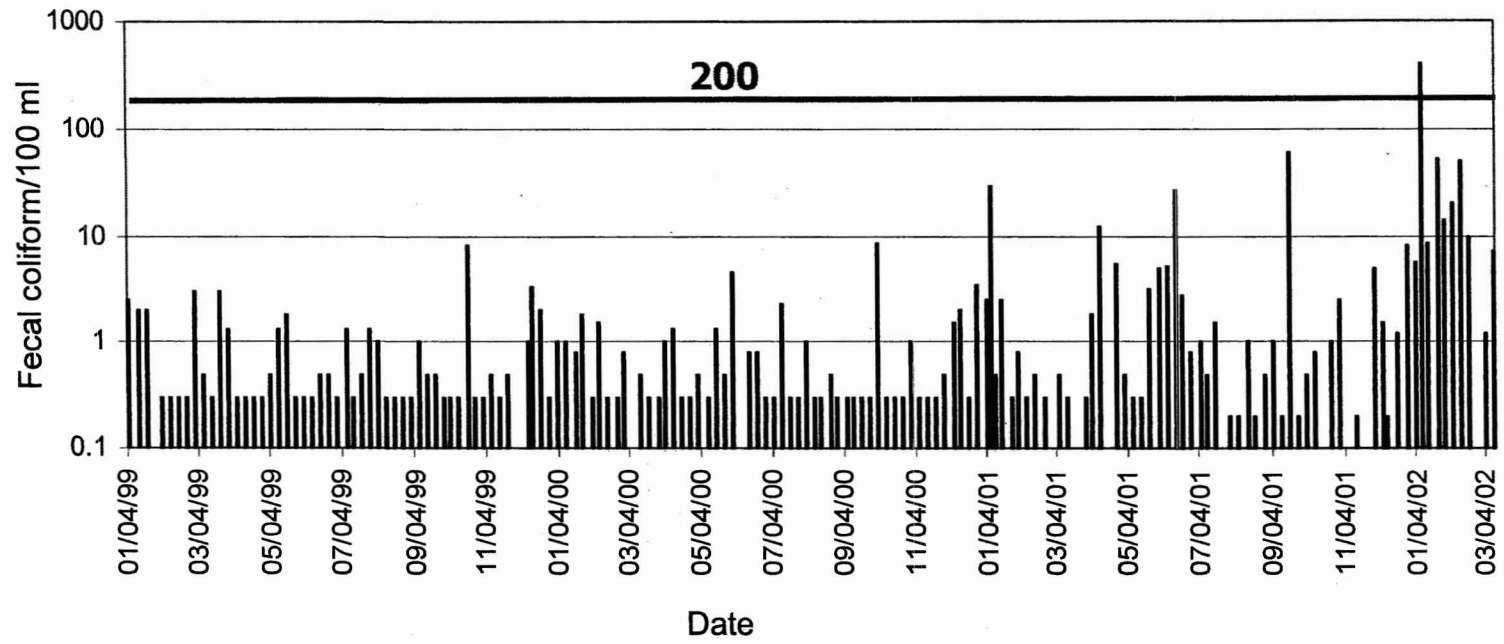
Figure 14. Fecal coliform at Kalapaki Beach site. The heavy horizontal line indicates the State's fecal coliform standard.

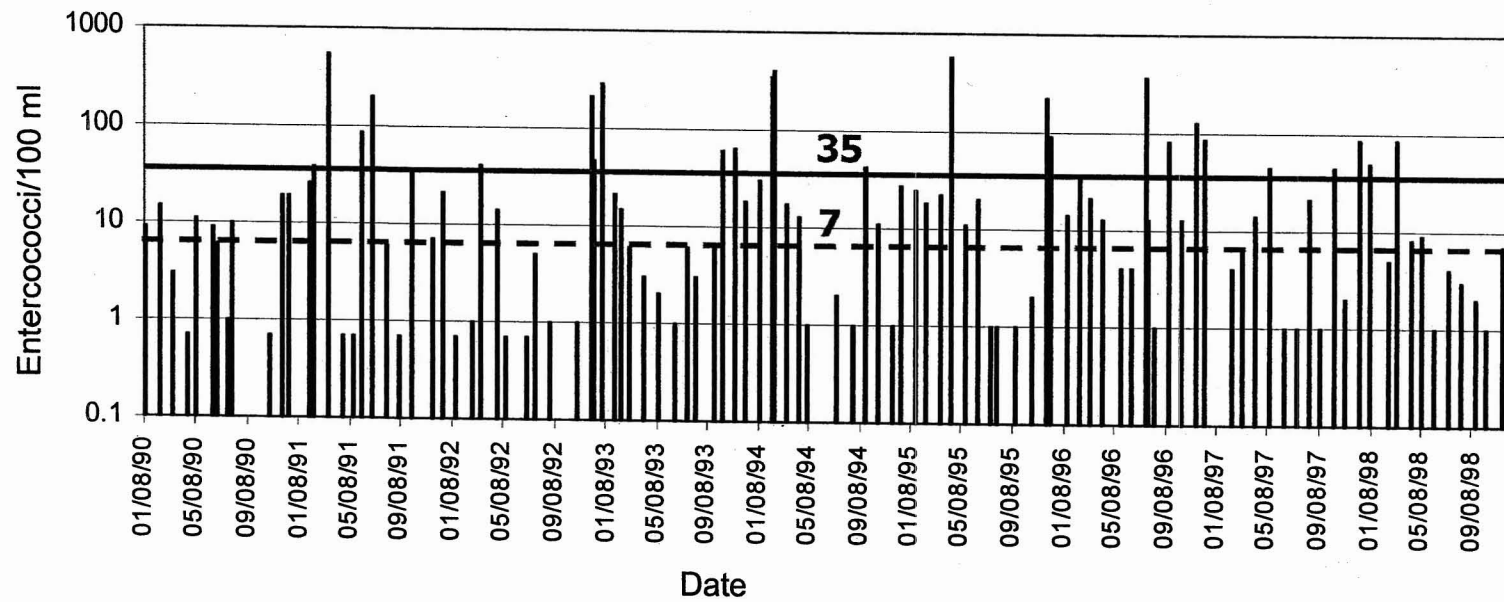
Figure 15. Enterococci at Kalapaki Beach site. The heavy horizontal lines identify the Federal (solid lines) and State (dashed line) standards.

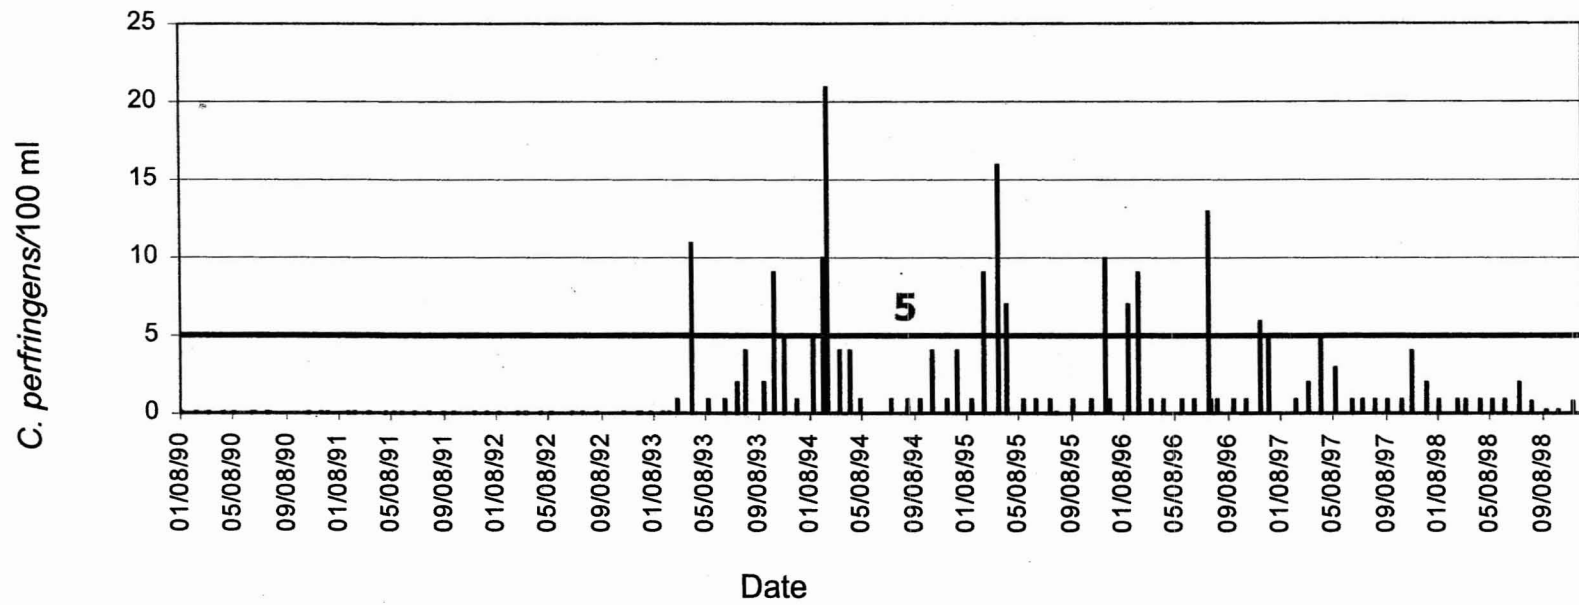
Figure 16. *C. perfringens* at Kalapaki Beach site. The heavy horizontal heavy line indicates the State's *C. perfringens* standard

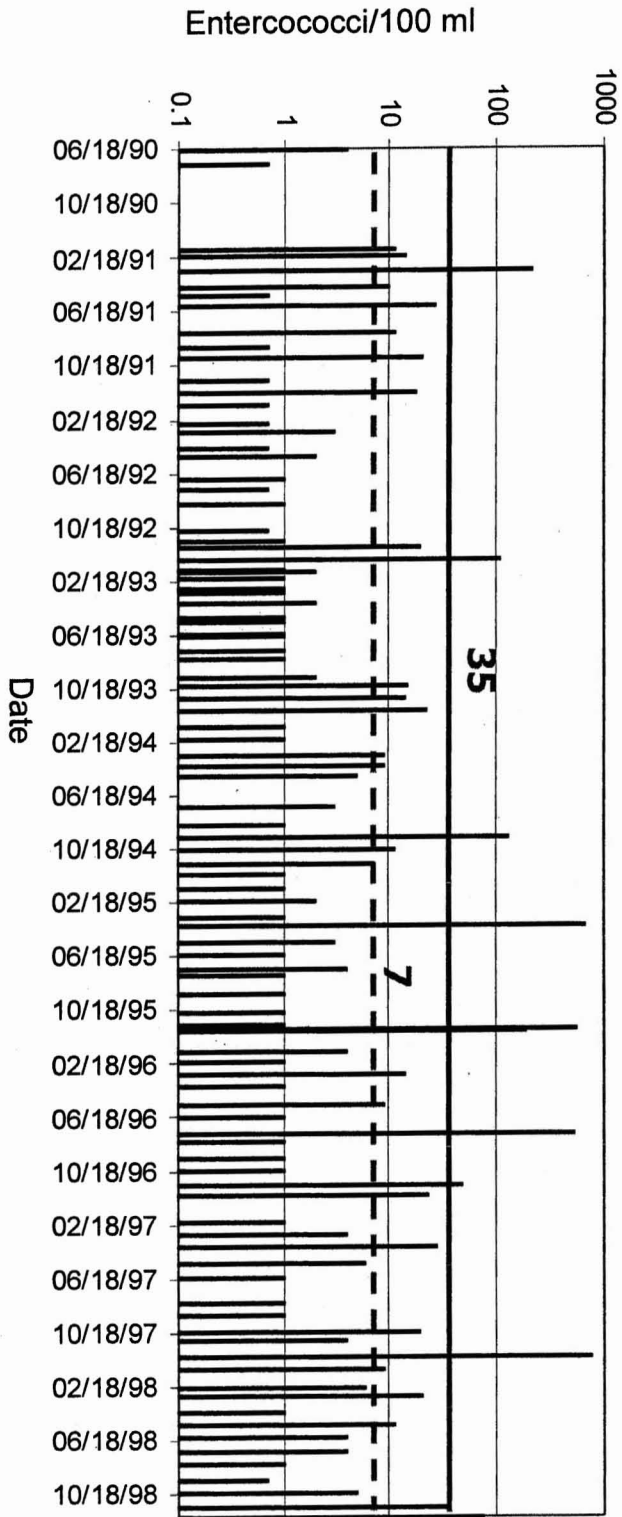
Figure 17. Enterococci at Nawiliwili Harbor site. The heavy horizontal lines indicates the Federal (solid line) and State (dashed line) standards.

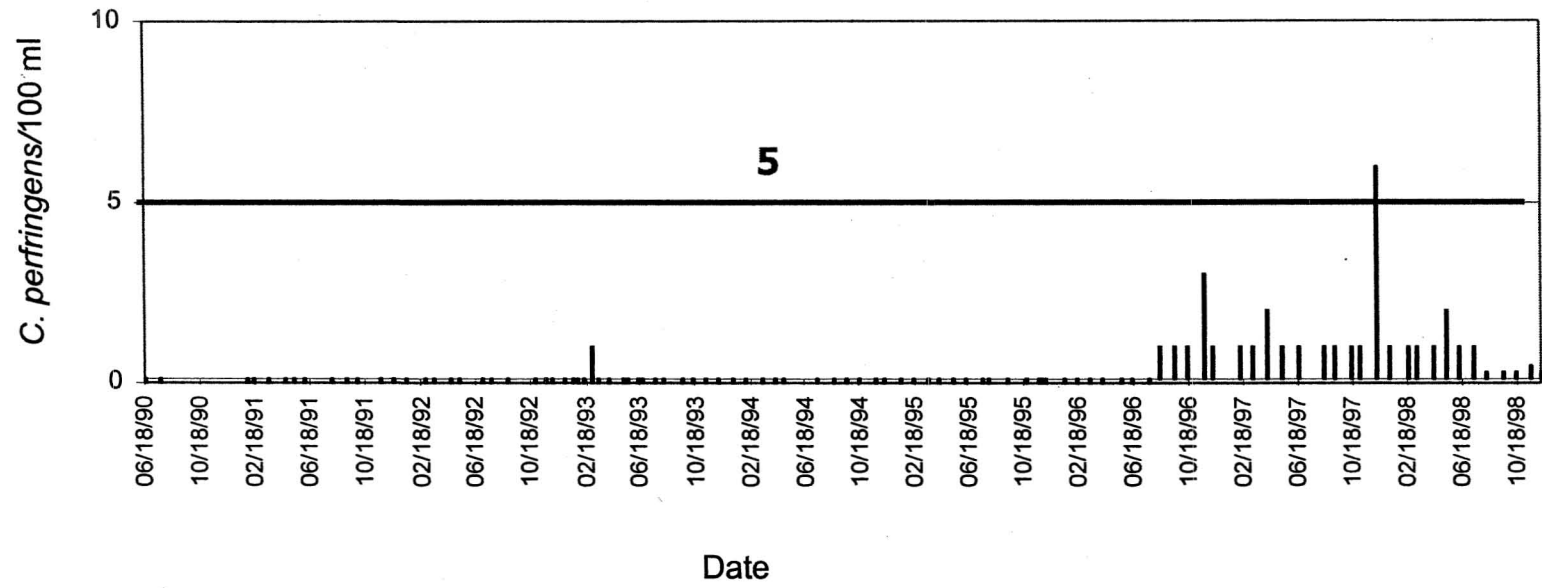
Figure 18. *C. perfringens* at Nawiliwili Harbor site. The heavy horizontal line indicates the *C. perfringens* standard.

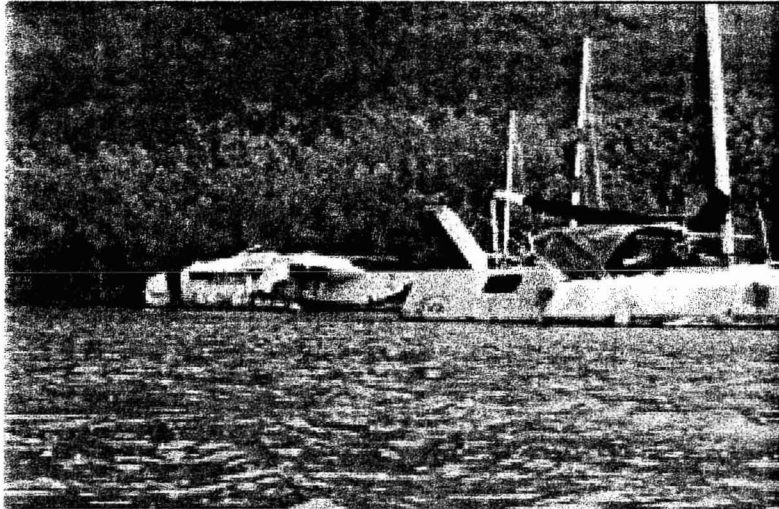
Figure 21. Termite damage and a big rain caused the hull of this boat to be sheered off, but it is still floating in the Hulē'ia Estuary.

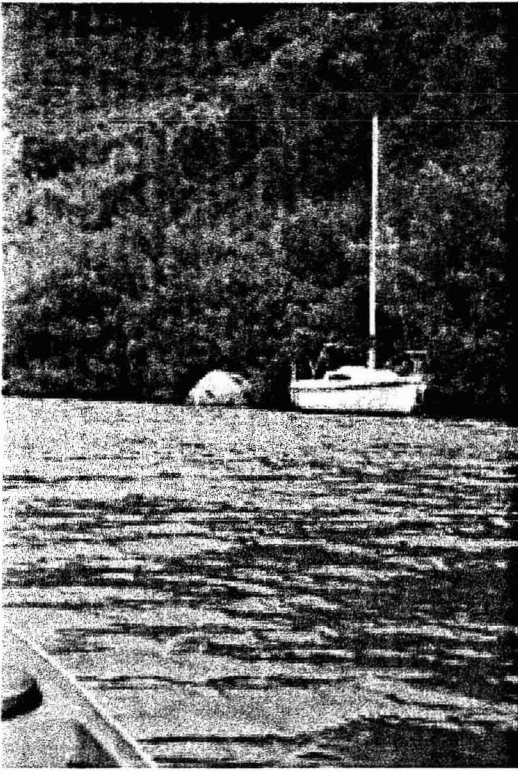
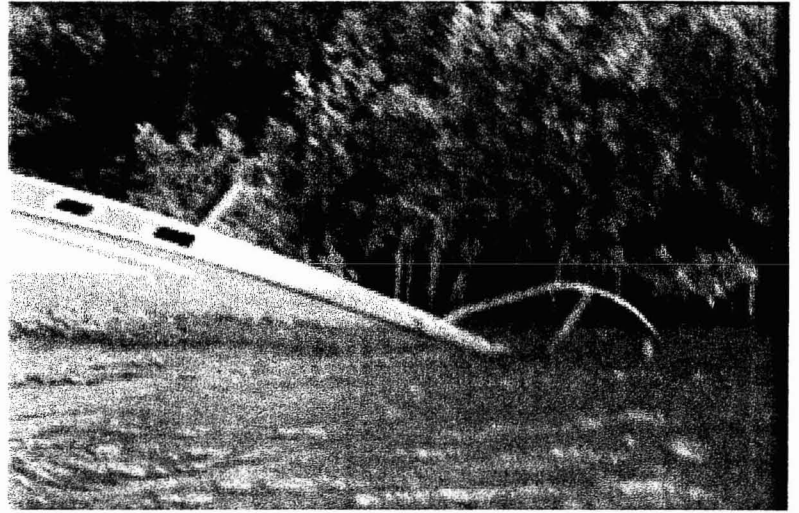
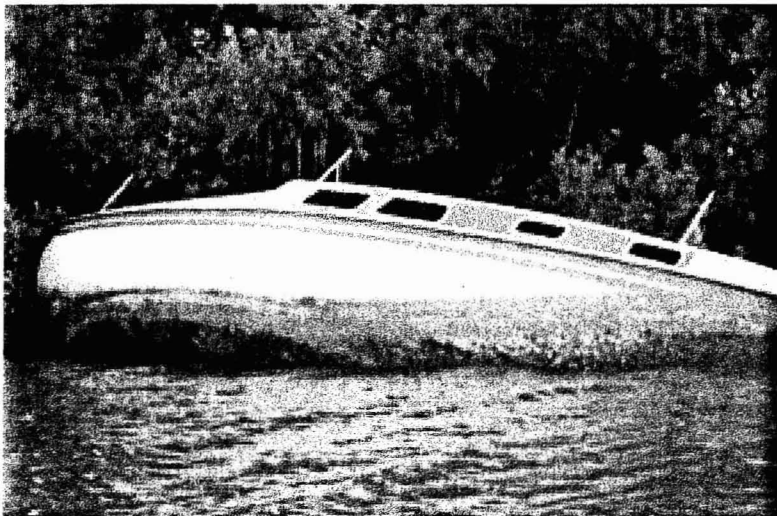
Figure 22. Views of a sailboat that sunk in Hulē'ia Estuary. Most of it is visible at a low tide.

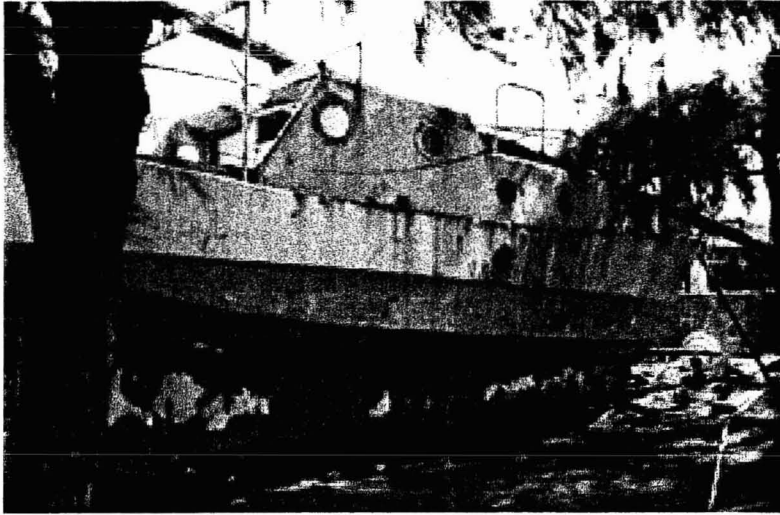
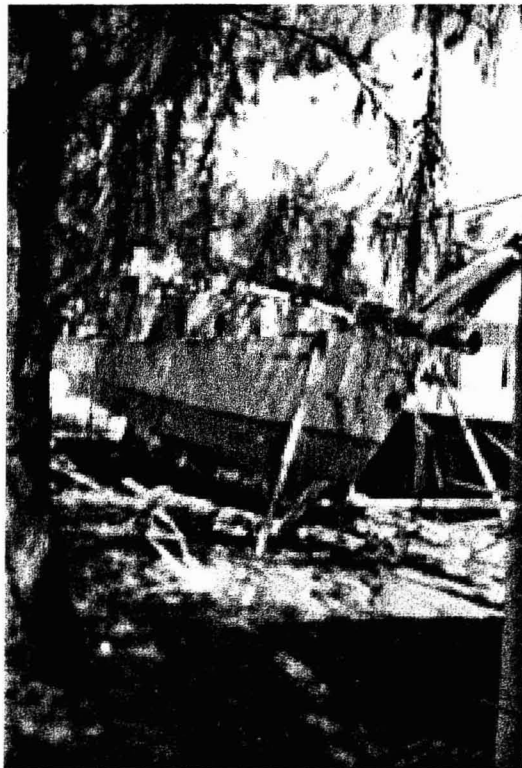
Figure 23. Two views of an abandoned vessel sunk in its slip in the Nawiliwili Small Boat Harbor

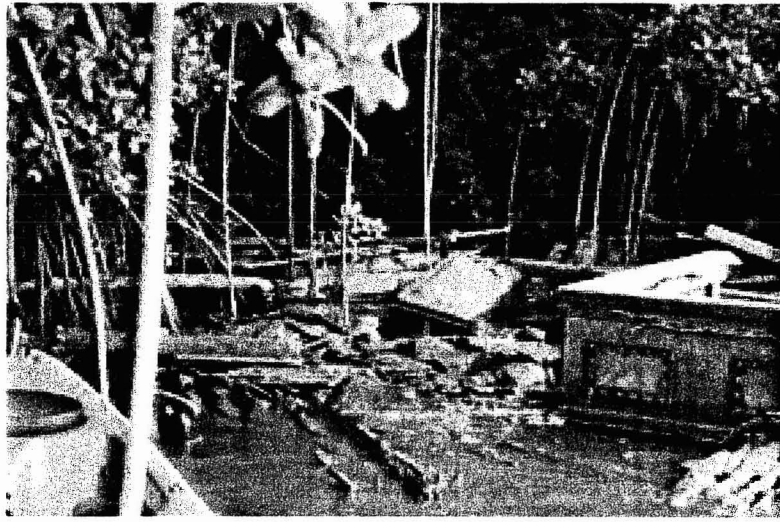
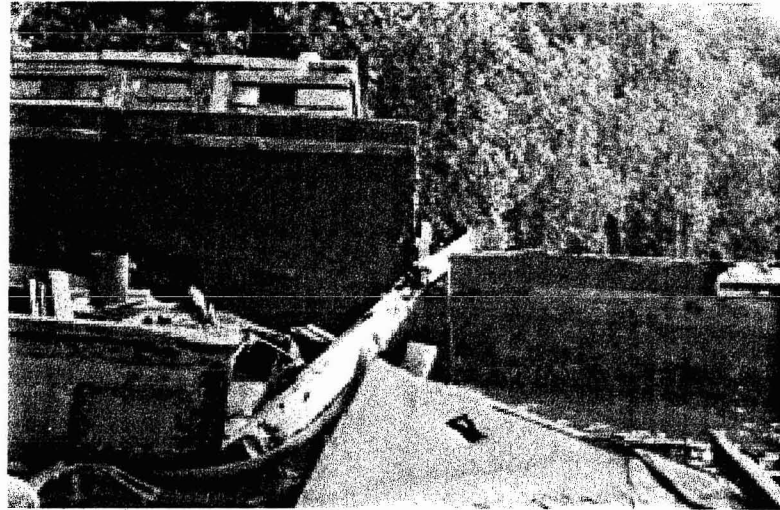
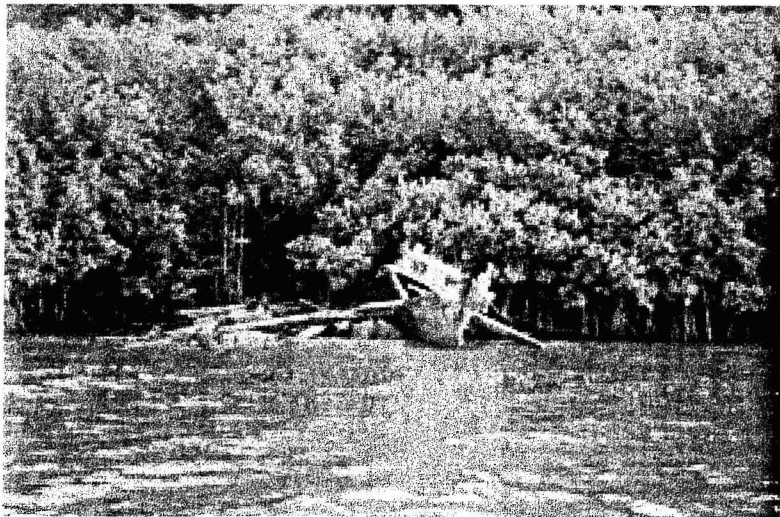
Figure 24. Views of a boat towed and parked in Hulē'ia Estuary, now busted up by human intervention and mangrove growth

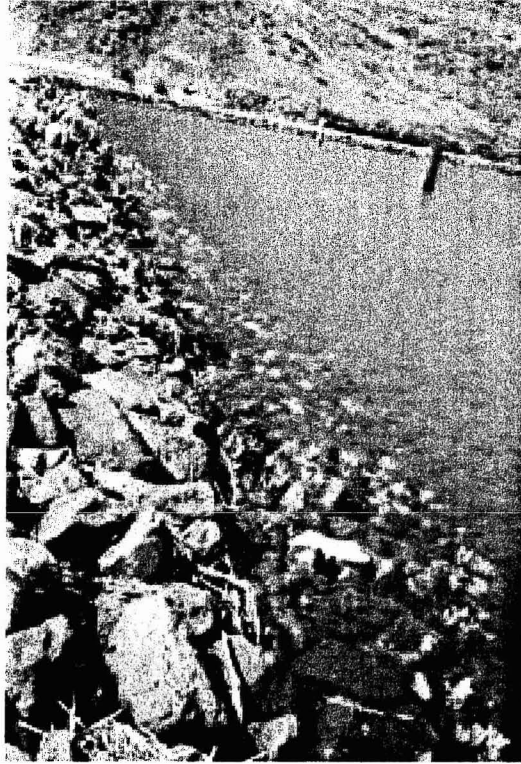
Figure 25. Rubbish generated by users of the Nawiliwili small Boat Harbor
