WRRC-2002-02

**Assessment and Protection Plan for the Nawiliwili Watershed:
Phase 1—Validation and Documentation of Existing Environmental Data**

PREPARED FOR
State of Hawai'i
Department of Health
Clean Water Branch

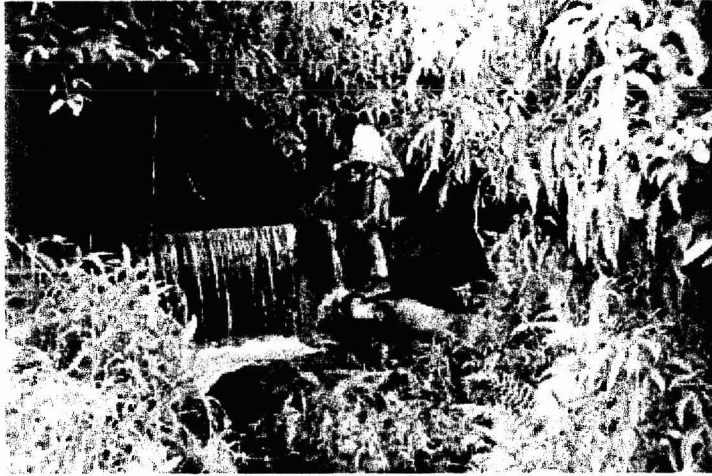
Figure 26*. The streams of Nawiliwili are interrupted and diverted by reservoirs and ditches in their upper reaches (Photo by Adam Asquith)

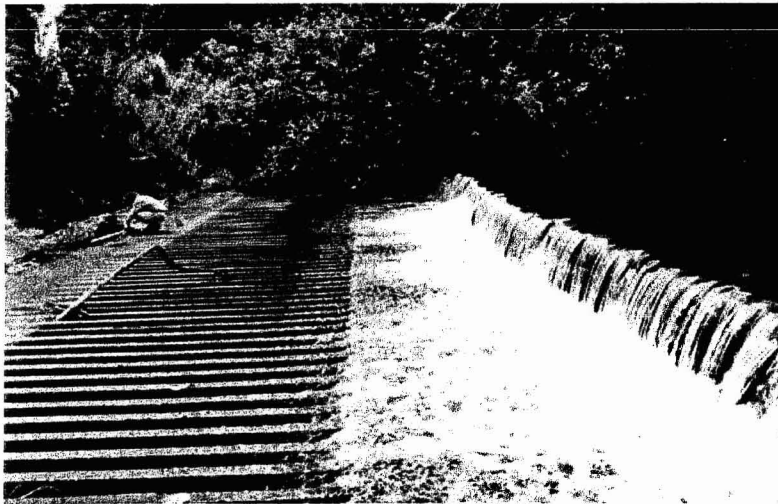
Figure 27*. Although the sugar industry is pau (ended), this diversion of 100% of Hulē'ia Stream's base flow continues to send water out of the watershed to Waita Reservoir. The streambed continues dry for a hundred yards, and then the groundwater begins to recharge the streamflow. (Photo by Adam Asquith)

Hulē'ia Stream undergoes the dynamics of dewatering from at least four diversions. The "main" diversion is located above Halfway Bridge. Under low-flow conditions, 100% of the water from Ku'ia Stream is diverted. However, depending on weather conditions, especially during heavy rains, that diversion may be turned off, returning the water to the stream channel (Alan Smith, Grove Farm, personal communication, 2002). Excess increased flows and tremendous spikes in turbidity have been recorded by NBWC after rain events. After a heavy rain in March 2002, NBWC recorded a reading of 83.7 nephelometric turbidity units (NTU), whereas the arithmetic mean for the year at the same site was 11.93 NTU. Turbidity measurements taken by Jon Schlegel of NRCS (personal communication, 2002) on the Rice Ranch in a reservoir just west of Hulē'ia Stream are 20 to 75 times the average measurements found in the stream. This area is now used for cattle ranching, and according to Schlegel, this activity can influence turbidity levels. Sediment that is causing the turbidity in this area undoubtedly finds its way into the stream during storm events.

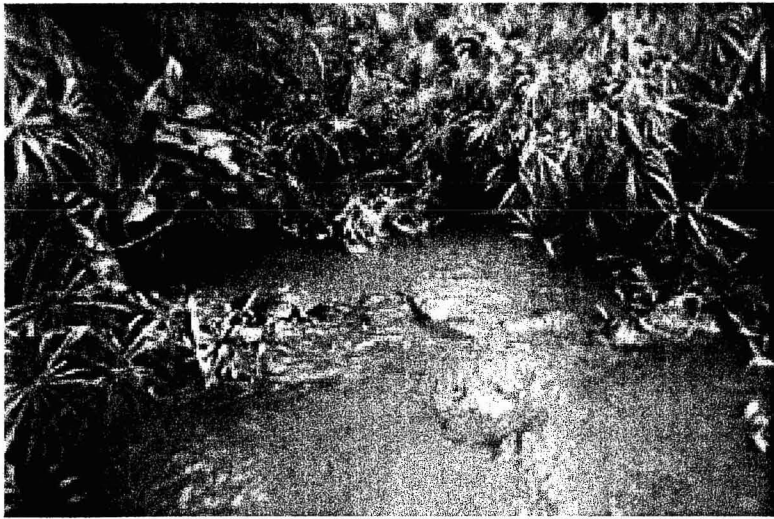
Figure 28. Sediment accumulated at the bottom of stream, Hulē'ia National Wildlife Refuge

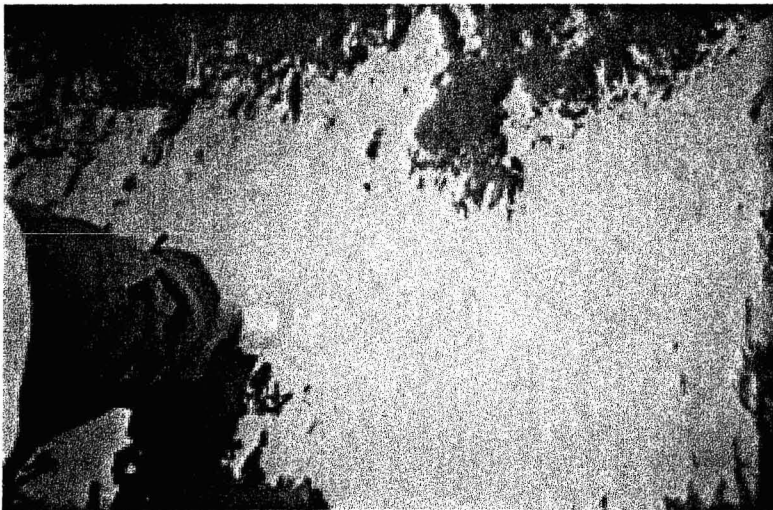
Figure 29. Sediment accumulated at bottom of lower Papakōlea site

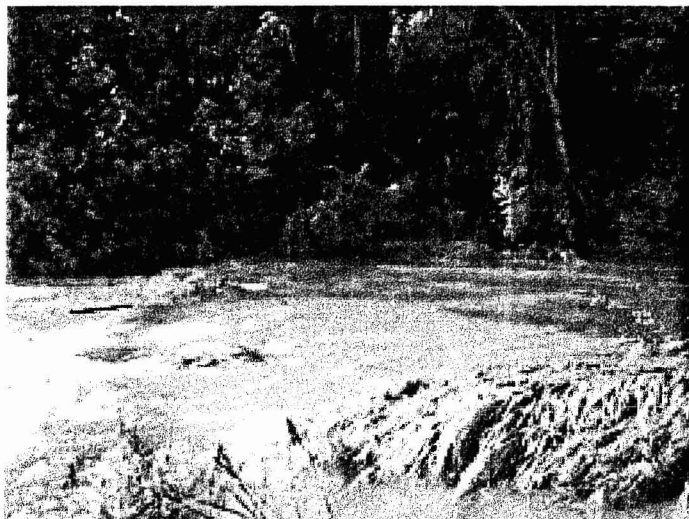
Figure 30. Hulē'ia Lower monitoring site turbid flow after a storm

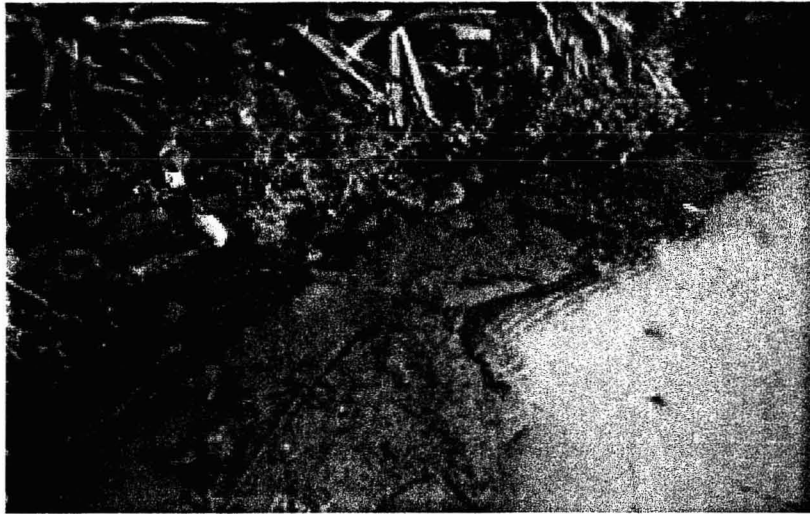
Figure 31*. In some streams chronic sedimentation over a long period of time has produced clay bottoms from solidified mud.

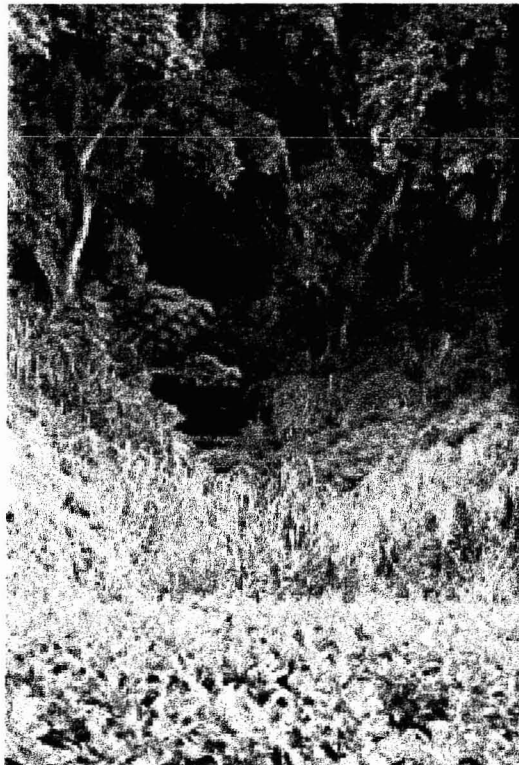
Figure 32. This stream runs through Kauai Lagoons Golf Course. The course is irrigated with effluent. When there is a spill, this stream catches the effluent and it is then diverted under the hotel to discharge at Duke's box culvert.

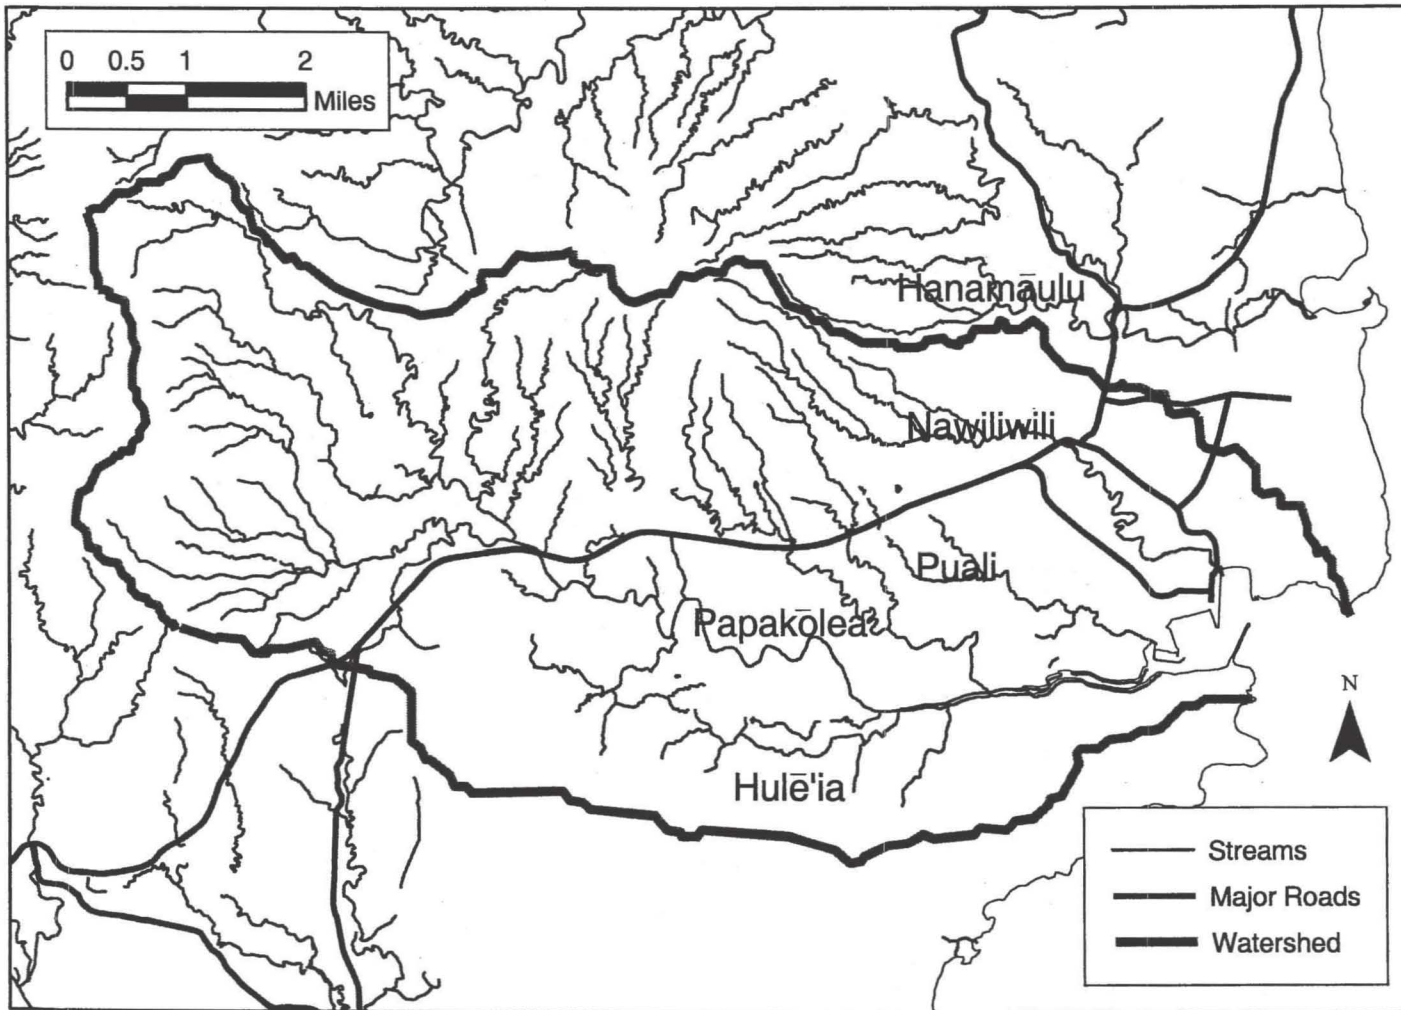
Figure B5. Perennial streams in the Nawiliwili Watershed

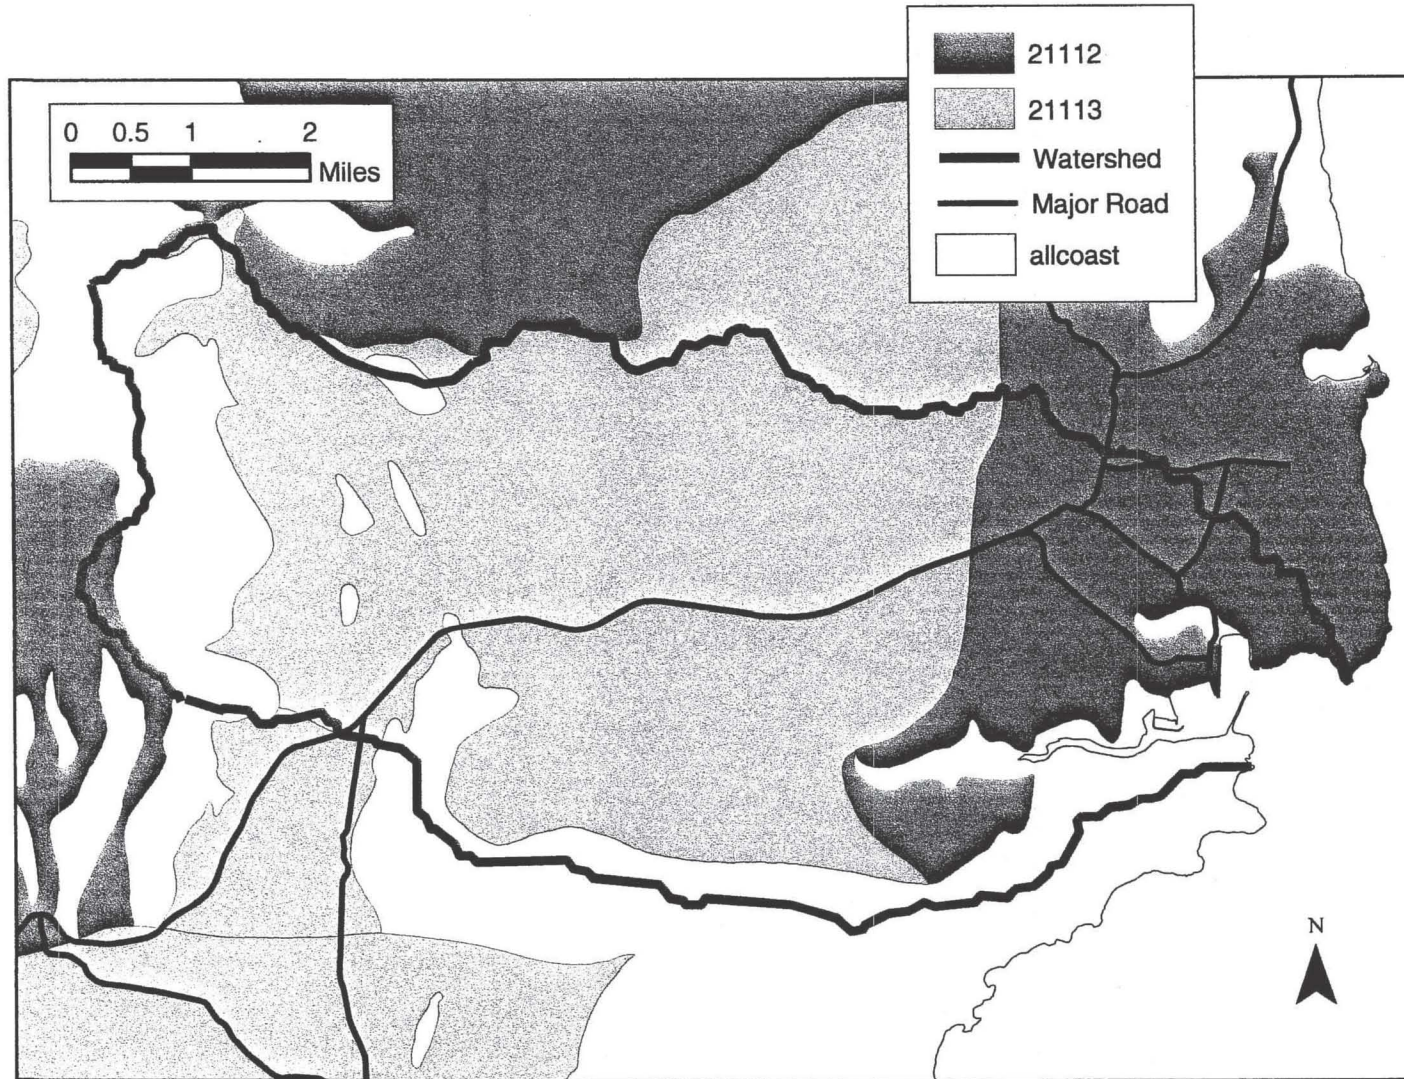
Figure B15. Status codes for lower aquifer, Hanamā'ulu system
