**EVALUATION OF REDUNDANCY IN COMPOSITE TWIN-TUB-GIRDER
BRIDGES WITH FINITE ELEMENT ANALYSIS**

A Dissertation

Lyles School of Civil Engineering

May 2018

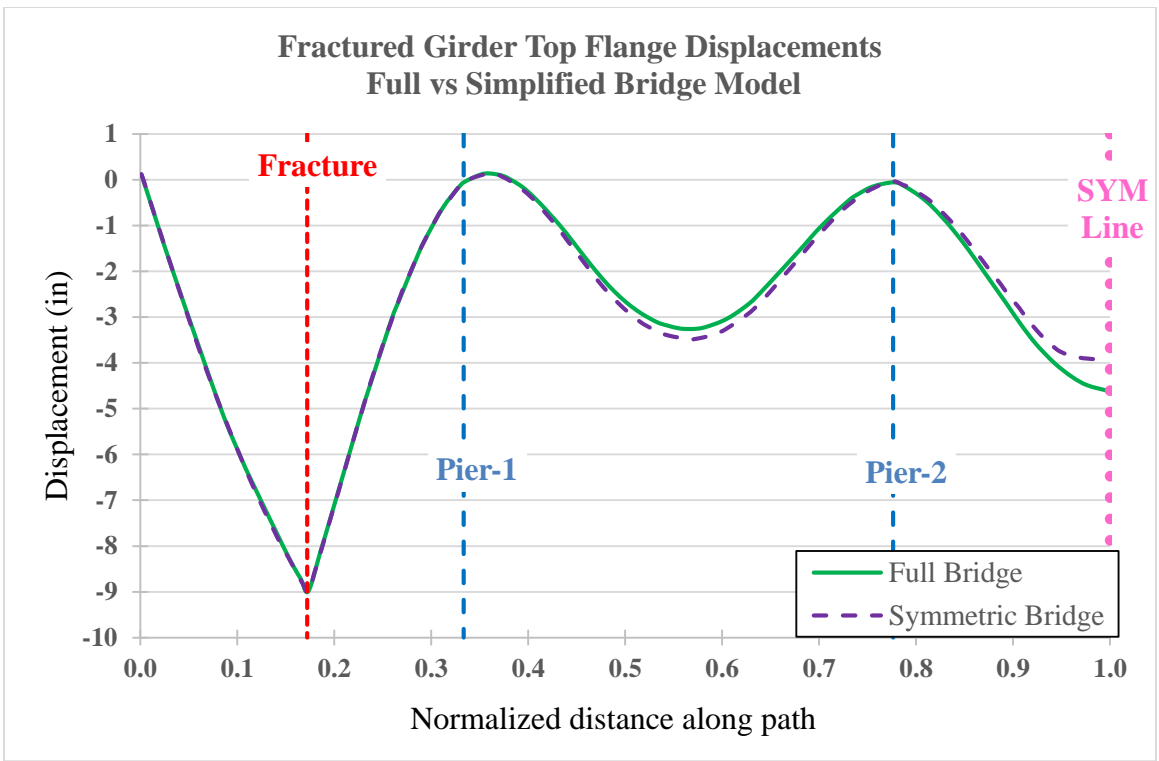
Figure 32 Fractured girder top flange displacements

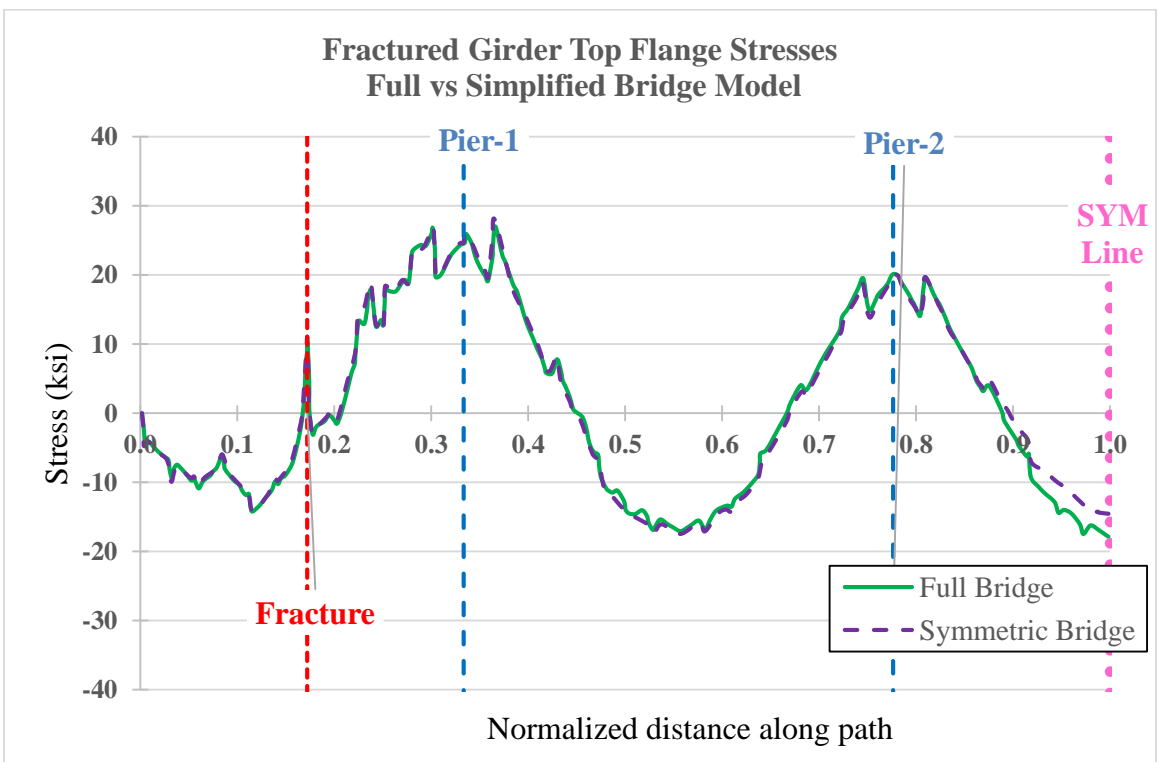
Figure 33 Fractured girder top flange stresses

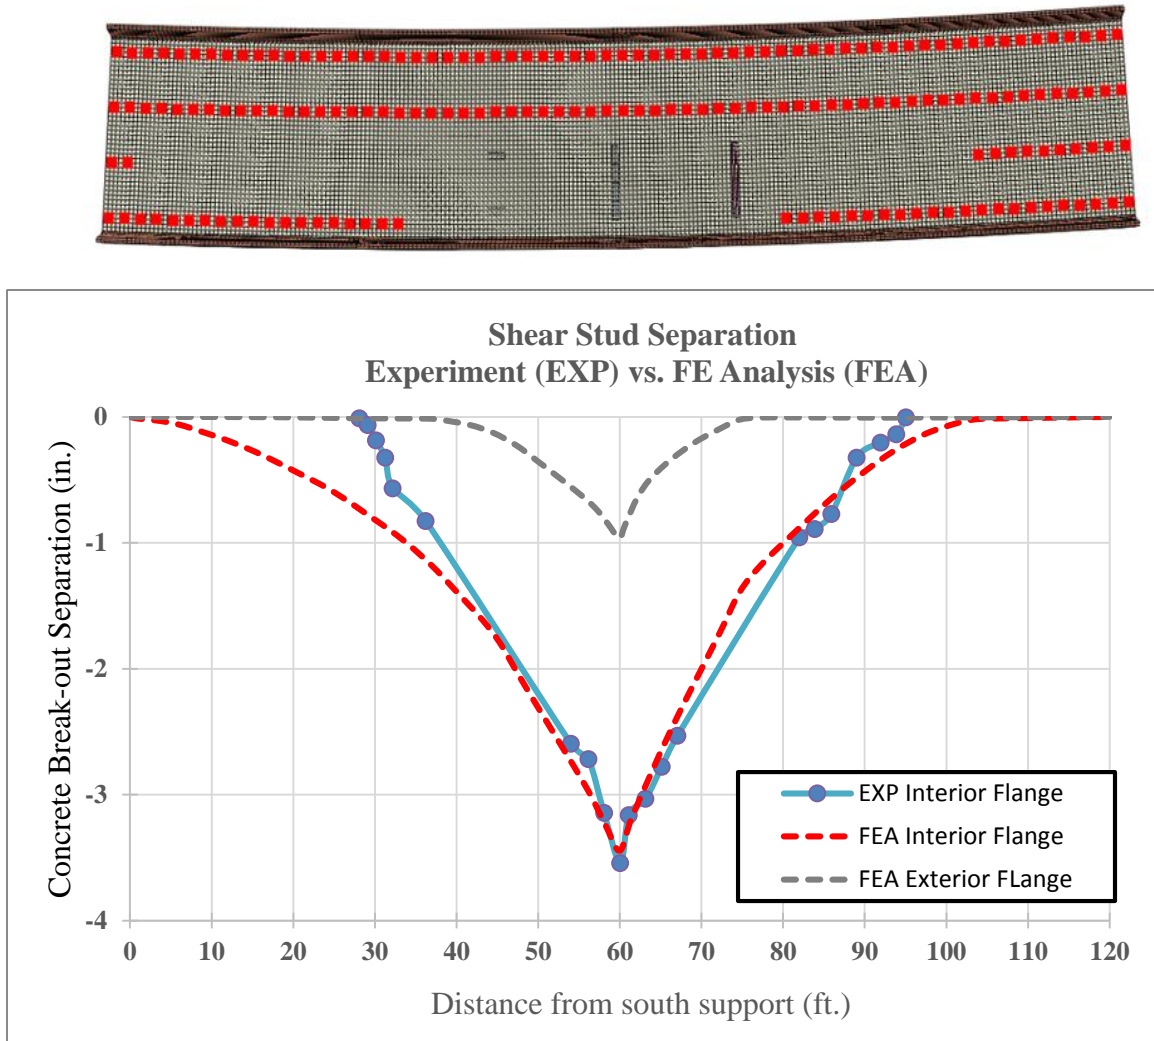
Figure 47 Experimental and analytical shear stud separation curves

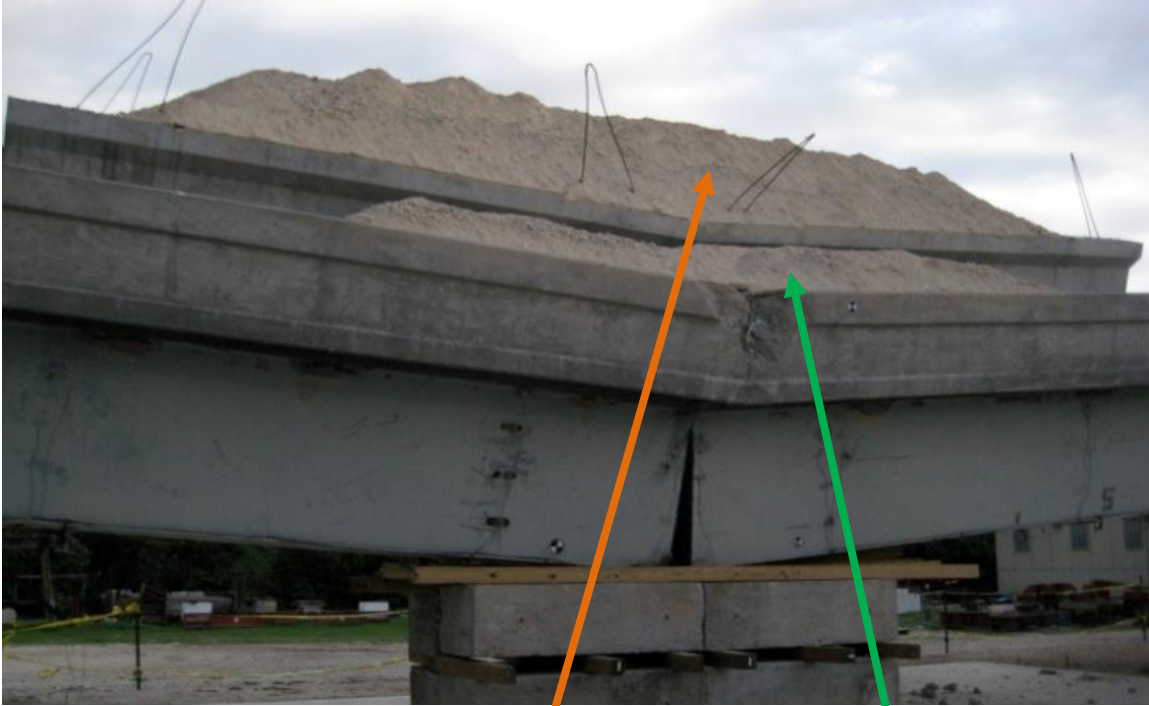
Figure 71 Test-3 details of the UT T-rib Girder Bridge from Neuman (2009) [3]

Implicit and explicit solvers were used to conduct the finite element analysis. In the implicit solver (the first step), the construction sequence was performed. In the explicit solver (the second step), quasi-static web and bottom fractures were applied by deleting element over bottom flange and the web up to top flange. The concrete weights over wooden block were placed on the deck. The concrete block weights were placed on the deck as surface traction. Finally, the sand load was increased incrementally up to the failure observed.
