Estimating Likelihood of Severe Damage due to Earthquakes in Reinforced Concrete Frame Buildings in Afghanistan

A Thesis

Master of Science in Civil Engineering

May 2018

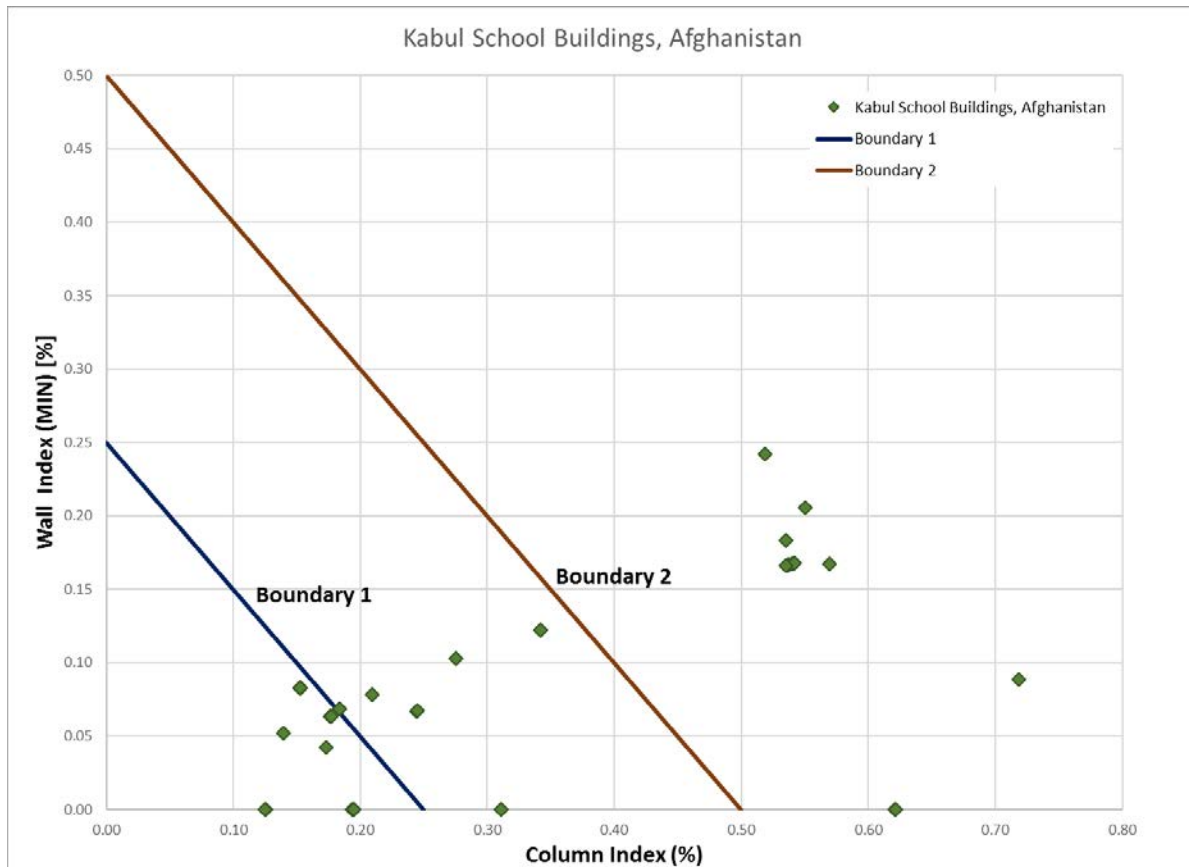
Figure 2.1. Column Index vs. Wall Index of Kabul school buildings

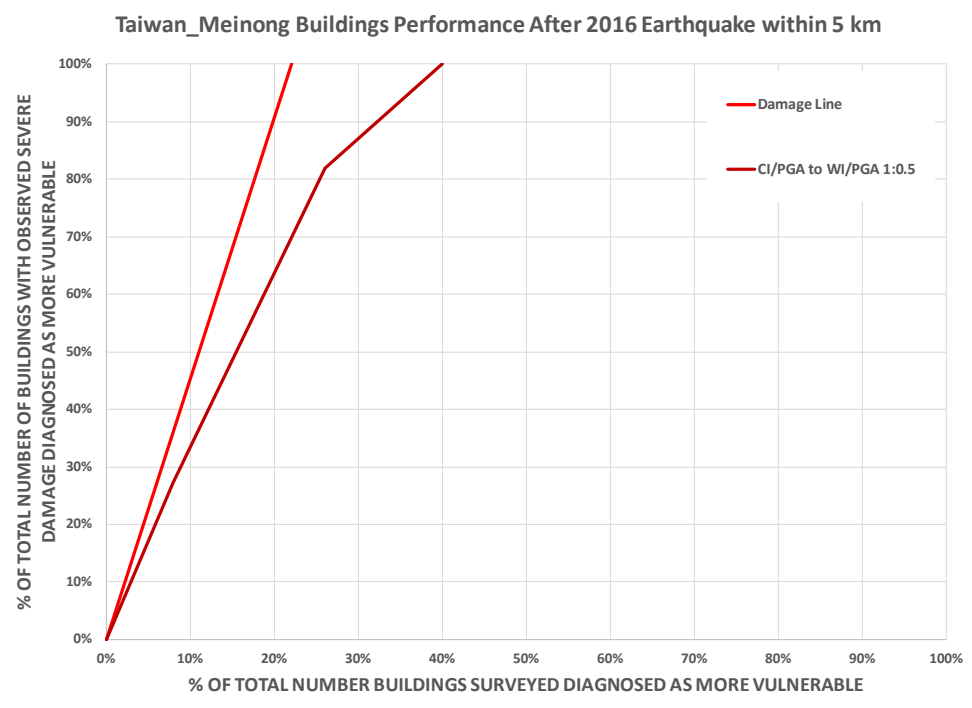
Figure 3.2. Fraction of buildings with observed severe damage successfully diagnosed as vulnerable versus fraction of total buildings diagnosed as vulnerable. 1:0.5 Column-Wall Index

Figs. 3.2, 3.4, 3.6, 3.8, 3.10, 3.12, 3.14 and 3.16 illustrate how successful various thresholds with different combination of Column and Wall Indices are. In these figures, the straight line (red colored) is the baseline illustrating the hypothetical “perfect” threshold expression which would identify only those buildings with observed severe as more vulnerable. Given the nature of ground motion and building response, however, the “perfect” threshold expression is not achievable. The piecewise linear graphs illustrate for different combinations of Column to Wall Indices. When compared with the baseline for the “perfect” threshold, these graphs indicate the success level of the thresholds considered. Each graph indicates while identifying a certain percentage of the observed severely damaged buildings as “more vulnerable to severe damage”, how many buildings which were not severely damaged are diagnosed by the respective threshold criterion as “more vulnerable to severe damage”.

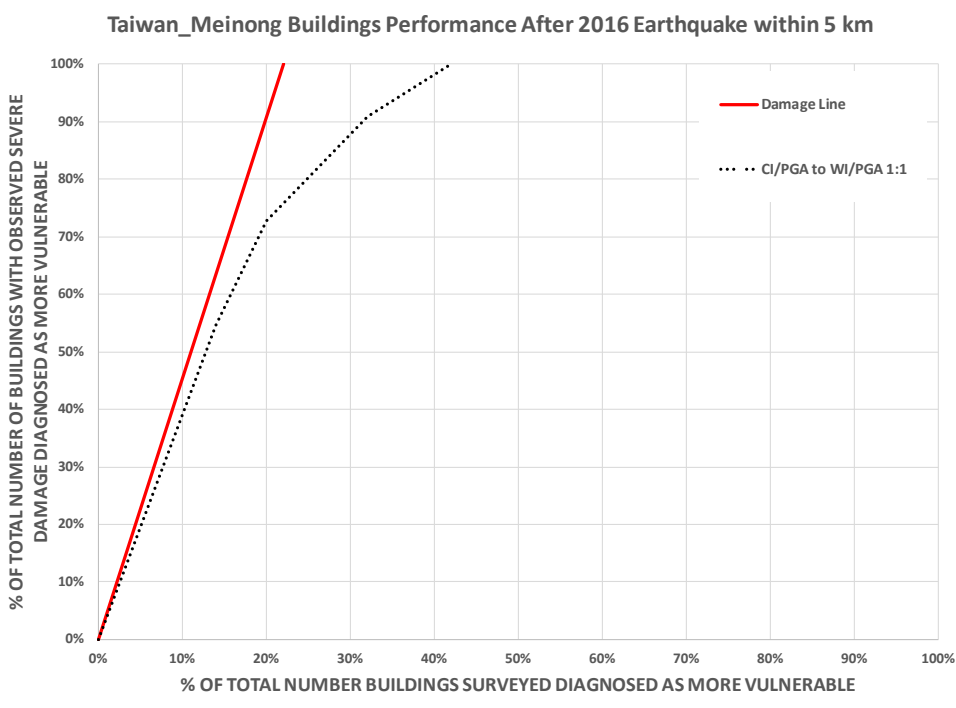
Figure 3.4. Fraction of buildings with observed severe damage successfully diagnosed as vulnerable versus fraction of total buildings diagnosed as vulnerable. 1:1 Column-Wall Index

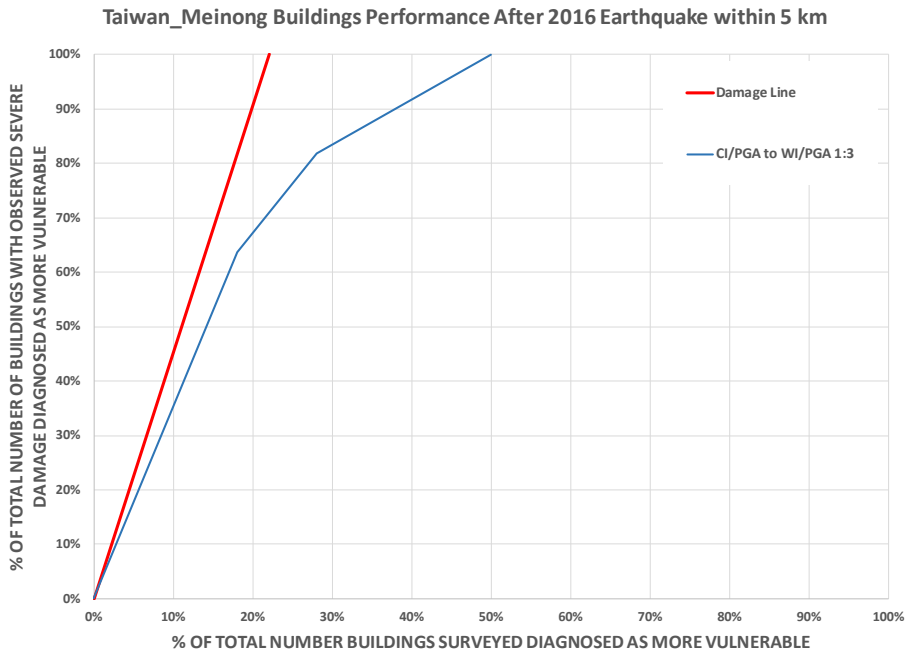
Figure 3.12. Fraction of buildings with observed severe damage successfully diagnosed as vulnerable versus fraction of total buildings diagnosed as vulnerable. 1:3 Column-Wall Index

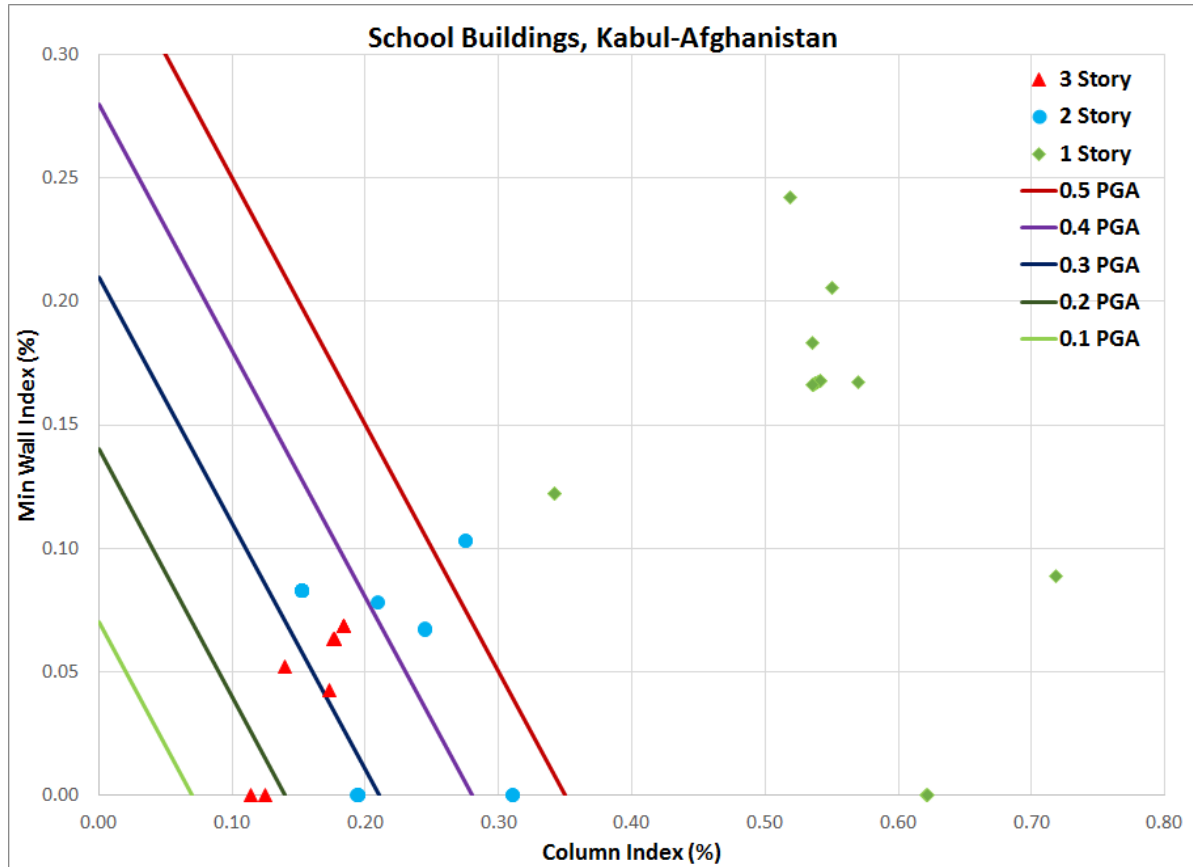
Figure 4.1. Estimated seismic performance of schools in Kabul, 1:1 column-wall index

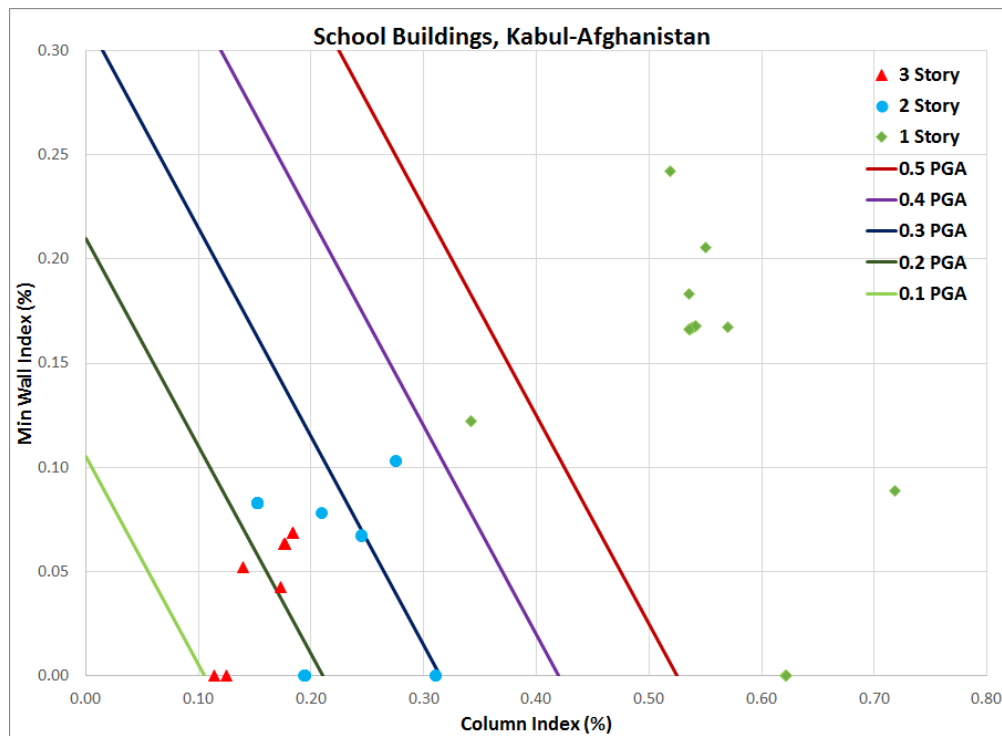
Figure 4.2. Estimated seismic performance of school buildings in Kabul, 1:1 column-wall index threshold increased by 50%

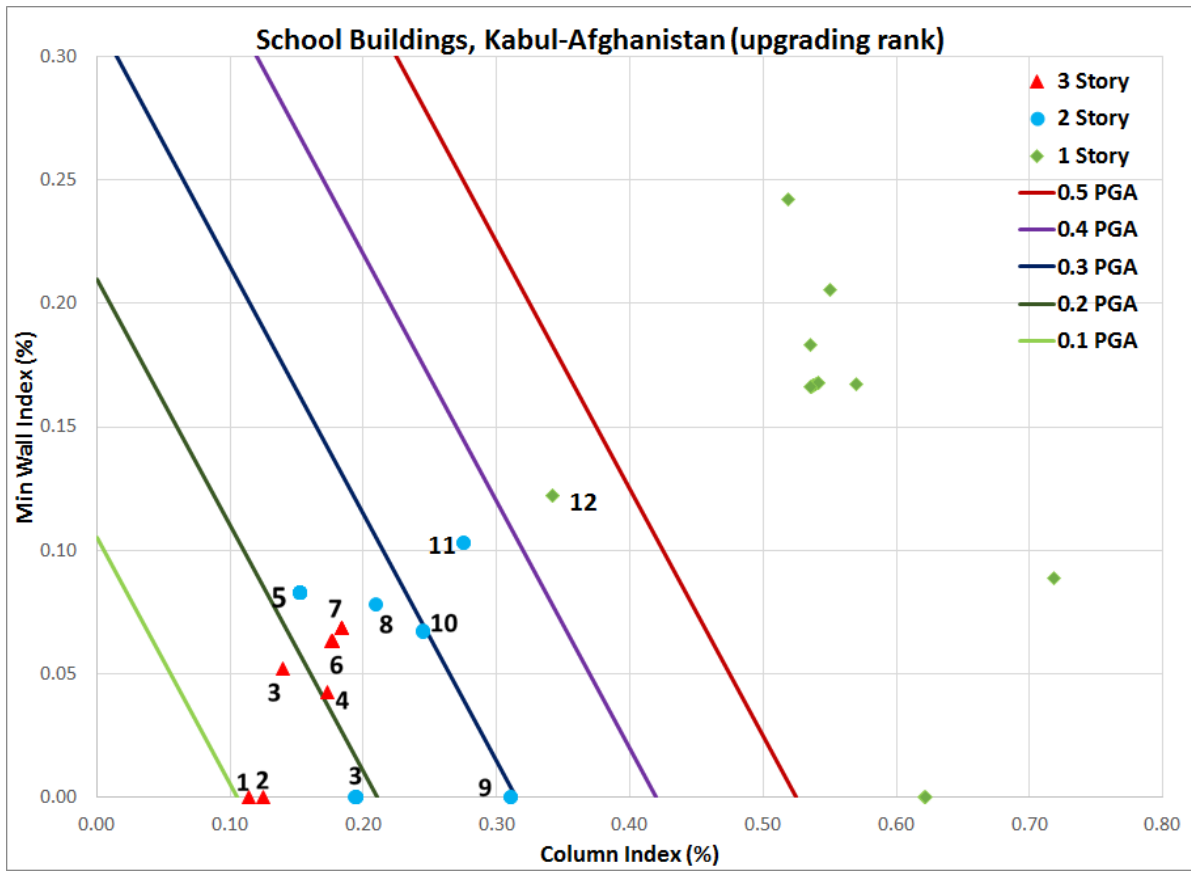
Figure 4.3. Upgrading of schools with more vulnerability, 1:1 column-wall index with threshold increased by 50%

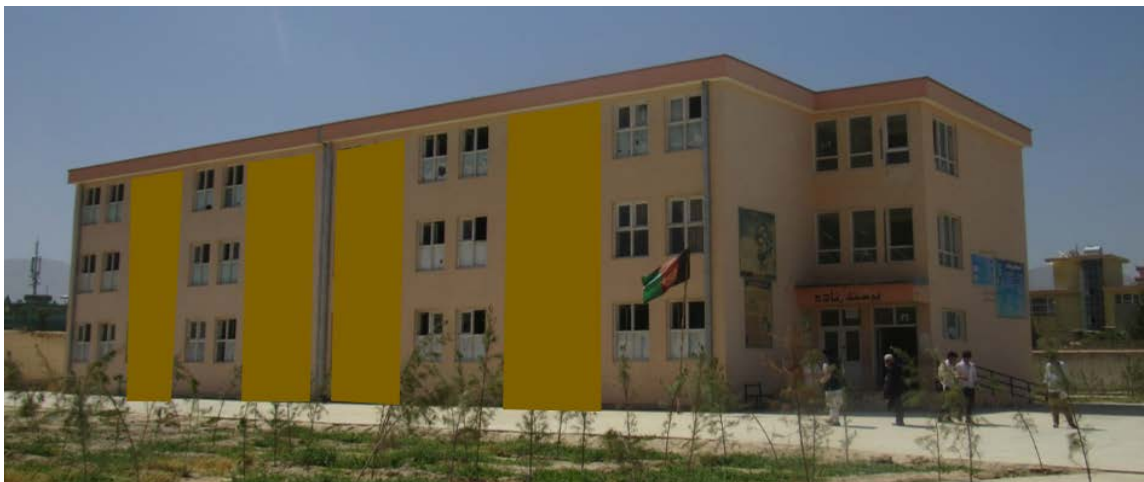
Figure C-4. Kabul School 49 (upgraded with solid masonry infill walls) (front view)

One approach to achieve this can be to enlarge the columns to 0.35x0.80 cm and fill every other wall around the perimeter to achieve full bay (column-to-column, floor –to-ceiling and without any opening) solid masonry infill walls (see Figs. C-4 and C-5).

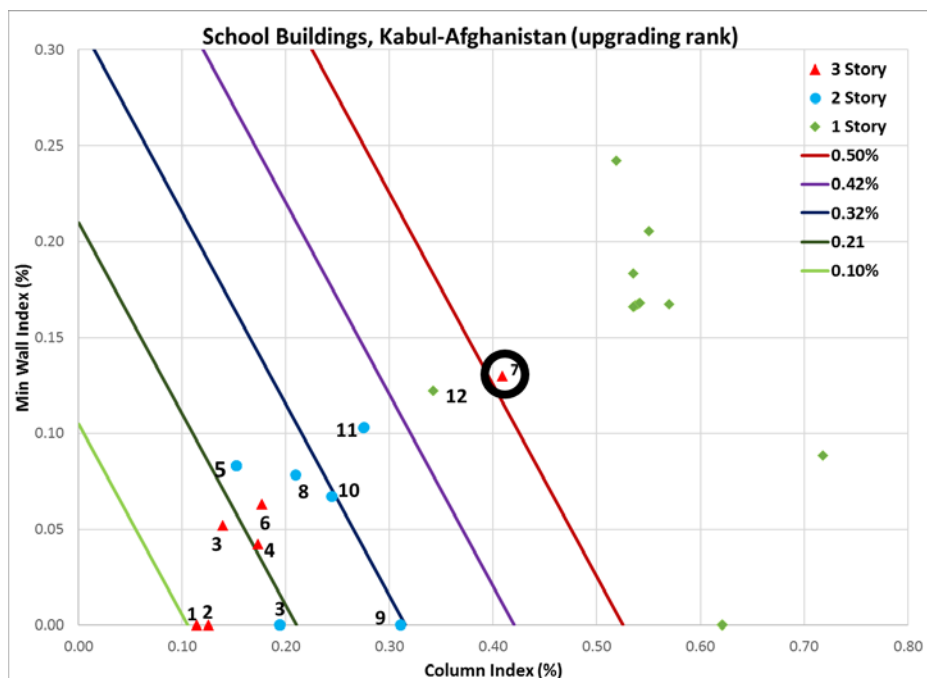
Figure C-6. Upgrading of Kabul School 49 (new location on the plot based on the use of larger columns and additional masonry solid infill walls)

The CI and WI for the upgraded building are shown in Figure C-10. Note that the building is still shown as “7” but only for identification purposes. The proposed upgrade would move Kabul school building 49 to outside the “more vulnerable to severe damage” zone.
