Alternate Interchange Signing Study For Indiana Highways

JTRP-4545

Presenters: Stanley Chien (PI), Jue Zhou, TASI, IUPUI

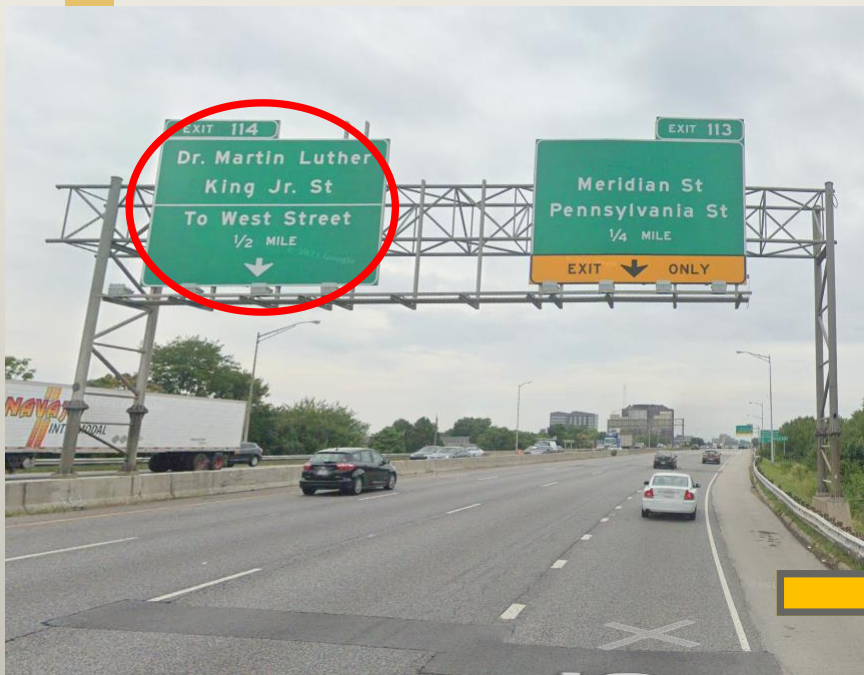
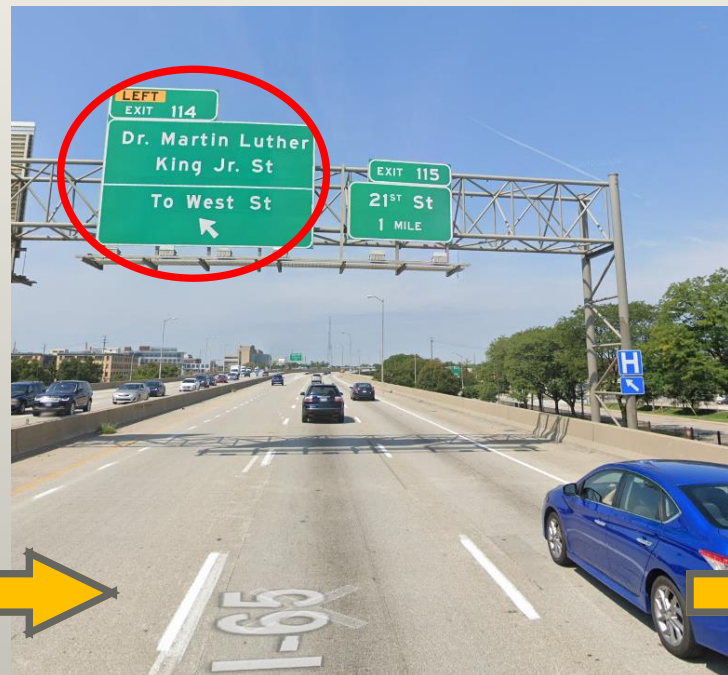
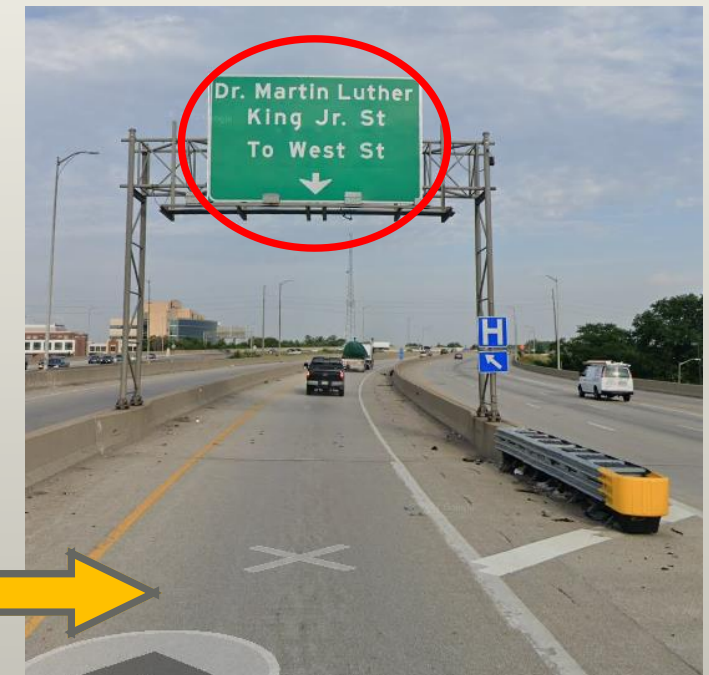
Confusing Sign Example (I-65 NB Exit 114):

- Problem:
 - *This is an area with a high amount of weaving after I-65 NB and I-70 WB come together from the North Split and a lane drops at Meridian Street shortly thereafter. There is a lot going on in a short distance. The signing is up for MLK and West Street but the first sign (1/2 mile) is likely missed due to the action occurring here.*

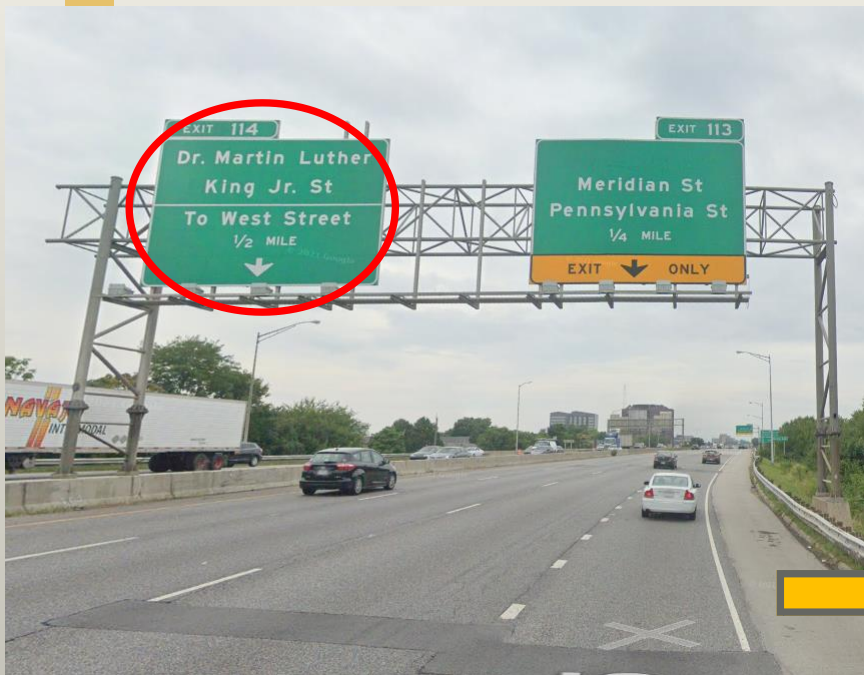
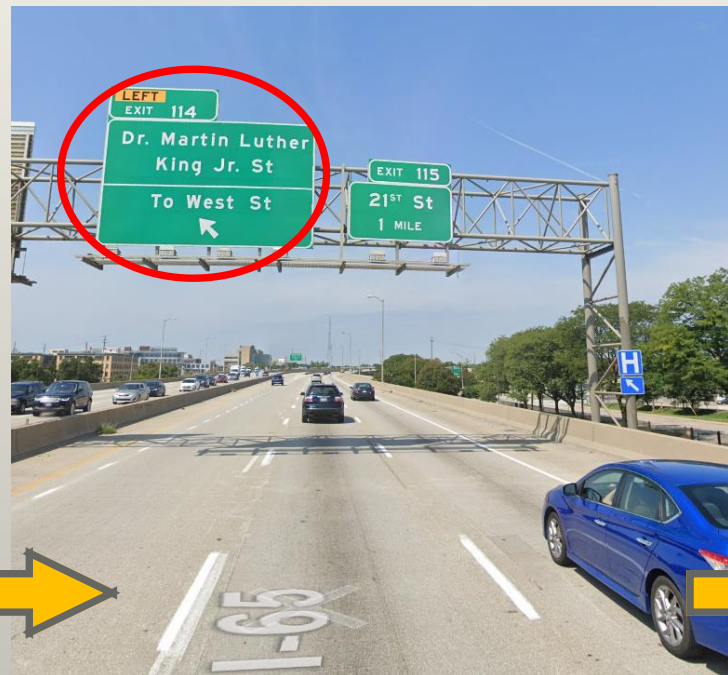
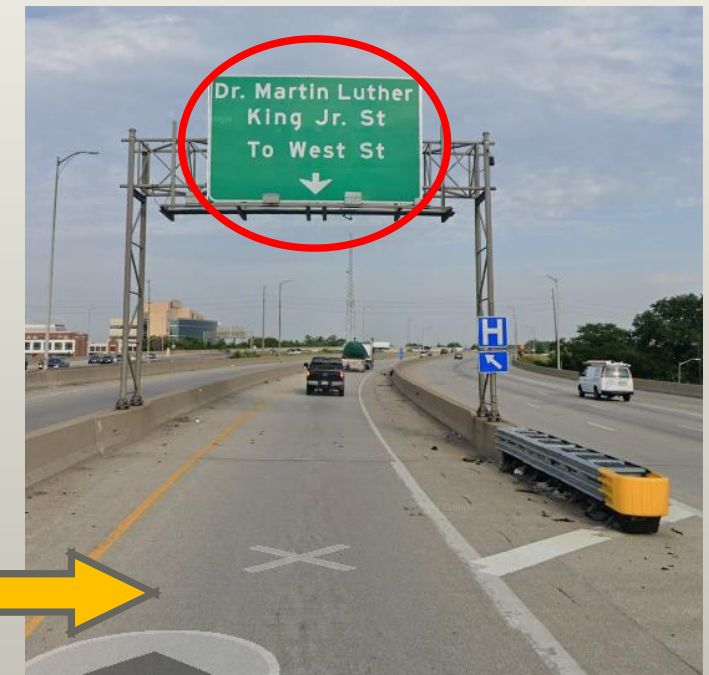
Confusing Sign Example (I-65 NB Exit 114):

- Type of Problem:
 - Signs being missed due to too much information presented in a short distance.
- Proposed Actions:
 - An additional left plaque could be put on the 1/2 mile sign for MLK/West Street.

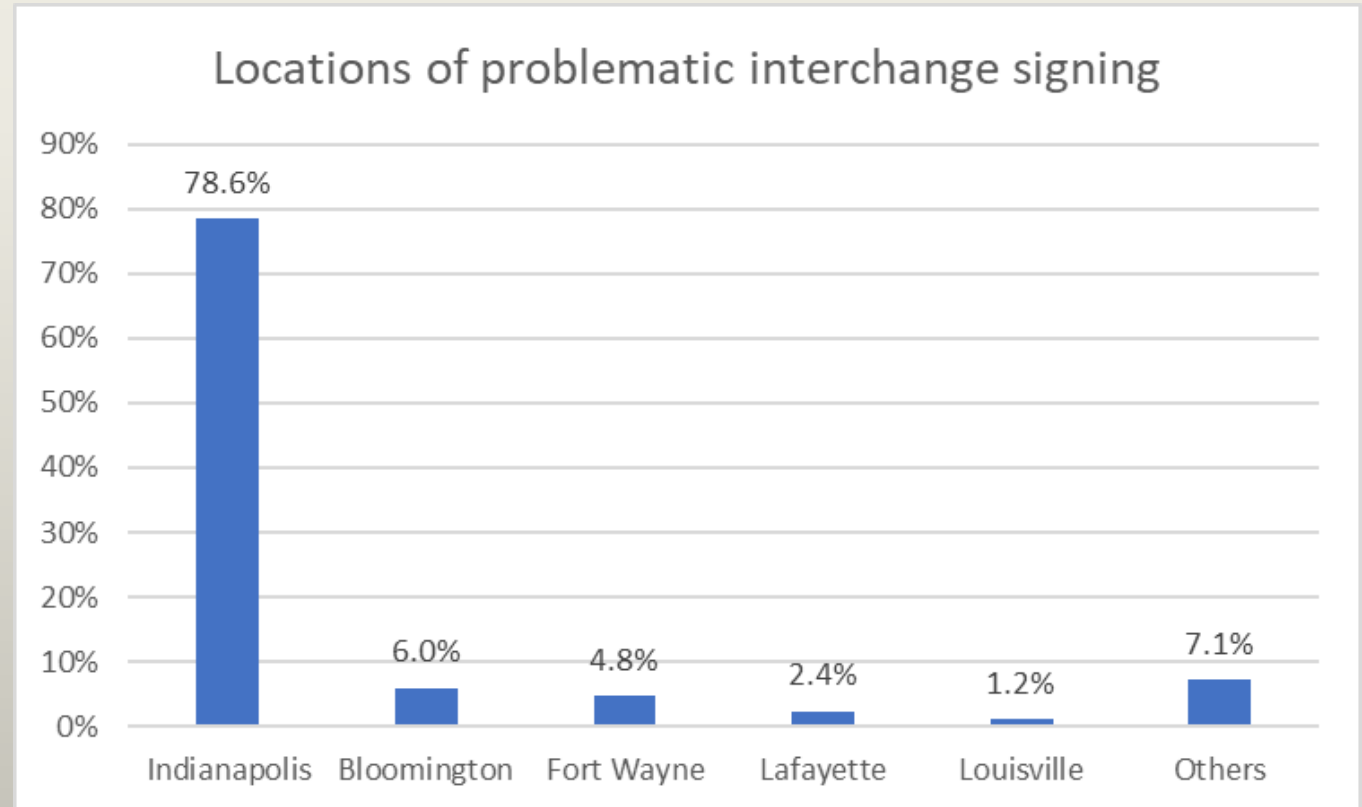
Survey Data Analysis: Location

- Most cases were located around the greater Indianapolis area since it has many highway interchanges and many uncommon interchanges in a densely populated area.

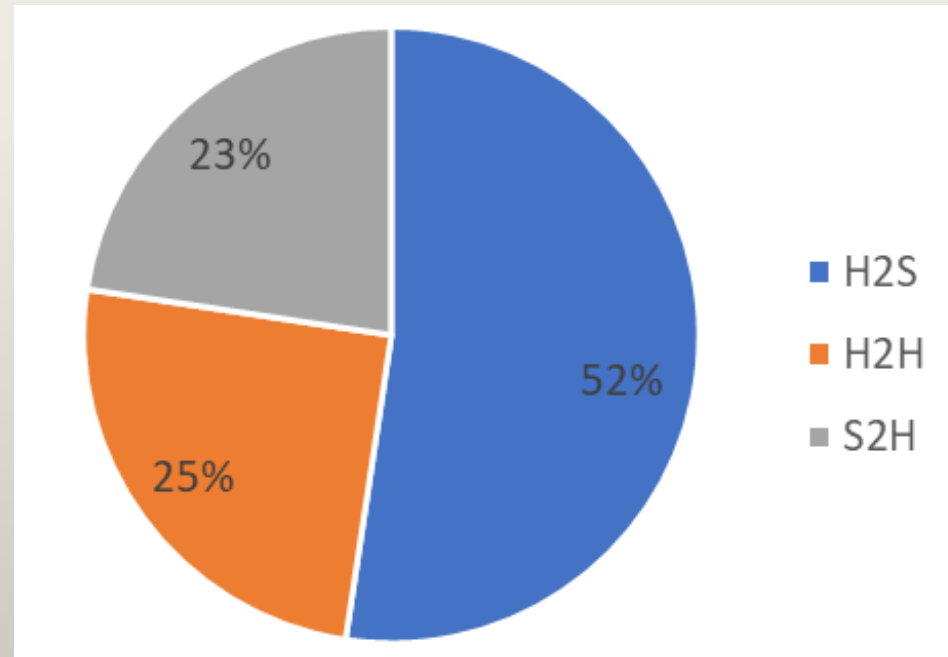
- Highway to local street (H2S) signs were reported most, while the highway to highway (H2H) and local street to highway (S2H) signs have the similar reported case number.

Distribution of problematic interchange signs in terms of highway entry and exit
