Quantifying Channel Responses to the Removal of the Glines Canyon Dam in the Middle Reach of the Elwha River, Washington

QUANTIFYING CHANNEL RESPONSES TO THE REMOVAL OF THE GLINES
CANYON DAM IN THE MIDDLE REACH OF THE ELWHA RIVER,
WASHINGTON

Master of Science

Geological Sciences

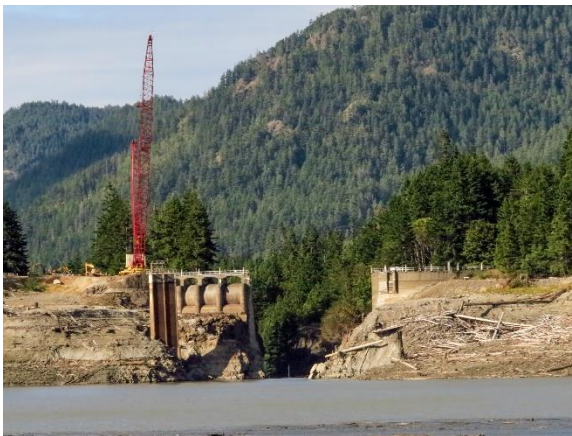
Figure 2: Glines Canyon Dam from the Lake Mills Reservoir taken August, 2012 prior to the coarse sediment release. Dam removal had already begun in June 2011 however, only suspended sediment was flowing at this point. (Photo taken by Bryon Free)

The removal of the two dams on the Elwha River within the Olympic Peninsula of Washington (Fig. 1) by the National Park Service and the Bureau of Reclamation was the largest dam removal project in history. The dam removal process consisted of simultaneously removing the upstream Glines Canyon Dam and downstream Elwha Dam starting June, 2011. In September 2012, the downstream Elwha dam was fully removed and the Glines Canyon Dam was finished in August 2014 (Figs. 1-3). The two dam removals were undertaken to restore natural fish passage and habitat to much of the mainstream river.

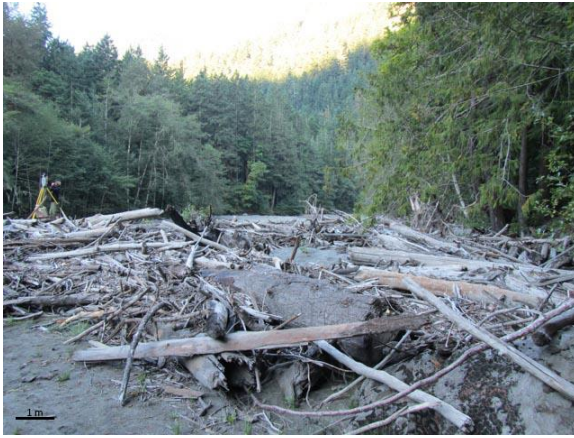
Figure 4: Example of large woody debris collected in the river during the dam removal process. Notice the TLS on the left side of the photo.

Photo location: Site 3, downstream end of the river bend on the right-hand bank, August 2014

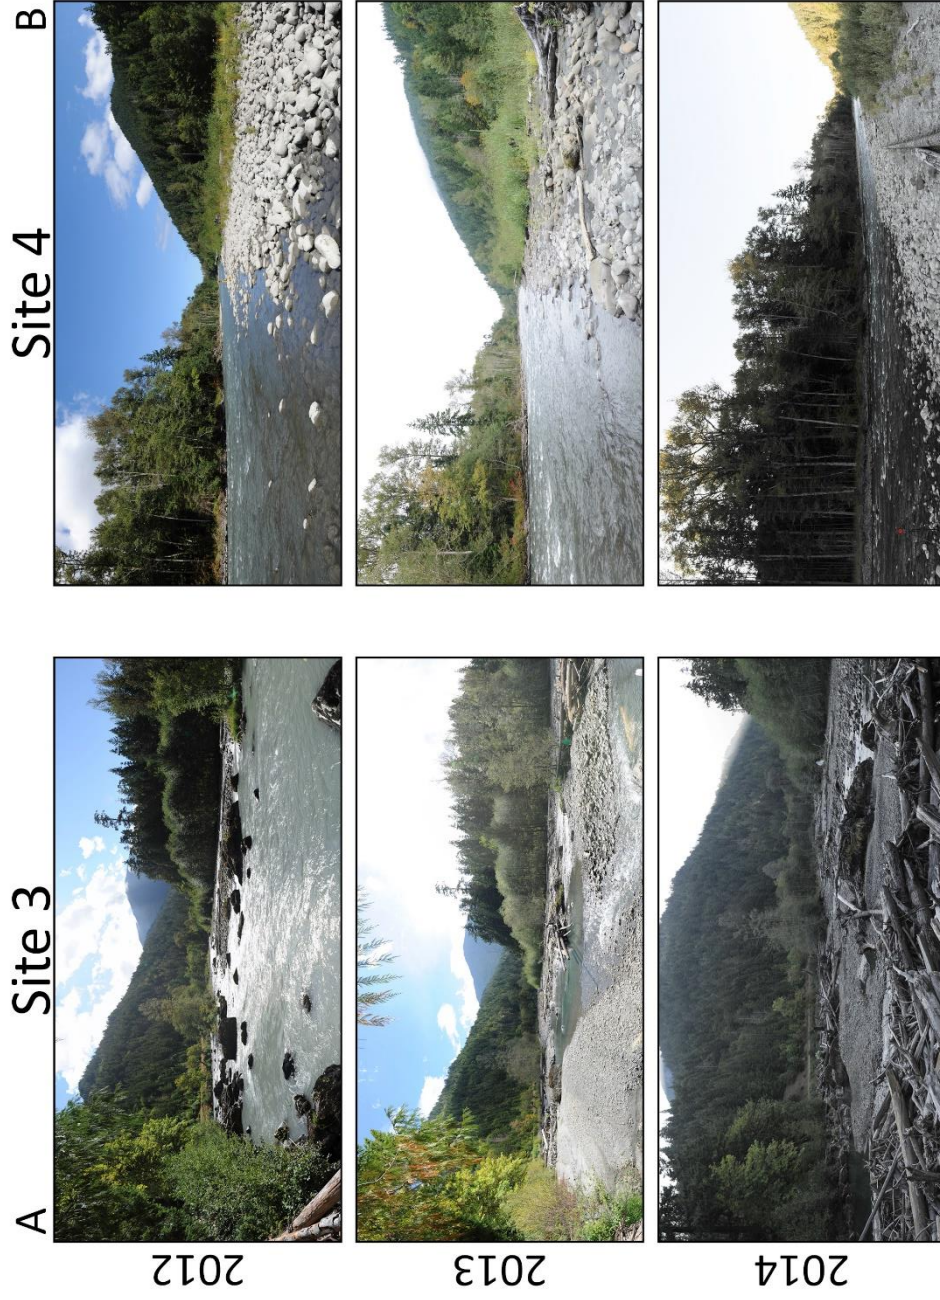
Figure 6a-b: Time series photos of Site 3 and Site 4. Photo series before during and after the dam removal. Each photo was taken during the Terrestrial Laser Scanning (TLS) surveys in late August. A: Site 3, there was a dramatic increase in Large Woody Debris and the forced migration of the multiple channels into the point bar. B: Site 4, there was an overall decrease in sediment size as it interstitially filled the existing cobbles that were in the site

show that the right channel was subject to more sediment deposition than that of the inside point bar and small vertical changes on the surface of the bars throughout the study reach (Fig. 13b). In turn, the center channel of the river was fully abandoned and the left most channel took on the greatest proportion of flow (Figs. 6a and 13b).

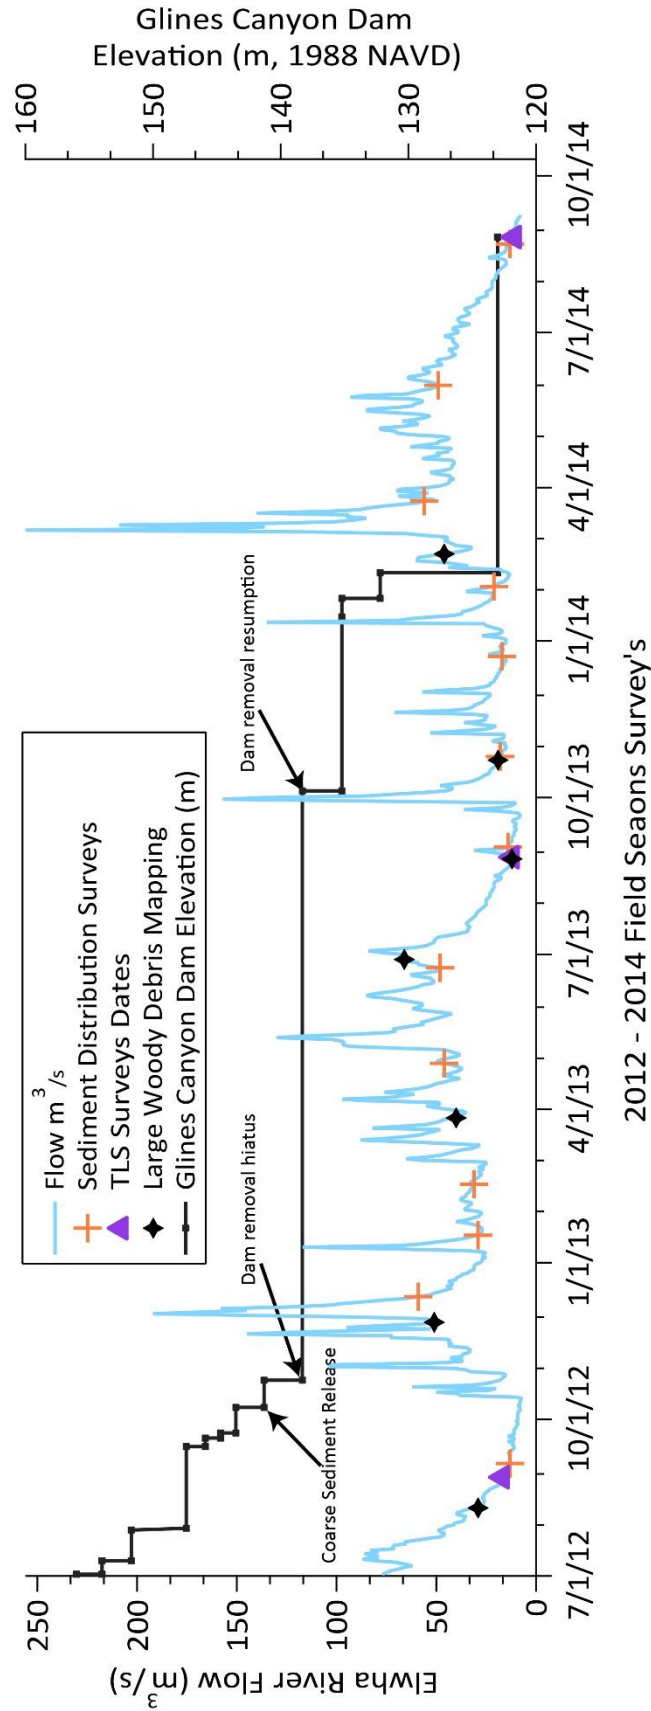
Figure 7: Elwha River hydrograph. The data was collected from the USGS gauging station # 12045500 located at the downstream end of the middle reach of the Elwha River at McDonald Bridge (RK 12.1). Each of the different survey dates, wood mapping and, dam draw down periods are plotted to see the connection of the Elwha River flow with the data collected.

There were three major periods when the river underwent significant events that could cause morphological changes. The first occurred on September 28, 2013 during the initial high discharge event of $\sim 150 \text{ m}^3/\text{s}$; the second was 7 days later when the resumption of the dam removal process began (Fig. 7), allowing more sediment to flow from the reservoir. The third event was in March, 2014 when the river discharge exceeded $250 \text{ m}^3/\text{s}$, which was the largest flow recorded during the first two years of the dam removal process (Fig. 7). Each site was affected differently according to its specific geometry.

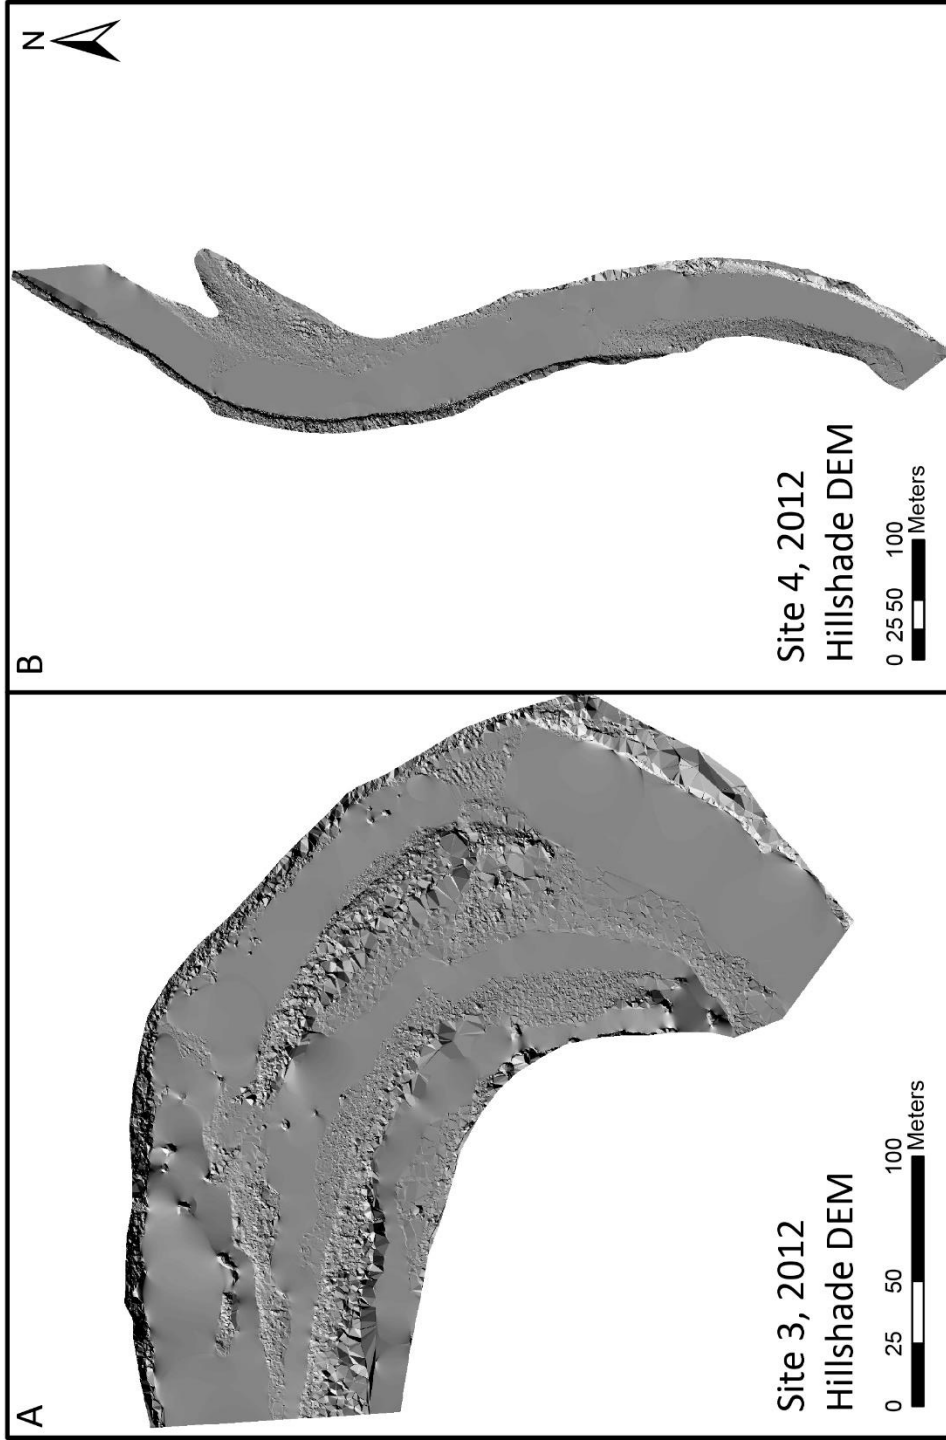
Figure 12a-b: 2012 Hillshade Site 3 and Site 4. A: Site 1, August 2012, hillshade surface prior to coarse sediment release with several flowing channels. B: Site 2, August 2012, hillshade surface prior to coarse sediment release with a single channel and prominent point bar.

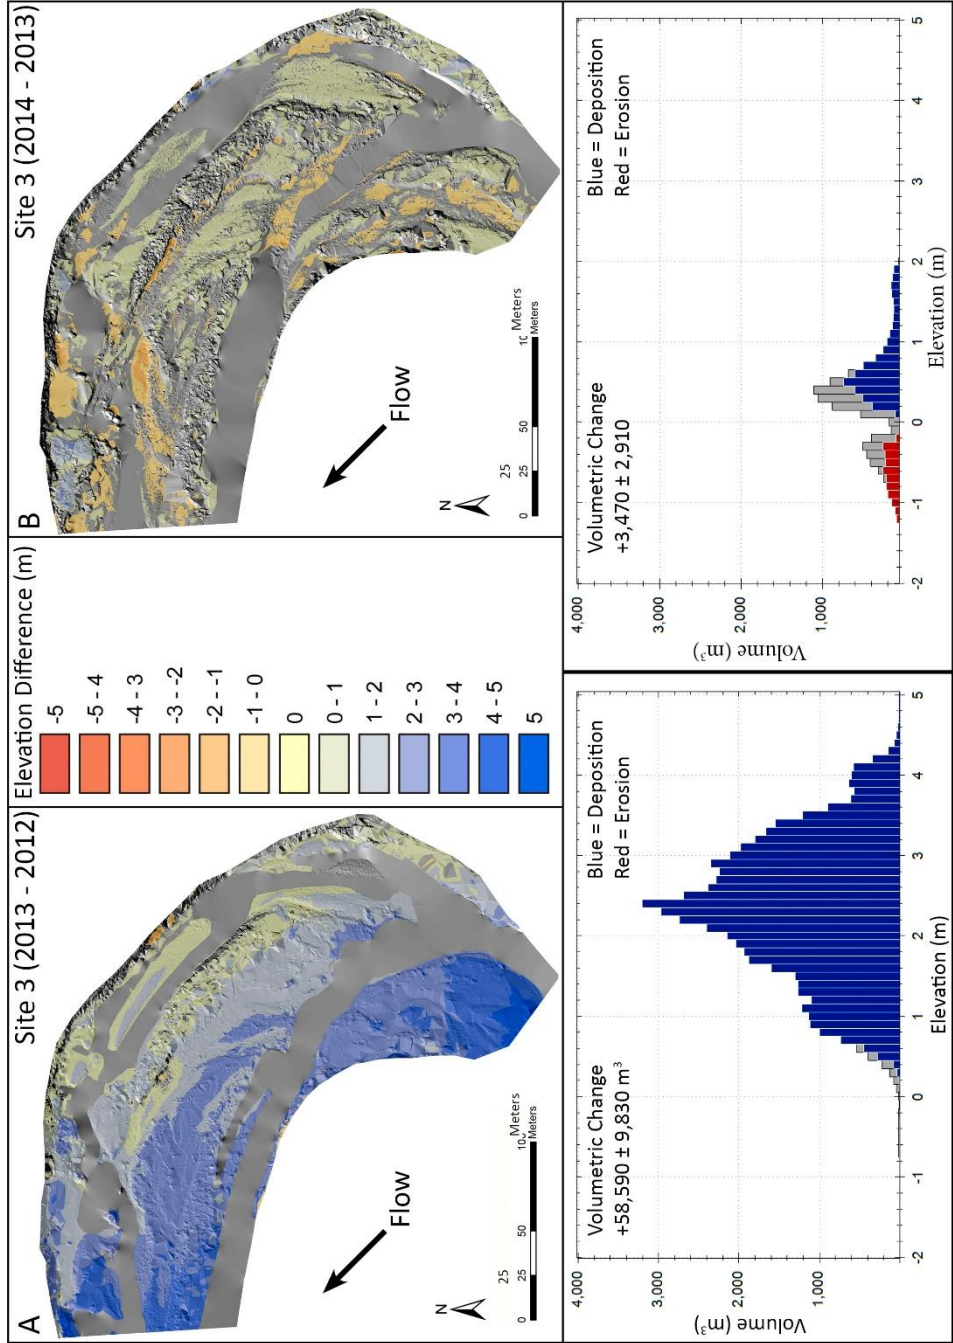
Figure 13: DEM of Difference (DoD), Site 3, demonstrates the change in vertical elevation of the ground surface between TLS surveys. Copious amounts of sediment deposition can be seen in Year 1 and 2 of dam removal. There was a loss of the multiple channels from the outside bend of the river moving the primary flow of the river to the inside bend. Grey areas in the map are surfaces that were not used in the differencing calculations due to the water surface errors discussed. The histograms depict the volume change over the elevation; the grey indicates the potential error in the volume over the change in elevation.

Over the second year of dam removal, the subaerial surface increased by 55% with an overall increase of 16,600 m² (Fig. 13b; Table 5). In contrast to the large increase in surface area, the topographic measurements indicate an indeterminate change in net volume measuring $33,470 \pm 2,910$ m³ this is likely due to the same error assessments that each of the other sites have experienced. Overall, there was still an average vertical change of 0.07 m (Figs. 6a and 13b; Table 4). During this time, the topographic changes

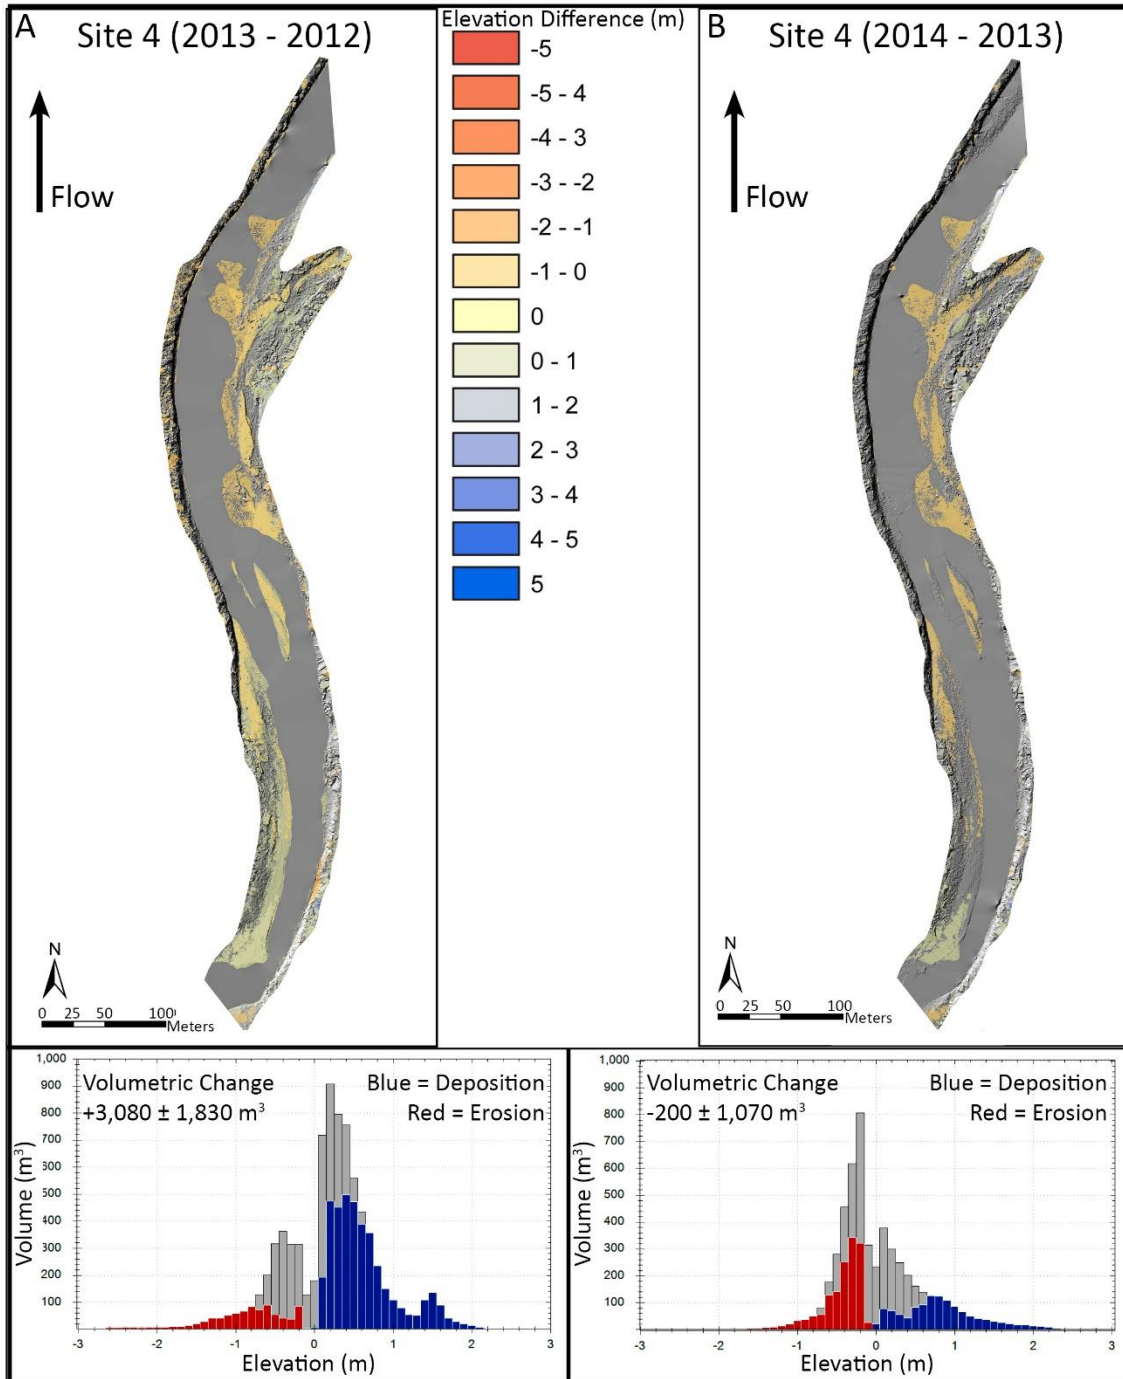
Figure 14: DEM of Difference (DoD), Site 4, demonstrates the change in vertical elevation of the ground surface between TLS surveys. The change that occurred at Site 4 is minor when compared to the other 3 sites. However, sediment did deposit as seen in the histograms. The primary sedimentation in year 1 is at the upstream end of the survey site. Grey areas in the map are surfaces that were not used in the differencing calculations due to the water surface errors discussed. The histograms depict the volume change over the elevation; the grey indicates the potential error in the volume over the change in elevation.

At the end of the second year of dam removal, there was a 9% increase in subaerial surface totaling 2,500 m² (Fig 14b; Table 5). However, the topographic measurement indicate an indeterminate change in net volume of -2200 ± 1,070 m³ (Fig. 14b; Table 4). The upstream end of the northern bar experienced the greatest amount of

Change during this period. The measurable changes in topography indicate low level vertical losses of sediment on the upstream end of the bar surface (Fig. 14b).

The sediment deposition at Site 4 is the least in the entire study area. With the low sinuosity of the river bends (Figs. 14a and 23), the sediment deposition occurred along the two long point bars. The sediment that collected filled the interstices of cobbles that armored the bar surface (Fig. 6b). A new mid-channel bar also formed at the top of the riffle in this reach (Figs. 12b, 14a and 23). The formation of the mid-channel bar is an indicator that there was plenty of sediment flowing through the channel at the time, but not reaching the banks in the volume that was observed at the upstream sites.

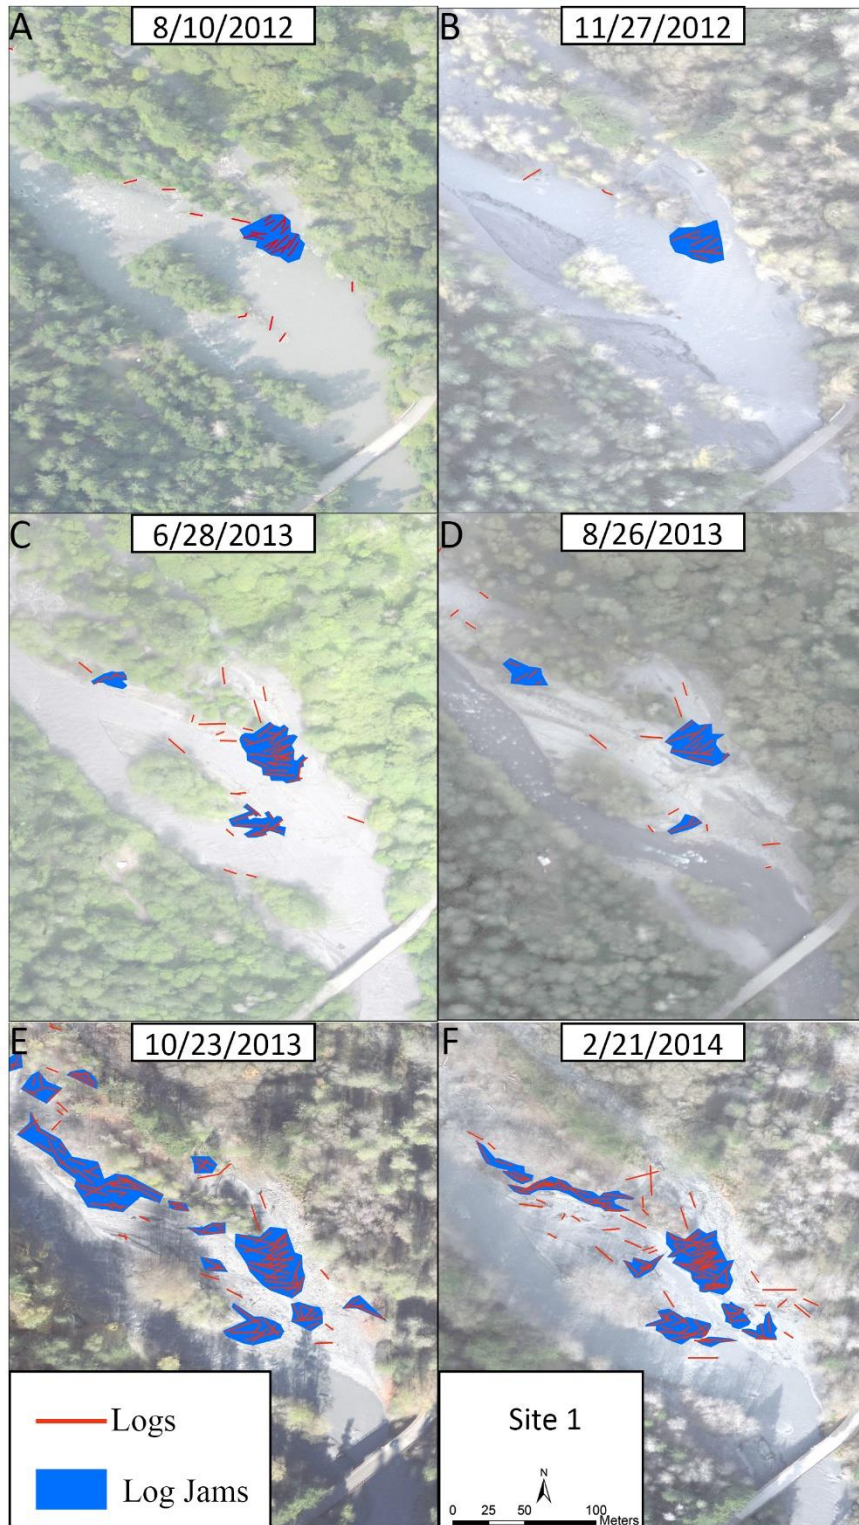
Figure 20: Site 1, Mapping showing the flux of woody debris at the survey site on orthophotographs taken from August 2012-February 2014. Blue = Log Jam Red = Individual logs >2 m in length.

The August 10, 2012 large woody debris mapping indicated as few as 26 logs and a single log jam at the apex of the main island (Figs. 19a, 19b and 20; Table 6). The November 27, 2012 map indicates a loss of woody debris with 11 logs and a continuation of the single log jam (Figs. 20a and 20b; Table 6). This loss of wood took place even though the mapping occurred directly after the reservoir sediment release in October 2012 (Fig. 7). However, after a minor flood event ($<120 \text{ m}^3/\text{s}$) that occurred in May 2013 (Fig. 7), there was an increase in woody debris as seen on the June 28, 2013 map (Fig. 20). During this time, 50 individual logs and 3 log jams were counted (Figs. 19a, 19b and 20; Table 6). Two of the log jams were located at the apex of the islands in the branching river and the third was located on the downstream end of the middle channel on river

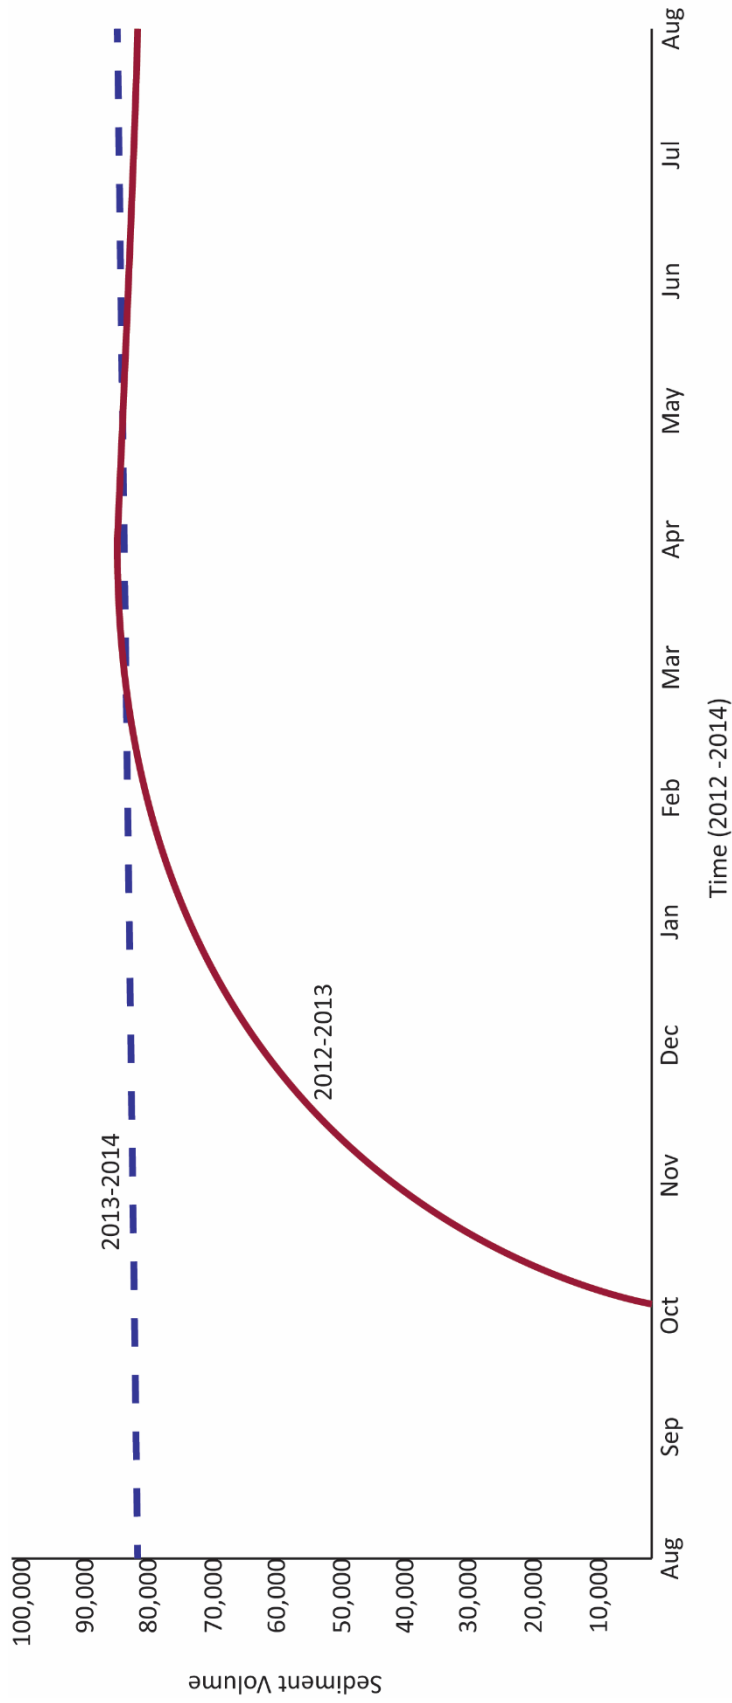
Figure 25: Conceptual total sediment inundation/flux in the entire middle reach of the Elwha River during the dam removal process. Year 1, the primary sediment load was deposited in the first few months after the dam breach. Year 2, there was equivalent deposition and erosion keeping the sediment levels relative to the first year's deposition.
