# Treatment of the Wooden Trunks in the Ceiling of the Burial Shaft of the Step Pyramid in Saqqara, Egypt

Ashraf Youssef Ewais\*

\* General Director of Saqqara Restoration Administration, the Supreme Council of Antiquities, Egypt

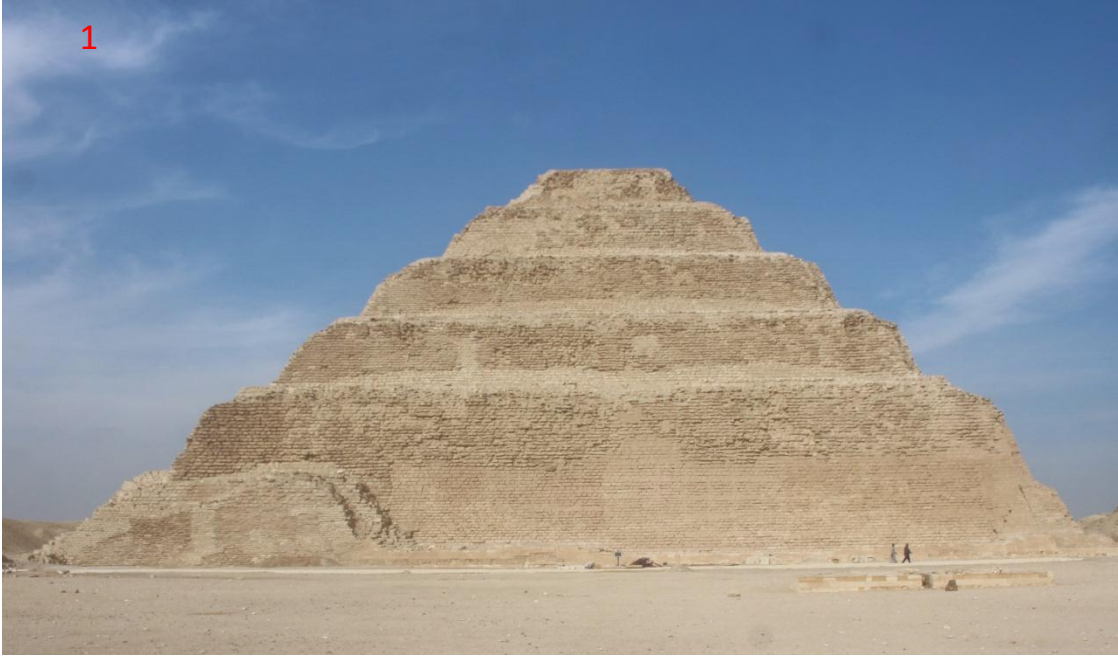
Photo 1 South façade of the Step Pyramid (after restoration) where there is the south entrance

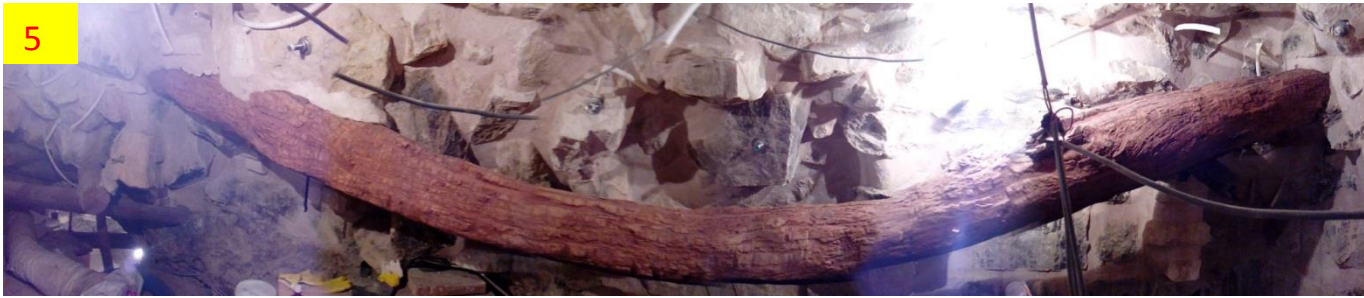
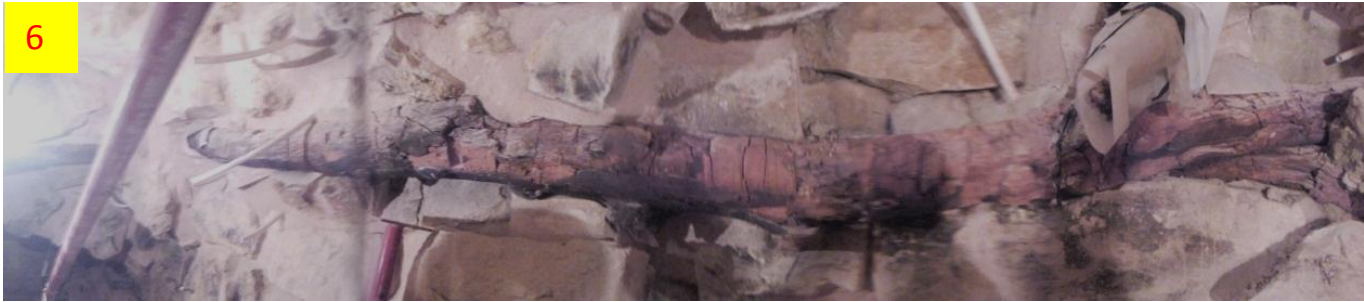
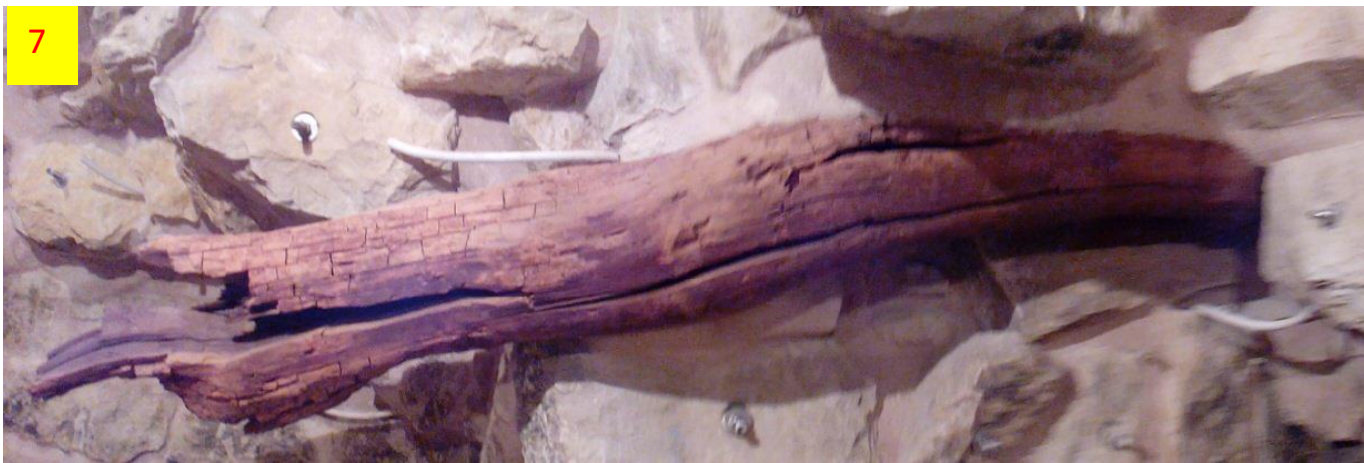
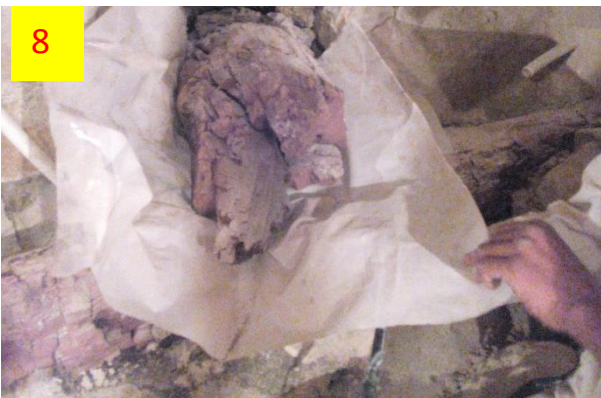
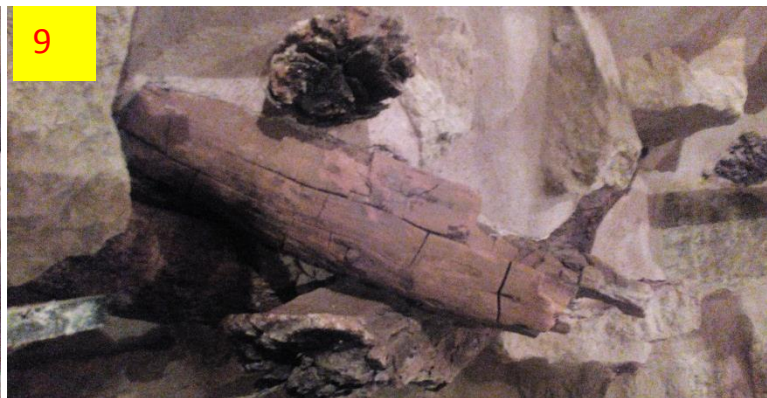
It is thought that the south entrance of the Step Pyramid was opened during the Saite period. During that period, some restoration work was done to the Step Pyramid, especially the entrance where some limestone columns were used to support the cracked ceiling. It seemed that the ceiling had a problem since that time. So, some wooden trunks were used to support the ceiling especially in the places which were collapsed. Those pieces of the wooden trunks are in different sizes, the longest of which is located on the western side under the ceiling, about 6.54m long. The second piece is located on the southern side under the ceiling. It is about 4.78m long. There are two small pieces in the southern side. One is located underneath the ceiling blocks from west to east, about 2.82 m long. The other is smaller, it is about 1.71m long. The eastern side has small pieces that are thrust in the ceiling. Although they were longer before, they might be broken because of falling blocks. All those trunks were in bad condition, and they were so fragile that some small pieces might separate and fall. The effect of brown rot could be seen in all trunks, and there are different sized cracks could be seen in all trunks.

Photo 5-9 Wood trunks before restoration

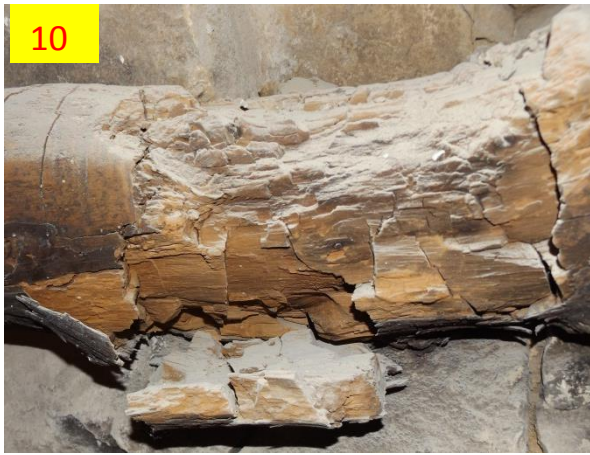
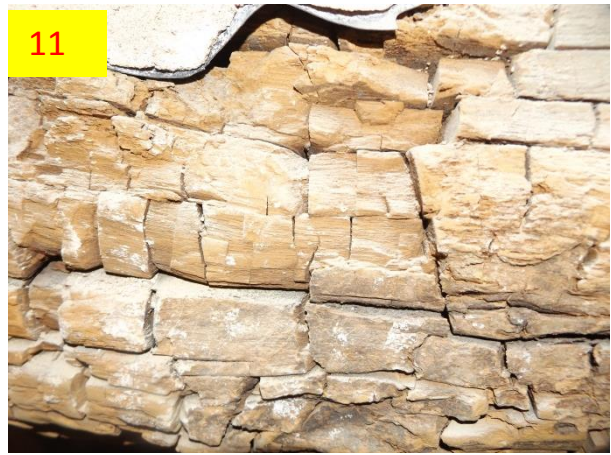
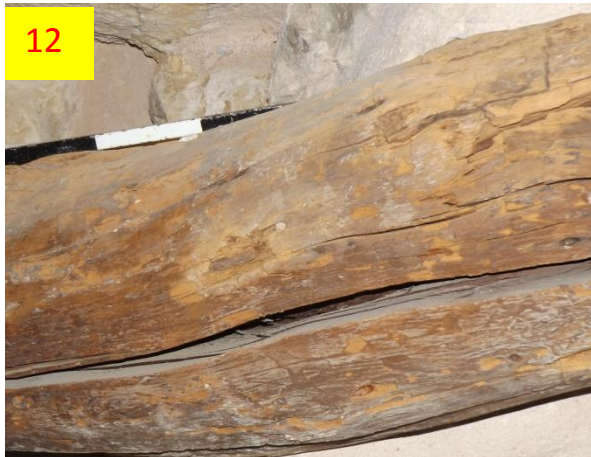
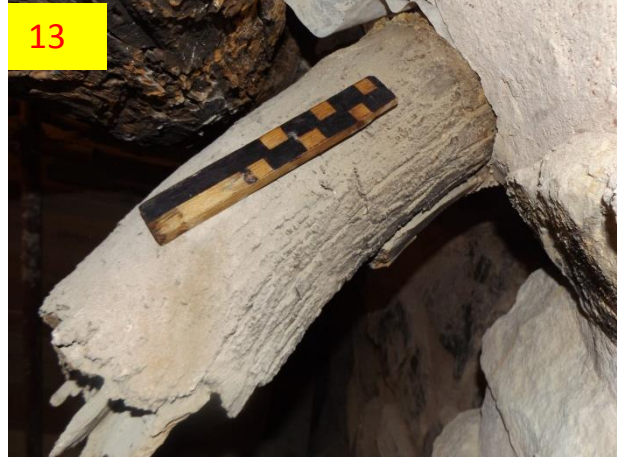
- There were some remains of mortar that covered some places of all the trunks. That mortar was used during the work of supporting the ceiling that was carried by current project. Because the mortar was lime based mortar, so it caused some places to be whitish. There were some traces of light pink color that could be used by ancient Egyptians during restoration work in the Saite time.

- there were remains of soot that might be produced by the fire which was used by ancient Egyptians during restoration work in the Saite time.

- the surface of the trunks turned into cubes in different sizes because of the brown rot fungus.

Photo 10-13 Deterioration forms on wood trunks

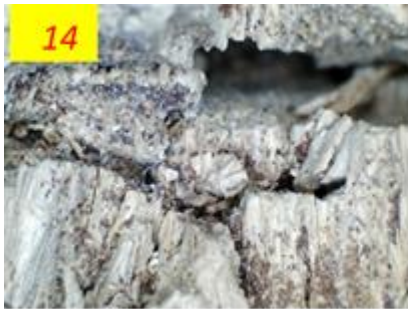
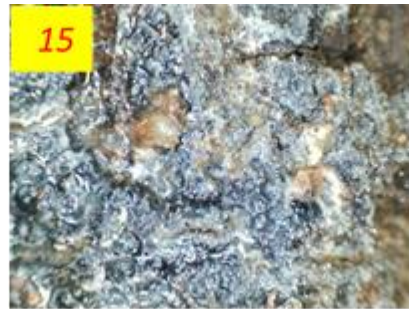
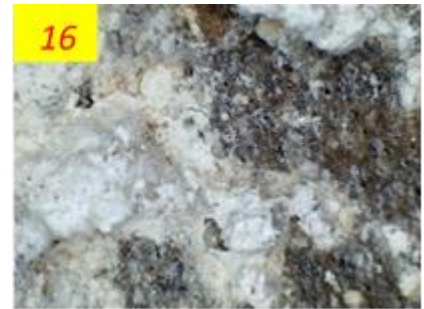
There were some deterioration products that can be seen on the wooden trunks. All the forms were produced because of the deterioration factors that worked all together.

The second step of treatment was consolidation. As it was mentioned that wood was fragile and spongy, it needed to be consolidated more than one time and with high concentration. Although Paraloid B72 is one of the most famous and effective consolidants, it could not be used in high concentration because it could cause the surface of the wood to be darker and shiny. It was decided to use Plexisol P550 solved in toluene as a consolidant. It was necessary to start with low concentration, then to higher concentration, which allows the consolidant to penetrate into the pores of the wood. Three concentrations were used, first 3% then 5% and finally 7% that led the wood to be harder than before.

The surface of the wood turned into separated cubes that fell one by one from time to time. It was necessary to fill among those cubes to fix them. However, when those cubes were touched anyway, they loosed off their places and fell down. It was decided to use a kind of net to fill among the cubes, on condition that the net was flexible to twist among all the cracks. So, it was decided to make that net by inserting cotton among the cracks, then it was injected by using Paraloid B72 20% to harden the cotton and make it like a net that links among the cubes. Filling with cotton was about 0.5cm under the surface of the wood. After filling by using cotton and Paraloid B72 20%, it was necessary to fill the cotton with a suitable substance with a suitable color to match the color to the original wood. Microballoon was used mixed with a suitable dust color and Paraloid B72 15%. There are some advantage of using microballoon, because it is so soft that it could be controlled well during work. It is resistant to microbiology growth. It was mixed with Paraloid B72 20% and that made it reversible. First a sample was applied to be sure if it would match the color of the original wood, then it was applied all over the trunks. It was applied to be about 2-3 mm under the surface of the original wood level.

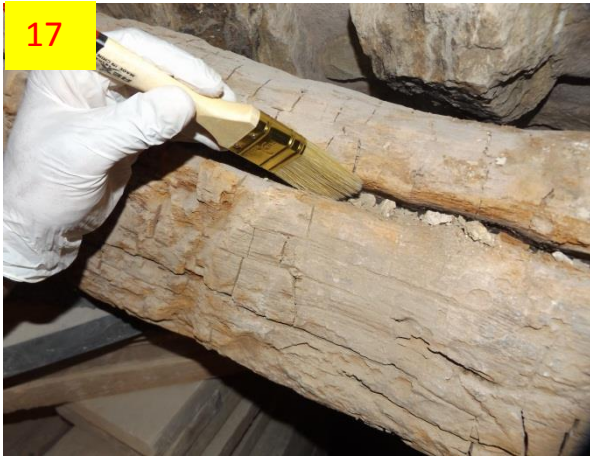
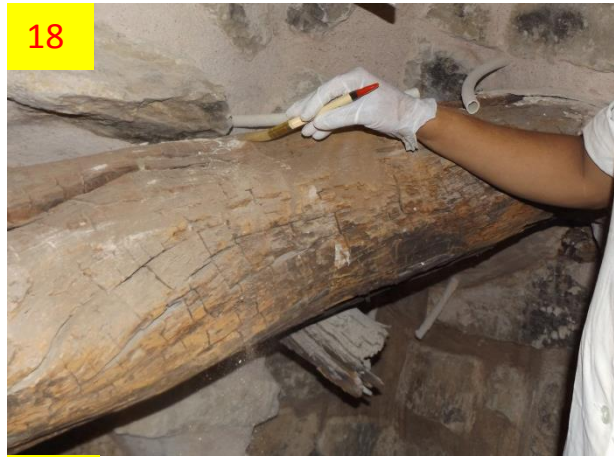
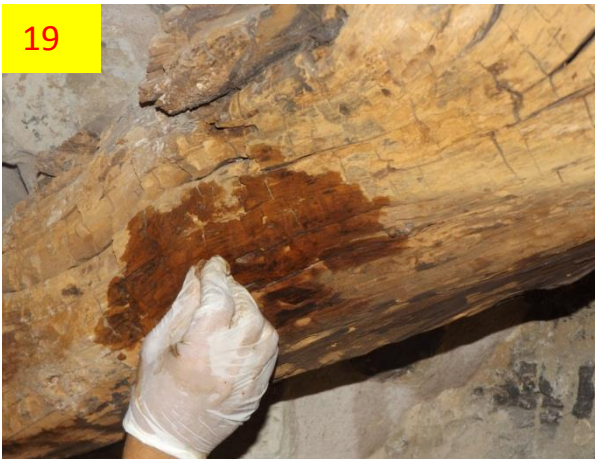
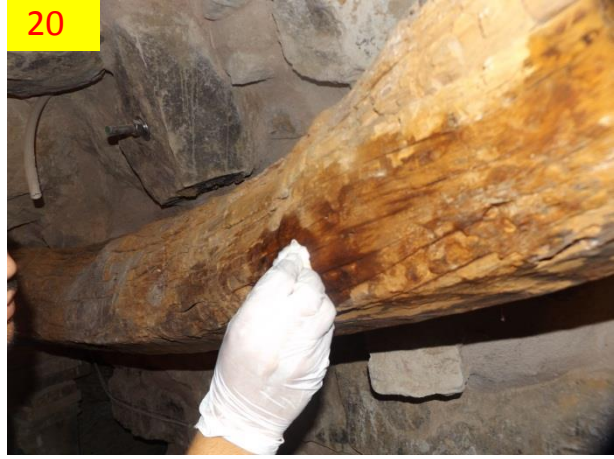
Photo 17-20 Mechanical and chemical cleaning

Cleaning is the first treatment process that is usually done to remove dirt that misshape the surface of the object and make it be ready to receive consolidants. Mechanical cleaning was done to remove dust and remains of mortar. It was necessary to be careful during removing the remains of the mortar because they were stuck to the surface of the wood firmly. It was necessary to use metal spatulas and scalpels besides using brushes.

Chemical cleaning was also important to clean and remove the remains of the mortar that were very tiny and inserted in the pores of the wood. It was also necessary not to use much water on the surface of the wood. So a mixture of ethanol and water 3-1 was used and gave a good result.

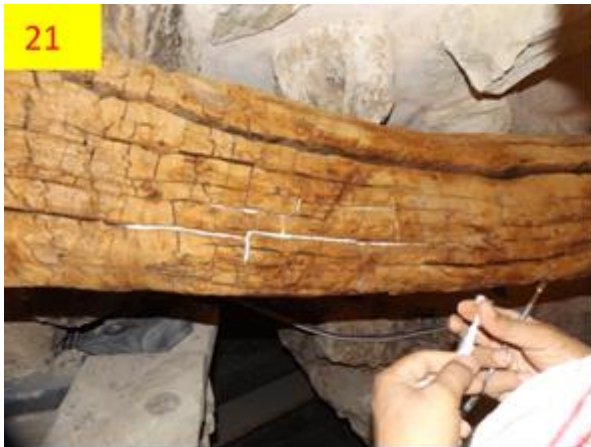
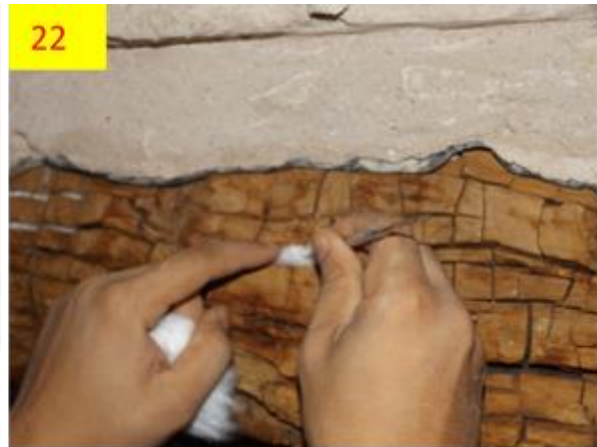
Photo 21-22 Filling among cracks by using cotton

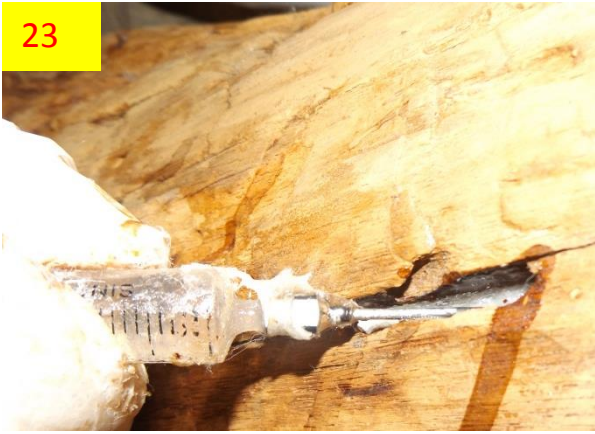
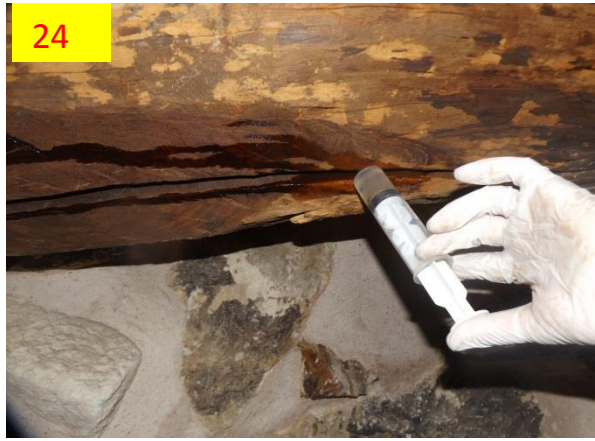
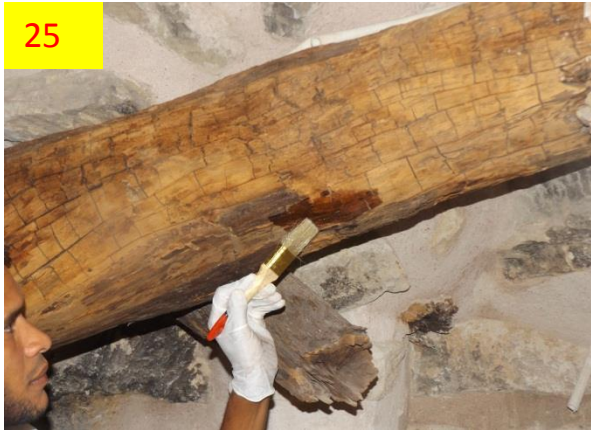
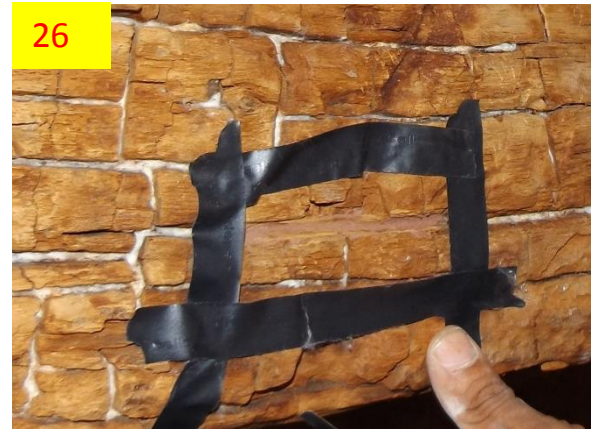
Photo 23-26 Injection by using B72 20 to harden the cotton, consolidating wood by using Plexisol P550 3-5-7% and making a test of filling on the cotton by using microballoon with a suitable color mixed with B72 15%

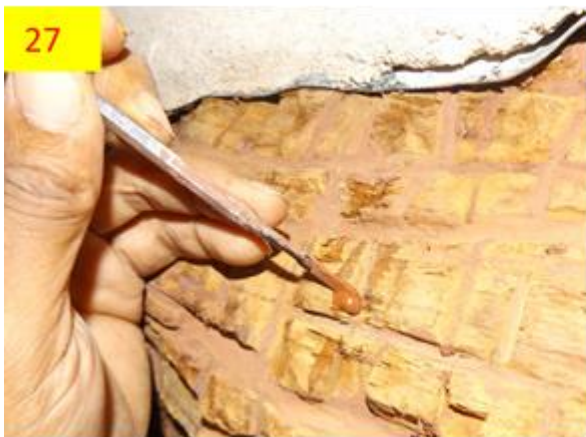
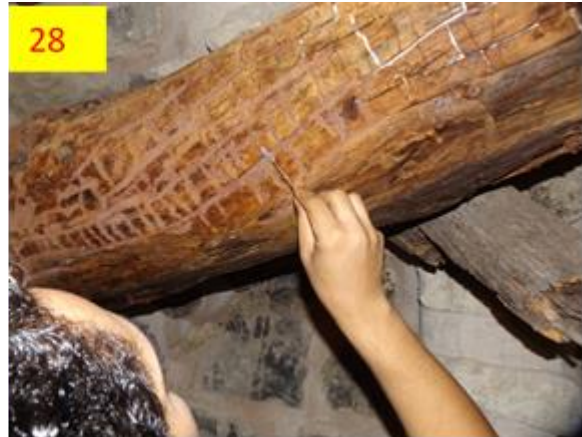
Photo 27-28 Filling on the cotton by using microballoon with a suitable color mixed with B72 15% after ensuring that the color of the filling matches the wood

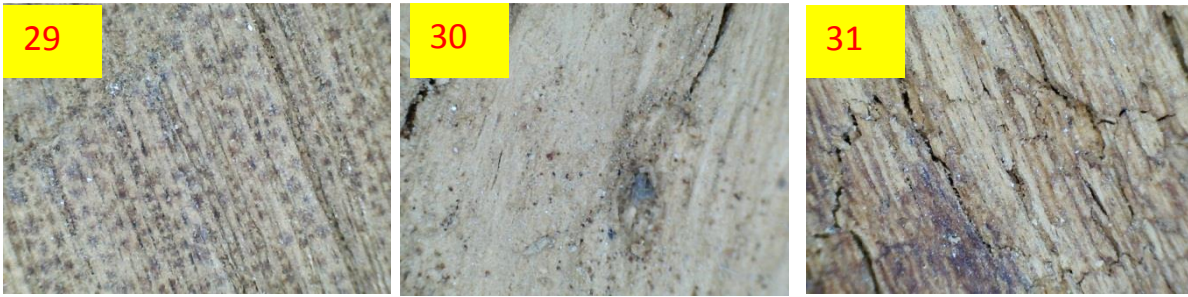
Photo 29-31 Digital microscope of the surface of the wood after mechanical and chemical cleaning

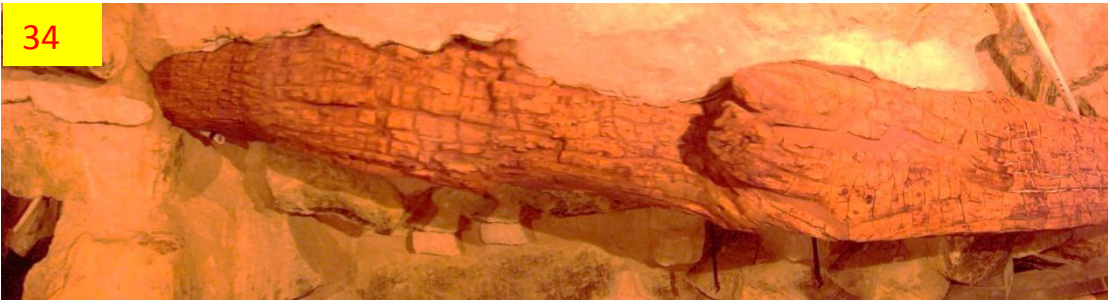
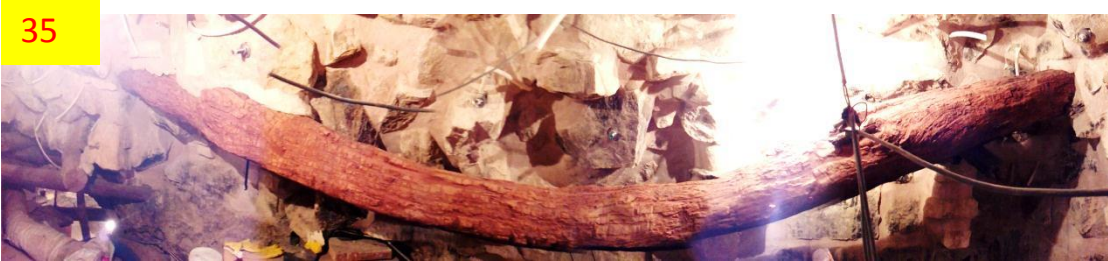
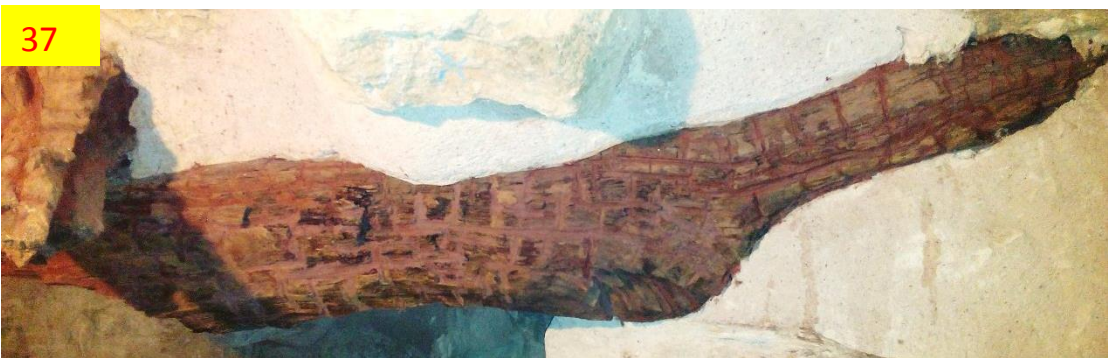
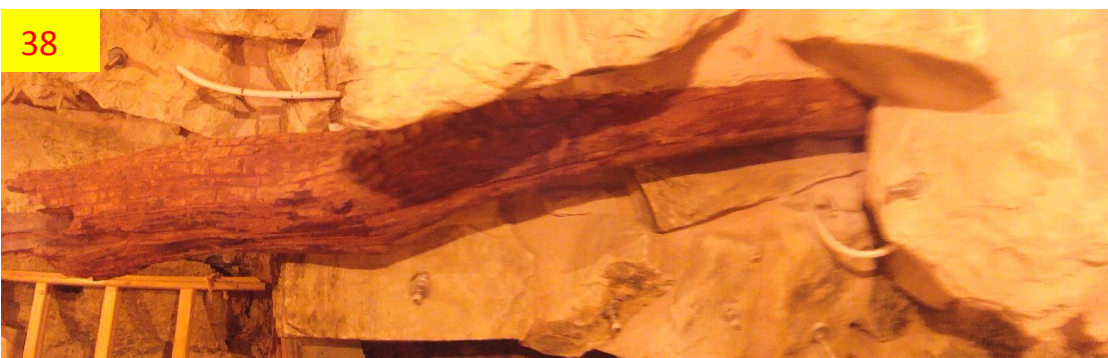
Photo 34-38 Digital microscope of the surface of the wood trunks after restoration work
