Deterioration Factors that Affect the Mural Paintings at Memi's Burial Chamber in Saqqara, Egypt

Memi's tomb is located to the west of king Djoser pyramid at Geser Al-mudir site. It is thought that it is dated back to the late fifth dynasty or the beginning of the sixth dynasty because of the style of construction. It consists of two parts, the mastaba which was built from limestone and the burial chamber which was cut in the bed rock underground. The burial chamber can be reached through a sloping passage. It is about 3.90m wide, 5.55m long and 2.60m height. The entrance up is 70cm height and 80cm wide. The sloping passage is 11.02m long and the entrance down is 1.30m height and 65cm wide. There is still the limestone sarcophagus which is located in a niche to the west wall of the burial chamber. It is 3.02m long, 1.40m wide and 1.25m height. The cover of the sarcophagus is 3.20m long, 1.45m wide and 45cm height. There are three walls of the burial chamber covered with awesome paintings on eastern, northern and southern walls. The plaster is so thin, and it is less than 1mm in some places. Salts are the worst problem in the burial chamber because they crystalized to form pins tha

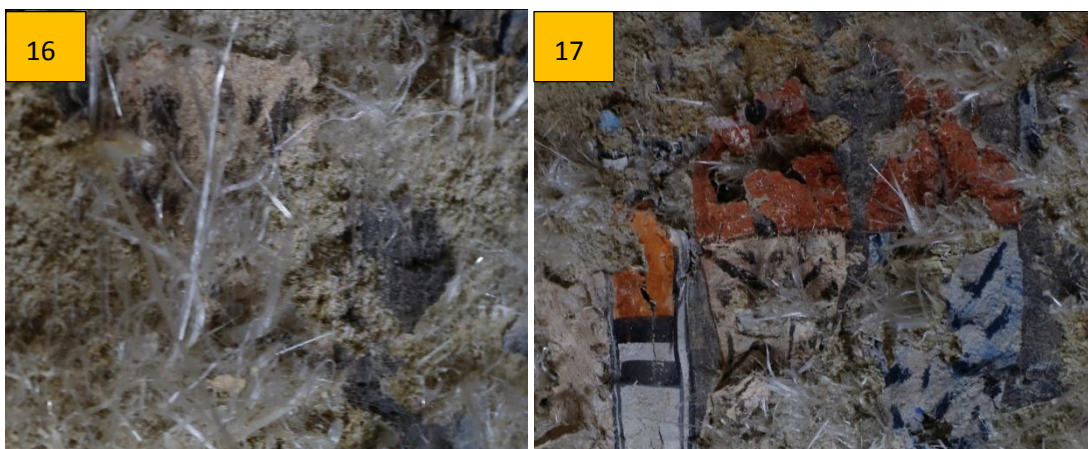
Photo 16-17 Crystallization of salts on the surface of the bedrock

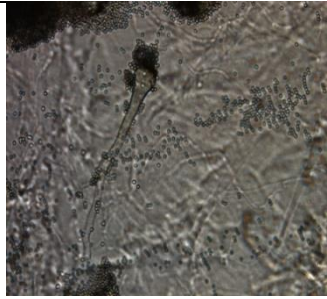
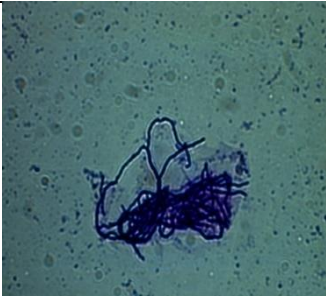
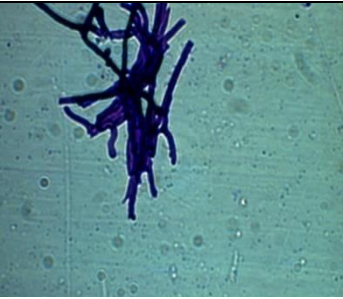
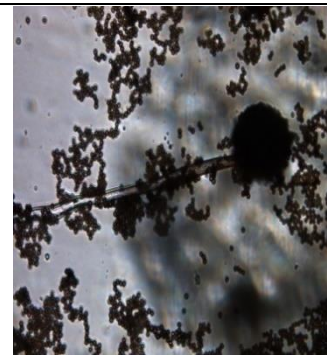
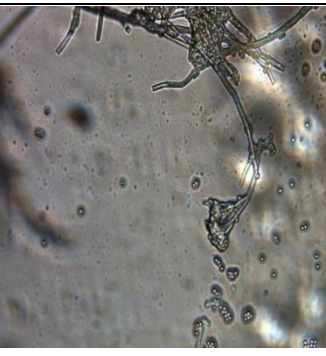
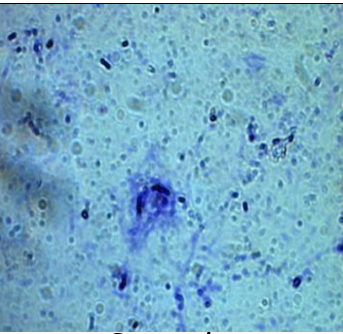
Table 2 Microphotos of the microorganisms that grow at Memi's burial chamber

As there was high humidity levels inside Memi's burial chamber, it was clear that there would be micro biology growth on the bedrock and the plaster. Therefore, two samples were taken by using swaps from the surface of the plaster. The result was that there are six different kinds of microorganisms may lead to the degradation and deformation of the mural paintings at Memi's burial chamber. Tables No 2-3 show species of microorganisms that grow in Memi's burial chamber..

<i>Aspergillus fumigatus</i>	<i>Streptomyces vinaceus</i>	<i>Saccharopolyspora hirsute</i>

<i>Aspergillus niger</i>	<i>Penicillium janthinellum</i>	<i>G+ve short bacilli spore former</i>

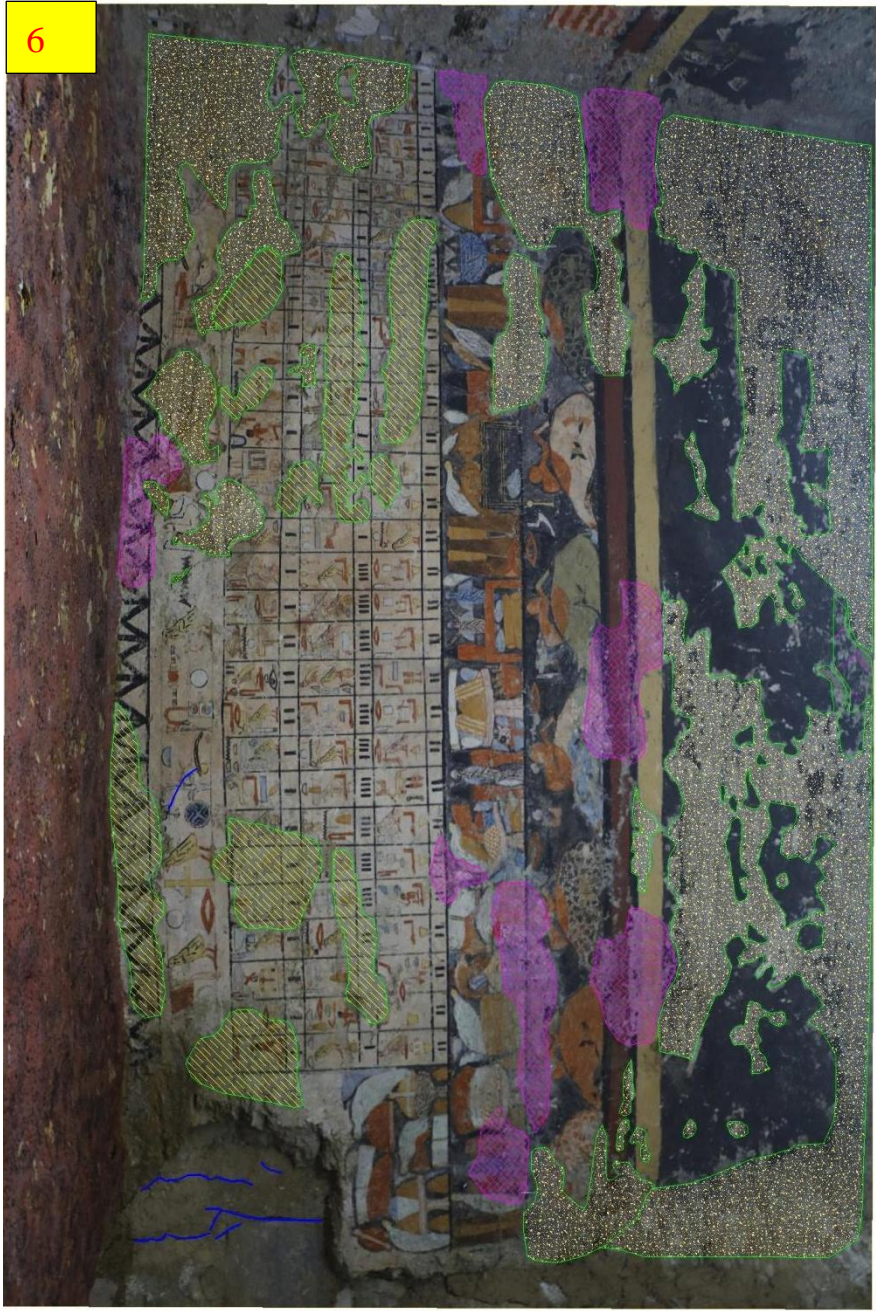
remains of colors with out plaster
	missing plaster
	fragile plaster remains
	fine cracks
	pin salts
	All plaster was covered with fine salts and dust

Fig 6 Deterioration products on the eastern wall

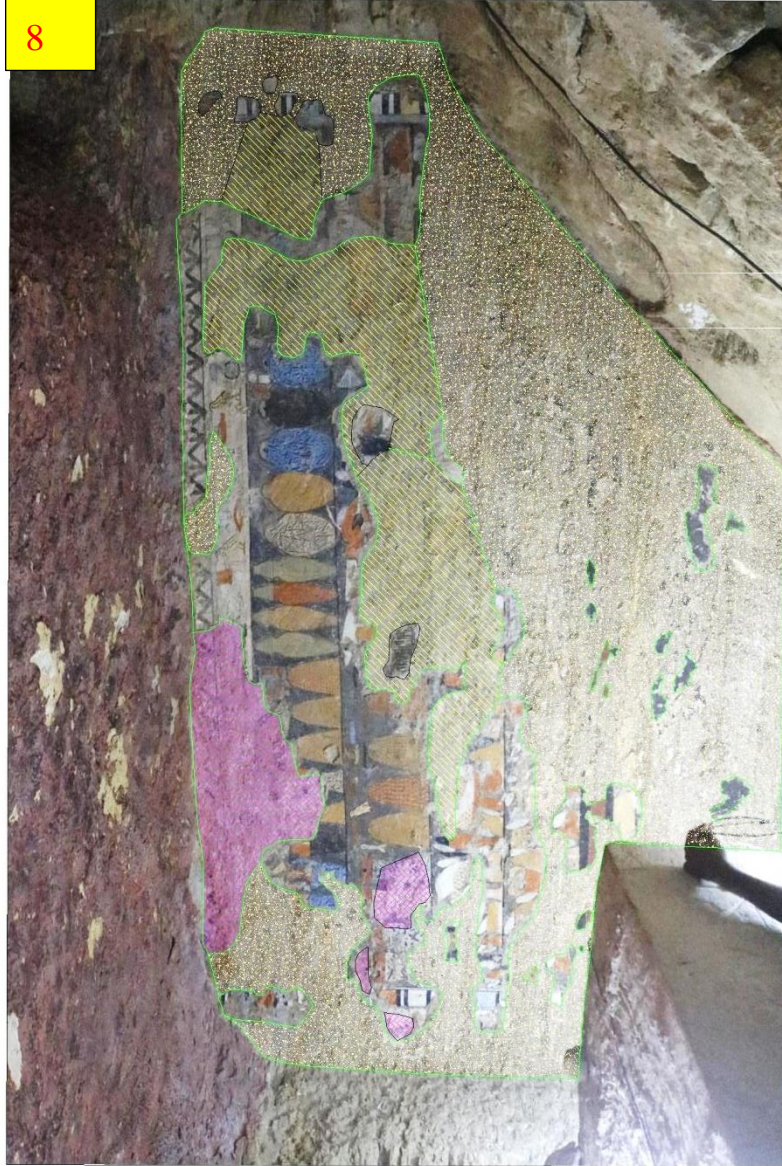
Fig 8 Deterioration products on the northern wall

remains of colors with out plaster

missing plaster

fragile plaster remains

fine cracks

pin salts
<p>All plaster was covered with fine salts and dust</p>

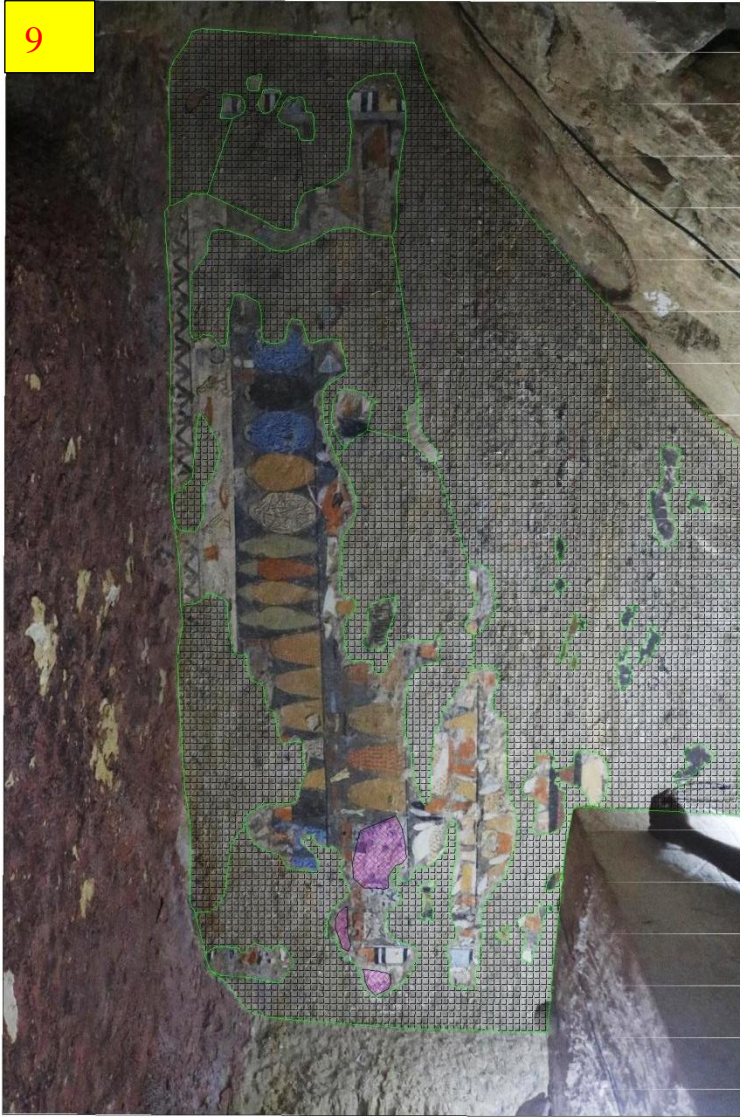
Fig 9 Deterioration products on the northern wall

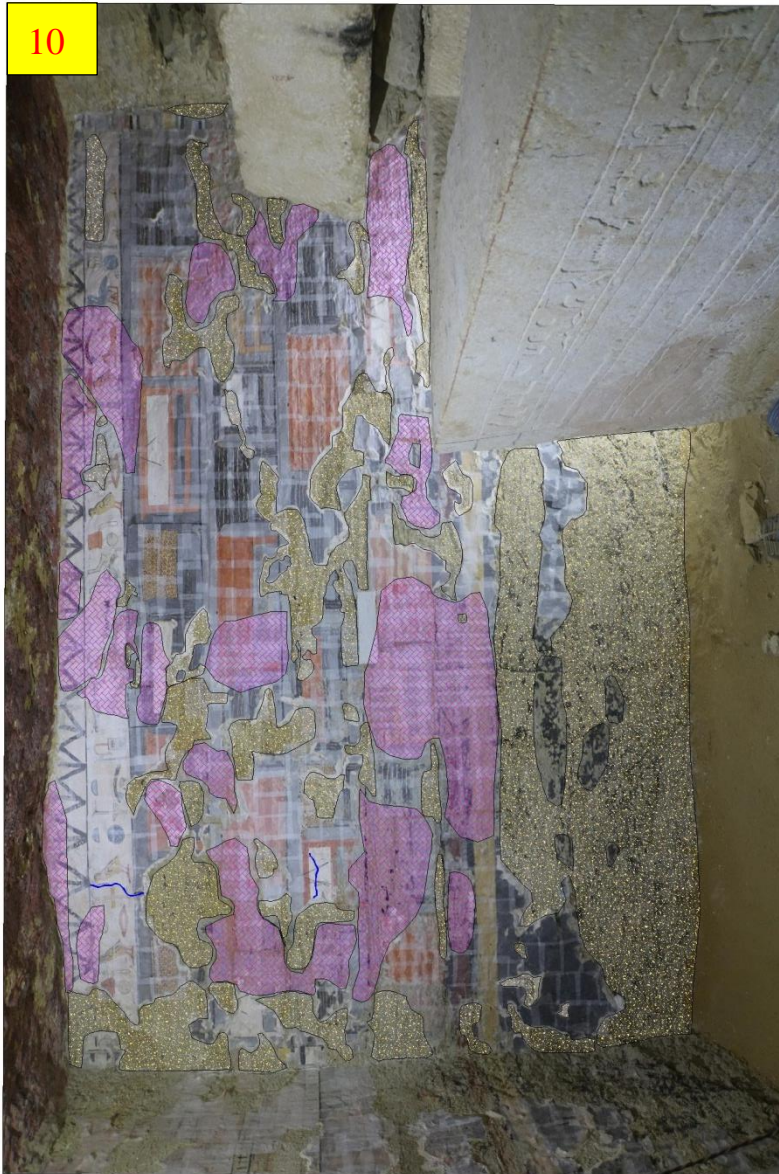
Fig 10 Deterioration products on the southern wall

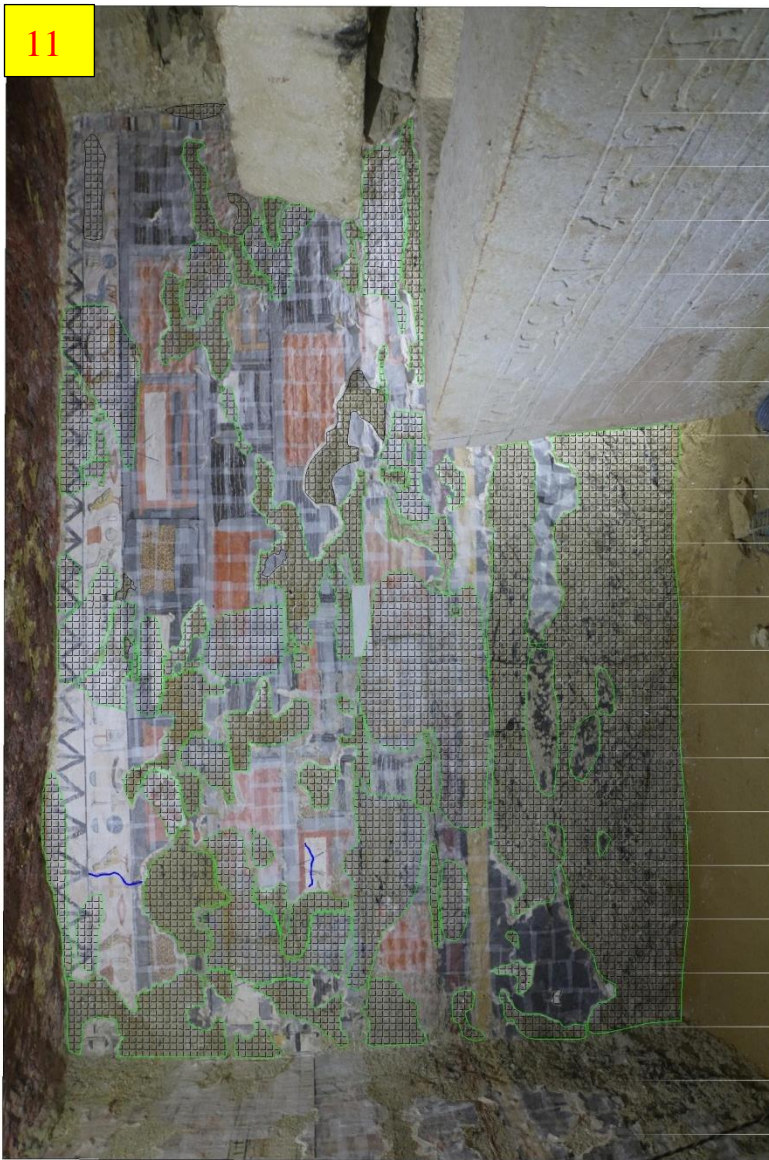
Fig11 Deterioration products on the southern wall
