*Dairy Day 2001*

## DRINKING WATER REQUIREMENTS FOR LACTATING DAIRY COWS

*M. J. Brouk, J. F. Smith,  
J. P. Harner<sup>1</sup>, and S. R. DeFrain*

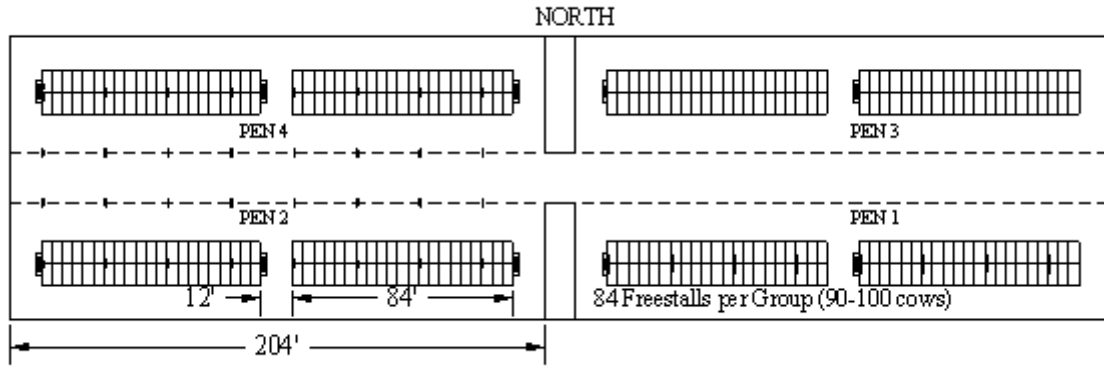
**Figure 1. Layout of Pens and Location of Water Troughs ☒ in a 4-Row Freestall Building.**

Three dairies were selected in north central Kansas for this study during the summer 2000. At the first dairy, Holstein cows were housed in a 4-row freestall barn, milked 2× and milk production averaged 72 lb/cow/day. Each pen contained 84 freestalls with a stocking density of 110%. Figure 1 shows the placement of the water troughs in the 4-row freestall building. Fans and a feedline sprinkler system were used for heat abatement. Walking distance from the back of the milk parlor to the housing area was less than 150 ft. Water space available was 3 cows per linear ft of trough.

The third dairy utilized Jersey cows producing an average of 65 lb of milk/cow/day. The herd was housed in a 4-row freestall barn and milked 2×. Building layout was similar to Figure 1 except the pens housed cows in different stages of lactation. Each pen housed 40 cows. The walking distance from the milking parlor to the freestall housing area was 30 ft. The water troughs were not emptied on a routine basis for cleaning at this dairy.

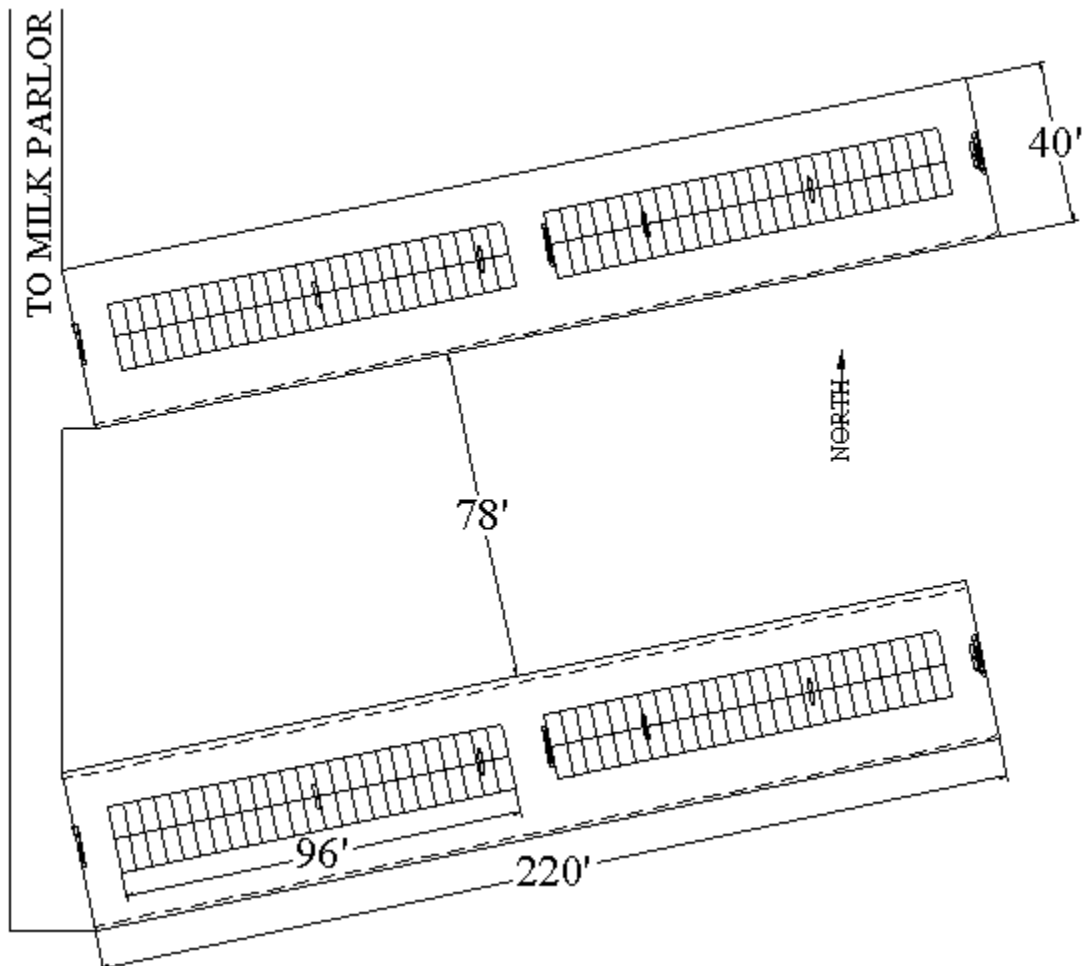
**Figure 2. Layout of 2-Row Freestall Buildings and Location of Water Troughs ☒.**

3× and milk production averaged 78 lb/cow/day. Figure 2 shows the water trough location in the 2-row freestall facility. The milk parlor was a double 12 parlor with two exiting lanes. Water troughs were located on the east and west side of a common exit lane and were equipped with water meters. Cows had to walk 400 to 500 ft from the milking parlor to the freestall buildings. Each freestall had 108 freestalls and was stocked at 100% capacity. Water space available was 3.6 cows per linear ft.

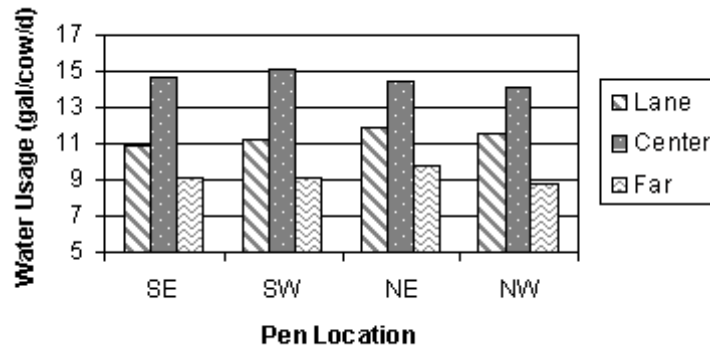
**Figure 3. Total Daily Water Disappearance from Water Troughs in Different Pens in a 4-Row Freestall Building Populated with Holstein Cows.**

Water usage at the first dairy (Figure 3) averaged 35.1 gallons/cow/day including the water used to refill the tanks after dumping. Figure 4 shows the water usage in each of the four pens. Higher producing cattle were located in the SW and NE pens. Over 40%

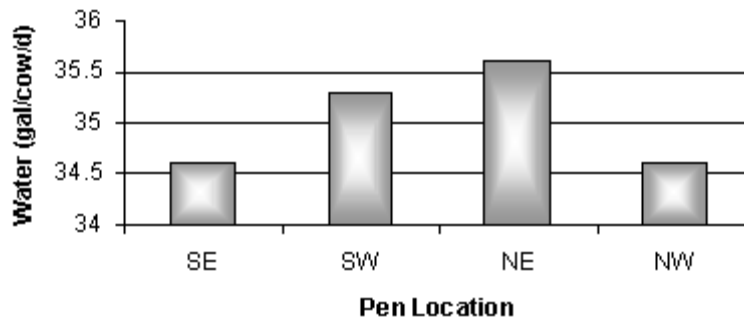
**Figure 4. Water Disappearance from Water Troughs Located in Different Sections of a 4-Row Freestall Building Populated with Holstein Cows.**

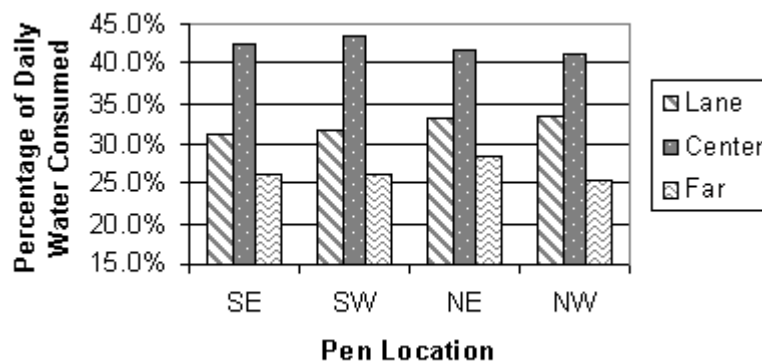
**Figure 5. Percent Water Disappearance from Water Troughs Located in Different Sections of a 4-Row Freestall Building Populated with Holstein Cows.**

of the water was consumed from the water trough located in the center cross alley (Figure 5). The water trough located farthest from the travel lane to the milk parlor had the lowest usage. Approximately 4.8 gallons/cow/day were needed to refill the water tanks after tipping. This represented 14% of the total daily usage in the freestall housing area, excluding water used for heat abatement.
