FLOOD PROCESSES AND MORPHOLOGICAL CHANGES IN AGGRADATIONAL EPHEMERAL RIVERS. RECONSTRUCTION OF THE OCTOBER 1957 FLOOD IN THE RAMBLA CASTELLARDA (SPAIN)

ABSTRACT. During the latter half of the twentieth century, Mediterranean ephemeral rivers underwent a profound metamorphosis. Fluvial adjustment processes narrowed the channels, simplified their planform pattern and notably reduced sediment availability. Today, this makes it extremely difficult to analyse the behaviour of this type of river in former aggradational contexts, such as those seen at the middle part of the twentieth century. For this reason, this paper addresses a reconstruction and analysis of the 1957 flood that occurred in the Rambla Castellarda, a tributary of the Turia river. The research is based, among other sources, on a series of extraordinary, high-precision aerial photographs carried out a few weeks after the flood. These images make it possible to recreate the processes observed in this ephemeral river and map the post-event river forms. Results show the behaviour of a Mediterranean aggradational ephemeral stream, very different from the current processes, and allows a comparative reflection to be made about

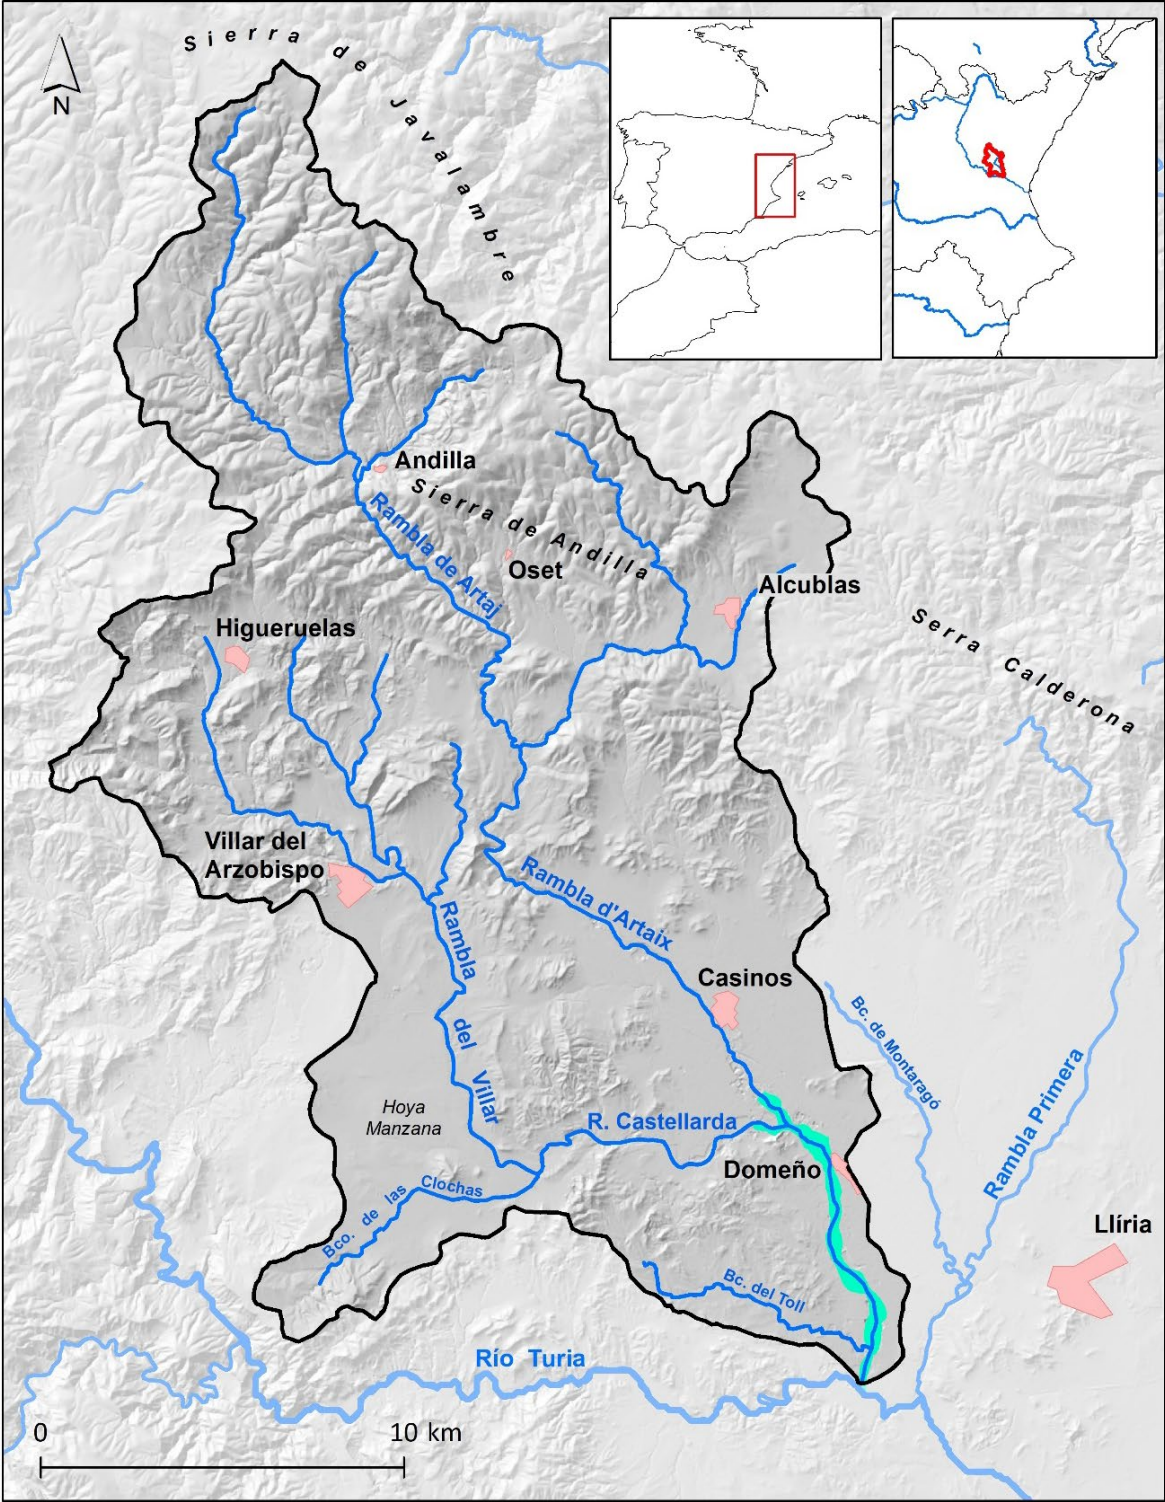
Figure 1. Rambla Castellarda basin and study area highlighted in turquoise.

The Rambla Castellarda is an IRES located in the Region of Valencia that is a tributary of the Turia river (Fig. 1 and 2). It has a basin of 447 km², between 112 and 1,568 m above sea level, and drains part of the south face of the Sierra de Javalambre and the Sierra de Andilla mountains. These predominantly calcareous reliefs are compartmentalised by small grabens filled with quaternary materials (Higueruelas, Alcublas, Oset and Artaj valleys), resulting from the different compression and distension phases that shaped the Iberian Range (Pérez Cueva, 1985). The transition between these mountains and the Turia river is established by a wide Pleistocene alluvial piedmont, only interrupted by some Mesozoic calcareous hills and by an outcrop of Miocene marls near the Turia river. Flash floods in ephemeral streams (Camarasa, 2021) are recurrent in this basin.

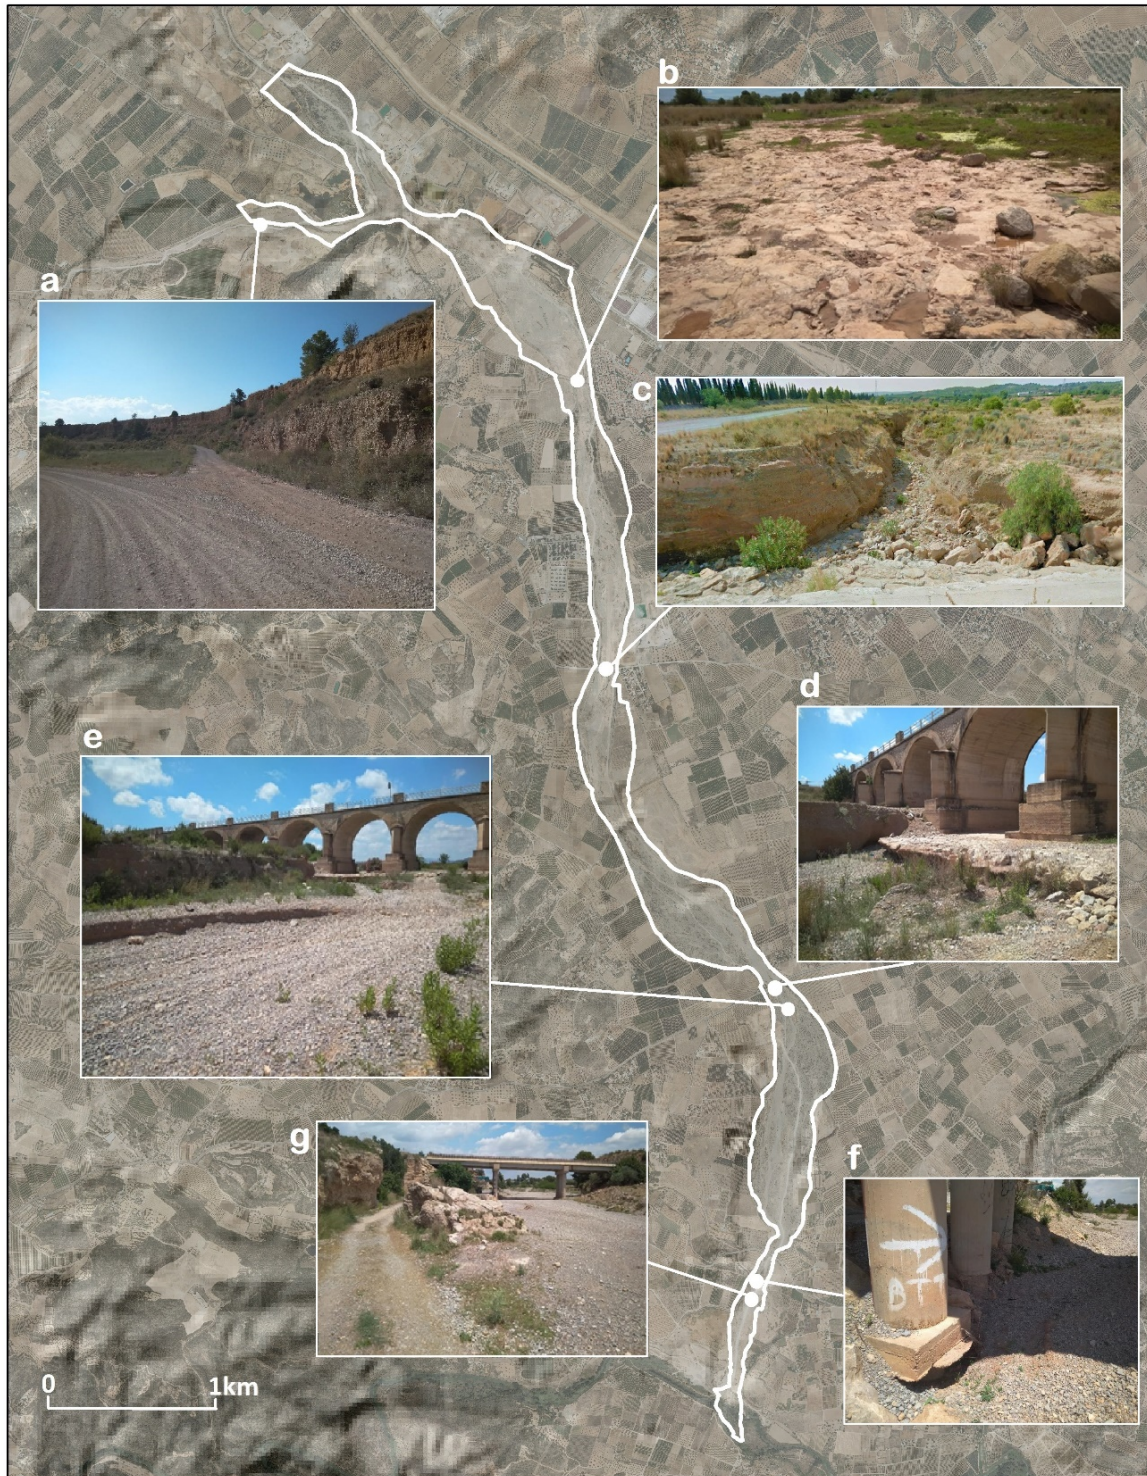
Figure 2. Study area and photographs taken in spring and autumn 2021, which show current processes, mainly as a result of the current sedimentary deficit: a) Rambla Castellarda converted into a road for gravel transport trucks; b) Exhumed crusts in the bed of the river next to the ford of Domeño; c) Fluvial incision next to the ford of Casas de Pablo; d) Undermining of the CV-376 bridge foundation; e) Microterraces generated by the recent incision downstream of the CV-376 bridge; f) Undermining of pillars under the CV-364 bridge; g) Rambla Castellarda at its narrowest section, downstream of the CV-364 bridge.

some scattered houses and a pyrotechnic factory, the new urban centre of Domeño was built on the left bank in 1967 (Fig. 7). It currently has an industrial park that occupies 16 ha and a scattering of leisure homes. The buildings of the polygon are located in the area that flooded, the waters conveyed by the old Villar Road towards the Montaragó ravine during the October 1957 event. In fact, the road has recently been dismantled and replaced by an open-air channel that crosses the industrial estate and disappears downstream among the cultivated fields. However, none of these zones is considered a relevant dangerous area by the official flood mapping, neither have they been taken into account by the regional flood risk planning instruments (PATRICOVA) nor by the national system of flooding zones (SNCZI). This is not an oversight: the massive removal of gravel deposits for construction, and the erosion of the channel experienced in recent decades has incised the active channel to such an extent (lateral slopes between 4 and 10 m depending on the sector), so it is very unlikely that new overflows will occur in this area, at least while the current morphosedimentary conditions are maintained in the IRES. The incision, on the one hand, facilitates the protection of the alluvial fan urbanisation, and on the other, undermines the transversal infrastructures on the riverbed (Fig. 2 c, d and f).

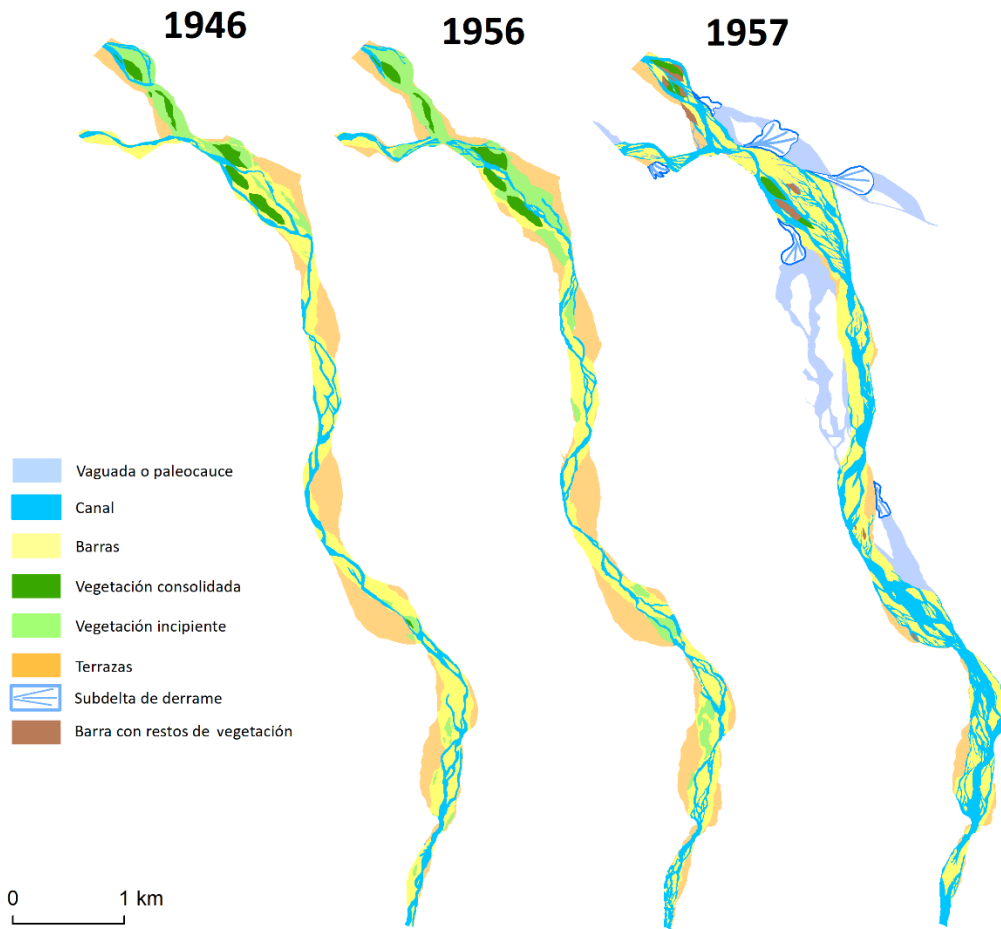
Figure 3. General view of the active channel forms in 1946, 1956 and 1957.

The aerial photographs taken in 1946 and 1956 show very similar forms (Table 2 and Fig. 3, 4 and 5), which define the pre-event situation. In those decades, the *rambla* (watercourse) had a wide channel, mainly covered by gravel bars, the active channel was only slightly incised, and the most significant direct human pressure was the agricultural use of the lateral microterraces.

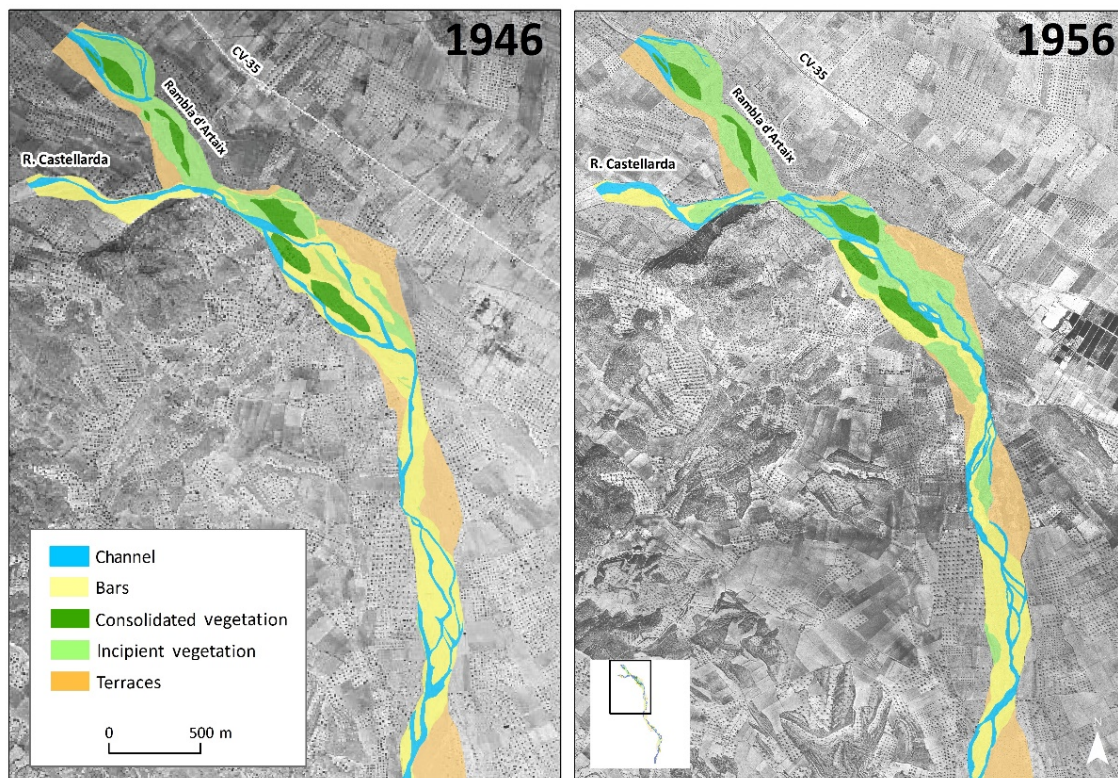
Figure 4. Active canal forms in the northern sector of the study area in 1946 and 1956.

After the confluence, the active channel (bars and channels) has a high sinuosity, alternately leaving wide terraces on one side and the other, in a regular sequence (Fig. 4 and 5). As occurs in many IRES in this Mediterranean region, the number of simultaneous channels rarely exceeded three, so it was closer to a wandering than to a braided type river.

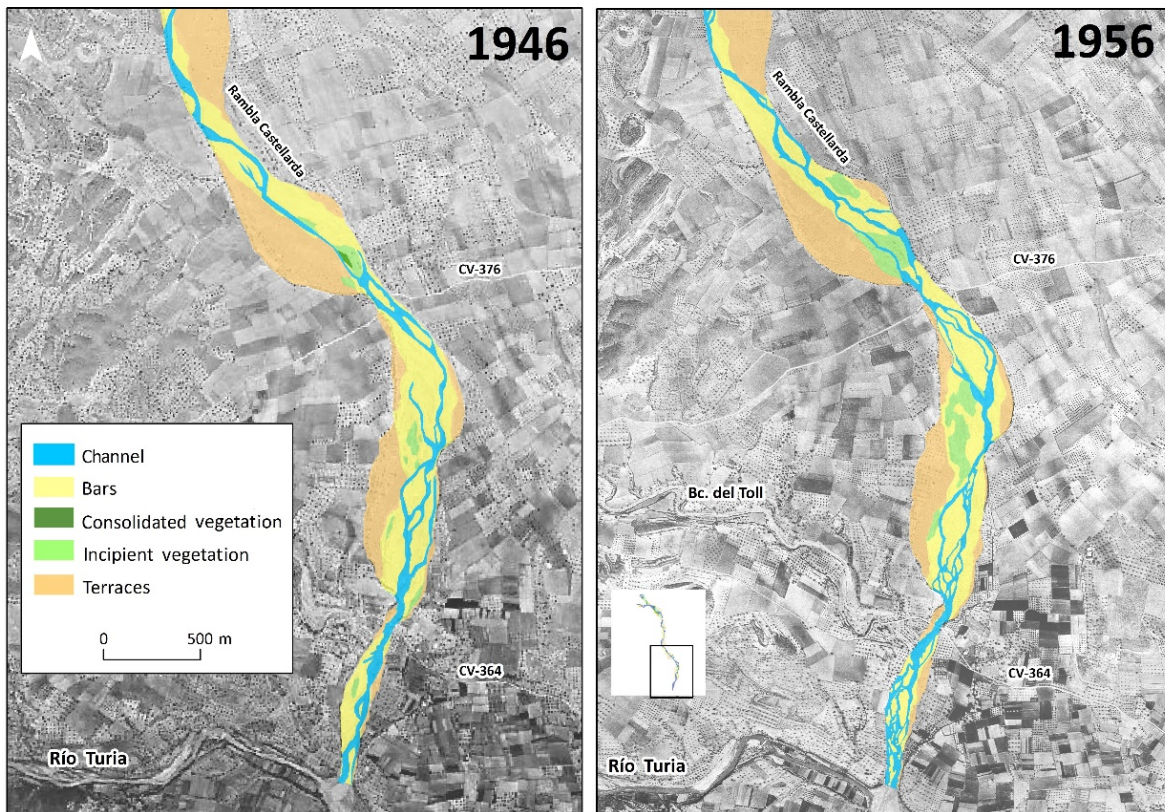
Figure 5. Active channel forms in the southern sector of the study area in 1946 and 1956.

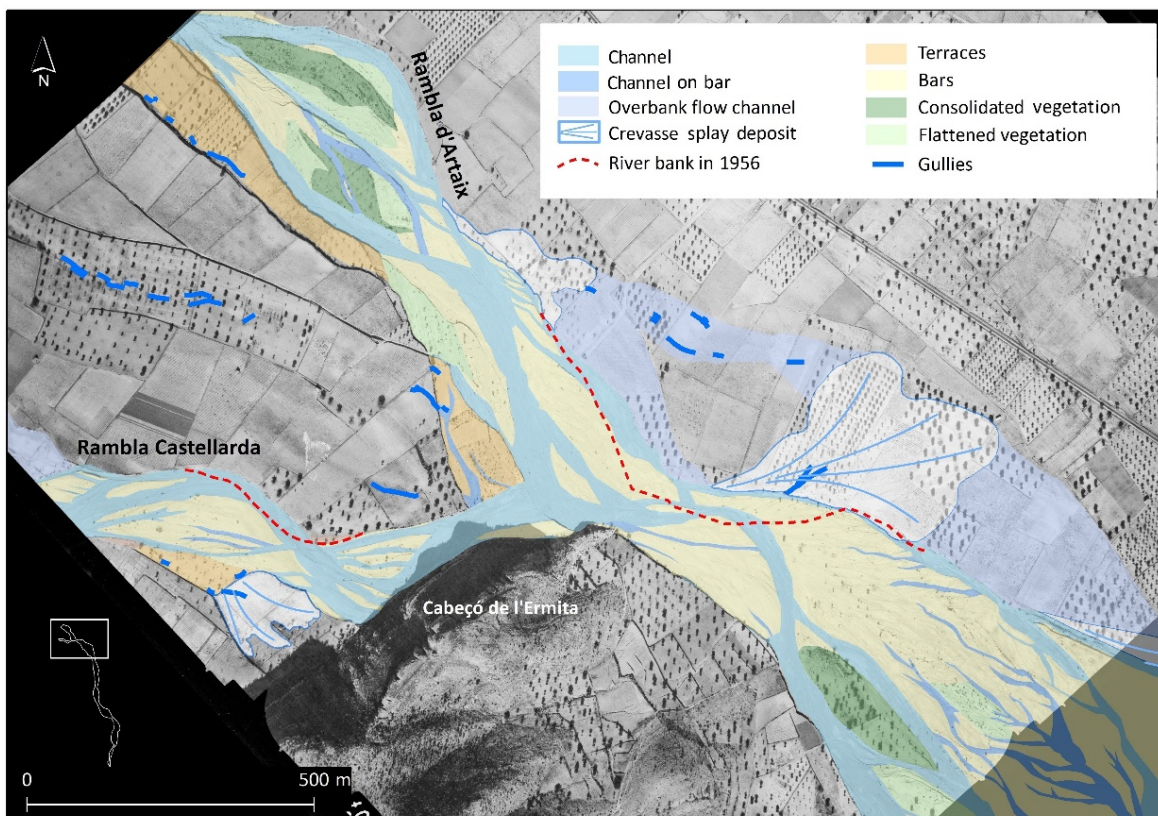
Figure 6. Confluence of the Artaix and Castellarda ramblas. Post-event forms in the first photograph of the IdT series.

In the upper sector, upstream the confluence with the Rambla de Artaix, the Rambla Castellarda formed a new medial bar (Fig. 6). On its southern shore, the waters overflowed the active channel, destroyed a plot covered with trees and formed a small crevasse splay deposit in the adjacent plots. The overflowing waters soon returned to the channel when colliding with the calcareous reliefs of the Cabeçó de l'Ermita. On the northern shore, the flood eroded the left bank, making the cliff recede 37 m, and followed its course in a straight line to merge with the Rambla de Artaix.

At the confluence, the IdT photographs show how the Rambla Castellarda channel was partially perched above the channel excavated by the Rambla de Artaix, a fact that indicates that the peak of the Rambla de Artaix flood was somewhat later than the Rambla de la Castellarda or that it had a greater erosive capacity. The coincidence of two asynchronous peak flows had another very clear hydraulic effect. The flow from the Castellarda, supported by the Cabeçó de l'Ermita hill, contributed to diverting the waters of Artaix towards the opposite shore, overflowing and forming a large semi-circular splay deposit, with a radius greater than 300 m. In the shadow of the aforementioned hill, protected from the main flow, a bar was formed, attached to the right bank (Fig. 6).

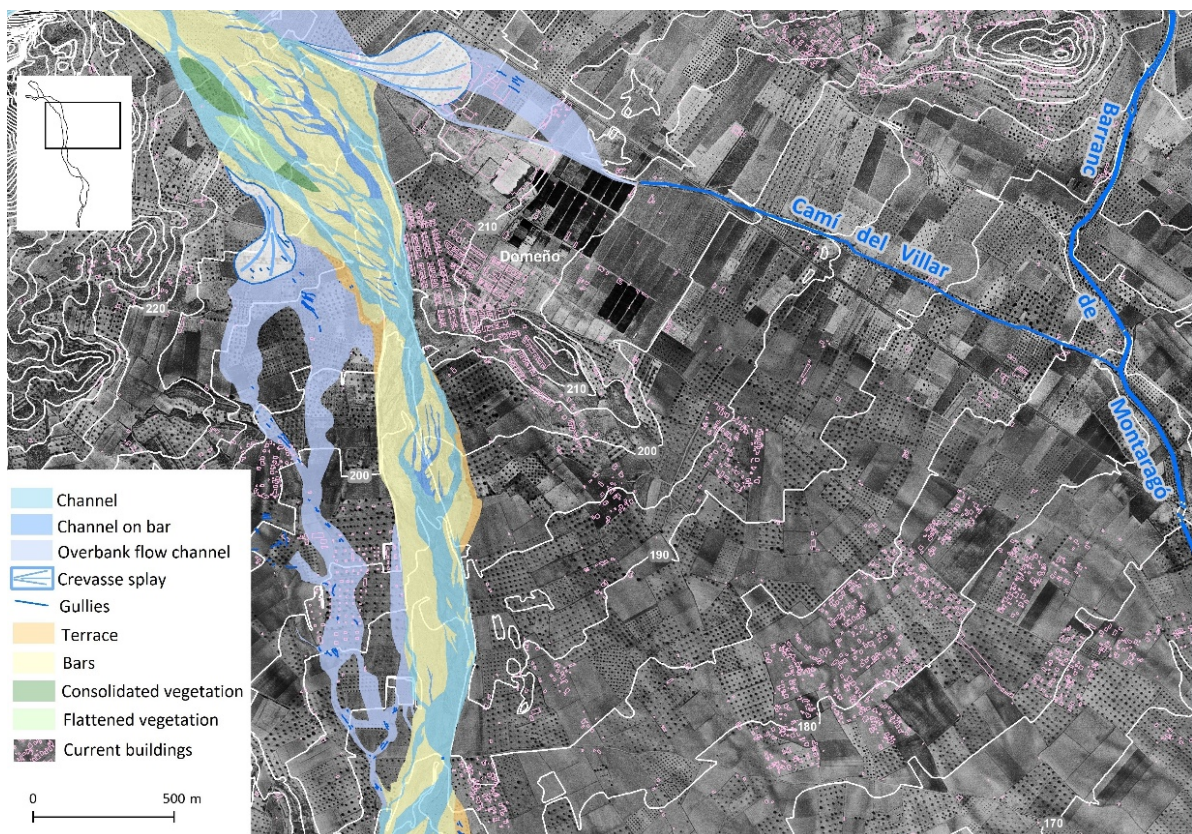
Figure 7. Forms of the Rambla Castellarda after the confluence with the Rambla de Artaix, in 1957. At the top, an overflow channel crosses the area where the industrial park of Domeño stands today and is captured by the ravine (barranc) of Montaragó. The contour lines show the convexity of the Castellarda alluvial fan, in its apical zone. The Rambla Castellarda crosses this sedimentary body and leaves, as evidenced by the contour lines and the humidity lines, various paleo-channels on the surface of the fan, one of which has been used as a road since the medieval period (Camí del Villar).

Downstream of the confluence, the Rambla Castellarda had its least incised sections (Fig. 7). The sediments were practically levelled with the river margins. These conditions favoured the dispersion of the flow and the overflow on both banks during the October 1957 flood. The waters covered all this space, passing over some areas that had been transformed in agricultural plots decades previously. The flood also formed a large medial bar on the left and other smaller ones, on the main channel, on the right.

On the left bank, right at the ford of the Villar Road, a third overflow took place. The ford gave rise to another splay deposit, and the medieval road transported the waters along the alluvial fan. The overbank flow was captured by the Montaragó ravine, which followed a sinuous path and fell on the Rambla Primera, 3.5 km from its mouth in the Turia (Fig. 7). On the right bank, the overflow took place 500 m after the previous one, it also formed a splay deposit and flowed south, forming a diffluence. The area affected by this flow cannot be specified with precision, but, by following the gullies over the fields, it is possible to identify divergent and convergent flow lines, sometimes forced by the small Jurassic reliefs that emerge in the margin of the alluvial fan (Fig. 7). These calcareous hills finally forced the waters to return to the rambla, 2.2 km after having abandoned it. Previously, to its right, this flow had received lateral contributions from small ravines and gullies that eroded the cultivated plots. To its left, more overflowing streams from the Castellarda joined this current (Fig. 7). In its last 500 m, this overbank flow channel activated erosive processes, clearly seen in two confluent channels, wider than 40 m at various points, which had vertical banks and gullies (Fig. 7 and 8).

In this 4 km long section with various outflow and return flows (Fig. 7), all the spontaneous vegetation and crops located within the 1956 channel were washed away by the waters, but there are no signs of destruction or retreat of the banks. The channel had its lowest sinuosity in the first 2 km of this reach. It circulated contiguous to a large lateral bar and only formed a medial bar in the initial section, which was wider. Further down, there are two consecutive wider areas that had a more complex

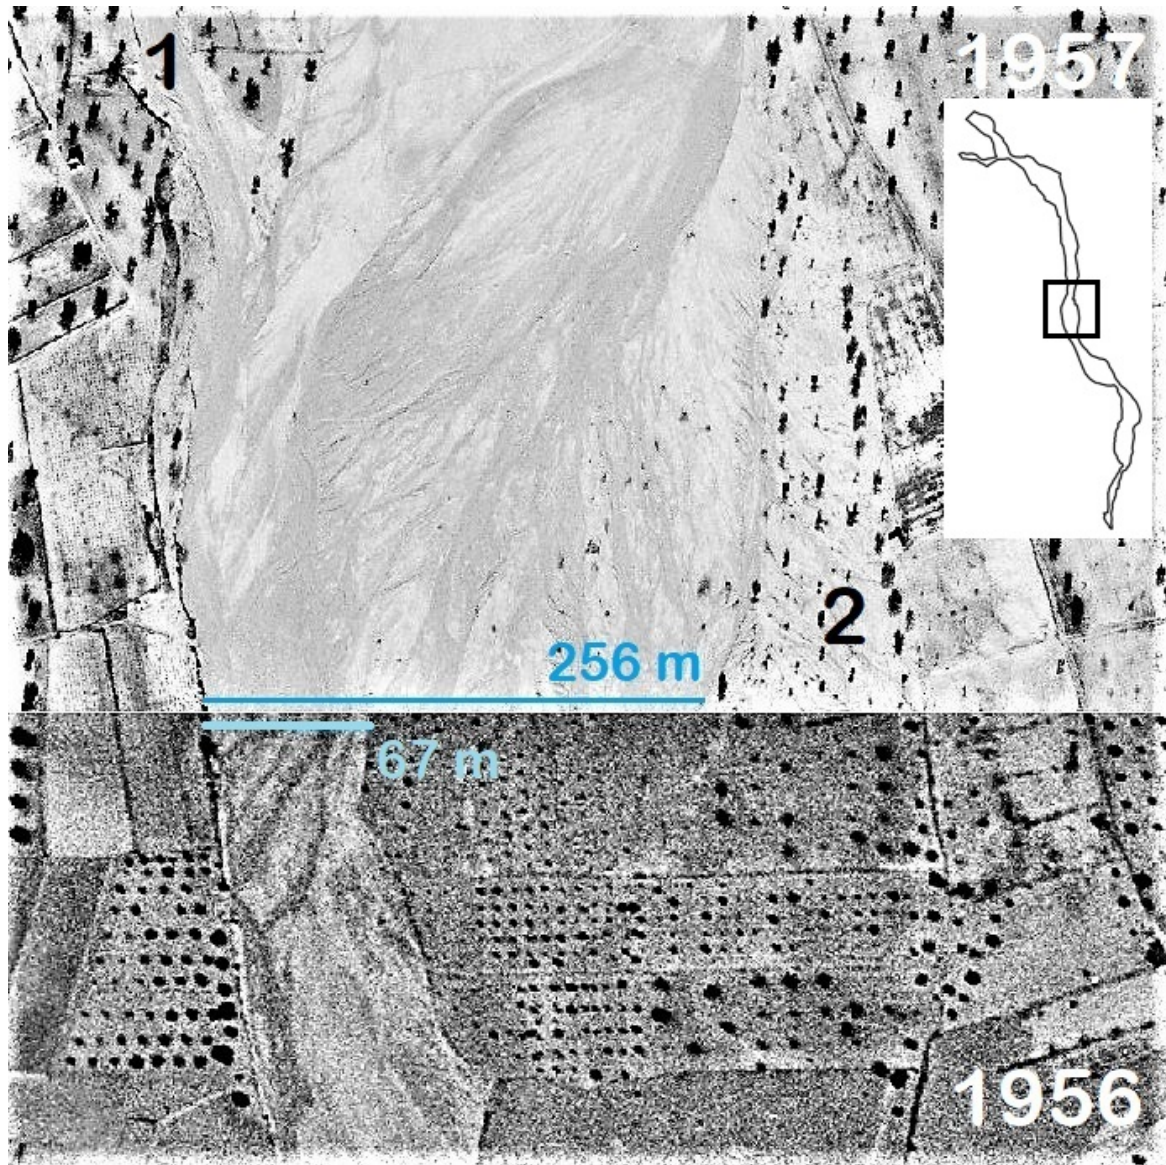
Figure 8. Comparison of pre- and post-event photographs. The contrast of the images has been increased to improve the perception of the printed version. Above, in the IdT image, a broad medial bar formed by the flood can be seen. In this image, at the top left, readers can see the channel excavated by the overbank flow channel that acted as a diffluence (1) and, to its right, (2) the overflow that occurs immediately downstream on the other bank. The blue lines represent the width of the active channel before and after the flood. Below, the image from 1956, with an active channel narrowed by rainfed crops.

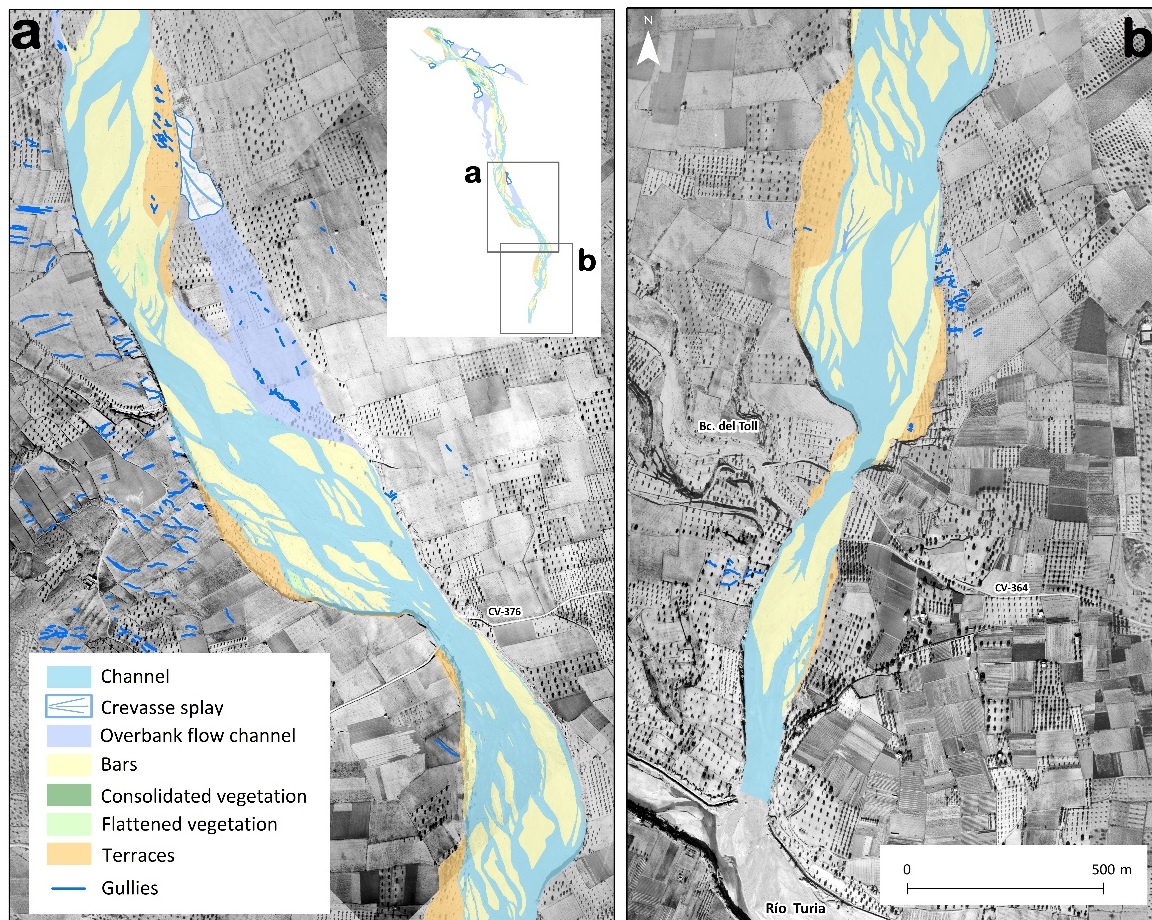
Figure 9. Rambla Castellarda forms after the 1957 event, in the two last reaches of the study area.

This pattern was repeated in the next reach of the Castellarda (Fig. 9), between the ford of the road CV-376 and the bridge of the CV-364, where the river is more incised, passing between vertical banks formed by silts, clays and cemented gravels. However, at the beginning of the narrow section used by the CV-364 bridge, the flow destroyed the left bank, which was lower than the right, and moved it 36 m from its former position. The road bridge, of which only the abutments remained, was also swept away, and 50 m of the access road to the bridge disappeared. Downstream, it also set back the left bank between 10 and 15 m, in a combination of the Venturi effect and the confluence of the Toll Ravine flow. This ravine also partially destroyed another bridge of the CV-364.

Downstream, in the last section of the rambla, the microchannels of the river clearly drew the network of convergence and divergence of flows typical of a large medial bar, which barely protruded from the adjacent channels, probably due to the intensity of the river flow in a narrow, straight and partially confined section. On the left bank, where the terraces gradually descend to the riverbed, the flood washed away several plots, expanding the active channel section up to 50 m. Finally, at the end of the study area, the waters of the Castellarda, together with those of the Turia, destroyed the Benaguasil irrigation canal and all the crops surrounding the confluence (Fig. 9).
