FLOOD ALLEVIATION AND RESTORATION ON THE LOURENS RIVER, SOMERSET WEST, SOUTH AFRICA

Flood alleviation and restoration on the Lourens River, Somerset West. South Africa

MSc. Dissertation, Department of Earth Sciences, Faculty of Natural Sciences, University of the Western Cape.

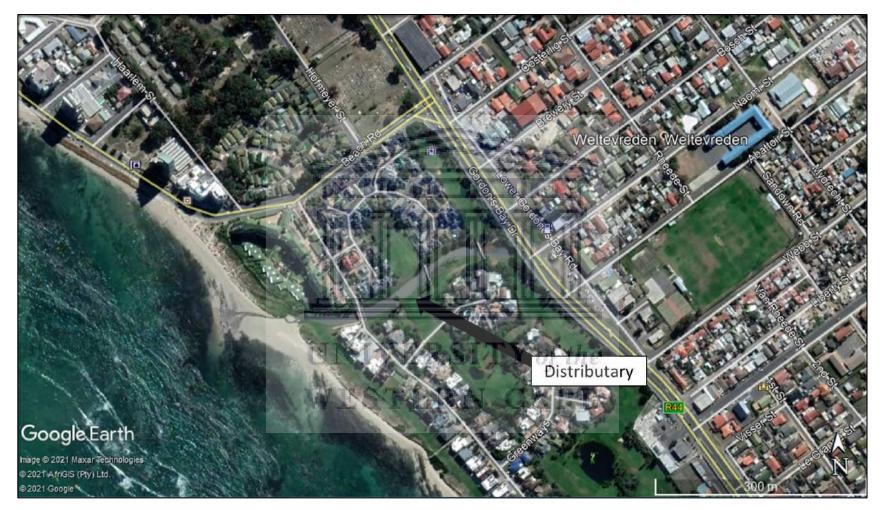
Appx. Figure 3: Distributary flowing through Greenways Golf Estate and entering the ocean by Gordon Bay (Maxar Technologies 2021).

The earliest evidence of the distributary's existence can be found in a historical map dating back to just over two decades ago (Univerzita Karlova 1789; Figure 3.8). Circumstantial evidence suggests that once settlement started in the valley, the distributary was used as an irrigation furrow for agriculture. The historical map shows a distributary flowing below a railway line; however, topographical maps dating back to the mid-1900 show a distributary that starts upstream of the railway. Evidence of the latter can be found in the 1:50 000 topographical maps from 1942 (Figure 3.7; Trigonometrical Survey Office 1944). This is also supported by the direction that the distributary flows, following main road (upstream of railway) for a while before continuing its course to the ocean. Topographical maps after the 1942 edition show the distributary becoming increasingly more fragmented over time. The topographical map of 2010, displays remnants of the distributary that exists downstream of the N2 national highway, passing through urban settlements. What remains of the distributary also seems to have been redirected at some point through stormwater drainage canals as the distributary disappears under the Weltevreden area of Strand and presents itself again just before the coastline (Appx. Figure 3).

The Lourens River historically comprised several tributaries, the main river channel and a flood channel that diverged from the main river channel downstream of Radloff Park. The main river channel did not always flow directly to the ocean as it does today. The 1942 topographic map shows that instead the main channel diverted northwards into a large wetland downstream of Paardevlei. An analysis of topographic maps also revealed progressive fragmentation of the distributary (flood channel) between 1942 and 2010 when only a small disconnected section remained (Figure 4.13). The distributary was subjected to infilling from urban developments such as the Vergelegen Medi-clinic hospital, retirement villages, shopping centres and the township immediately below the N2 highway called 'Nomzamo/Lwandle¹⁰'. The distributary flows through several urban suburbs, those upstream of the N2 highway known as 'Cherrywood Gradens' and 'Heritage Mews' and those downstream, known as 'Onverwacht' and 'Weltervreden'. Stormwater runoff from the distributary enters the ocean through 'Greenways Golf Estate' (Appx. Figure 3).

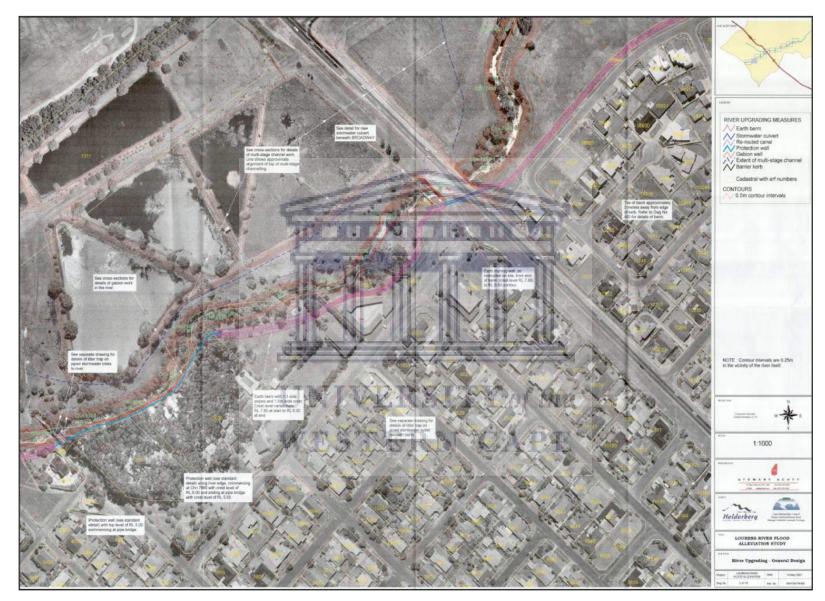
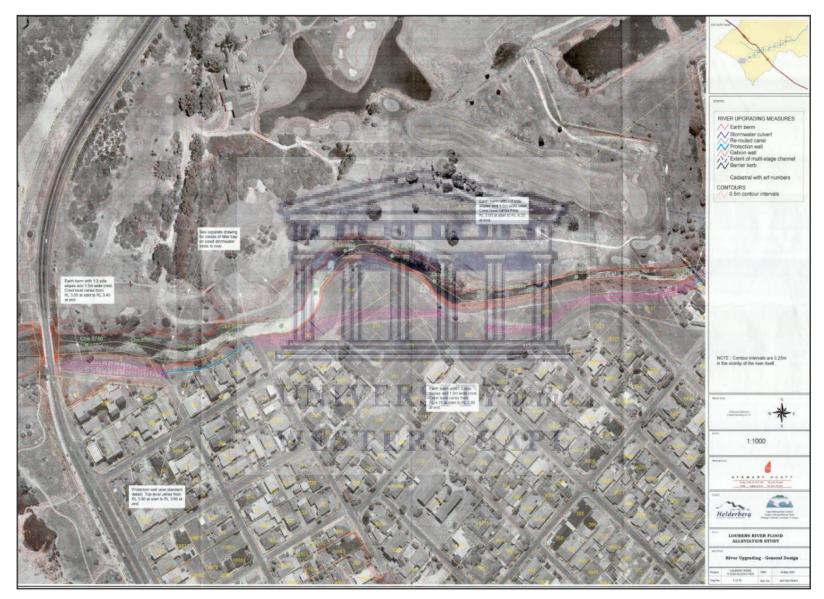
Appx. Figure 10: Aerial photographs of engineering proposals, Map 7 out of 10 (SSI 2001).

Appx. Figure 11: Aerial photographs of engineering proposals, Map 8 out of 10 (SSI 2001).

Appx. Figure 12: Aerial photographs of engineering proposals, Map 9 out of 10 (SSI 2001).

Appx. Figure 13: Aerial photographs of engineering proposals, Map 10 out of 10 (SSI 2001).
