## Conservation compatible energy retrofit technologies

*Part III: Documentation and assessment of materials and solutions for wall insulation in historic buildings*

**Part III** - Documentation and  
assessment of materials and  
solutions for **wall insulation**  
in historic buildings

**October 2021**

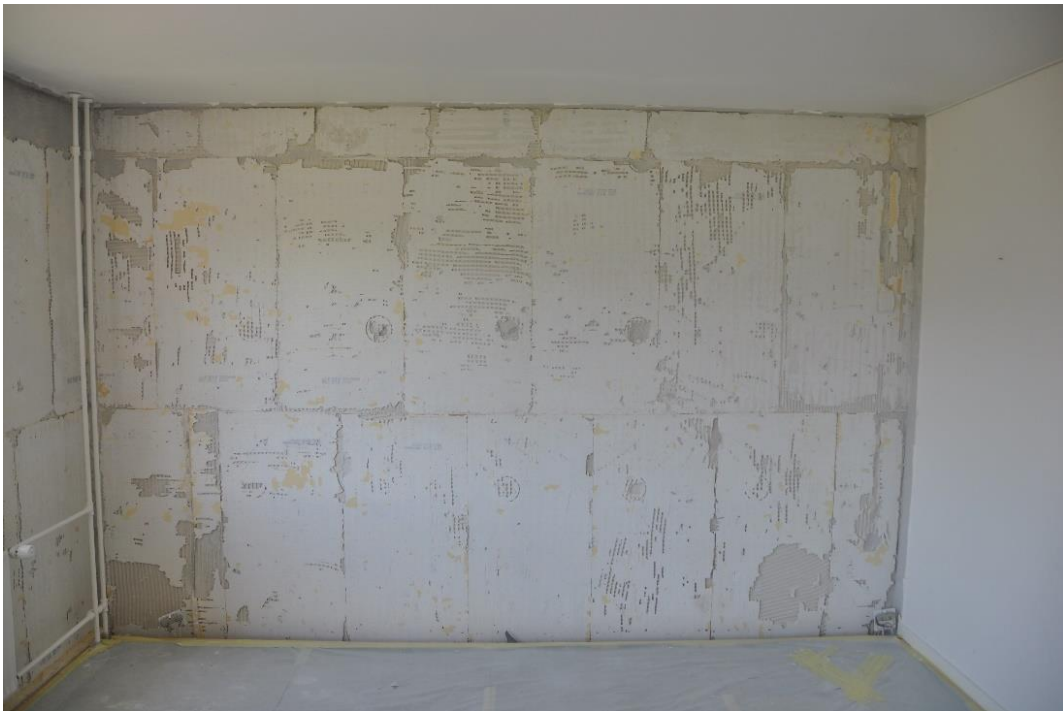
*figure 13: View of gable wall after removing the internal insulation, to look for mould growth two years after installation. No mould growth was identified; however, the view shows that the insulation system did not fully bond to the existing wall. © AAU*

some of the test apartments, the insulation was removed again after two years to see whether there was any mould growth at the interface between the insulation and the original wall.

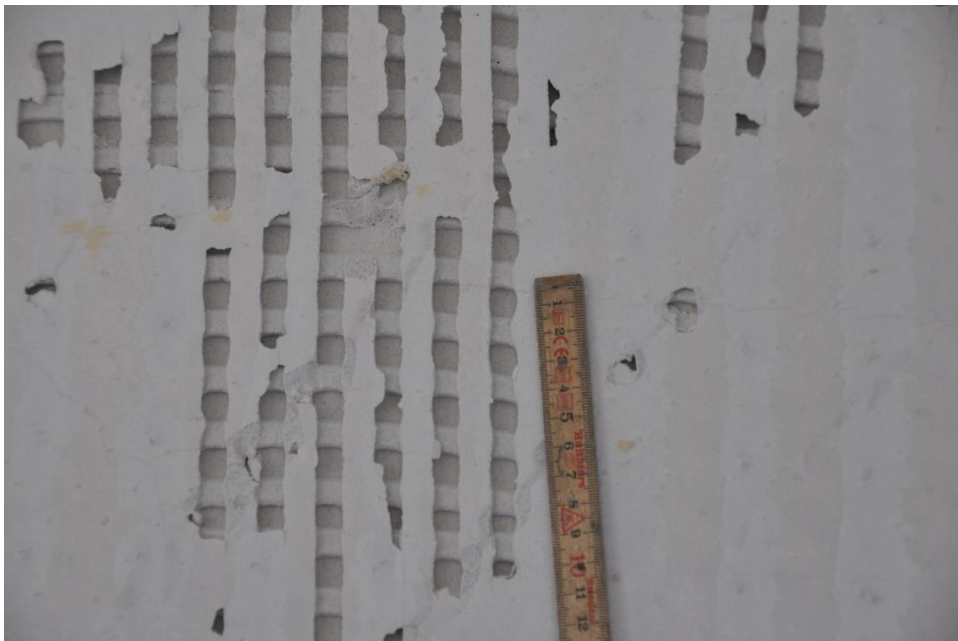
*figure 14: Close up of the wall in figure 13 showing the size of the areas with no bonding. According to the producer, opening of max 4x4 cm are accepted © AAU*

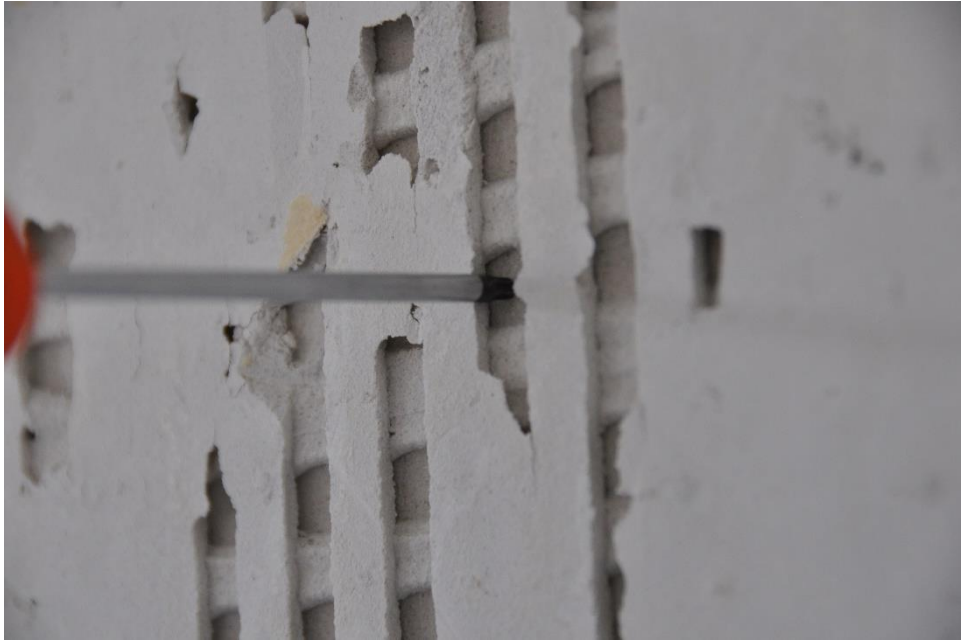
figure 15: Close up of the wall in figure 13 indicating the depth of the area without bonding. © AAU

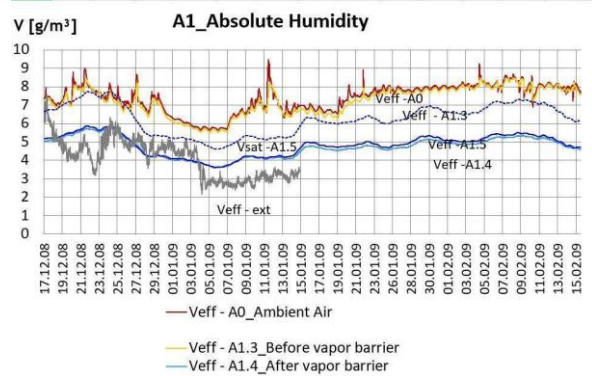
figure 52: Monitoring system: construction's absolute humidity ©Eurac

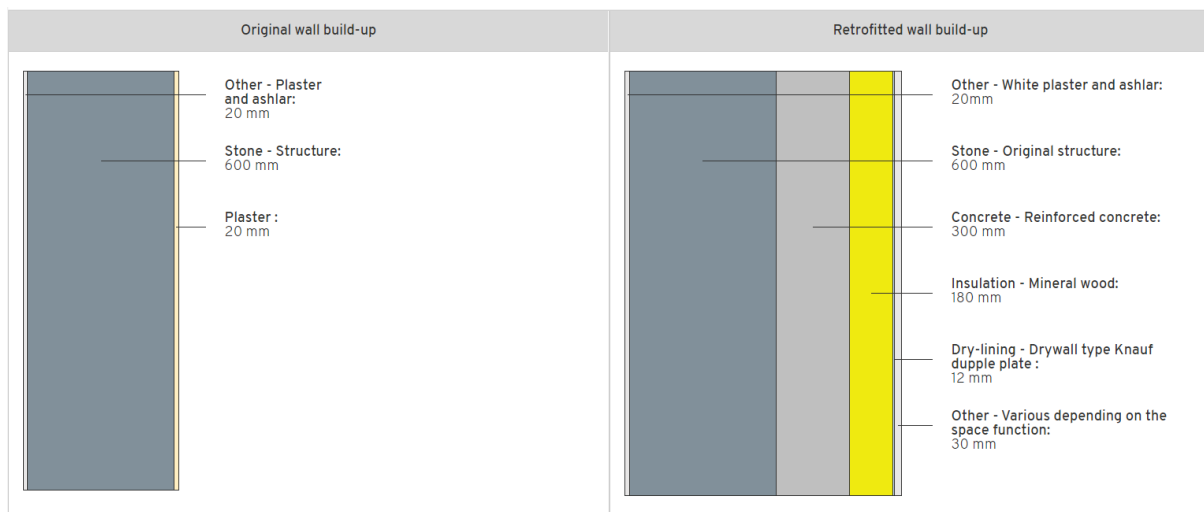
figure 59: Cross section before and after the intervention

The original structure has been largely maintained as far as the outer ring of the building is concerned, while the central part has been demolished to make room for the new spaces of the building with that change the use completely. The new building rises reusing the pre-existing structure of the Palazzo Scolastico in Piazza Remo Rossi in Locarno, Switzerland to be reconverted in the new PalaCinema, a multicultural platform for the cinematic arts located in the historical centre of the city. The new core of the building was inserted inside the old building by fortifying the external existing plastered stone walls (60 cm thick) with an additional 30 cm thick of reinforced concrete structure, thermally and internally insulated with 18 cm of mineral wool. In addition to this insulation, a vapour control layer and a drywall (type Knauf, double plate) of 1.25 cm were placed from the inside.

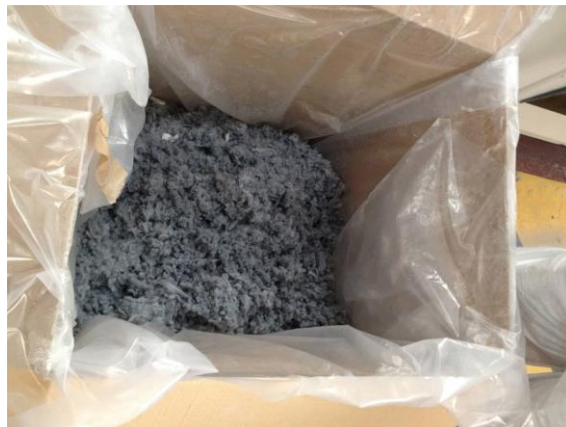
*figure 83: Loose material, © Elena Lucchi (Eurac)*

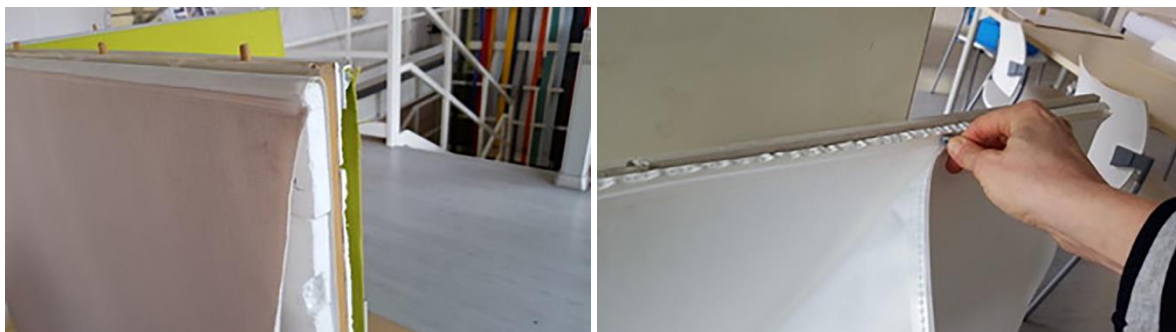
figure 89: Details of the wallpaper system, ©Polimi

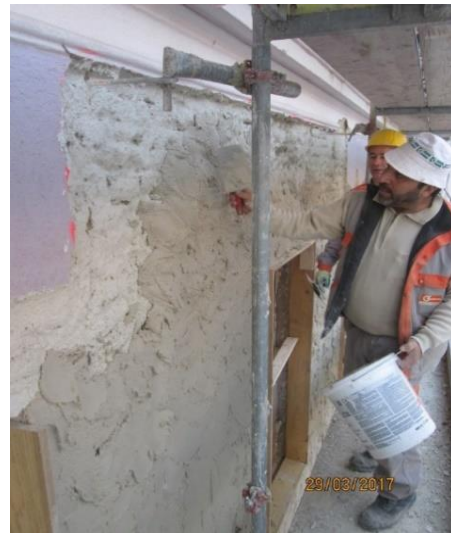
figure 125: Application of the aerogel plaster, © Trimmel Wall Architekten ZTGmbH

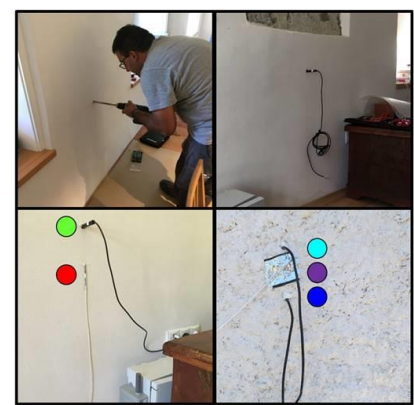
figure 139: Monitoring system of the construction, © Eurac

**Das Überwachungssystem**  
Kombinierte Sensoren für Temperatur und relative Luftfeuchtigkeit

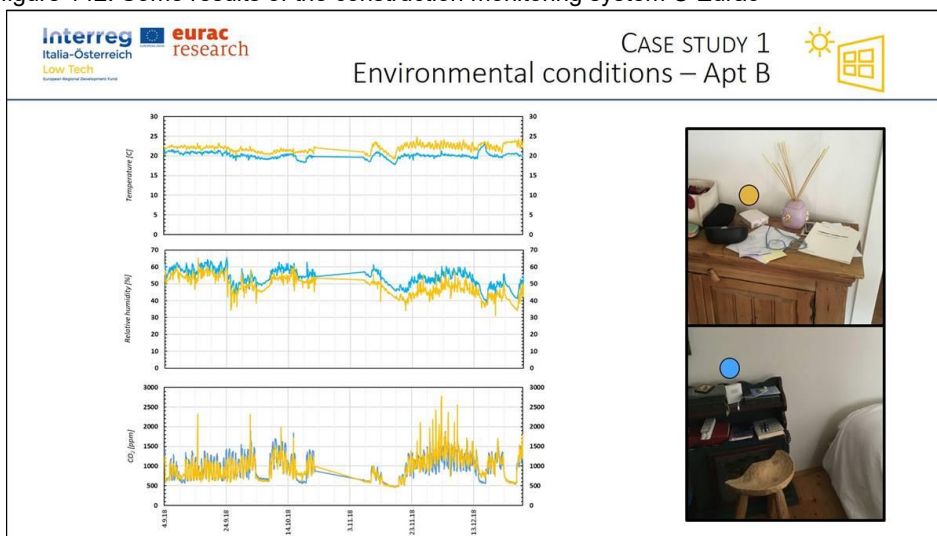
figure 143: Some results of the environmental conditions © Eurac

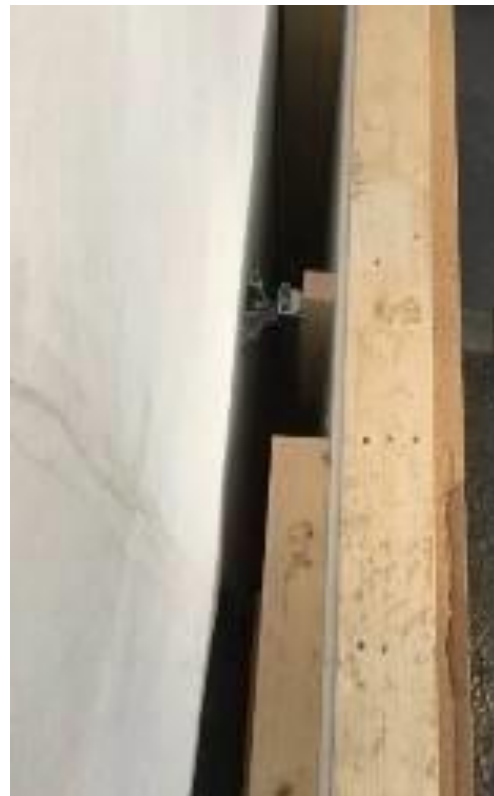
figure 154: Detail of the facade, © Michael Flach

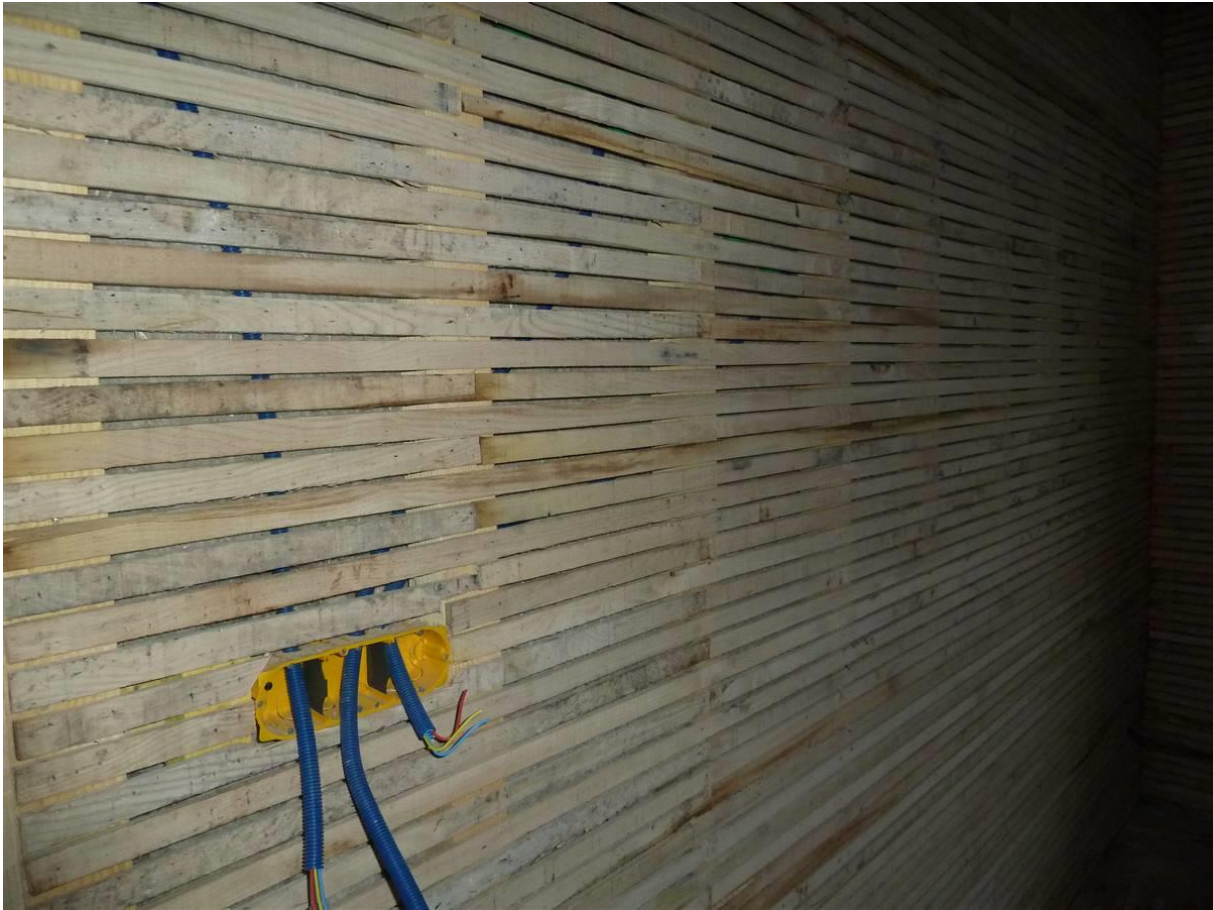
figure 164: Chestnut laths as a support for the earth render

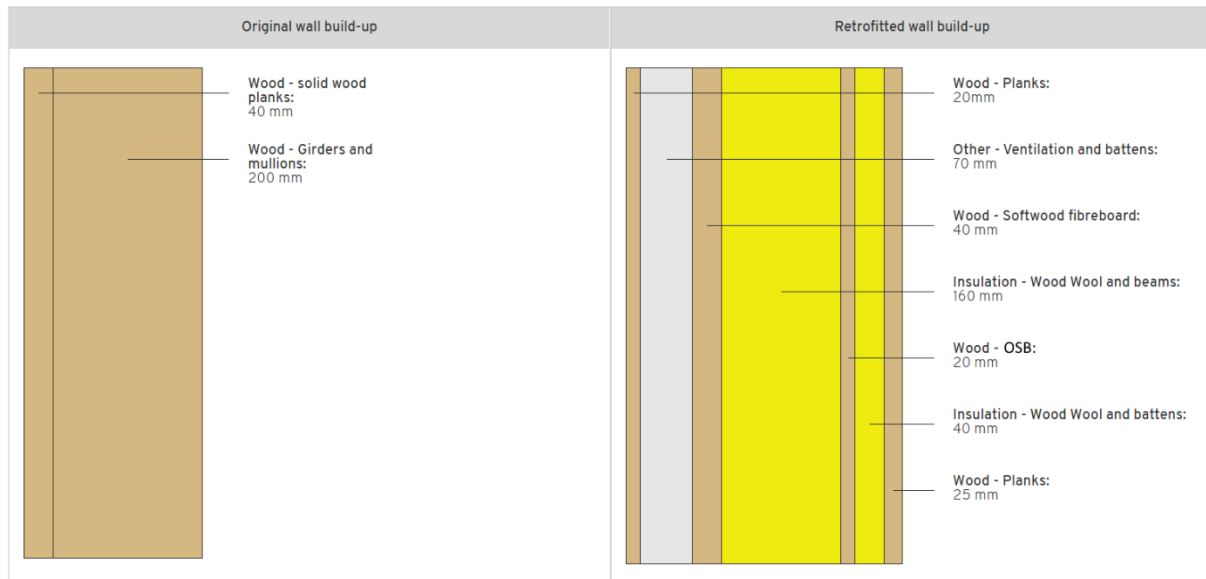
figure 170: Cross section before and after the intervention

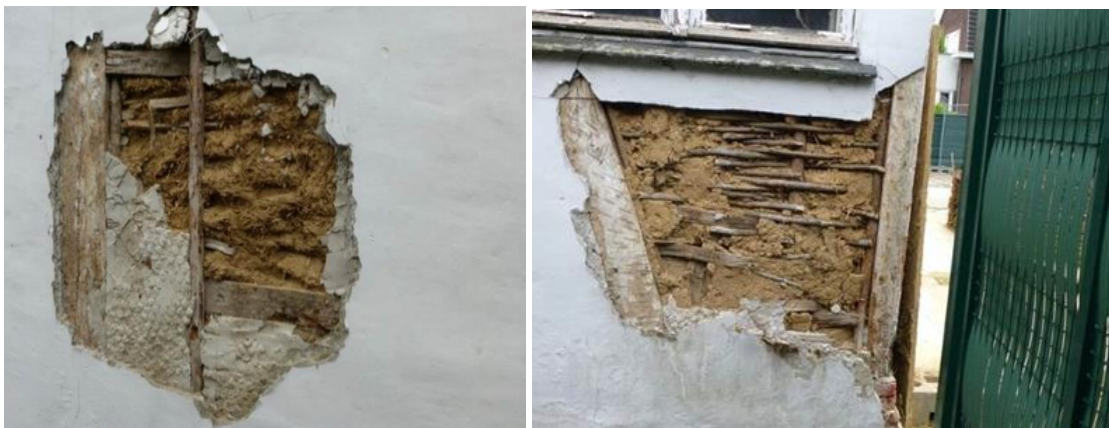
figure 177: Details of the original wall composition with wooden fence, visible wickerwork and loam (copyright Erfgoed en Visie bvba)
