Impact of GNSS-Band Radio Interference on Operational Avionics

Abstract

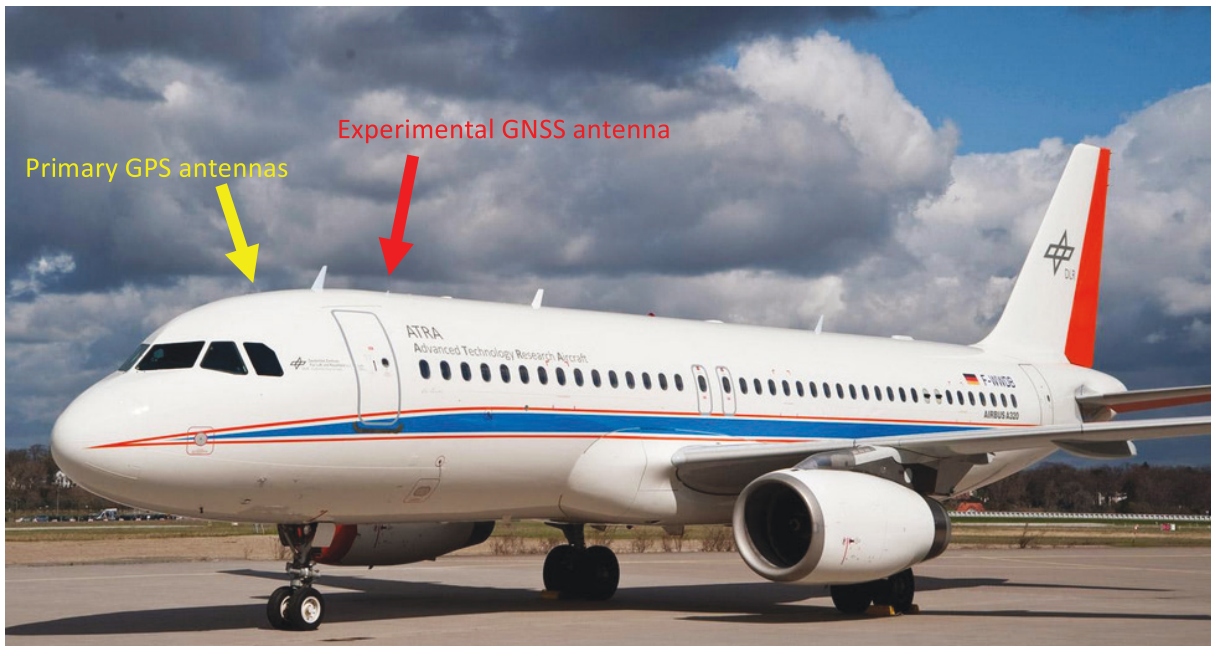
FIGURE 2 The cockpit is connected to two primary GNSS antennas providing GPS-only L1 signals. The experimental equipment is connected to the experimental GNSS antenna and captures L1, L2, and L5 from GPS, GLONASS, and Galileo.

The experimental equipment in the cabin included a Collins GLU925 MMR and a Spirent GSS6450 I/Q radio frequency (RF) data recorder for inspection of the radio spectrum. The data recorder and the GLU925 were fed from an experimental ANTCOM 3GNSSA-XT-1 multiband GNSS antenna. This experimental antenna is a multi-band GNSS antenna installed on the upper side of the fuselage, behind the primary operational GNSS antennas as shown in Figure 2.

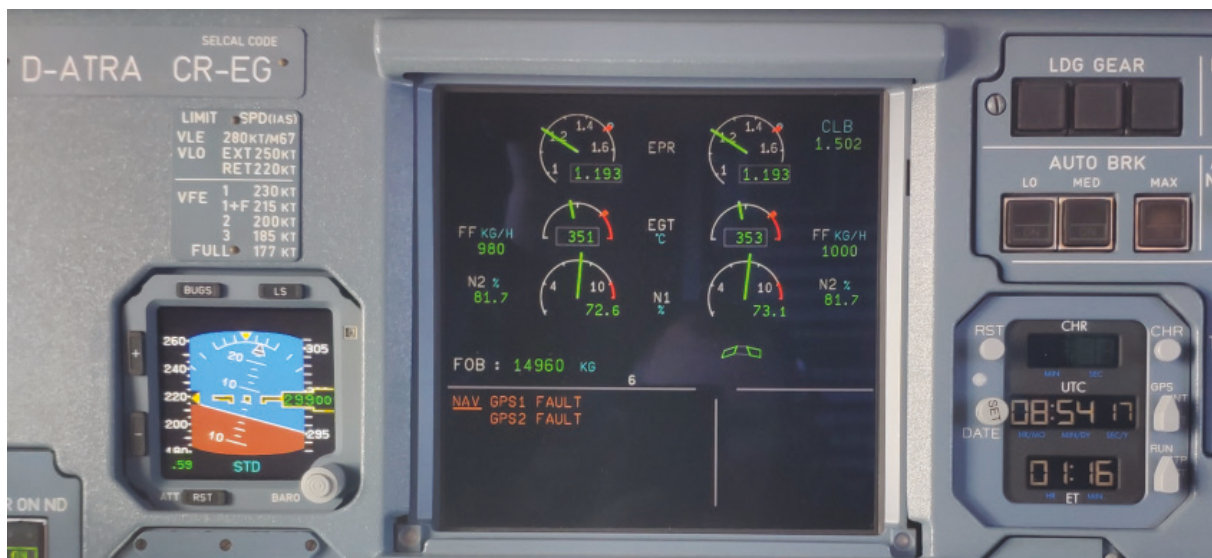
FIGURE 4 *GPS 1 Fault* and *GPS 2 Fault* refer to the GPS part of the two MMRs that operate independently of each other as part of the standard A320 avionics in D-ATRA. The error message suggests that both GPS receivers have failed, when in reality, they are operational but no useful GPS signal is available to them.

The loss of GPS navigation was not immediately apparent in the cockpit, as the aircraft coasted through GPS outages with its high-grade inertial reference systems. After approximately an hour of flying, which happened roughly at waypoint APLON (indicated in Figure 3) before turning toward waypoint VELOX to the East, both GPS receivers successively reported faults. These are shown in Figure 4 and indicate that the *actual navigation performance* (ANP) was greater than the RNP. At the same time, the primary flight display showed the message *GPS Primary Lost*.

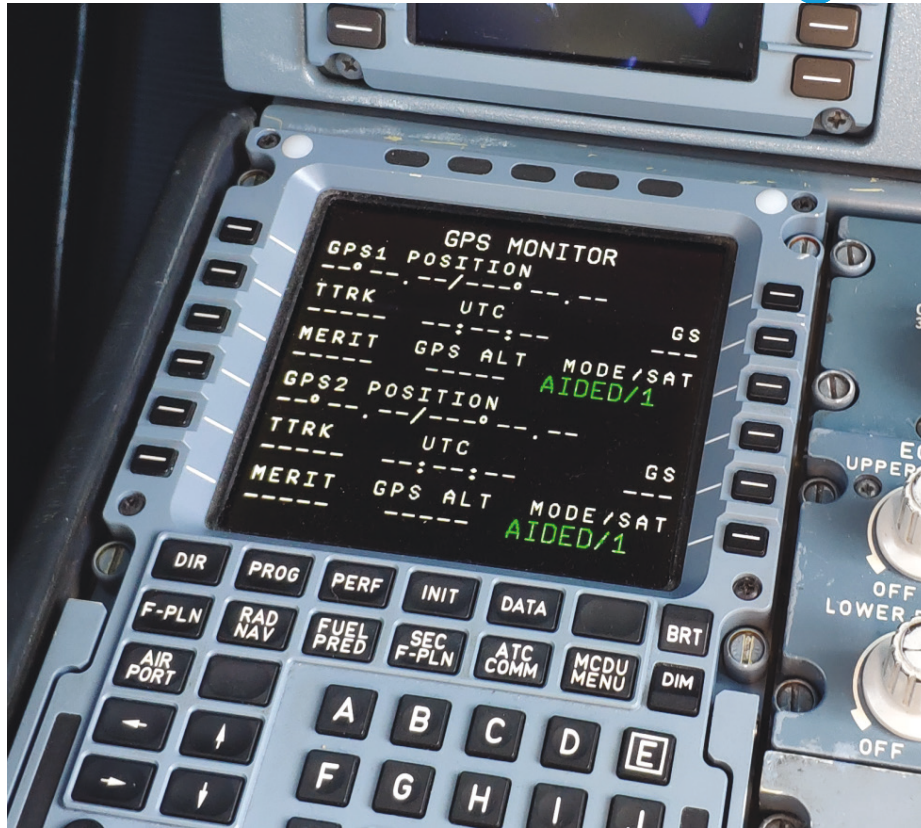
FIGURE 5 When the number of available satellites drops below four, the receiver goes into *Aided Mode* in which navigation avionics use the inertial platform to coast the navigation solution as primary position and velocity.

For a pilot not explicitly looking for GPS interference, this would have been the first indication of a degraded navigation capability. A pilot actively looking out for RFI can have information displayed on the GPS status page of the multi-function control and display unit (MCDU), shown in Figure 5. This page is, however, not routinely monitored in regular commercial traffic.

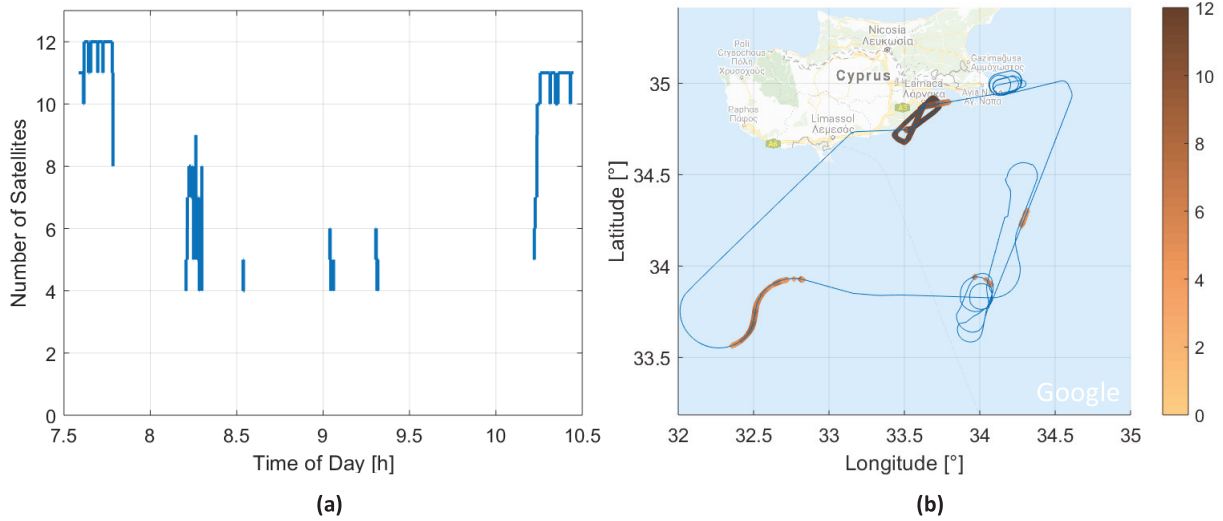
FIGURE 6 Number of satellites tracked by the experimental MMR: (a) shows the number over time, with higher numbers corresponding to taxiing, takeoff, and landing phases; and (b) shows the number along the flight path.

In Figure 6, we show the number of GPS satellites tracked by the MMR for the entire flight. For most of the airborne time, fewer than four satellites were available to the MMR, making GPS unavailable. It should be noted, however, that the relatively short periods of GPS availability, visible in both graphs, were sufficient to recalibrate inertial systems, which in turn allowed the aircraft Flight Management System (FMS) to coast and continue providing navigation services.

Overall, the experimental MMR was denied from computing a position solution for 80% of the experiment time; note that this includes taxiing, takeoff, and landing. The results in Figure 6 show the number of satellites available for a position solution for the entire flight route. At points with four or more available satellites,

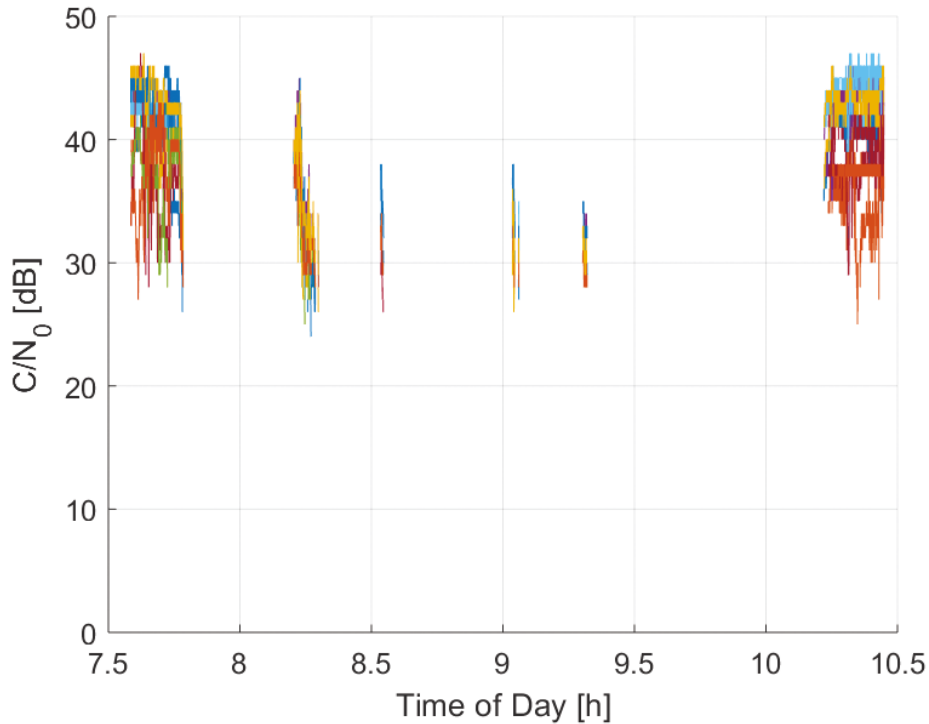
FIGURE 7 Carrier-to-noise ratio of the available satellite signals (gaps in the plot correspond to periods in which no satellites could be tracked at all due to the RFI)

The C/N_0 provided by the experimental MMR is visualized in Figure 7. Under nominal conditions, when the RFI does not affect the MMR, there is a spread of about 10 dB in C/N_0 between the best-received and the worst-received satellites. This is usually attributed to the fact that signals from satellites at different elevation angles experience different antenna gains and atmospheric effects. In Figure 7, it is evident that this condition is only given on the ground and at low altitudes, as it occurs only until shortly after take-off time (i.e., before 8:00 am) and before landing (i.e., after 10:00 am). Readers interested in the details of the antenna gain pattern on the experimental equipment may consult Caizzone et al. (2019).

Under RFI conditions, it is evident from Figure 7 that all satellites have degraded C/N_0 . For some legs of the flight, this degradation leads to a loss of lock condition.

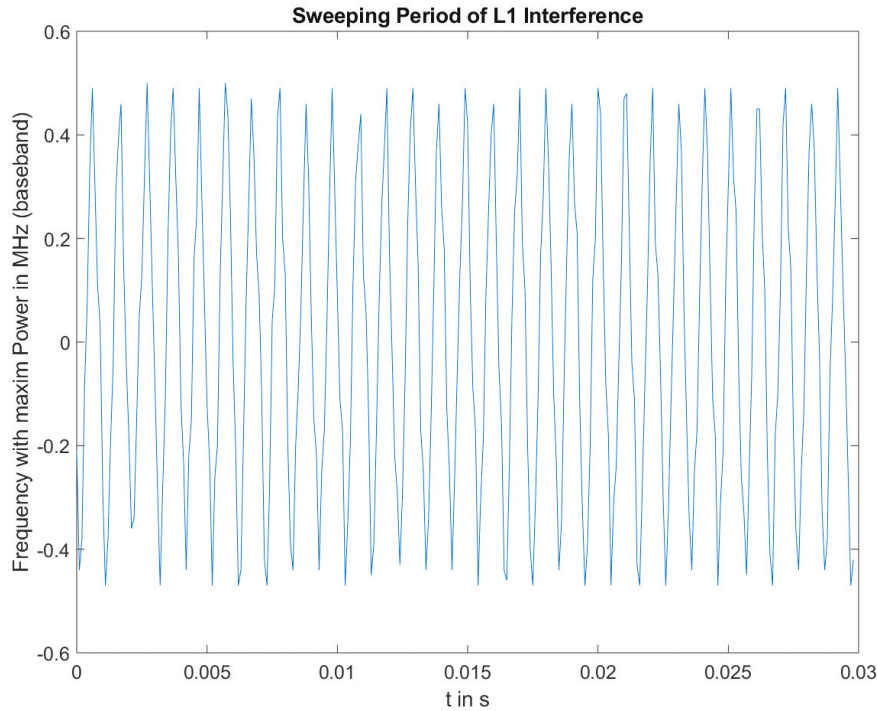
FIGURE 9 Time-domain behavior of the chirping signal at the L1 frequency; this type of triangle-wave frequency chirp is expected behavior for a high-power RFI source.

To better understand the time behavior of the RFI signal, we analyzed the signal in the L1 band over a shorter time. We computed the frequency with the maximum power spectral density over a few ms to better visualize the triangular frequency chirp, a telltale sign of intentional RFI. The excerpt in Figure 9 shows a section of 30 ms, starting at 09:00. The shape of the signal corresponds to a frequency sweep with 1-MHz bandwidth and a period of approximately 1 ms. These parameters are very much in line with what can be expected from intentional, high-power RFI (Fernández Hernández, et al., 2019).
