Intensive Archeological Survey for the Bridge Replacement Project on County Road 1511 at Resaca Creek, Leon County, Texas

Report for Archeological Survey

Bryan District

CSJ: 1145-01-044

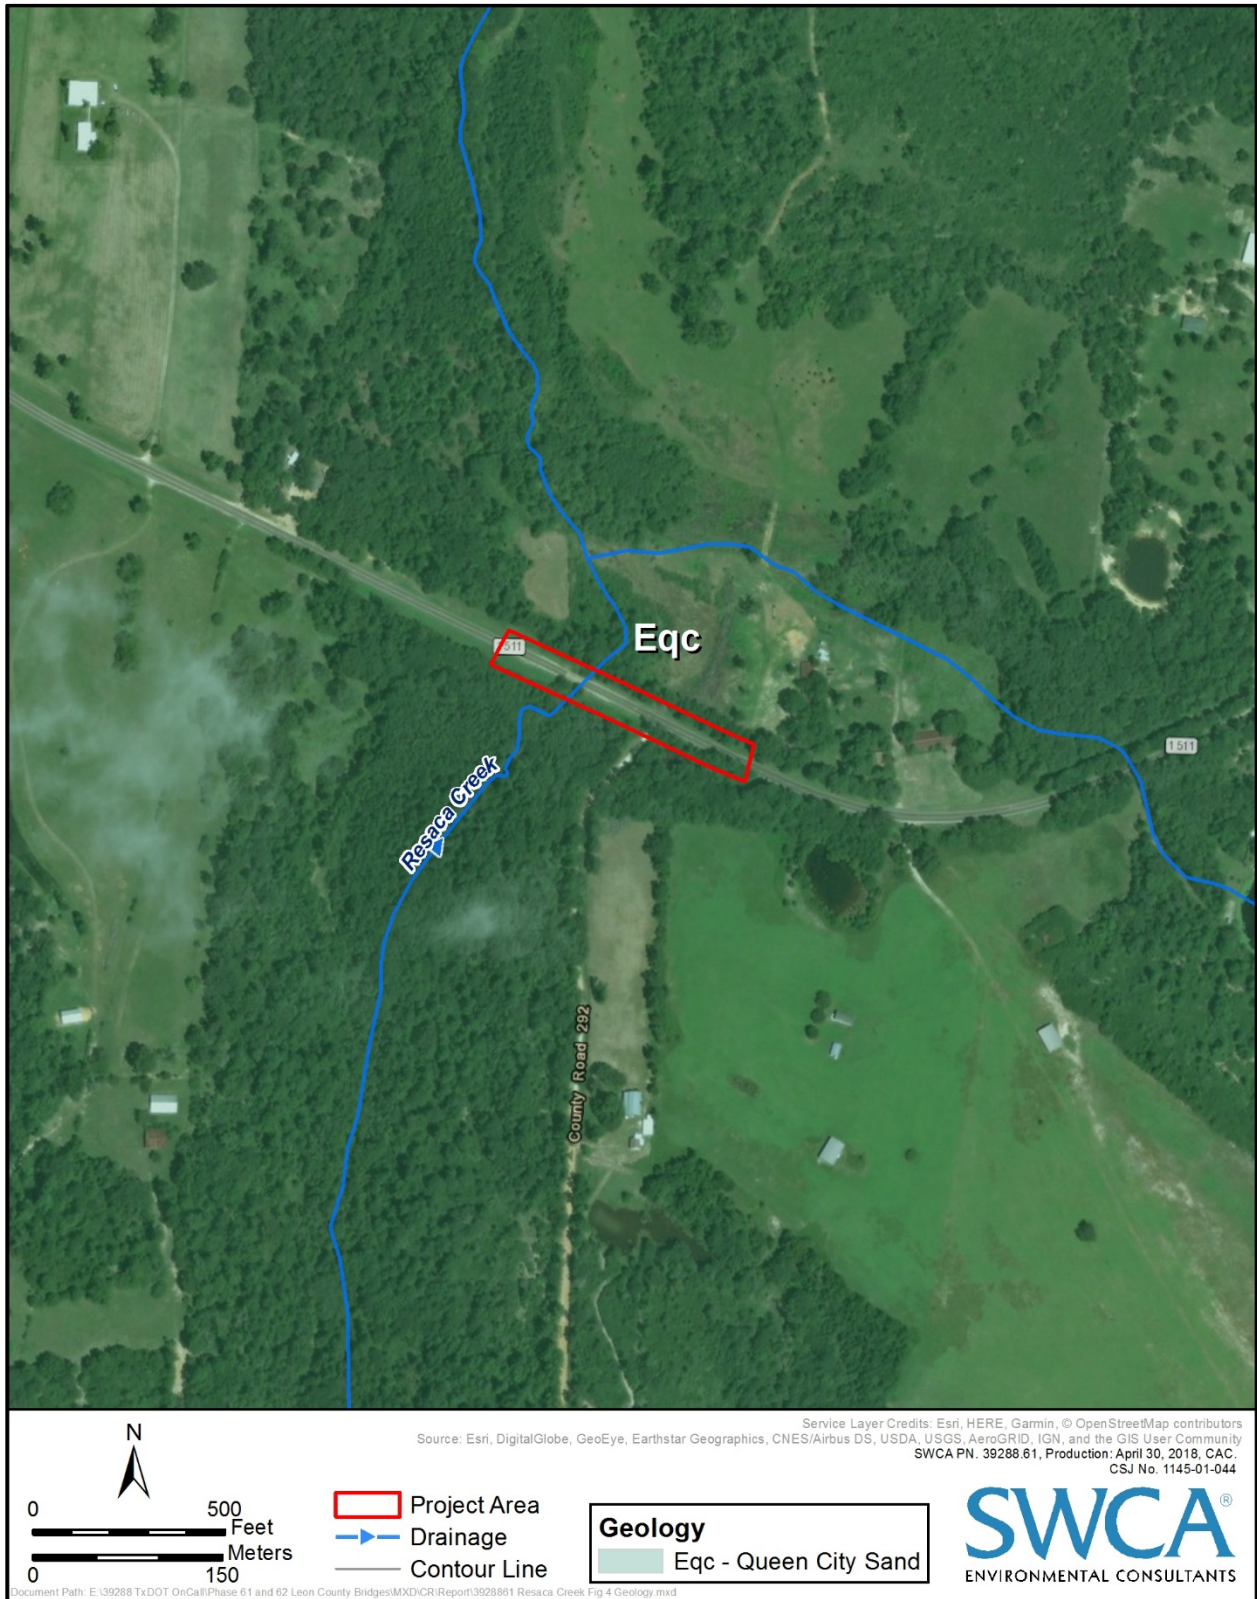
Figure 3. Project area geology.

Geology: The project area is located within the Queen City Sand formation (Figure 3). The Queen City Sand formation consists of quartz sand and clay as well as fine- to medium-grained sand. The sand weathers red and white with mottles of ironstone concretions (Barnes 1967).

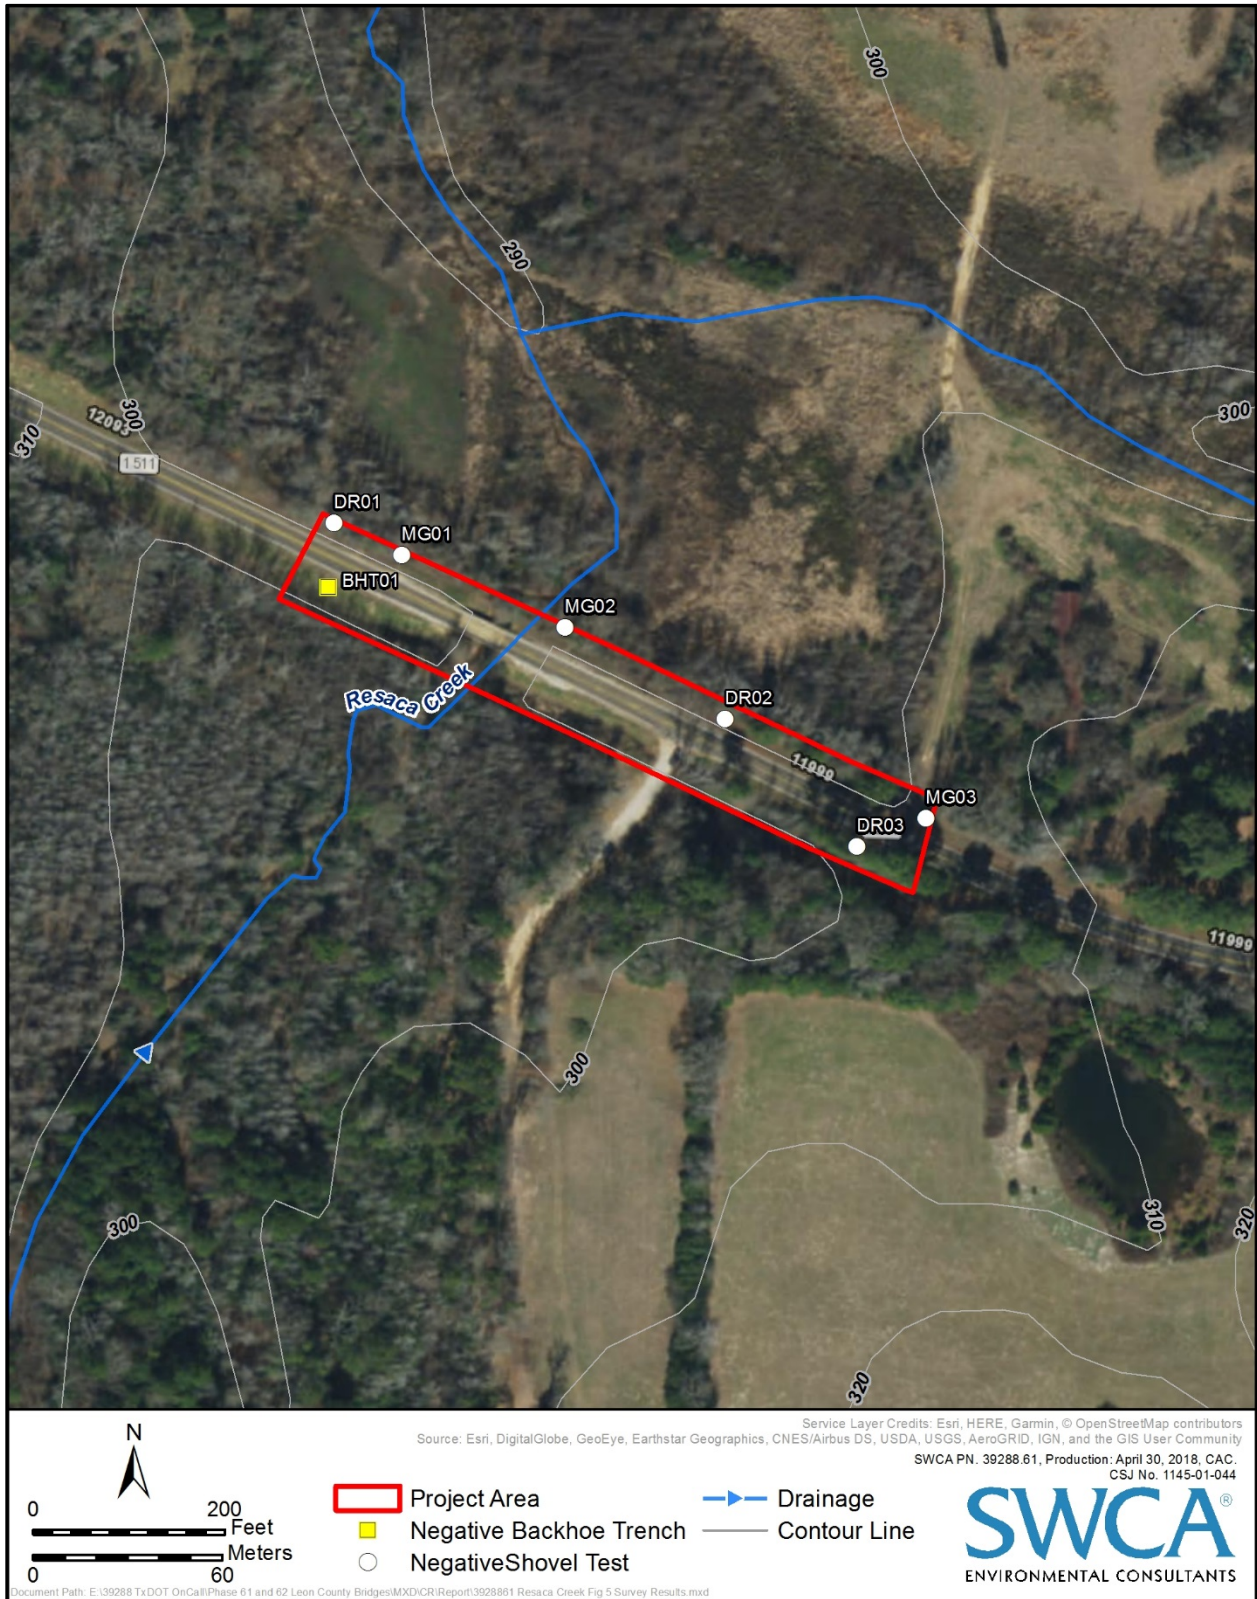
SWCA archeologists conducted backhoe trenching within the accessible portion of the APE (see Figure 5; Table 2). One BHT was excavated, on the southern side of the existing ROW, west of Resaca Creek. The extensive wetlands and soft saturated ground conditions precluded additional BHTs in the project area. In lieu of trenching, SWCA archeologists conducted five shovel tests along the northern side of the existing ROW for which there was no marked buried telephone utilities and standing water.

Figure 5. Results map. Wetlands prevented trenching throughout APE.

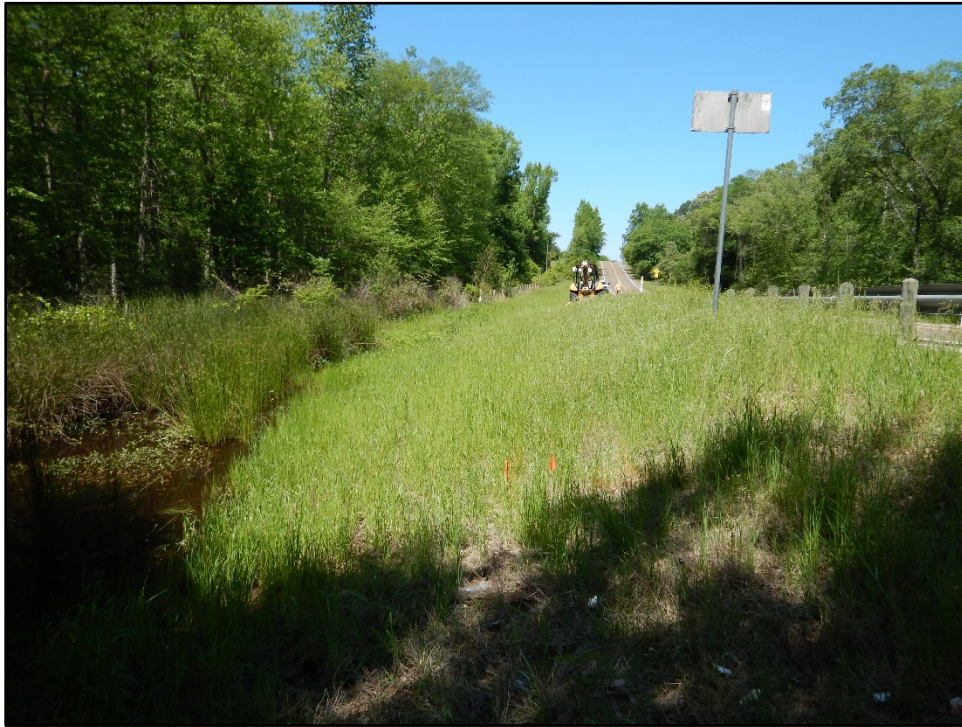
Project Area Description: The project area setting is entirely within the Resaca Creek floodplain within the existing FM 1511 ROW (Figures 5–9). The ROW has been disturbed by road and bridge construction and maintenance (including grading, fill, and runoff culverts), as well as two buried telephone utility lines. Vegetation within the APE consists mainly of short grasses with areas of wetland vegetation and standing water on both sides of the raised road bed. Beyond the ROW, vegetation includes older pine, red cedar, pecan, oak, dense areas of wetland vegetation, and areas of standing water.

Figure 6. South side of FM 1511, on the west bank of Resaca Creek, with flagged utilities in foreground, standing water wetlands (left), and backhoe at BHT1 location, facing northwest.

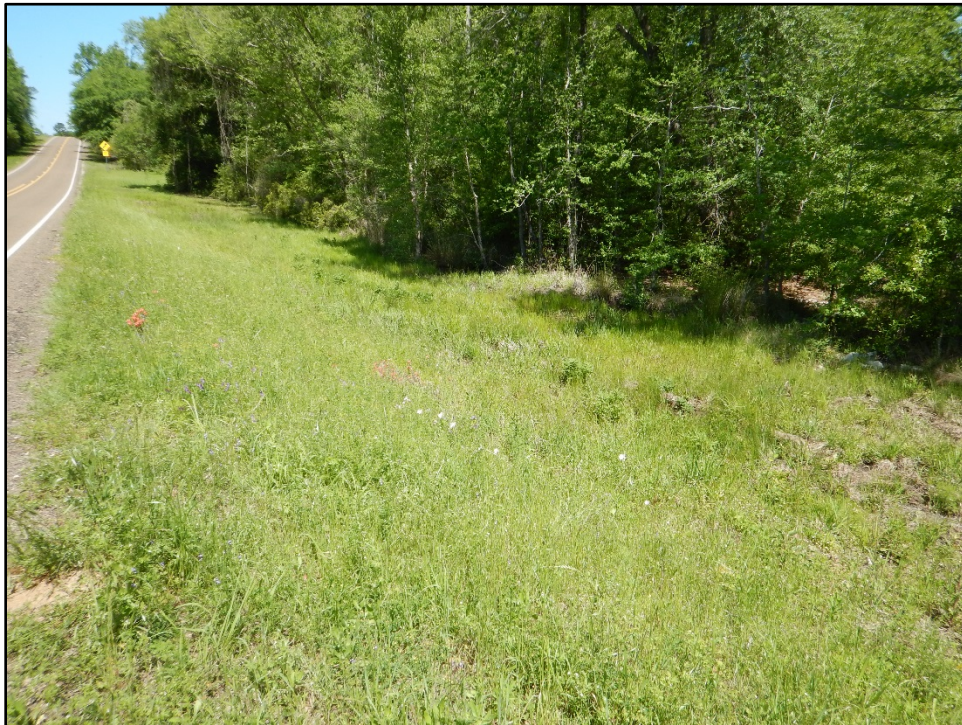
Figure 7. North side of FM 1511, on the west bank of Resaca Creek, with bare mud and wetland grasses (right) and raised road bed (left), facing northwest.

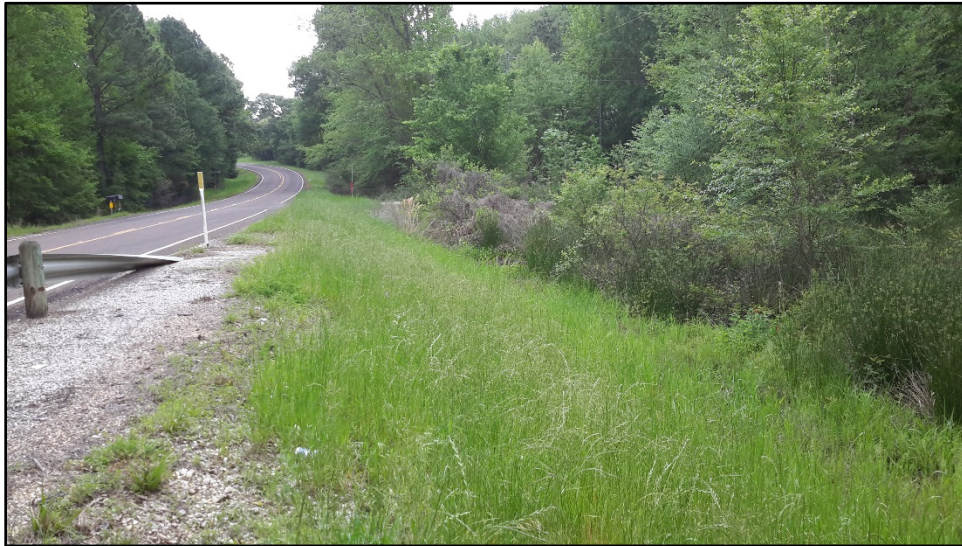
Figure 8. South side of FM 1511, on the east bank of Resaca Creek facing southeast. Note the steep raised road grade with standing water wetlands at base (right), utilities are marked along this side, but are not visible in this picture.

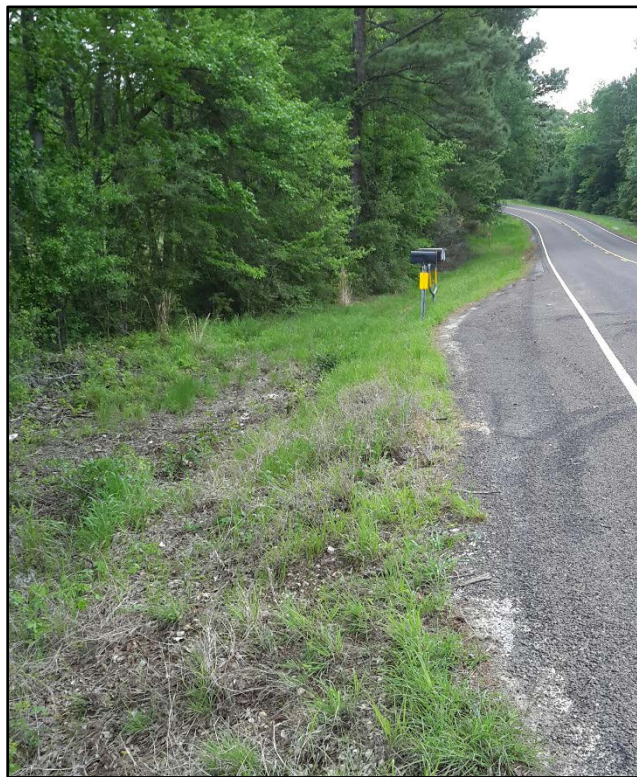
Figure 9. North side of FM 1511, on the east bank of Resaca Creek facing southeast. Note the steep raised road grade. The saturated ground and wetland grasses (right) are located near a standing waterbody (just left of view) from a culvert just east of the bridge.

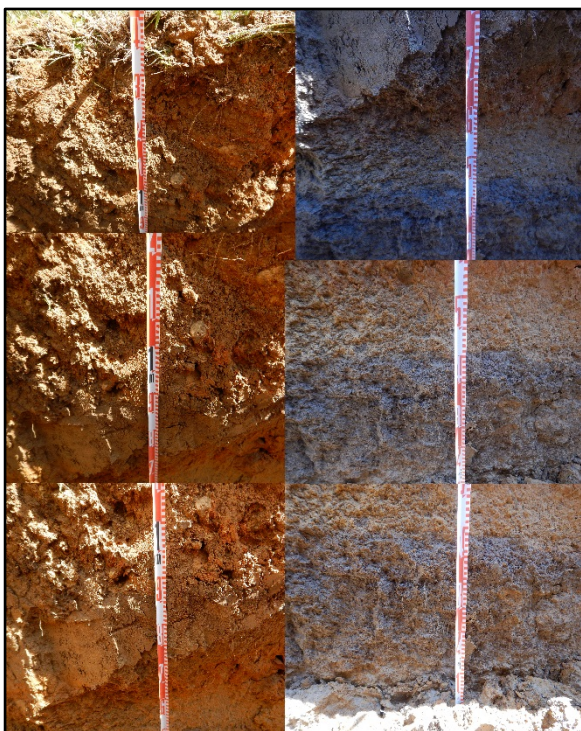
SWCA excavated BHT1 on the southwestern side of the existing Resaca Creek bridge approach, on the southern side of Resaca Creek (Figure 10). Measuring approximately 3 m (10 feet) long, 0.6 m (2 feet) wide, and 1.8 m (6 feet) deep, the trench was placed on the bottom of the raised road bank to avoid as much of the artificial disturbances as possible, while also avoiding the saturated wetlands immediately south of the slope. The top 71 cm (28 inches) of the trench consisted of a brown (7.5YR 4/3) fill with a sandy loam containing 10 percent pebbles and imported gravel inclusions. Below this, from 71 to 91 cmbs (28–36 inches below surface) was a strong brown (7.5YR 5/8) sandy clay with a blocky structure containing 10 percent angular gravels, 2 percent pin holes, and 2 percent worm casts. This second stratum likely represents the remainder of the original A horizon prior to bridge construction. Between 91 and 104 cmbs (36–41 inches below surface), the soil became a light yellowish brown (10YR 6/4) sandy clay. Beneath this was a 10YR 4.2 dark grayish brown sandy clay loam containing 10 percent manganese and iron redoximorphic mottling and water table flowing in the trench at various depths (Figure 11); this stratum extended between 104–183 cmbs (41–72 inches below surface). Trench BHT1 was negative for cultural materials.

Figure 10. BHT1 north trench wall profile composed of overlapping photographs. The trench began to collapse before an adequate profile overview with scale could be taken.

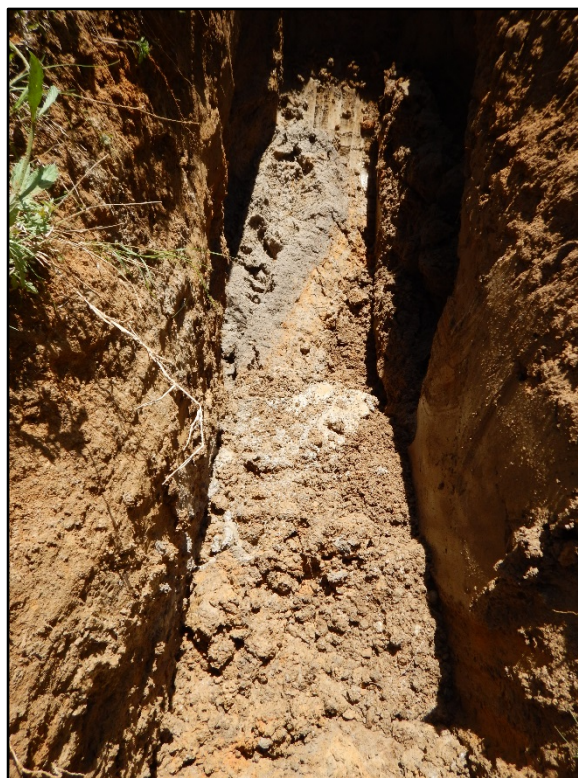
Figure 11. BHT1 trench floor with wall collapse and water table filling the trench, facing northwest.
