Intensive Cultural Resources Survey For The Proposed Farm-To-Market 1625 Realignment Project, Travis County, Texas

INTENSIVE CULTURAL RESOURCES SURVEY
FOR THE PROPOSED FARM-TO-MARKET 1625
REALIGNMENT PROJECT, TRAVIS COUNTY,
TEXAS

TEXAS ANTIQUITIES PERMIT NO. 7975
CSJ: 1535-01-012
MAY 2018

PREPARED BY
SWCA Environmental Consultants

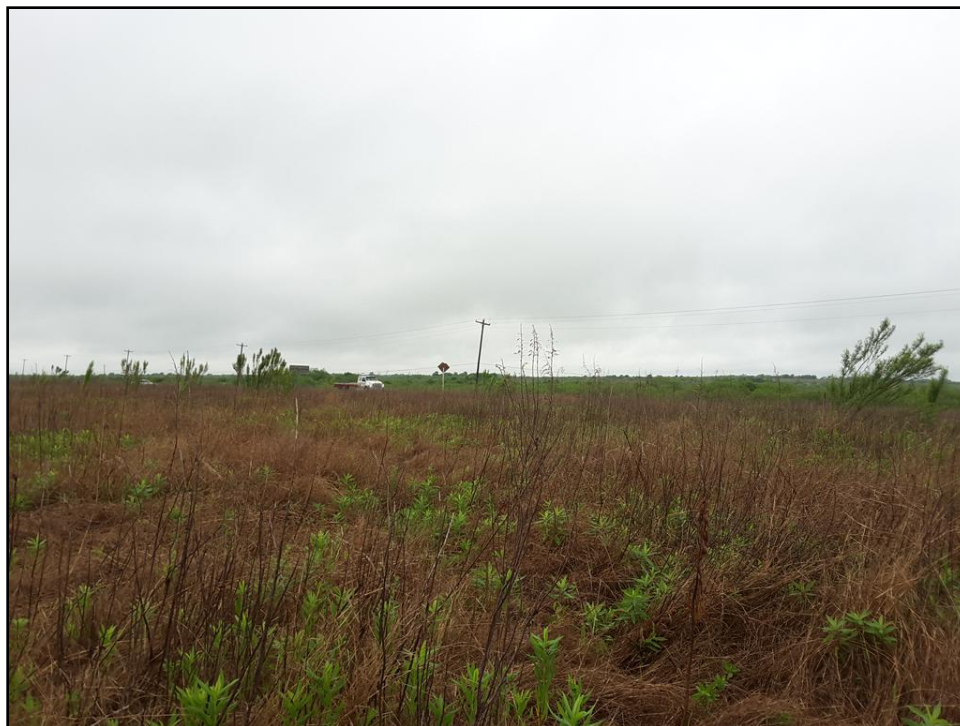
Visual examination of the project area revealed a primarily semi-rural setting surrounded with open pastures and scattered residential housing. Vegetation throughout the 0.3-mile FM 1625 realignment project area consists of tall, dense grasses and short scrub, which reduced the estimated surface visibility to a range between 0 and 10 percent (Figure 5). SWCA archaeologists excavated a total of six shovel tests within the project area (Table 1). The encountered soils consisted of a dark gray to very dark gray (10YR 4/1 to 10YR 3/1) dense clay at the surface. The density of the clay impeded manual excavation beyond a depth of 40 cmbs, and reduced the likelihood of deeply buried archaeological deposits. Neither the surface, nor the subsurface investigations identified any historic or prehistoric cultural material.

Figure 5. Overview of vegetation in project area from shovel test AE01, facing south.

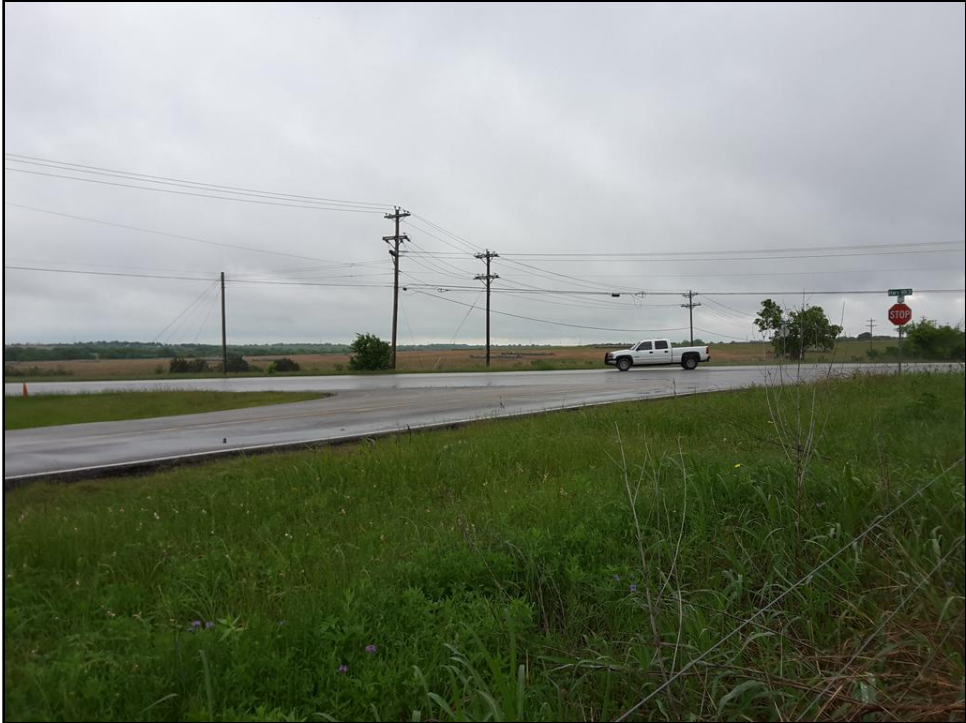
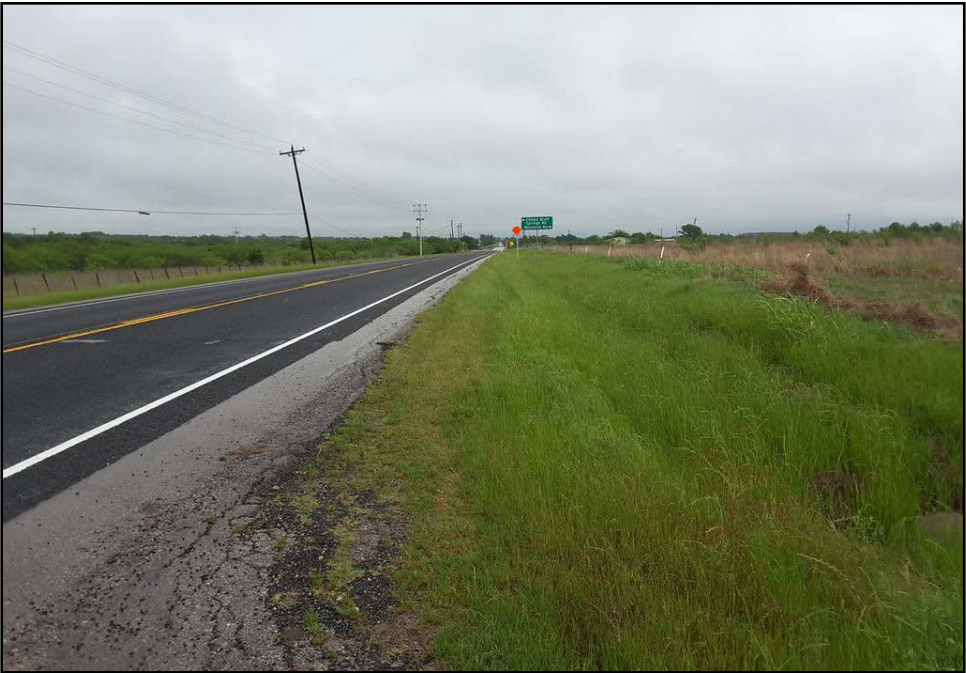
An examination of the 970-foot-long section (0.18 mile) of McKenzie Road and the 2,270-foot-long sections (0.42 mile) of FM 1625 scheduled for pavement removal revealed that the area of impact would be entirely within a pre-existing paved road (Figures 6 and 7); the pavement removal would not generate any additional disturbance to potential cultural resources in the area. Additionally, the examination of the bridge spanning North Fork Dry Creek determined that the disturbance produced by the initial bridge construction was at such an extent that the removal of the bridge would not impact any potentially remaining, intact cultural features (Figures 8 and 9). Further, the drainage and surrounding soils are not conducive to the preservation of deeply buried, intact cultural deposits. Specifically, the North Fork Dry Creek at this crossing is a relatively shallow incised drainage with shallow (less than 4 feet) cut banks. The drainage is incised into the Tinn clay and bracketed by the Houston Black clay series that contribute to the Tinn clays (NRCS 2017). The dense clays at the crossing are derived from clayey residuum from calcareous mudstone of Cretaceous Age (Houston Black) or calcareous clayey alluvium from the Blackland Prairies (Tinn) and not typically associated with deeply buried stratified archaeological sites. Similarly, the floodplain at this crossing is slightly sloping within a narrow (about 100-m-wide) valley. Considered together, the crossing appears more erosive than depositional and does not have the potential for deeply buried, intact cultural deposits. Further, the presence of shallow calcium carbonate encountered in the shovel tests excavated approximately 750 feet from the bridge, suggest the deposits aligning the drainage may be of considerable age.

Figure 6. Intersection of US 183 and FM 1625, facing northwest.

Figure 7. Overview of proposed pavement removal area on FM 1625, facing north.

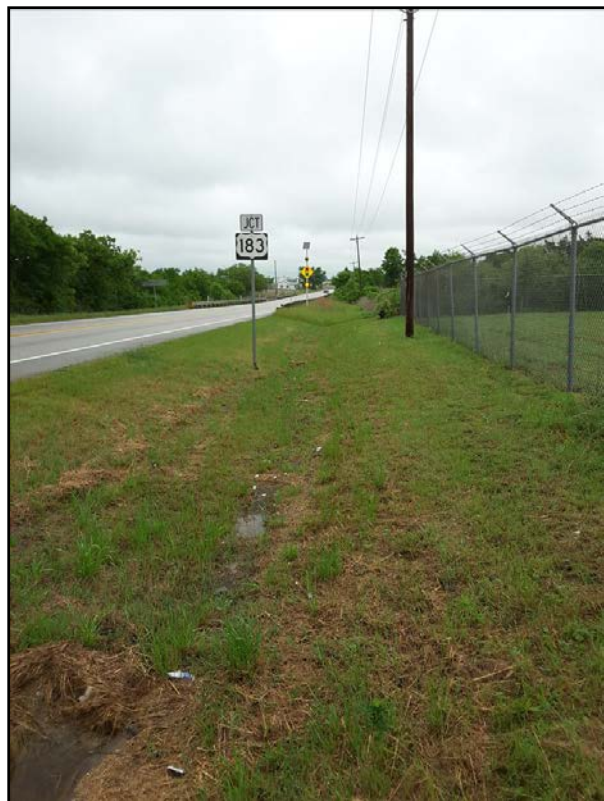
Figure 8. Overview of approach along FM 1625 to bridge spanning North Fork Dry Creek, facing northwest.

The soils surrounding the bridge crossing at the North Fork Dry Creek have been significantly impacted by previous construction. The road bed approaching the bridge has been artificially raised about 3 feet, and road side ditches have been cut below grade roughly 3 to 4 feet on each side to channel runoff into the drainage. Concrete and steel pilings have been driven into the drainage for bridge support. Concrete retaining walls extend for approximately 12 feet at a diagonal angle from the bridge on both banks and on each side. Guard rails have been placed on both sides of the bridge in each direction and are held in place by a series of large, wood posts. The direct impacts from construction of the road leading to the bridge, as well as the indirect impacts from the heavy machinery used in construction, have significantly disturbed the deposits in and around the drainage. Further, roadside utilities, such as the telephone poles located on the east side of the bridge, will have further disturbed the surrounding area. Given the seemingly erosive nature of this setting and the low potential for buried cultural deposits, combined with the high degree of disturbance from previous construction and maintenance, any potential, intact cultural deposits will have already been destroyed and the removal of the bridge will not have any further impacts.

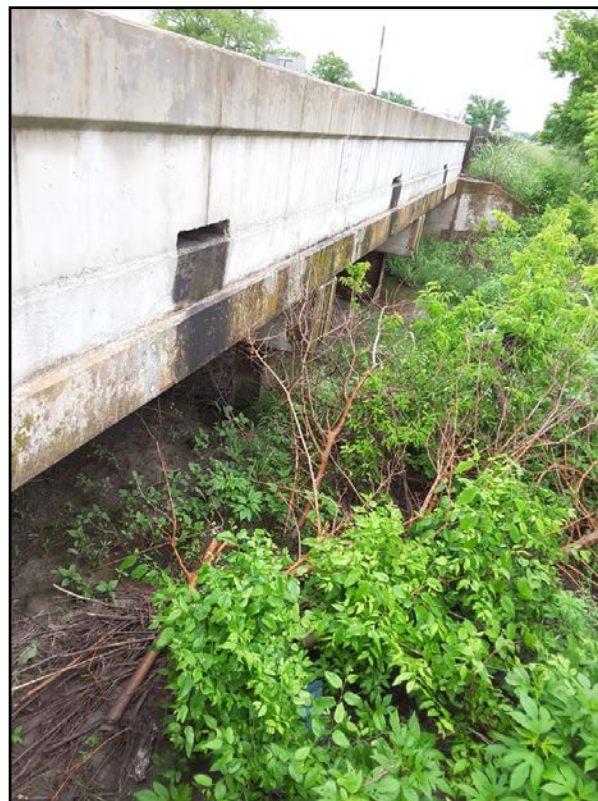
Figure 9. Overview of FM 1625 bridge at North Fork Dry Creek, drainage, and pilings; facing northwest.
