**Archaeological Monitoring of Improvements to Building
652, Port of San Antonio,
San Antonio, Bexar County, Texas**

Antiquities Permit #7201

**Prepared for:
The Port of San Antonio**

**Pape-Dawson
10801 N MoPac Expy.
Bldg. 3, Suite 200
Austin, TX 78759
June 2018**

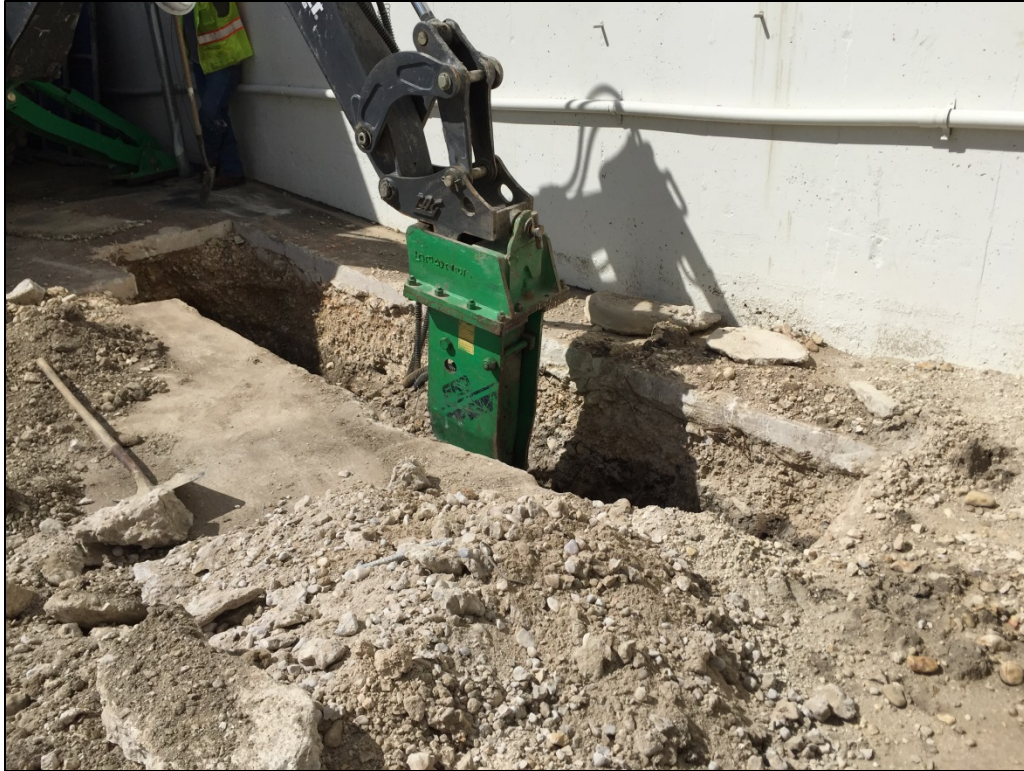
Pape-Dawson archaeologists intermittently monitored construction of the flood control walls between May 26 and September 3, 2015. Nesta Anderson was the Principal Investigator and Jacob Sullivan served as the field crew. Archaeologists monitored the excavation of a series of trenches measuring approximately 2 ft. (0.60 m) wide by 4 ft (1.2 m) long by 3 ft (1 m) deep (Figure 4). Trenches were typically spaced 11.5 ft (3.5 m) apart, and were placed 2.1 ft (0.64 m) from Building 652. The purpose of these trenches was to allow a series of piers to be drilled as anchors for the wall. The construction contractor used a bobcat backhoe with a 2 ft (0.60) wide bucket to excavate the trenches (Figure 5).

Figure 5 Backhoe digging trench for Wall 2

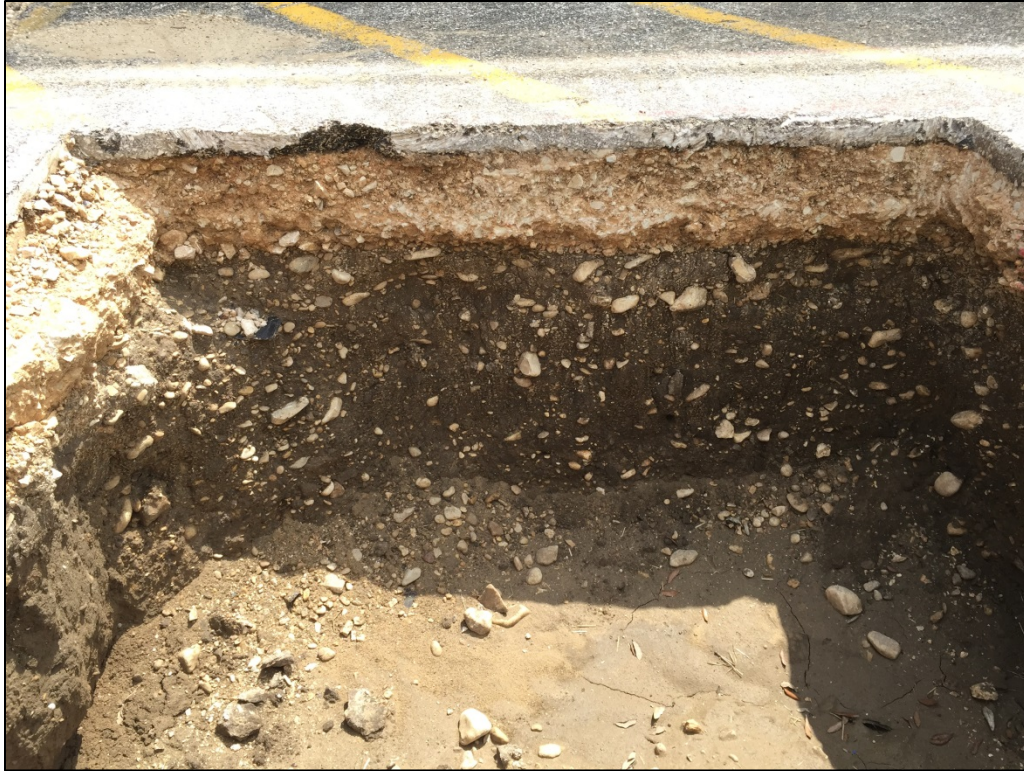
Trenches were excavated on the north, south, and west sides of Building 652, in order to lay the foundations for Walls 1, 2, and 3. Wall 1, which is located along the northwest side of the building, is in an area that appears to have been graded to subsoil (Figure 6). Typical profiles on the northwest side of the building show a caliche road base over a dark brown clay loam with approximately 40-50% limestone cobbles, which is representative of the B horizon in Sunev soils mapped for the project area. Pape-Dawson archaeologists observed the initial excavation of trenches associated with the wall and to find utilities; no cultural materials were observed during monitoring of this area.

Figure 6: Typical trench profile for Wall 1 facing east

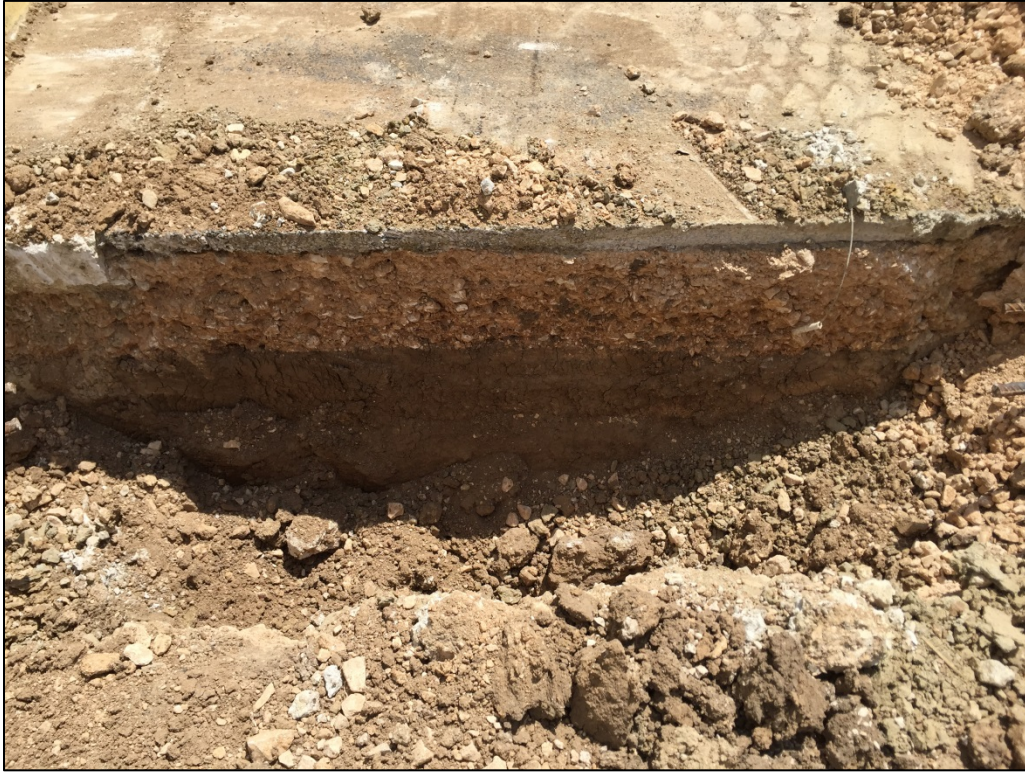
Wall 2 is on both the east and southeast sides of the existing building. Archaeologists observed trench excavation associated with pier installation for this wall. Trenches contained a compact top layer of light brown sandy clay with dense limestone cobbles (caliche fill) that extended from below the asphalt at ground surface to 30-47 cm below ground surface. Below this layer, soils exhibited some variation, showing soil disturbance and fill. Soils underlying the caliche layer in the northernmost trenches consisted of dark yellowish brown silty clay loam to about 80 cm below ground surface (Figure 7). Soil underlying the caliche layer in the more southern trenches was a light gray sandy clay with limestone cobbles to a depth of approximately 90 cm below ground surface (Figure 8). Both these soils are not consistent with the soils mapped for the area and represent fill episodes.

Further evidence of disturbance was observed in the southernmost trench, which is closest to the building's southeast side. In this trench, soils below the caliche layer consisted of a dark grayish brown sandy clay to about 73 cm below ground surface and a very pale brown sand to about 1 m below ground surface. Below these layers was a concrete slab reinforced with rebar (Figure 9). Given that this trench was just over 1.5 feet (0.5 m) northeast of the existing wall of the building, it is likely that the reinforced concrete is associated with the construction of building 652. In addition, the project manager mentioned that another building and storage tanks were present in the area in the past. Although the aerial photographs reviewed do not show another building in this area, a structure predating 1955 could have

Figure 7 Trench 15 profile (Wall 2) facing east

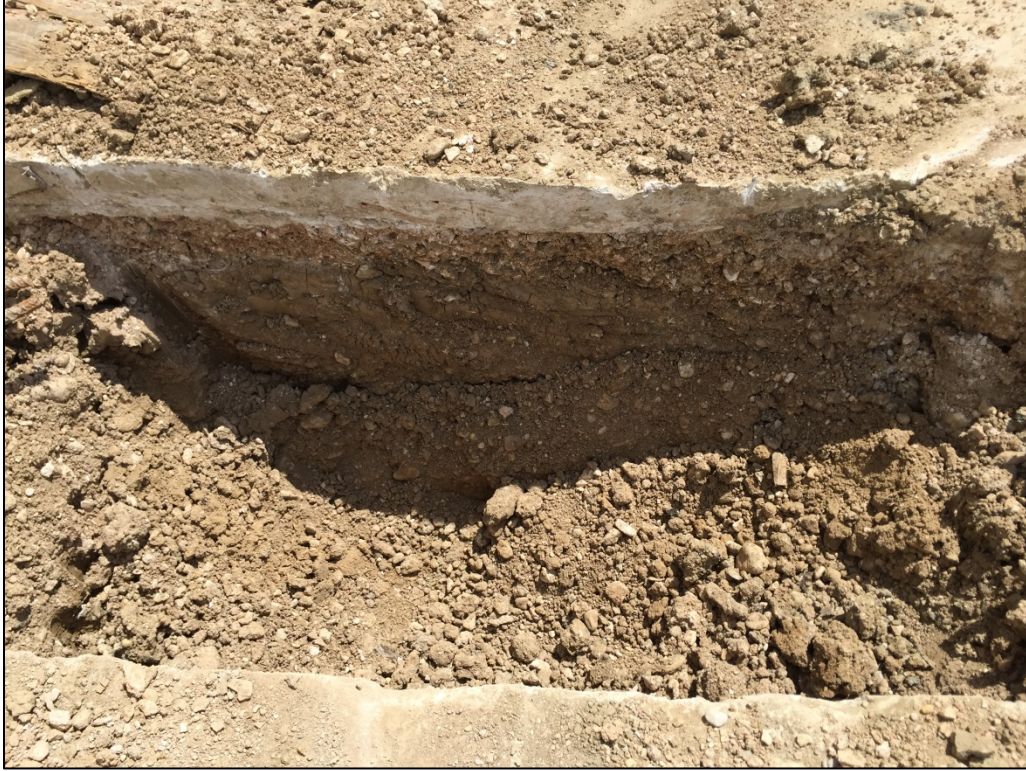
Figure 8 Trench 9 profile (Wall 2) facing east

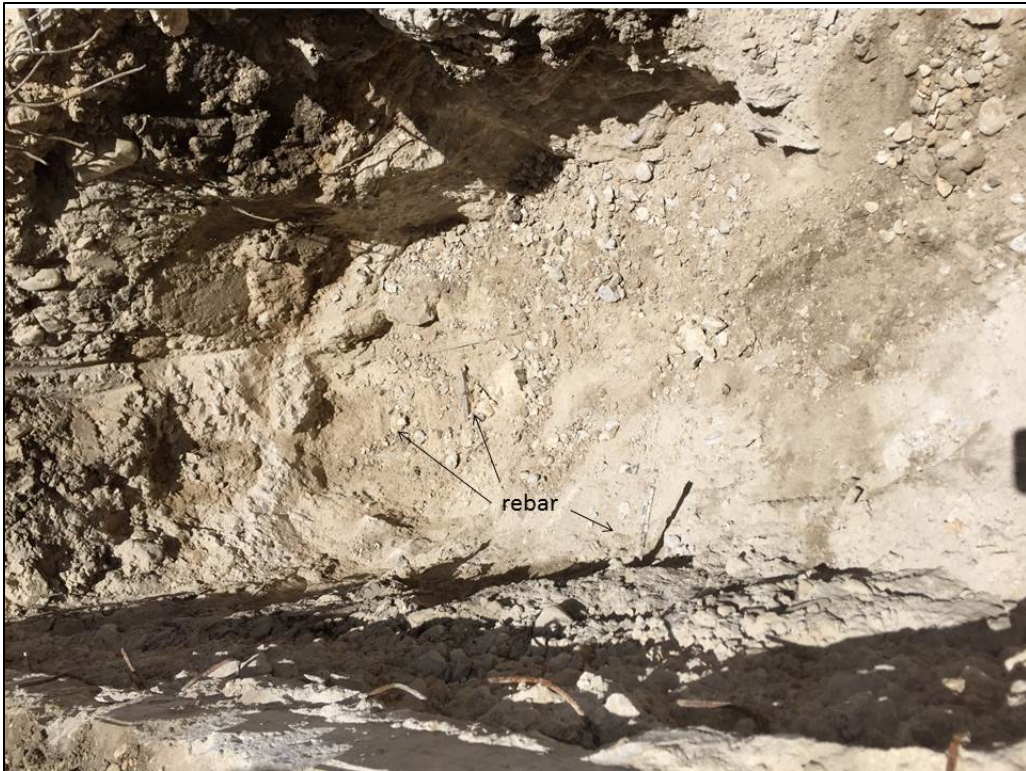
Figure 9 Rebar in trench closest to the building

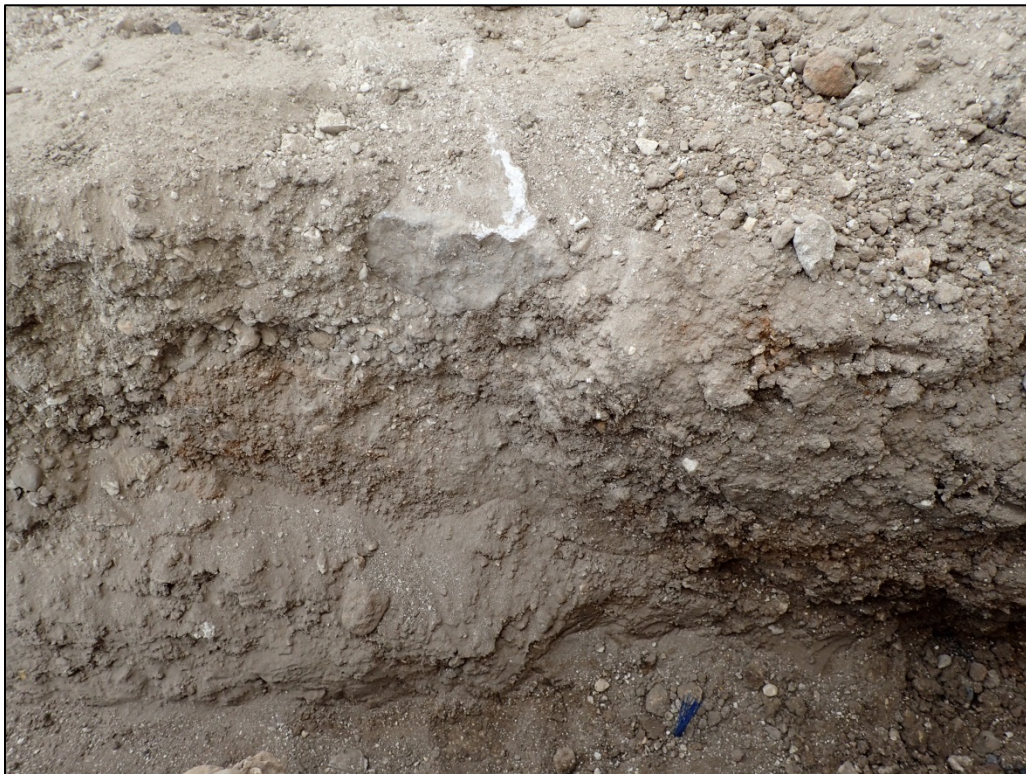
The foundation trenches for Wall 3, located along the southwest side of the building, had already been excavated before Pape-Dawson archaeologists were called to monitor. While piers had already been drilled and installed, archaeologists were able to observe the soil profiles in the trenches that connected the piers (Figure 10). Soils consisted of a dark yellowish brown clay loam with 50-75% small limestone gravels that extended anywhere from 0-80 cm below ground surface, but in some areas were capped by a compact caliche-based fill (Figure 11). This fill layer varied from 0-50 cm below ground surface. The gravels in the clay loam were mixed with chunks of asphalt down to 80 cm below ground surface, showing the soils had been disturbed; although this disturbance could have been associated with the current wall construction efforts. Archaeologists did not observe any cultural materials or deposits in association with these trenches.

Figure 10: Typical trench profile for Wall 3 facing west

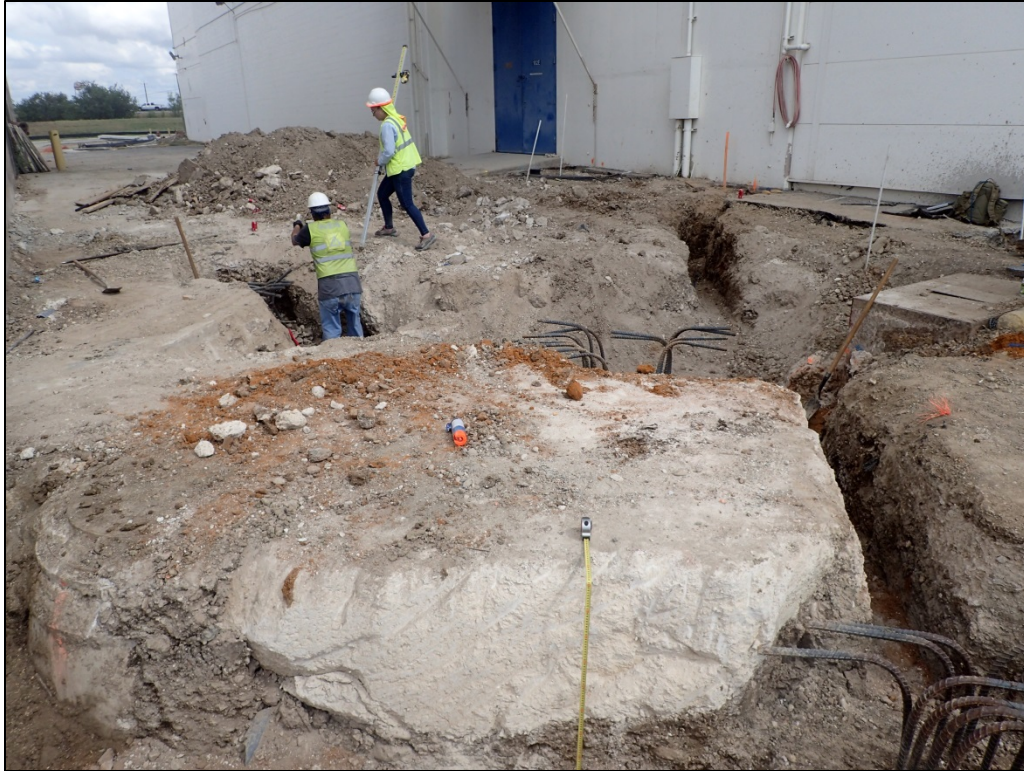
Figure 11 Overview of Wall 3 and utility trenches showing caliche layer facing north
