Cultural Resources Survey for the Eden Road Realignment Project, City of Arlington, Tarrant County, Texas

CULTURAL RESOURCES REPORT

Prepared for:
Texas Historical Commission
Texas Antiquities Permit #8398

Cultural Resources Report
August 2018

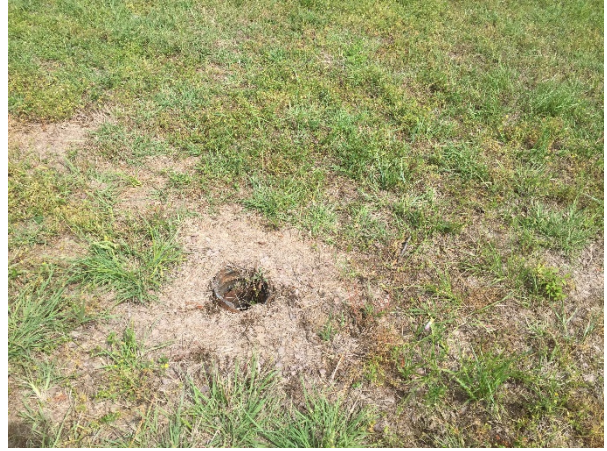
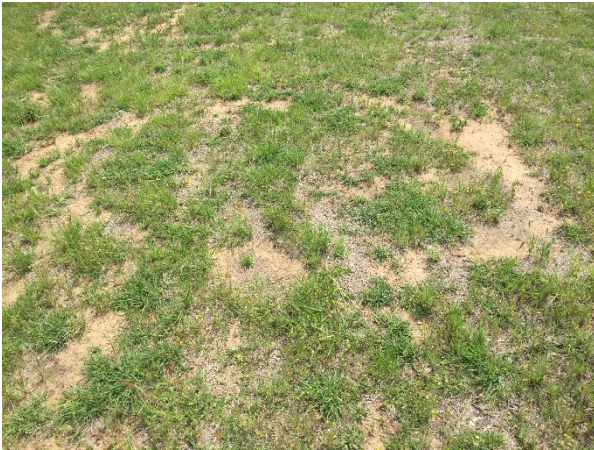
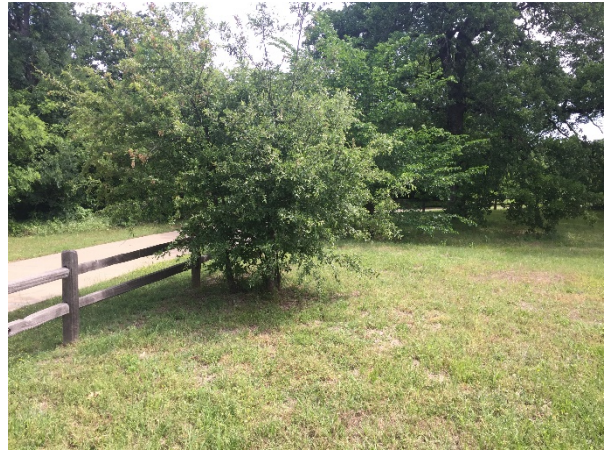
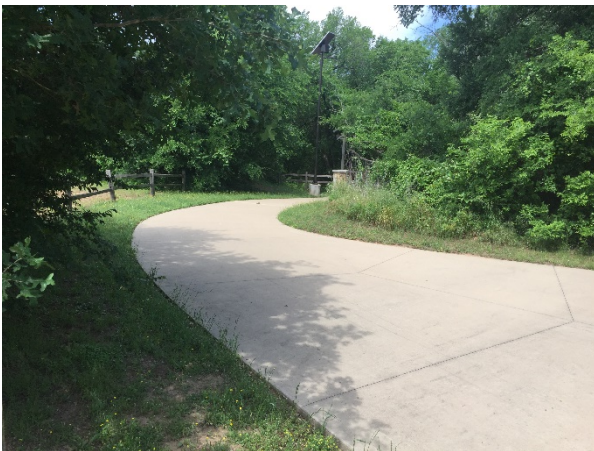
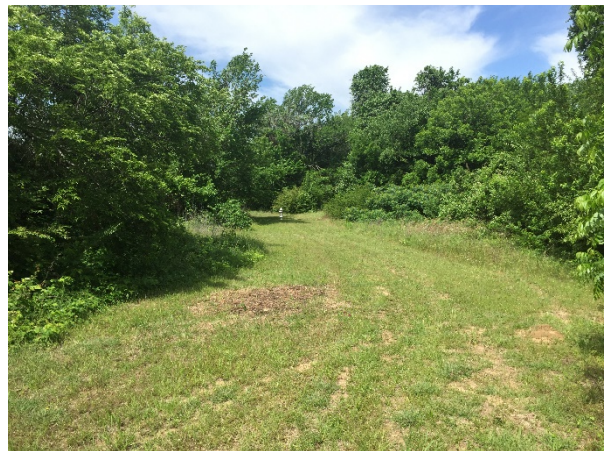
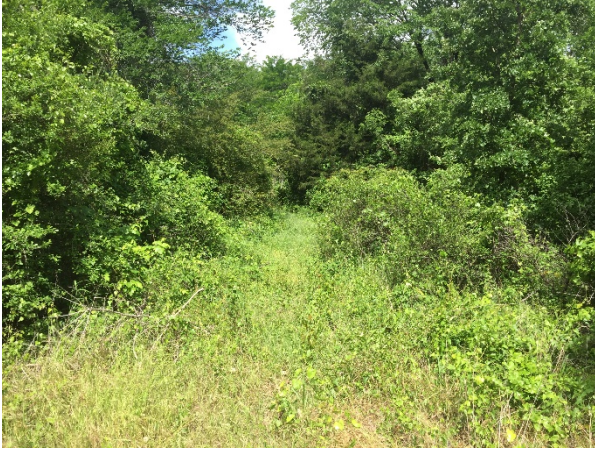
During the background review conducted for this project, it appeared that the portions of the APE west of Ridge Estates Court had avoided significant previous ground-disturbing activities, and these portions of the APE had retained a reasonable context. The majority of the overall APE occupies the existing ROW of Eden and Curry roads (**Appendix A, Photographs 1 through 20**). The existing roadways are paralleled by drainage ditches and well-maintained grass cover. Commercial and residential developments line Curry Road. The western 0.5 mile of the APE expands beyond the existing ROW to include open and wooded undeveloped land (**Appendix A, Photographs 21 through 40**). A sewer line was constructed through this portion of the APE, and a trail system associated with the adjacent Sublett Creek Linear Park was constructed adjacent to the northern boundary of the APE (**Appendix A, Photographs 32 through 37**).
