Archeological Survey Report Farm-to-Market Road 549 Improvements Project

Farm-to-Market Road 549 Improvements Project From: State Highway 276 To: State Highway 205 CSJ: 1015-01-024 Rockwall County, Texas February 2019

Prepared by: Integrated Environmental Solutions, LLC Christopher Goodmaster, Principal Investigator (972) 562-7672; cgoodmaster@intenvsol.com

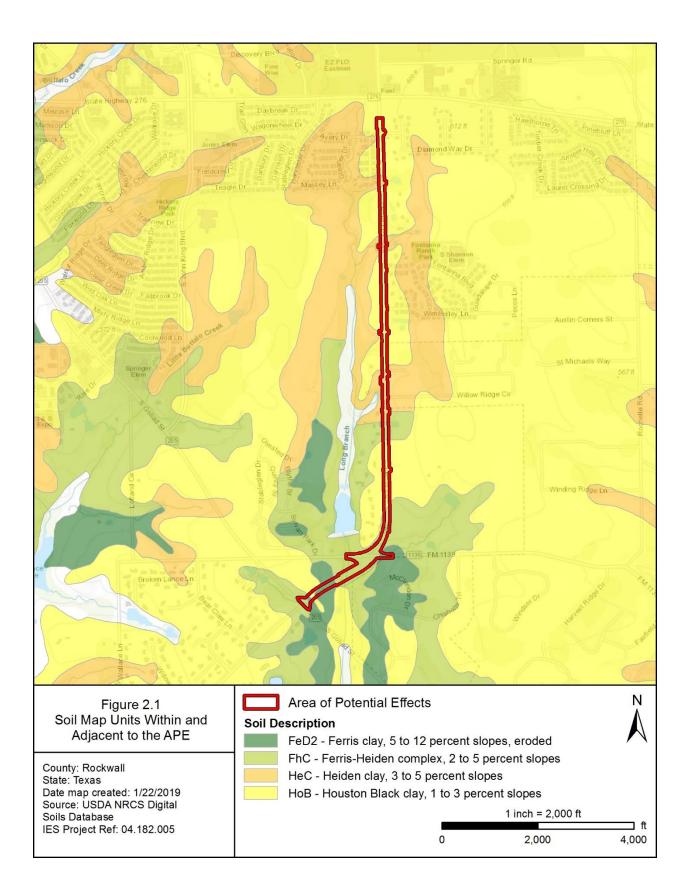
The *Soil Survey of Kaufman and Rockwall Counties, Texas* (Pringle 1977) indicates that there are four soil map units within the APE (**Table 2.1**; **Figure 2.1**). The entire APE contains soils typical of upland settings within the Northern Blackland Prairie region. Soil data were reviewed from the U.S. Department of Agriculture (USDA) Natural Resources Conservation Service (NRCS) Web Soil Survey (Web Soil Survey 2018).

Soil Map Unit Description		
Fed2 - Ferris clay, 5 to 12 percent slopes, eroded - This component is described as clay located on ridges. Depth to bedrock is 39 to 60 in. The natural drainage class is well drained.	5.7	
FhC - Ferris-Heiden complex, 2 to 5 percent slopes - This component is described as clay located on ridges. Depth to bedrock is 39 to 60 in. The natural drainage class is well drained.	25.5	
HeC - Heiden clay, 3 to 5 percent slopes - This component is described as clay located on ridges. Depth to regolith is 40 to 65 in. The natural drainage class is well drained.	14.5	
HoB - Houston Black clay, 1 to 3 percent slopes - This component is described as clay located on ridges. Depth to a root restrictive layer or bedrock is more than 80 in. The natural drainage class is moderately well drained.	54.4

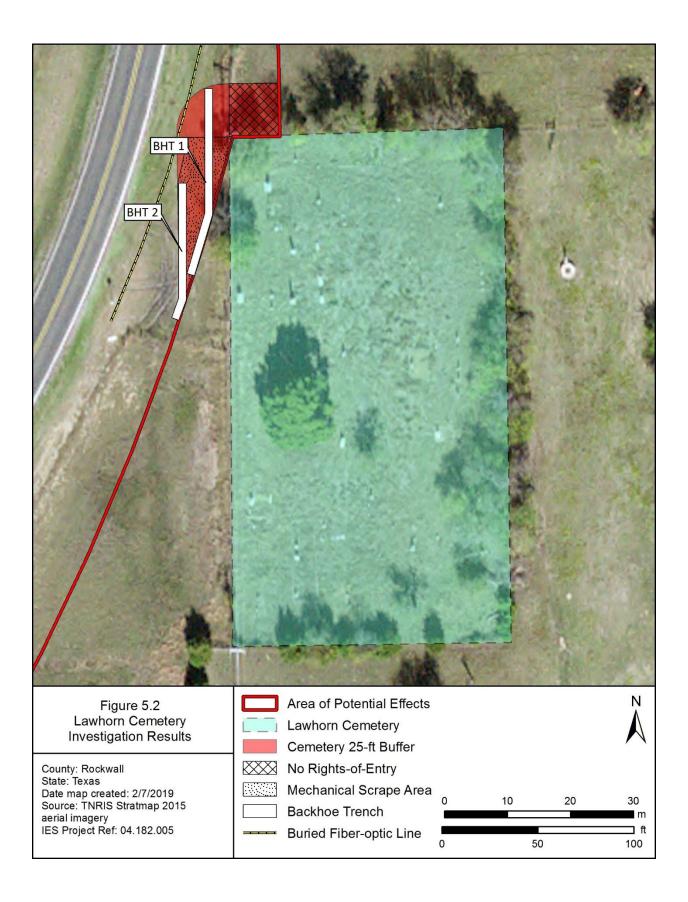
In total, 50.5 m (165.7 ft) of trenches were mechanically excavated within the portion of the APE adjacent to the Lawhorn Cemetery. The upper 50 cm of each trench exhibited the dense construction fill initially encountered during the mechanical scraping effort (Table 5.1). The construction fill was comprised of sand, gravel, asphalt fragments, and modern refuse including plastic bottles, modern tires, and modern lumber. Within the northern portion of BHT 1, light yellowish brown (10YR 6/4) roadway cushion sand was encountered at a depth of 38 to 50 cm below surface (cmbs) and a 4-in-diameter brass TxDOT survey monument set in concrete was encountered at 45 cmbs (Appendix A, Photographs 20 and 21). By a depth of 50 cmbs, the soil profiles exposed within both trenches transitioned to relatively undisturbed very dark gray to dark gray (10YR 3/1 to 4/1) clay that gradually transitioned to gravish brown (10YR 5/2) silty clay between 80 and 100 cmbs. Within BHT 1, a 2-in-diameter steel pipe related to a decommissioned rural water supply line was encountered at a depth of 110 cmbs (Appendix A, Photographs 22 and 23). The steel pipe occupied a 16-in-wide trench and extended for approximately 29 ft (8.8 m) generally paralleling BHT 1. In addition, a 2-in-diameter polyvinyl chloride (PVC) decommissioned water supply line pipe was encountered within BHT 1 at a depth of 130 cmbs. The PVC pipe occupied a 4-in-wide trench and extended for approximately 34 ft (10.4 m) along BHT 1, generally paralleling the steel pipe (Appendix A, Photographs 24 and 25). Gravish brown (10YR 5/2) massive clay or silty clay subsoil was encountered within both trenches by depths of 100 to 120 cmbs. Within BHT 1, white chalky limestone regolith was encountered in southern portion of trench at a depth of 220

cmbs. BHT 2 was terminated at a depth of 200 cmbs when light gray (10YR 7/2) massive clay was encountered (see **Table 5.1**).

The current boundary of the Lawhorn Cemetery does not appear to have changed since the early 1940s, based on a review of historical aerial photography. The uppermost 50 cm of the area investigated adjacent to the cemetery contained recent construction fill as a result of the use of the area for construction staging during the 2017 roadway maintenance and culvert replacement project. In addition, two rural water supply pipelines were previously placed parallel to the western cemetery boundary. No human remains, evidence of grave shafts, grave monuments, or coffin-related hardware were encountered within the portion of the APE investigated adjacent to the Lawhorn Cemetery.

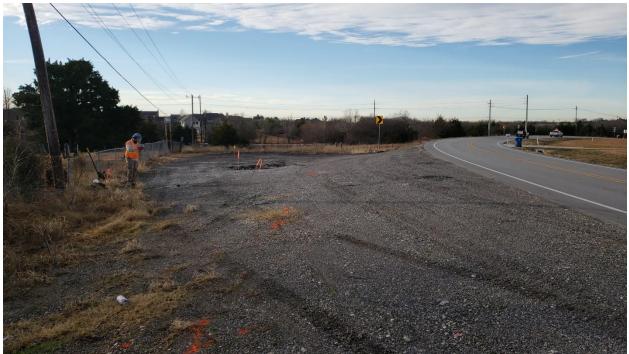
Photograph 17 – Mechanical scraping area adjacent to APE, view to the south.

Mechanical scraping was initiated within the existing and proposed new ROW near the northwest cemetery corner to ascertain the presence of unmarked graves. Dense construction fill, comprised of gravel, asphalt, concrete, and other modern refuse, was encountered across all of the 25-ft cemetery buffer area within the APE. Due to the large volume of modern fill present, coupled with the limited area within the APE in which to stockpile the excavated material, mechanical scraping efforts ceased in favor of backhoe trenching. Two backhoe trenches were excavated within the 25-ft cemetery buffer area (see **Figure 5.2**). Backhoe Trench (BHT) 1 was excavated within the proposed new ROW portion of the APE parallel to the western cemetery boundary. BHT 1 was placed in a generally north-to-south orientation approximately 2.5 m (8.2 ft) west of the existing cemetery fence. During excavated generally parallel to BHT 1 approximately 6.5 m (21.3 ft) west of the cemetery fence and within the existing FM 549 ROW. The presence of a buried fiber optic line paralleling the roadway limited the northern extent of BHT 2.

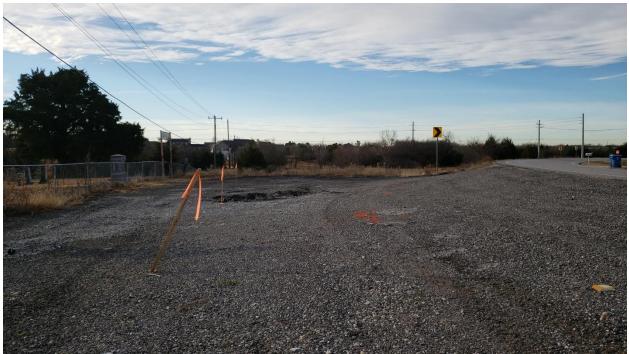
Photograph 18 - Mechanical scraping area adjacent to APE, view to the south.

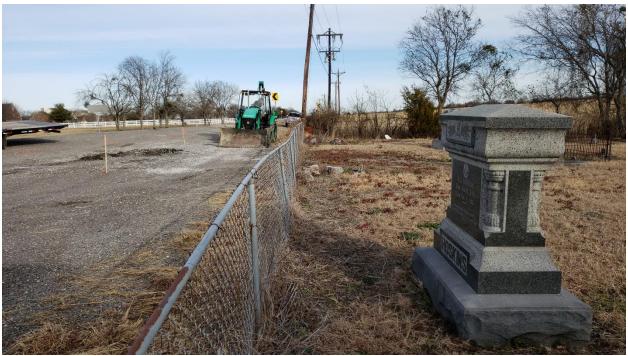
Photograph 19 - Mechanical scraping area adjacent to APE, view to the north.

The area immediately north of the currently fenced cemetery boundary was not accessible during the mechanical excavation due to an overhead electrical utility pole and associated guy lines located immediately adjacent to the northwestern corner of the cemetery, as well as a barbed wire fence separating the adjacent pasture from the proposed new ROW. Therefore, mechanical excavation efforts focused on the portion of proposed new ROW and existing ROW west of the current cemetery boundary (**Appendix A**, **Photographs 17** and **18**). The existing cemetery fence is approximately 6 m (20 ft) east of the existing FM 549 ROW limits at its closest point, which occurs at the northwestern corner of the cemetery (**Figure 5.2**). A portion of the proposed new ROW will be adjacent to the northwestern cemetery corner and will increase to approximately 30 m (98 ft) as the FM 549 alignment turns to the west approaching the intersection with FM 1139. Within the Lawhorn Cemetery, an uninscribed headstone fragment and socketed pedestal base was observed approximately 1.67 m (5.5 ft) east of the existing cemetery fence and the H. C. Hoskins family monument was observed approximately 1.98 m (6.5 ft) east of the fence (**Appendix A**, **Photograph 19**).

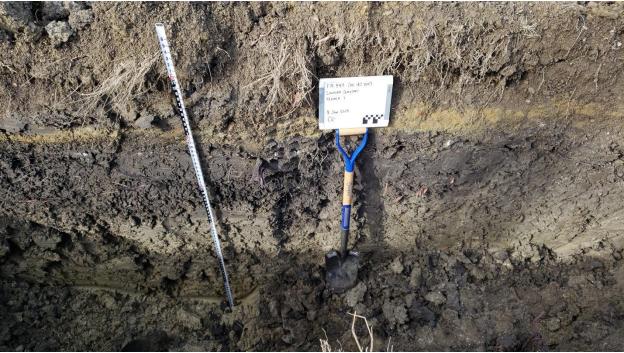
Photograph 20 – BHT 1 soil profile, view to the west.

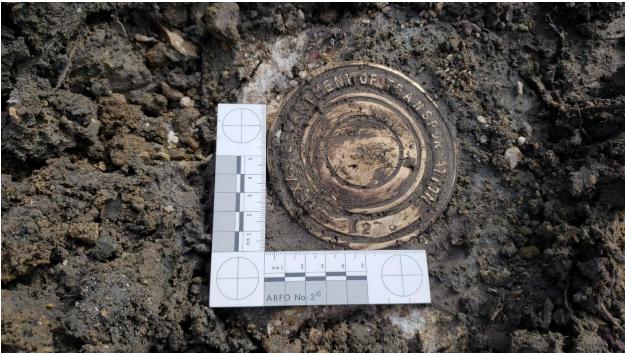
Photograph 21 – TxDOT survey monument encountered at 45 cmbs within BHT 1.

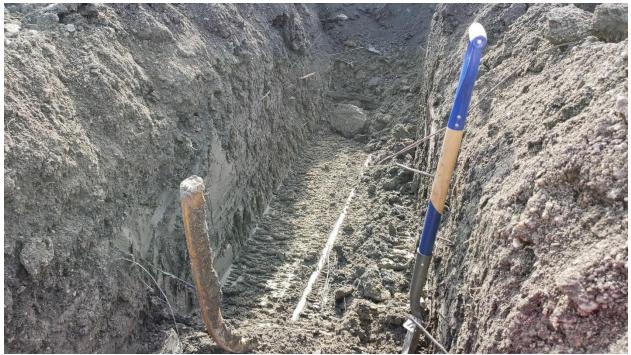
Photograph 22 – Two-inch steel rural water supply line encountered at 110 cmbs in BHT 1, view to the south.

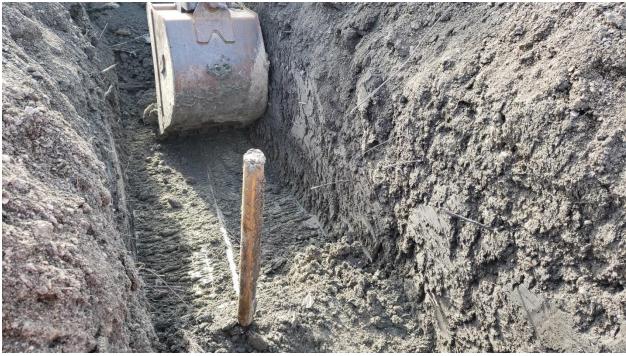
Photograph 23 - Two-inch steel rural water supply line encountered at 110 cmbs in BHT 1, view to the south.

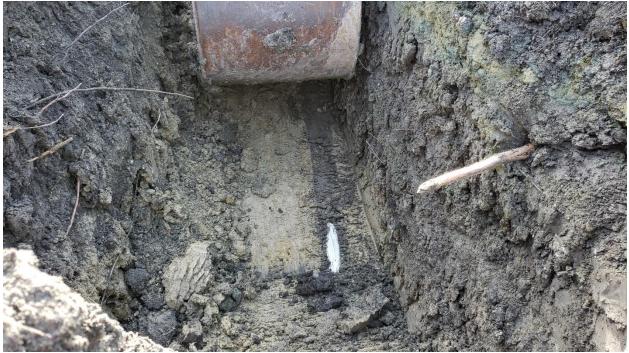
Photograph 24 - Two-inch PVC rural water supply line encountered at 130 cmbs in BHT 1, view to the south.

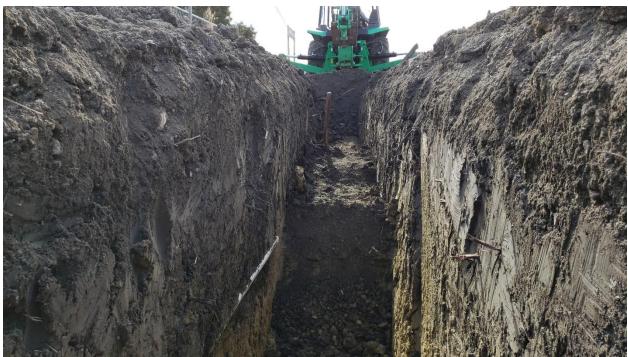
Photograph 25 – Parallel steel and PVC rural water supply lines within BHT 1, view to the south.
