**LABORATORY AND FIELD EVALUATIONS OF
EXTERNAL SULFATE ATTACK**

Dissertation

the University of Texas at Austin

December 2007

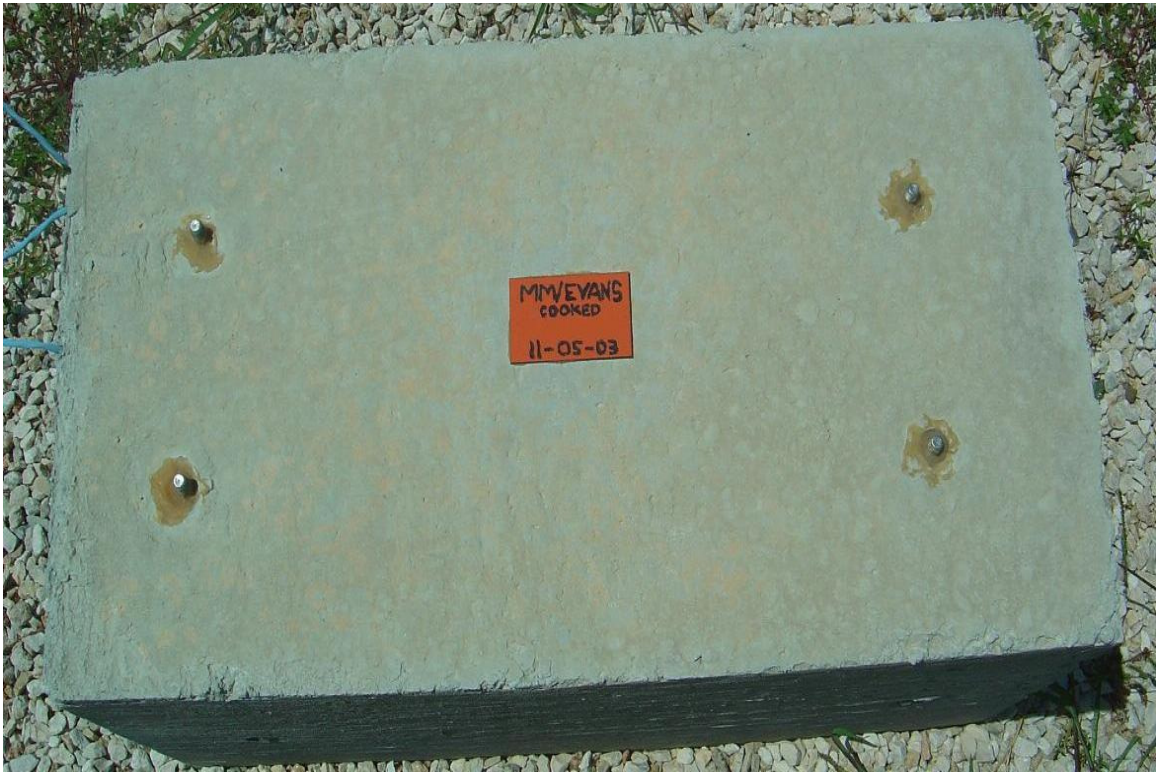
Figure 2-1: Exposure block containing non-reactive aggregates and heat cured up to 183 °F (83 °C), showing no signs of distress after 3 years

blocks are the same age. The block in Figure 2-1 contains a non-reactive sand and non-reactive coarse aggregate (with regard to ASR), while the block in Figure 2-2 contains a highly-reactive sand with the same non-reactive coarse aggregate as used in the block in Figure 2-1. The heat-treated block with reactive aggregate (Figure 2-2) shows considerably more cracking than the heat-treated block with non-reactive aggregates in Figure 2-1. A non-heat-treated block containing the same highly-reactive aggregate (Figure 2-3) has shown considerable cracking, but nowhere near as much cracking as the heat-treated block shown in Figure 2-2, highlighting the synergy in distress triggered by ASR plus DEF (Drimalas 2004).

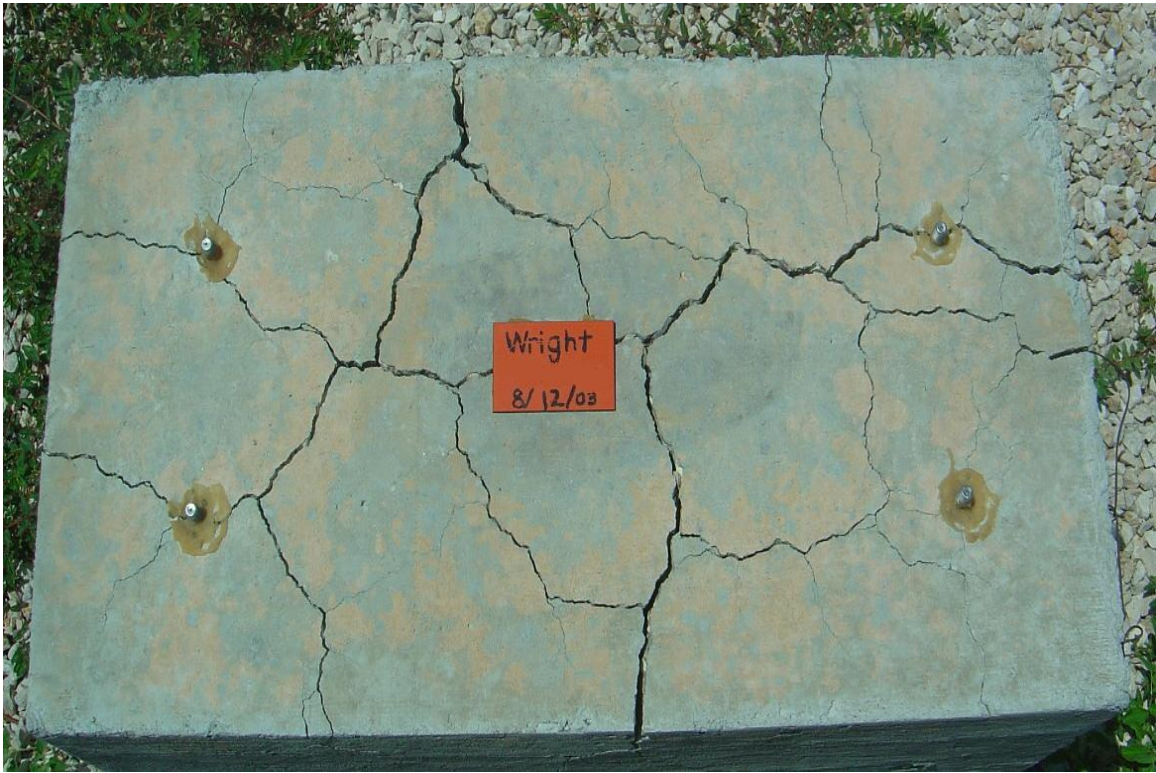
Figure 2-2: Exposure block containing highly-reactive aggregate and heat-cured up to 183 °F (83 °C), showing signs of significant cracking after 3 years

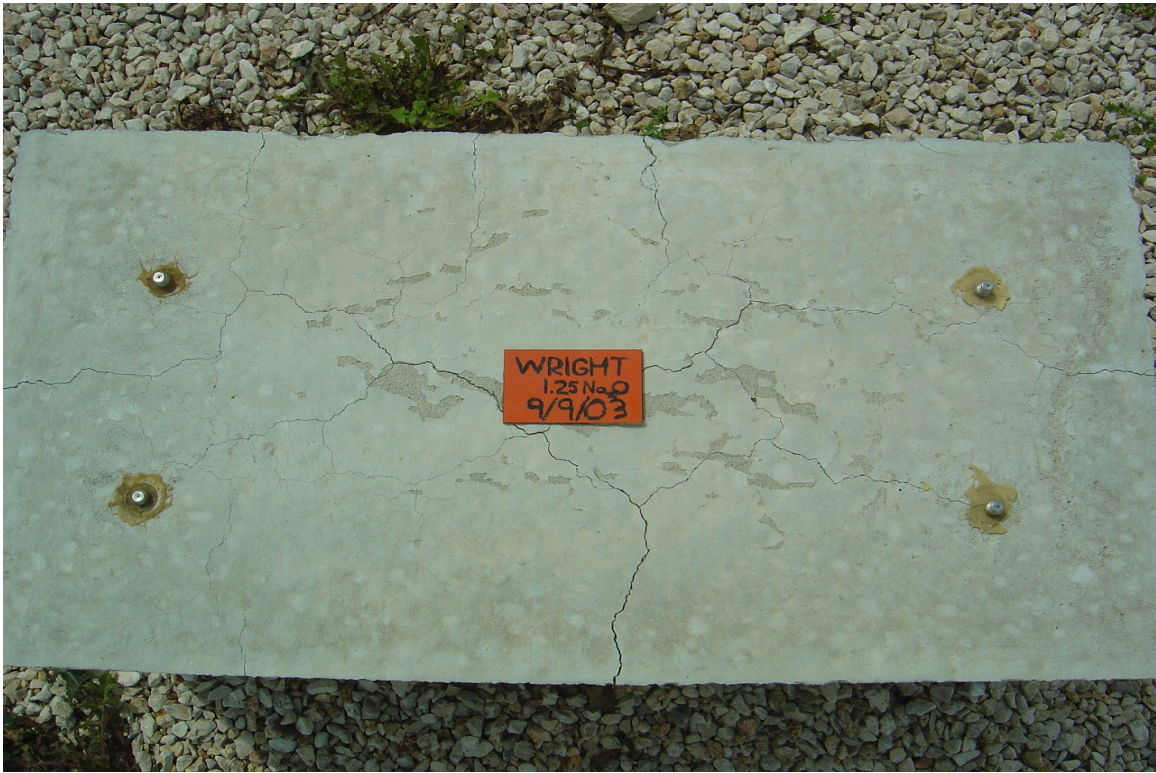
Figure 2-3: Exposure block containing highly-reactive aggregate showing less cracking after 3 years

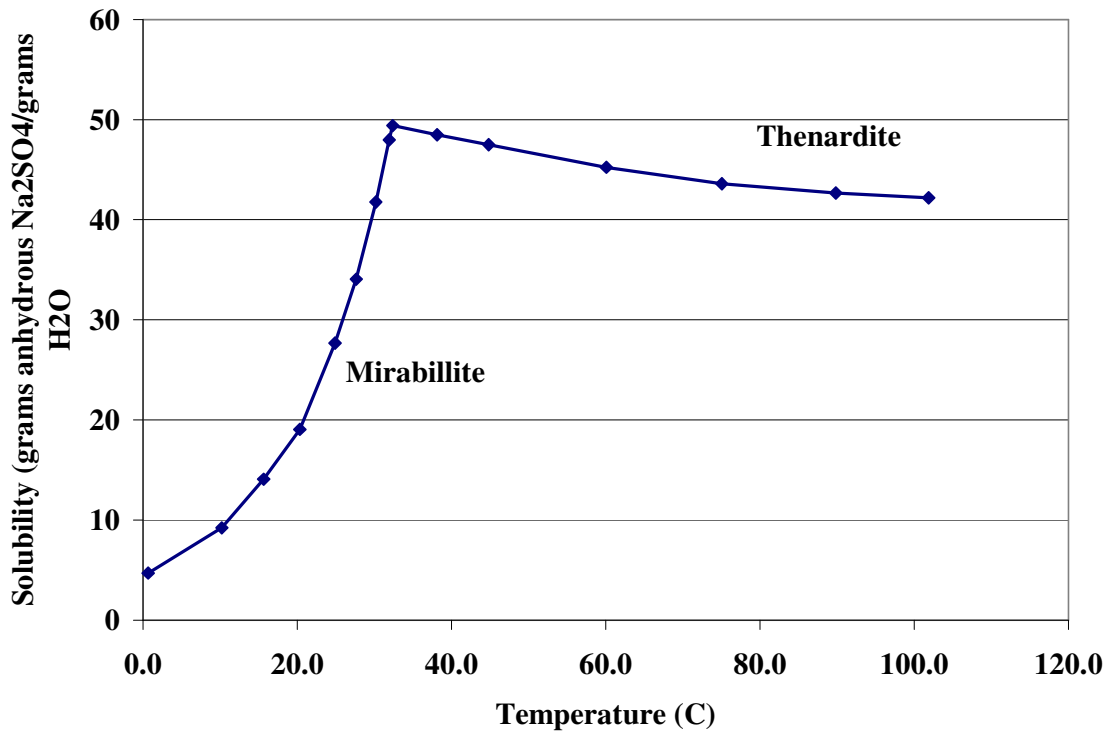
Figure 2-4: Solubility curve for sodium sulfate /water system (Berkeley 1904)

In the early 1990's, Folliard and Sandberg (1994) proposed that crystallization of sodium sulfate within concrete, triggered by temperature changes, was the predominant cause of distress due to physical salt or sulfate attack. Figure 2-4 shows the solubility curve for sodium sulfate, which shows the change between thenardite and mirabilite at approximately 91 °F (33 °C). After cycling concrete specimens in 30% sodium sulfate solution from 41° to 86 °F (5° to 30 °C), substantial mass loss occurred in the samples. X-ray diffraction on these samples did not show any sign of ettringite formation or any other deleterious product from chemical attack. In parallel tests, it was shown that the total volume of the sodium sulfate/water solution increased by approximately 3 % as crystallization was triggered upon a temperature drop. In essence, this type of distress is similar to freeze-thaw distress in that physical distress is triggered by a volume change of the water or solution inside concrete. Samples cycled from 95° to 230 °F (35° to 110 °C) did not show any weight loss and the majority of these samples gained weight (Sandberg and Folliard 2004), confirming that the distress only occurs when temperatures drop below about 91 °F (33 °C) and when a high concentration of sodium sulfate is present in the pores of concrete.

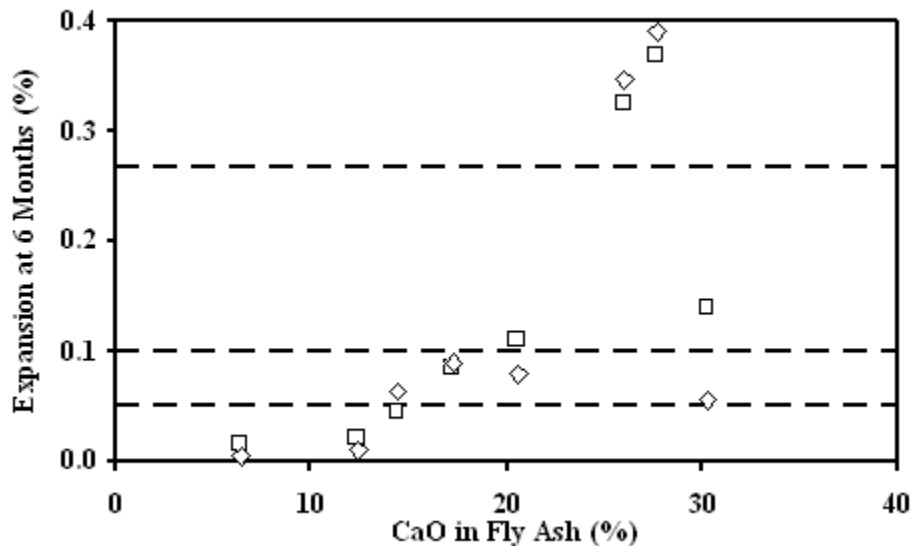
Figure 2-5: Relationship between C₃A content in fly ash to 6 month expansion in ASTM C 1012 testing (Shashiprakash and Thomas 2001)

Figure 2-5 shows the strong relationship between the CaO content of the fly ash and the expansion at six months in ASTM C 1012 testing. More research is needed to better differentiate the behavior of different high-lime ashes; using CaO as an index of potential expansion may not hold for all fly ashes.

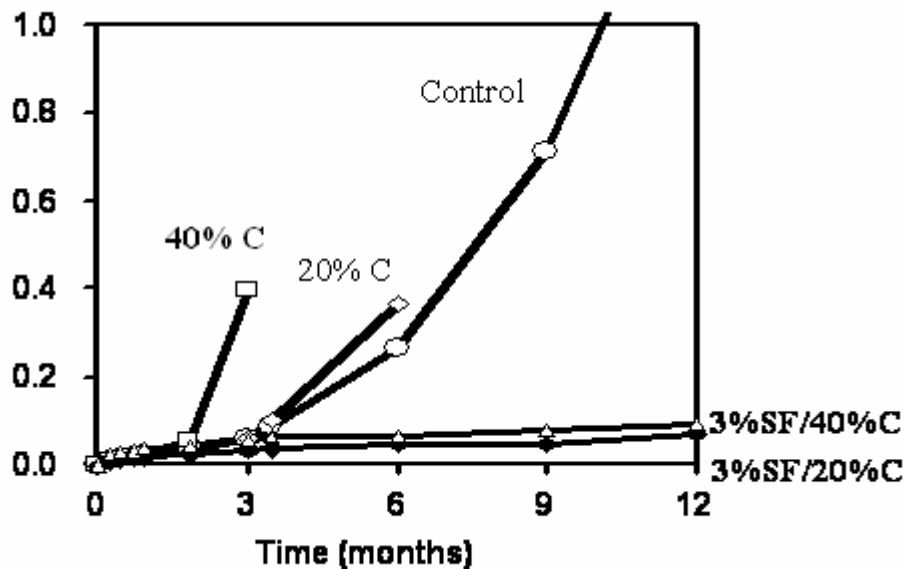
Figure 2-6: The effect of ternary blends with silica fume and Class C fly ash on expansion of mortars compared to mortars using only Class C fly ash (Shashiprakash and Thomas 2001)

In addition to linking the mineralogy and chemistry of fly ashes to sulfate resistance, Shashiprakash and Thomas (2001) also performed significant research on combining high-CaO ashes with silica fume, with emphasis on mixtures with between 3 and 6% percent silica fume (by mass of total cementitious materials). Figure 2-6 shows the effects of just a small dosage of silica fume (3%) on the sulfate resistance of concrete with a high-calcium fly ash.

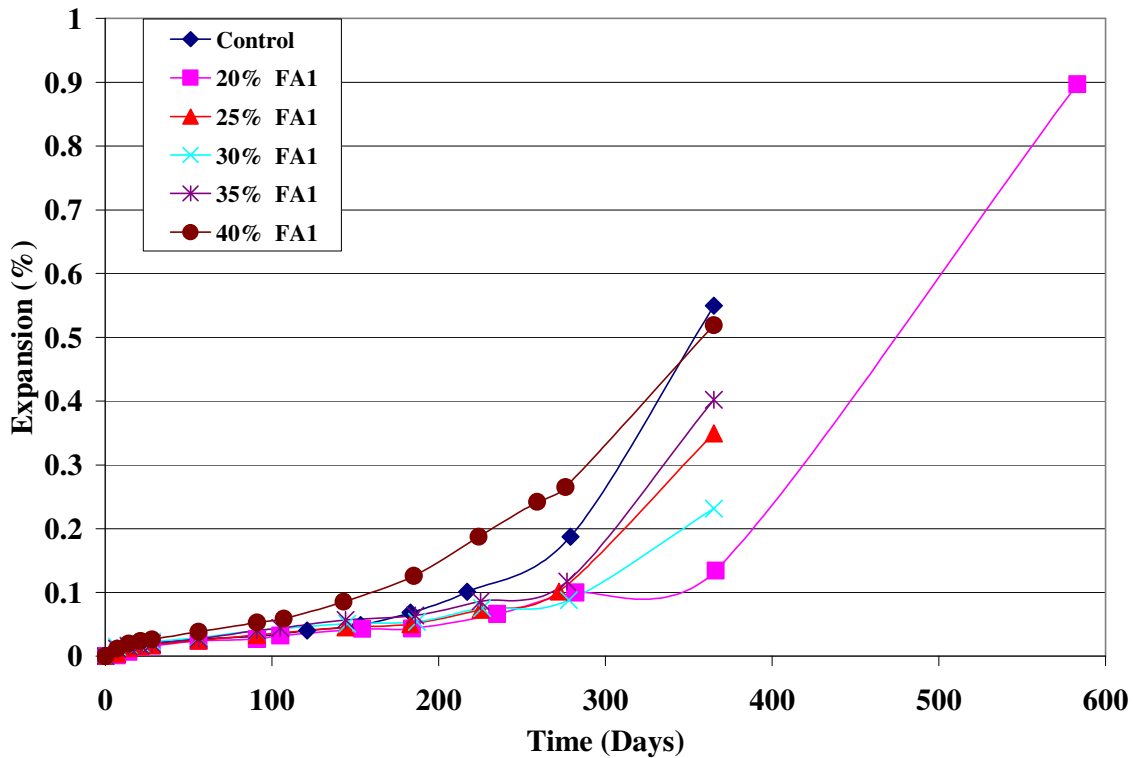
Figure 3-1: Expansions of FA1 at different replacement dosages

Figure 3-1 shows the behavior of mortar containing fly ash FA1. This mixture begins to expand earlier than the control, and the onset of expansion occurs earlier as the dosage of fly ash is increased. Only the mixture containing 20% FA1 (by mass replacement of portland cement) was intact at the end of the 18 month test; all other mixtures with higher dosages of FA1 deteriorated prior to this time and subsequent measurements were not possible. The increased storage duration of the mortar bars for 18 months shows that 20% FA1 lasts for that period unlike the other replacements; however, it has the highest ultimate expansion compared to the other replacement levels at one year. Increasing the dosage of FA1 tended to increase the expansions. In fact, the mixture containing 40% FA1 “failed” the aforementioned 0.1% expansion limit at 6 months. The increasing replacement dosages of Class C fly ash deteriorated the mortar bars at faster rates due to greater amounts of reactive phases placed into the system. Similar findings by Tikalsky and Carrasquillo (1993) showed a decrease in sulfate resistance with Class C fly ash.

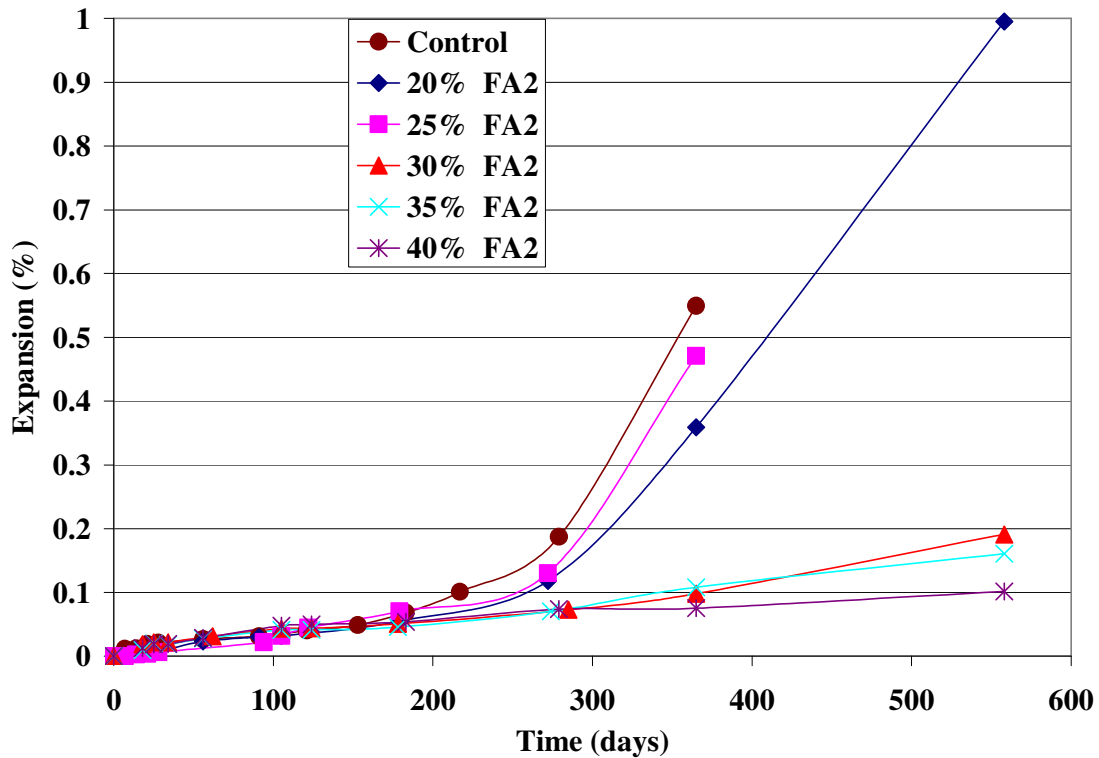
Figure 3-2: Expansions of FA3 at different replacement dosages

All but one of the other Class C fly ashes tested in this program performed similarly to FA1, with increasing fly ash dosages leading to increasing deterioration. The only exception was FA2, which had similar bulk chemistry to FA1, but performed quite differently in ASTM C 1012 testing, as shown in Figure 3-2. Increasing the dosage of FA2 did not result in an increase in expansion, and in fact, after six months, all of the mixtures containing FA2 showed exhibited expansions less than 0.1%. After one year, mixtures containing 20 and 25% FA2 expanded more than the nominal 0.1% expansion limit, mixtures containing 30 and 35% FA2 were approximately at this expansion limit, and the mixture containing 40% FA2 was below this expansion limit. After 18 months, all the mixtures containing FA2 expanded greater than 0.1%.

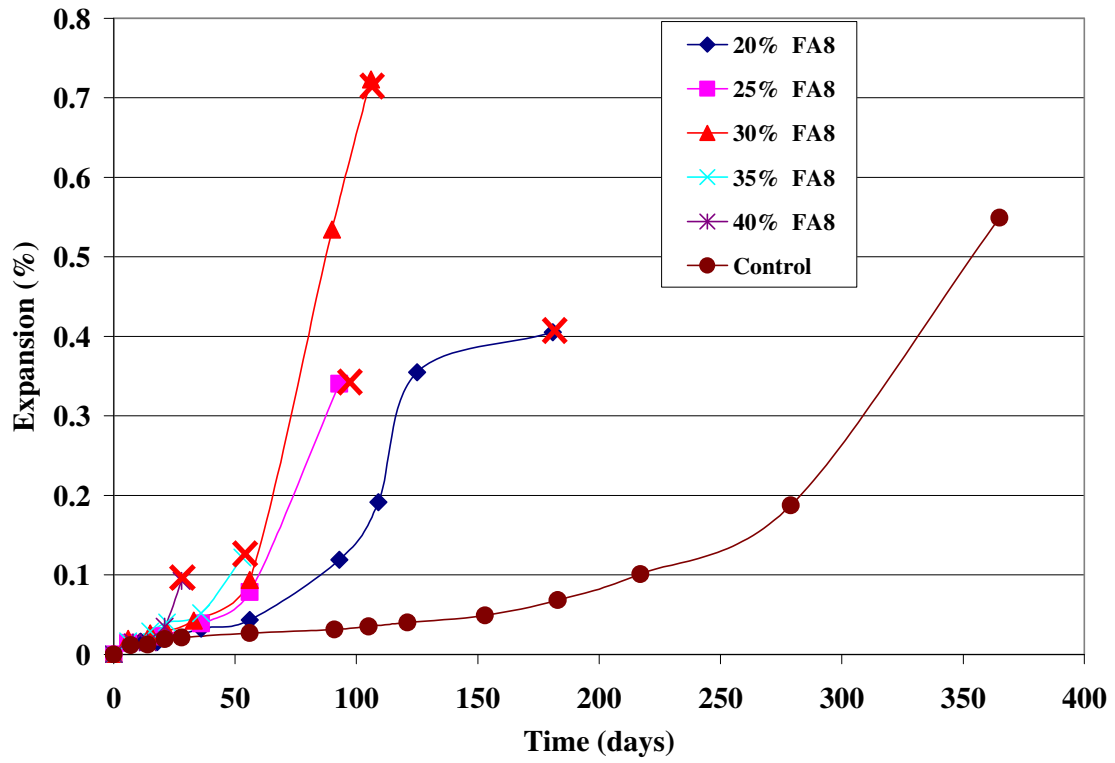
Figure 3-3: Expansion of FA8 fly ash at different replacements

failure to a level of expansion. Figure 3-3 illustrates the expansions observed for mortars containing FA8 in which deterioration occurred after minimal times exposed to sulfate solution and without actually passing the nominal 0.1% expansion threshold. Figure 3-4 shows a photograph of mortar bars containing 40% FA8 after only 56 days immersion in sodium sulfate solution in the ASTM C 1012 test. The bars have completely deteriorated, yet expansion was not detected prior to failure. The deterioration of mortar containing FA2 (as well as most of the other high-calcium ashes in this study) is also quite interesting as the mode of failure seems to change as the percent replacement of fly ash for portland cement increases. At lower replacement levels the bars would increase in expansion and break eventually; however at higher replacement levels the bars deteriorate so quickly that they would fail prior to significant expansion. Clearly, this creates yet another interesting challenge when using ASTM C 1012. The technical viability of using expansion limits when testing certain Class C fly ashes clearly comes into question here as the dramatic deterioration occurs without measured increases in expansion. More discussion on the mechanisms responsible for this behavior and the practical implications of such behavior is provided later in this chapter.

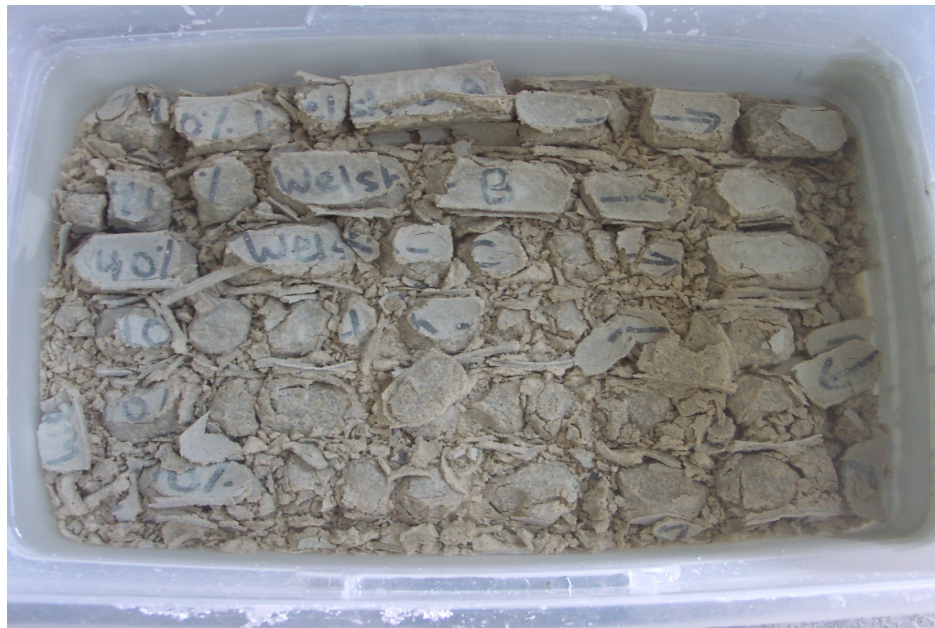
Figure 3-4: Mortar Mixture with 40% FA8 after 56 days in ASTM C 1012 testing

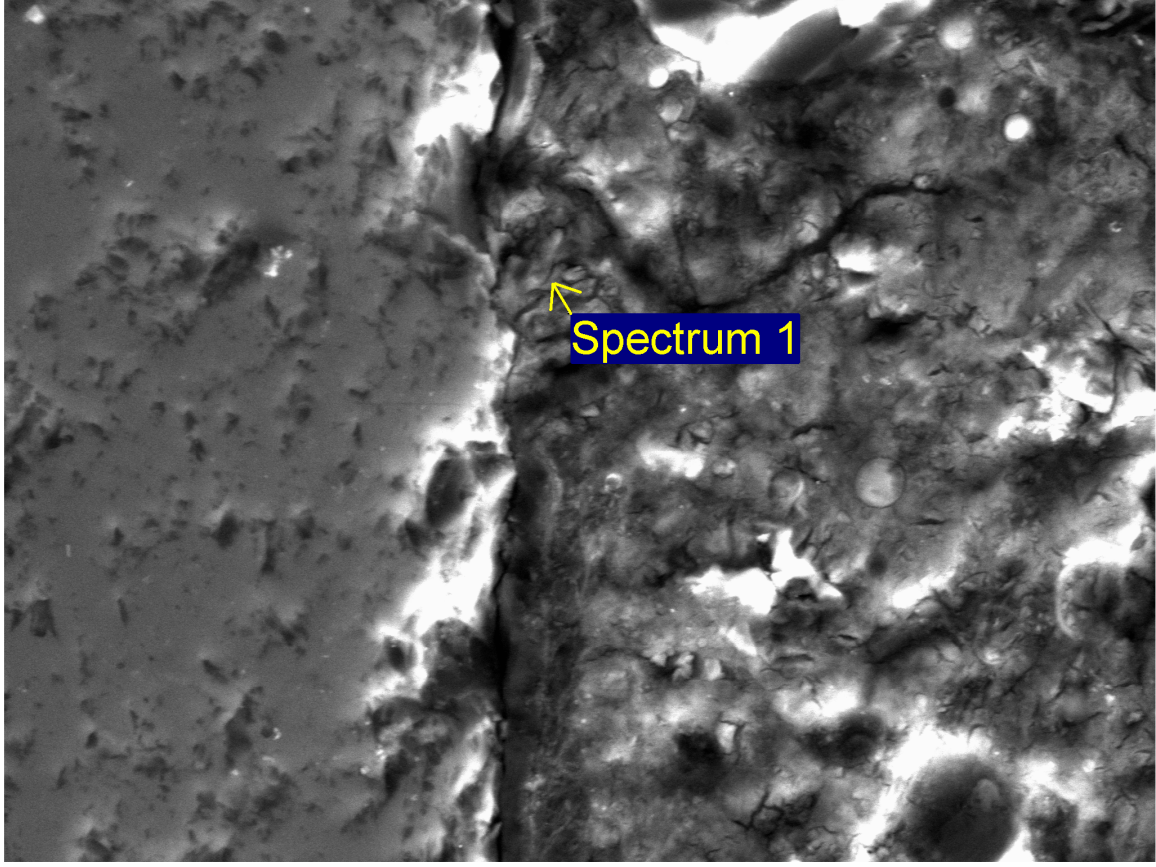
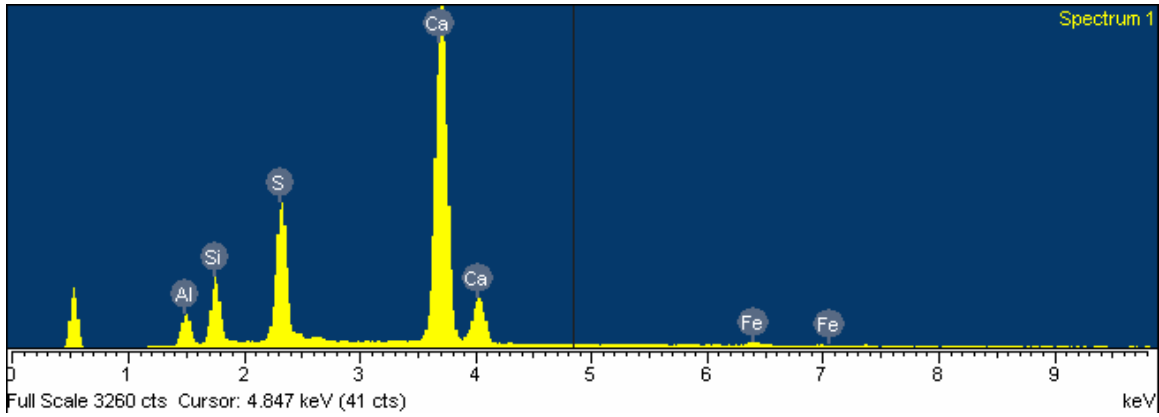
Figure 3-5: SEM image and EDS spectrum of 25% FA2 after 18 months storage in sodium sulfate solution showing ettringite pockets.

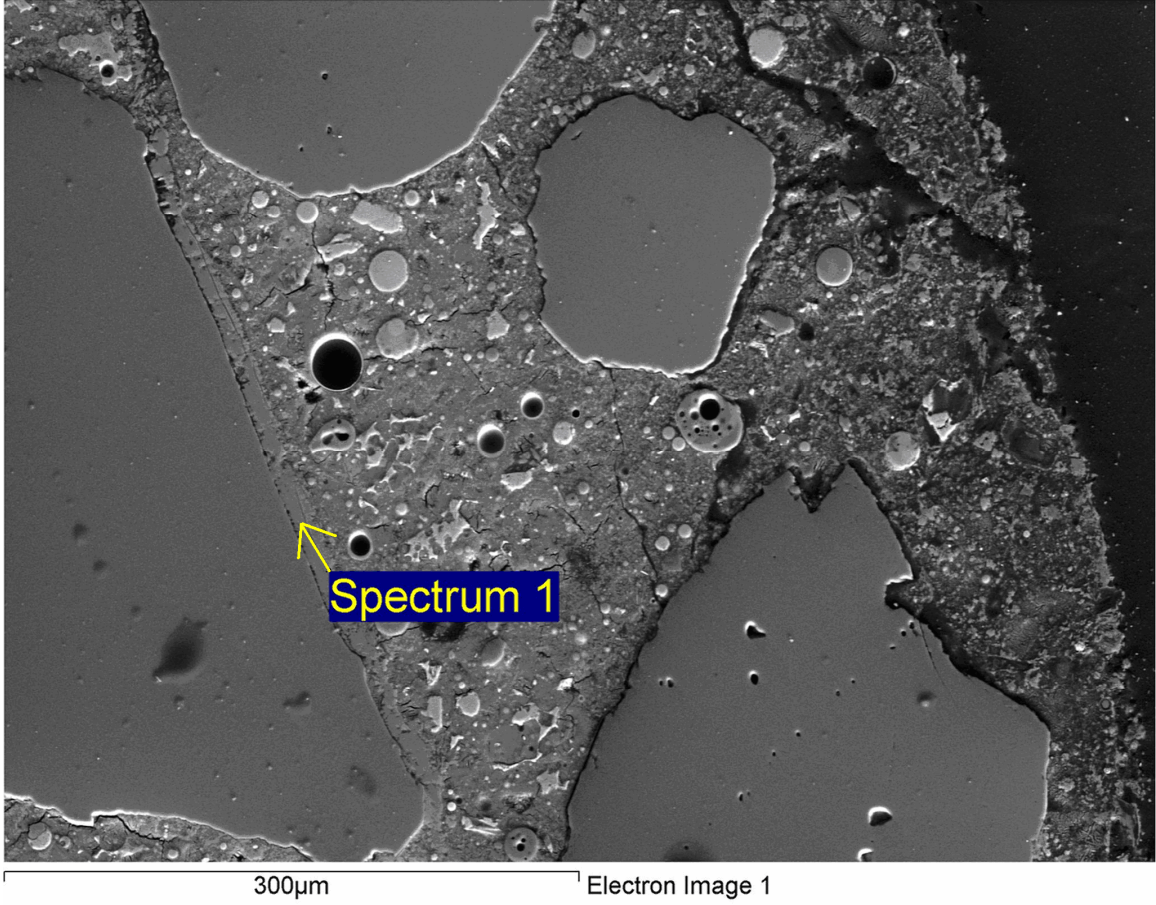
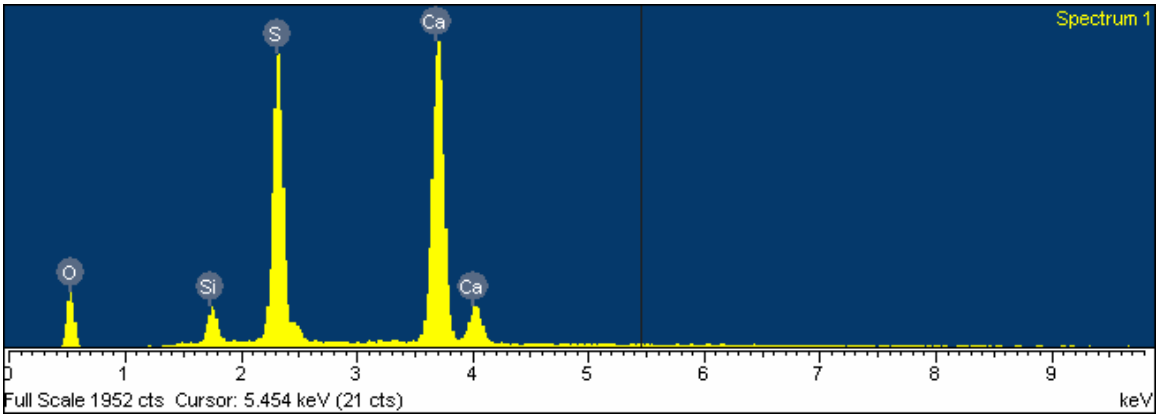
Figure 3-6: SEM image and EDS spectrum of 20% FA1 after 18 months of storage showing gypsum formation around aggregates

Comparing FA1 and FA2 at lower replacements, 20% FA2 had expanded early compared to 20% FA1 which expanded after 1 year. Figure 3-6 is a SEM image of 20% FA1 after 18 months of storage in sodium sulfate. There are many large bands of gypsum that surround many of the aggregates in the system. There was more gypsum observed around aggregates and very little ettringite was detected within the paste. The EDS spectrum shows large amounts of calcium (Ca) and sulfur (S), reflecting gypsum in the system. In parts of the mortar bars, it is evident that gypsum could be converting to ettringite. The late expansion of 20% FA1 is noticed from the conversion of gypsum to ettringite in the sample. At 20% FA1 replacement there is less reactive calcium aluminates than compared to 40% which may suggest attack is occurring more on the calcium hydroxide in the 20% FA1 mortar bars and could contribute to the later formation of ettringite from its conversion from gypsum. Figure 3-7 shows this possible conversion in an area of ettringite and gypsum formed in the same area. Gypsum and ettringite are in this same area as seen in the EDS spectrum.

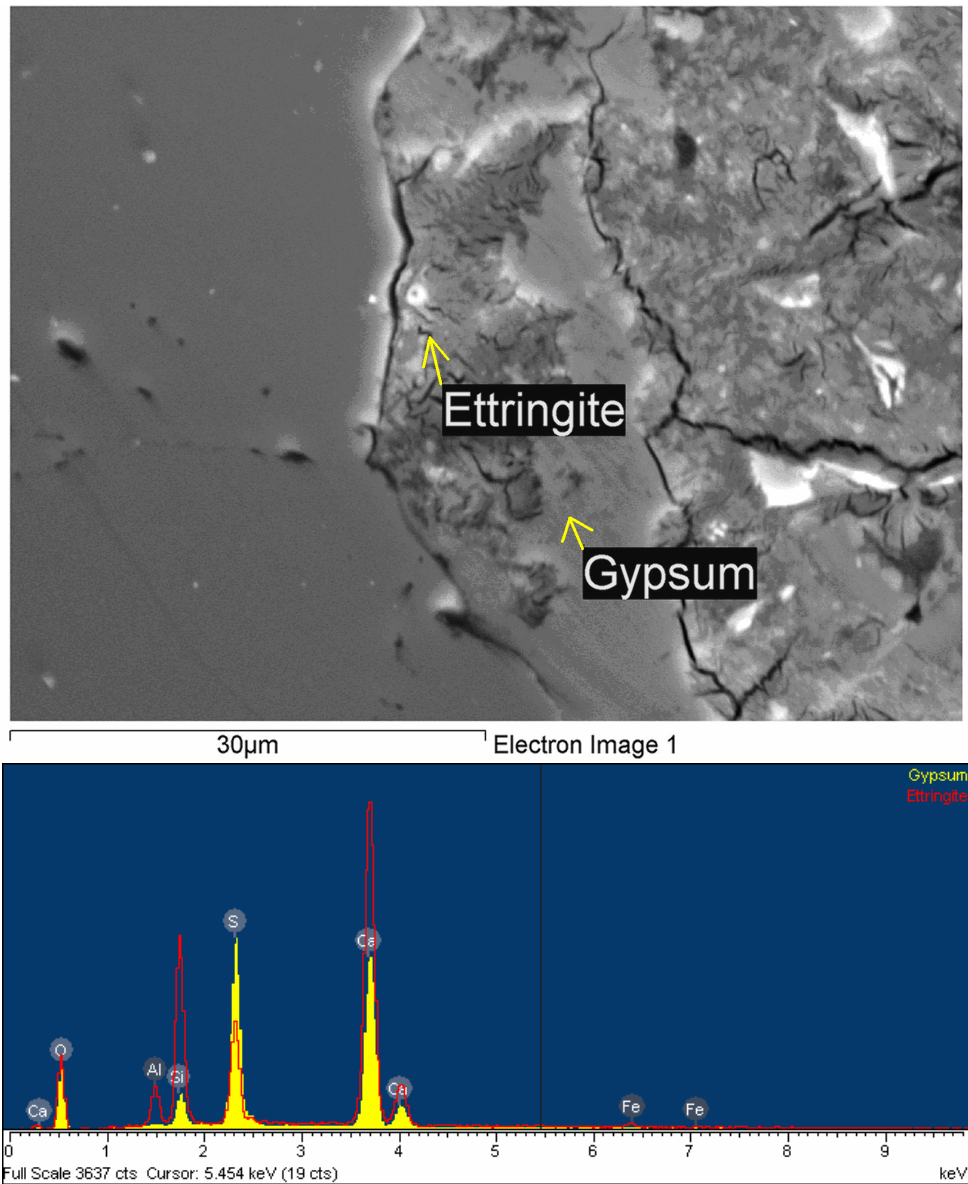
Figure 3-7: SEM image and EDS spectrum of 20% FA1 mortar after 18 months storage in sodium sulfate showing possible conversion of gypsum into ettringite.

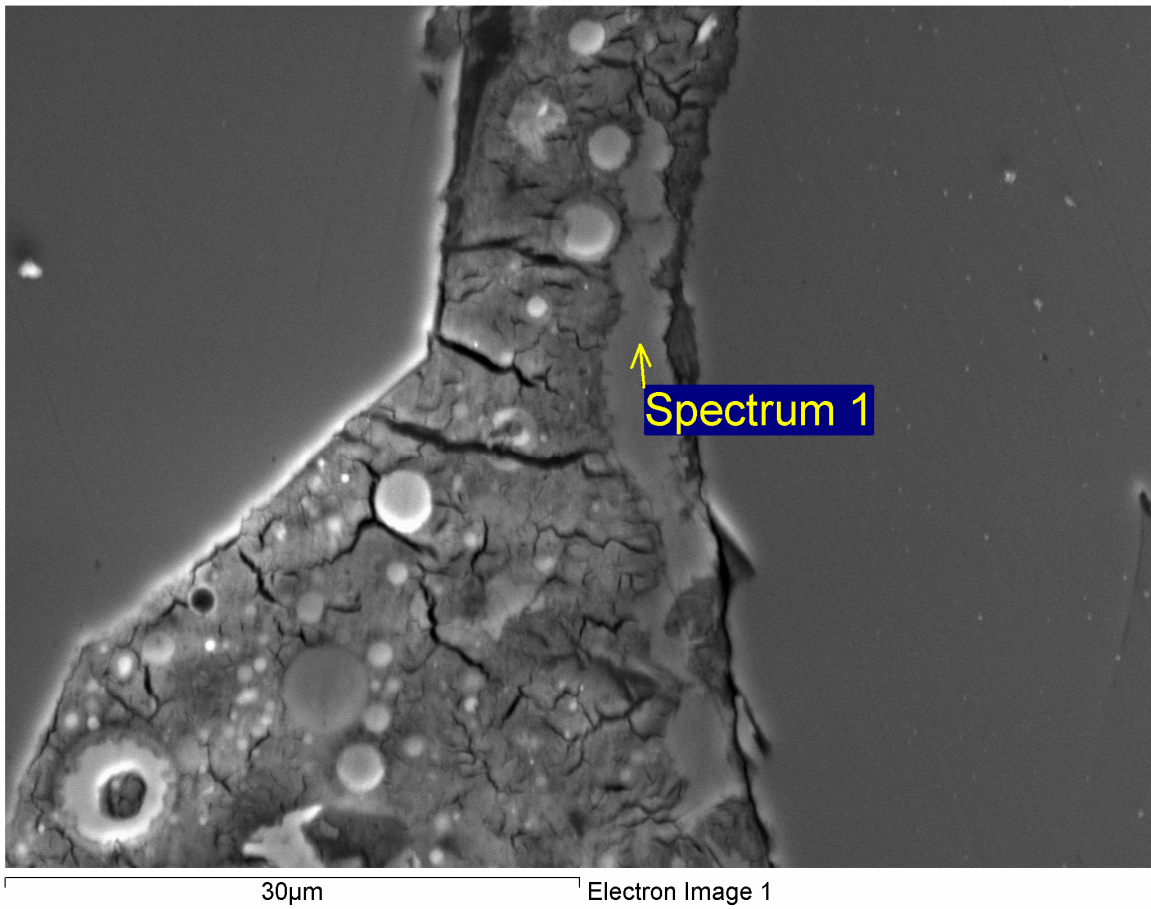
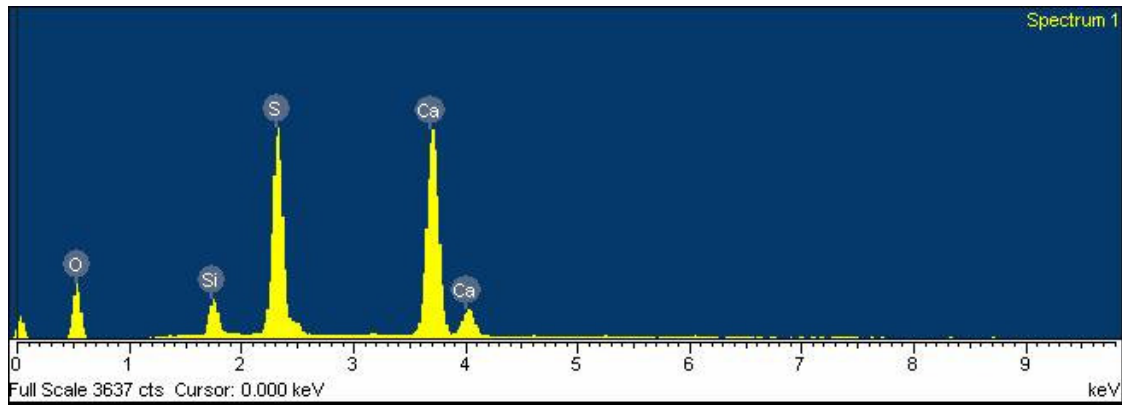
Figure 3-8: SEM image and EDS spectrum analysis of 40% FA1 after 18 months in sodium sulfate solution ettringite and gypsum formations.

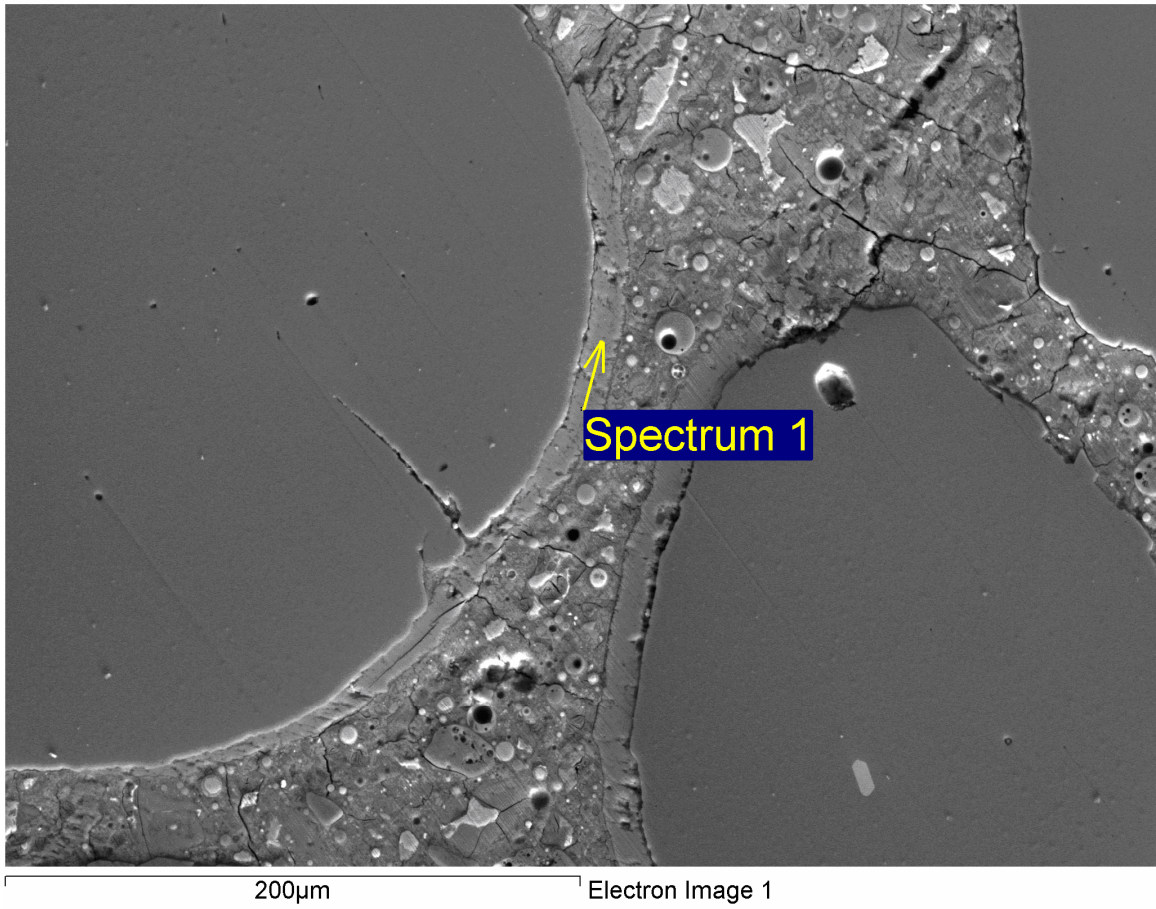
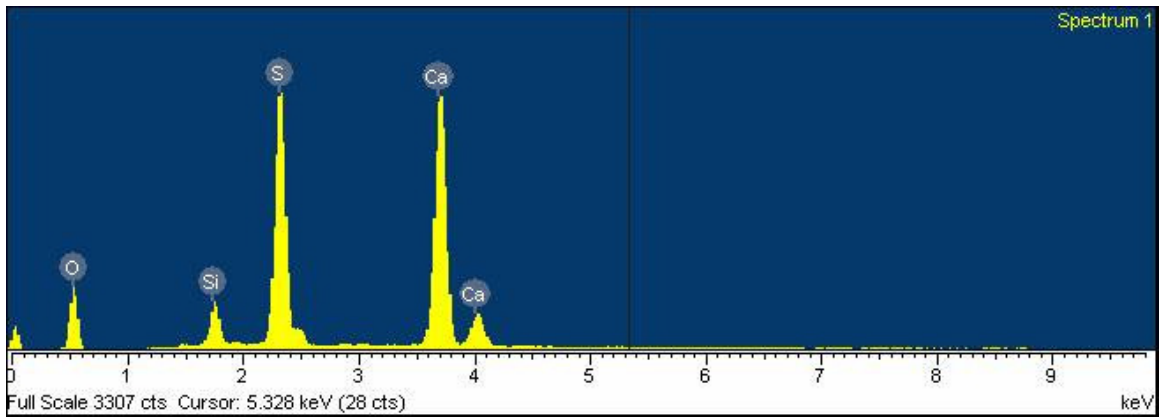
Figure 3-9: SEM image and EDS spectrum analyses of 35% FA2 after 18 months of storage in sodium sulfate showing gypsum formation around aggregates

throughout the paste, with small amounts of gypsum near aggregates. The EDS spectrum confirms the small area of gypsum occurring near the aggregate. In comparison, 35% FA2 has gypsum formation lining aggregates and very small amounts of ettringite. Gypsum deposits are found lining aggregates and in some cases branching into the paste and connecting to other aggregates. The bands are similar to ettringite filled cracks often observed in delayed ettringite formation, but in this case the cracks are filled with gypsum. The gypsum bands that form around the aggregates have not converted to ettringite possibly due to aluminates from monosulfoaluminate not being available. In addition, the FA2 may not present any reactive calcium aluminates that may react at later times to react with gypsum to form ettringite. There are a few small areas that have ettringite filled voids within the sample. The bulk chemistries of these two ashes were quite similar, but subsequent quantification of the glassy phases showed distinct differences in composition, as described later in this chapter.

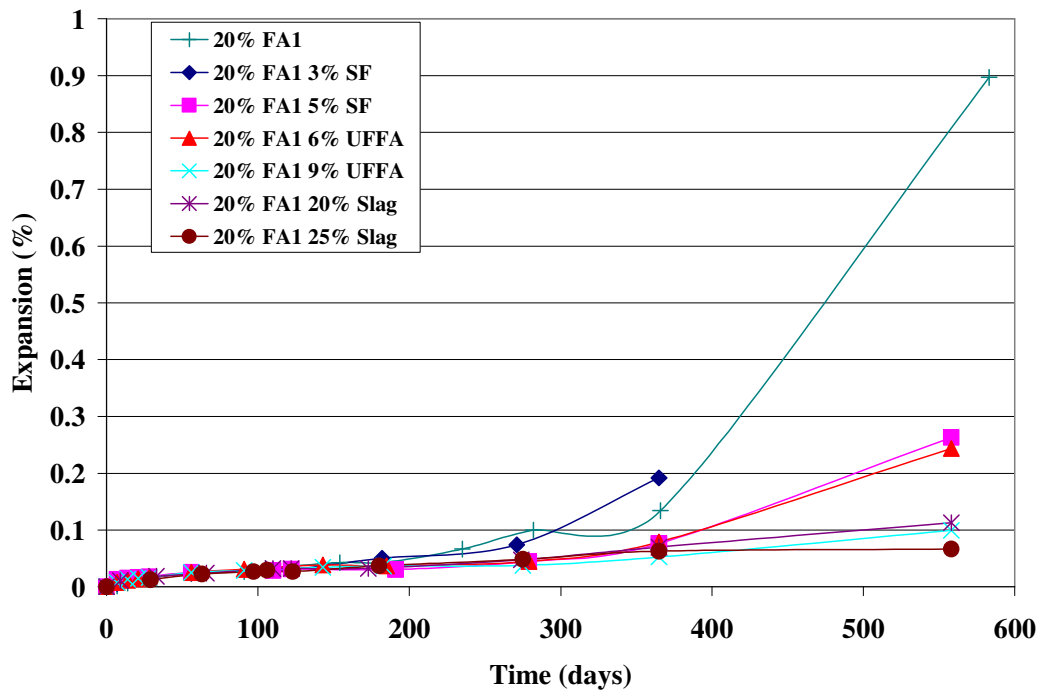
Figure 3-10: Mortar mixtures with 20% FA1 and ternary blends

ternary blends with 6 and 9% UFFA exhibited excellent sulfate resistance. A surprising trend noticed was an increase in protection of ternary blends as the replacement levels of FA1 increased, which was the opposite when FA1 was used separately (without silica fume or ultra-fine fly ash). Figures 3-10 and 3-11 provide the ternary blends for 20 and 40% FA1. The decrease in expansion with ternary blends at higher replacement dosages may be related to reductions in permeability, which slow down and reduce the ingress of sulfate solution into the bars. GGBFS performed well in a ternary blend with either 20 or 25% FA1 with 25% GGBFS. The performance of GGBFS is substantial as it usually takes at least a 50% replacement dosage to control sulfate attack. The addition of Class C fly ash and GGBFS provides a combination that removes nearly 50% of the cement.

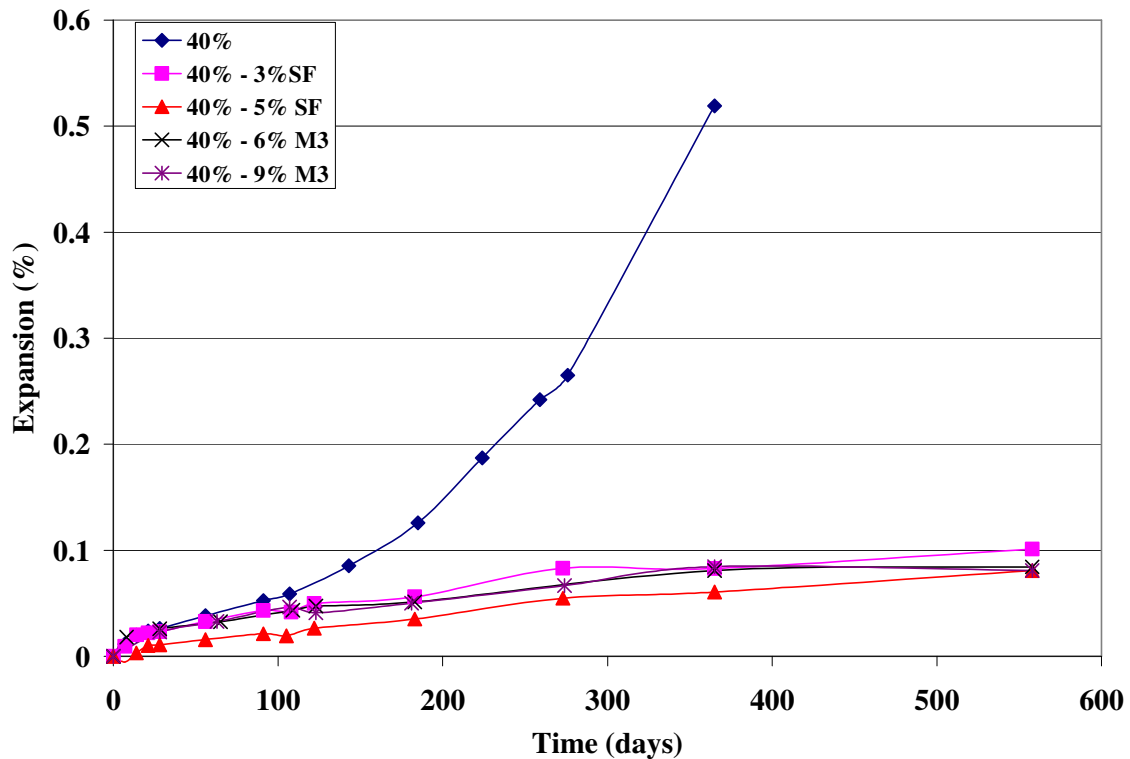
Figure 3-11: Mortar mixtures with 40% FA1 and ternary blends

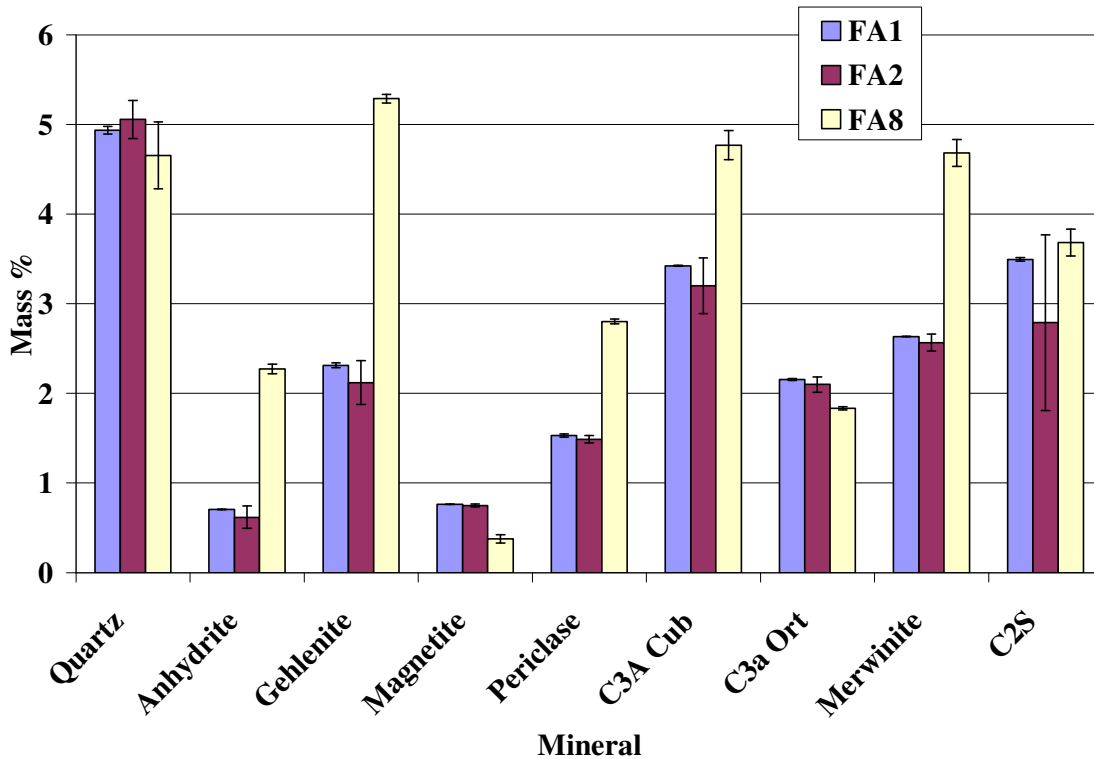
Figure 3-13: Quantitative XRD Rietveld analyses for FA1, FA2, and FA8.

mineralogy of fly ash, including both the crystalline and amorphous phases. Figure 3-13 shows the XRD quantitative Rietveld analyses for FA1, FA2, and FA8. FA1 and FA2 showed similar crystalline phase compositions, and these were quite different from the crystalline composition of FA8.

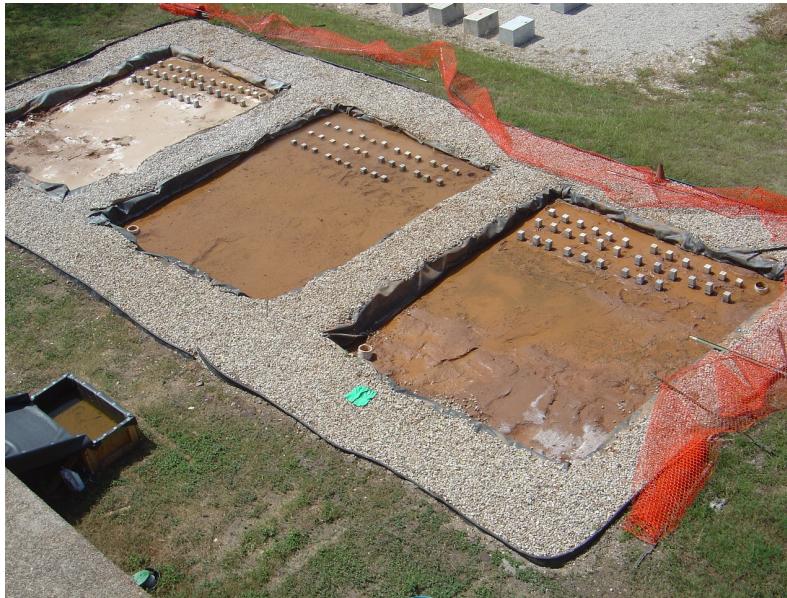
Figure 4-1: Outdoor sulfate exposure site located in Austin, TX. From left to right, the trenches contain calcium sulfate, sodium sulfate and magnesium sulfate.

The development of an outdoor sulfate exposure site began in 2005 at the Concrete Durability Center (CDC) in Austin, Texas. Figure 4-1 shows the outdoor sulfate exposure site. The design of this site was based loosely on the PCA site in Sacramento, but various modifications were employed to evaluate a more comprehensive range of exposure conditions and test parameters. Detailed information on the key features of this site in Austin, Texas is presented next.

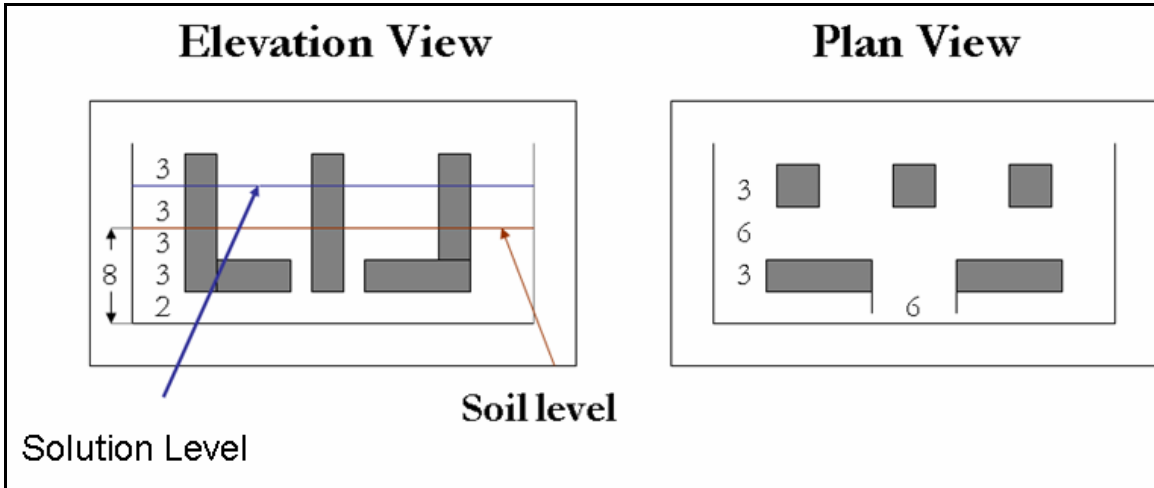
Figure 4-3: Placement of prisms in each outdoor exposure trench. The units are in inches.

The concrete prisms were strategically placed in the outdoor sulfate exposure sites to provide multiple storage conditions per mixture. Figure 4-3 shows how each mixture was placed in the respective sulfate trench. From each mixture in each trench, two prisms were placed below the soil level, roughly 2 in (51 mm) above the bottom of the trench, and three prisms were placed vertically. The vertical prisms were halfway submerged to provide the following three areas of exposure: submerged (in sulfate solution below grade), soil/solution interface zone (wetting/drying zone), and non-contact zone (above solution but subject to wicking action for some salts).

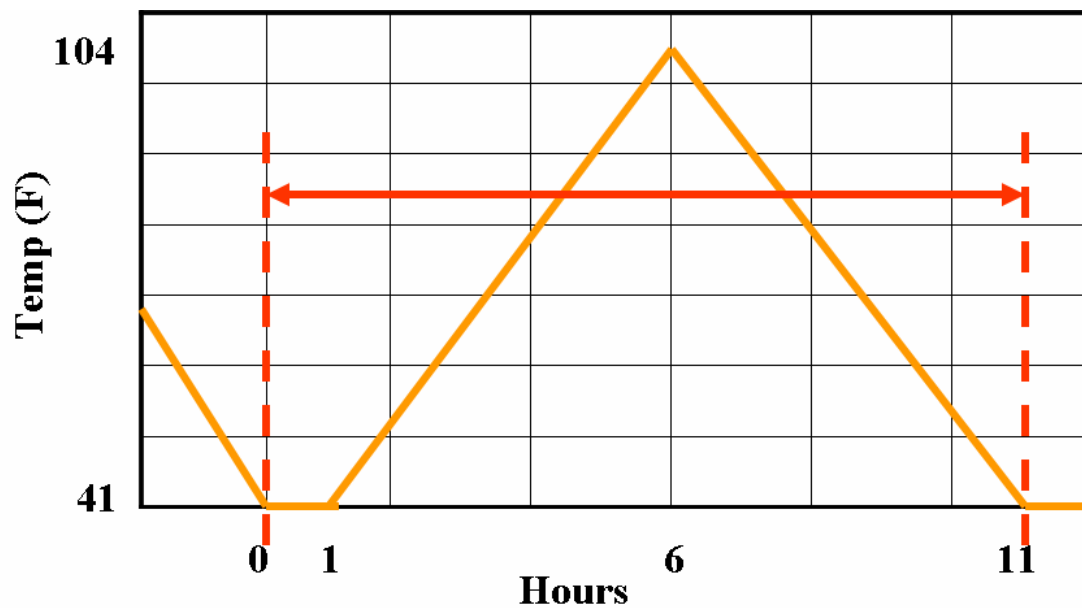
Figure 4-5: Temperature Cycle for mortars subjected to physical sulfate attack.
