**LABORATORY AND FIELD EVALUATIONS OF
EXTERNAL SULFATE ATTACK**

Dissertation

the University of Texas at Austin

December 2007

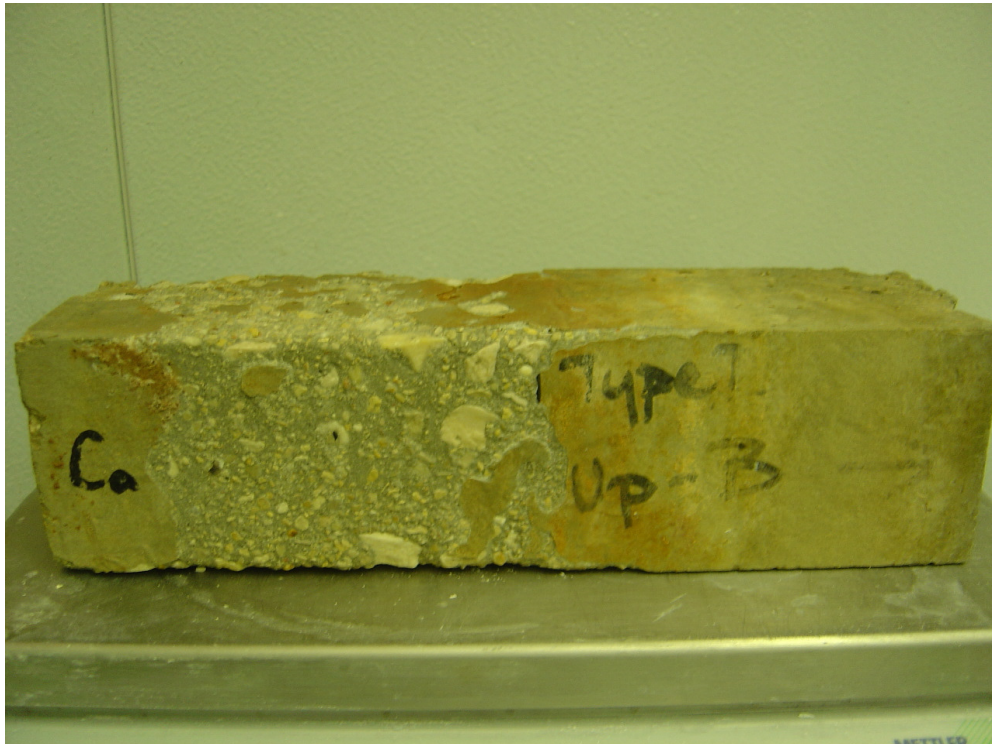
Figure 4-7: Concrete prism with a 0.4 w/cm placed vertically in the outdoor calcium sulfate exposure site. In this photograph, the left side shows the portion of the prism that was below the soil level.

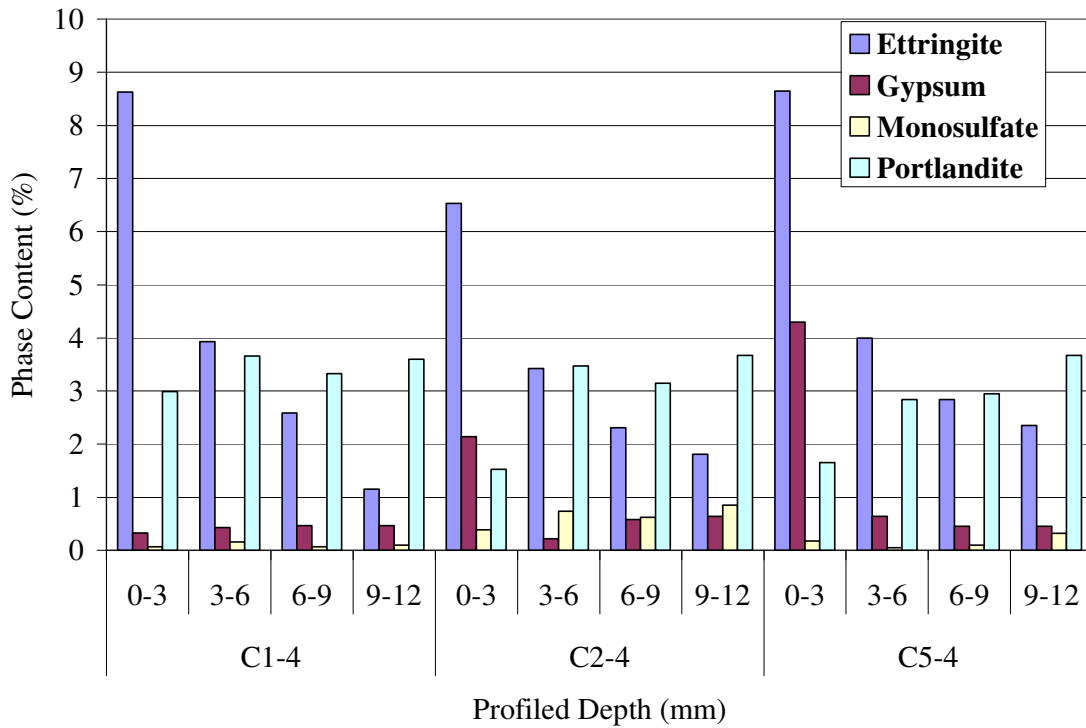
Figure 4-8: Semi-quantitative Rietveld analysis showing differences in cement types for prisms at 0.4 w/cm, placed indoors in calcium sulfate.

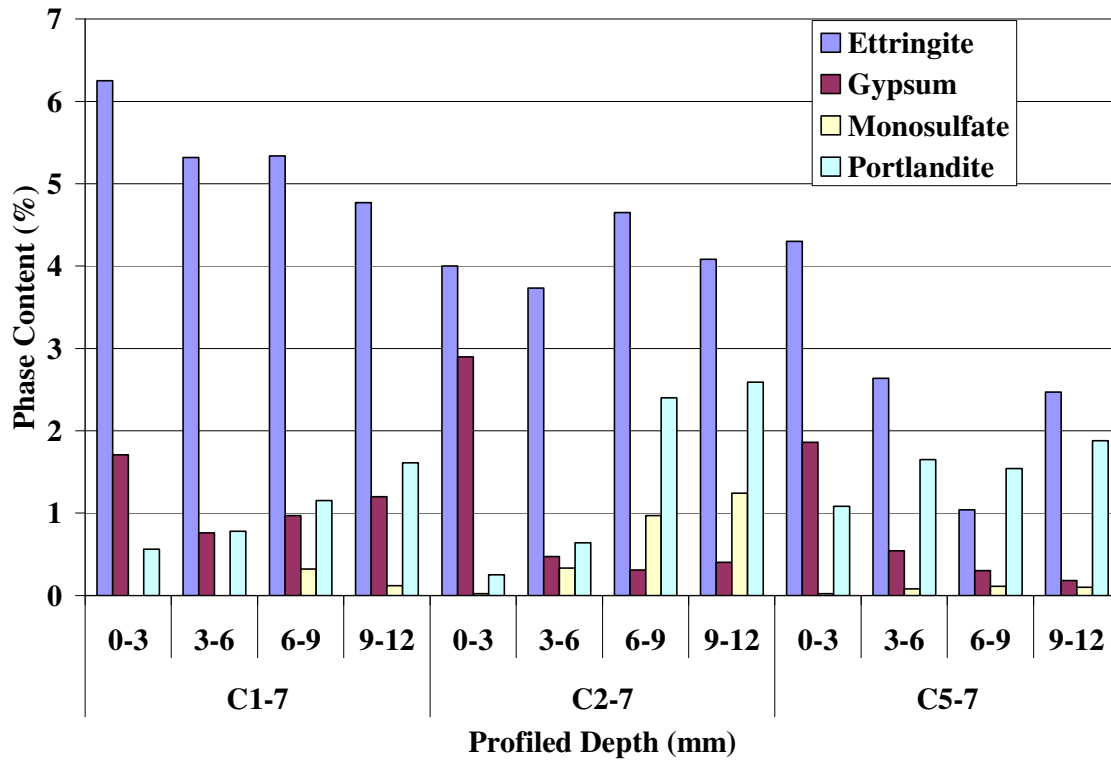
Figure 4-9: Quantitative analysis showing differences in cement types for prisms at 0.7 w/cm placed indoors in calcium sulfate.

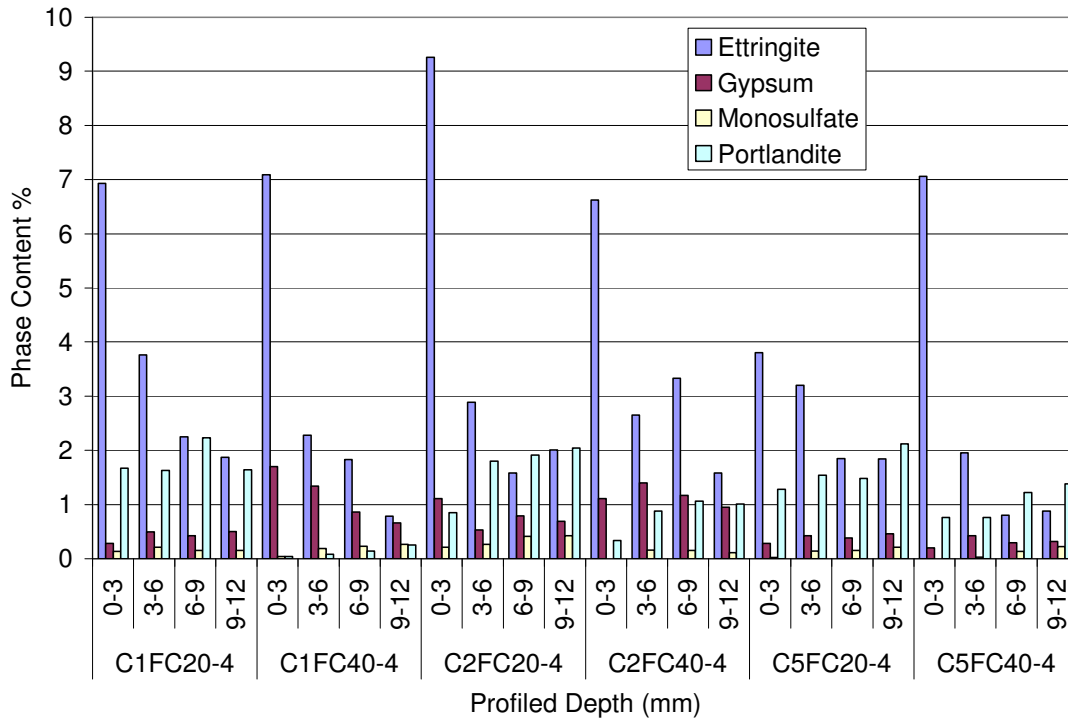
Figure 4-10: Semi-quantitative XRD analysis of profiled prisms containing Class C fly ash at a 0.4 w/cm

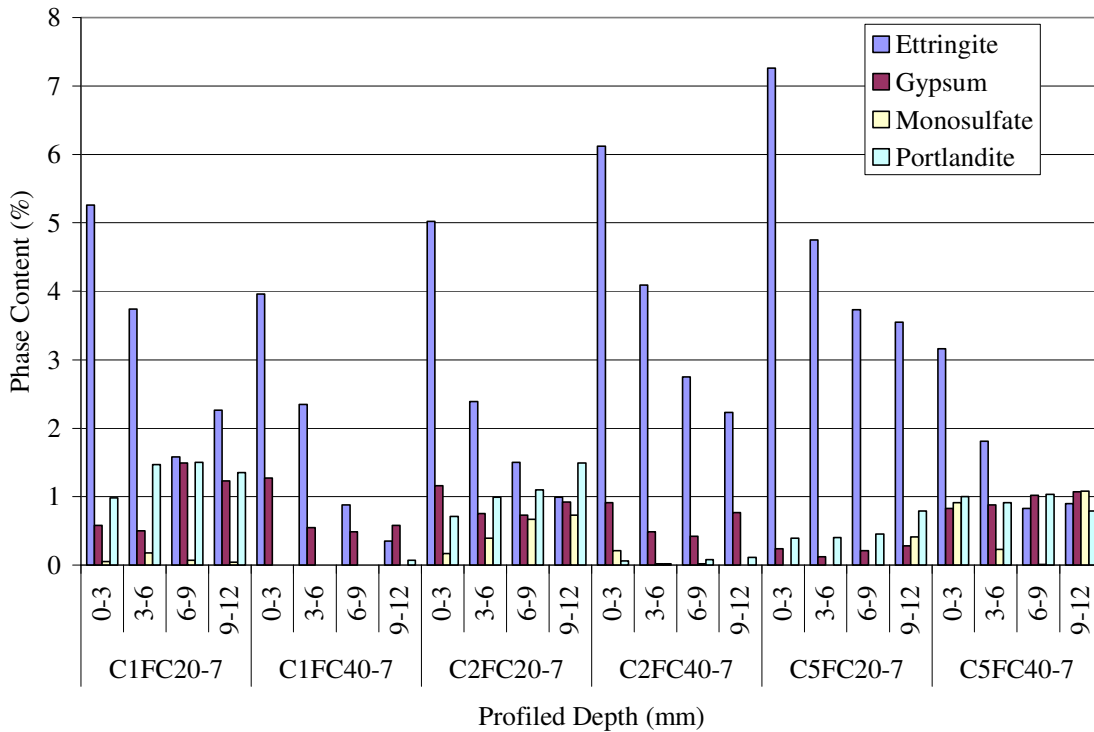
Figure 4-11: Quantitative XRD analysis of profiled prisms containing Class C fly ash at a 0.4 w/cm to determine phase content at different milled depths

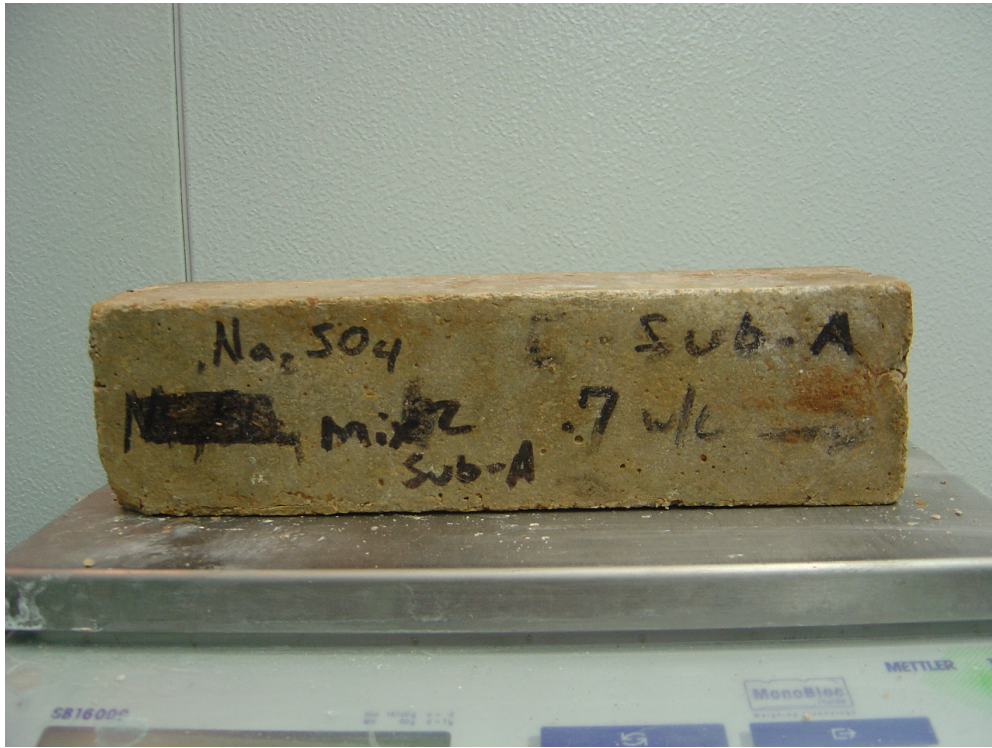
Figure 4-12: C1-7 prism submerged in the outdoor sodium sulfate exposure site after 18 months

Similar distress was found at the PCA (2002) exposure site in Sacramento, California which they contributed to physical sulfate attack.

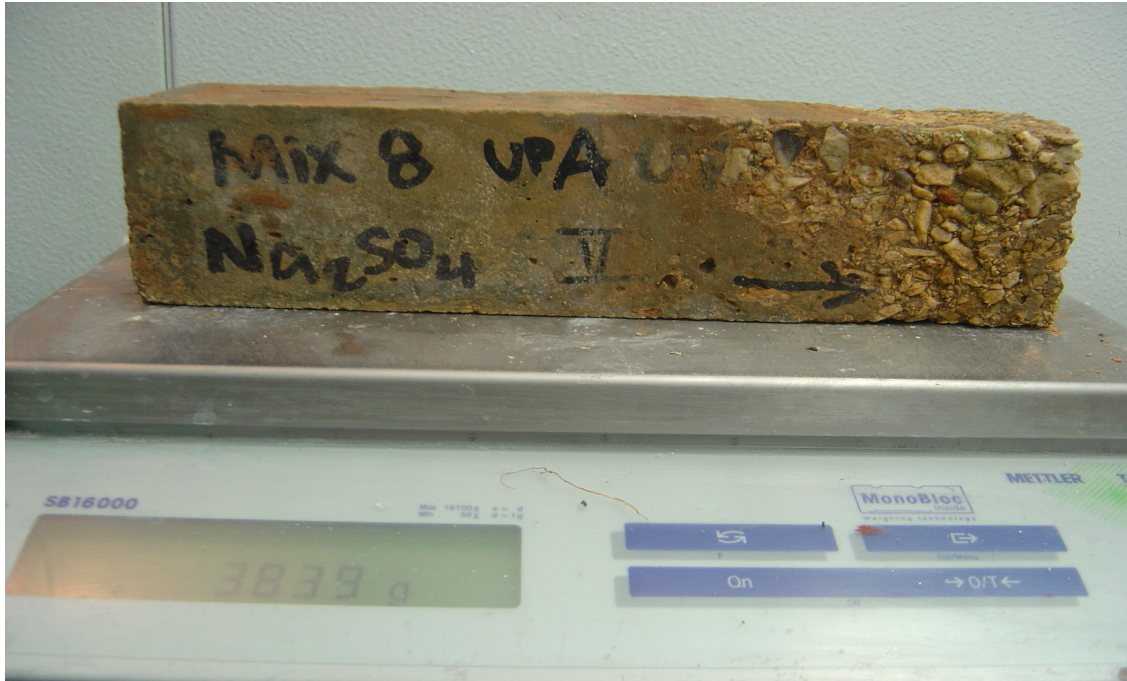
Figure 4-13: Mixture C5-7 after 18 months of outdoor exposure to sodium sulfate. This prism was placed vertically, with the section on the left fully submerged below sulfate-saturated soil.

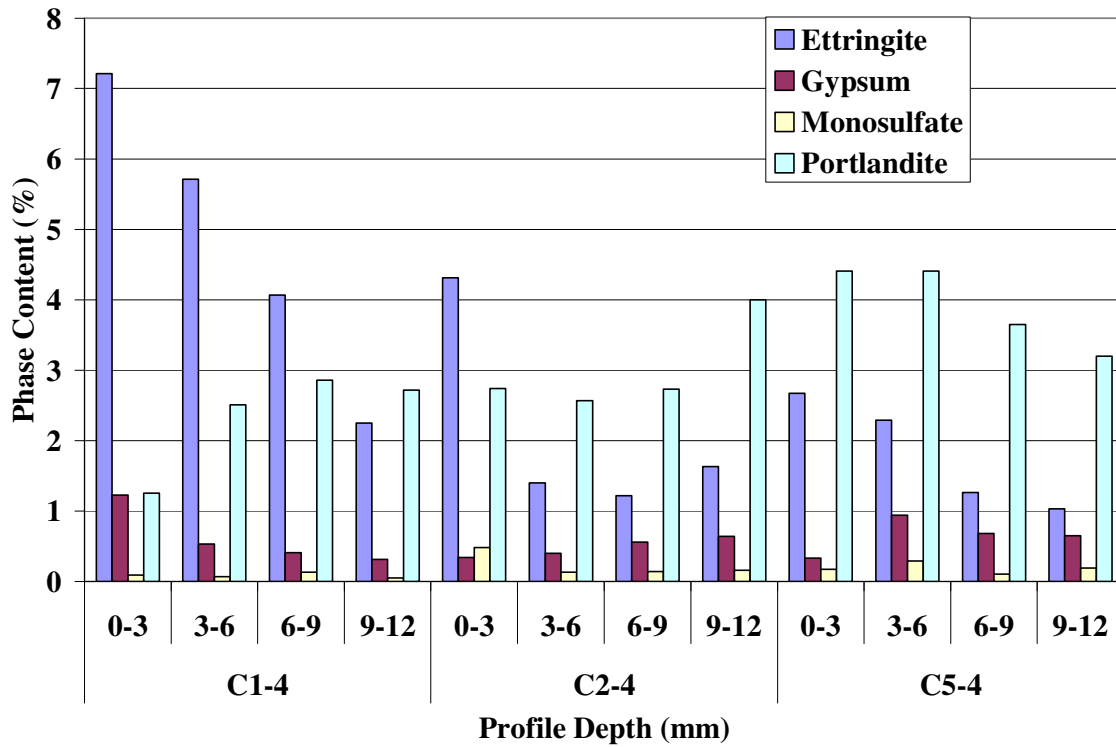
Figure 4-14: Semi-quantitative XRD Rietveld analyses of concrete prisms at 0.4 w/cm, placed indoors in sodium sulfate solutions after 18 months

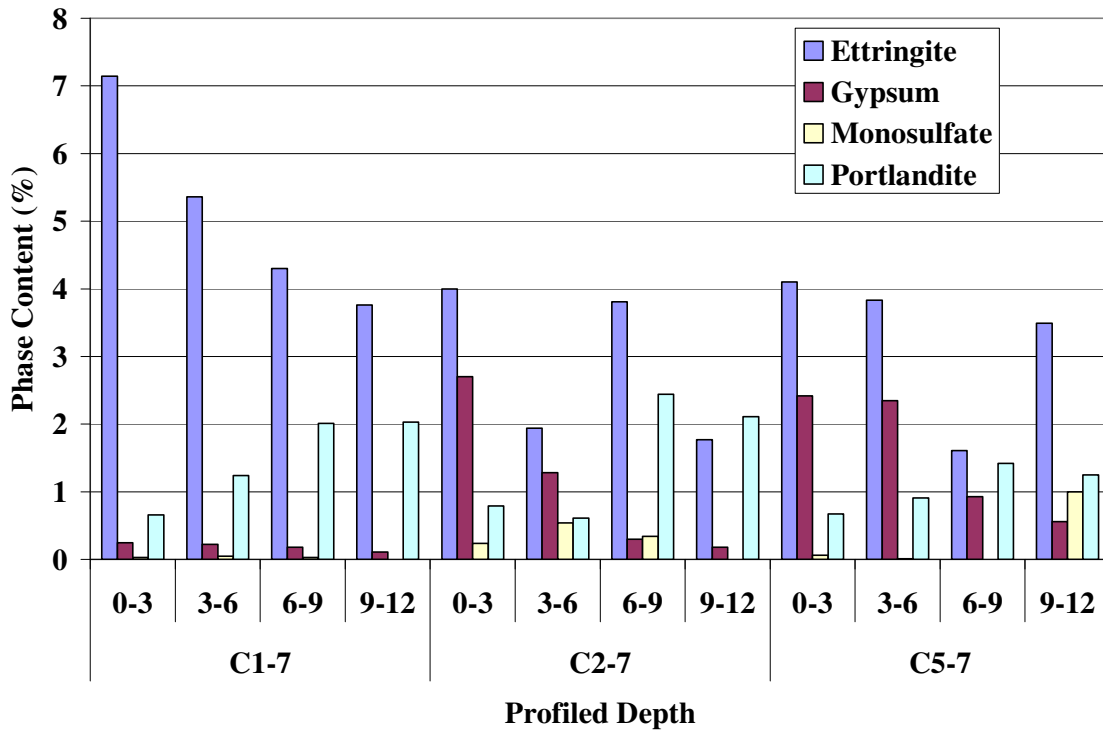
Figure 4-15: Semi-quantitative XRD Rietveld analysis of concrete prisms at 0.7 w/cm, placed indoors in sodium sulfate solutions after 18 months

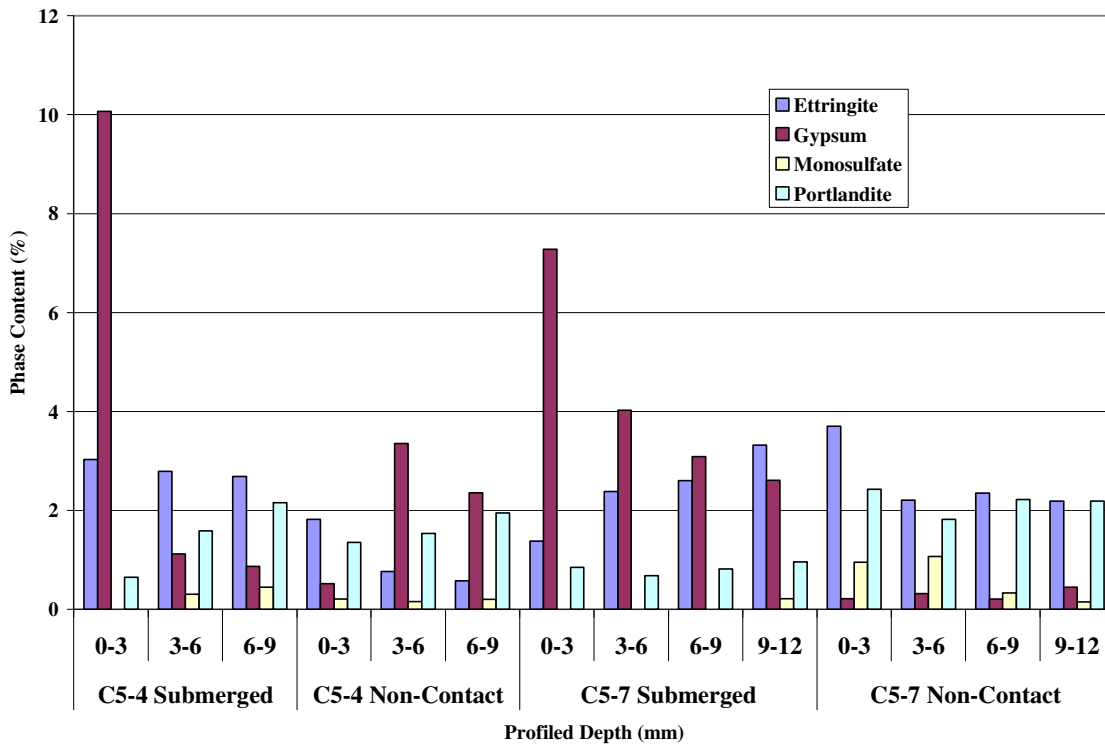
Figure 4-16: Semi-quantitative XRD analysis from mixtures containing sulfate resistant cement at in the outdoor sulfate exposure site

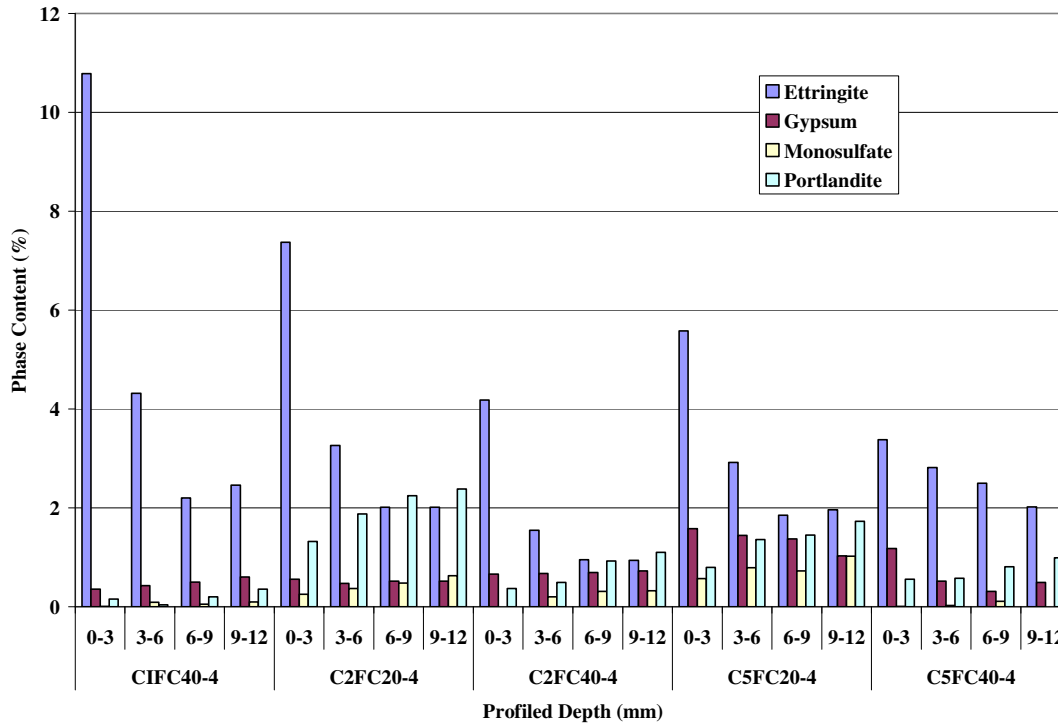
Figure 4-17: Semi-quantitative XRD Analysis of Concrete prisms at 0.4 w/cm placed in sodium sulfate solutions for 18 months

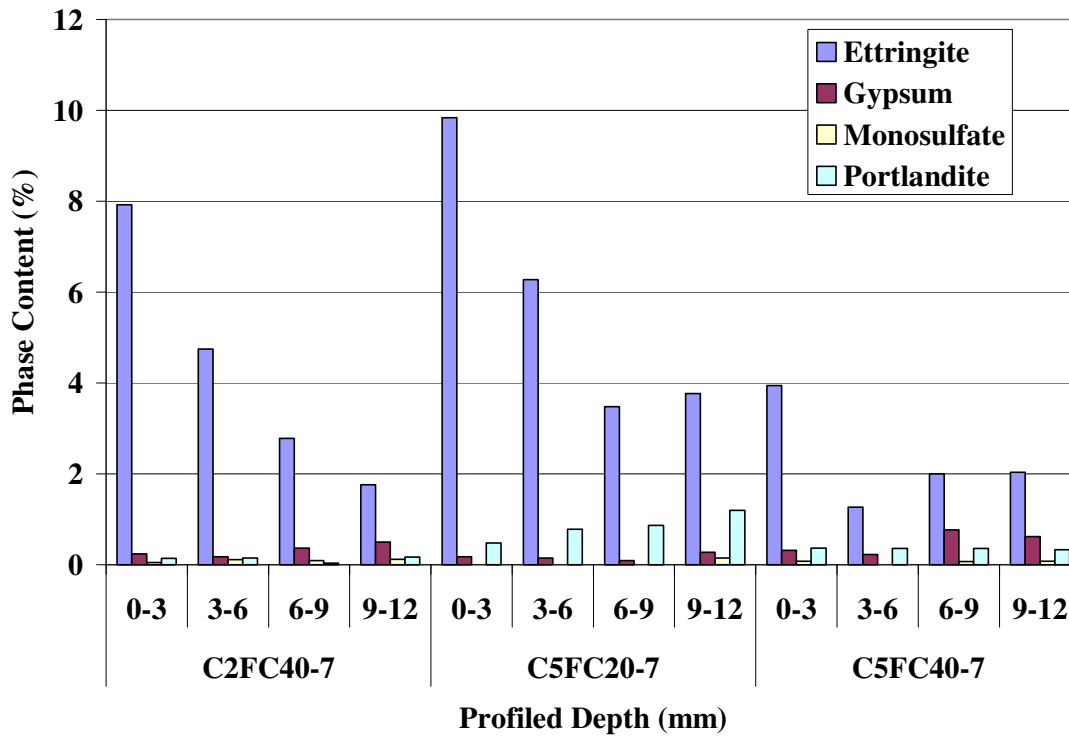
Figure 4-18: Quantitative XRD analysis of prisms at 0.7 w/cm placed tested indoors in sodium sulfate solutions

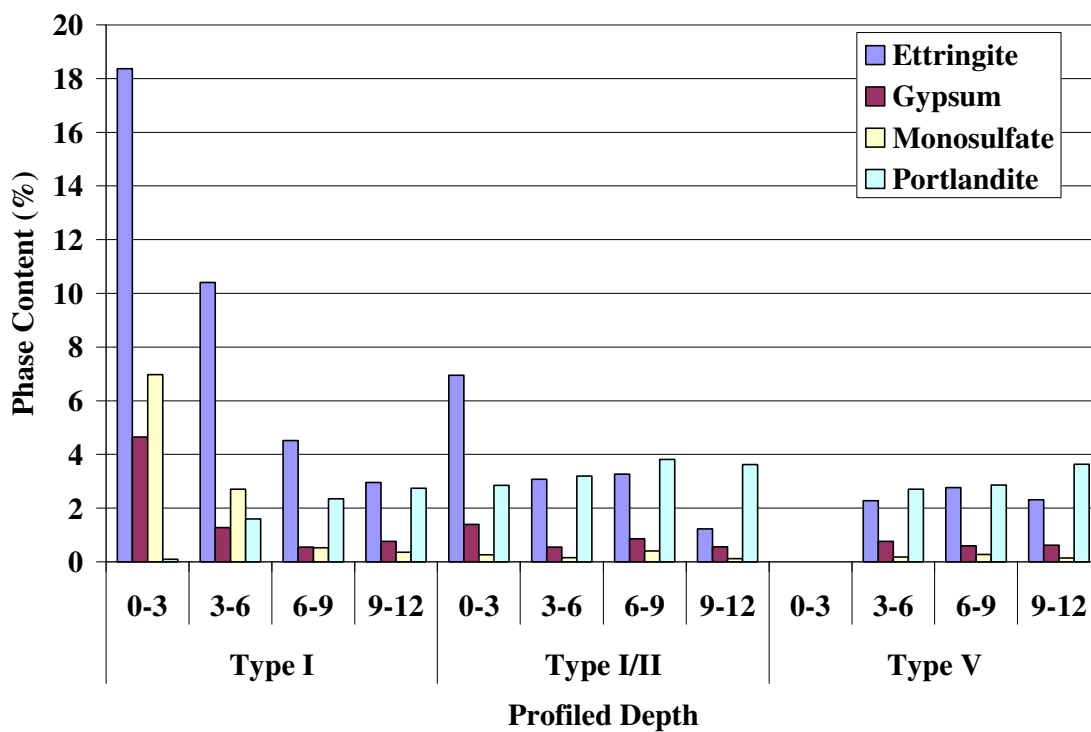
Figure 4-19: Semi-quantitative XRD analysis of concrete prisms at 0.4 w/cm placed in indoor magnesium sulfate conditions

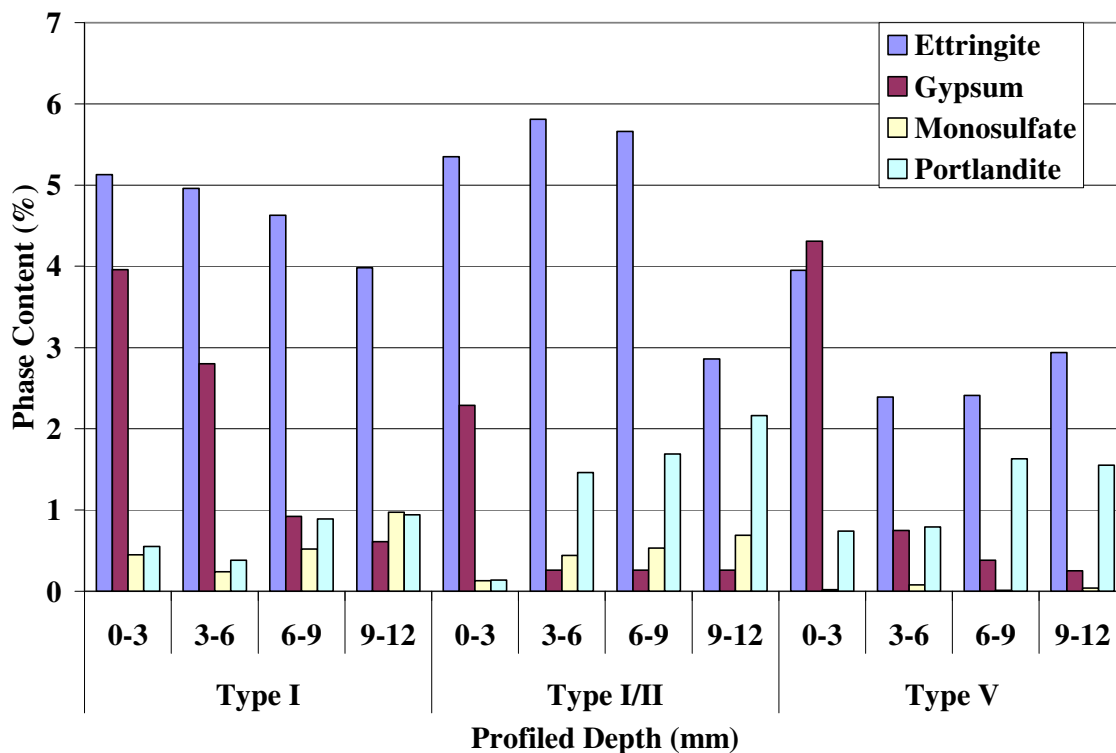
Figure 4-20: Semi-quantitative XRD Rietveld analysis of prisms placed in magnesium sulfate conditions

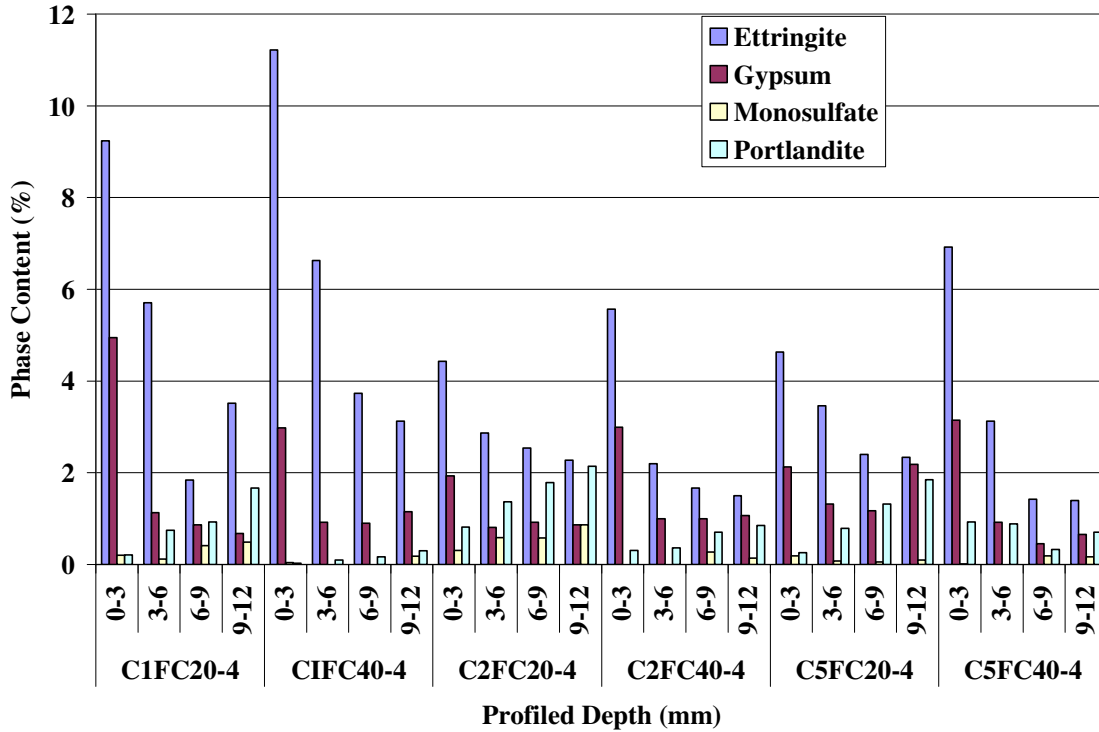
Figure 4-21: Semi-quantitative XRD Rietveld analysis of prisms containing SCMs in indoor magnesium sulfate conditions

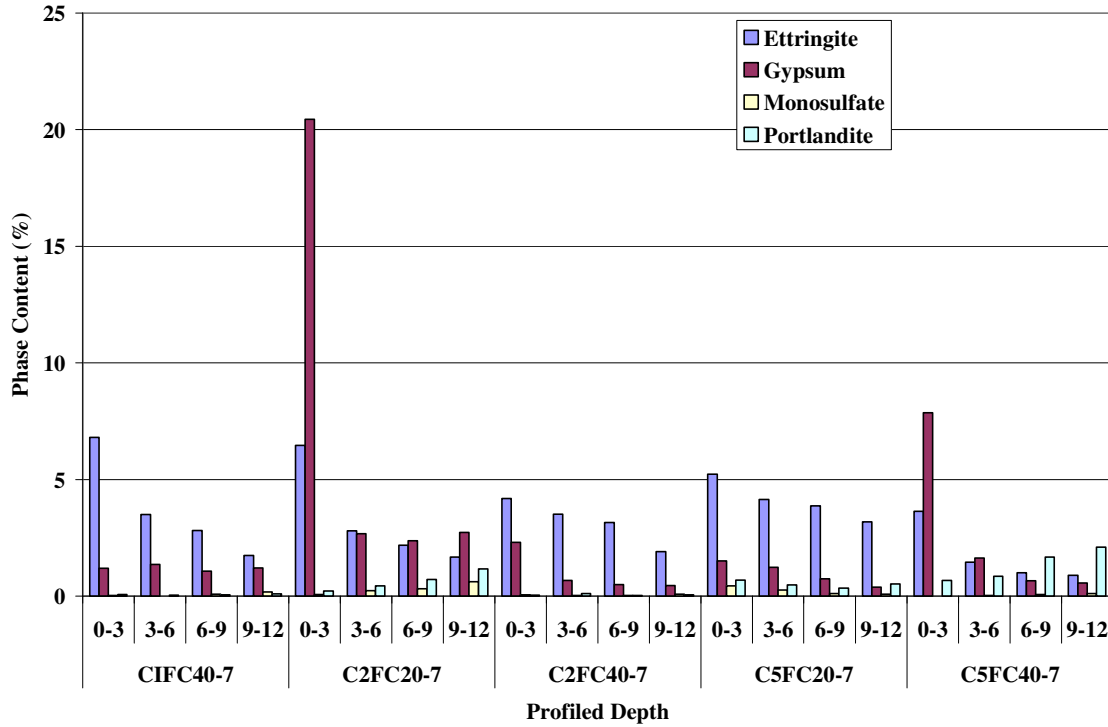
Figure 4-22: Semi-quantitative XRD Rietveld analysis of prisms with SCMs placed indoors in magnesium sulfate solution

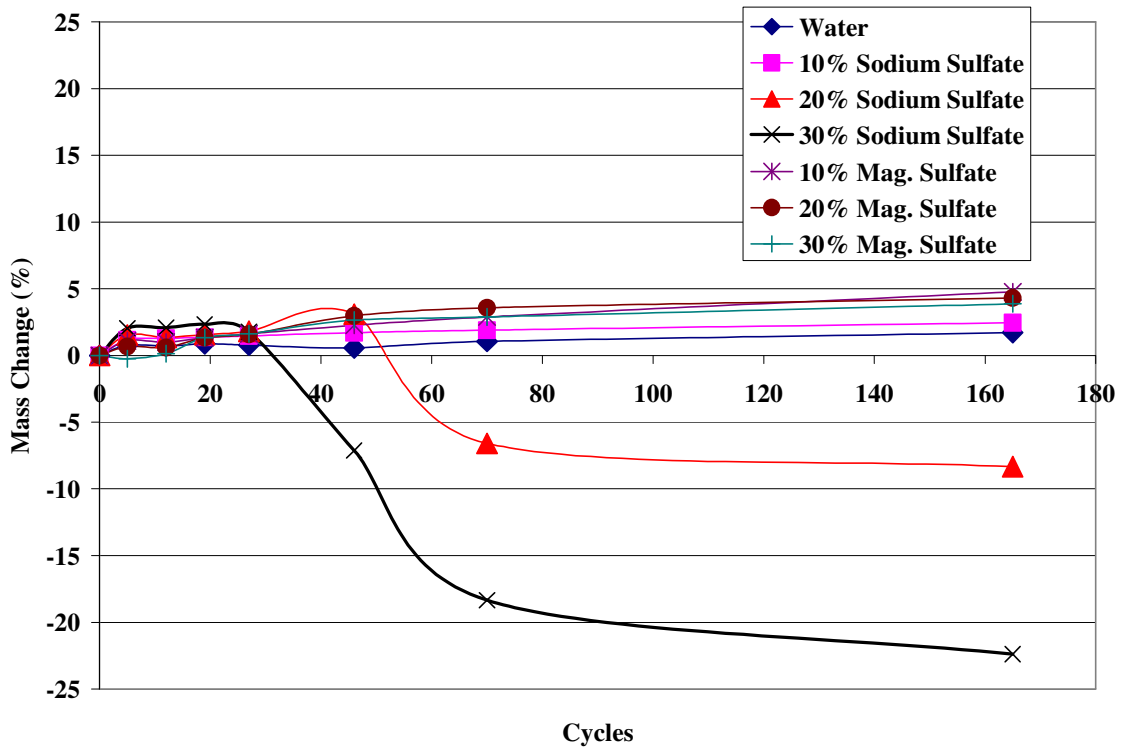
Figure 4-23: Physical sulfate testing of non-air-entrained mortars containing Type V cement (w/cm=0.7)

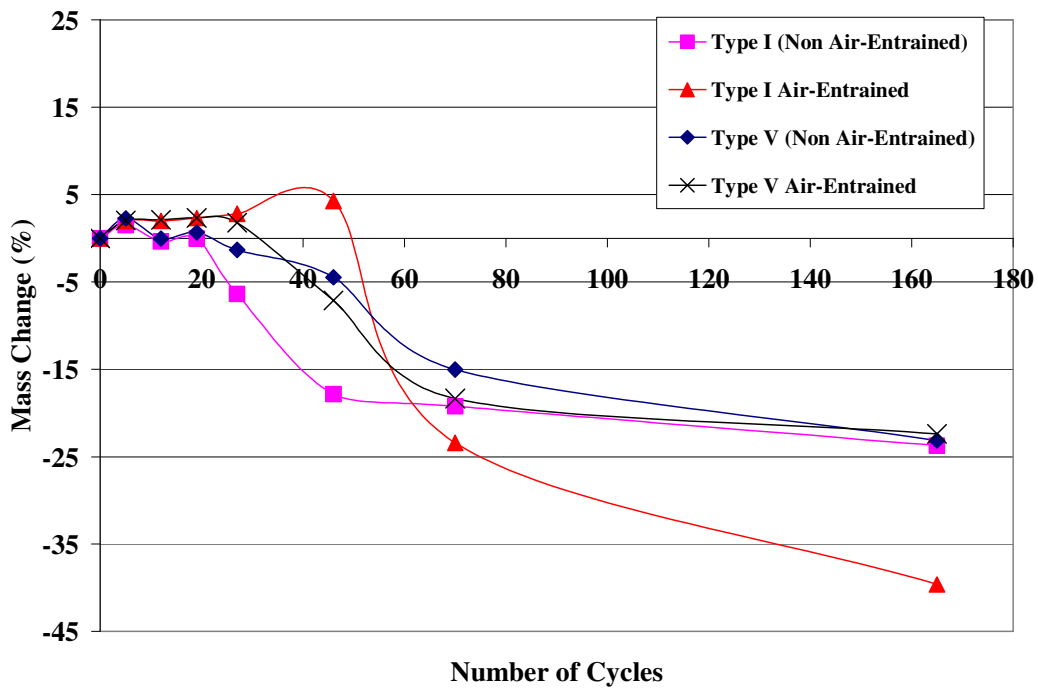
Figure 4-24: Physical sulfate testing of air-entrained and non-air-entrained mortars (w/cm=0,7) immersed in 30% sodium sulfate solution and subjected to temperature changes.

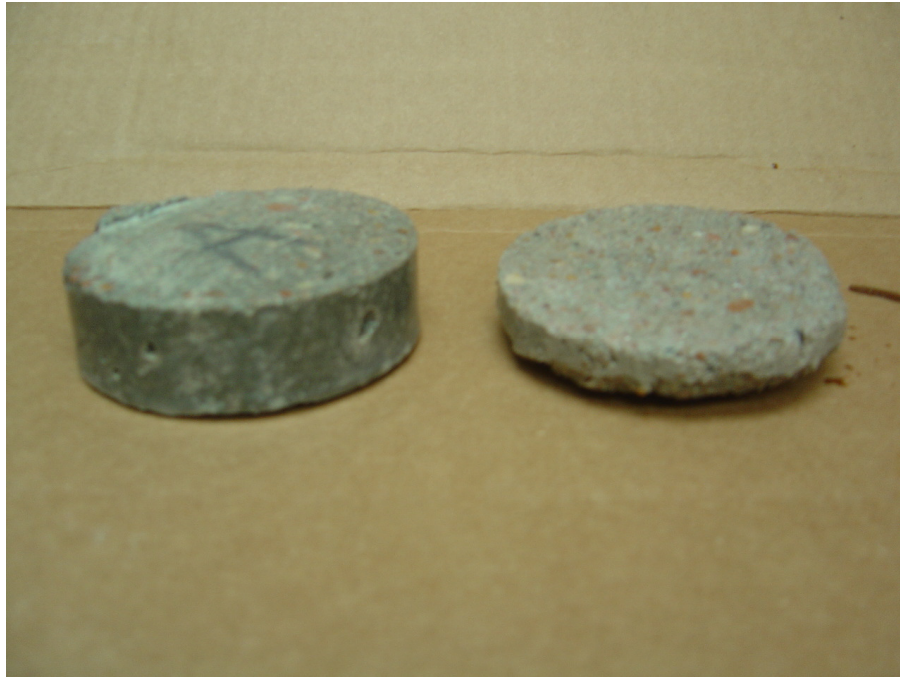
Figure 4-25: Mortar specimens before and after physical sulfate testing. The mixture contained Type V cement at 0.7w/cm. The disk on the left was prior to testing and the disk on the right went through 150 cycles.

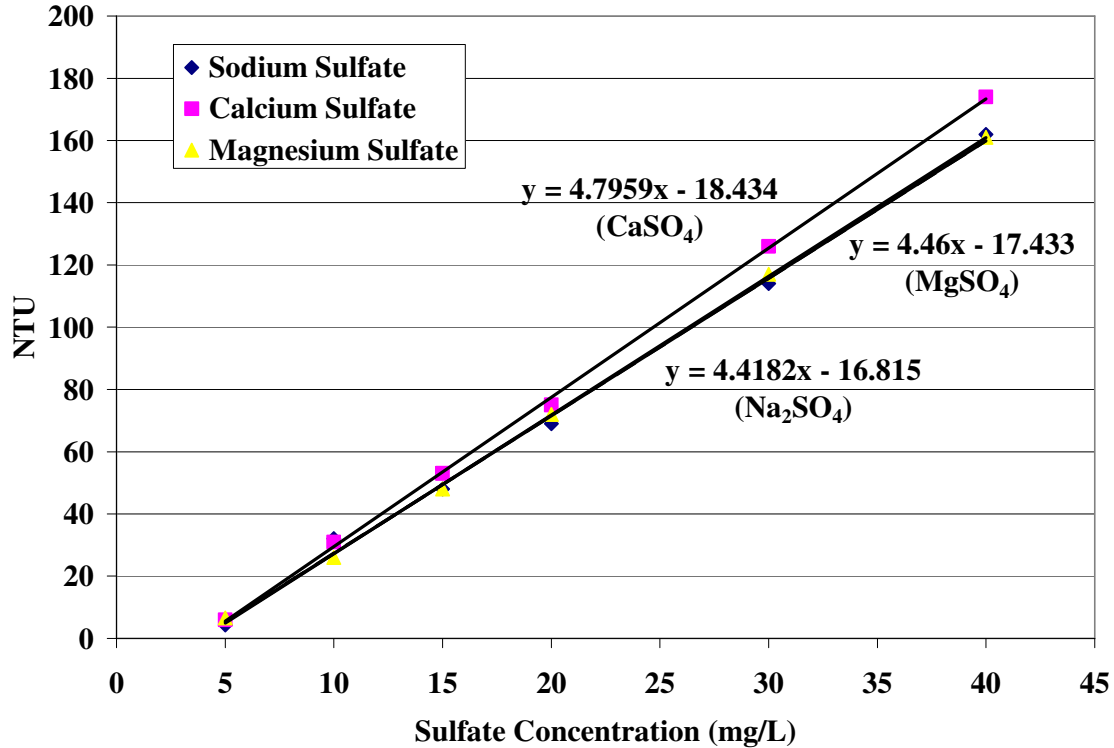
Figure 5-2: Calibration curve for sulfate using the turbidimeter

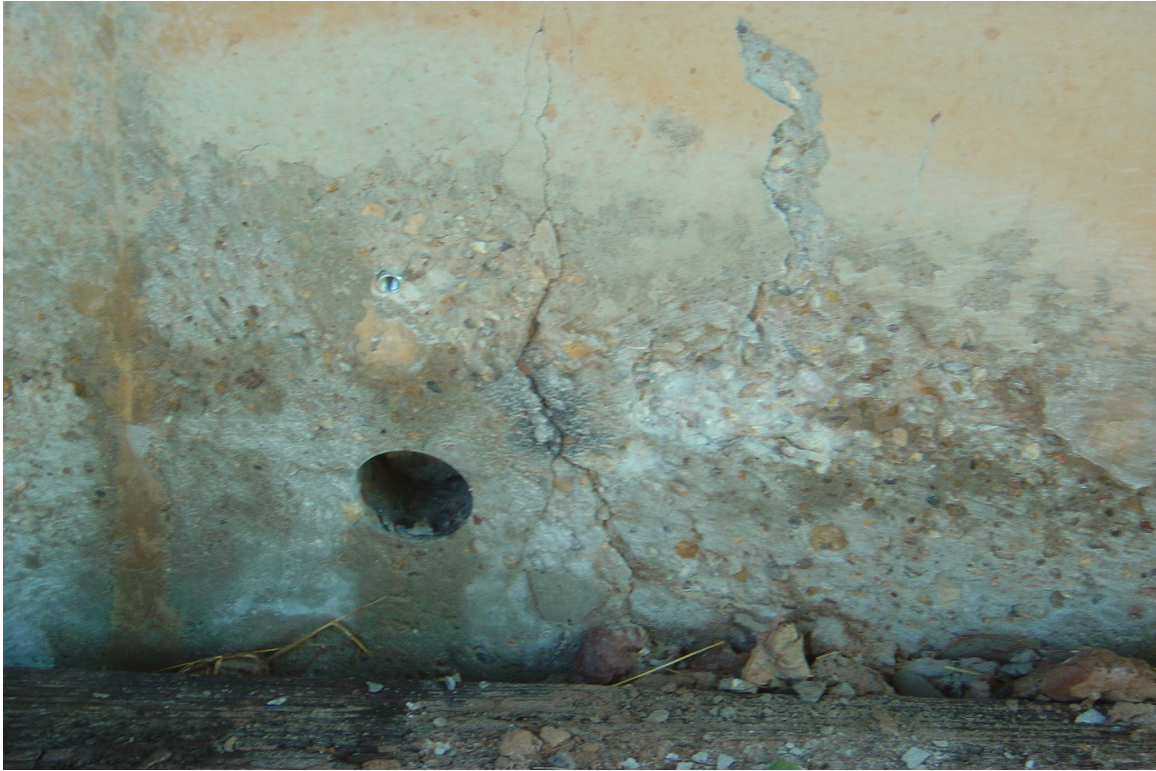
Figure 5-3: Damage to the lower part of a wall below US 83 in Childress District

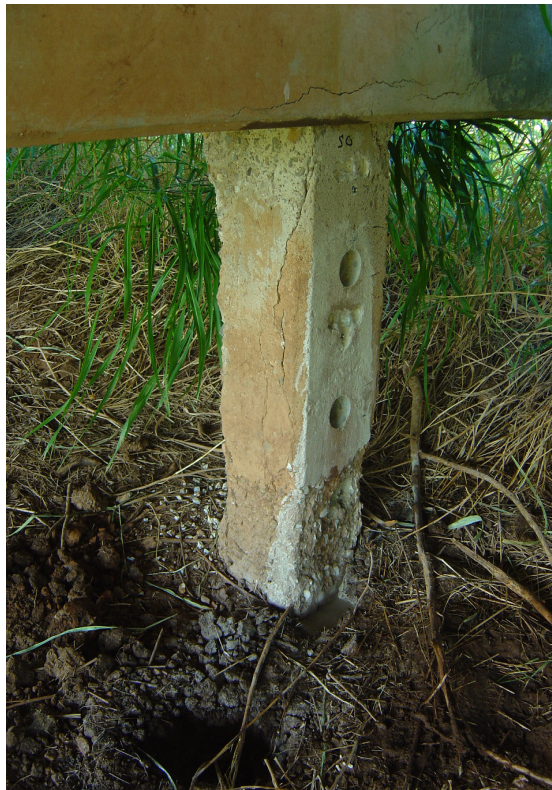
Figure 5-4: Damage to a bridge column on FM 2278, south of Childress, Texas

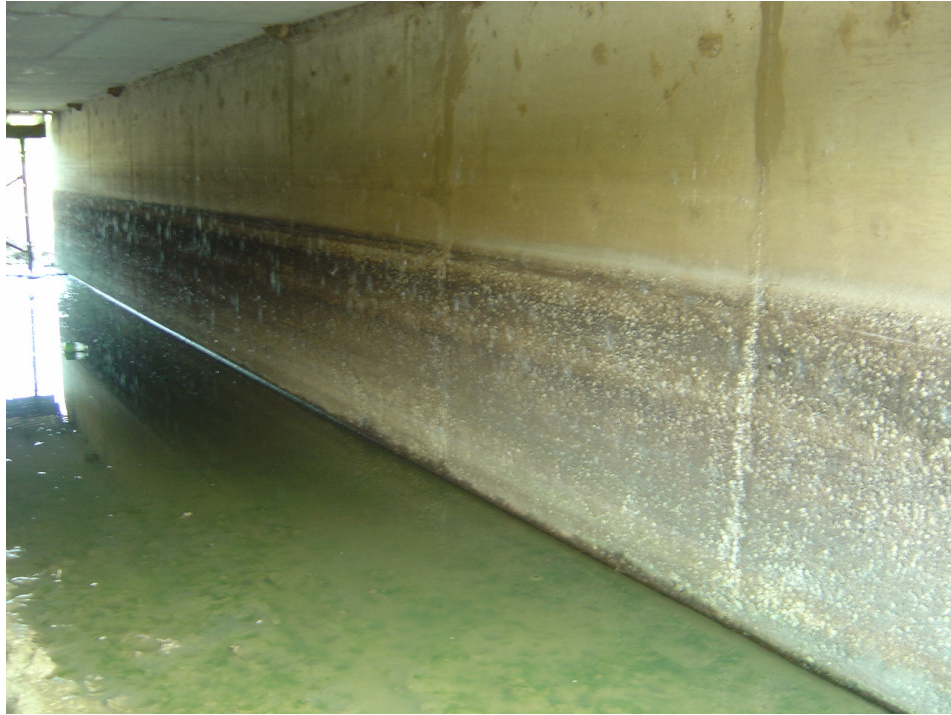
Figure 5-5: Deterioration commonly found in culverts in the Paris District. The distress begins near the base of the culvert and continues up the side, likely in line with the highest level of water.

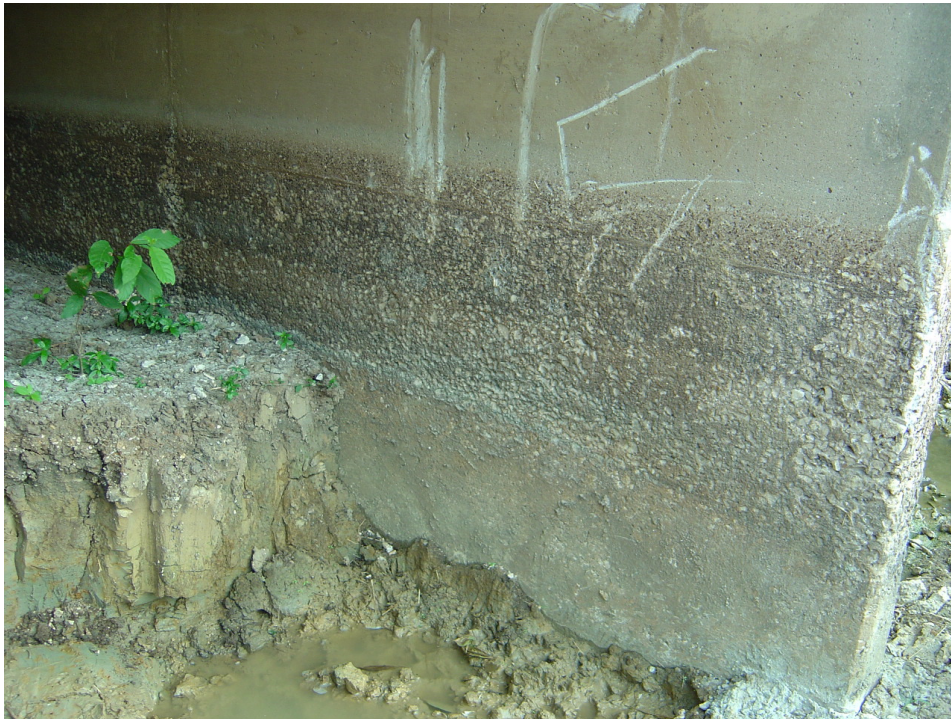
Figure 5-6: Deterioration of a culvert above the soil level, with no deterioration visible below the level of the soil (after excavation).

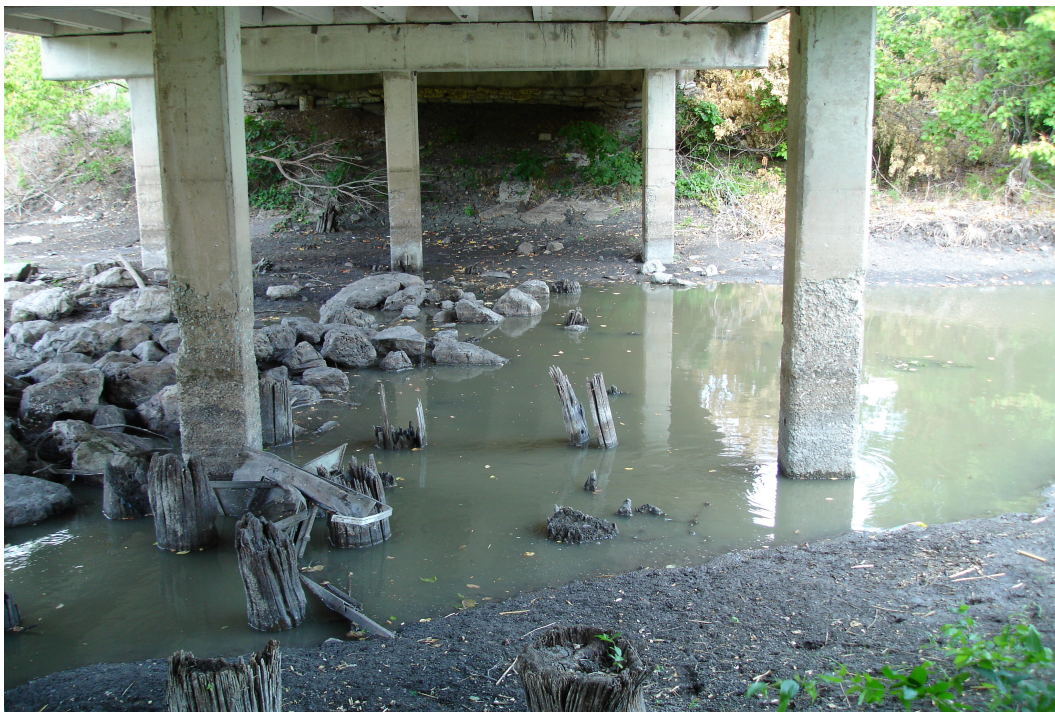
Figure 5-7: Deteriorated concrete columns from a bridge in the Paris District

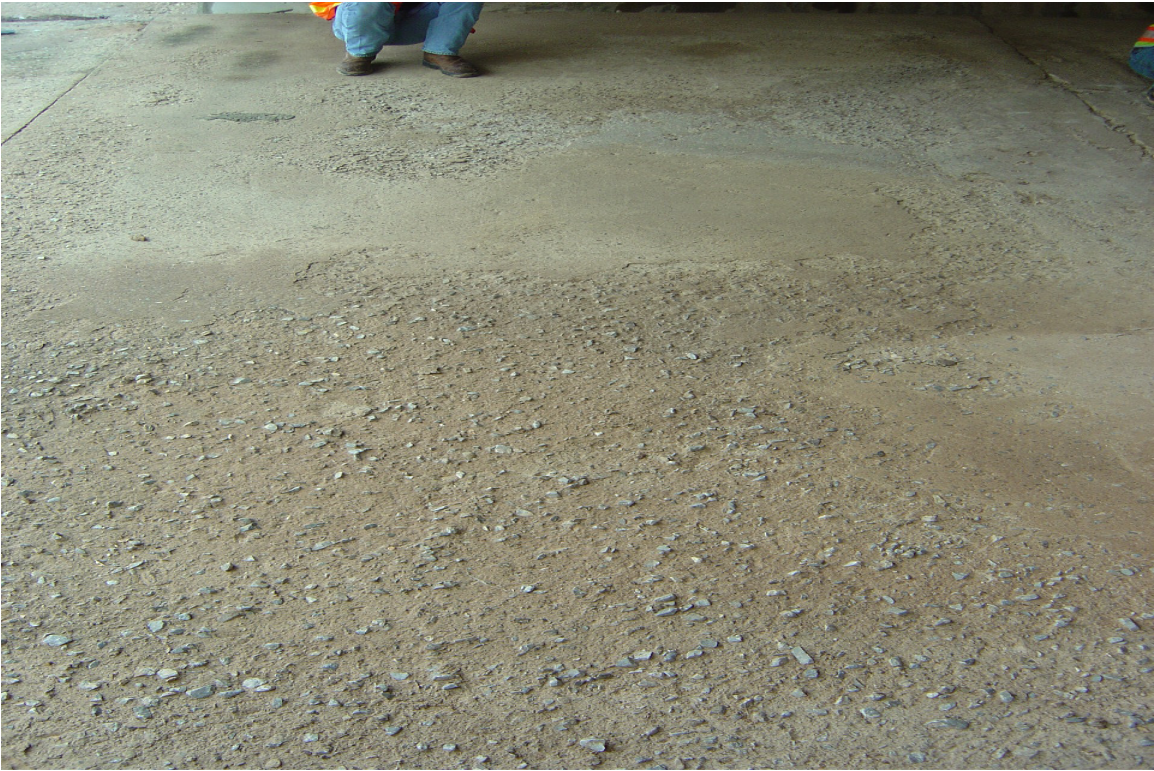
Figure 5-8: Riprap deterioration occurring on the embankment below a bridge

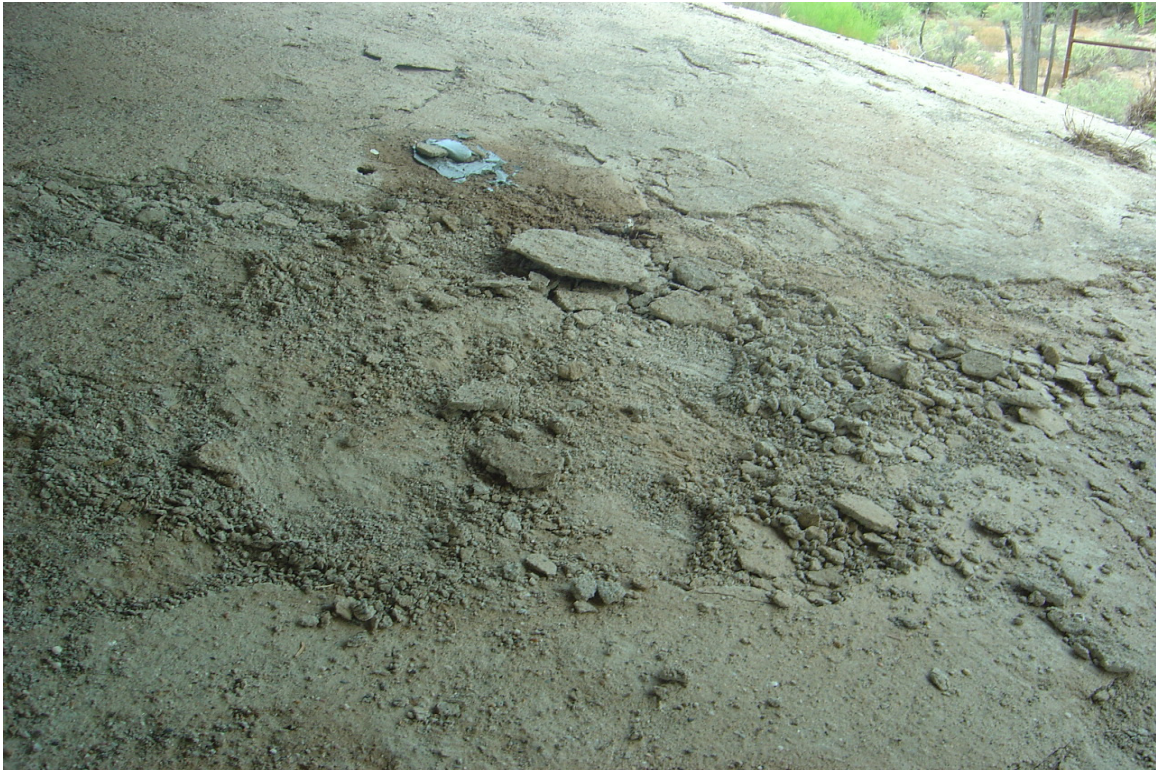
Figure 5-9: Riprap deterioration at Site 31 in the El Paso District

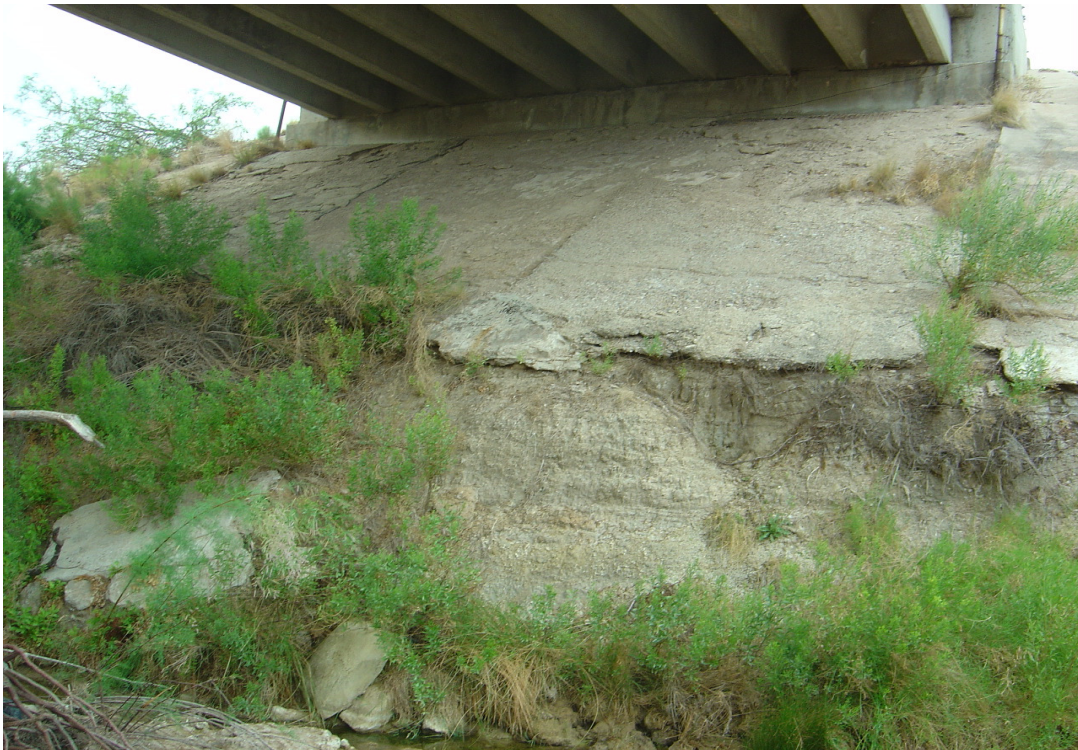
Figure 5-10: Deteriorated riprap at Site 32 located on FM 652 in the El Paso District

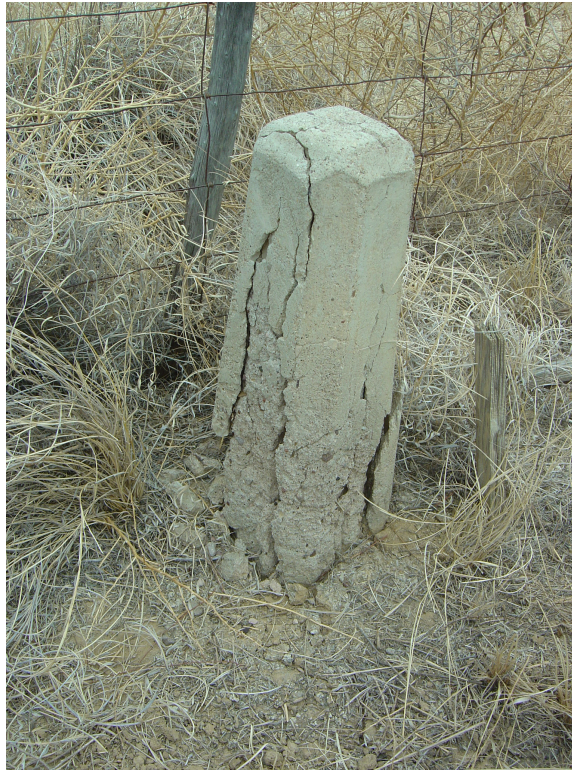
Figure 5-11: ROW marker deteriorating in west Texas.
