**LABORATORY AND FIELD EVALUATIONS OF
EXTERNAL SULFATE ATTACK**

Dissertation

the University of Texas at Austin

December 2007

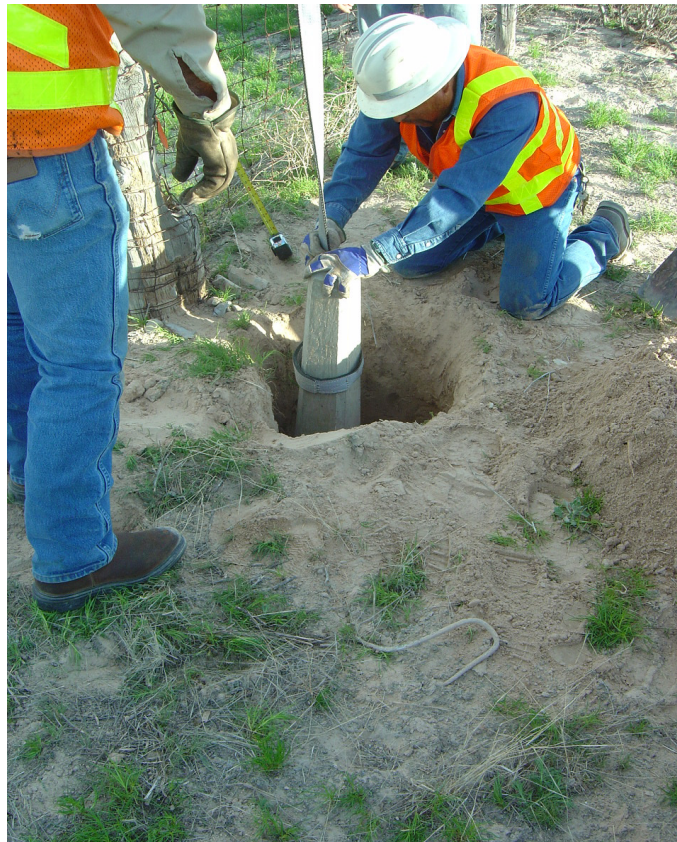
Figure 5-13: Placement of new ROW marker in the existing location of the deteriorated ROW marker

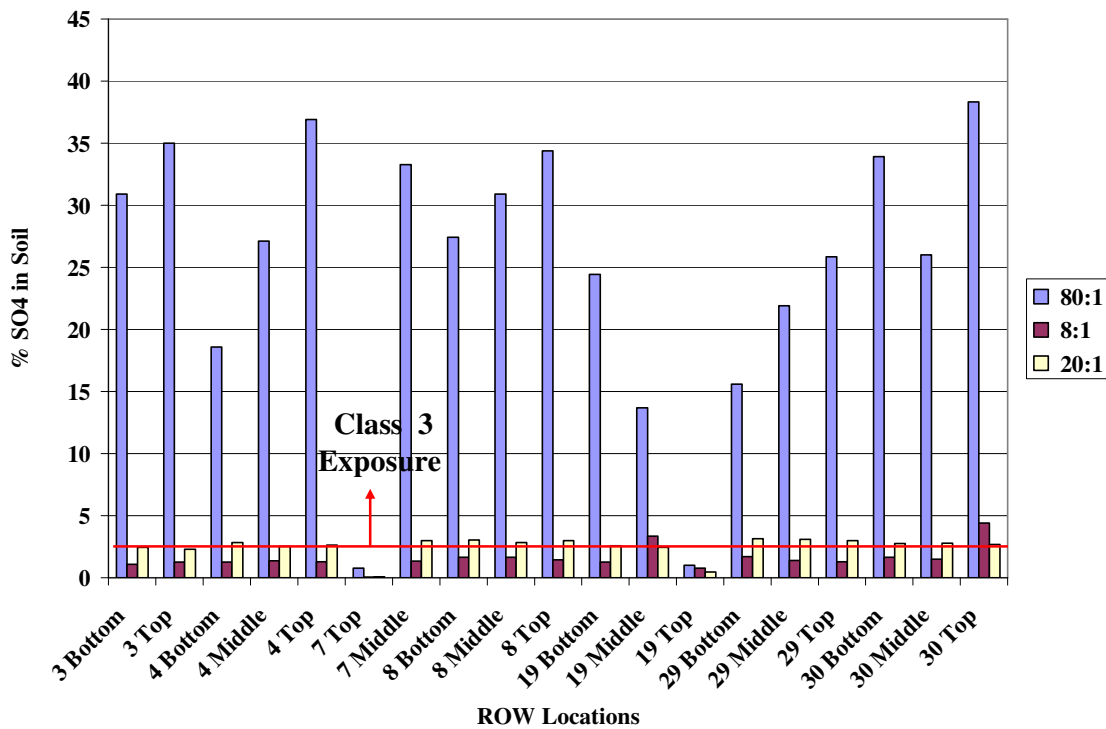
Figure 5-14: The sulfate content of soils taken from each of the ROW locations using ASTM C 1580 and TEX-135-E Test Methods

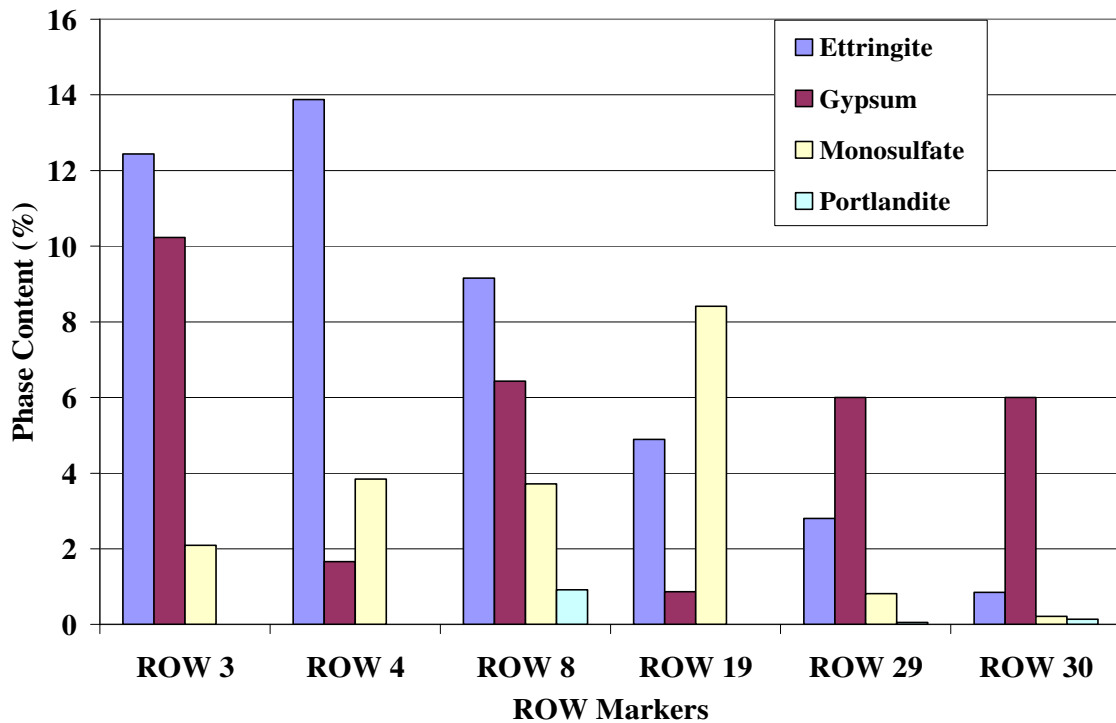
Figure 5-15: Semi-quantitative XRD Rietveld analyses from ROW markers in the El Paso District

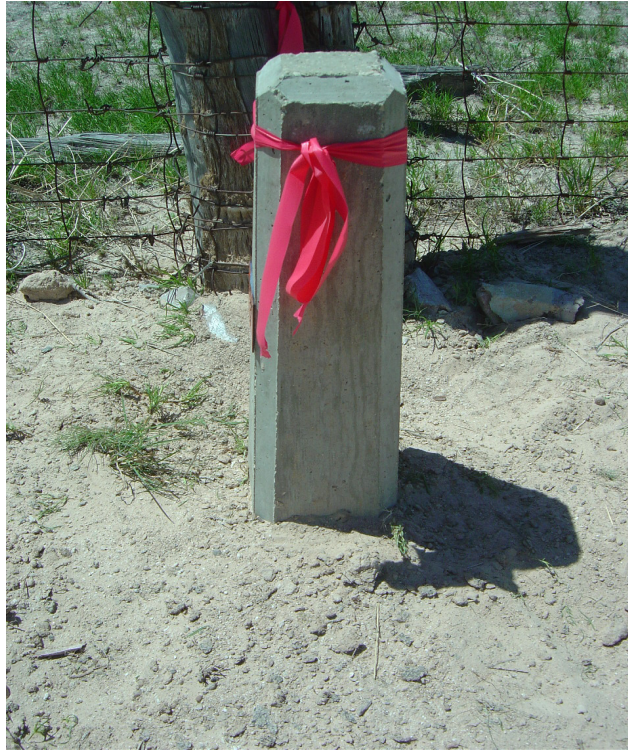
Figure 5-16: New ROW marker with Class C fly ash at 0.4 w/cm after 3 months of exposure in gypsiferous soils
